# Grave Creek Restoration Project

## Phase 1 and Phase 2 Monitoring Report

River Design Group, Inc.  
5098 US Highway 93 South  
Whitefish, MT 59937

June 2011

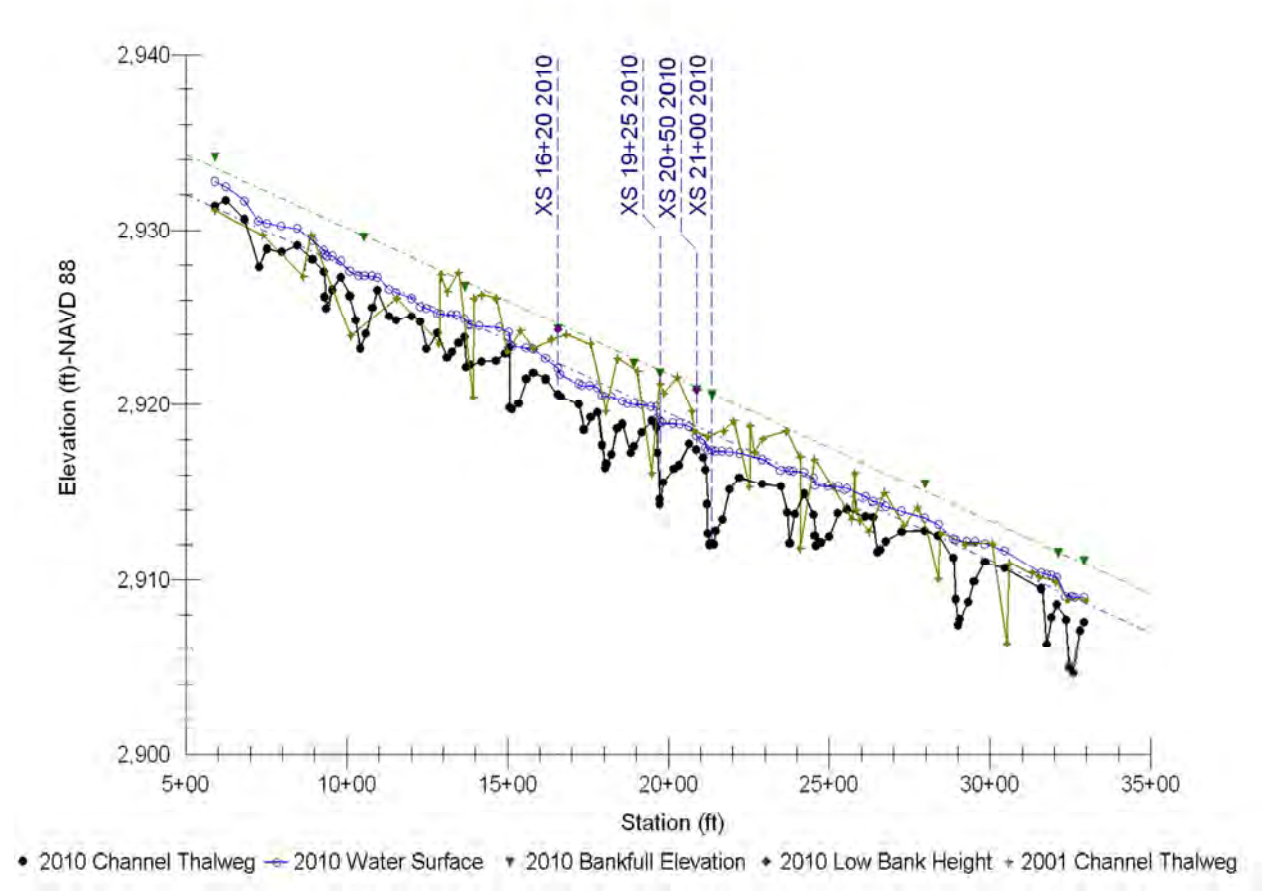
**Figure 2-3.** Longitudinal profile of Phase 1 displaying pre and post-restoration channel thalweg, water surface, and bankfull floodplain elevations.

The restoration project reduced the energy gradient by approximately 92.4% with the increased channel length and sinuosity. The data related to pool habitats indicate increased frequency and length of pool features. A 300% increase in pool habitat was noted and a corresponding decrease in the availability of riffle habitat. Maximum depths for all channel units increased throughout the project area.

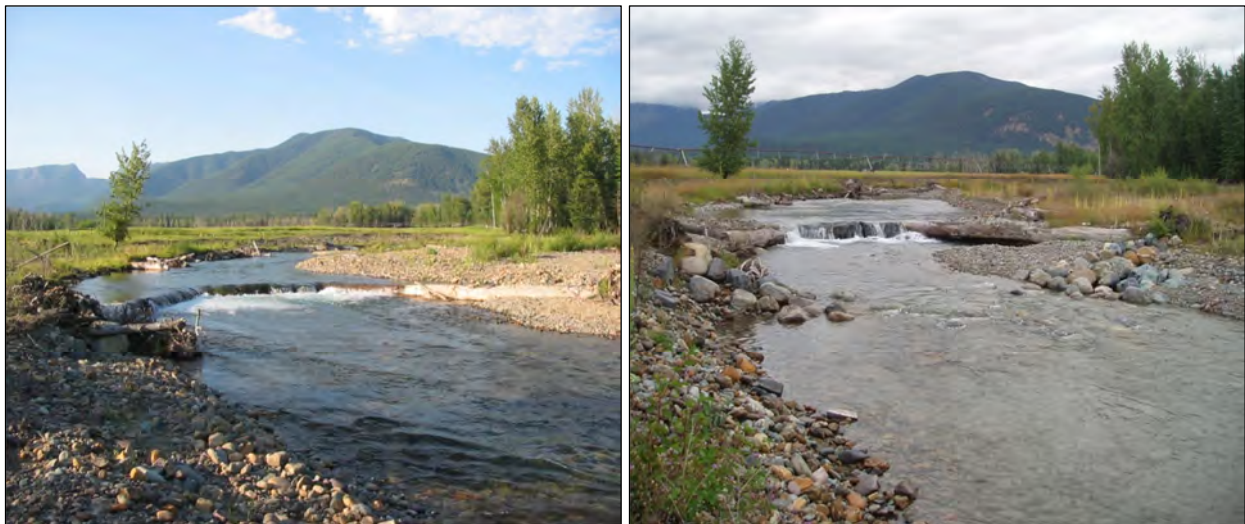
**Figure 2-4.** Photos of Phase 1 in 2004 (left) and 2009 (right). A log cross vane built to maintain vertical grade control at the pool tailout is visible in the photos.

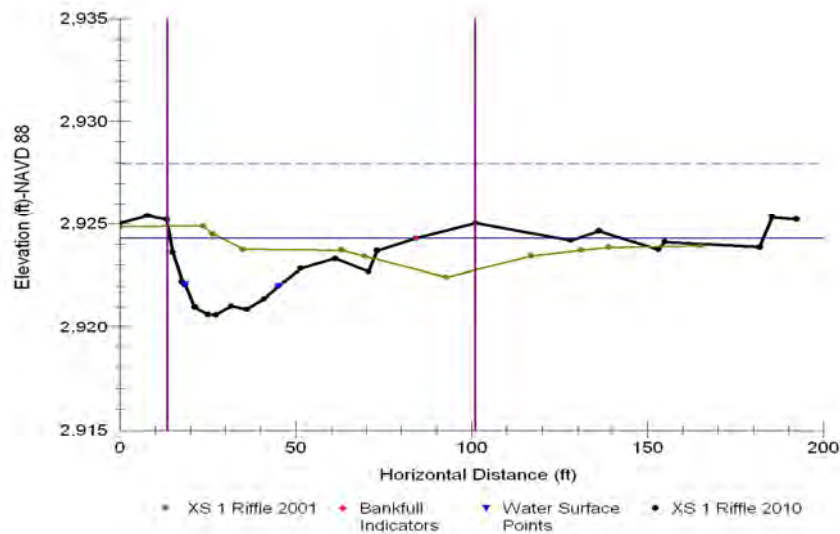
elevation. The graph demonstrates the wide, shallow riffle that existed in 2001 as well as the narrower, lower width to depth ratio post-restoration channel.

**Figure 2-5.** Riffle cross-section at Station 16+20 displaying pre and post-restoration conditions.

Table 2-4 includes a comparison of select morphological variables for cross section 16+20 in 2001 and 2010. The post-restoration floodprone width is similar in extent to the pre-restoration width; however the active channel width has been reduced by over 50%. Both mean and maximum depths have increased while bankfull area has decreased by 32%. Channel width to depth ratio decreased from 103 to 36.7 and the entrenchment ratio increased to 4.3, reflecting the improved channel-floodplain hydrologic connectivity relative to pre-restoration conditions.

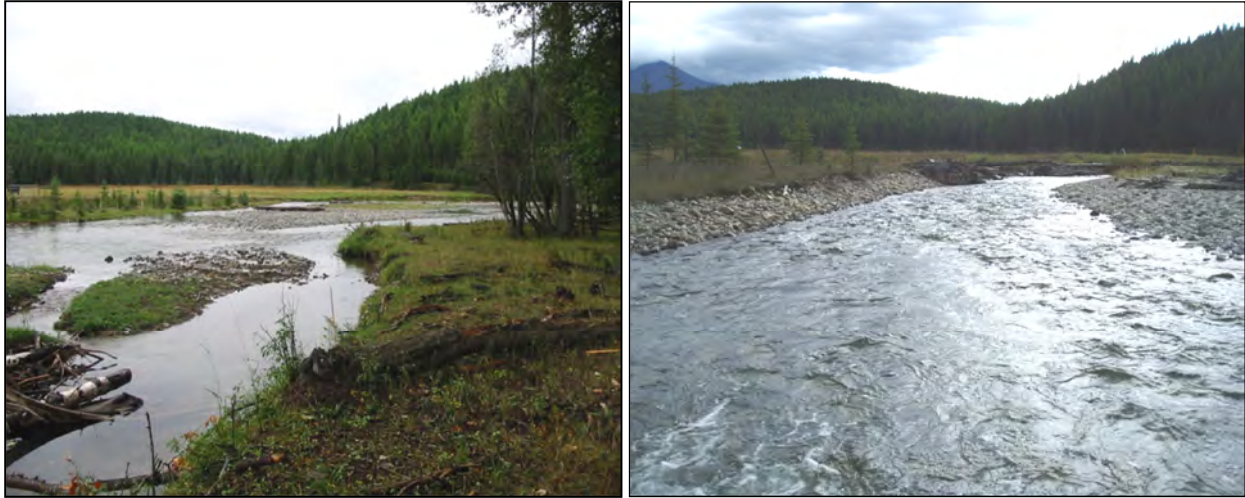
Figure 2-6 contains photographs of the riffle feature at Station 16+20 for pre and post-restoration conditions. The 2001 channel condition was characterized by extensive mid-channel and transverse bar deposits, braiding and high bank erosion conditions. The 2010 photograph depicts the lower width to depth ratio, dominant channel, absence of mid-channel depositional features and improved streambank stability.

**Figure 2-6.** Photos of the riffle cross-section at Station 16+20 ft in 2001 (left) and 2010 (right).

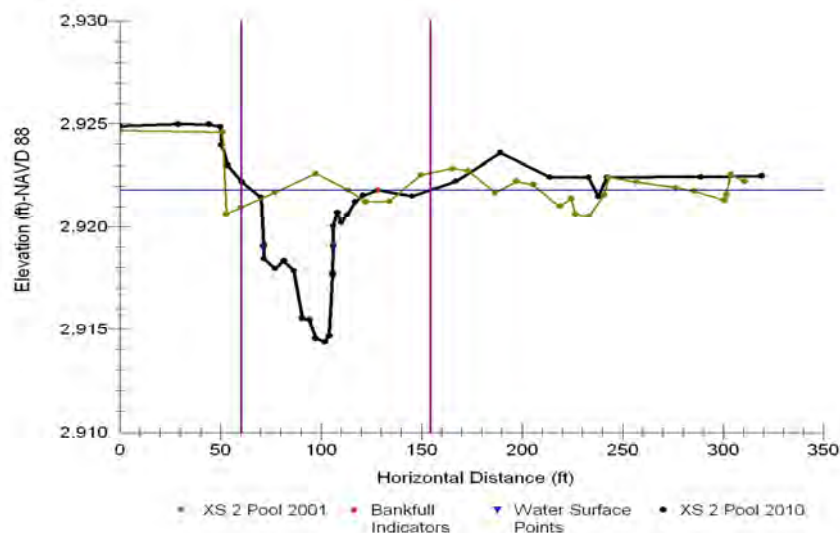
Figure 2-7 displays the 2001 and 2010 pool cross-section at Station 19+25. The graph shows a laterally extensive, high width to depth ratio, multiple channel riffle that existed at the site in 2001. Also shown is the narrow, deep pool that was constructed and the adjacent point bar and floodplain surface.

**Figure 2-7.** Pool cross-section at Station 19+25 ft, displaying pre and post-restoration conditions.

The pre-restoration and post-restoration data for cross section 19+25 are summarized in Table 2-5. Conversion from a braided riffle condition to a dominant channel has reduced

the active channel width from 237 ft to approximately 90 ft. Mean and maximum channel depths increased by 188% and 257%, respectively. The channel width to depth ratio has been reduced from 285 to 38.7. Bankfull channel cross-sectional area remains within 3% of the pre-restoration condition.

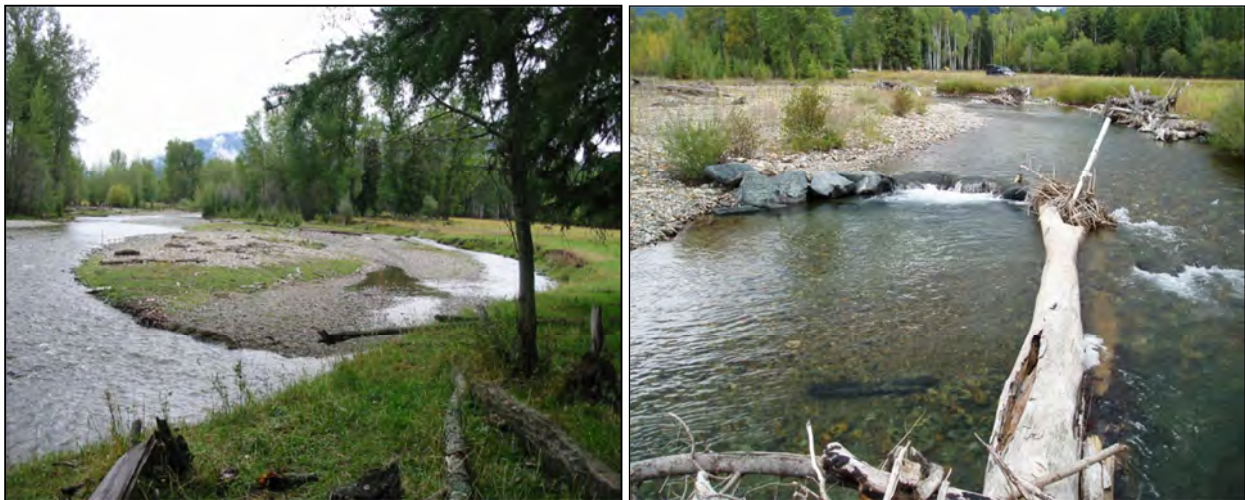
Figure 2-8 contains photographs of the cross-section location at Station 19+25 for pre and post-restoration conditions. A braided channel form was present in the 2001 pre-restoration photograph and a mid-channel bar results in flow divergence. The depositional feature consists of sand and gravel size particles and occupies a large portion of the cross-sectional area. The 2010 photograph displays the constructed pool feature and the adjacent point bar with colonizing willows and riparian shrubs.

**Figure 2-8.** Photos of the pool cross-section at Station 19+25 ft in 2001 (left) and 2010 (right).

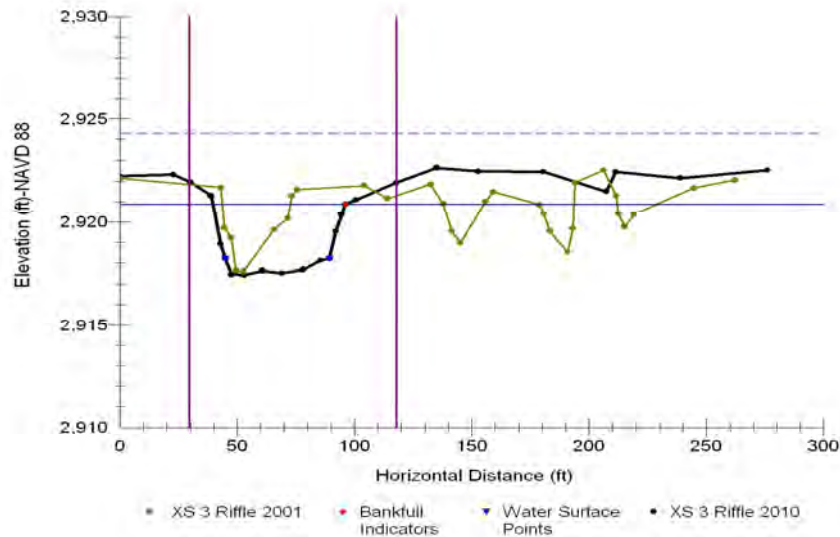
Figure 2-9 presents the 2001 and 2010 channel conditions for the riffle cross-section at Station 20+20. The graph shows a laterally extensive, multiple channel riffle that existed at the site in 2001. Overlaid is the single-thread riffle feature of the post-restoration design. Also shown is the constructed floodplain surface that previously existed as part of the active channel.

**Figure 2-9.** Riffle cross-section at Station 20+50, displaying pre and post-restoration conditions.

The pre-restoration and post-restoration data are summarized in Table 2-6. The active channel width has decreased from 166 ft in 2001 to 57 ft in 2010, a 66% change. The mean depth has increased 133%. Conversion from the braided channel condition has reduced the width to depth ratio from 142 to 20.3 and has resulted in a 155% increase in the entrenchment ratio. The bankfull channel area has remained within 20% of the 2001 existing conditions.

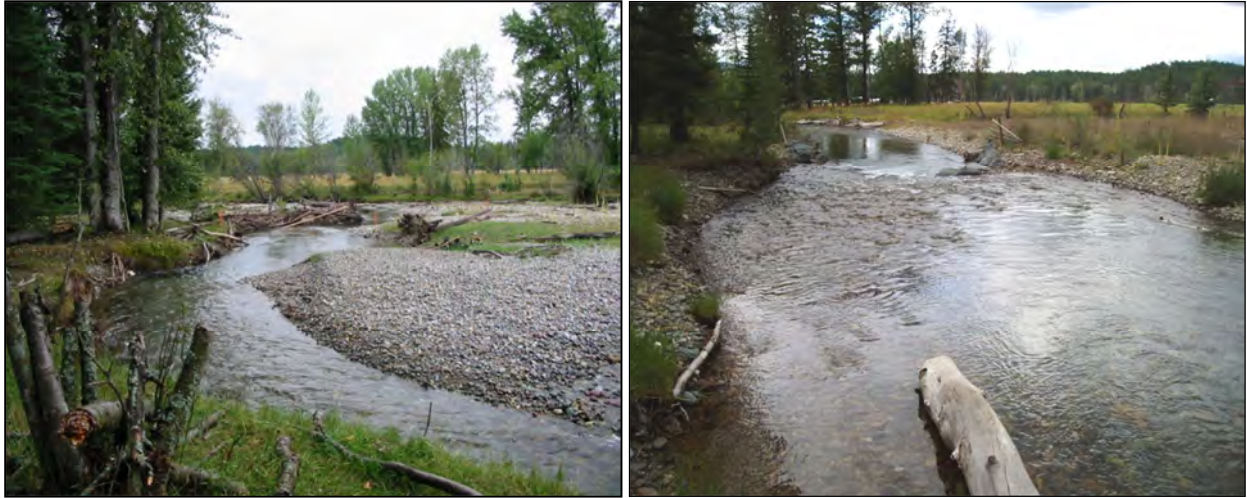
Figure 2-10 contains photographs of the riffle feature at Station 20+20 for pre and post-restoration conditions. A multi-threaded channel exists in 2001, characterized by mid-channel and transverse bar deposits. These depositional features lacked stabilizing vegetation due to frequent bed scour and deposition. The 2010 post-restoration photograph reflects the single-threaded riffle feature and the adjacent point bar floodplain constructed in 2002.

**Figure 2-10.** Photos of the riffle cross-section at station 20+50 ft in 2001 (left) and 2010 (right).

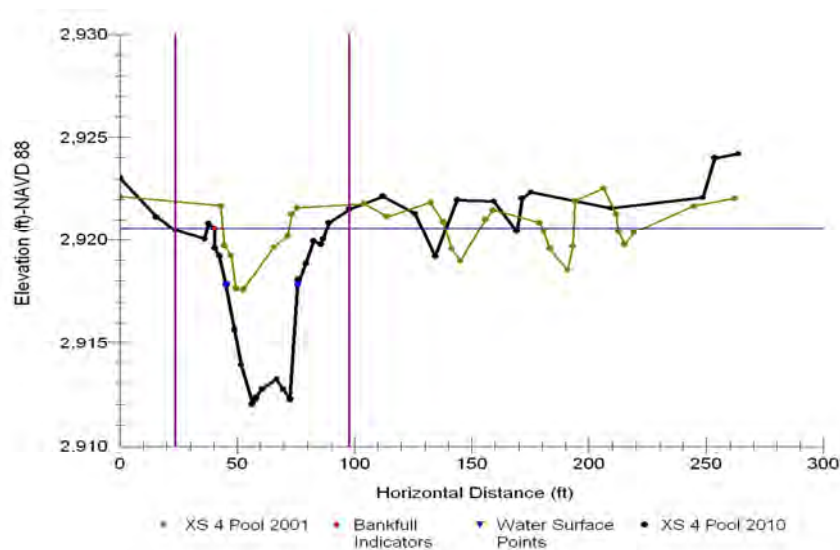
Figure 2-11 displays the 2001 and 2010 channel conditions at Station 21+00. Similar to the site at Station 20+50, a laterally extensive, multi-threaded riffle characterized the channel in 2001. Three mid-channel bars are evident from the survey data. During the restoration process, the shallow multi-channel riffle feature was converted to a dominant channel and pool habitat feature in this location. Also shown is the constructed floodplain surface including floodplain swales that serve to hold moisture and facilitate the establishment of riparian vegetation.

**Figure 2-11.** Pool cross-section at station 21+00 ft, displaying pre and post-restoration conditions.

increased 217% and 107%, respectively. The width to depth ratio has decreased from 141 to 16.1. The bankfull channel area has remained within 21.5% of the 2001 conditions.

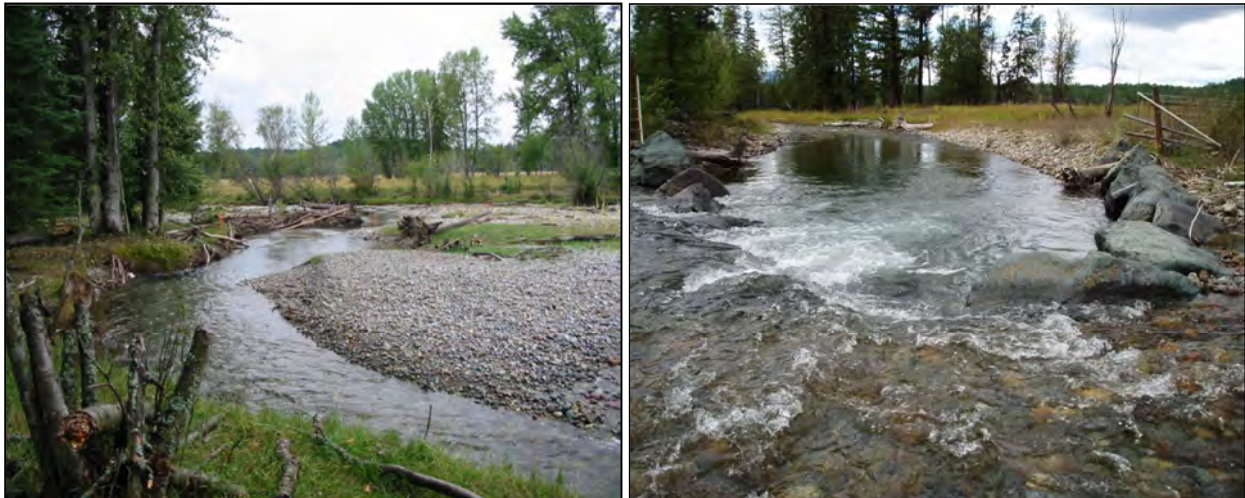
Figure 2-12 contains photographs of the pool feature at Station 21+00 for pre and post-restoration conditions. The presence of an un-vegetated, mid-channel gravel bar in the 2001 photograph suggests recent bed scour and deposition. The expansive depositional feature occupies a large portion of the channel cross-sectional area. The 2010 post-restoration photograph shows the dominant pool feature and the adjacent floodplain surface. The Phase 1 fencing enclosure is visible in the upper right.

**Figure 2-12.** Photos of the pool cross-section at Station 21+00 in 2001 (left) and 2010 (right).

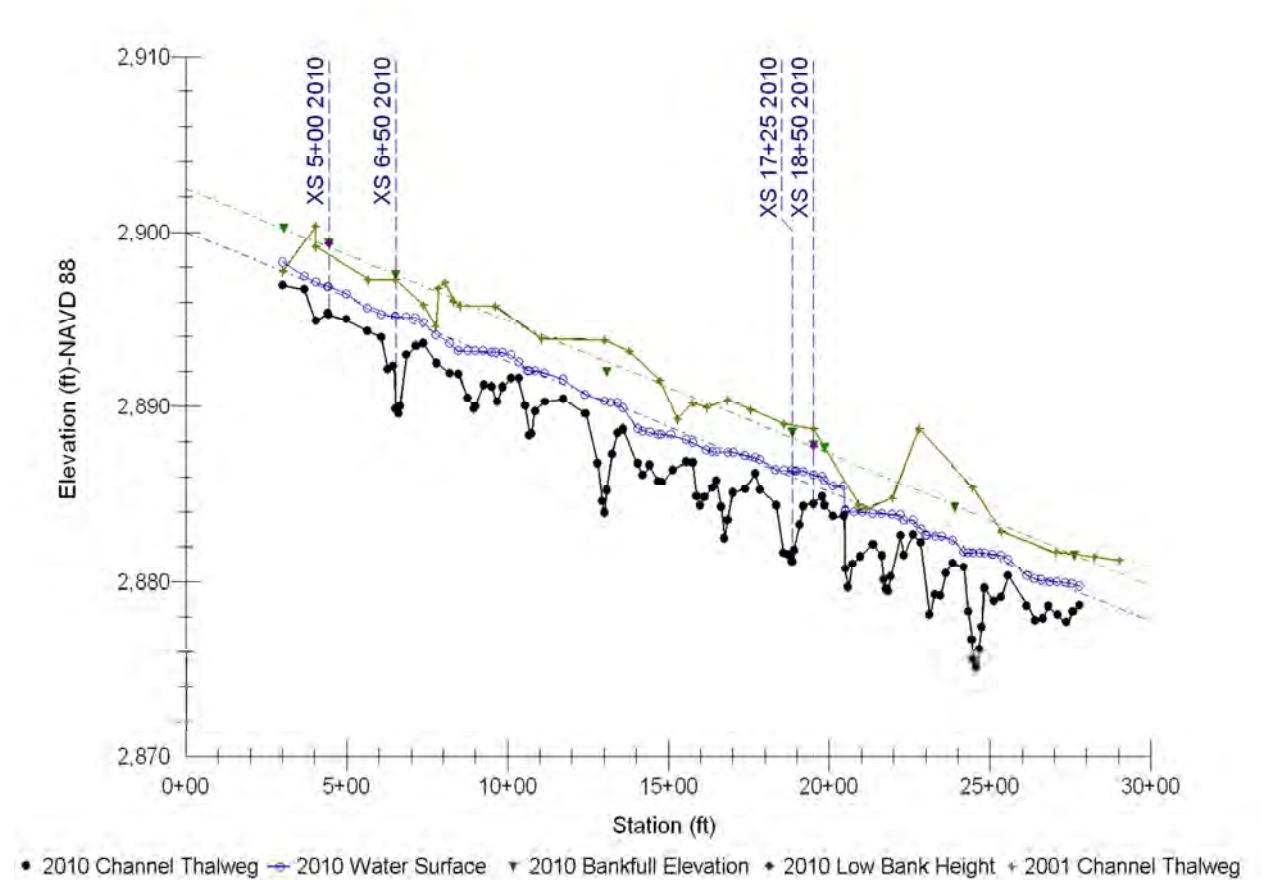
**Figure 3-3.** Longitudinal profile of Phase 2 displaying pre and post-restoration channel thalweg, water surface, and bankfull floodplain elevations.

The restoration project reduced the energy gradient by approximately 93.1% by increasing channel length and sinuosity. The data related to pool habitats indicate increased frequency and lengthening of pool features. A 333% increase in the number of pools was noted and a corresponding decrease in the availability of riffle habitat. Maximum depths for all channel habitat units increased throughout the project area. Results are presented in Table 3-1.

The longitudinal spacing of pools decreased from 725 ft in 2001 to 208 ft in 2010. A 333% increase in the number of pools was observed with a decrease in the longitudinal distribution of riffle habitat types. Maximum depths for all channel units increased throughout the project area.

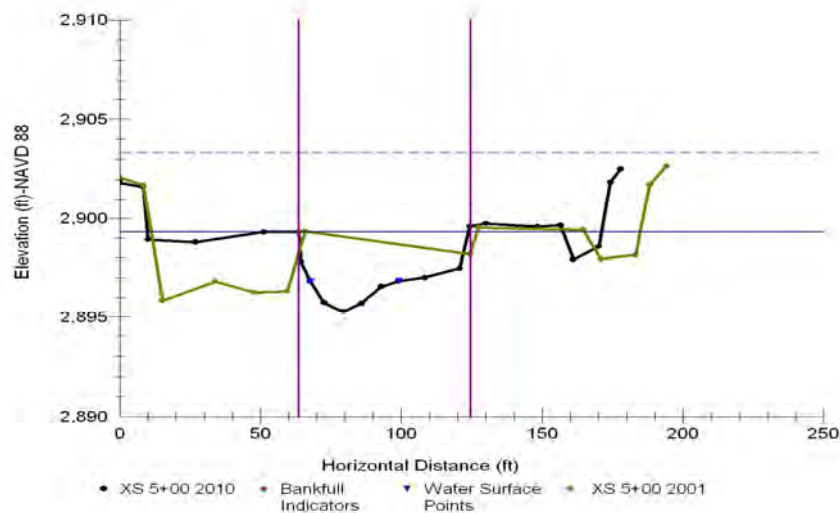
Cross-sections demonstrating the pre and post-restoration channel dimensions in Phase 2 are reported in the following section. Figure 3-5 displays the 2001 and 2010 riffle cross-section at Station 5+00. The solid line represents the 2010 bankfull elevation and the dashed line indicates the floodprone elevation.

**Figure 3-5.** Riffle cross-section at Station 5+00, displaying pre and post-restoration conditions.

Table 3-6 includes a comparison of select morphological variables for the 2001 and 2010 data sets. The post-restoration floodprone width has increased 11.1% and the active channel width has been reduced by 65%. Both mean and maximum depths have increased by 108% and 8.1%, respectively, while bankfull area decreased by 30%. Channel width to depth ratio has decreased from 131 to 22.5 and the entrenchment ratio has increased to 4.3, reflecting the improved channel-floodplain hydrologic connectivity relative to pre-restoration conditions.

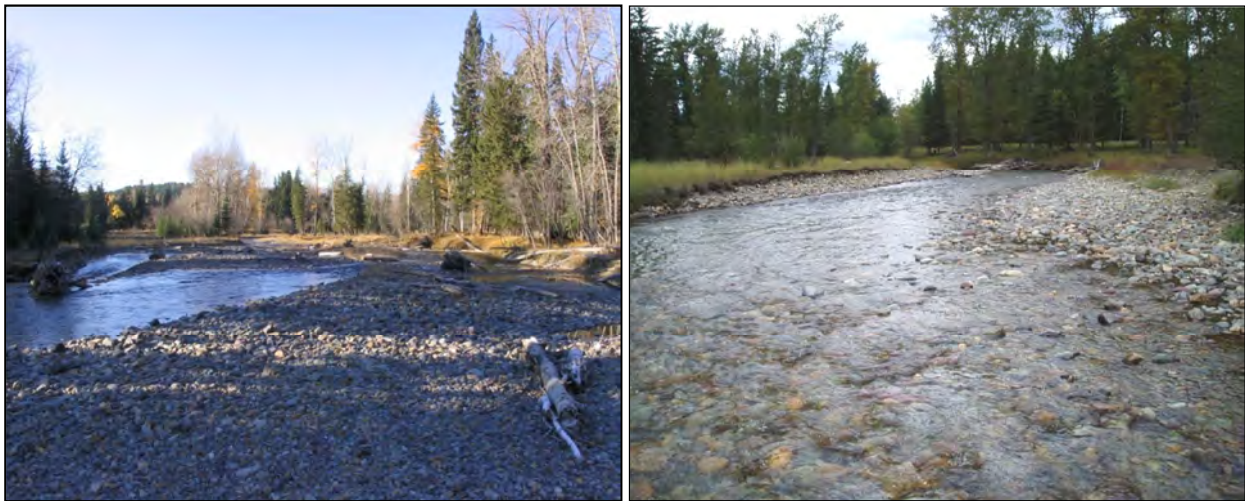
Figure 3-6 contains photographs of the riffle feature at Station 5+00 for pre and post-restoration conditions. The 2001 channel condition was characterized by extensive mid-channel and transverse bar deposits, braiding, and high bank erosion conditions. The 2010 photograph depicts a single-thread channel and the absence of depositional mid-channel depositional features and improved streambank stability.

**Figure 3-6.** Photos of the riffle cross-section at Station 5+20 in 2001 (left) and 2010 (right).

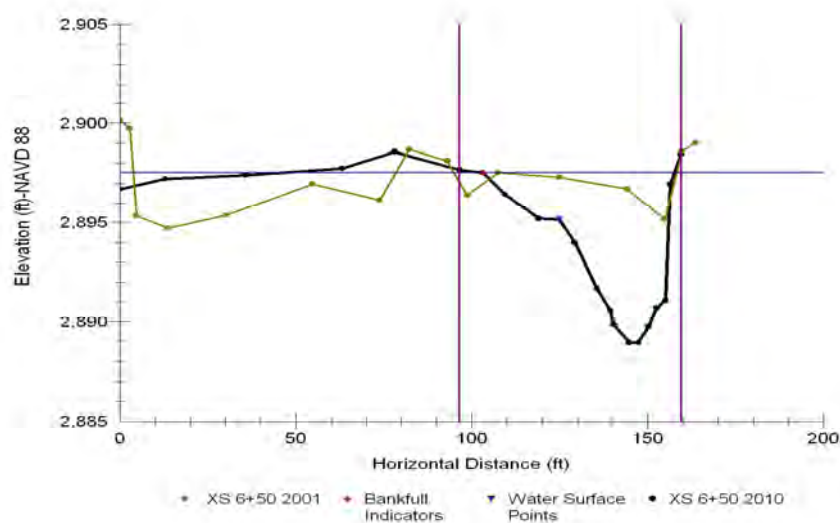
**Figure 3-7.** Pool cross-section at Station 6+50, displaying pre and post-restoration conditions.

The pre-restoration and post-restoration data are presented in Table 3-5. Conversion from a braided riffle condition to a dominant channel has reduced the active channel width from 155 ft in 2001 to approximately 54.5 ft in 2010. Mean and maximum channel depths increased 110% and 121%, respectively. Channel width to depth ratio has decreased from 76.3 to 13.0. Bankfull channel cross-sectional area decreased 27.3% compared to 2001 conditions.

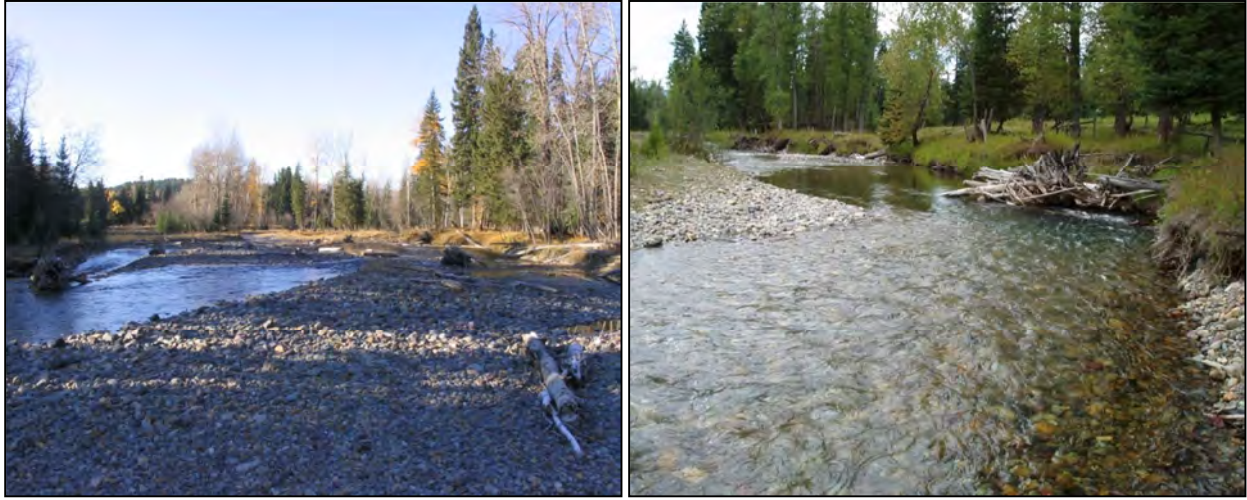
Figure 3-8 contains photographs of the cross-section location at Station 6+50 for pre and post-restoration conditions. A braided channel form is present in the 2001 photograph, characterized by sediment loading, high width to depth ratios, and streambank instability. The depositional features consisted of sand, gravel and small cobble size particles and serve to reduce channel cross-sectional area and pool development. The 2010 photograph displays the constructed pool feature and the adjacent point bar.

**Figure 3-8.** Photos of the pool cross-section at Station 6+50 in 2001 (left) and 2010 (right).

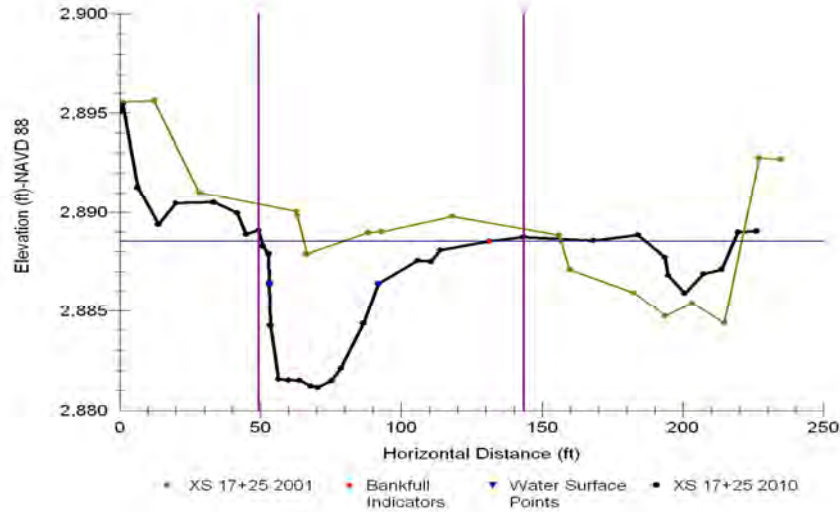
Figure 3-9 presents the 2001 and 2010 channel conditions for the riffle cross-section at Station 17+25. The graph reflects a shallow, high width to depth ratio, multi-channel riffle feature in 2001 and the post-restoration channel morphology in 2010. Side channel habitat was enhanced during construction and is visible on the right side of the graph.

**Figure 3-9.** Pool cross-section at Station 17+25, displaying pre and post-restoration conditions.

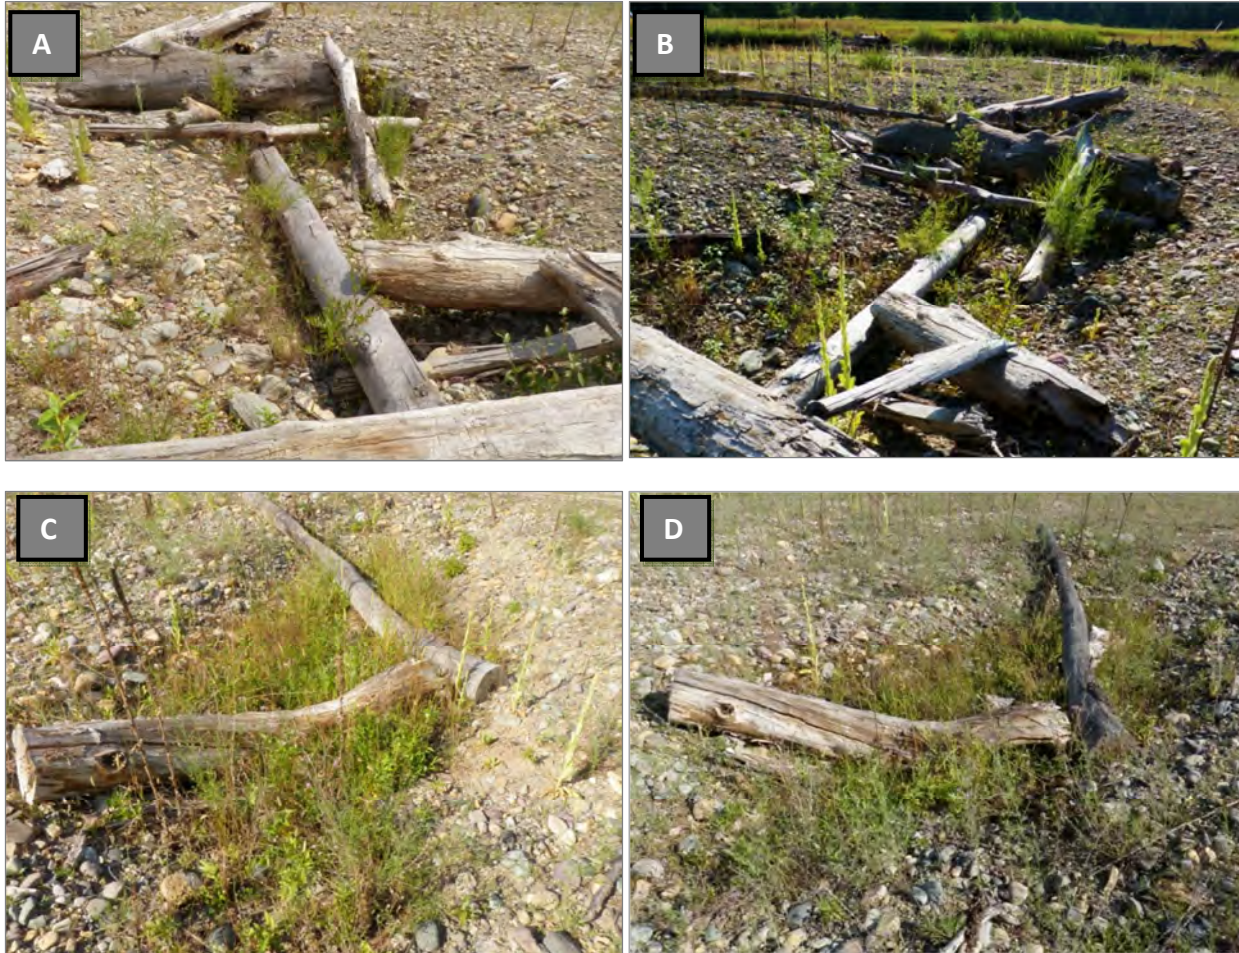
**Figure 4-5.** Photographs show the difference between a planted swale located inside and outside the electric wildlife fence as well as comparing swale conditions in 2008 and 2010. Photographs A and B are of Point Bar 4 Plot 2 inside fence (photo A 2008 and B 2010). Photographs C and D are of Point Bar 4 Plot 3 outside fence (Photos C 2008 and D 2010).

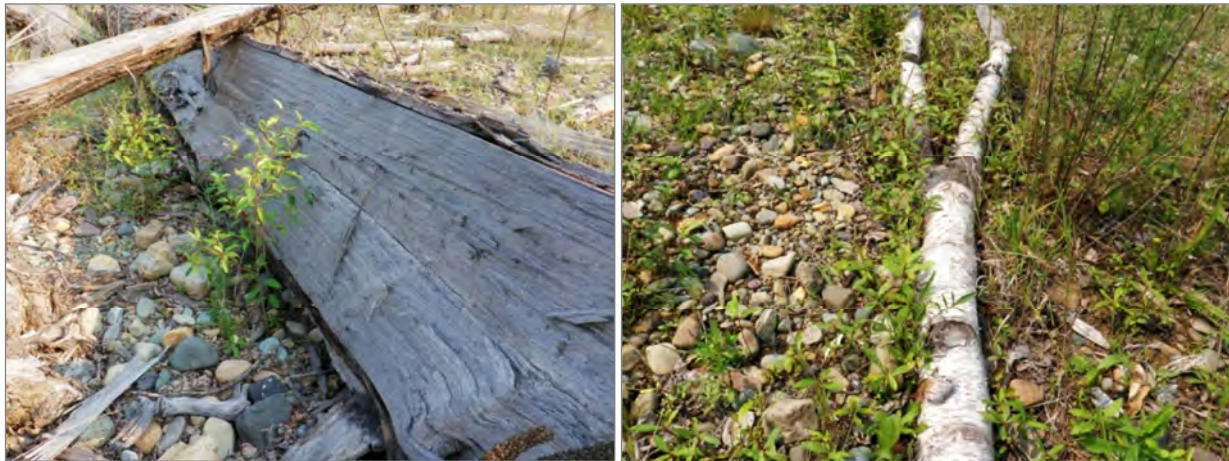
**Figure 4-13.** Photographs of cottonwood seedlings of various age classes growing in microsities created by large woody debris placed on floodplain surfaces.

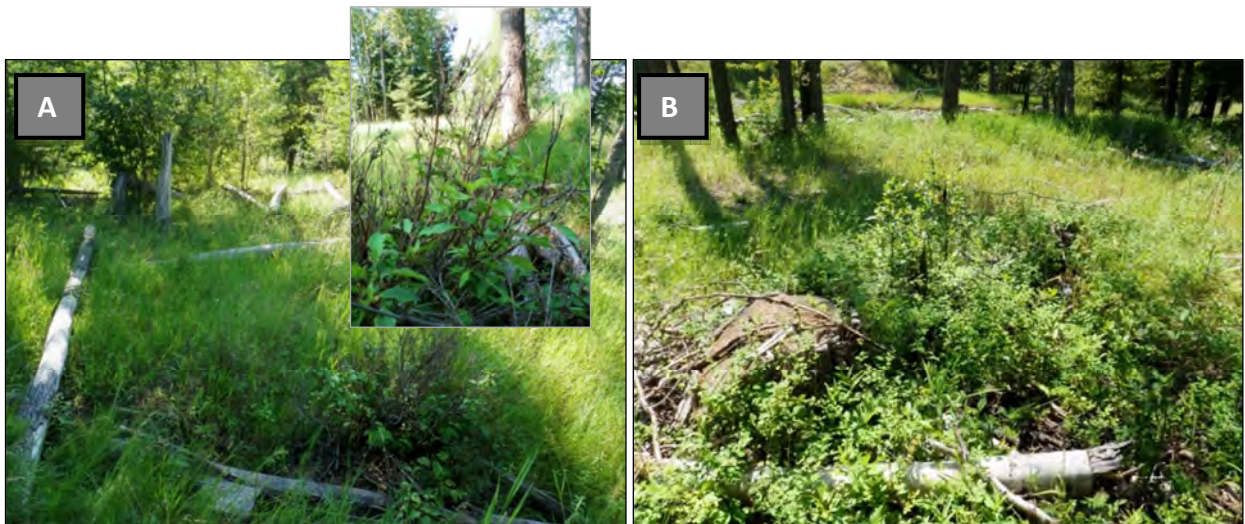
**Figure 4-18.** Photograph of a forested plot outside the fence (A) and a forested plot inside the fence (B). Inset photograph is of browse on shrub within the forested plot outside of the enclosure fence.
