# Therriault Riparian Revegetation Plan Implementation Report

Contract #080067

Geum Environmental Consulting, Inc.  
307 State Street  
Hamilton, MT 59840

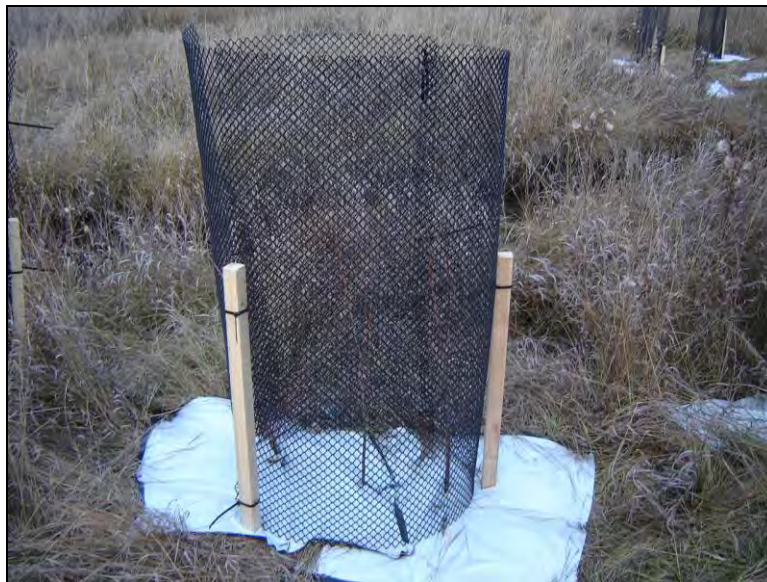
**Figure 2.** Photograph of large diameter browse protector used to protect a group of residual shrubs.

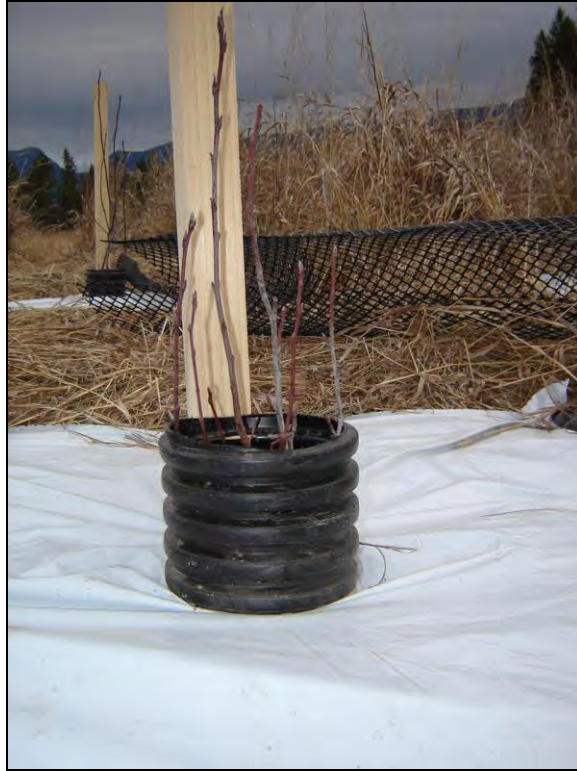
**Figure 3.** Containerized plant fitted with vole protection and brush blanket (prior to browse protector installation).

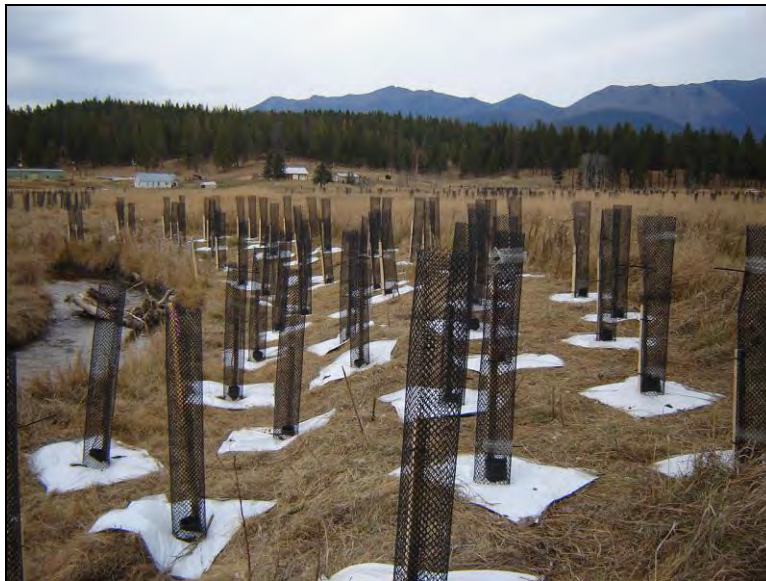
**Figure 4.** Planting site along an outer meander bend where topography consists of a low terrace bench along the channel and a higher terrace planting away from the channel. Containerized plant treatments include vole protectors, brush blankets, and browse protectors.

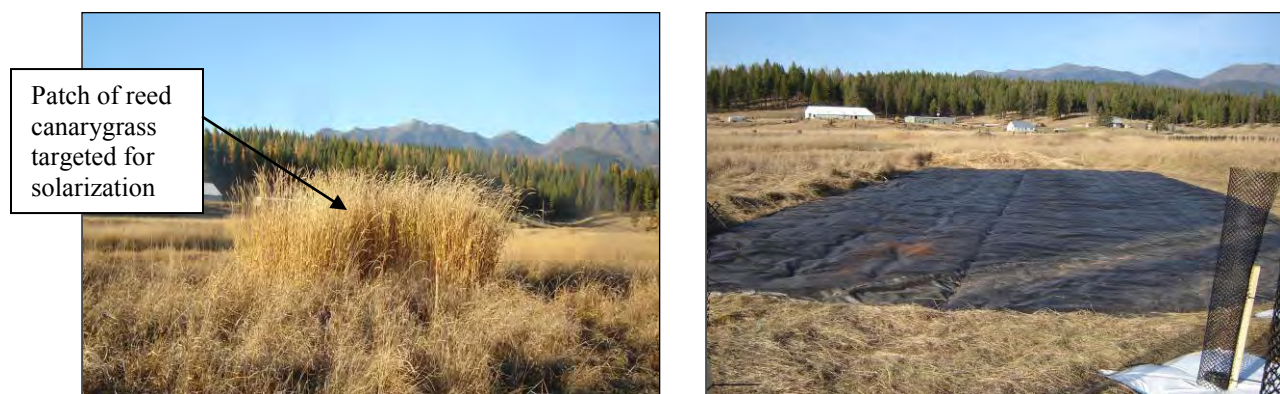
**Figure 5.** Temporary solarization plot before (left) treatment and after treatment (right).

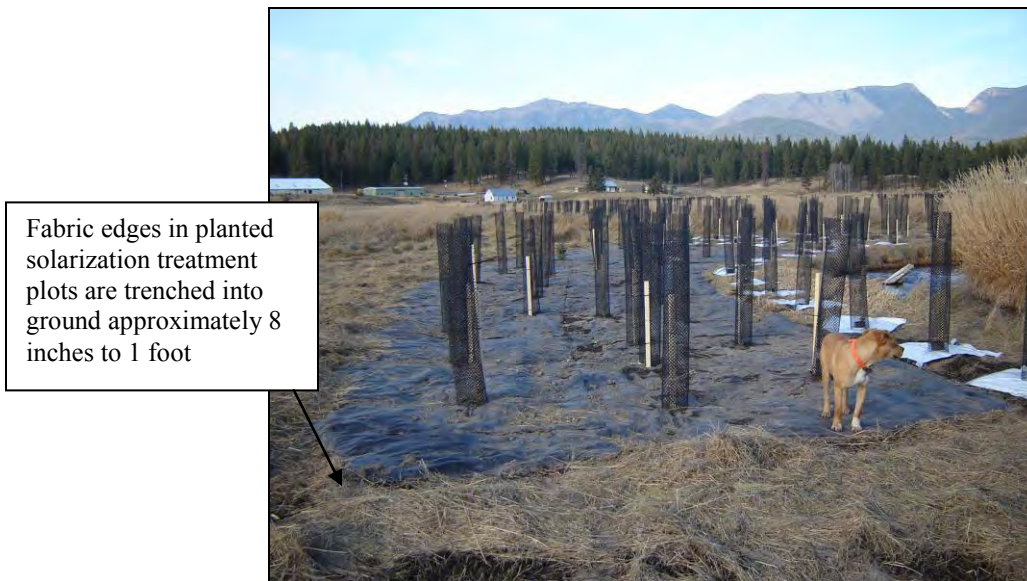
**Figure 6.** Long-term, planted solarization treatment plot 1 after planting. The patch of reed canary grass on the opposite bank is an example of what the site looked like prior to treatment.

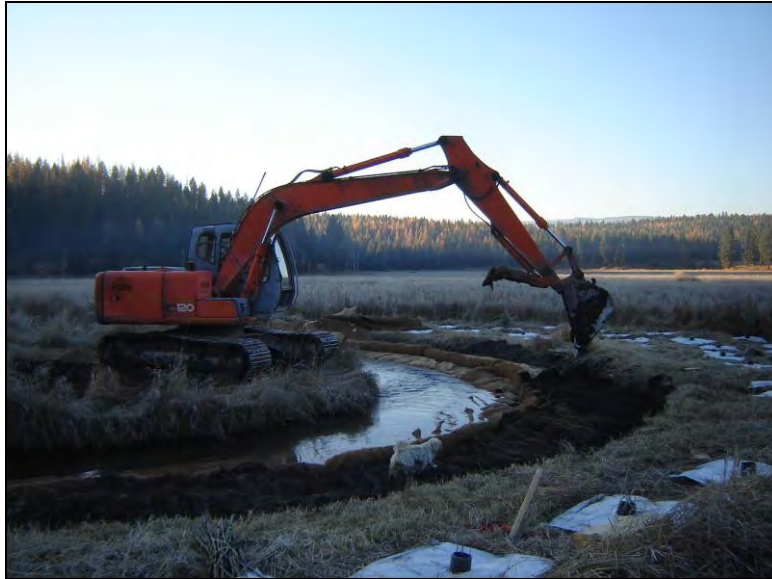
**Figure 7.** Soil lift 2 during construction.

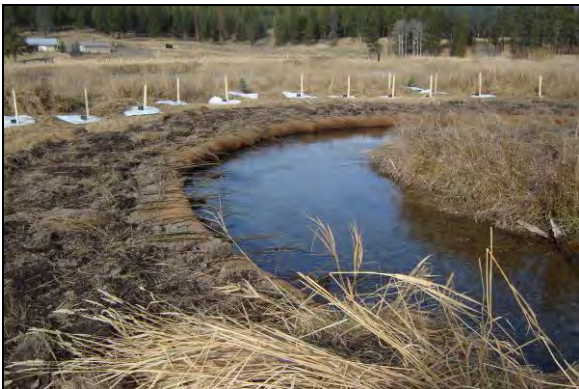
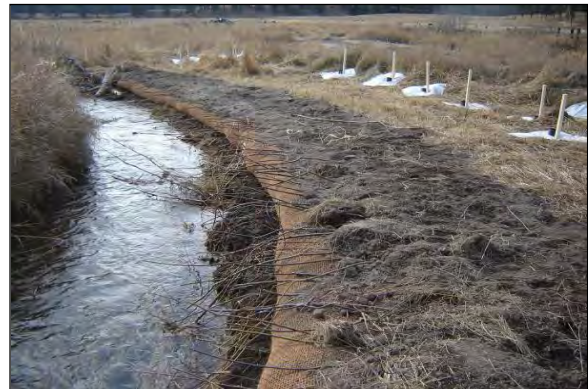
**Figure 8.** Soil lift 1 (left) and soil lift 2 (right) after construction.

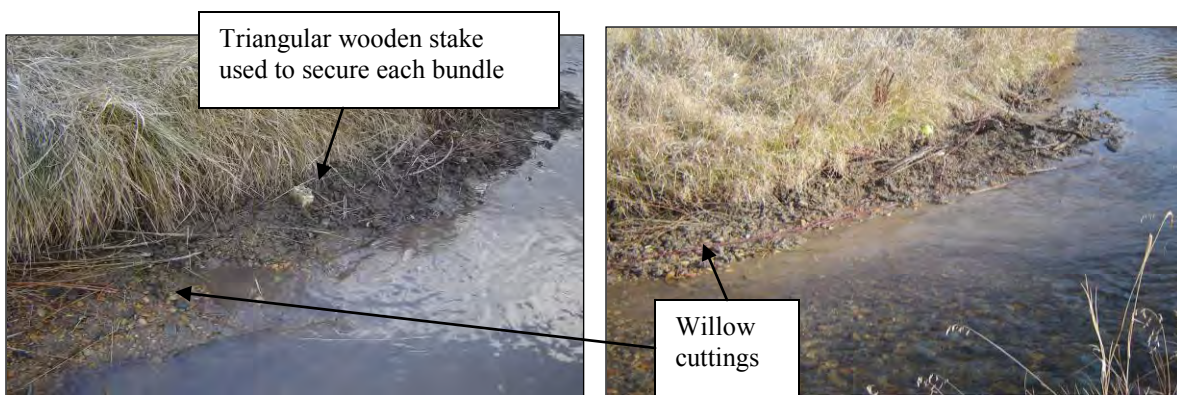
**Figure 9.** Live willow fascines in depositional areas just below bank. The tips of the willow cuttings can be seen sticking out of the trench.

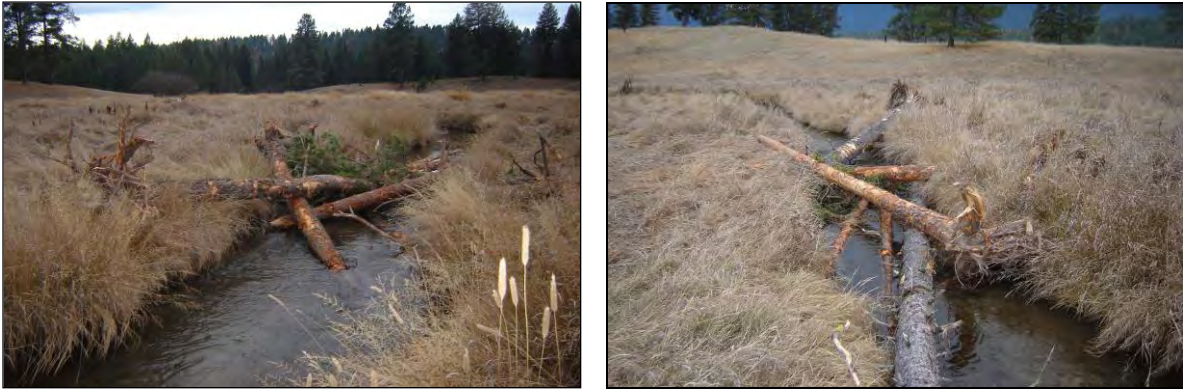
**Figure 10.** Large woody debris structures #5 (left, looking downstream) and #1 (right, looking downstream).

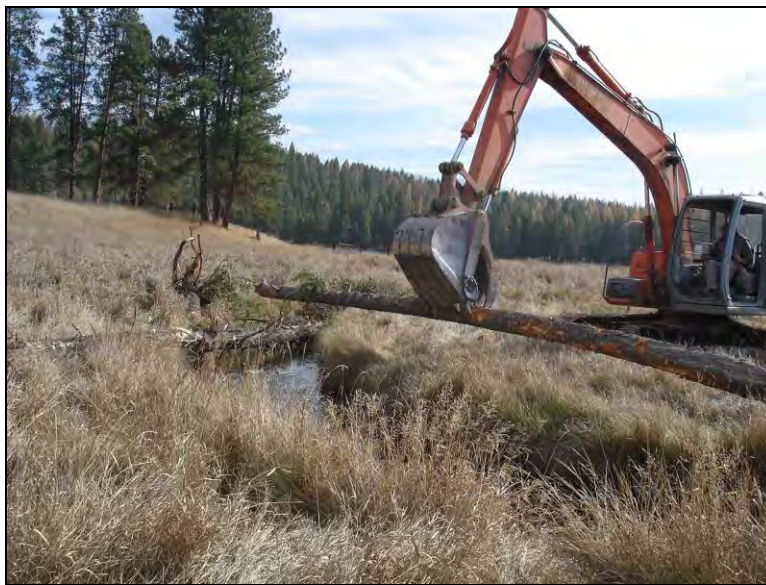
**Photo 11.** Large woody debris structure during construction.

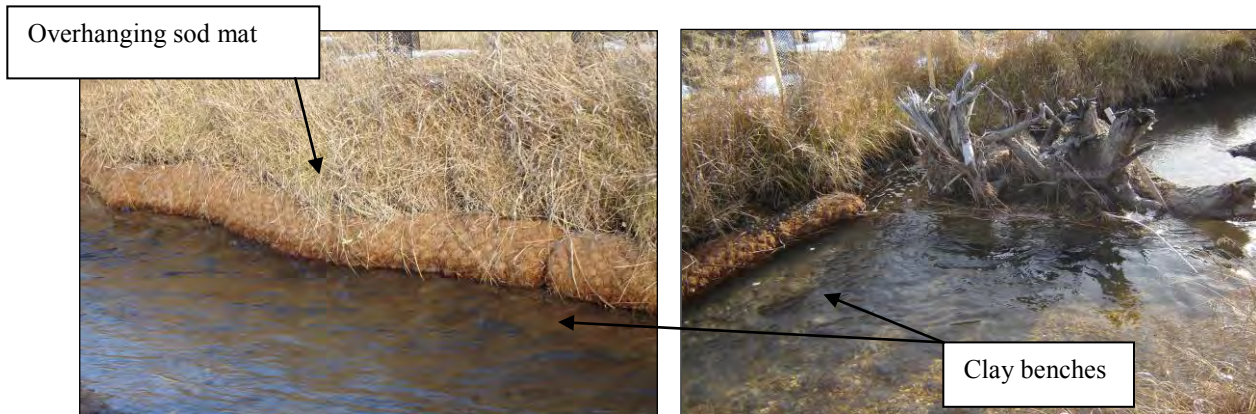
**Figure 12.** Close-up photos of coir log site 5 (left) and coir log site 4 (right) showing clay benches and overhanging sod mats.

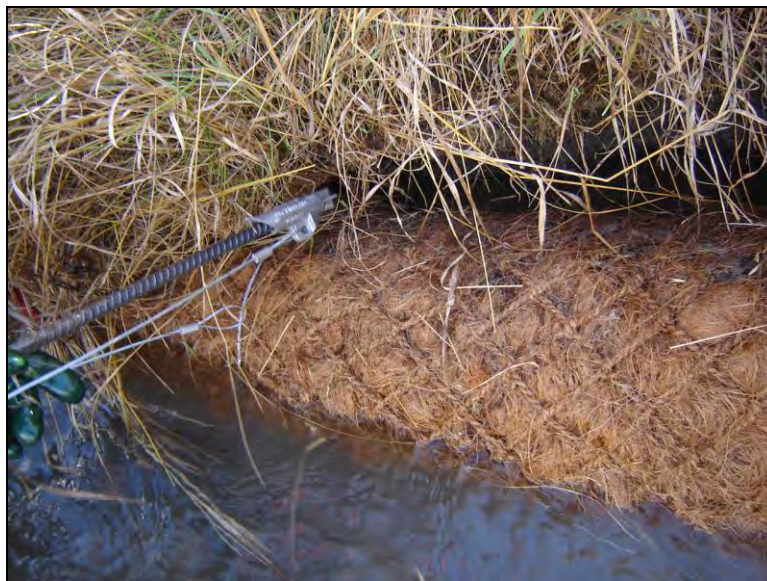
**Figure 13.** Anchoring coir log in place using Duckbill earth anchors.

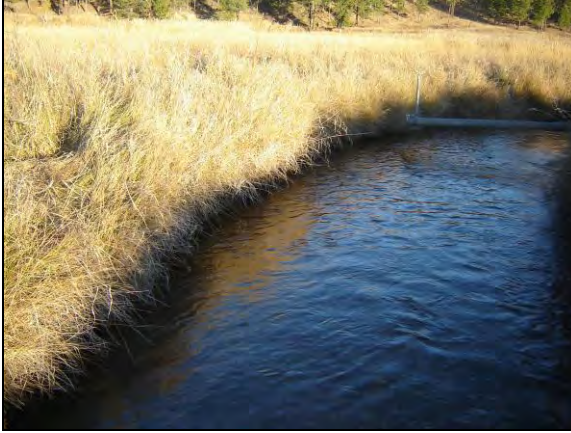
**Figure 14.** Coir log site 3 before (left) and after (right) installation.
