Therriault Creek Riparian Revegetation 2014 Monitoring and Maintenance Report

Contract #150017

Montana Fish, Wildlife and Parks
385 Fish Hatchery Road
Libby, MT 59923

Geum Environmental Consulting, Inc.
307 State Street
Hamilton, MT 59840

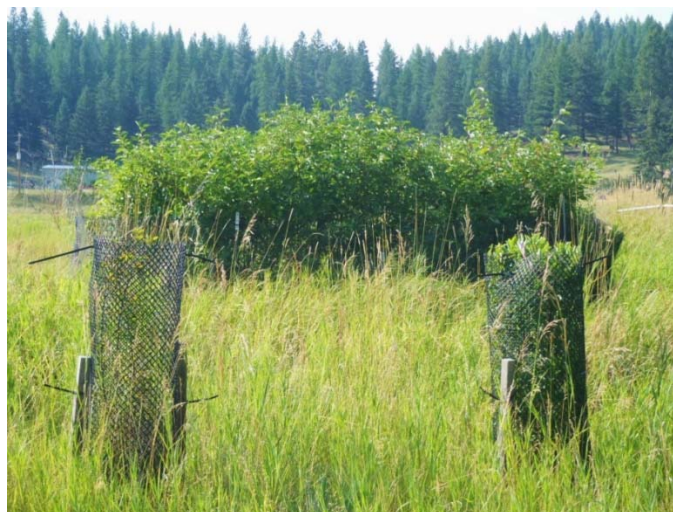
Figure 3. Residual shrubs, seen in the background, that have formed dense clumps.

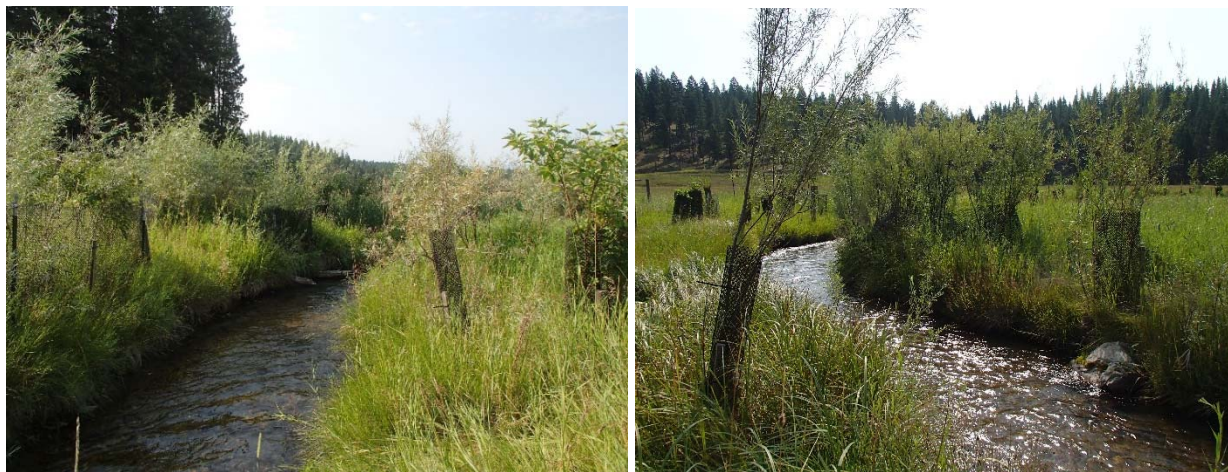
Figure 4. Since being protected from browse, residual shrubs have grown significantly and now provide shade and overhanging vegetation in some stretches of the project area.

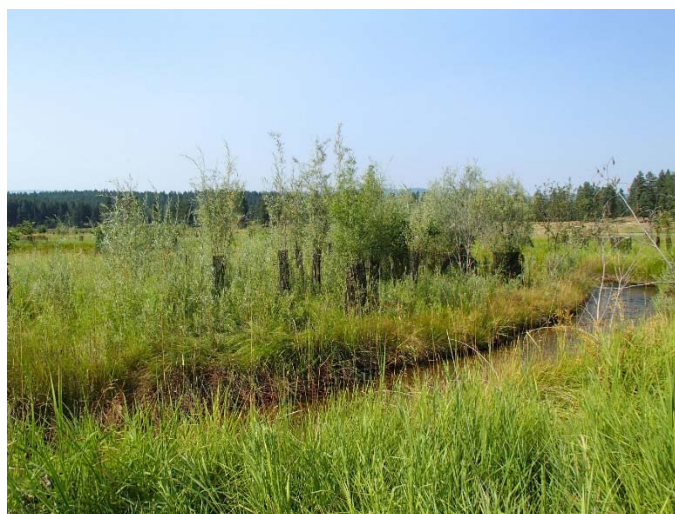
Figure 5. Inside meander across from Phase I planting unit 3 where residual sandbar willow have suckered and expanded significantly.

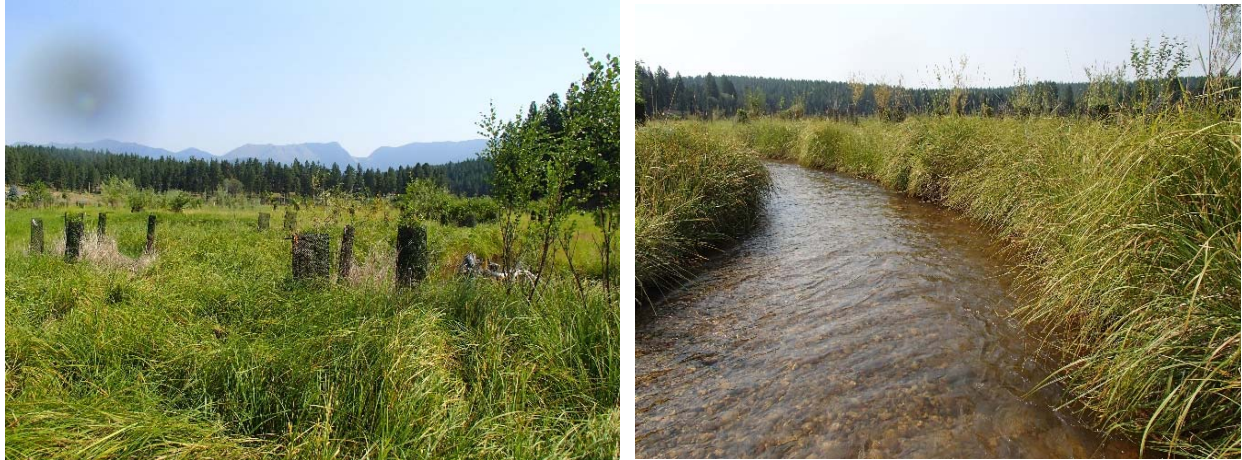
The herbaceous vegetation in both Phases I and III remains a mix of pasture grasses, sedges, rushes, native grasses, and native forbs. In general, the cover of native, wetter species continues to increase in both Phases I and III (Figure 6). The lower end of Phase I and upstream portion of Phase III support large areas dominated by sedges. One major difference observed in herbaceous cover was in Unit 6 which in the past has been saturated or inundated and had dense cover of native sedges, however, in 2014 this area was dry and much of the sedge cover had turned brown and appeared dead. Small patches of reed canarygrass were found in this area for the first time (Figure 7). Unit 6 is located just upstream of the hayfield drainage ditch that was dug by the landowner in 2012. This observation indicates that the drainage ditch is likely having at least localized effects on the hydrology within the project area.

Figure 6. Herbaceous vegetation within some planting units is now dominated by native sedges, such as Phase I planting unit 4 (left photo) and Phase III planting unit 2 (right photo). Others are still dominated by dense pasture grasses.

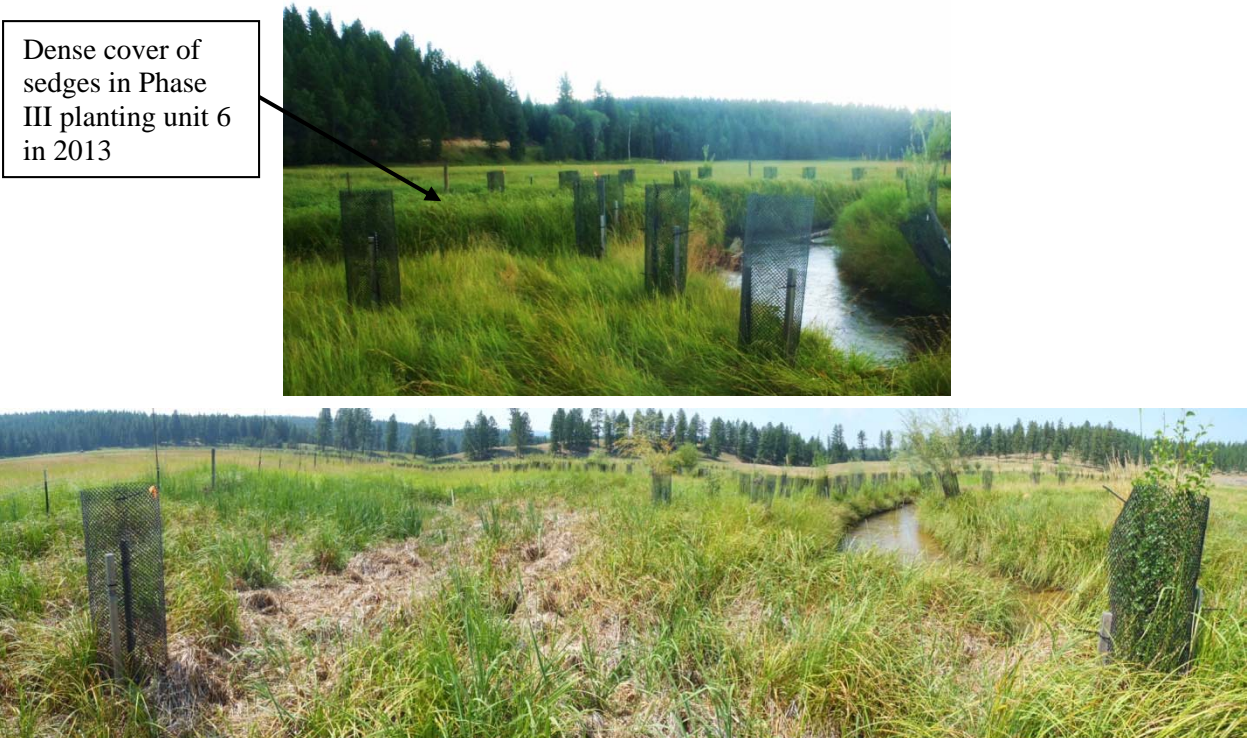
Figure 7. Photographs of herbaceous vegetation in Phase III planting unit 6 in 2013 (top photo) and 2014 (bottom photo).

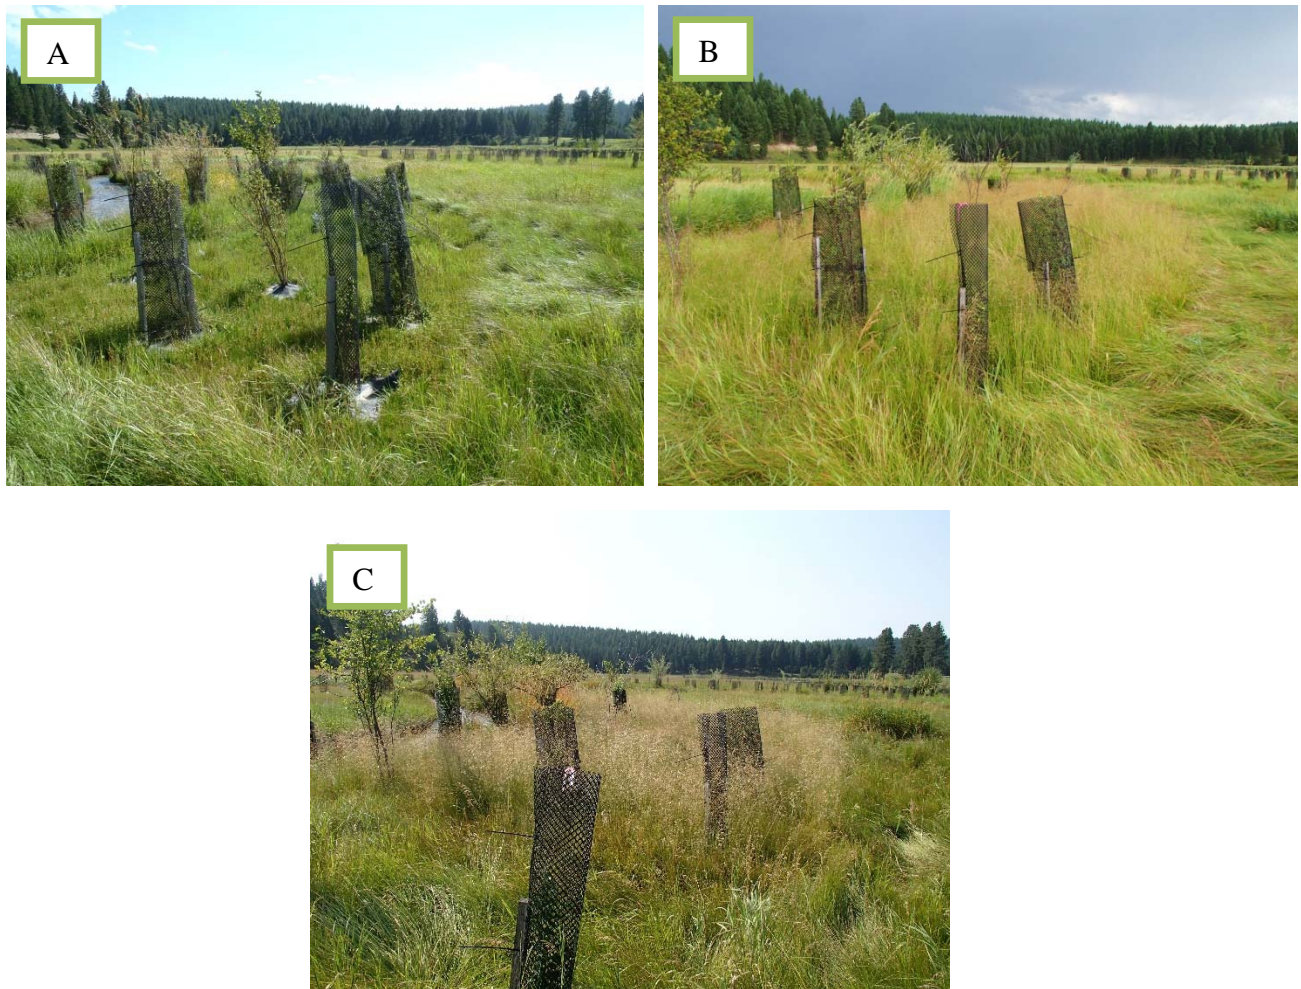
General observations of planted solarization plots were made in August 2014. Herbaceous cover of both seeded and naturally colonizing species in Planted Solarization Plot 1 remains high (Figure 8). Plot 1 is dominated by bluejoint reedgrass (*Calamagrostis canadensis*) and seeded species are also present including tufted hairgrass (*Deschampsia cespitosa*), sawbeak sedge (*Carex stipata*) and daggerleaf rush (*Juncus ensifolius*). Reed canarygrass (*Phalaris arundinacea*) is also present inside the plot, but cover is low. The young willows that colonized the exposed mineral soils in 2012 are still present but are heavily browsed. An overall decline in survival occurred after removal of fabric in 2011, but general observations of survival in 2014 suggest that plant survival remains similar to levels observed in 2013.

Figure 8. Planted Solarization Plot 1 in August 2012 (A), August 2013 (B) and August 2014 (C). Herbaceous species cover continues to increase and is dominated by seeded species and bluejoint reedgrass.

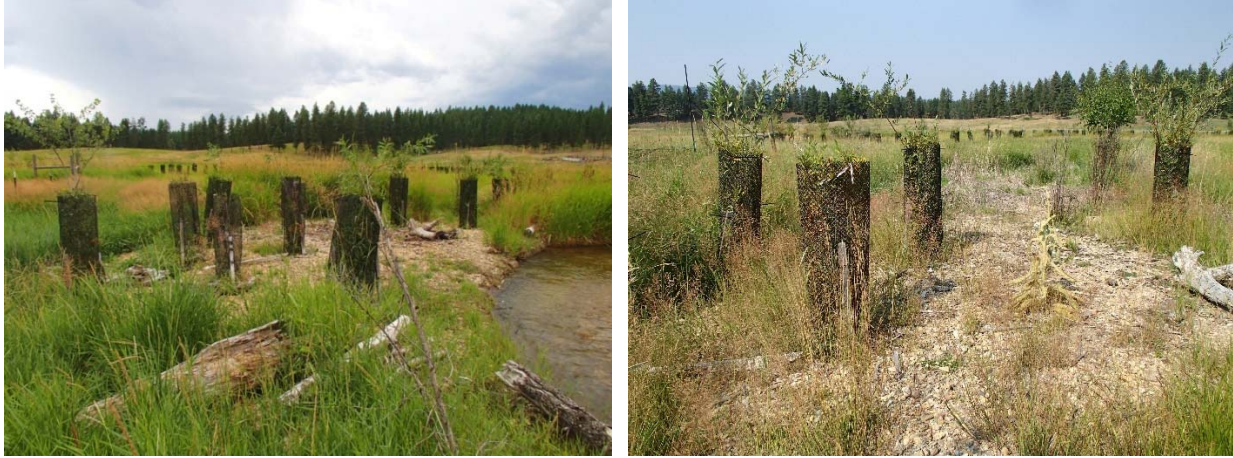
In 2014, conditions in Planted Solarization Plot 2 were similar to 2013 (Figure 9). Survival of planted shrubs did not appear to have changed. Sediments deposited on the floodplain in 2012 were being colonized by a mix of grasses, shrubs and weedy species such as mullein. Planted shrubs continue to grow and expand in this plot.

Figure 9. Overview of Planted solarization Plot 2 in August 2013 (left photo) and August 2014 (right photo). Shrubs, grasses and forbs have begun to colonize the gravel surface.

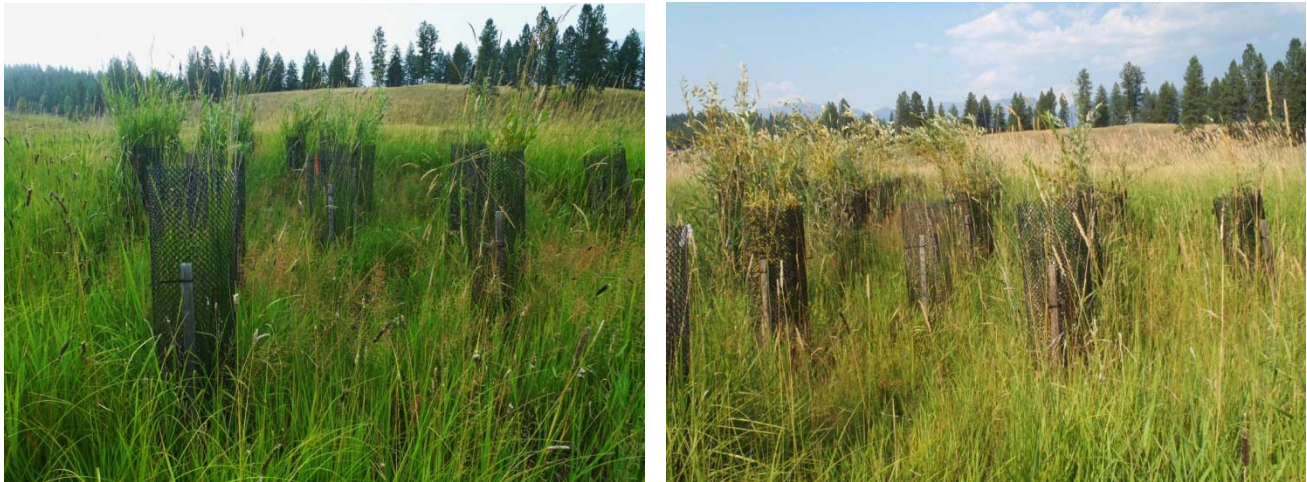
Figure 10. Phase III planted solarization plot showing the growth of shrubs between 2013 (left photo) and 2014 (right photo). The fabric has provided an advantage for shrub growth by limiting the amount of competition from reed canarygrass even though reed canarygrass dominates the surrounding area.

- In 2014, no maintenance actions are required. The solarization fabric in Phase III Planting Unit 15 should be left in place permanently to limit the spread of reed canarygrass and encourage
- In 2015, consider removing reed canarygrass through use of herbicide or hand pulling from Planted Solarization Plot 1.
- In 2015, consider installing willow cuttings in Planted Solarization Plot 1 to increase woody vegetation cover.

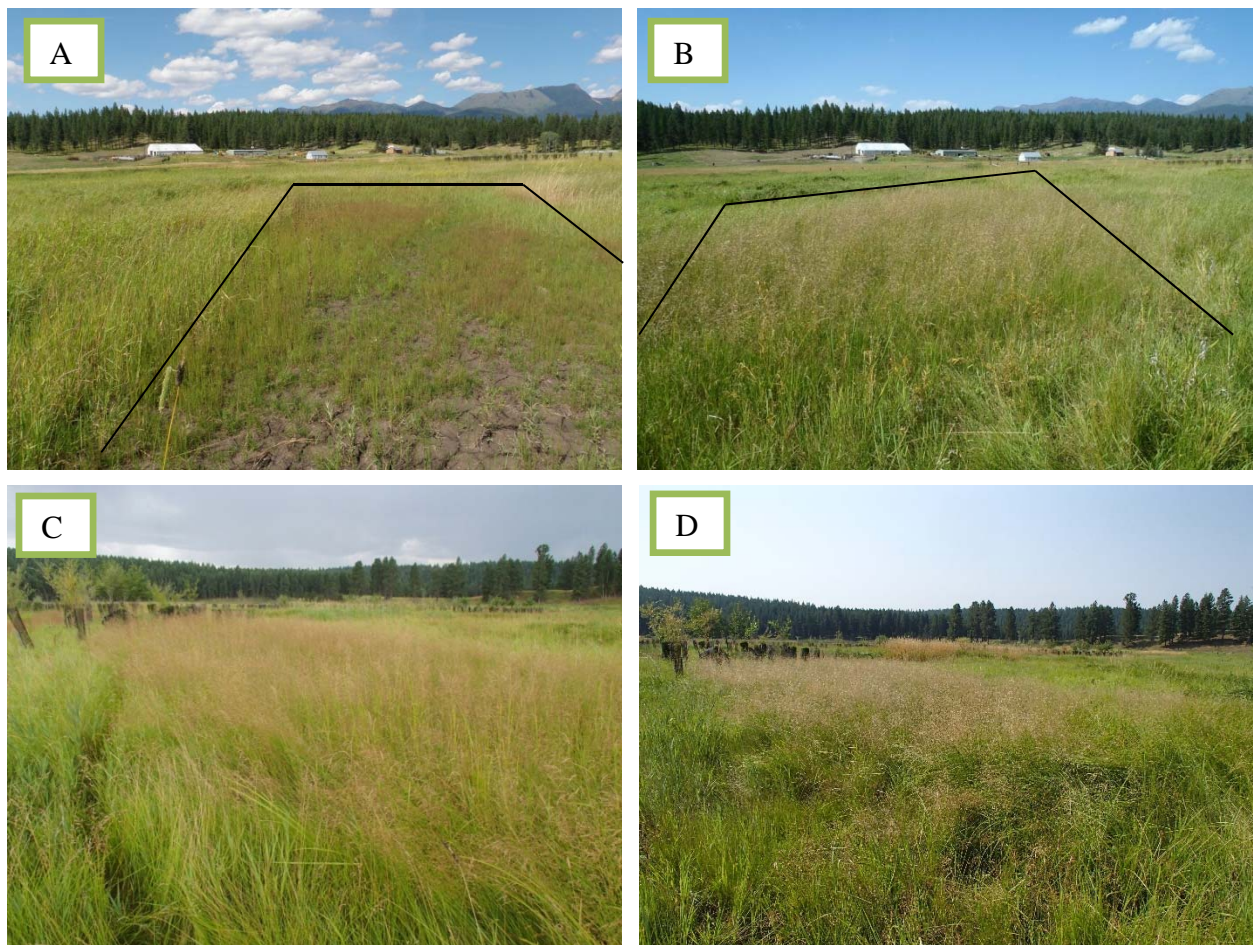
In 2014, general observations were made of the three temporary solarization plots. In Temporary Solarization Plot 1, conditions observed in 2014 were similar to 2013. This plot is dominated by bluejoint reedgrass and sawbeak sedge. Young willows have colonized this site naturally but are suppressed by browse. The plot is generally surrounded by dense stands of sedges. Figure 11 shows the transition of this plot through the years.

Figure 11. Photograph of Temporary Solarization Plot 1 in July 2011 (A) and in August 2012 (B). Black lines in the figure represent the approximate extents of where the solarization fabric covered the plot. Photo C taken in 2013 (from the opposite direction) shows the dense cover of grasses dominating the plot. Photo D taken in 2014 shows similar conditions in the plot as 2013.

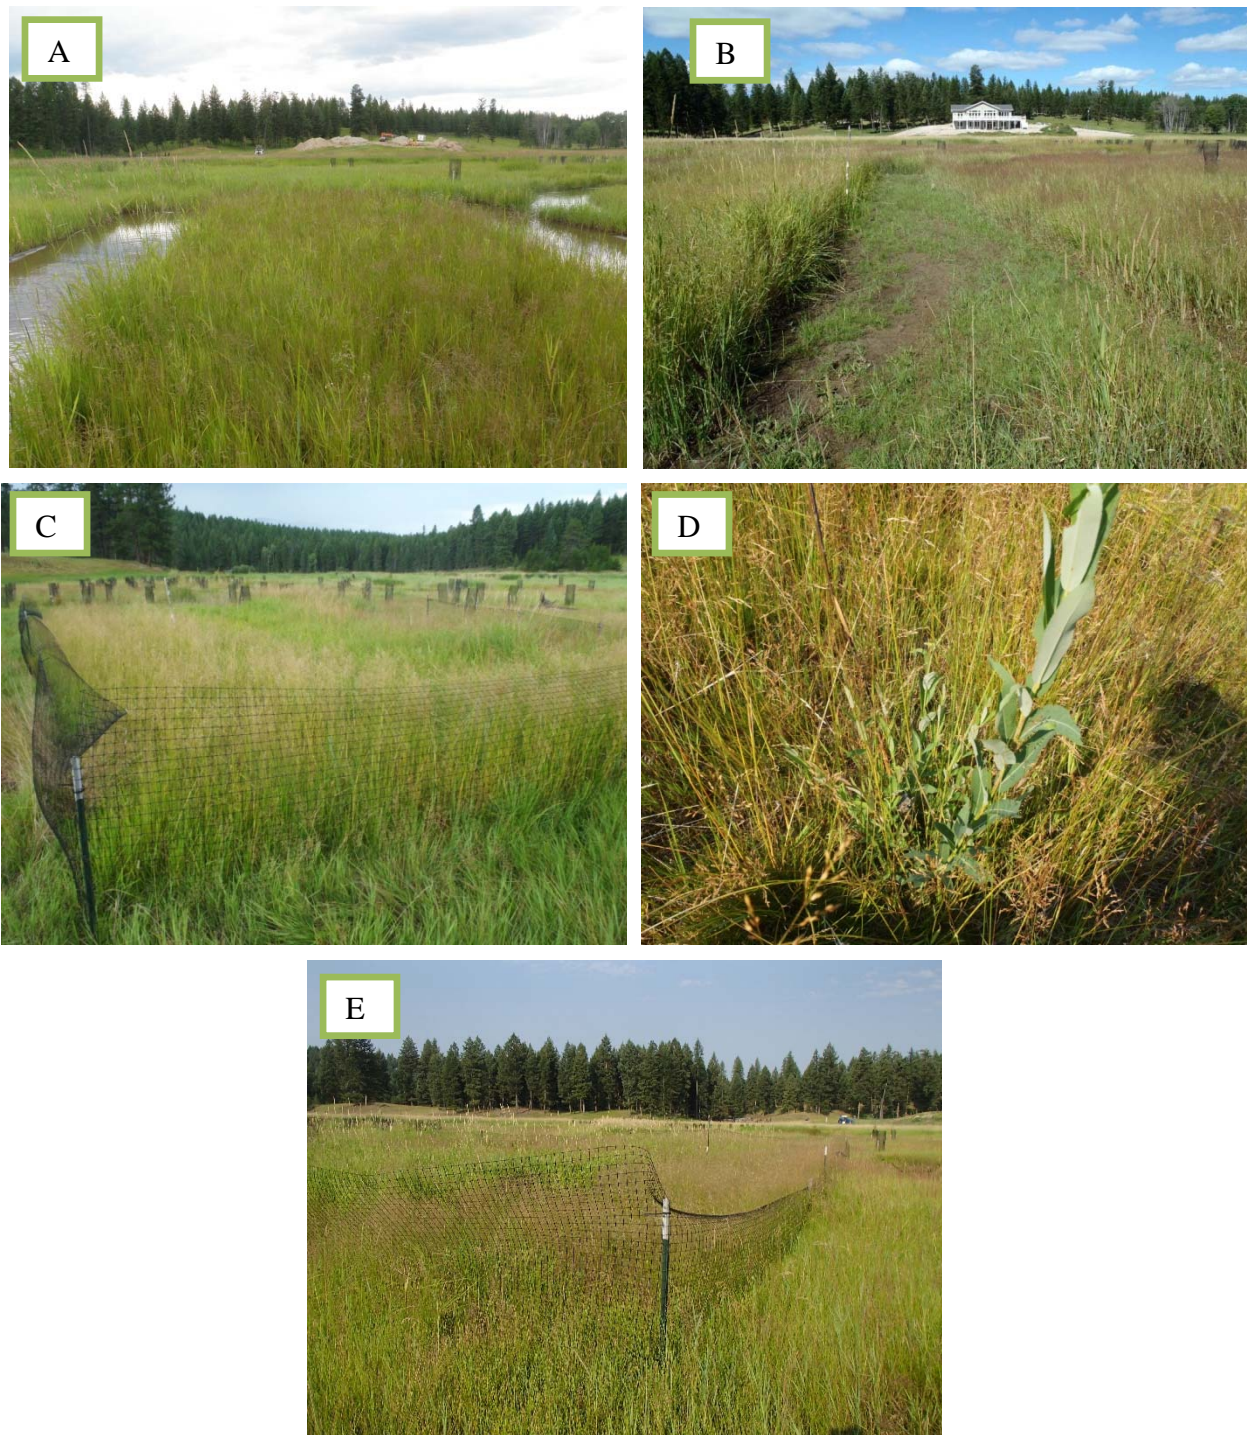
In Temporary Solarization Plot 3, a variety of desirable seeded grasses as well as some recolonization of non-native pasture grass species was observed in 2014. Seeded species observed in 2014 include American mannagrass (*Glyceria grandis*), sawbeak sedge, and daggerleaf rush. Other desirable species that have colonized on their own include Northwest Territory sedge (*Carex utriculata*), field mint (*Mentha arvensis*), and other sedge species. Reed canarygrass is starting to recolonize this plot. Willow cuttings installed in 2012 continue to grow but are suppressed by browse and grasses. The browse protector enclosure installed around this

plot in 2013 has slumped and is doing little to protect the willow cuttings from browse. Figure 12 shows the transition of this plot through the years.

Figure 12. Photograph of Temporary Solarization Plot 3 in 2011 (A) and in 2012 (B). In photo A the area between the standing water is the original plot location that was exposed and seeded in fall 2009. The areas of standing water have fabric under the water that was placed around the original plot. This fabric was removed in fall 2011 and the exposed soil area is shown in photo B. Photo C taken in 2013 (from the opposite direction) shows the browse enclosure and the fully vegetated plot. Photo D was also taken in 2013 shows the growth of willow cuttings that were planted in fall 2012. Photo E shows the plot in 2014.

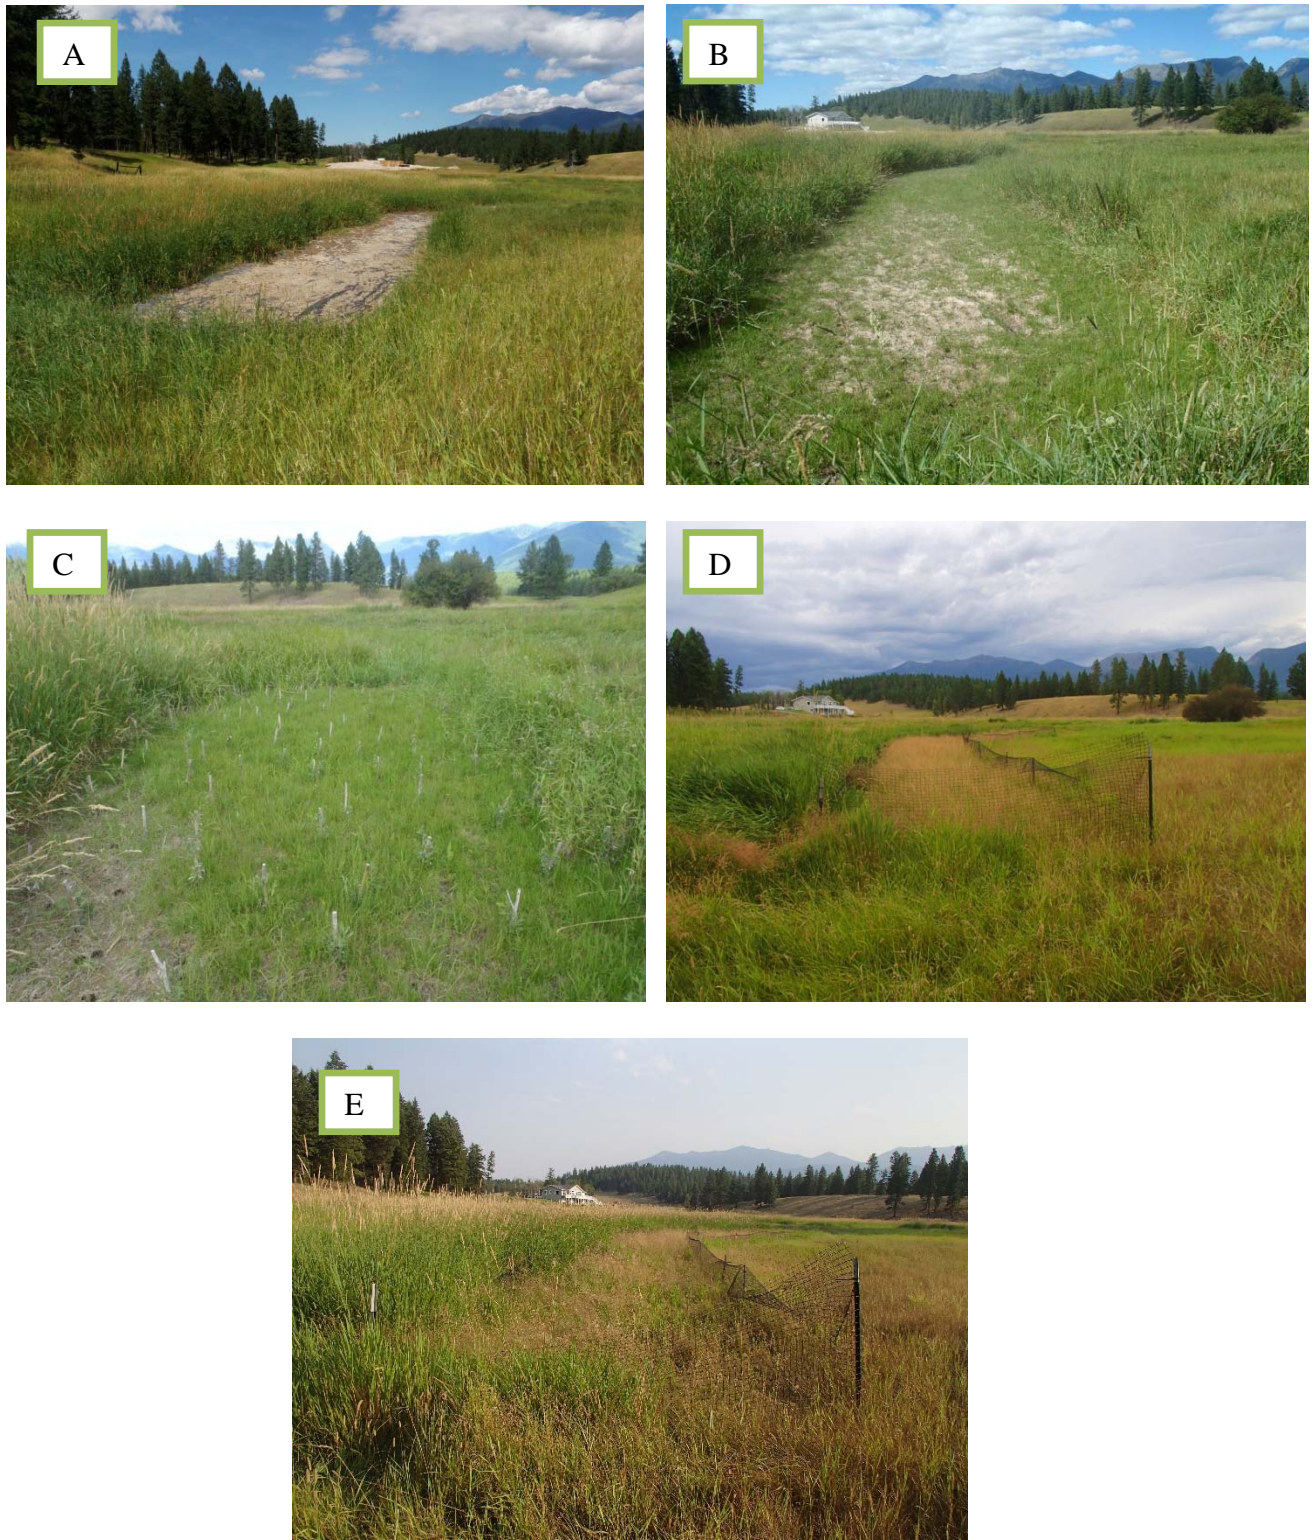
In Temporary Solarization Plot 2, reed canarygrass has started to re-colonize the streamside edge of the plot where there is an existing dense stand of reed canarygrass. Willow cuttings installed in the plot in 2012 are surviving but are heavily browsed. The browse protector enclosure installed around this plot in 2013 has slumped and is doing little to protect the willow cuttings from browse. Desirable species observed in 2014 include bluejoint reedgrass, American mannagrass and field mint. Figure 13 shows the transition of this plot through the years.

Figure 13. Photograph of temporary solarization plot 2 prior to fabric removal and seeding in fall 2011 (A), in August 2012 one year after fabric removal (B), after willow cuttings were planted in fall 2011(C), in 2013 showing grass cover (D) and in 2014 (E).

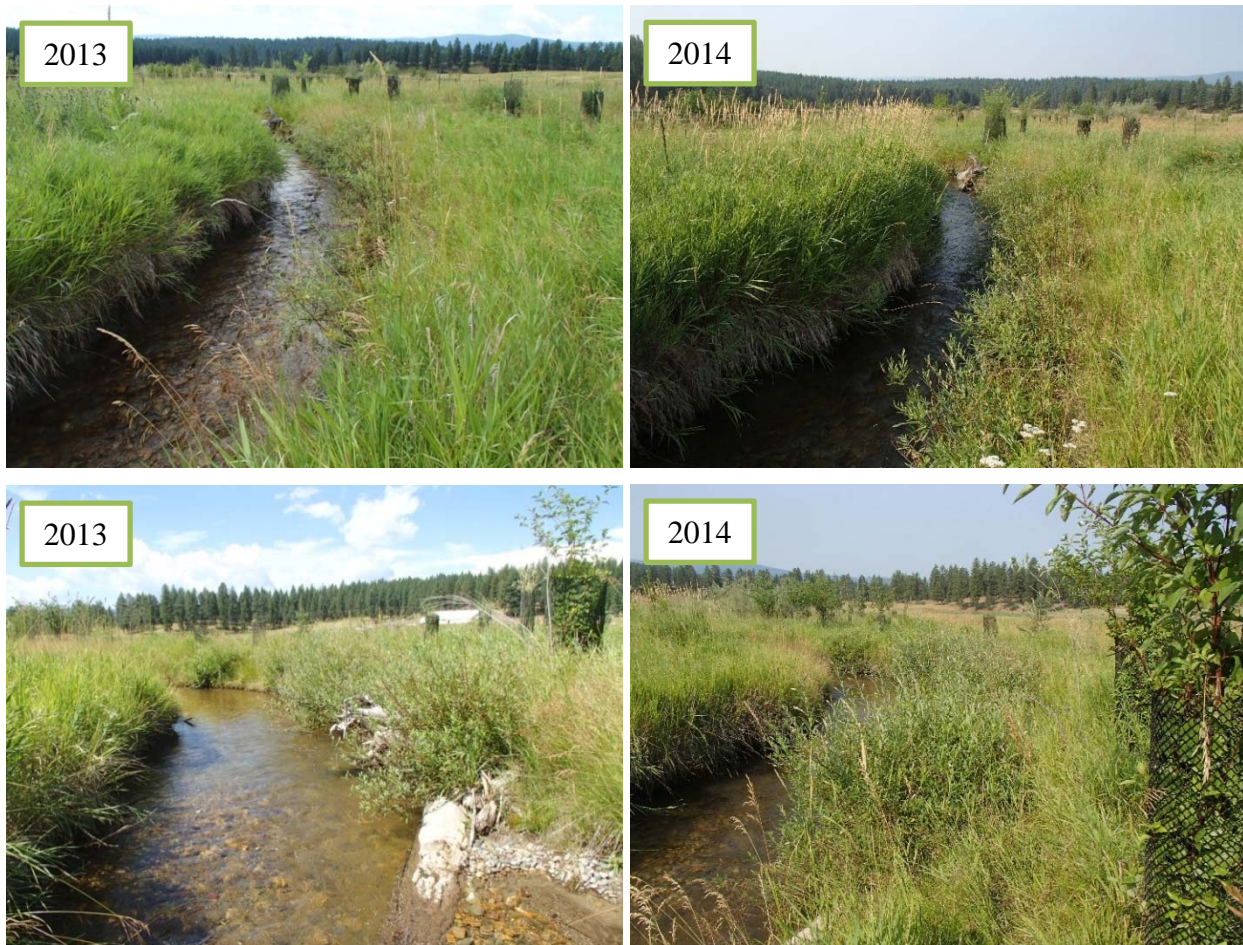
Figure 14. Photographs of vegetated soil lifts in 2013 and 2014. The top photos are of Vegetated Soil Lift 1 and the bottom photos are of Vegetated Soil Lift 2. The riparian protection fence that was installed in fall 2013 includes Vegetated Soil Lift 2.

- In 2014, repair riparian protection fence to reduce browse on vegetated soil lift 2.
- In 2015, repair riparian protection fence as needed.
- No additional maintenance or monitoring of these structures is anticipated.

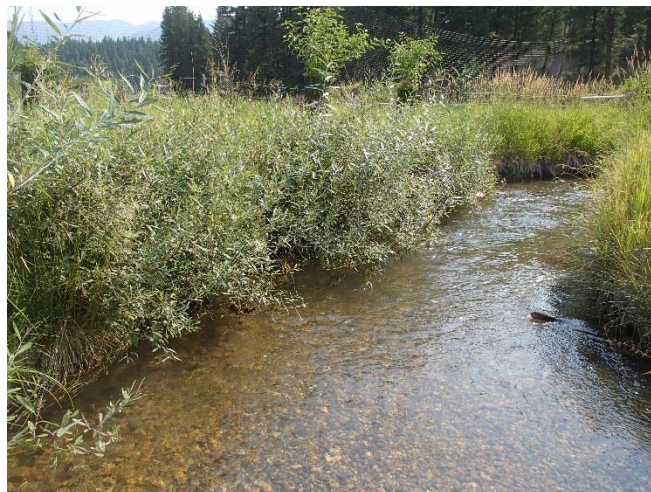
Figure 15. Dense willow growth overhanging channel at Vegetated Soil Lift 2.

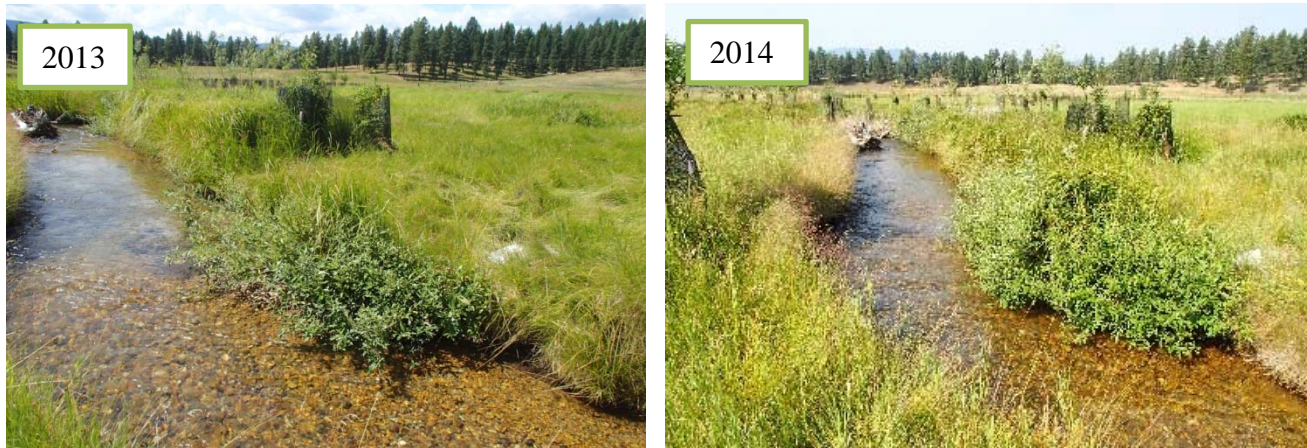
Figure 16. Willow fascine located within the riparian protection fence in 2013 prior to protection and 2014 after protection. Although the fence was down in many places in 2014, willows were partially protected from browse and showed increases in height.

- In 2015, repair riparian protection fence as needed.
- No additional maintenance or monitoring of these structures is anticipated.

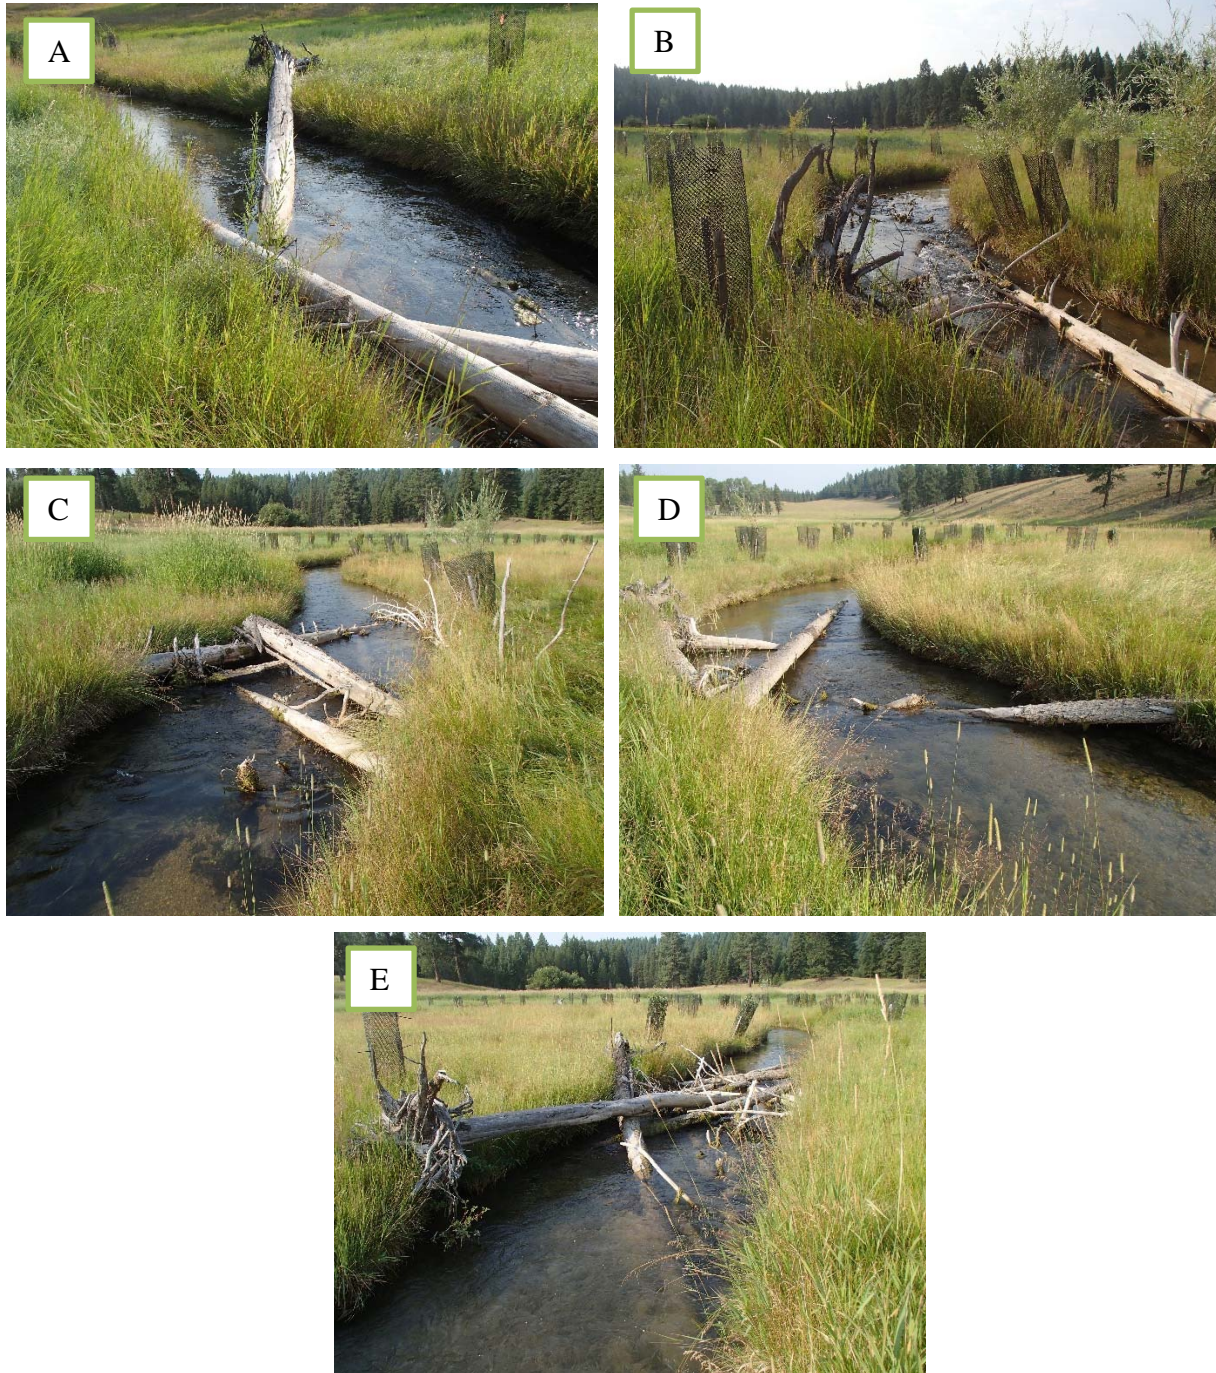
In 2014, general observations were made of all large woody debris structures. These structures continue to function as they have in previous years providing increased floodplain connectivity; creating diverse in-stream habitat for fish and other aquatic species; and creating bare surfaces for new vegetation to colonize. The few willow seedlings observed along the margins of these structures are still present and continue to grow. Figure 17 shows the condition of the structures and surrounding area in 2014.

Figure 17. Large woody debris jams 1 through 5 (A through E). The various sediment, gravel and organic debris deposition patterns, both within the channel and along channel margins, can be seen in some of the photos. Smaller debris continues to accumulate on top of the structures.

- No additional maintenance or monitoring of these structures is anticipated.

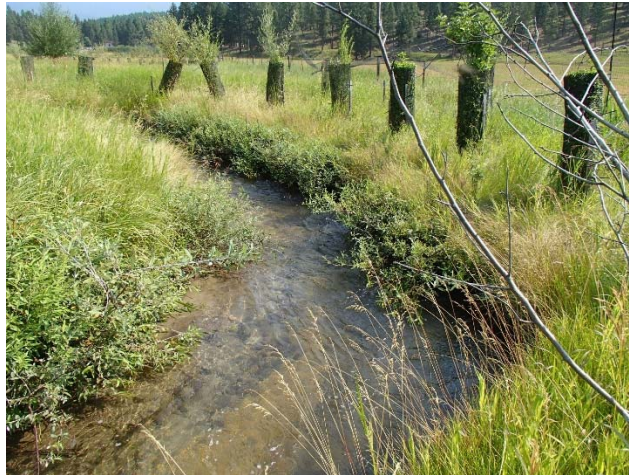
Figure 18. Coir Log 3 and willow fascine on inside bend (across from planting unit 11) showing increased height of willow cuttings.

- In 2015, repair riparian protection fence as needed.
- No additional maintenance or monitoring of these structures is anticipated.

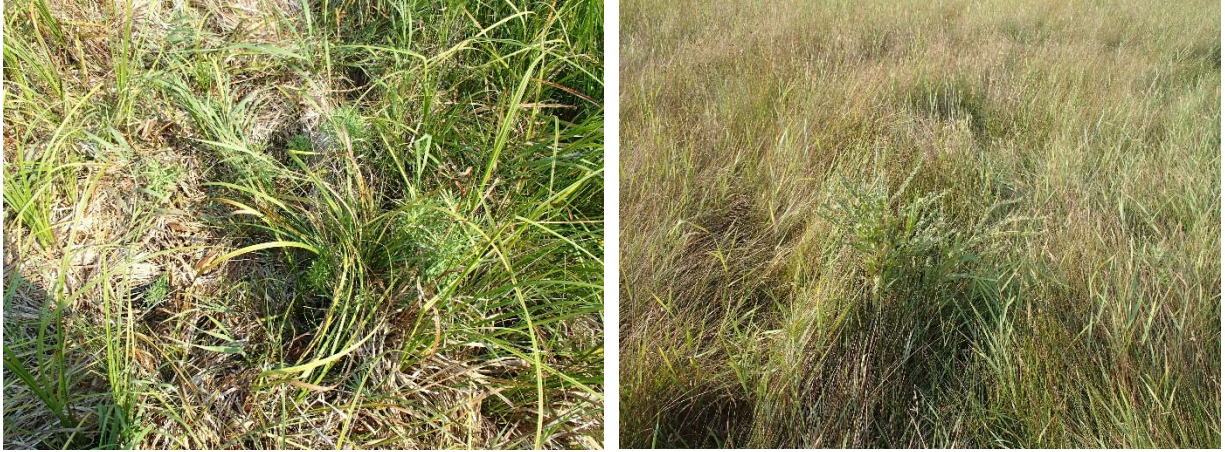
Houndstongue is present primarily above the access road and in the lower portion of the project area. The only other invasive species identified in the project area that is targeted for control is common mullein (*Verbascum thapsus*), which is also found sporadically below the access road. This species is not a high priority but is selectively treated as it occurs with noxious weeds. Perennial pepperweed (*Lepidium latifolium*), a noxious weed, was identified in the Phase III area in 2013 and treated. It was not found in 2014. Reed canarygrass, an invasive species, also remains widespread and continues to spread throughout the project area. Herbicide treatment of

Figure 19. Young yellow toadflax plants in dense grasses and sedges below the access road near the upstream end of the project area (photo left) and mature houndstongue plant at the downstream end of the project (photo right).

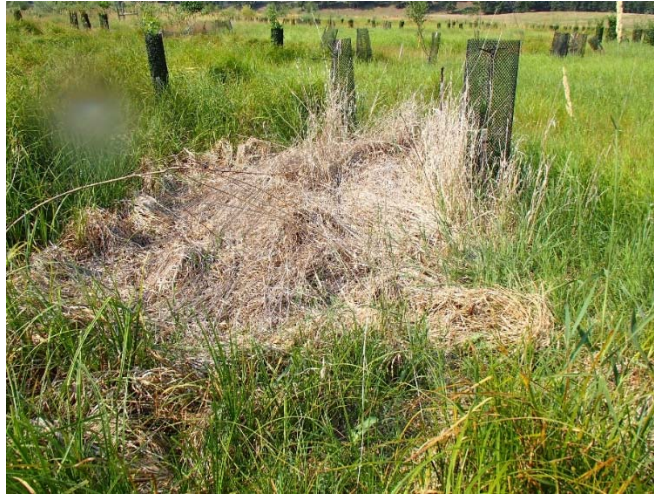
Figure 20. Clump of reed canarygrass treated with Roundup® in 2014.

- In 2015, continue to treat isolated patches of reed canarygrass in the project area. Reed canarygrass cannot be eradicated from the site but selective control has prevented spread in the floodplain at the upstream end of the project area. Despite control efforts, reed canarygrass is increasing in all areas of the project. For areas where reed canarygrass has been killed, supplemental revegetation such as seeding or bank stabilization may be required (Figure 21). Evaluate and implement these treatments as needed in 2015.

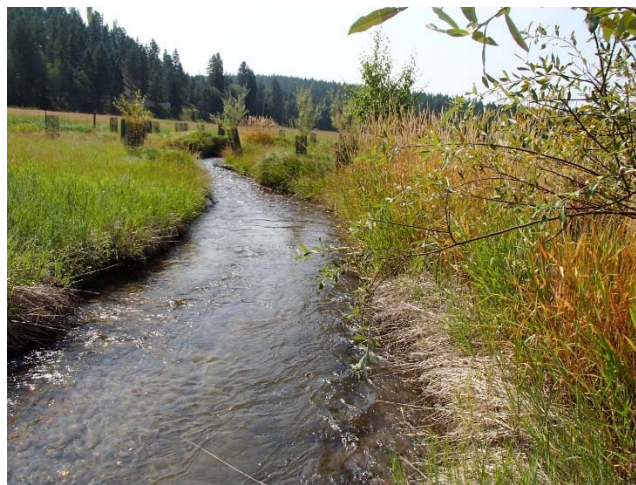
Figure 21. Area of treated reed canarygrass along a streambank. These areas may require additional revegetation.

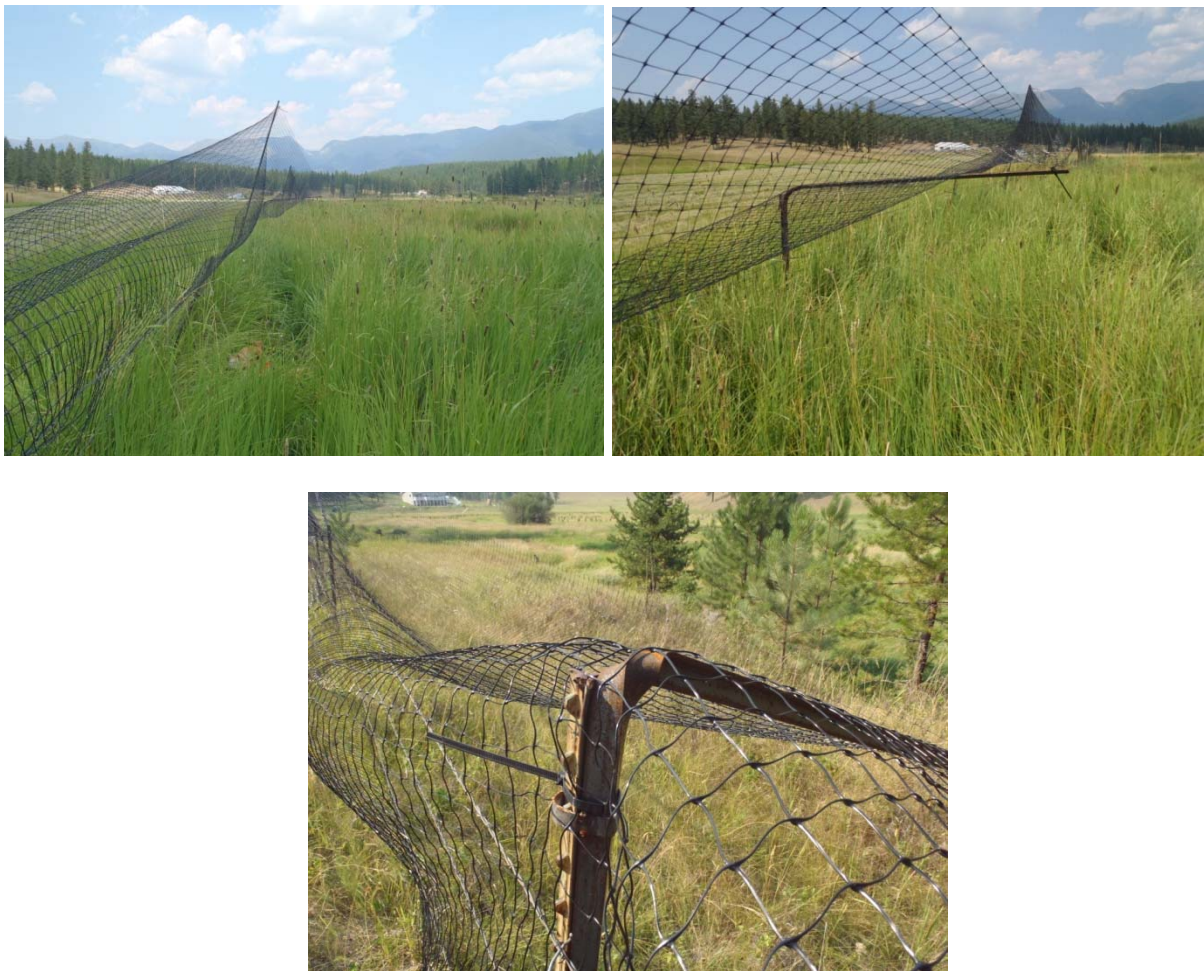
During 2014 monitoring, a number of maintenance activities were identified. High priority maintenance needs included: repair and reconstruction of the riparian protection fence; removal of all browse protectors within the riparian protection fence; and removal of all vole protectors from Phase I. As described in the previous sections, other maintenance needs were identified; however, these were a lower priority compared with repair of the riparian protection fence and removal of browse and vole protectors in Phase 1. Therefore, these needs are identified as priorities for 2015 in the previous sections. The riparian protection fence installed in 2013 required repair throughout the entire length of the fence. The exact causes of fence failure are unclear and are probably a combination of snow load and animal pressure that resulted in the angle iron extensions bending causing the netting to sag and collapse (Figure 22). In many areas the netting also broke loose from the cable ties attached to the top of the angle iron extensions.

Figure 22. Photographs of riparian protection fence failure due to bending of the angle iron extensions.

The fence was repaired in October, 2014 by installing ten foot t-posts between existing t-posts. The fence netting was attached to the newly installed ten foot t-posts using a combination of cable ties and 16-gauge tie-wire.

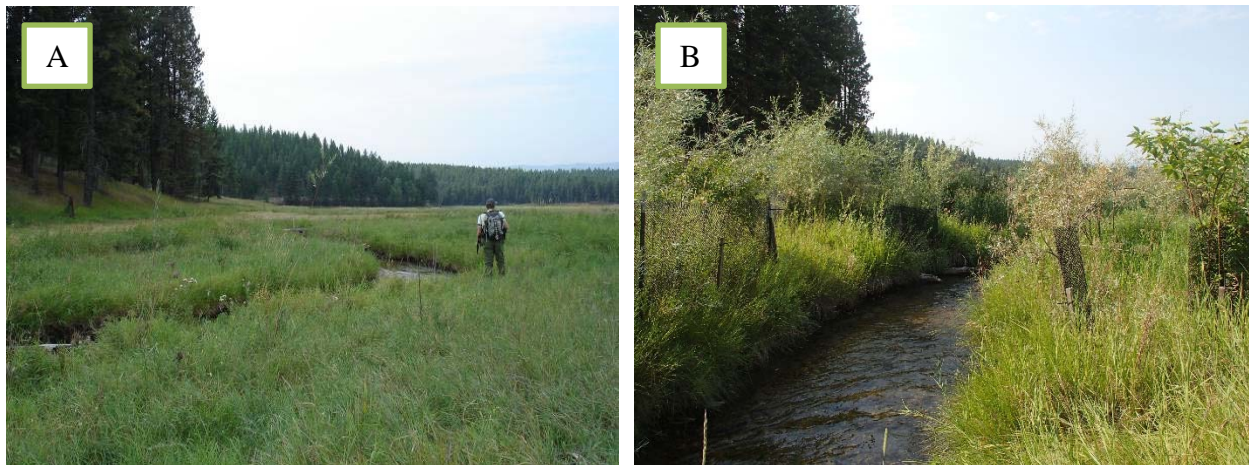
Figure 23. The upstream end of the project reach in 2006 (A) and 2013 (B).

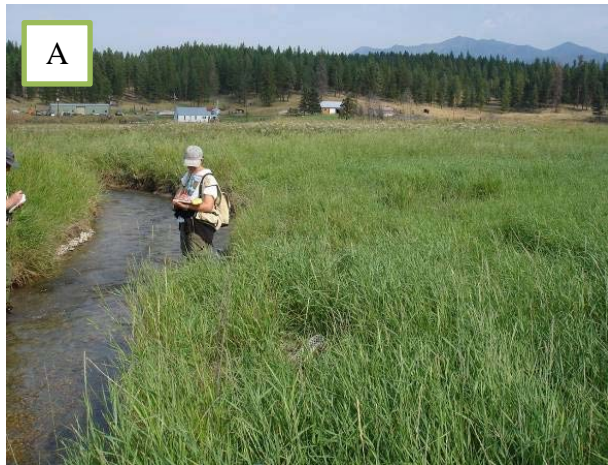
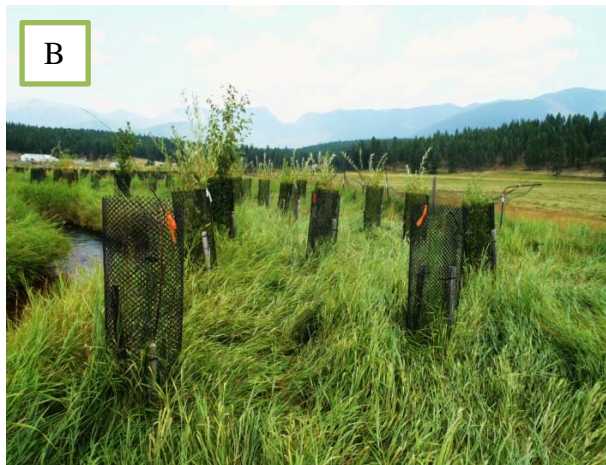
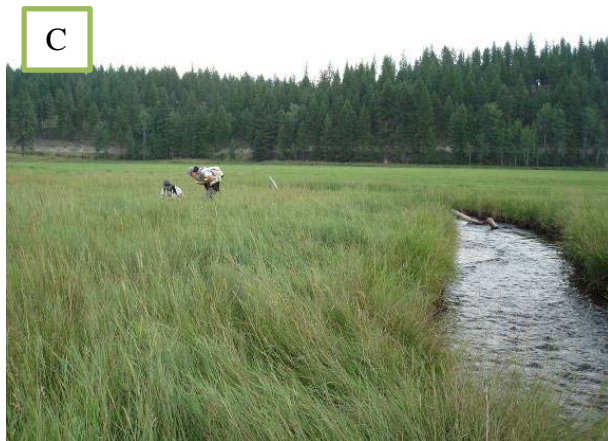
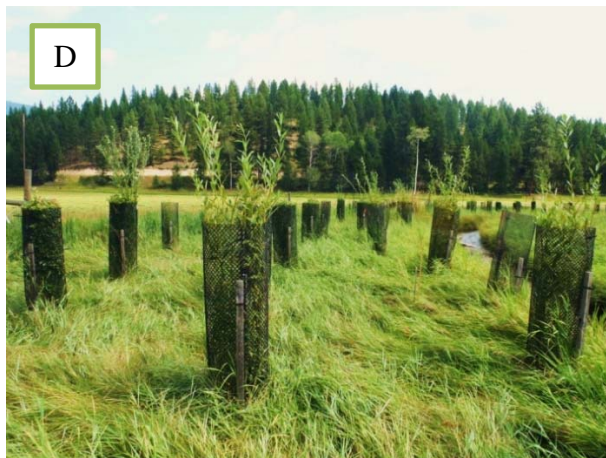
Figure 24. Photos showing the difference in vegetation conditions in the middle to lower end of the project area in 2006 (A and C) and 2014 (B and D).
