TO: Jim Dunnigan, Montana Fish, Wildlife and Parks
FROM: Amy Sacry and Jesse Wallace, Geum Environmental Consulting, Inc.
DATE: November 27, 2019
RE: Therriault Creek 2019 As-built and Maintenance Summary

This memo describes restoration treatment installation and revegetation maintenance work completed in 2019 at the Therriault Creek Restoration Project Site under Montana Fish, Wildlife and Parks (FWP) Task Order 19-0010. Restoration treatments and maintenance tasks were identified by Geum Environmental Consulting (Geum). Installation of restoration treatments and maintenance tasks was completed by Westslope Forest Management (Westslope) and Geum. Weed control was completed by Mountain Valley Plant Management (MVPM).

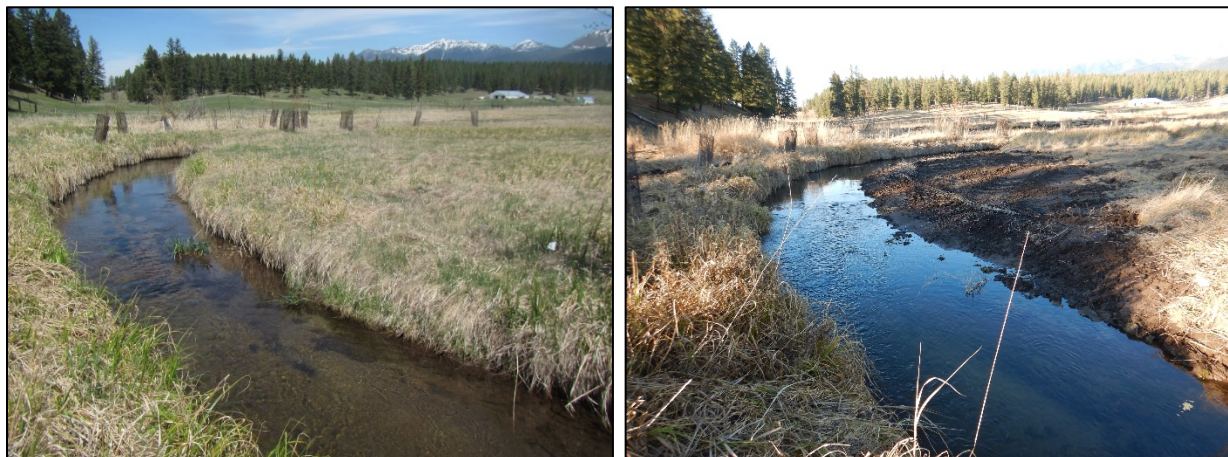
Figure 2. Point Bar Lowering Site 1 before (photo left) and after (photo right) treatment.

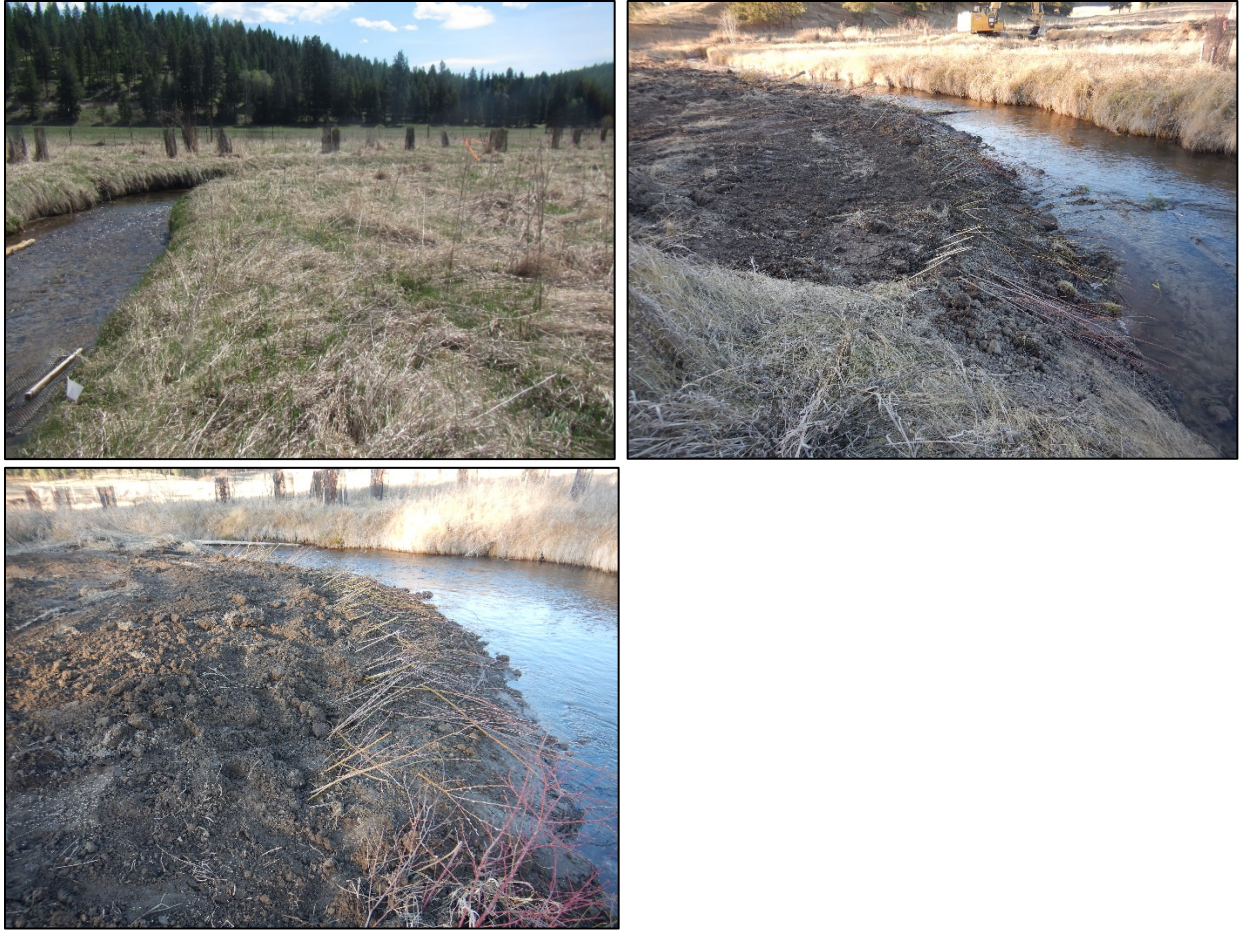
Figure 3. Point Bar Lowering Site 2 before (top left photo) and after (top right and bottom photos) treatment.

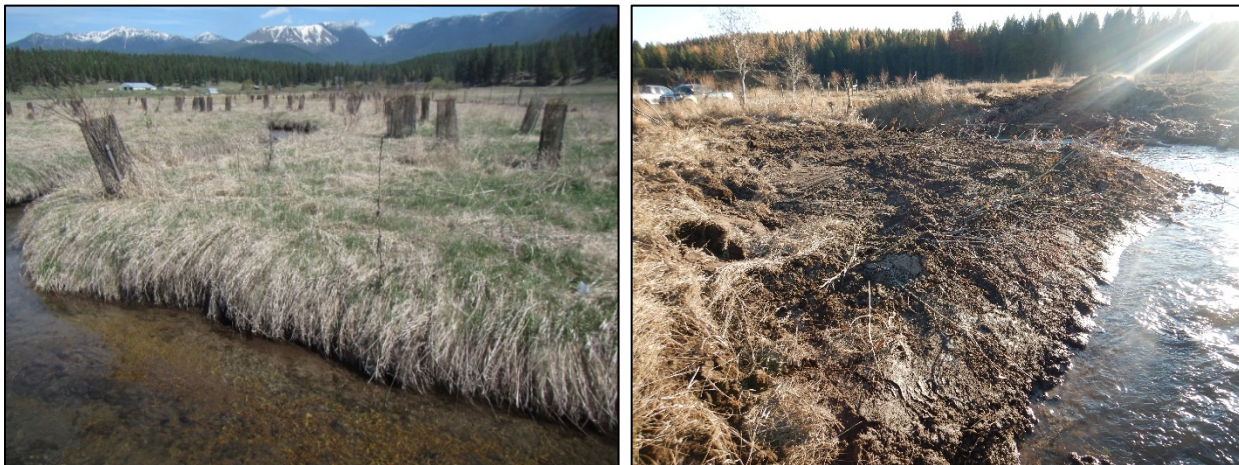
Figure 4. Point Bar Lowering Site 3 before (photo left) and after (photo right) treatment.

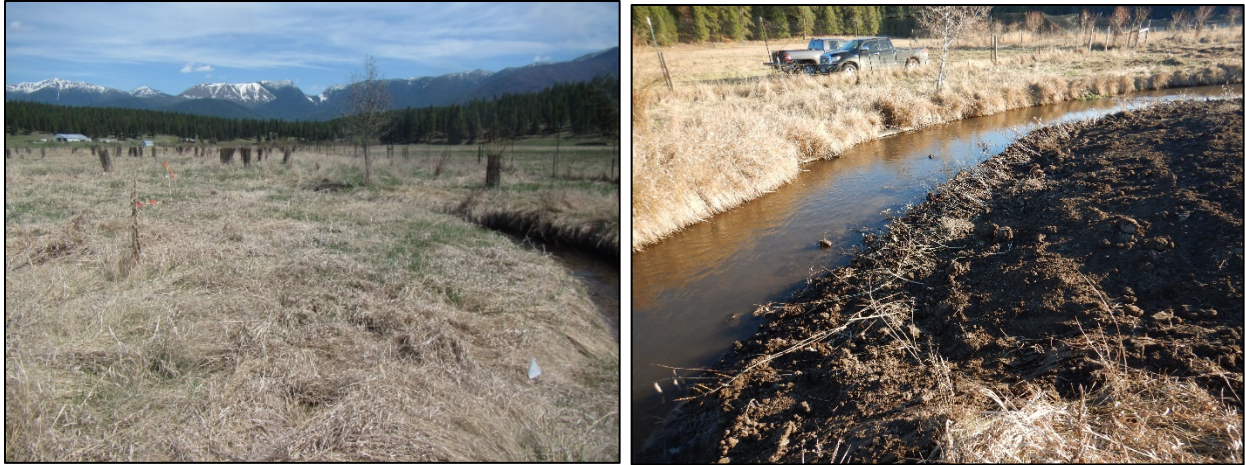
Figure 5. Point Bar Lowering Site 4 before (photo left) and after (photo right) treatment.

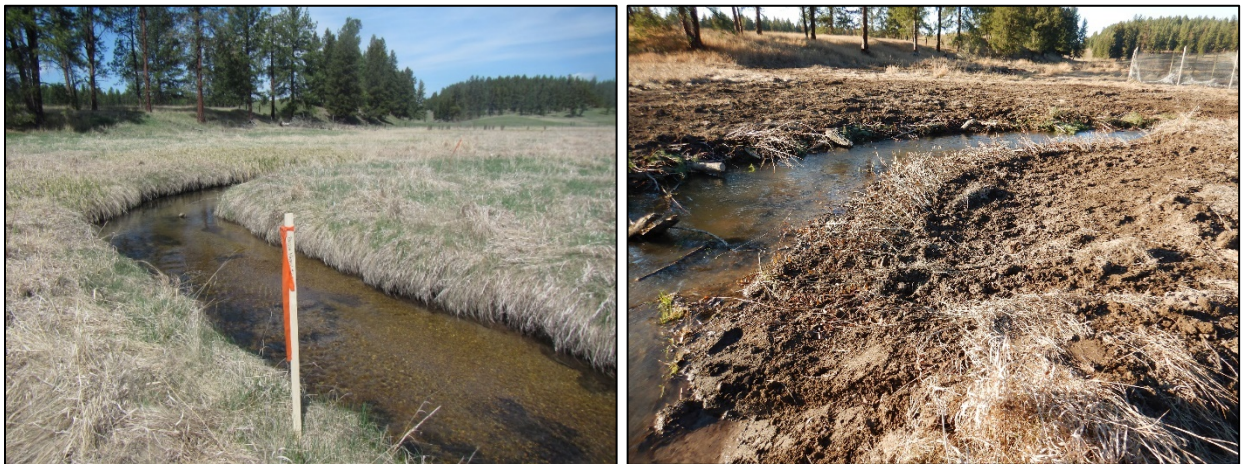
Figure 6. Point Bar Lowering Site 5 before (photo left) and after (photo right) treatment.

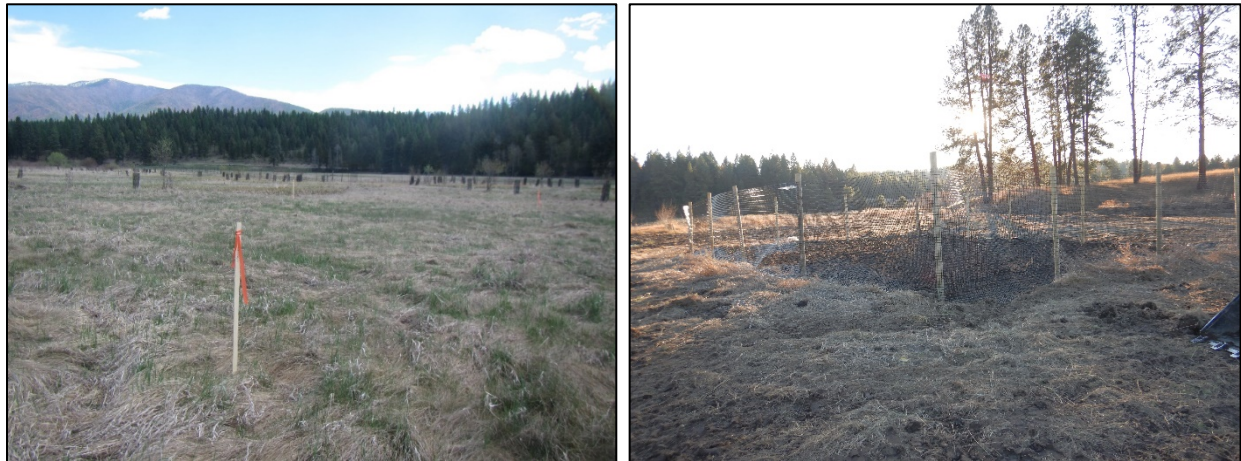
Figure 7. Grass Sod Scalping and Planting Site 1 (S1) before (photo left) and after (photo right).

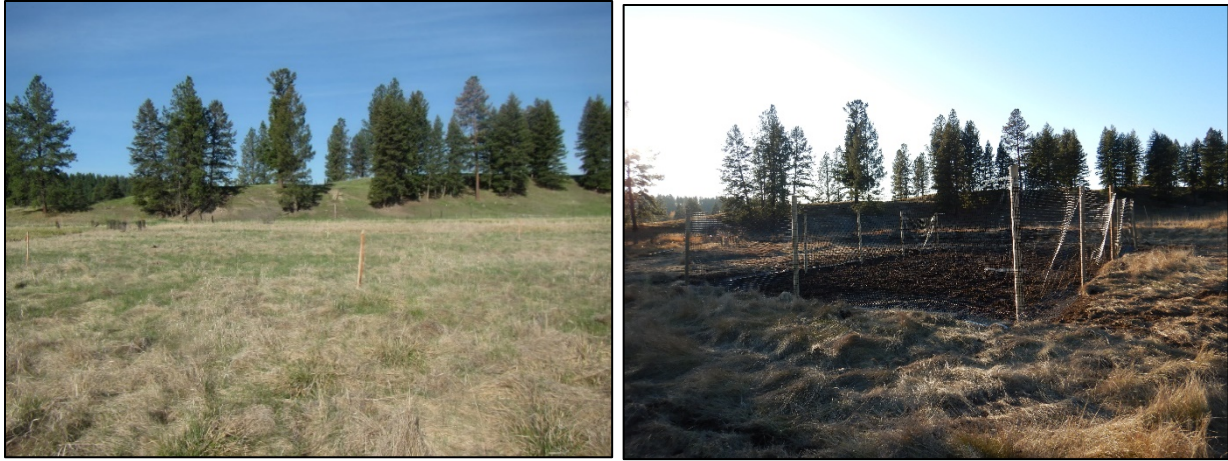
Figure 8. Grass Sod Scalping and Planting Site 2 (S2) before (photo left) and after (photo right).

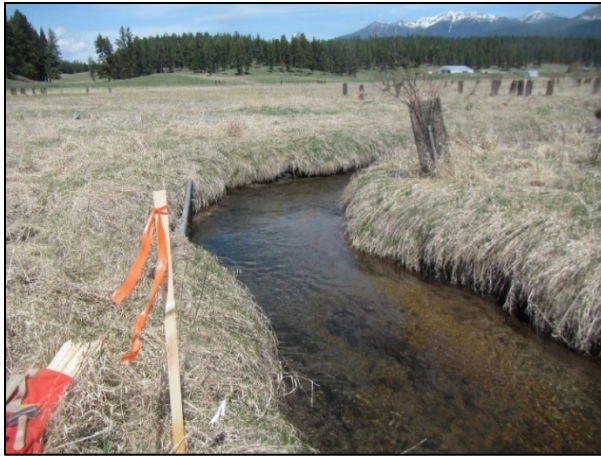
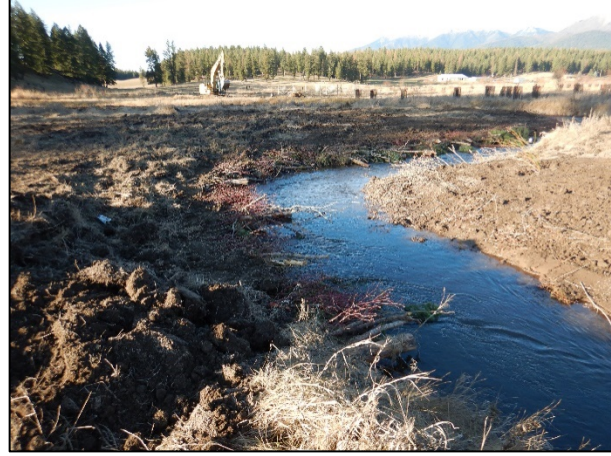
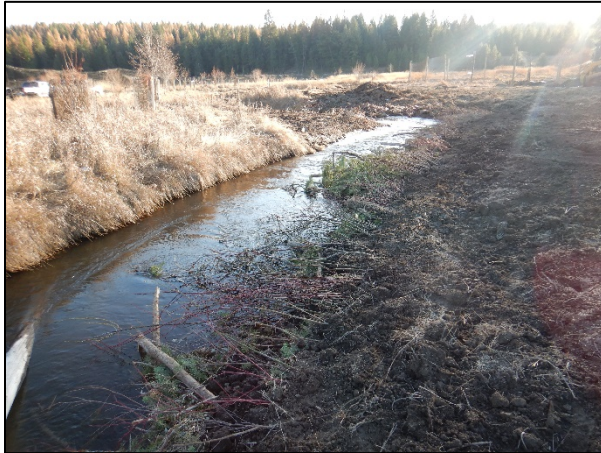
Figure 9. Brush Matrix Site 1 before (top left photo) and after (top right and bottom photos).

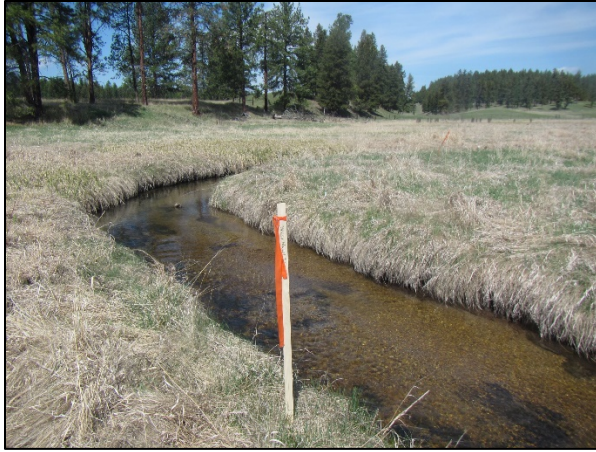
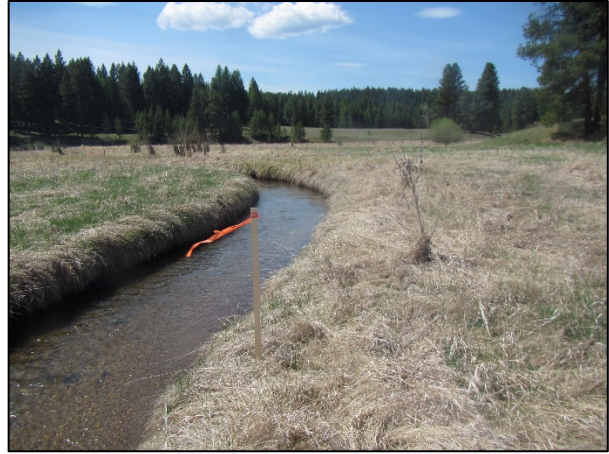
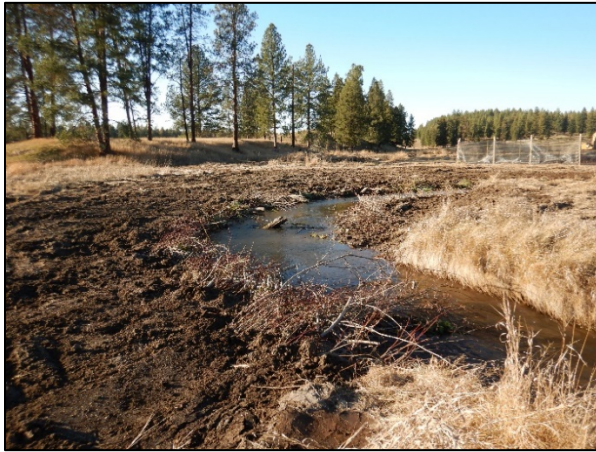
Figure 10. Brush Matrix Site 2 before (top photos) and after (bottom photo).

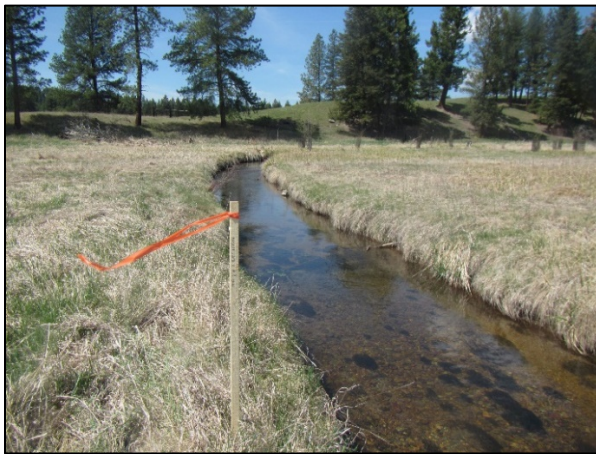
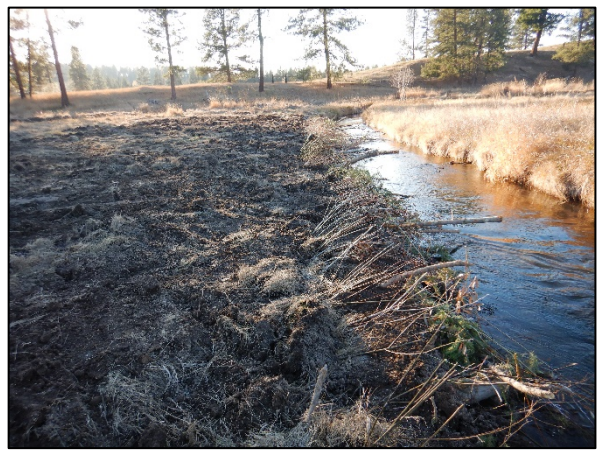
Figure 11. Brush Matrix Site 3 before (left photo) and after (right photo).

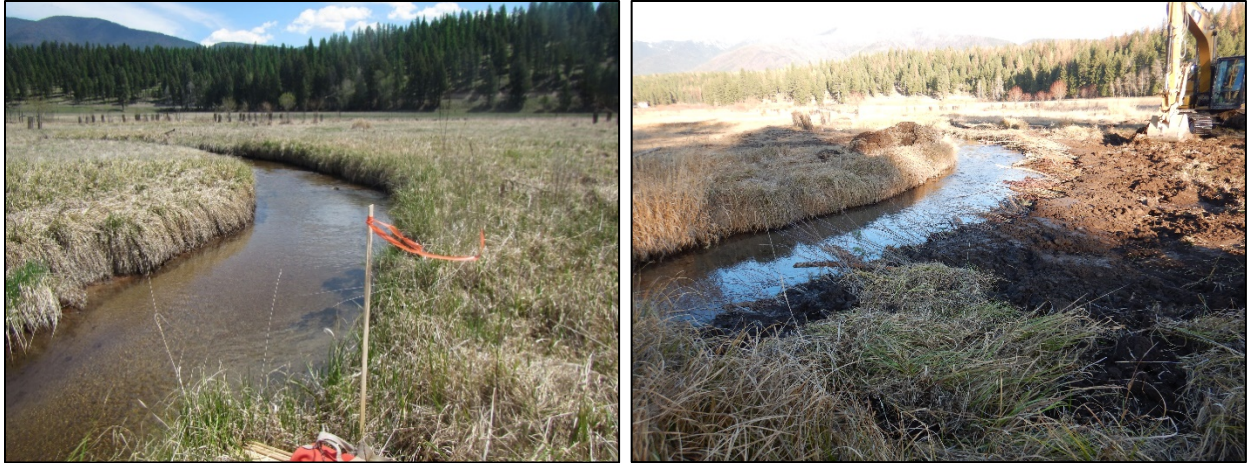
Figure 12. Brush Matrix Site 4 before (left photo) and after (right photo).

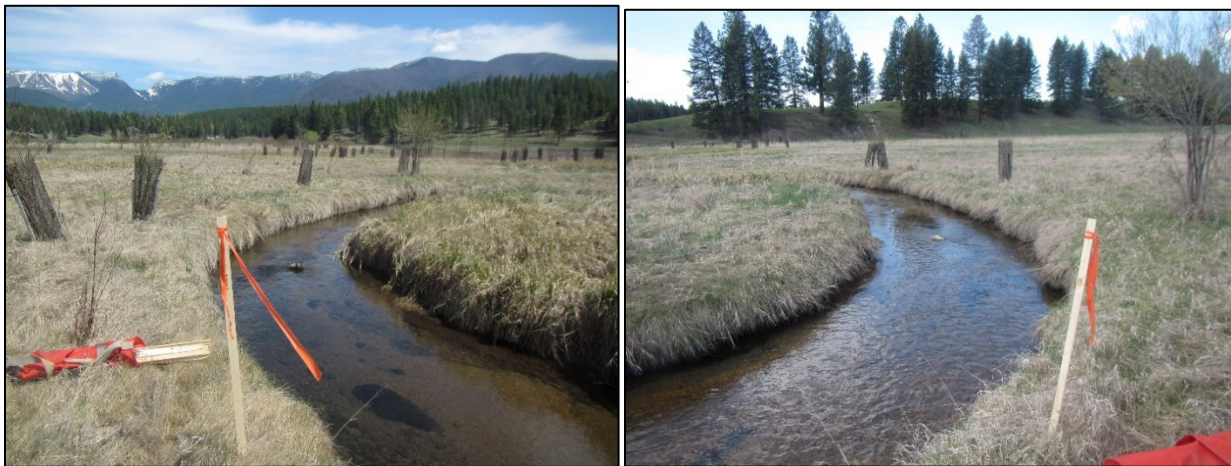
Figure 13. Brush Matrix Site 5 before (left photo) and after (right photo).

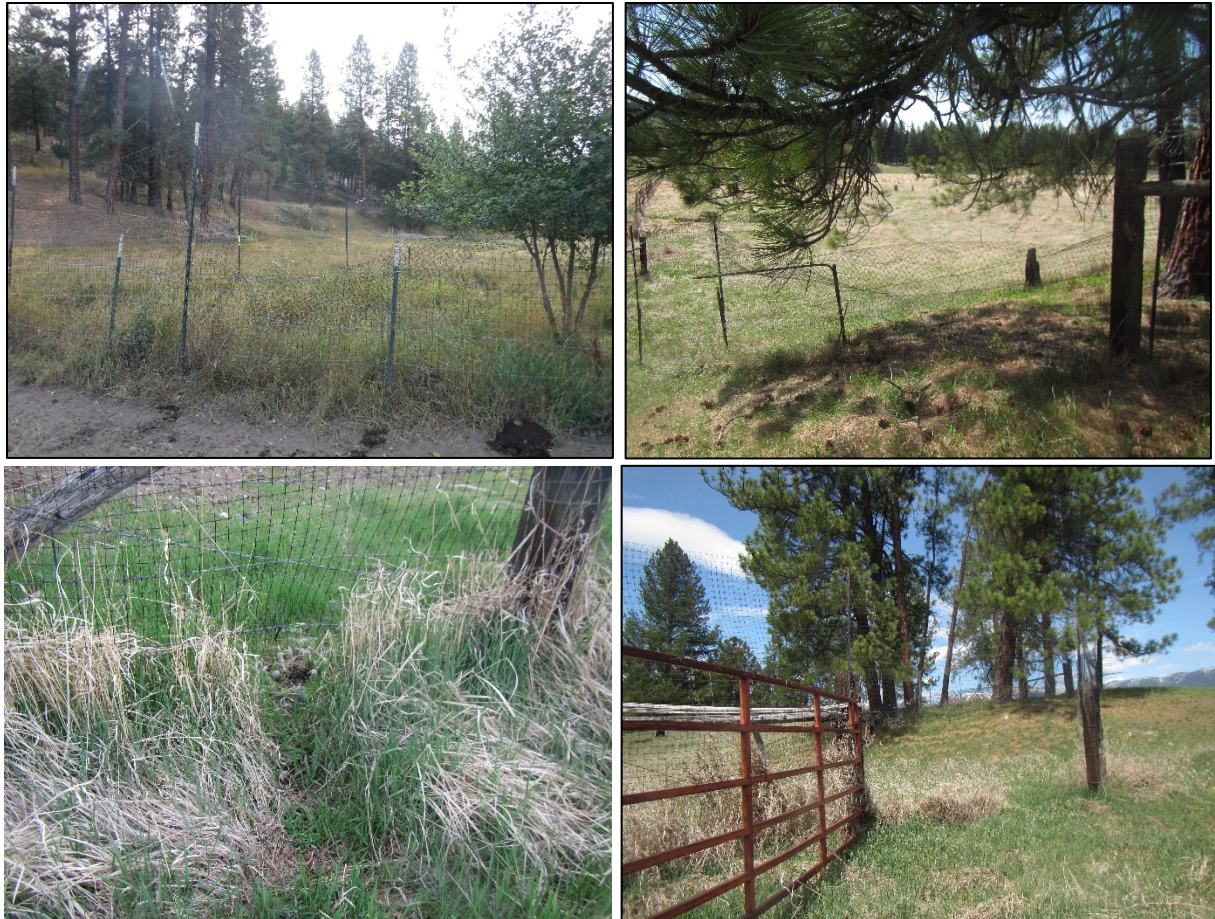
Several locations were identified where the riparian protection fence netting was sagging, ripped, or where deer had created holes underneath the fence (Figure 14). Fewer maintenance locations were identified in 2019 compared to 2018. Specific maintenance tasks provided to the maintenance subcontractor with instructions to address the repairs as follows:

Figure 14. Examples of riparian fence damage requiring maintenance (top photos). Hole under fence from deer (bottom left photo). Open gate at downstream, west side of project that was open again in 2019 (bottom right photo).

- Patch larger rips and tears in the netting with zip ties, salvaged fence, and/or browse protector materials.
- Re-secure fencing to posts with zip ties, and straighten any damaged or leaning posts.
- Re-secure fence netting to the ground with ground staples.
- Repair holes under the fence with salvaged fence material and/or browse protector materials.
- The subcontractor was also instructed to make repairs to any additional locations they observed.

A total of 290 linear feet of riparian protection fence was repaired in 2019 (Table 1). Repair of the existing riparian fence included patching small holes and tears in the fence netting, straightening bent or damaged fence posts, re-securing fence netting to existing fence posts, re-securing fence netting to the ground, and patching holes under the fence. Exact locations of fence repairs in 2019 were not recorded.

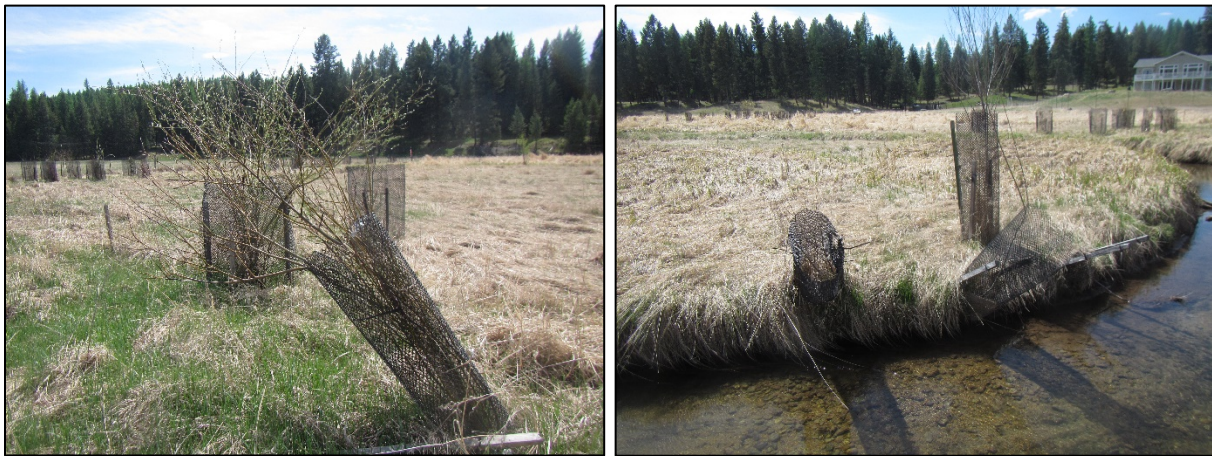
These plants require longer-term protection from ungulate browse, and the existing browse protectors have exceeded their expected life span of five years. Photographs showing browse protector maintenance needs are provided in Figure 15. Geum recorded the approximate number of browse protectors to be removed, repaired, enlarged, or replaced in each 2010 planting unit and provided the following instructions to the maintenance crew:

Figure 15. Example of browse protectors needing repair.

- Within the riparian protection fence:
 - Remove browse protectors from all dead plants and re-use protectors for the following two tasks: 1) enlarge protectors around plants that have outgrown the protector; and 2) install new protectors on shrubs outside of the riparian protection fence with no existing browse protection.
- Outside of the riparian protection fence:
 - Remove all damaged or outgrown black plastic browse protectors and install metal browse protectors around surviving trees and shrubs. Some intact and functioning black plastic browse protectors were left in place.

A total of 174 browse protectors were removed and 92 were enlarged or installed for a total of 266 browse protectors maintained in 2018 (Table 6 and Table 7). Browse protector maintenance included removing browse protectors (netting and posts) from dead shrubs, enlarging existing browse protectors around shrubs that had outgrown original browse protectors, and installing new browse protectors on shrubs without browse protection. Removed browse protectors were used to enlarge other protectors or install protectors on plants with no protection. The removal of the majority of black plastic browse protectors outside of the riparian protection fence was not included in the original estimate, and sufficient materials were available to complete additional browse protector maintenance inside the fence, resulting in the completion of more browse protector maintenance than originally estimated. Table 7 summarizes the actual number of browse protectors removed and enlarged/installed within each 2010 planting unit.

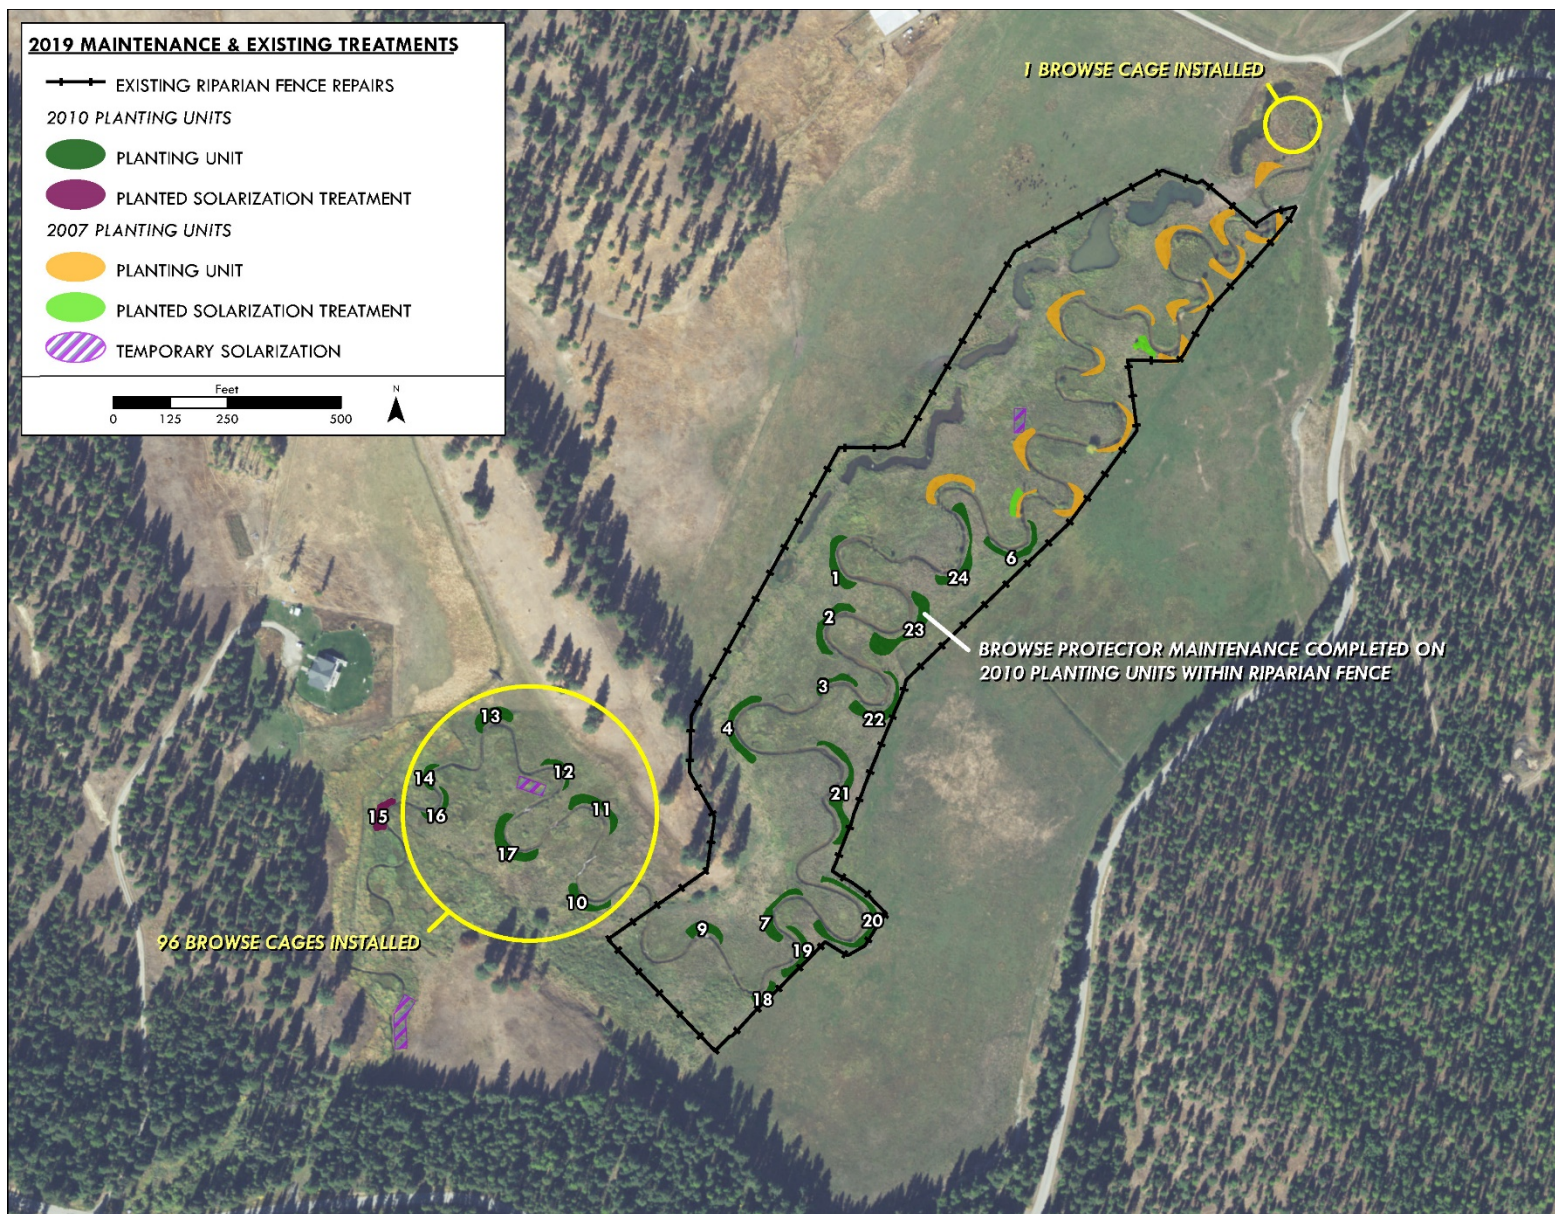
Figure 16. Completed maintenance locations at the Therriault Site in 2019.
