TO: Jim Dunnigan, Montana Fish, Wildlife and Parks
FROM: Amy Sacry, Geum Environmental Consulting, Inc.
DATE: January 28, 2021
RE: Therriault Creek 2020 Maintenance Summary

This memo describes observations made and maintenance work completed in 2020 at the Therriault Creek Restoration Project Site under Montana Fish, Wildlife and Parks (FWP) Task Order 19-0010. Maintenance tasks were identified and completed by Geum Environmental Consulting (Geum). Weed control was completed by Mountain Valley Plant Management (MVPM). This memo also provides a budget status update for Task Order 19-0010 and a list of recommended next steps.

The Therriault Creek Restoration Project was evaluated by Geum on June 23, 2020. Stream flows were at bankfull during the site visit. The purpose of the site evaluation was to determine revegetation treatment maintenance needs, determine weed control needs, and evaluate restoration treatments installed in 2020. A detailed description of observations related to the overall condition of the site is provided in a separate document, *Therriault Creek Restoration Project – Five-year Vegetation Management Plan* (Geum, 2019). This plan identified restoration treatmen

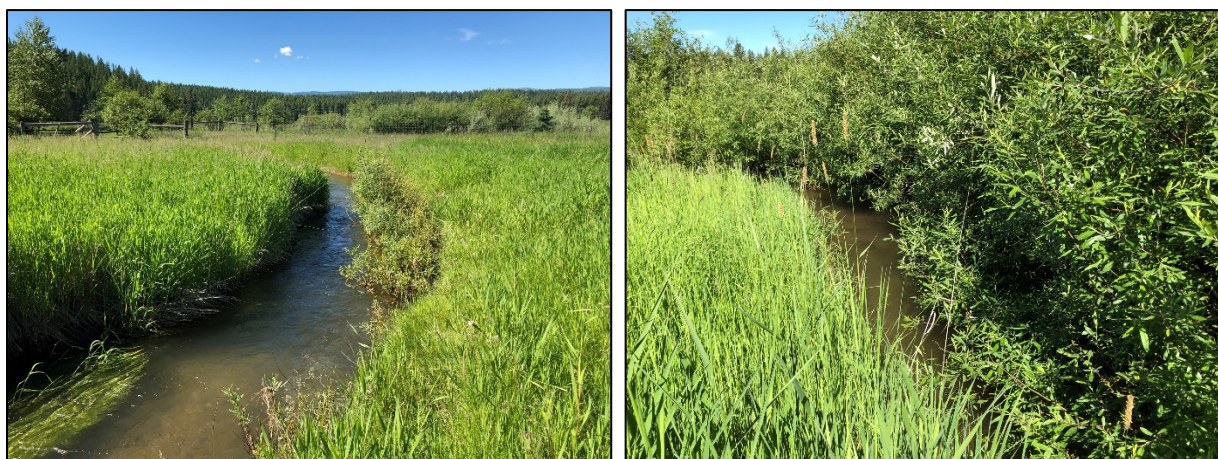
Browse continues to be a primary threat to woody vegetation establishment at the site. However, since installation of the riparian protection fence in 2014, natural expansion of woody vegetation on inside meander bends and streambanks treated with willow cuttings in the 2008 phase of the project has greatly increased (Figure 2 and Figure 3). Expansion from these areas will continue to be very slow due to the extensive cover of aggressive introduced pasture grasses; however, this area has probably reached a desirable level of woody vegetation cover given on-going site constraints, and phasing out the riparian protection fence in this area should be considered.

Figure 2. Browse remains a significant issue at the site (left photo outside riparian protection fence and right photo inside fence).

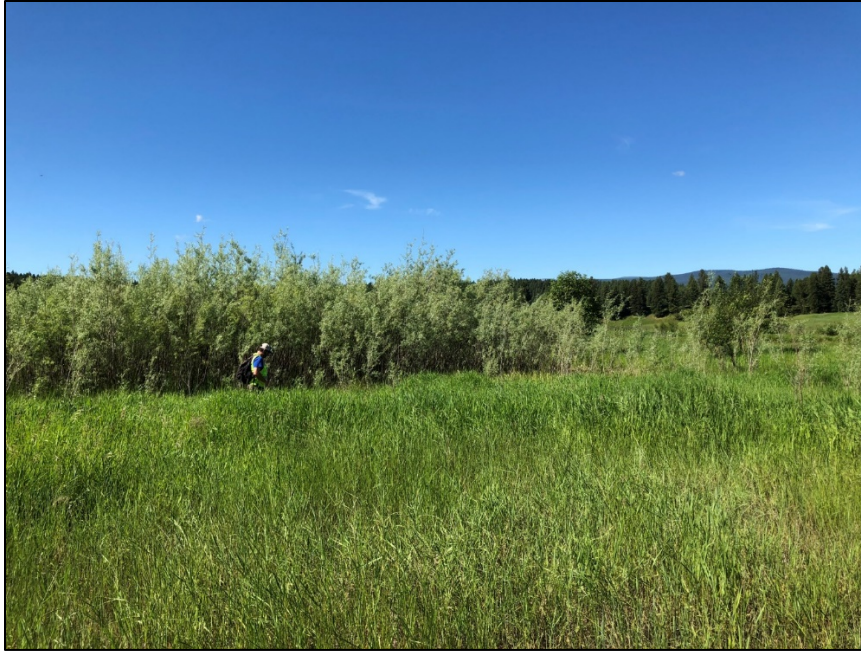
Figure 3. Willow expansion on inside meander bends within the riparian exclosure fence. These areas have dense cover and continue to expand.

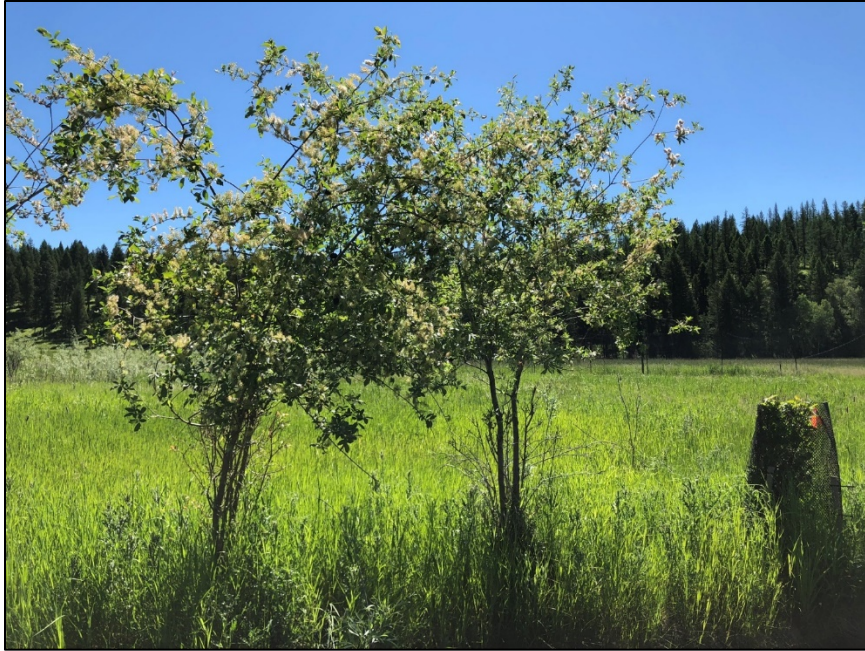
Within the riparian protection fence, browse is still occurring but significant growth on some shrubs was observed in 2020 and many more shrubs are now resistant to browse (greater than 8 feet in height with sufficient lower branch growth). Common browse impacts include: browse of lower branches, particularly where 8-inch diameter plastic browse protectors had originally altered growth form (Figure

Figure 4. 2010 Unit 24 showing lower stem browse partly resulting from growth form impacts from original, small diameter browse protectors. Photo is of two female willow plants producing a lot of seed.

| Plot ID | Remove | Repair/Enlarge | Notes |
|---|---|---|--|
| 2010-24 | 0 | 1 | 9 browse protectors left, plants still alive but are not big enough to remove protectors and should be left on, 1 protector needs to be expanded. |

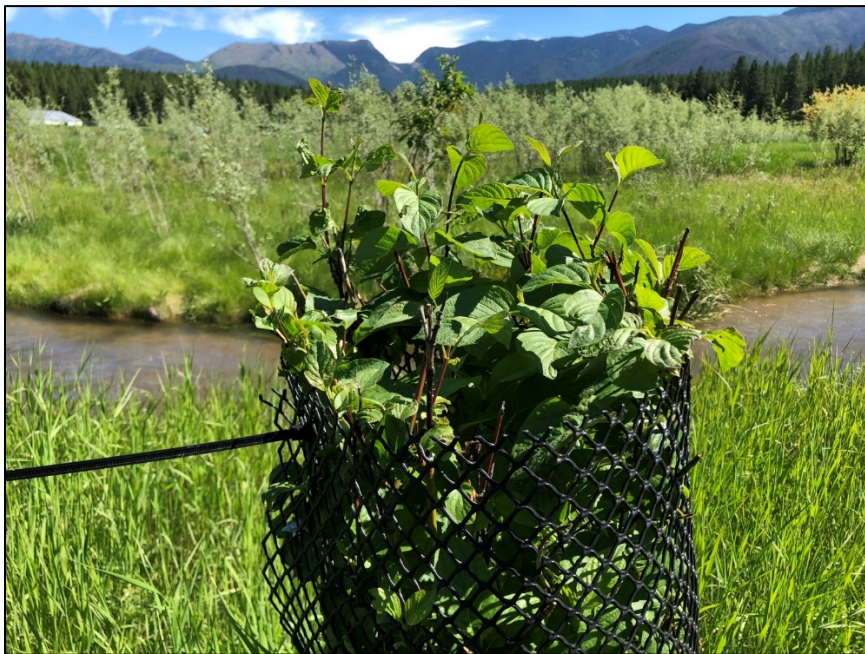
4); and hedging at the top of browse protectors for highly palatable species such as red-osier dogwood (Figure 5).

Figure 5. Unit 2010-1 dogwood browse to top of protector.

| Plot ID | Remove | Repair/Enlarge | Notes |
|---|---|---|---|
| 2010-1 | 3 | 0 | 12 browse protectors left, plants still alive but are not big enough to remove protectors and should be left on. 3 can be removed due to plant mortality. No other maintenance needed. |

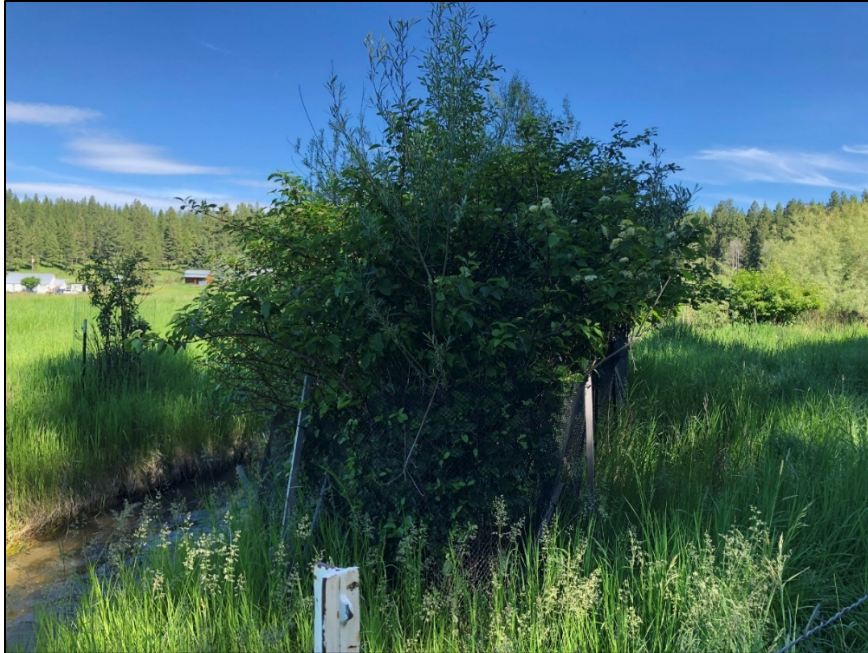
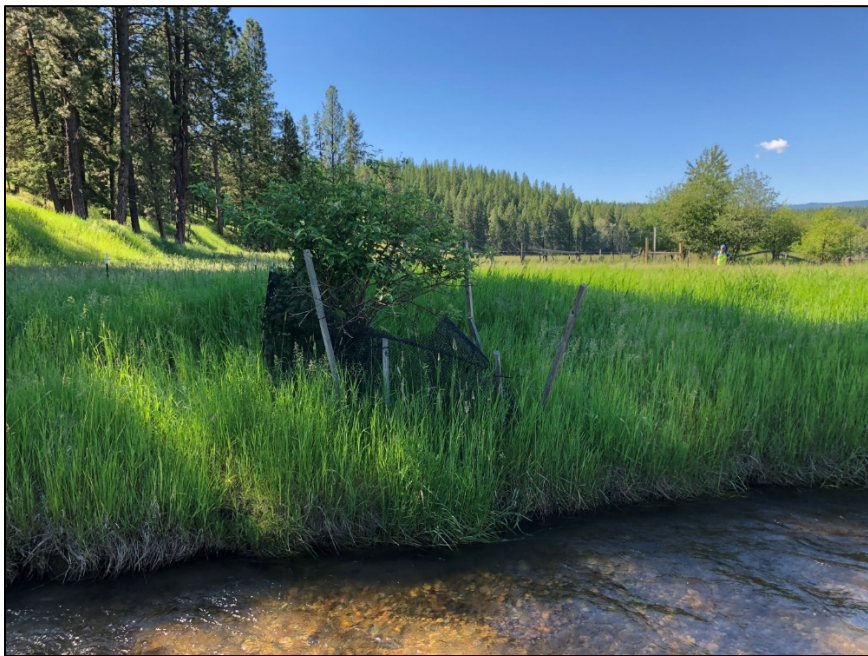
- No repairs were needed to metal cages installed in 2019.
- Some metal cages with dead plants inside should be relocated to protect other living shrubs outside of the riparian protection fence that are still protected by black plastic cages with wooden posts (7).
- Continue to remove plastic browse protectors with wooden posts where shrubs are now large enough to resist browse (19).
- Continue to replace plastic protectors supported by wooden posts with metal cages and t-posts.
- Black plastic netting and wooden posts around clumps of plantings at the upstream end of the site should be removed. These browse protectors have allowed these shrubs to expand and they are now resistant to continued browse (Figure 6).

Figure 6. Clump plantings at the upstream end of the project where black netting should be removed.

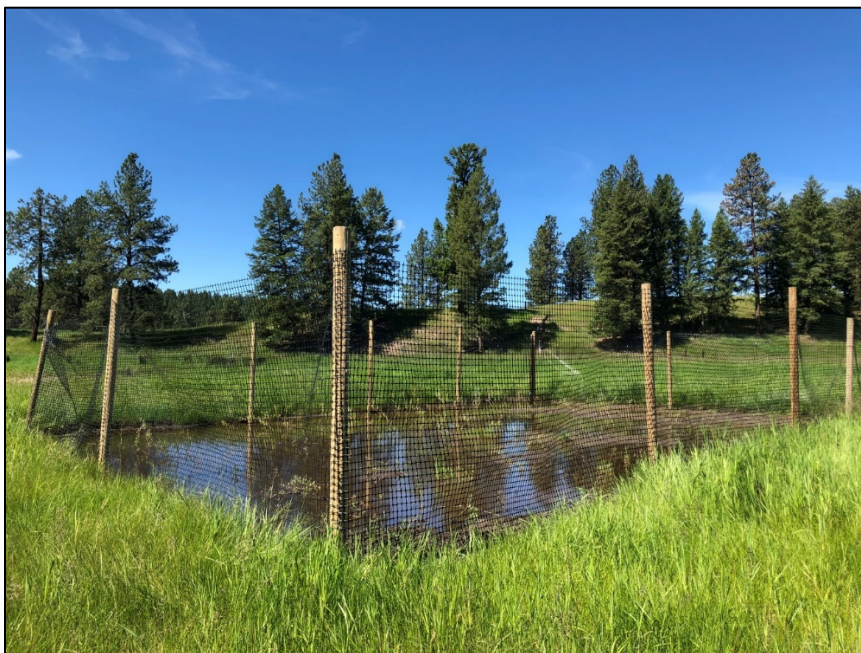
Figure 7 shows Sod Scalping and Planting treatment site S1. This site had 2 to 6 inches of standing water present at the time of the field review. While at least 80% of the planted willows were alive, the standing water at the site may affect survival and growth. Figure 8 shows Sod Scalping and Planting treatment site S2. This site had 90% or higher survival of planted willows. It was too early to determine seeding response. Exclosure fence netting was sagging in some spots but no deer browse or hoof prints were observed within either site.

Figure 7. Sod Scalping and Planting treatment S1.

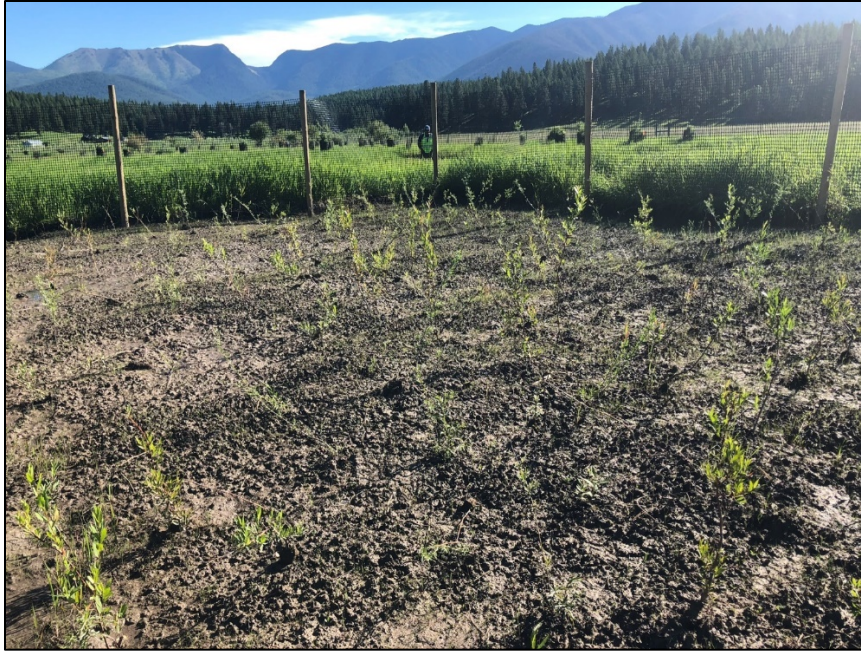
Figure 8. Planted willows in Sod Scalping and Planting treatment (S2.

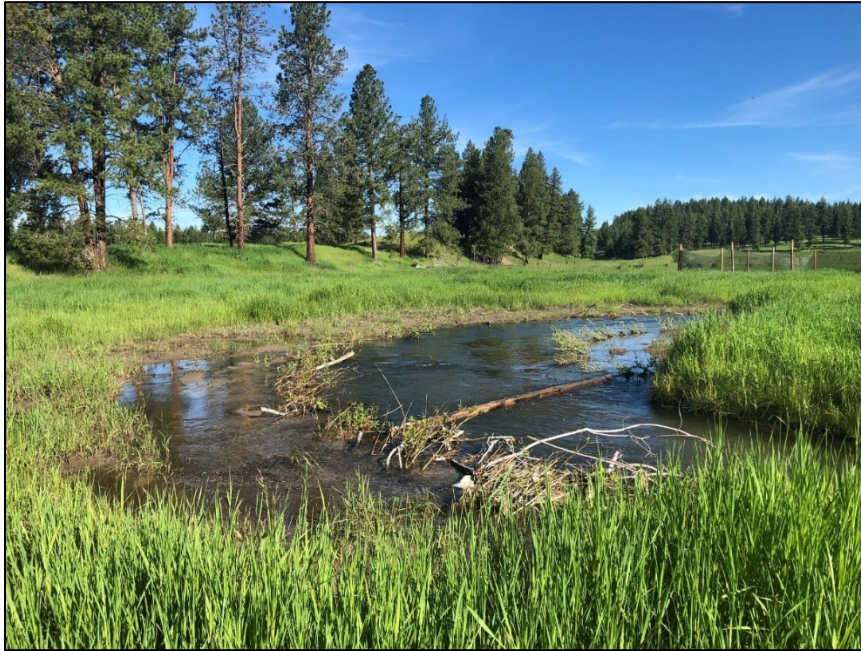
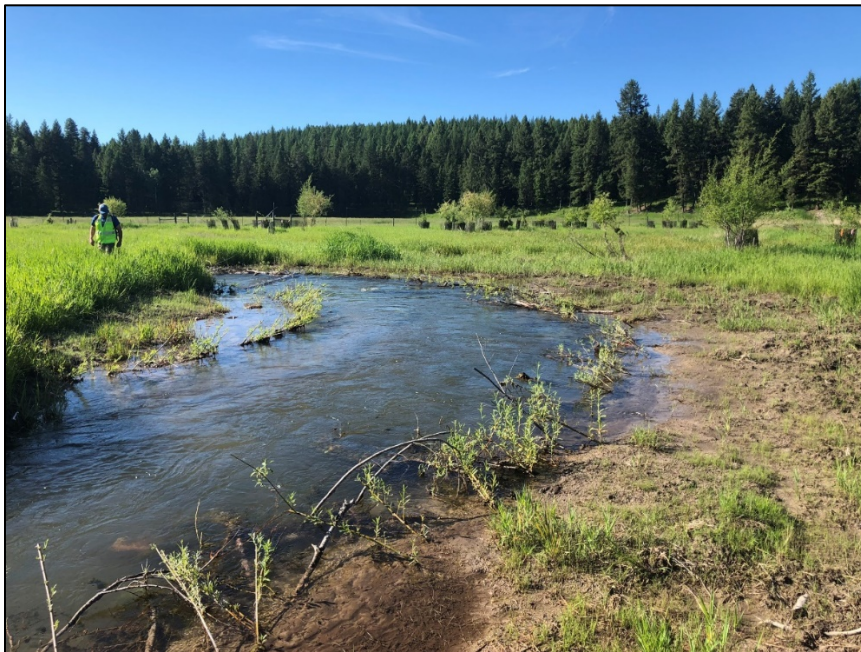
Figure 9. Brush Matrix 2 (BM2) and Point Bar 5 (PB 5) looking downstream to upstream (top photo) and looking upstream to downstream (bottom photo).

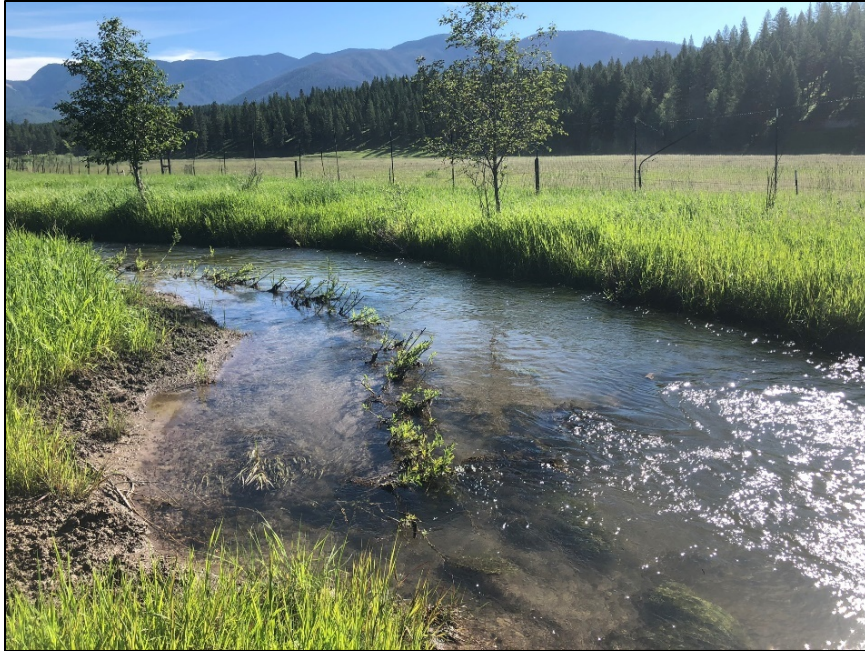
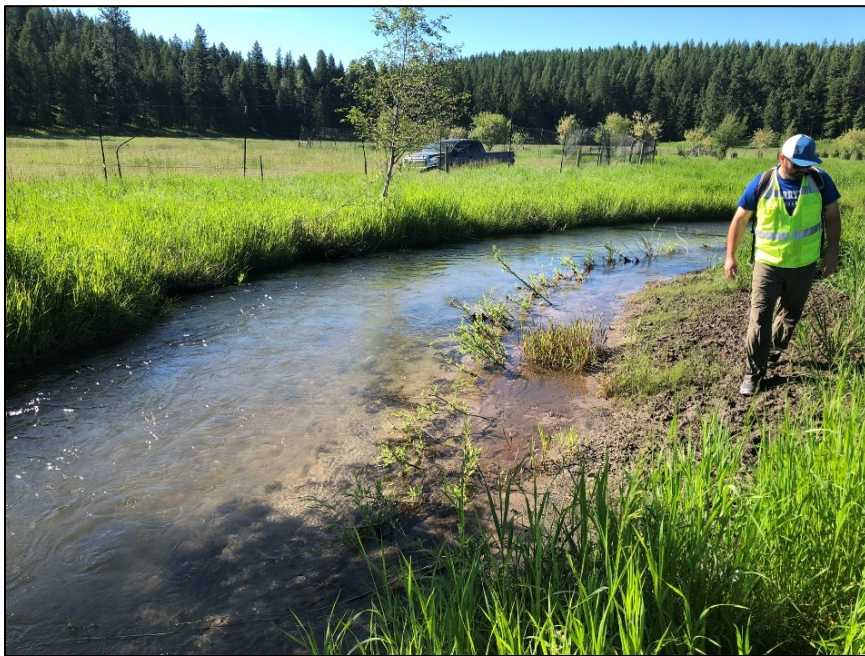
Figure 10. Point bar (PB4) looking downstream to upstream (top) and upstream to downstream (bottom)

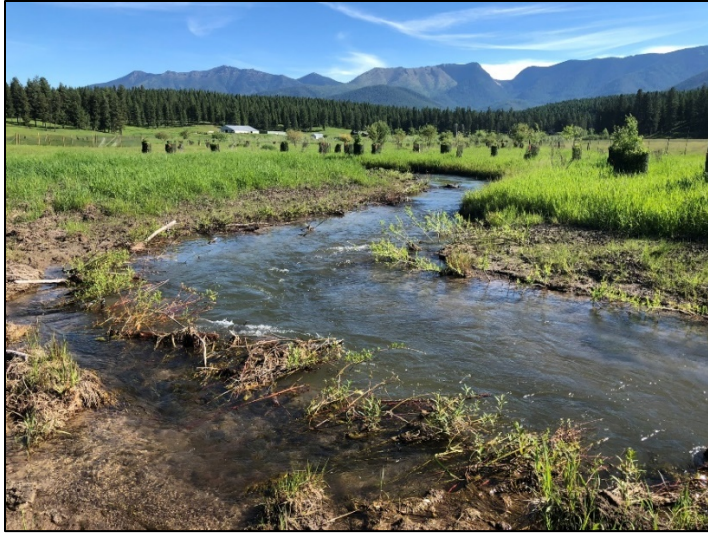
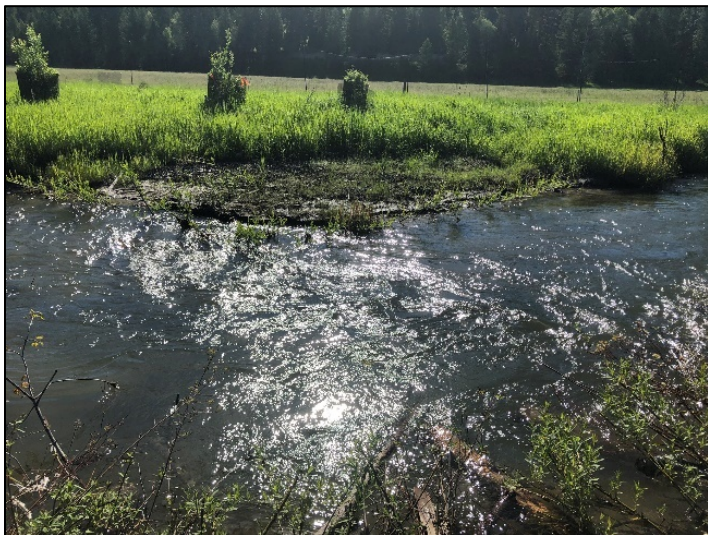
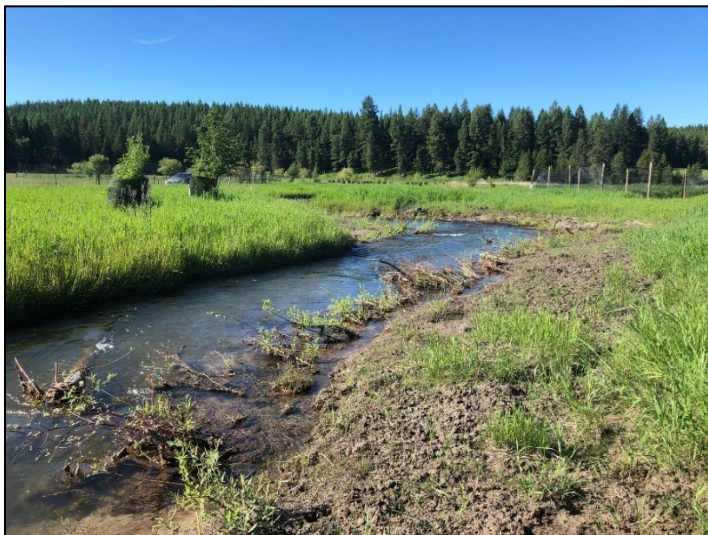
Figure 11. Brush Matrix 1 (BM1) and Point Bar 3 (PB3) looking downstream to upstream (top), looking across at PB3 (middle), and looking upstream to downstream (bottom).

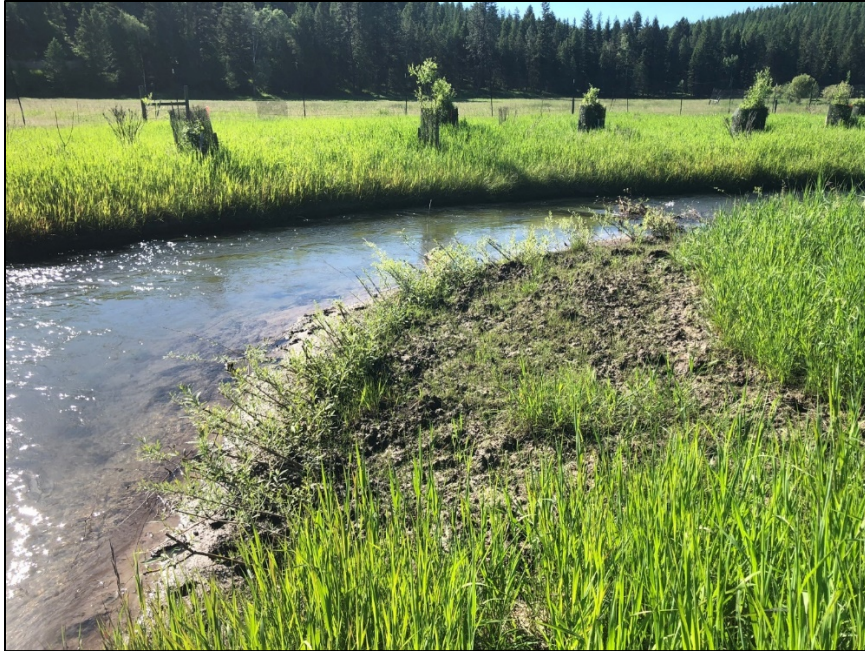
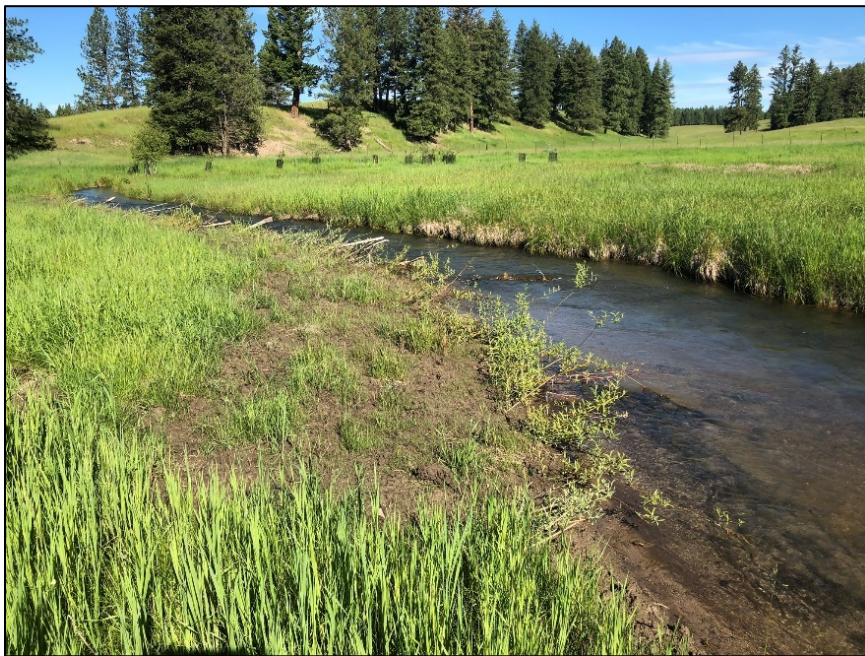
Figure 12. Point bar 2 downstream portion looking upstream to downstream (top) and Point Bar 2 upstream portion looking downstream to upstream (bottom).

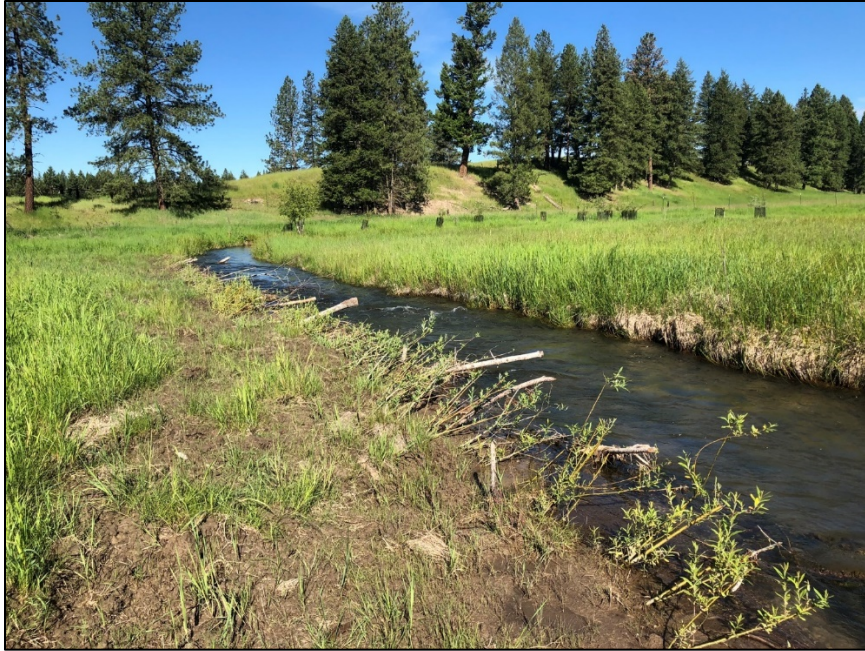
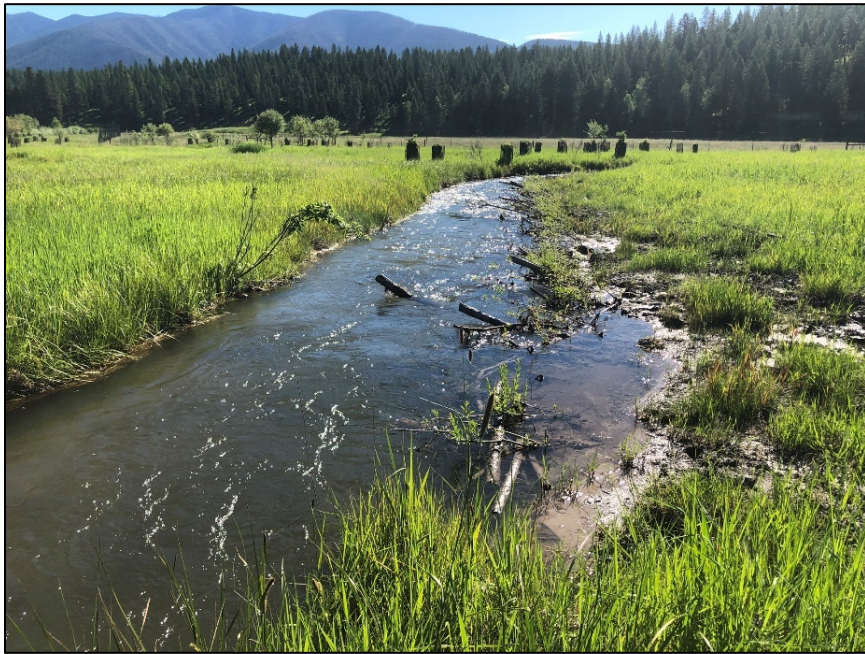
Figure 13. Brush Matrix 3 looking downstream to upstream (top) and upstream to downstream to downstream (bottom).

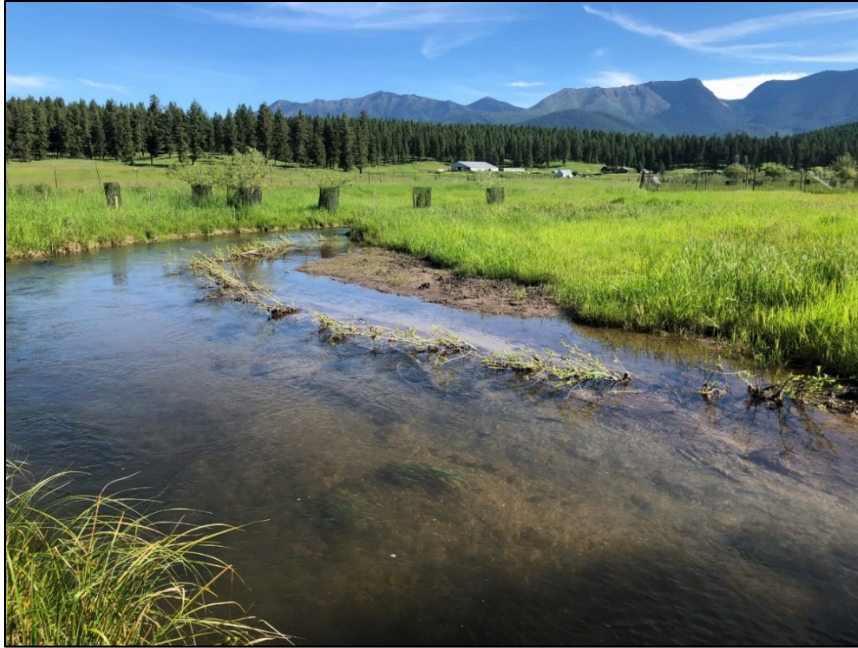
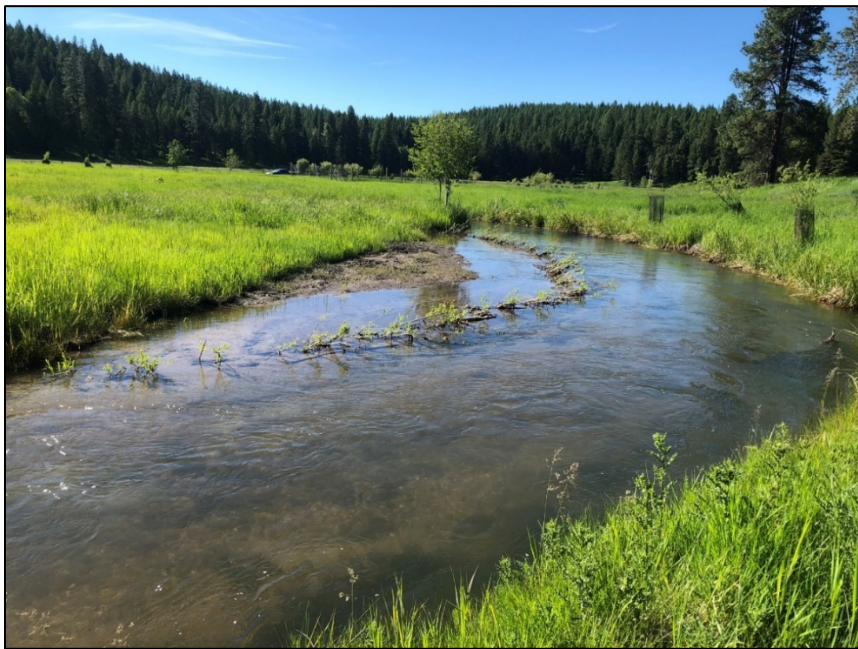
Figure 14. Point bar 1 (PB1) looking downstream to upstream (top) and looking upstream to downstream (bottom).

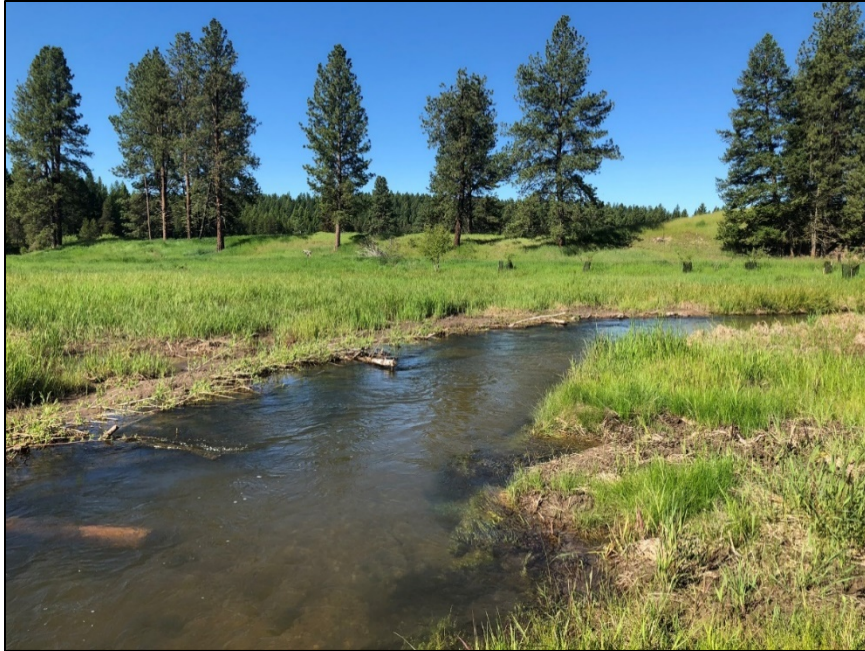
Figure 15. Brush Matrix 4 (BM4) looking upstream to downstream.

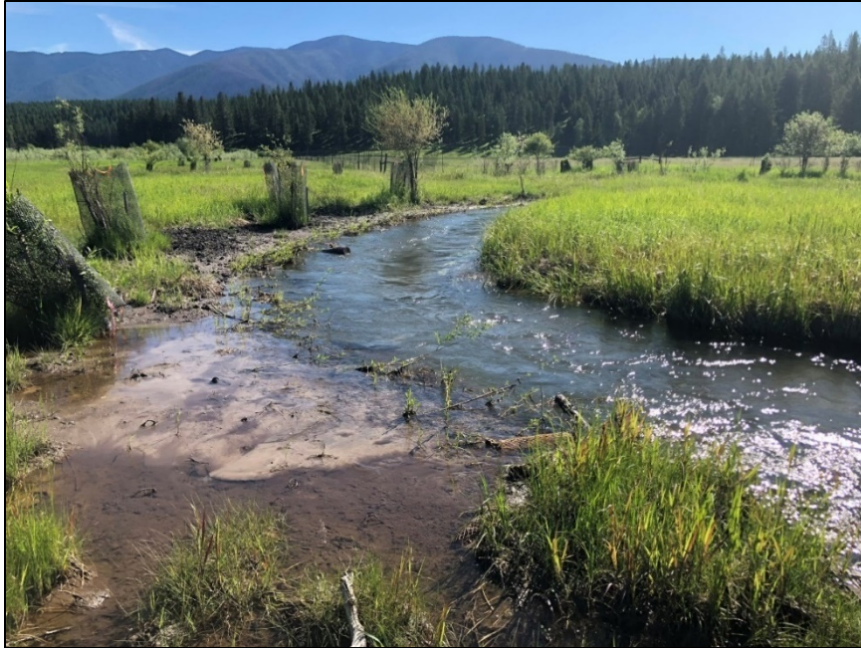
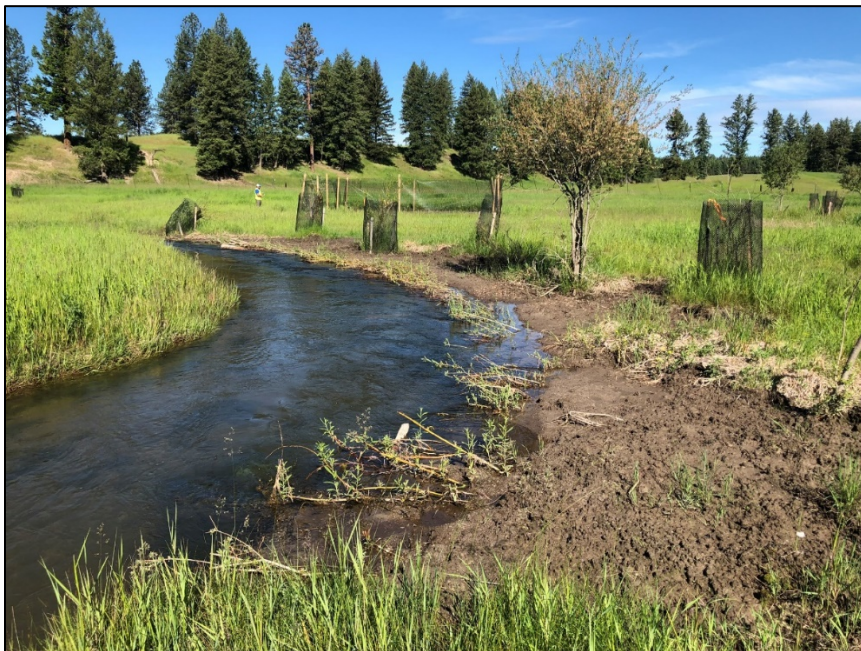
Figure 16. Brush Matrix (BM5) looking downstream to upstream (top) and upstream to downstream (bottom).

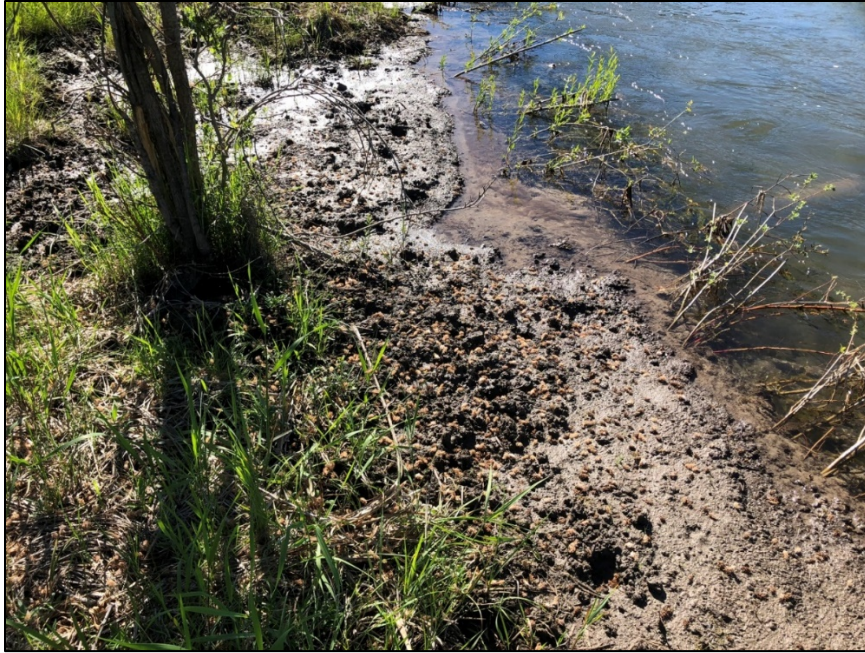
Water was above the top of the bank at all structures in June, 2020. Willow survival appeared to be high, but real success of these treatments is determined by suckering and rapid expansion of willows onto the floodplain behind the structure and will become apparent after one or two more growing seasons. Some scour of streambank material was occurring near the downstream end of two structures. Significant deposition of fine sediments was also occurring in several areas and fresh willow seed was observed on these sediments at streambank BM5 (Figure 17).

Figure 17. Willow seeds covering bare substrates at BM5.

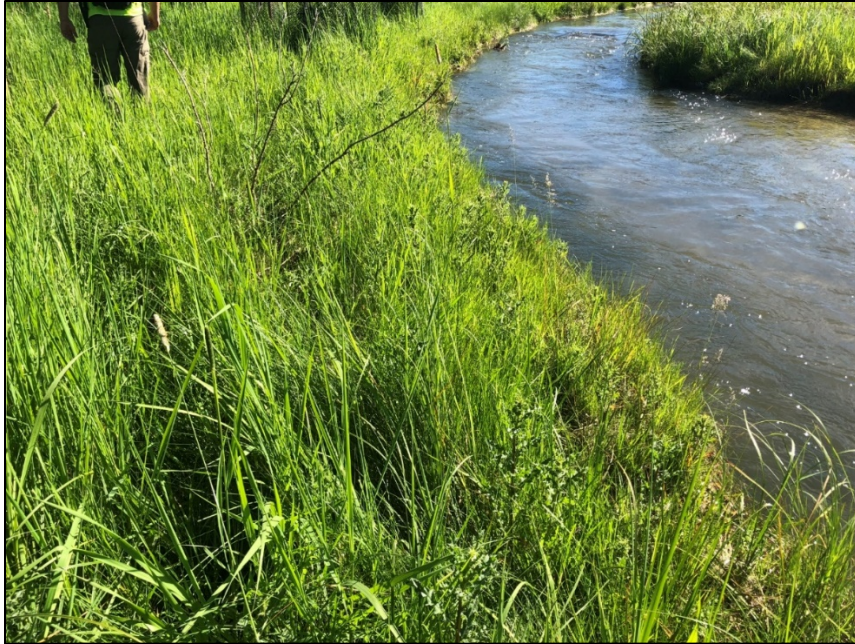
Despite reduced infestations in 2020, Canada thistle is still widely distributed throughout the project area and a significant seedbank likely exists. Canada thistle is still very common along streambanks where it is difficult to treat with herbicide (Figure 18). A similar level of effort of weed control should continue in 2021. Treating isolated clumps of reed canarygrass has prevented its spread and should also continue (Figure 19). Other noxious weed species are scattered throughout the site but have very low cover overall (Figure 20). These species should continue to be treated as well.

Figure 18. Canada thistle infestation along streambank.

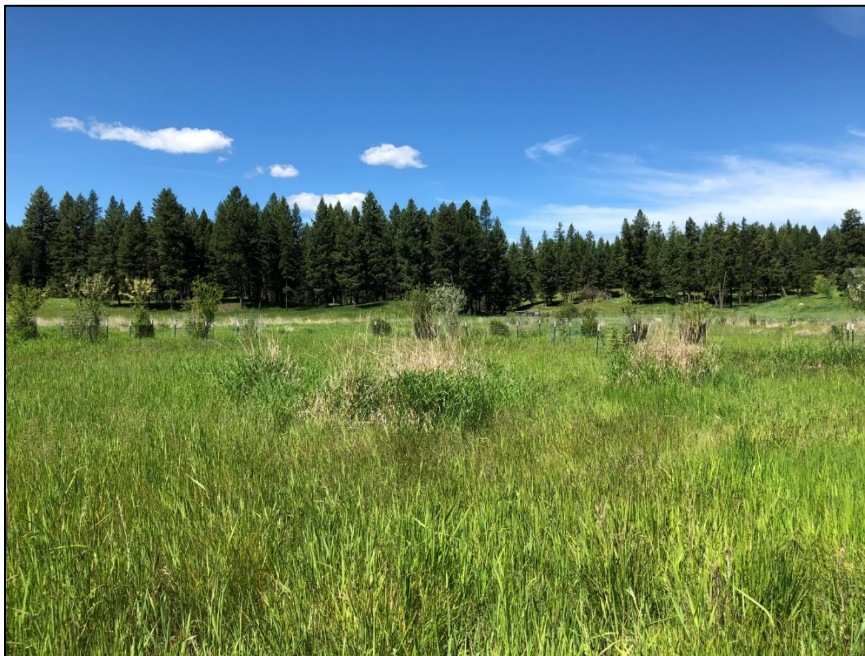
Figure 19. Isolated RCG clumps to continue to target with herbicide.

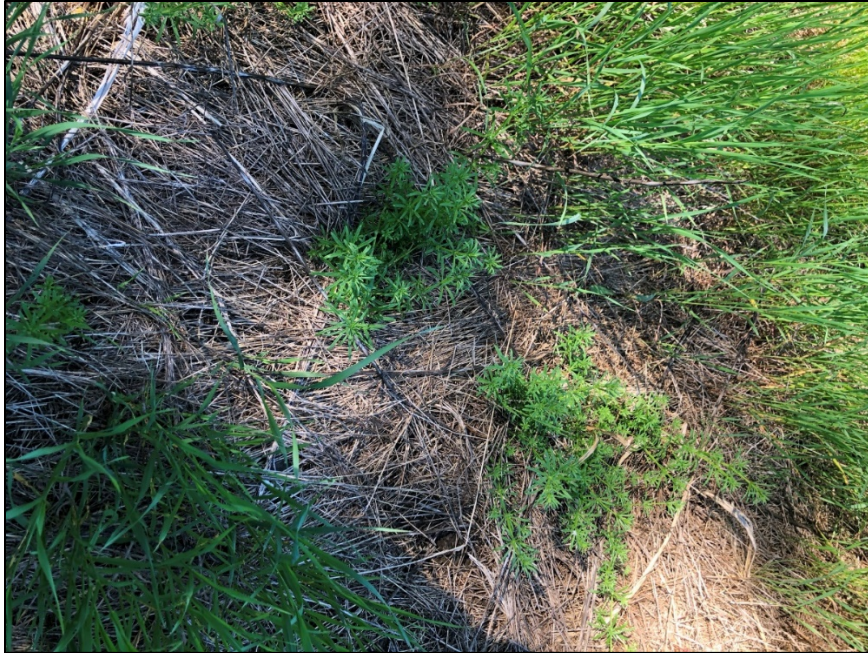
Figure 20. Common toadflax (*Linaria vulgaris*) that continues to persist at the upstream end of the project area.

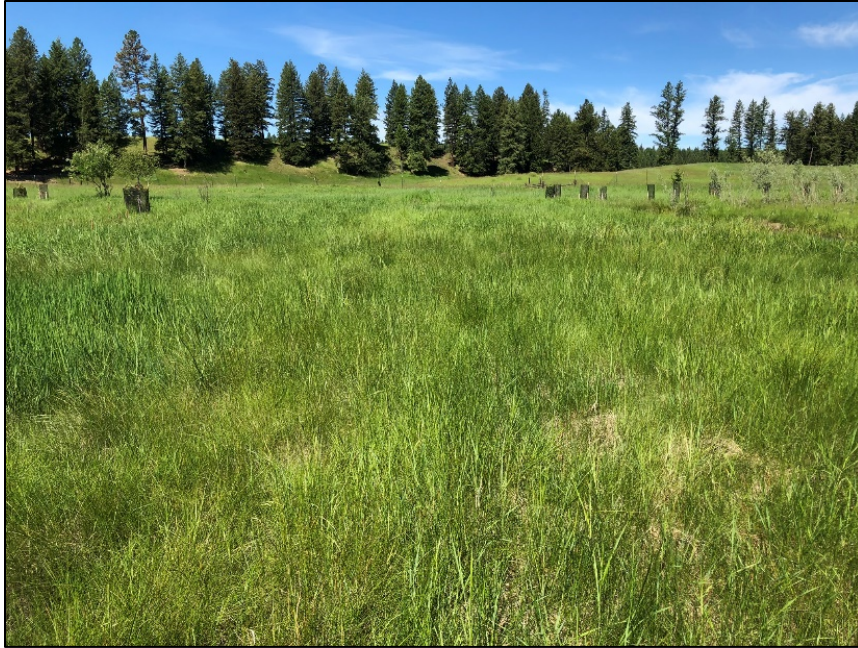
Figure 21. Good area to implement more sod scalping and planting treatment on an inside meander bend between units 2010 1-2.

- Continue sod scalping and planting treatments in areas that are not too wet, to continue to create patches of diversity within the aggressive introduced grass areas (an example area is shown in Figure 21 – this is Site 2 on Figure 23). Establishing several areas such as this will hopefully promote shrub expansion and increase overall woody riparian vegetation cover over time. A reasonable level of effort for this treatment is shown in Figure 23. These locations are close enough to sod disposal areas (i.e. the abandoned channel where sod can be used to diversify wetland margins) for this to be cost-effective, and it would create sufficient patches to increase woody riparian vegetation cover. It is not possible to convert all areas dominated by invasive grasses to woody vegetation, but many of these areas continue to transition to more

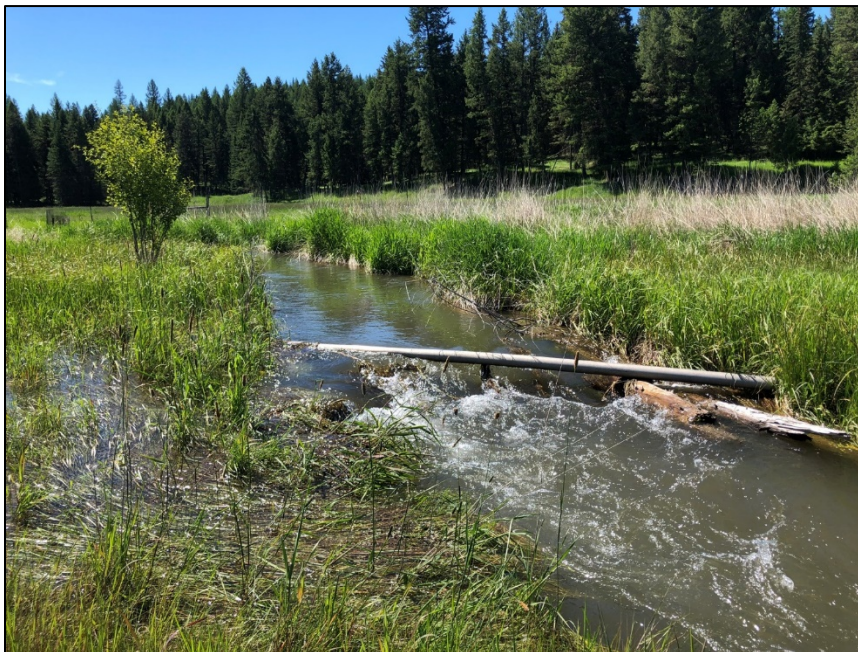
Figure 22. Example potential brush matrix streambank treatment that would allow for removal of reed canarygrass along the streambank (Site 4 on Figure 23).

- Continue to install brush matrix streambank treatments on select outside meander bends to create pockets of woody cover along the channel (Figure 22).
