GRAVE CREEK RIPARIAN REVEGETATION 2008 AS-BUILT AND 2009 MONITORING REPORT

KOOTENAI RIVER NETWORK
P.O. BOX 491
LIBBY, MT 59923

GEUM ENVIRONMENTAL CONSULTING, INC.
307 STATE STREET, P.O. BOX 1956
HAMILTON, MT 59840

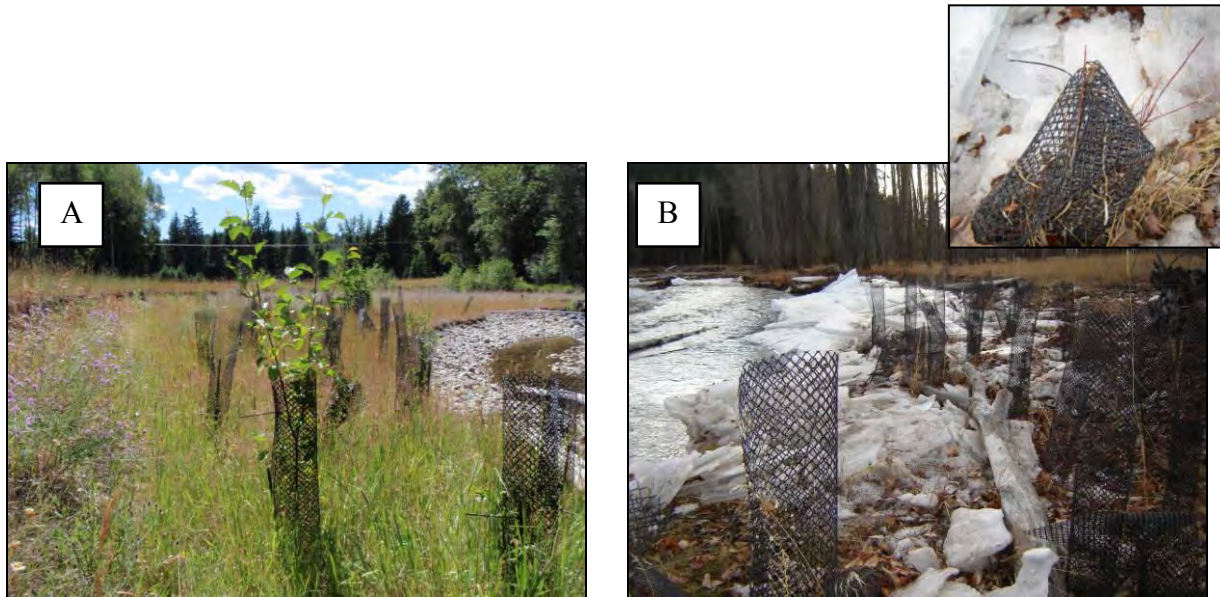
- Plant growth is being suppressed and/or contorted by damage to browse protectors from ice and debris (Figure 2).

Figure 2. Planting Area Monitoring Plot 4 (Photograph A) is located at the downstream end of the project reach and browse protectors have remained relatively intact compared with Planting Area Monitoring Plot 1 (Photograph B), which is located at the upstream end of the project reach where ice is more prevalent.

Browse continues to affect planted containerized stock. Treatments proposed in the 2008 plan included removal of all browse protectors placed around containerized plants to reduce the damage to plants resulting from ice flows bending and distorting the rigid mesh protectors. Based on the 2008 observations, this treatment was modified to expand existing browse protectors in locations where ice damage was minimal and remove browse protectors in areas closest to the channel and vulnerable to ice damage.

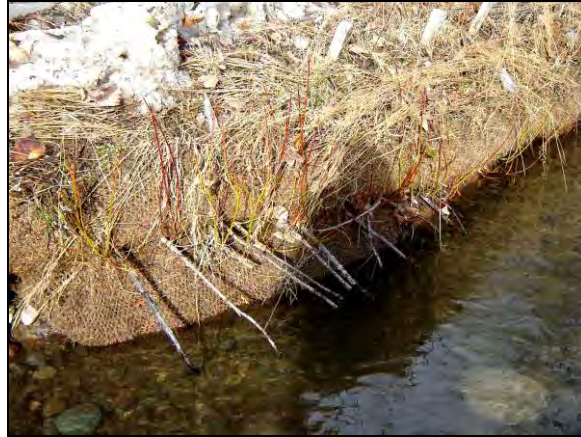
Figure 3. Photograph showing vegetated soil lift installed in 2005 with new willow shoot growth near the base of the stems.

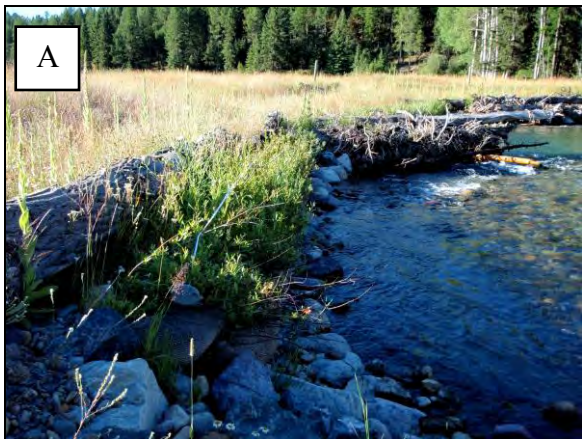
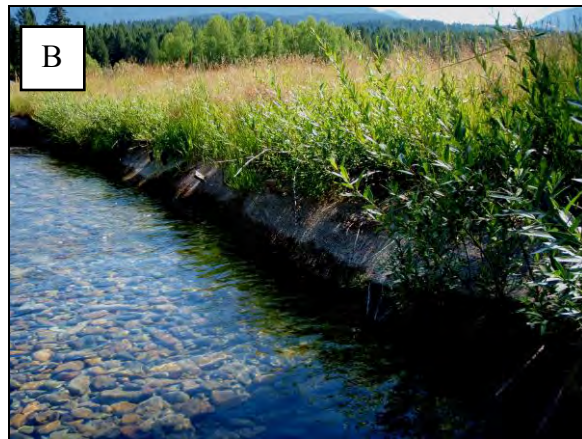
Figure 4. Photograph A shows soil lift 2 constructed in 2006 with a log and rock toe. Photograph B shows soil lift 4 constructed in 2005 without only a cobble toe. Soil lift 4 has more than 80% toe scour and soil lift 2 has 0% toe scour. Willow survival is high on both vegetated soil lifts. Willows growing in the top layer of both lifts had signs of browse.

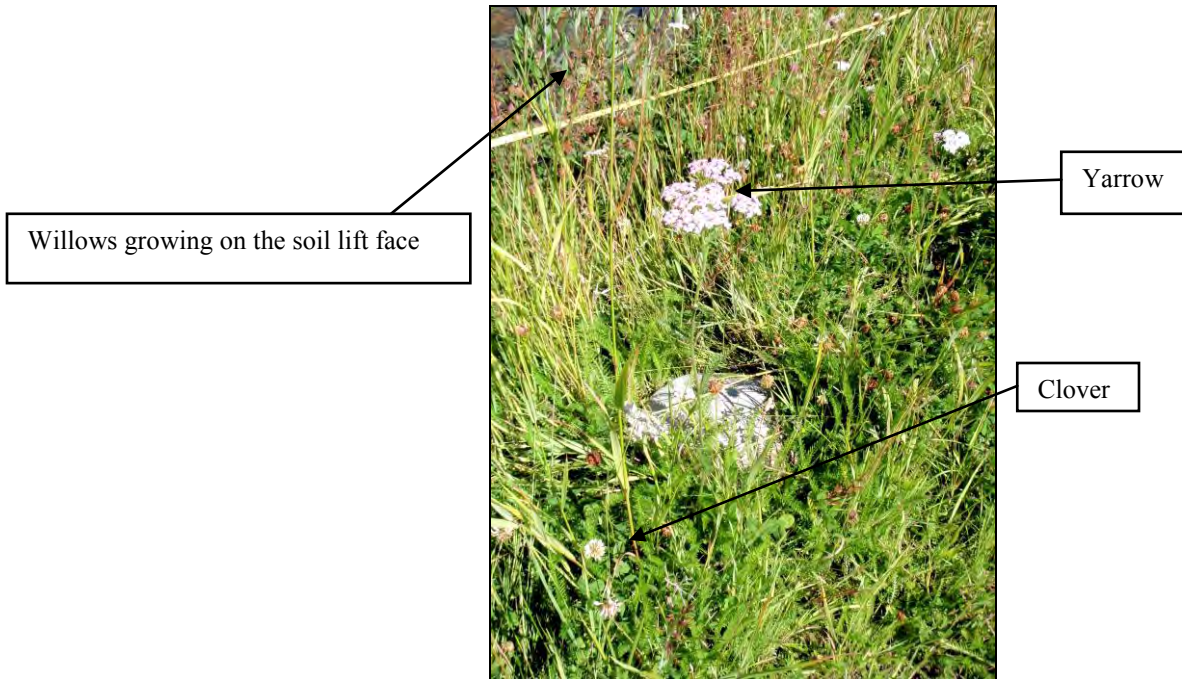
Figure 5. Photograph shows the back edge (floodplain side) of soil lift 4, where species such as yarrow and clover are abundant.

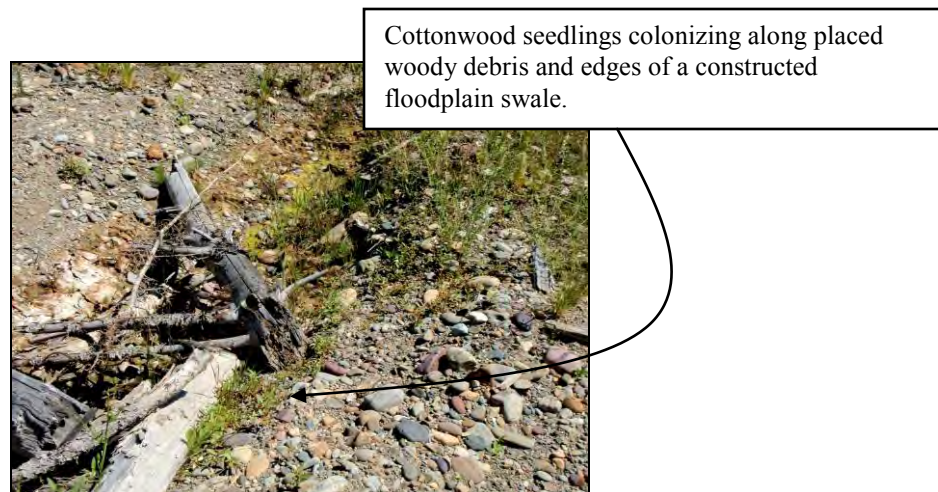
Three constructed point bars were monitored in August 2008 (Figure 1). Monitoring data collected at each site is provided in Table A-3 in Appendix A. The results of this monitoring indicate that constructed point bars are creating conditions where desired pioneer plants can colonize and plant community succession has the potential to progress. Results of effectiveness monitoring data collected in August 2008 were similar to those collected in December 2007 except that a greater amount of cottonwood seedlings were observed on all point bars in 2008 (Figure 6).

Figure 6. Photograph shows the high density of cottonwood seedlings around and within constructed floodplain swales observed during 2008 monitoring.

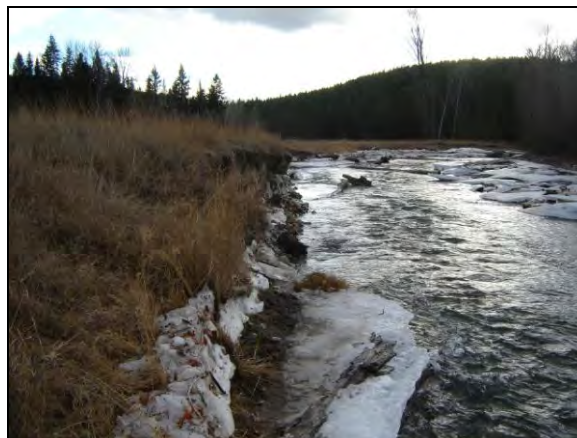
During 2007 monitoring, accelerated lateral erosion resulting in an approximately six-foot high actively eroding bank was observed (Site 2) (Figure 7). This site has been identified as a potentially major contributor of fine sediment in the project reach. Streambank instability and lateral erosion limit the establishment of woody vegetation and prevent plant community succession from occurring. The 2008 Revegetation Plan included treating the site by constructing a vegetated setback bank in the anticipation of continued erosion. A vegetated set back bank establishes woody vegetation parallel to, and set back from, the eroding stream bank. The setback distance allows woody species time to develop dense root systems that will provide structure to the stream bank as the channel migrates toward the setback bank.

Figure 7. Photograph shows Site 2 eroding bank in December 2007.

After considering these options, project partners selected the vegetated setback bank as the most cost-effective option for Site 2. This would allow the channel to continue to migrate and adjust without compromising either existing channel structures or the long-term stability of the project reach.

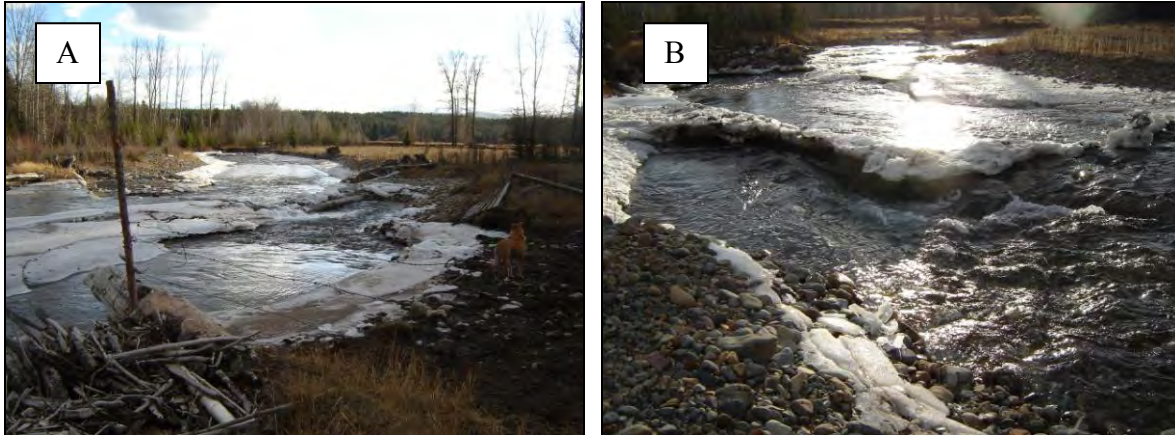
During 2007 monitoring, areas of localized channel incision were observed. This was of particular concern in one section of stream where channel incision occurred when the river flanked two channel structures (Figure 8). The purpose of these structures is to maintain the channel elevation and form temporarily while streambank vegetation establishes and channel

Figure 8. Photograph A shows the structure at Site 7 requiring repairs due to flanking behind the structure arm resulting in accelerated lateral bank erosion. Photograph B shows the structure at Site 8 requiring repairs also due to flanking behind the structure arm.

substrates are sorted. Therefore, repairs to these structures were included in the 2008 Revegetation Plan. During August 2008 monitoring and final design, two additional woody debris jams were added at this site to reduce scour of an eroding floodplain terrace and allow for construction of a vegetated soil lift to establish woody vegetation.

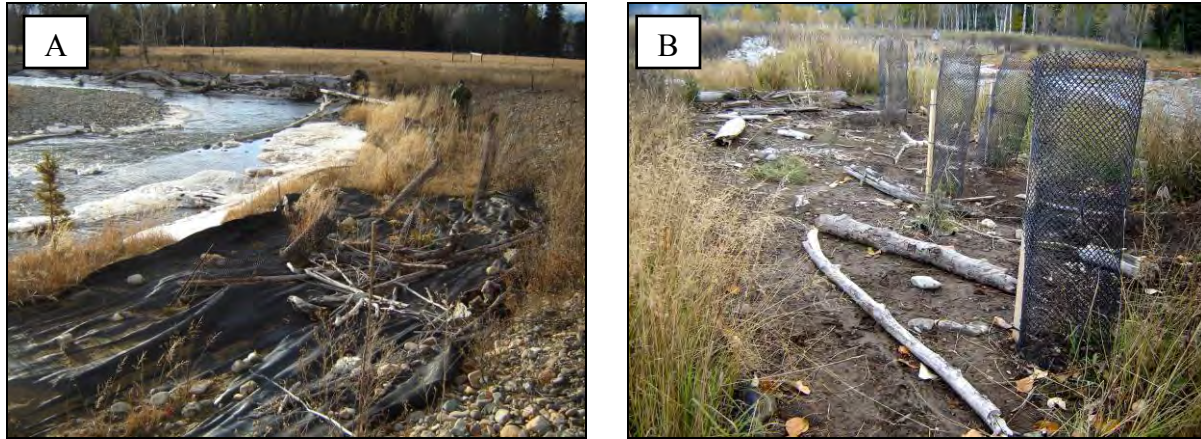
Figure 11. Photograph A shows Planting Area 2 before 2008 maintenance and Photograph B shows Planting Area 2 after 2008 maintenance. Most browse protectors were removed, while others were adjusted to allow plants to expand. Wooden stakes were used as support instead of rebar. Rebar bent during ice flows resulting in damage and constriction to plants.

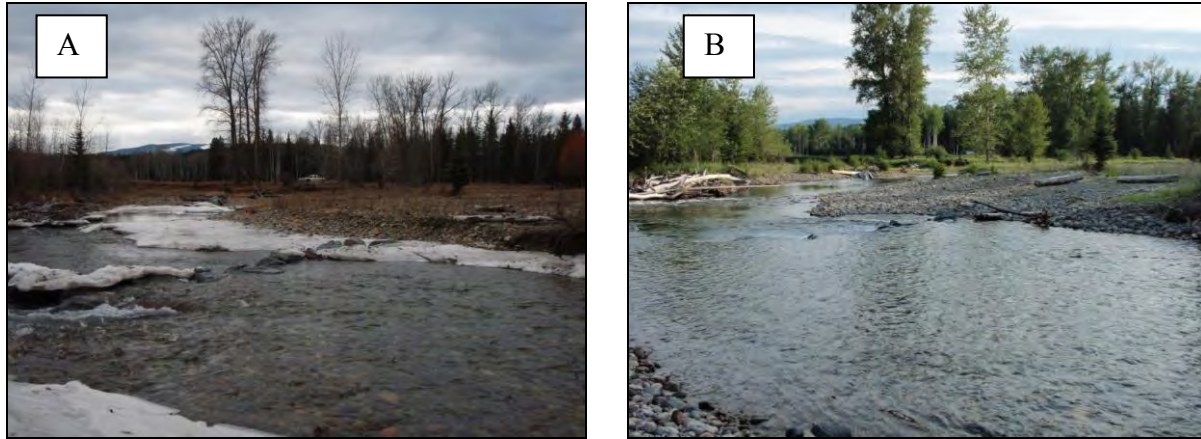
Figure 13. Photograph shows Site 8 before grading (A). Minor channel incision has reduced the potential hydrologic connection between the channel and floodplain. Photograph B shows the site the summer following grading.

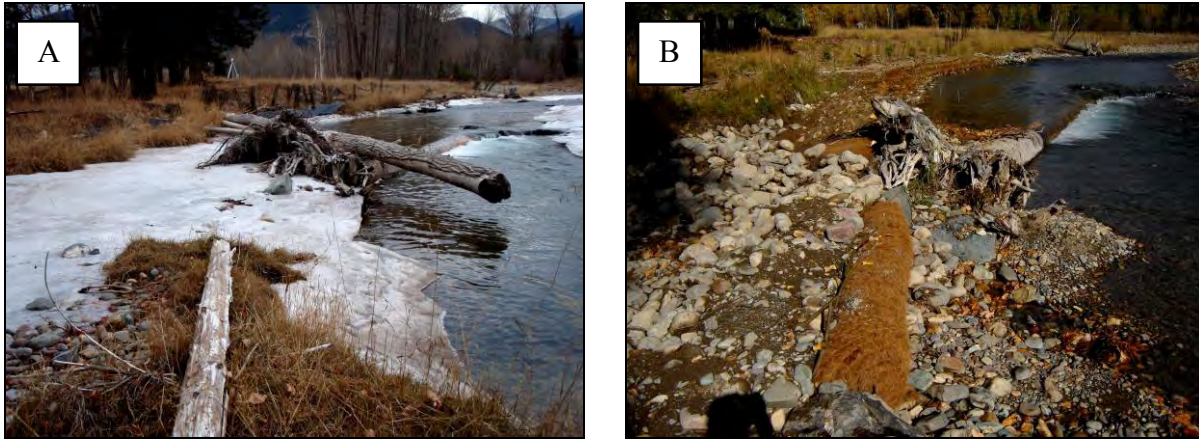
Figure 19. Photograph A shows the downstream end of Site 5 before construction. The ice accumulation represents the area that scoured behind and downstream of the log j-hook channel structure. Photograph B shows the downstream end of Site 5 after the installation of 16-inch, 9 pound density coir logs in the scour area (foreground) and a vegetated soil lift to reconstruct the bank line upstream of the J-hook channel structure (background).

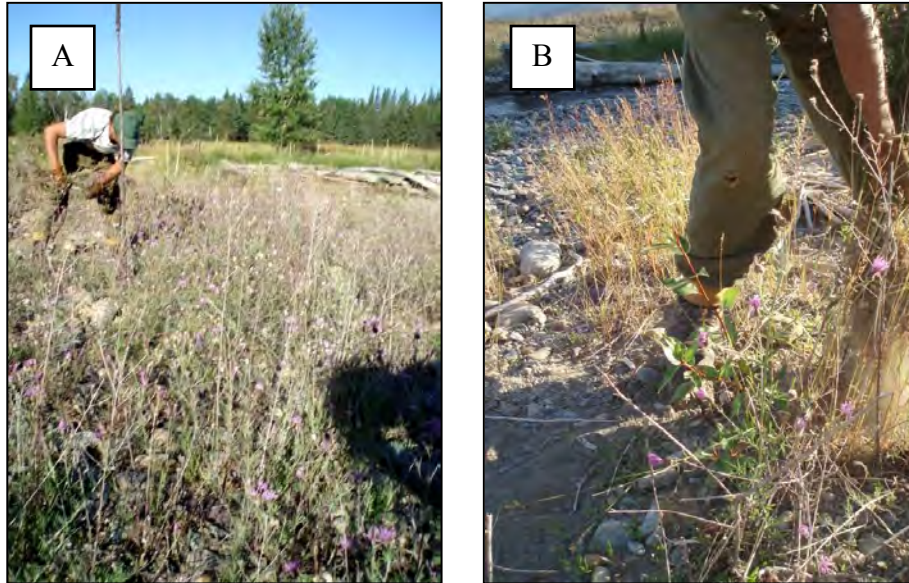
Figure 24. Photograph A is an example of a knapweed infestation occurring on a floodplain surface within the project reach. Photograph B demonstrates how the method of pulling weeds by hand allows for the removal of weeds from sensitive areas, such as where cottonwood seedlings are establishing.

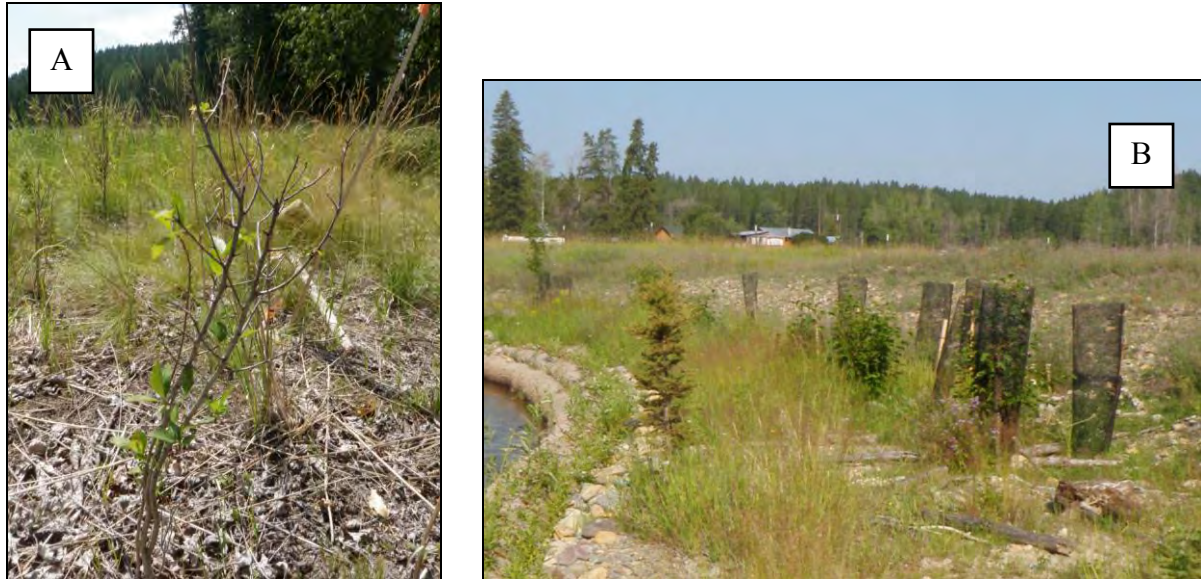
Figure 28. Photograph A shows a shrub that was released from browse protection in October 2008. Although damaged by ice and browse since being planted in 2005, the shrub has begun to re-sprout. Photograph B shows planted shrubs that were retro-fitted with larger browse protectors in October 2008. Many of these shrubs have expanded within the larger browse protectors and grown in both width and height.

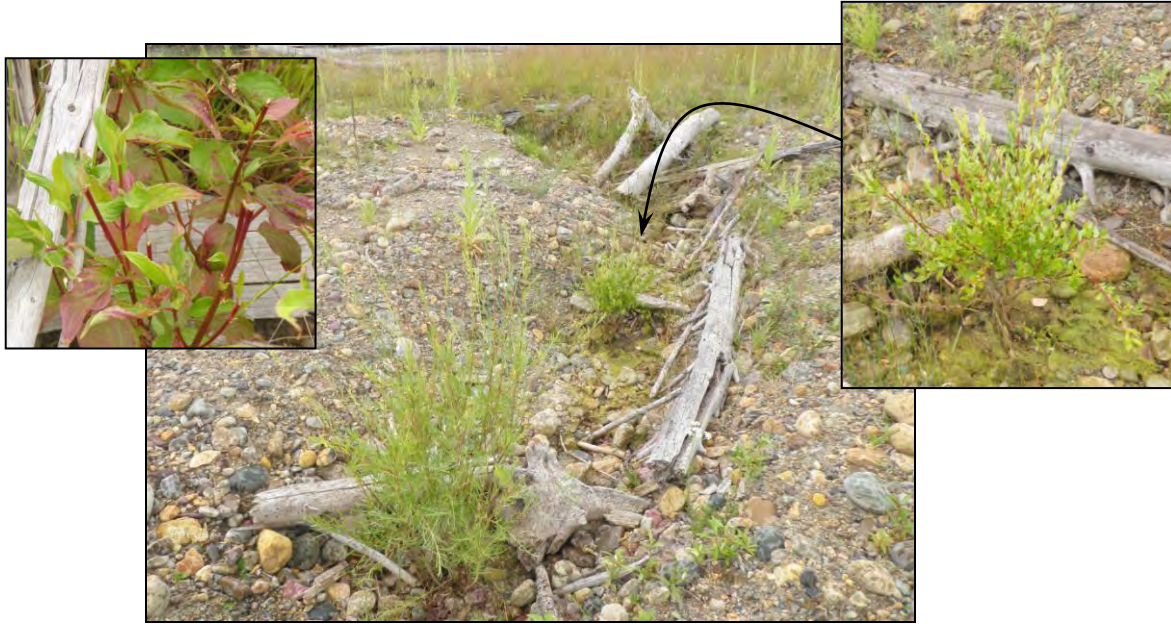
Figure 30. Photograph of planted swale at Site 12 (outside the electric fence). Plants installed during 2008 have a high rate of survival but show signs of slight to moderate browse. Plants within these swales are one to two feet shorter than those within the electric wildlife fence. Inset photos are examples of the browse occurring within swales outside of the electric fence.

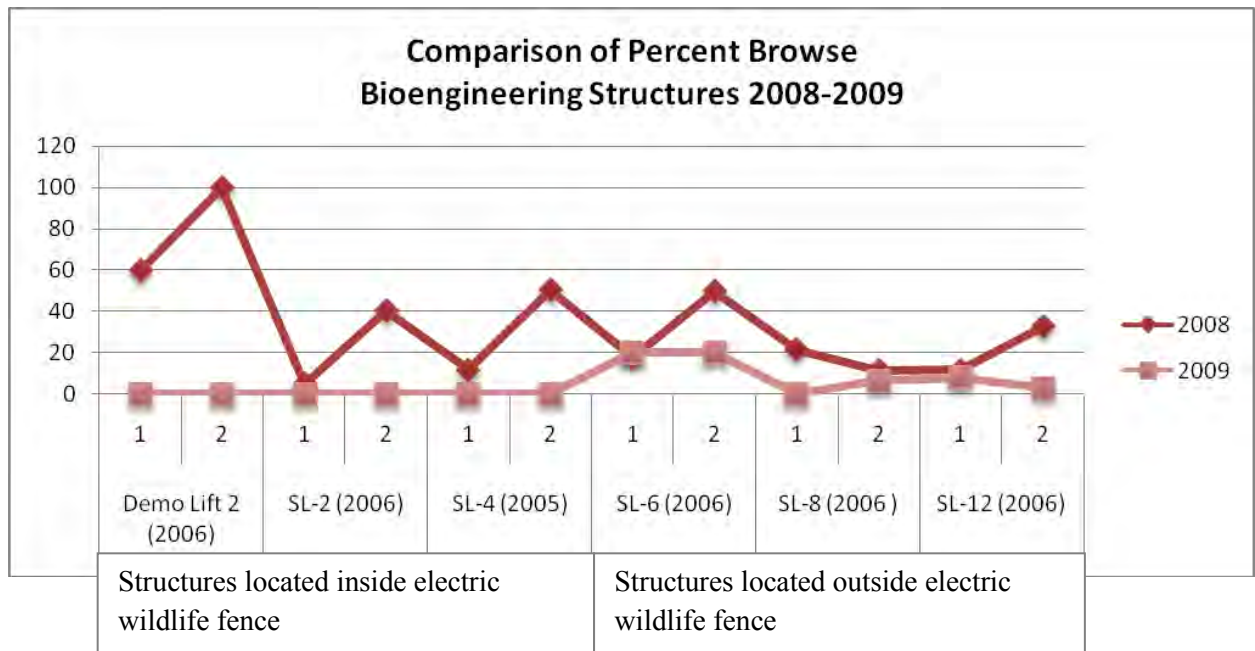
Figure 37. Comparison of percent of willows showing signs of browse on vegetated soil lifts in 2008 and 2009. For each structure, the bottom layer is designated as ‘1’ and the top layer is designated as ‘2’. Top layers have higher percent of stems browsed because they are more easily accessed.

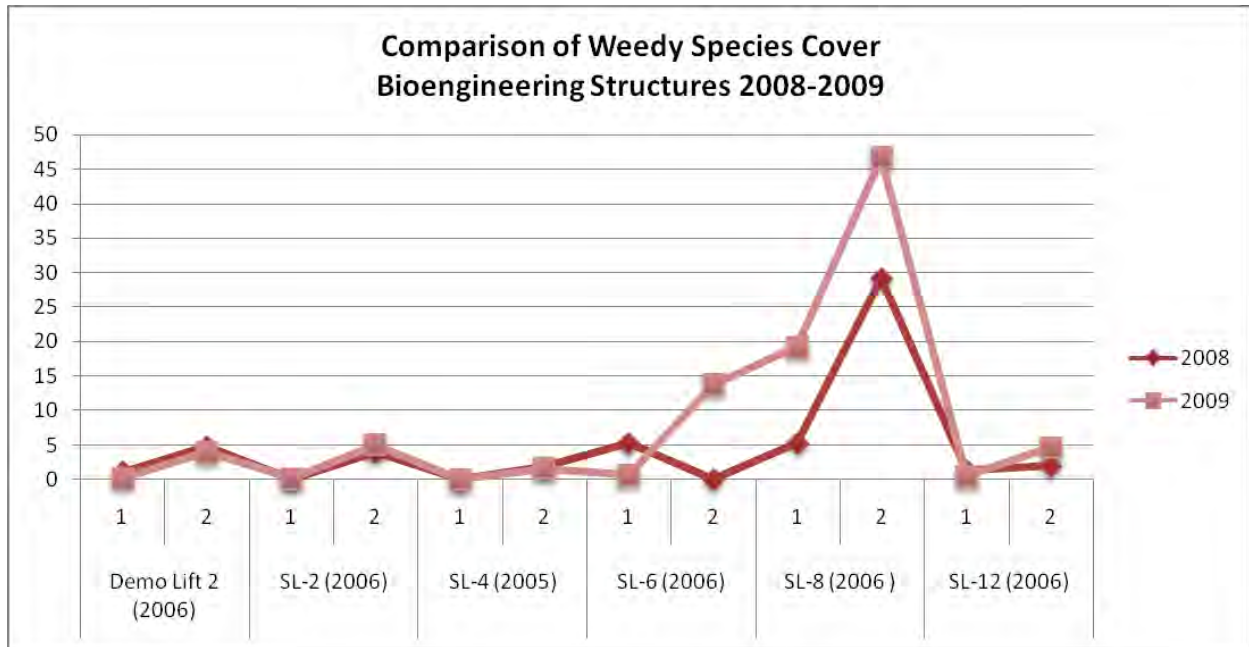
Figure 38. Comparison of weedy species cover on vegetated soil lifts 2008 and 2009. For each structure, the bottom layer is designated as '1' and the top layer is designated as '2'. Top layers have higher percent cover of weedy species.

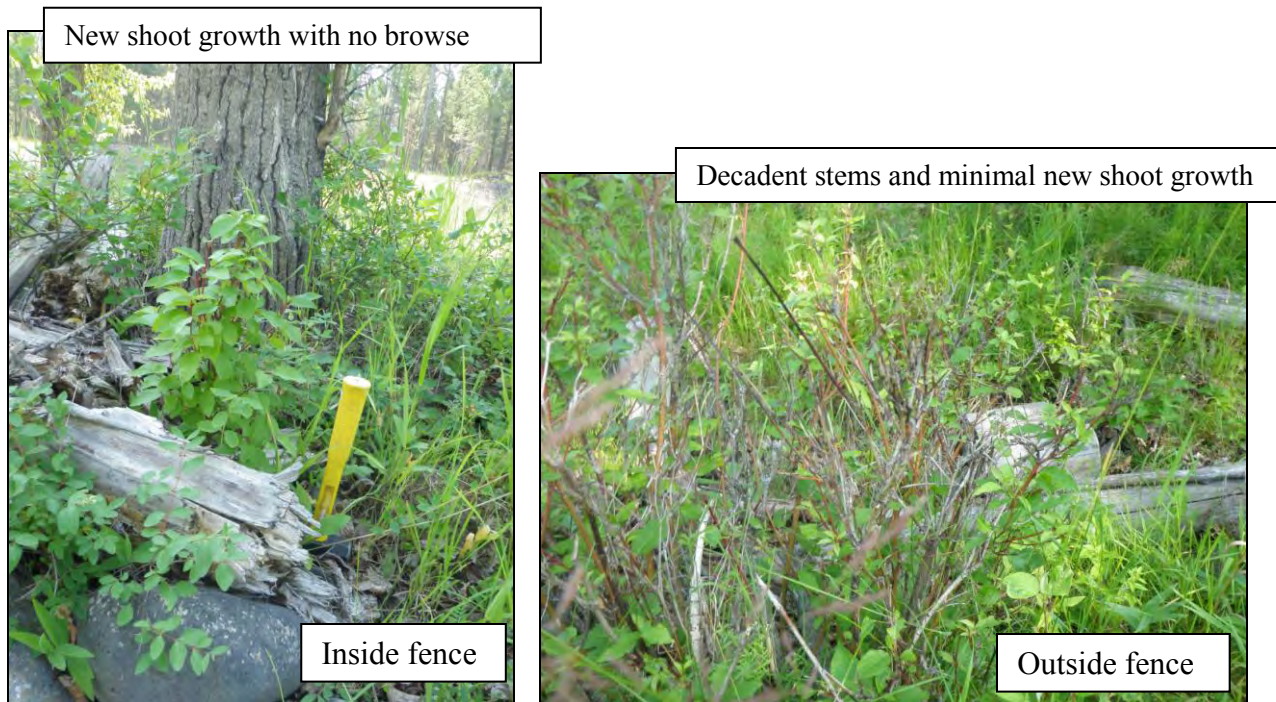
Figure 45. Photographs showing the difference in growth form of dogwoods found in (left) and outside of (right) the electric fence. Dogwood are highly palatable plants and thus a good indicator of browse pressure.
