Grave Creek Demonstration Project Area Riparian Revegetation and Vane Maintenance As-built Report

Task Order #0906

GEUM
ENVIRONMENTAL
CONSULTING, INC

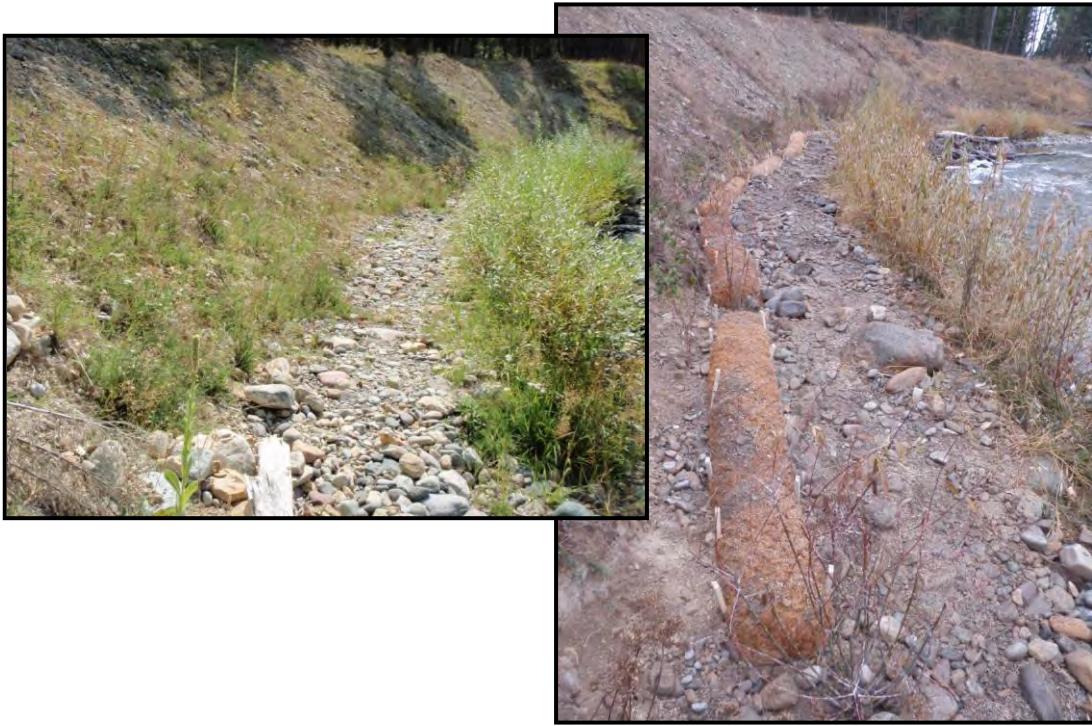
Figure 3. Photographs of revegetation of the terrace slope using 16-inch high density coir logs, 16-gallon willows, and one and two-gallon shrubs. This treatment was focused on the interface of the terrace slope and bankfull bench. Photograph on the left shows the bench prior to treatment. Photograph on the right shows the bench after treatment.

A trench was excavated to a depth of approximately eight inches (half the diameter of the 16-inch coir logs). The coir logs were placed in the trench, back-filled with material from the slope and staked into place using 1-inch x 2-inch x 24-inch wooden stakes and coir twine. Sixteen-gallon plants were installed between the coir logs and one- and two- gallon shrubs were installed between the coir logs and the bottom edge of the slope. The bench between the coir logs and vegetated soil lifts was seeded with a native seed mix (species are listed in Table 2).

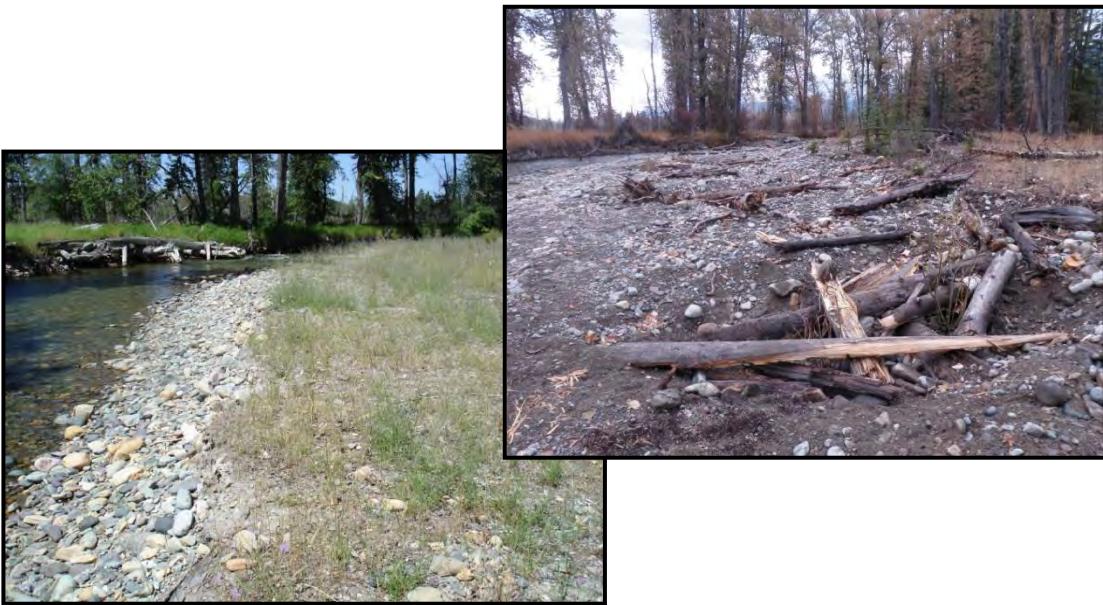
As described in the revegetation plan, the primary limiting factor to revegetation identified in the Demonstration Phase reach was a lack of connectivity between the floodplain and channel in the upstream portion the reach. To address this limiting factor, approximately 400 cubic yards of floodplain material (mainly sand, gravel and cobble) was removed from the floodplain to lower the floodplain surface and re-establish connectivity with the channel. The floodplain surface was lowered between 1 and 3 feet. The remaining floodplain surface was re-shaped by constructing five floodplain swales (Figure 4). These swales provide lower elevation microsites where planted shrubs can grow in a wetter, more protected location and other vegetation can establish naturally from seed. Swale dimensions range from between ten and twenty feet long and five and ten feet wide. Swales are two to three feet deep at their deepest point. To create additional microsites where plants can become established, large wood was partially buried within the swales during construction. Large container plants (16 gallon Drummond willow) were installed in each swale (Figure 5). Coarse wood was scattered within and around swales on the floodplain surface after containerized shrubs were installed. Each swale was seeded with the seed mix listed in Table 3. A total of 20 pounds of seed were applied to the floodplain and swales.

Figure 4. Photographs of Demonstration Phase floodplain surface before (left photograph) and after (right photograph) removal of 400 cubic yards of material, construction of floodplain swales, and placement of woody debris and 16-gallon willows in swales.

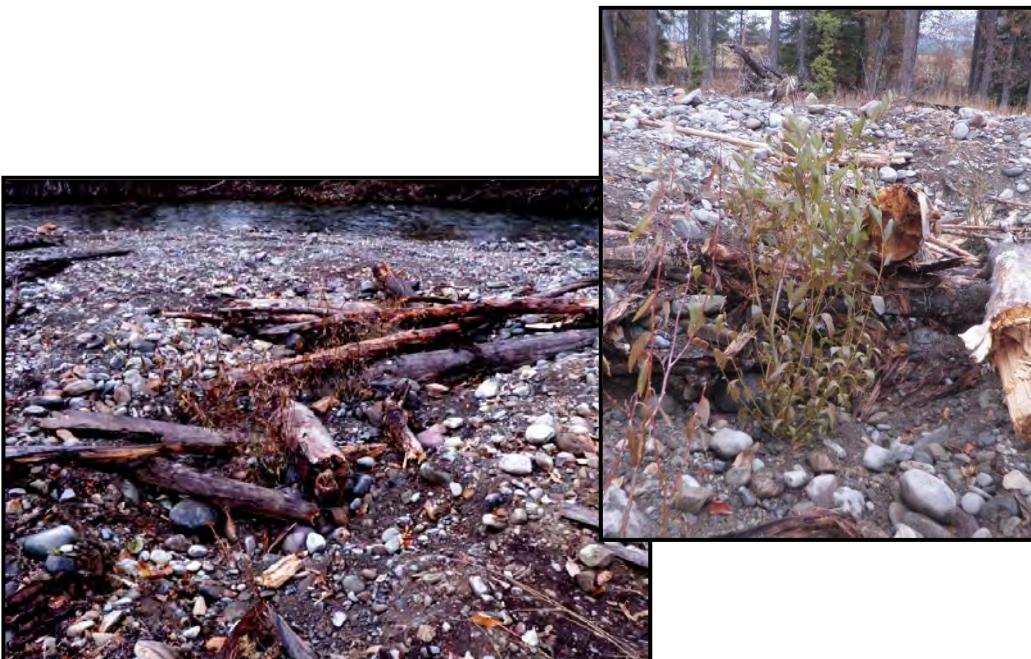
Figure 5. Photographs of a constructed floodplain swale planted with 16 gallon Drummond willow. Large woody debris was partially buried into the floodplain during swale construction, and coarse woody debris was placed around planted shrubs to create microsites.

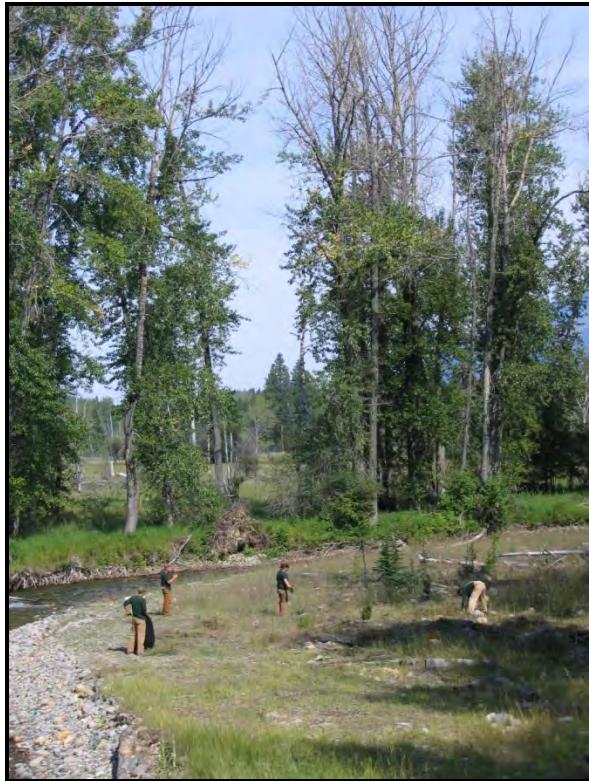
Another limiting factor identified for the Demonstration Phase floodplain in the revegetation plan was the increasing density of noxious weeds and other invasive species on floodplain surfaces. The flat, uniform floodplain surfaces constructed during channel restoration resulted in a dense cover of spotted knapweed and other noxious weeds. To address this limiting factor, weeds were pulled by hand prior to removal of floodplain material to reduce the canopy cover and potential spread of weeds by seed. Weeds were hand-pulled by a Montana Conservation Corps (MCC) crew on August 17, and 18, 2009 (Figure 6). A total of 0.4 acres of knapweed and houndstongue were hand-pulled in the Demonstration Phase (Figure 2).

Figure 6. Photograph of Montana Conservation Corps (MCC) crews hand pulling knapweed on the Demonstration Phase floodplain surface.

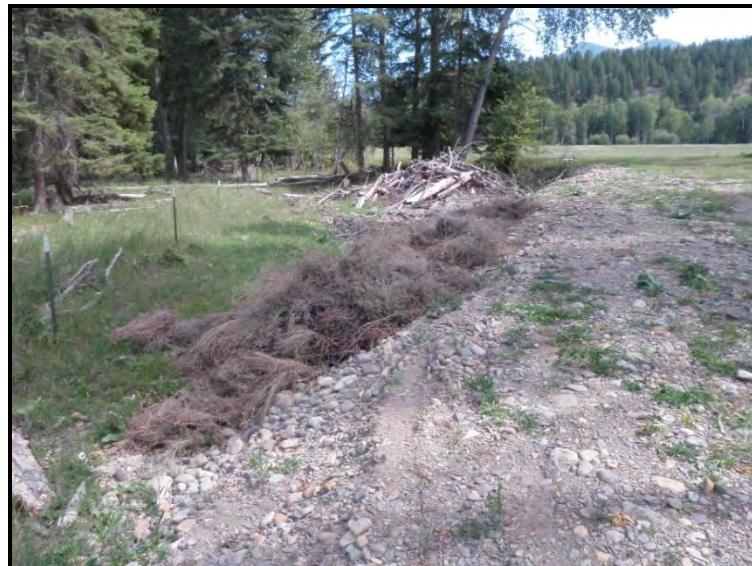
Figure 7. Photograph of weed disposal area. Fill removed from the floodplain in the Demonstration Phase was used to expand the road grade and bury weeds.

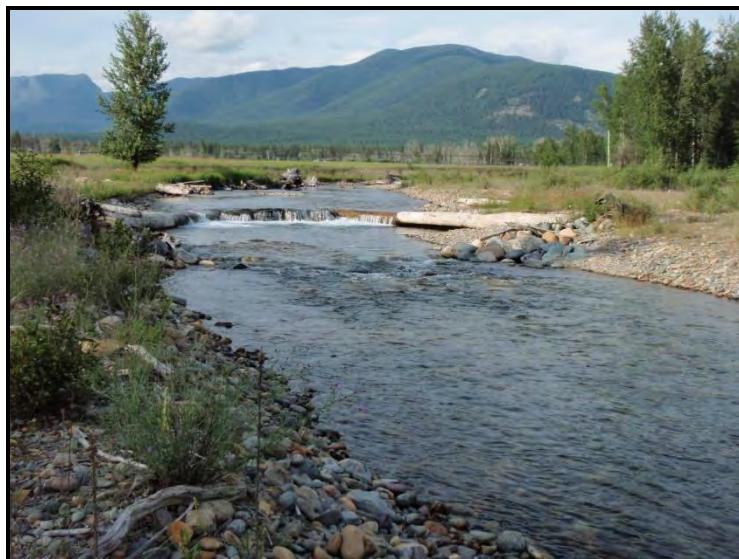
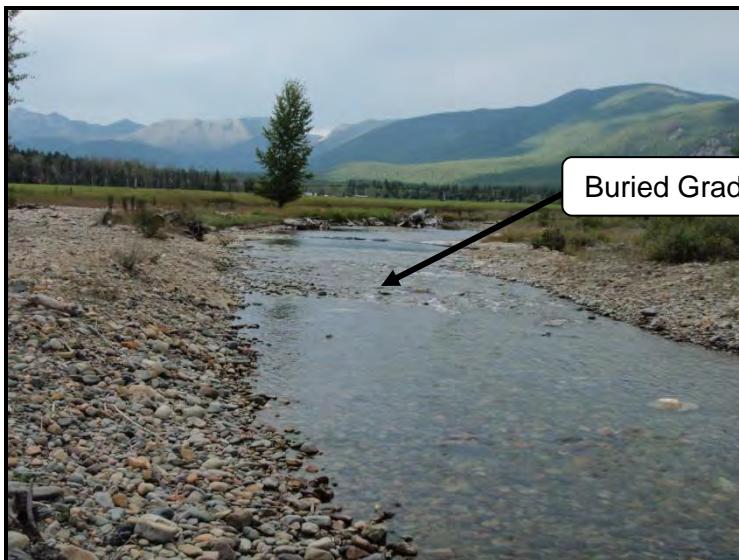
In addition to work completed in the Demonstration Phase, described above, maintenance work was completed on one log vane structure located in Phase 2 (Figure 1). As a result of flows scouring the cobble placed over the arm of the structure in 2004, the riffle downstream of this structure down-cut leaving a drop over the vane throat in excess of two feet (Figure 8). This drop may have prevented upstream passage of juvenile fish. To address this issue, a boulder grade control structure was installed at the glide/top of riffle transition downstream of the vane. This reduced the total drop over the log vane throat at base flow to less than 0.5 feet. Cobble needed for the vane repair work was generated during re-shaping of the floodplain surface in the Demonstration Phase reach. Vane maintenance was completed by River Design Group on August 31 2009.

Figure 8. Photographs of vane maintenance in Phase 2. Top photograph shows the structure prior to installation of the boulder grade control. Photograph on the bottom shows the structure after installation of the boulder grade control which reduced the drop over the structure from 2 feet to approximately 0.5 feet.

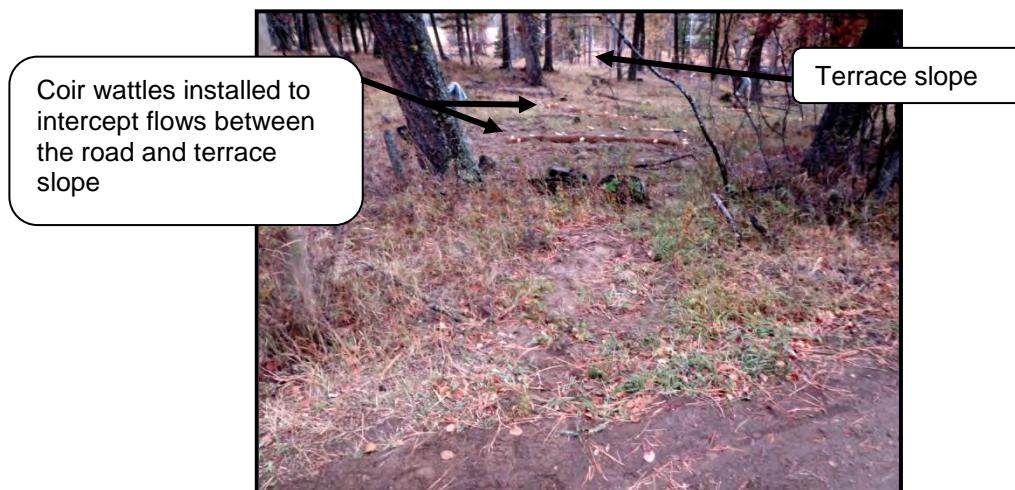
Run-off from the road above the Demonstration Phase slope was identified as the cause of deep rills observed in the terrace slope during the August 2009 final design site visit. For slope revegetation and stabilization to be successful, it was necessary to address this source of erosion. Two treatments were implemented to reduce the velocity of overland run-off: 1) two water bars were constructed on the upper portion of the road to slow run-off and route water so it is dispersed into existing vegetated areas before reaching the terrace above the slope (Figure 1); and 2) coir wattles were installed in a staggered pattern perpendicular to the path of overland flow between the road and the terrace slope (Figures 1 and 9). Seven coir wattles were partially buried and staked in a similar manner as the coir logs at the toe of the slope. The top of the slope and any disturbed ground were seeded with the seed mix shown in Table 1.

Figure 9. Photograph showing the concentrated route of road run-off leading to the top of the terrace slope in the Demonstration Phase. Coir wattles were installed in a staggered pattern to reduce the velocity of overland flows, shorten the effective slope length, and prevent further erosion of the slope.
