Therriault Creek Riparian Revegetation 2012 Monitoring and Maintenance Report

Contract #130013

Geum Environmental Consulting, Inc.
307 State Street
Hamilton, MT 59840

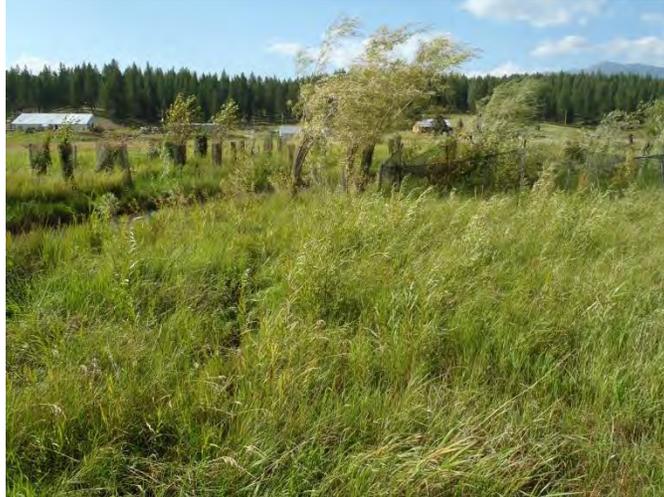
Figure 3. Young sandbar willow plants (photo foreground) that have colonized from seed and suckering from residual protected shrubs (photo background).

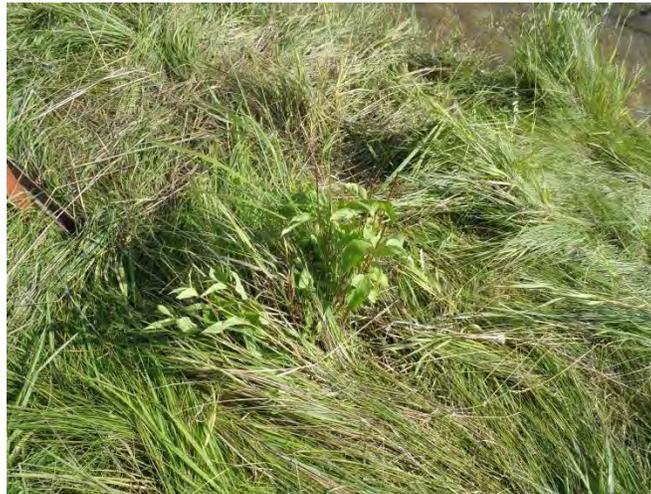
Figure 4. Residual dogwood shrub located and protected in 2012.

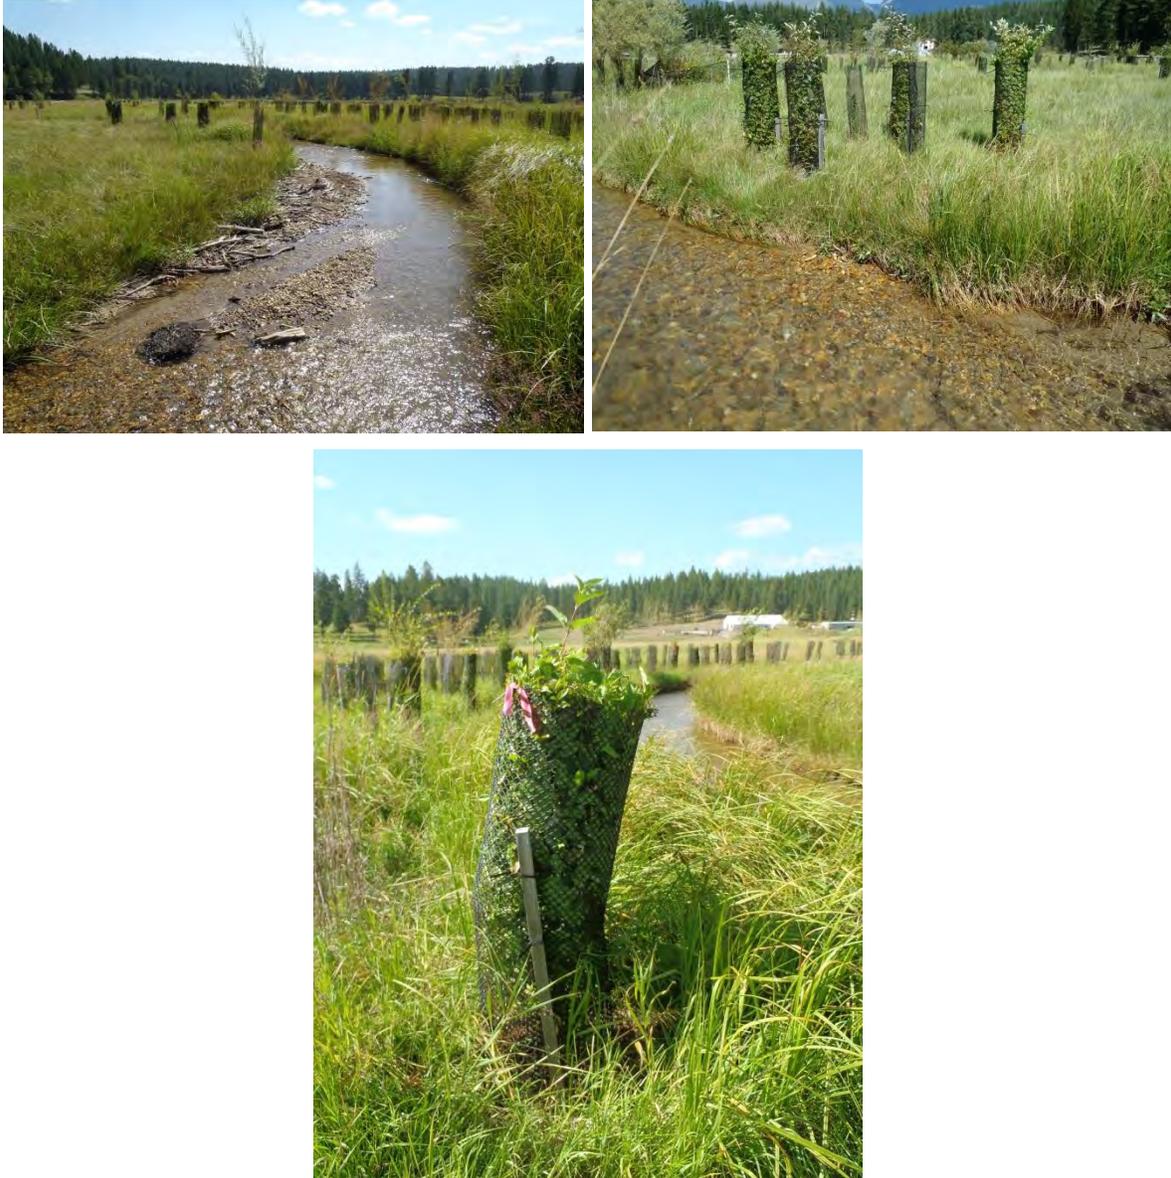
Figure 5. Examples of residual shrubs where browse protectors were removed in 2012. The top left photograph shows a sandbar willow on the left bank that is greater than three feet above the top of the browse protector. The top right photograph shows a group of residual shrubs where individual browse protectors were removed and a small enclosure was constructed around the group of shrubs. The bottom photograph shows a dogwood that has filled the browse protector but has less than one foot of growth above the top of the protector.

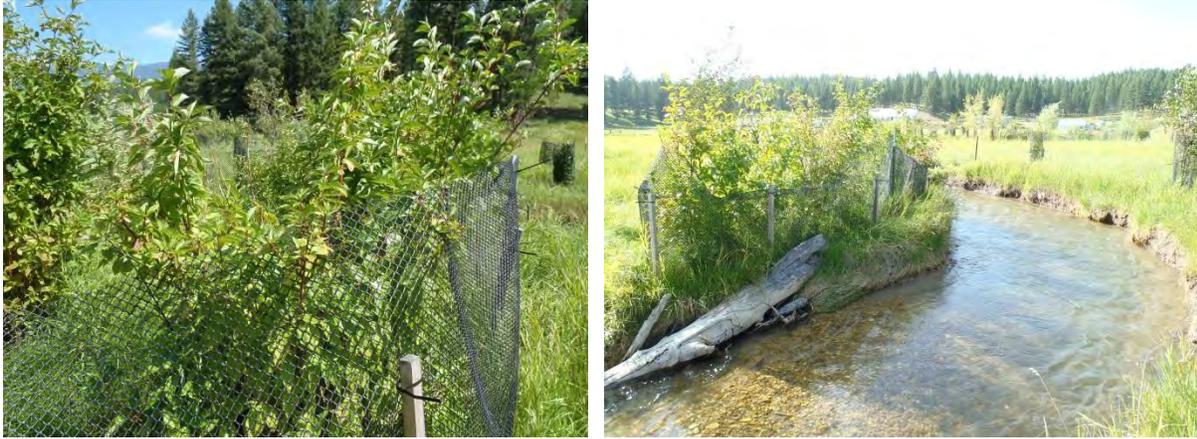
Figure 6. Photographs of clumps of residual shrubs fit with small enclosures in 2011. The shrubs in these enclosures have grown taller and expanded in width to provide additional cover.

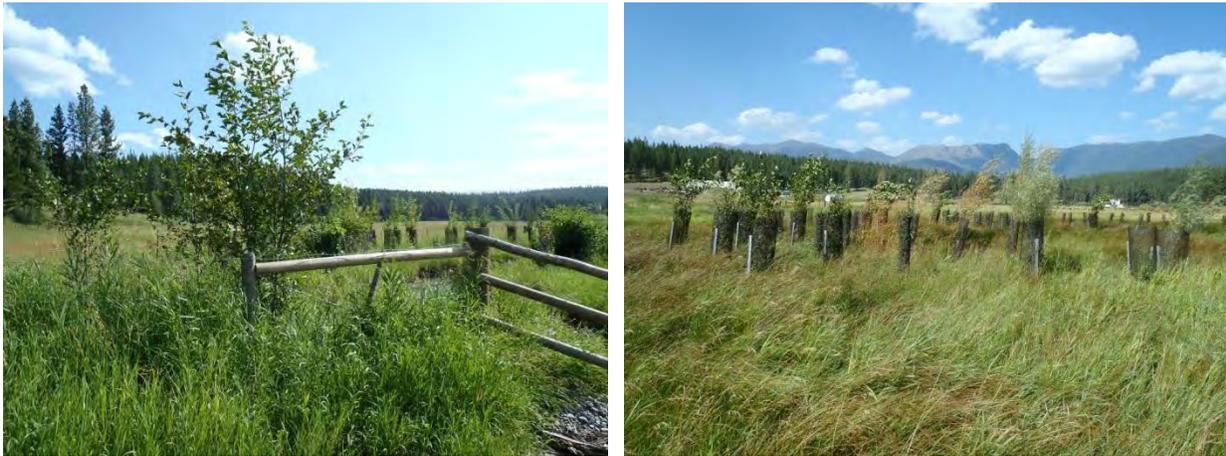
In Phase I, 2012 is the fifth growing season for planted shrubs and trees. Many of the shrubs are very large and have outgrown protection measures. Browse protectors have been removed from most of the large shrubs in Phase I. Some continued browse of these shrubs was observed in 2012. Many shrubs have filled the capacity of the browse protector but continue to be browsed down to the height of the browse protector. On many of these shrubs, the browse protectors are beginning to restrict horizontal growth of the shrubs. Some shrubs are still small and well contained within the existing browse protector. The vole protectors have worked very well at preventing damage by rodents; however, for some fast-growing multi-stemmed shrubs such as alder the stems have filled the vole protector and in some cases the vole protectors have damaged some of the stems. The vole protectors and mulch continue to help maintain high moisture content near the base of the plant.

Figure 7. Shrub growth in Phase I planting area.

- In Phase I, for planting units where multiple shrubs were close to out-growing their browse protectors, individual browse protectors were removed and a small enclosure was constructed around the planting unit or a portion of the planting unit. Twenty small enclosures were constructed. The purpose of the small enclosures is to continue to protect shrubs from browse and damage while reducing the need for continued annual expansion and removal of browse protectors and reducing growth restriction of multi-stemmed shrubs.

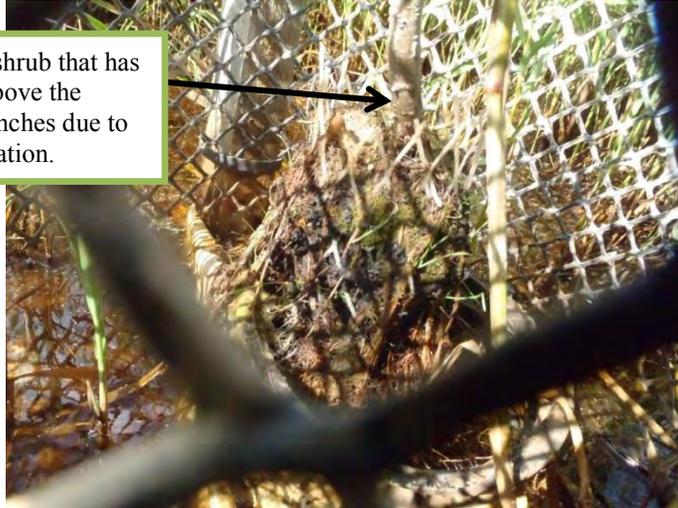
Base of planted shrub that has been uprooted above the ground about 6 inches due to prolonged inundation.

Figure 9. Plant in Phase III that was uprooted due to prolonged inundation.

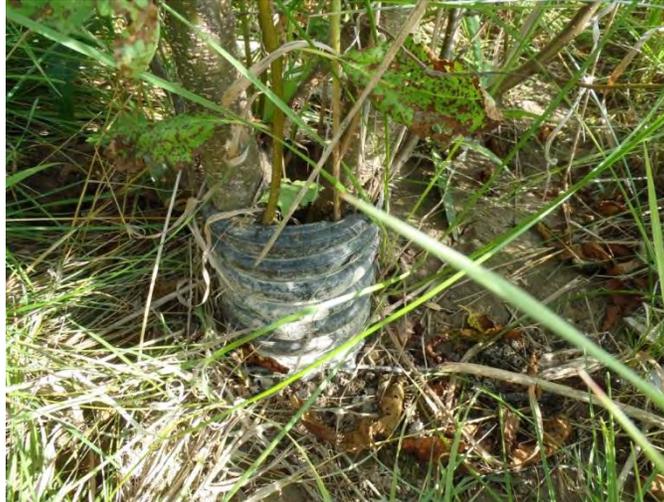
Figure 11. Alder stems that are being restricted by the vole protector.

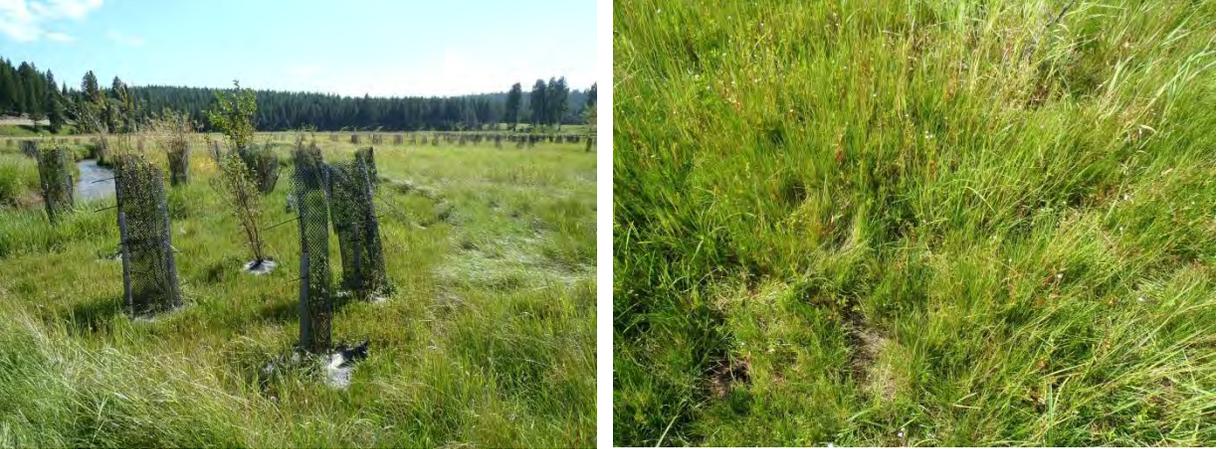
colonize. In August 2012, herbaceous cover in Planted Solarization Plot 1 was high (Figure 12). Species included both seeded and naturally colonizing species. Most of the sedges and grasses were very small and could not be identified. Species that could be identified included: willow herb (*Epilobium angustifolium*), forget-me-not (*Myosotis laxa*), common timothy (*Phleum pratense*) and reed canarygrass (*Phalaris arundinacea*). Only a few small reed canarygrass plants were observed and these were hand-pulled at the time of observation. Numerous sandbar willow seedlings were observed in Planted Solarization Plot 1 indicating that the bare substrate provided suitable substrate for natural colonization of woody species (Figure 13). Planted Solarization Plot 2 is located on an outside meander bend where a channel avulsion is occurring. The channel at this location has filled with gravels and most of the water is flowing overland through this plot. As a result, most of the bare substrate in this plot has either been eroded or covered with small gravels (Figure 14). No natural colonization was observed on the new gravel but that is probably because water is flowing through this area. If water is returned to the channel this gravel should support rapid colonization of woody and herbaceous species.

Figure 12. Planted solarization plot 1 in August 2012. Photograph on the left provides an overview of plot conditions. Photograph on the right shows the species colonizing the exposed mineral soil.

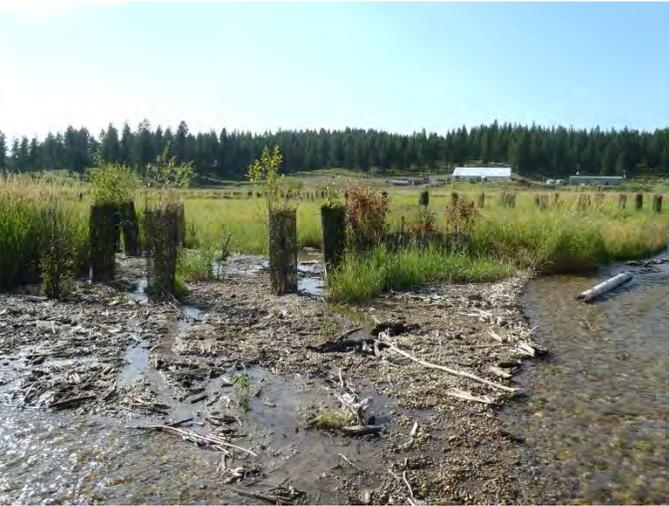
Figure 14. Planted Solarization Plot 2 showing deposition of gravels.

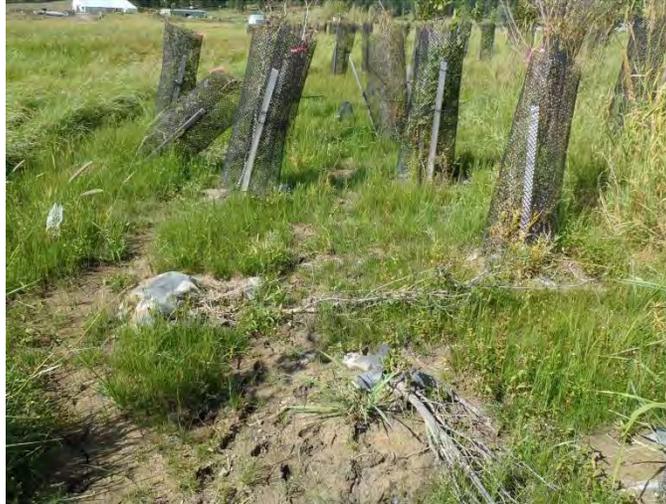
Figure 15. Shrubs in Planted Solarization Plot 1 that have fallen over as a result of loss of grass sod under the fabric.

- Remove browse protectors on plants greater than three feet above browse protectors or robust enough to resist browse.
- Straighten and secure collapsed shrubs where possible.
- Continue to observe and monitor natural colonization in Phase I planted solarization plots.
- Continue to observe and monitor the Phase III planted solarization plot.

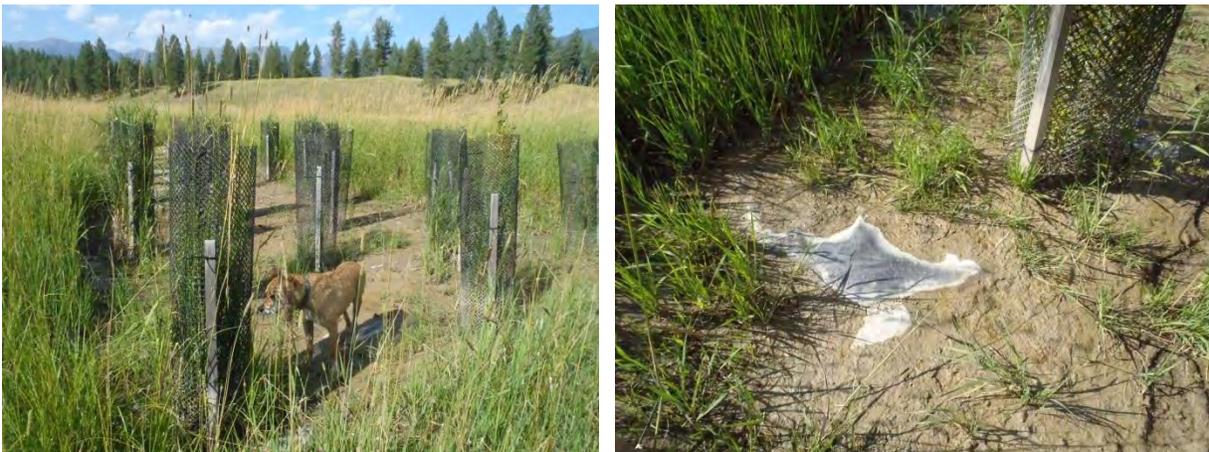
Figure 16. Phase III planted solarization plot showing deposition of fine sediment from overbank flows in 2011 and 2012.

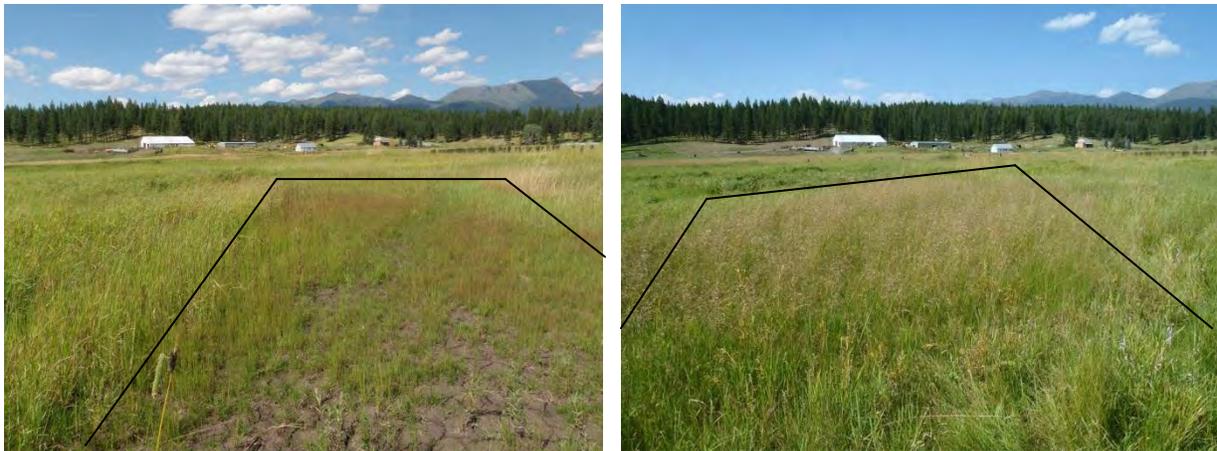
In plot 1, the bare mineral soil has been colonized by a range of species (Figure 17). In 2011, grasses observed in this plot included a mix of seeded species (tufted hairgrass, fowl mannagrass, and slender wheatgrass), and pasture grasses present adjacent to the plot (quackgrass, redtop, smooth brome, and timothy). Other seeded species observed in the plot included: red-osier dogwood, chokecherry, and Baltic rush. Other species observed in plot 1 include both native species (sedges, sandbar willow, field mint, violet, common willowherb, cattail and knotweed) and invasive species (reed canarygrass and Canada thistle). This plot had standing water in it until the middle of August 2011. In 2012, most of the same species were present but the plot

Figure 17. Photograph of temporary solarization plot 1 in July 2011 (photo left) and in August 2012 (photo right). Black lines in the figure represent the approximate extents of where the solarization fabric covered the plot.

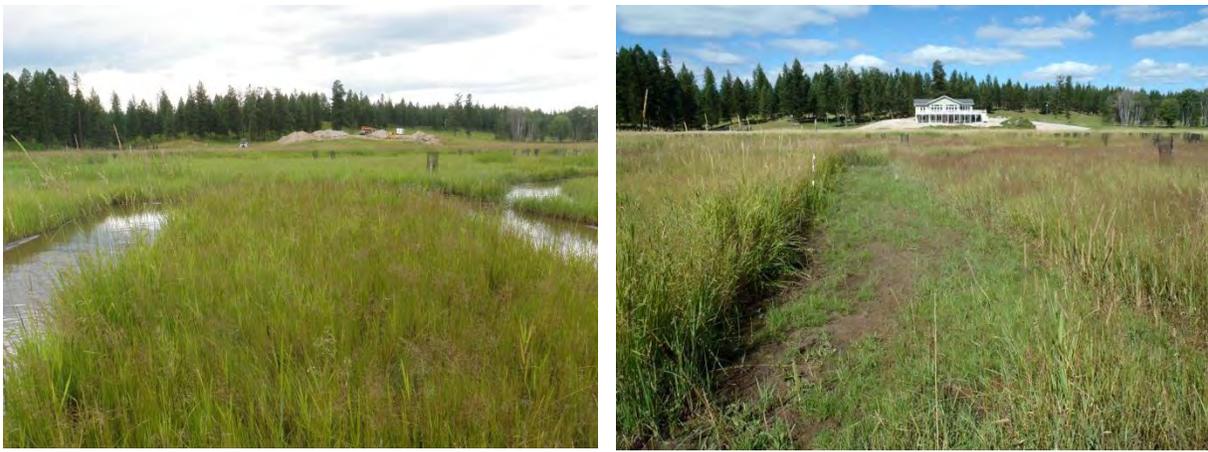
In plot 3, the remaining fabric was removed in fall 2011. The exposed soil was seeded with American mannagrass, fowl bluegrass, tufted hairgrass, sawbeak sedge, small-winged sedge, and daggerleaf rush. The exposed soil was also seeded with sterile triticale to provide rapid cover and reduce habitats available for reed canarygrass to colonize. Very few of these species were observed growing on the newly exposed surfaces (Figure 18). Redtop was the dominant species on the newly exposed surface. No natural colonization of woody species was observed in this plot. The surface that was exposed in 2009 in this plot continues to transition to pasture grass species. This surface has transitioned from a mix of wet grass and graminoid species to increasing dominance by pasture grasses over the period of three years.

Figure 18. Photograph of temporary solarization plot 3 in 2011 (photo left) and in 2012 (photo right). In the left photo the area between the standing water is the original plot location that was exposed and seeded in fall 2009. The areas of standing water have fabric under the water that was placed around the original plot. This fabric was removed in fall 2011 and that exposed soil area is shown in the photo on the right.

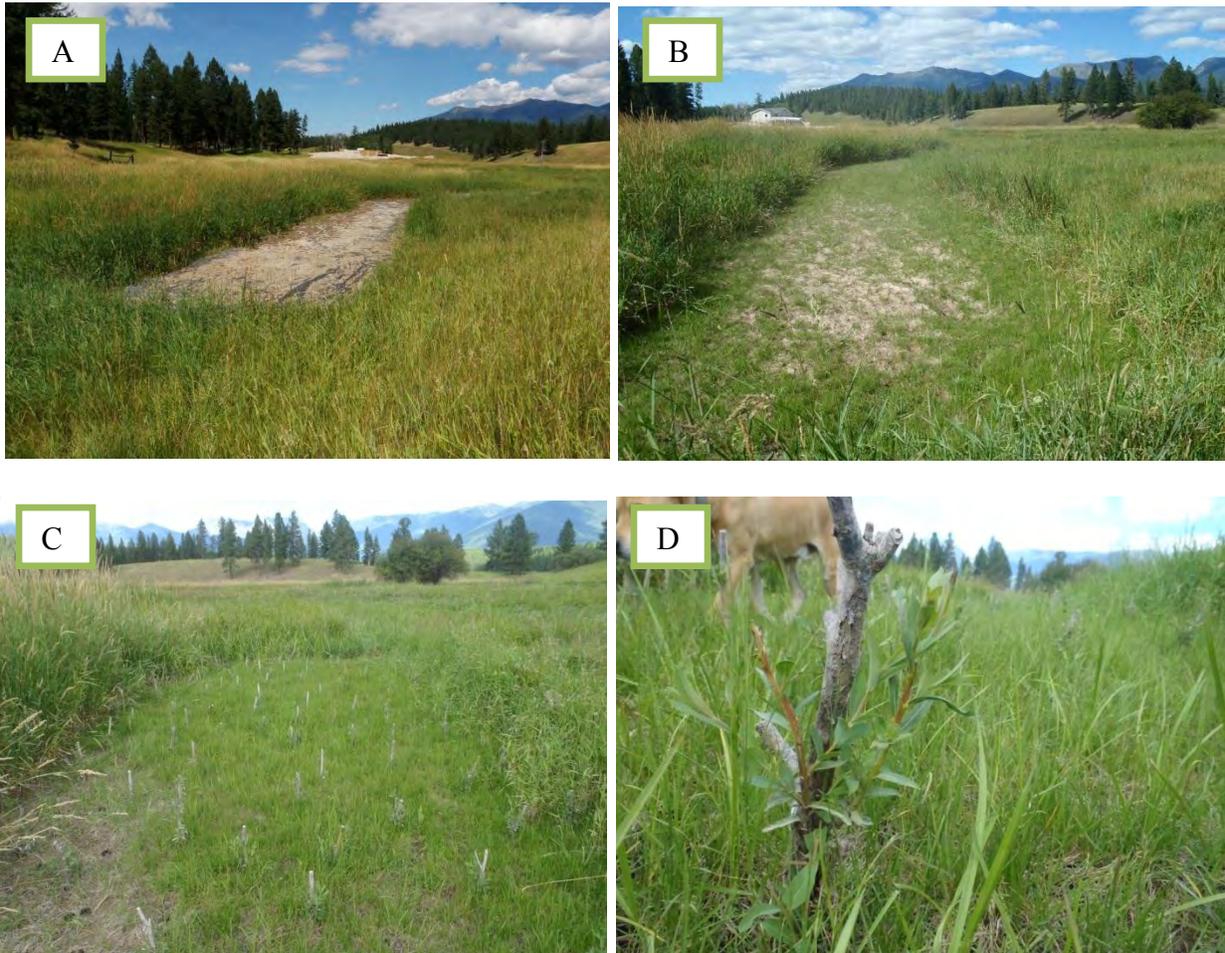
In plot 2, the fabric was removed in 2011 and the exposed soil was seeded with American mannagrass, fowl bluegrass, tufted hairgrass, sawbeak sedge, small-winged sedge, daggerleaf rush, and sterile triticale. Half of the plot was planted with dormant willow cuttings collected from on site. In 2012, a number of grass species were observed colonizing this plot but it was not possible to identify them due to their small size (Figure 19). All of the willow cuttings were alive but all had been browsed down to the stem.

Figure 19. Photograph of temporary solarization plot 2 located at the downstream end of the project site prior to fabric removal and seeding in fall 2011 (A), in August 2012 (B), willow cuttings installed in fall 2011(C), and browse of willow cutting growth (D).

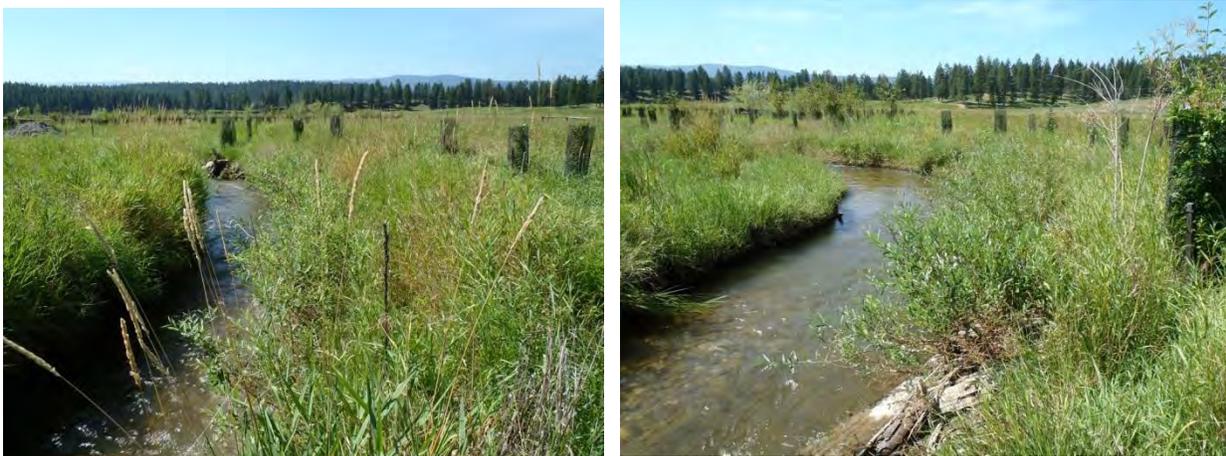
Figure 20. Photograph of vegetated soil lift 1 (right bank in the left photo) and vegetated soil lift 2 (right bank in the right photo) showing dense but browsed bands of willows.

- Continue to observe function of the structures but no future maintenance or monitoring is anticipated because the dense growth and associated deep binding root mass is providing the desired function of bank stability.

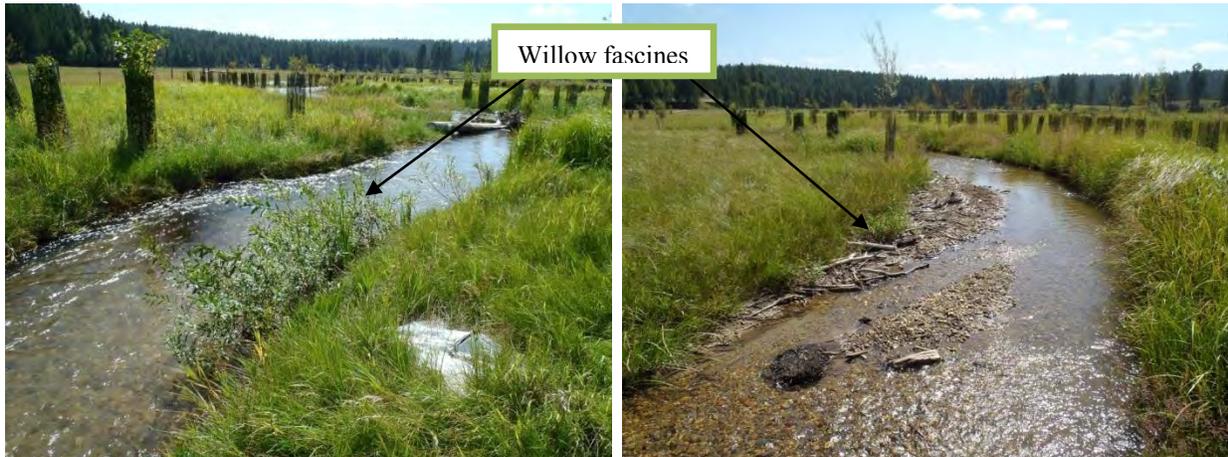
Figure 21. Photographs showing various conditions of willow fascines.

- No maintenance of structures is necessary. The fascines are functioning to trap sediment and debris and establish vegetation within the channel margins.
- Continue to observe the function of the willow fascines but no future maintenance or monitoring is anticipated.

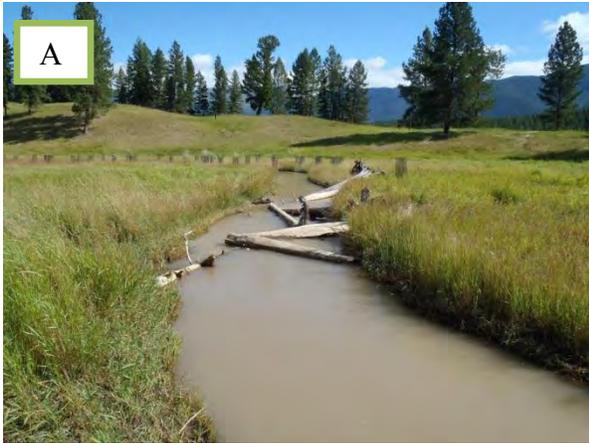
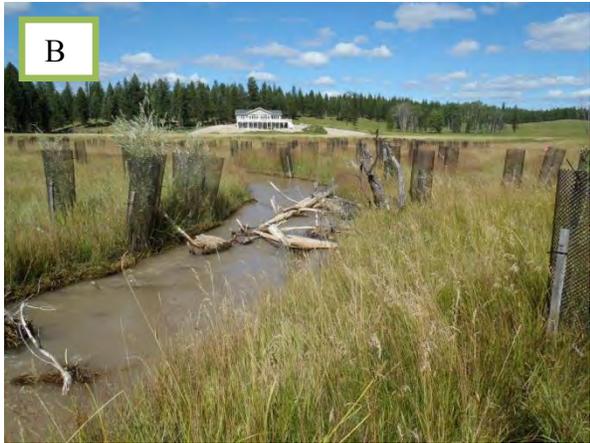
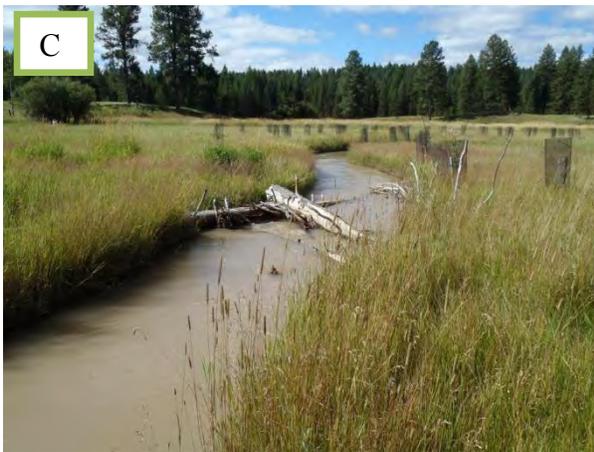
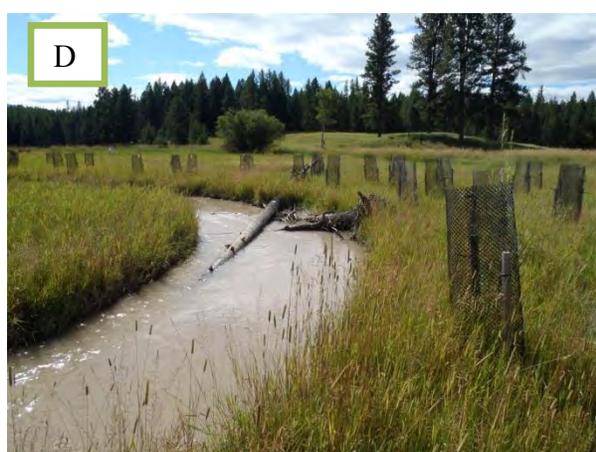
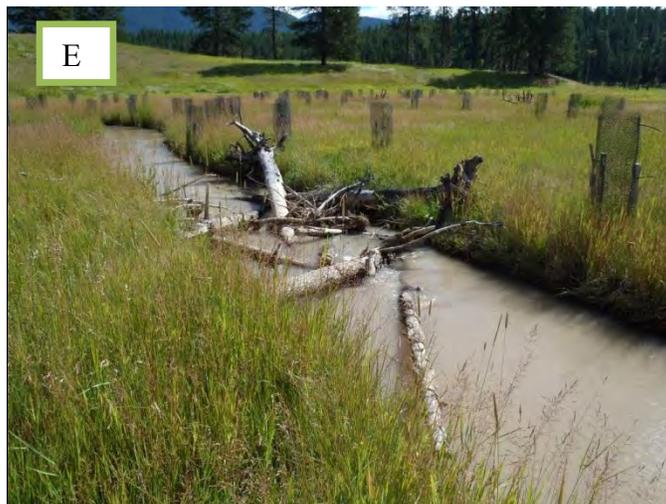
It was difficult to observe some of the intended functions of the large woody debris structures, such as sediment, debris and seed recruitment, due to turbidity in the stream at the time of monitoring (Figure 22). Some sediment deposition was observed along with natural colonization of woody vegetation (Figure 23).

Figure 22. 2012 photos of woody debris structures: structure 1 (A), structure 2 (B), structure 3 (C), structure 4 (D), and structure 5 (E).

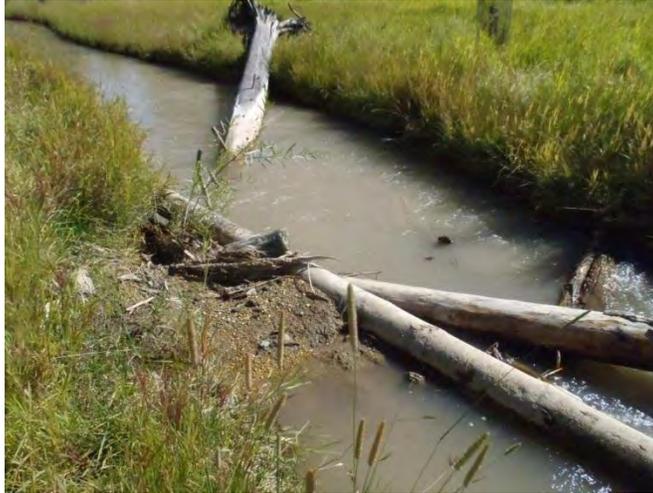
Figure 23. Sediment deposition and willow colonization at woody debris structure.

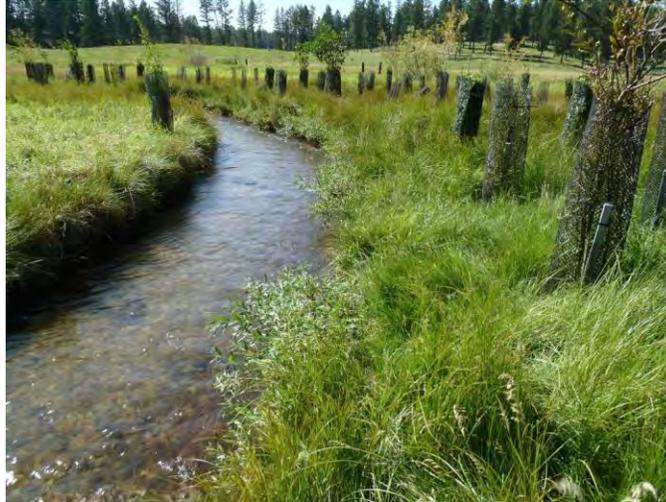
In 2012, general observations were made of all coir log structures. Overall survival, percent cover and willow height are consistent with observations made in 2011. In general, willow cuttings are beginning to form a dense band of woody vegetation along the streambank (Figure 27). The 2012 spring flood caused some changes at coir log installation sites. A number of coir logs are no longer visible due to deposition of gravels in the channel (Figure 28). No lateral migration of the channel was observed at any of the coir log sites as a result of 2012 spring floods; however, the channel both deepened and filled to varying degrees. More browse was observed on willow cuttings compared with 2011. At coir log site 4 willows from the coir log and a willow fascine on the opposite bank are beginning to provide instream cover (Figure 27).

Figure 27. Coir log site 4 with consistent growth of willows along right bank. Most willows showed some signs of browse.

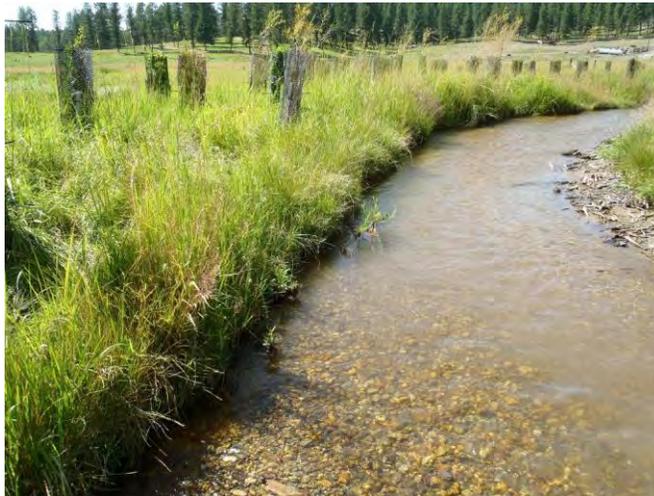
Figure 28. Coir log site where gravel deposition in the channel buried the coir log.

- No maintenance of structures is necessary.
- Continue to observe the function of coir logs but no future maintenance or monitoring is anticipated. Willow survival and percent cover is adequate at all sites to expect willows to maintain streambank and floodplain stability once the coir logs degrade.

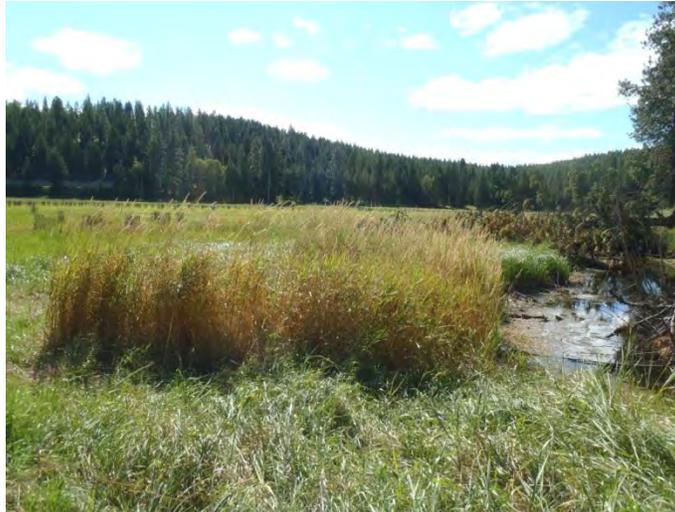
Figure 30. Isolated patch of reed canarygrass treated with herbicide in July 2012.

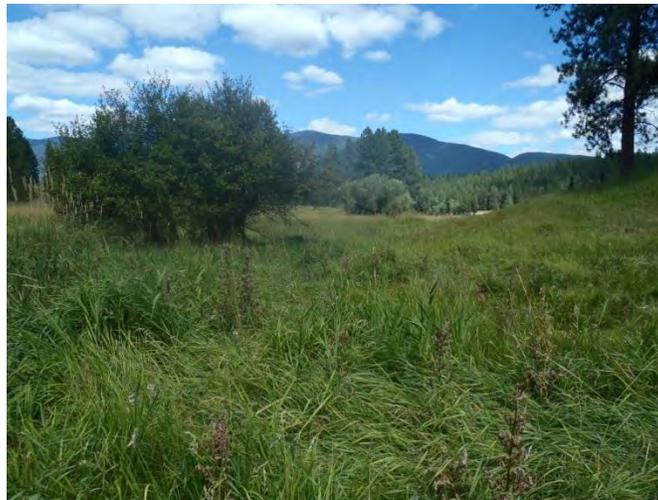
Figure 31. Canada thistle plants treated in July 2012.

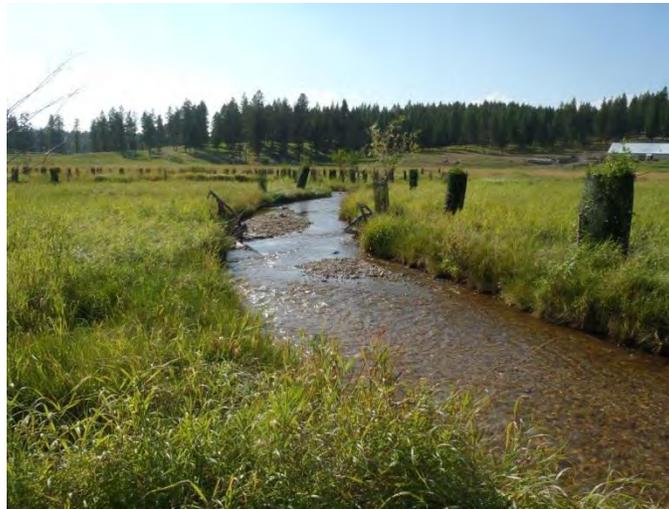
Figure 39. Channel filled with gravel from 2012 spring flood.

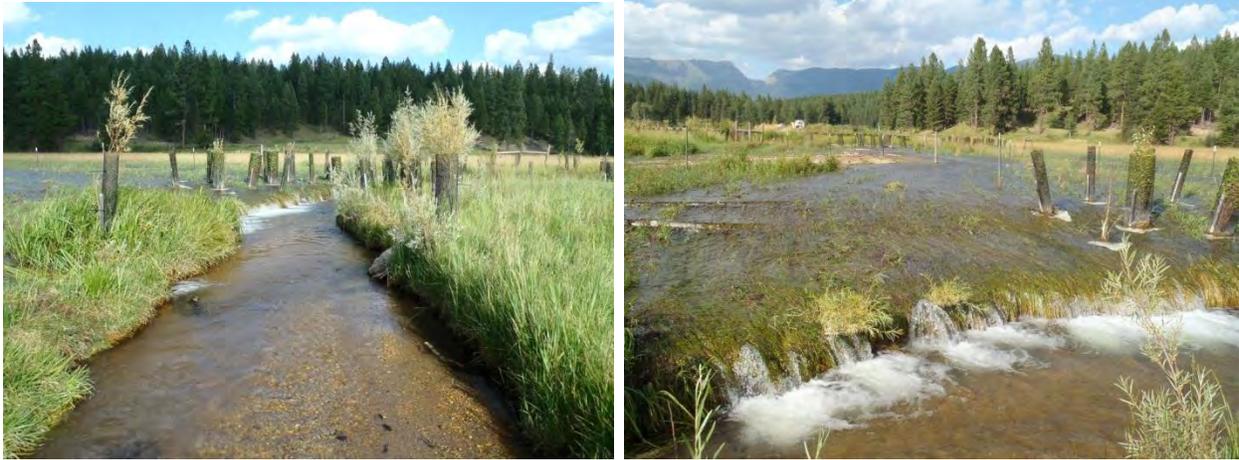
Figure 40. Channel overflow return point and view of channel overflow route and gravel deposition on the floodplain.
