Therriault Creek Riparian Revegetation 2010 Monitoring, Maintenance and Phase III Implementation Report

Contract #110032

Montana Fish, Wildlife and Parks
385 Fish Hatchery Road
Libby, MT 59923

Geum Environmental Consulting, Inc.
307 State Street
Hamilton, MT 59840

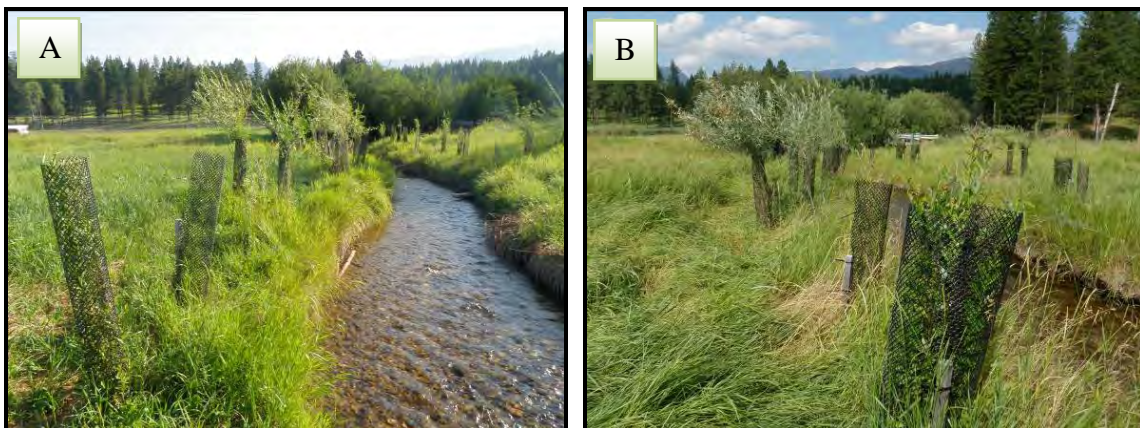
Based on visual observations made in August 2010, it appears that all residual shrubs that have been fitted with browse protectors are alive and have grown both vertically and horizontally. Some plants have grown as much as three feet above the browse protector (Figure 3). Figure 3 shows the growth of some residual shrubs between 2009 and 2010. Figure 4 also shows the growth of protected shrubs and the condition of a residual shrub that was not protected. The amount of growth appears to differ somewhat between species, with willow species showing the most pronounced growth and other species such as dogwood showing less pronounced growth. This treatment has been successful in releasing previously planted shrubs from browse suppression.

Figure 3. Photographs comparing residual shrubs protected in 2007 in 2009 (A) and 2010 (B). Some protected shrubs, particularly sandbar willows, have grown more than 3 feet above the height of the browse protection. Other protected shrubs, such as those in the foreground of the photographs have shown significant growth but continue to be hedged by browse to the height of the browse protection.

- Repair and re-secure browse protectors during summer 2010.
- Protect all remaining residual shrubs that can be located within the project reach during summer or fall 2010.

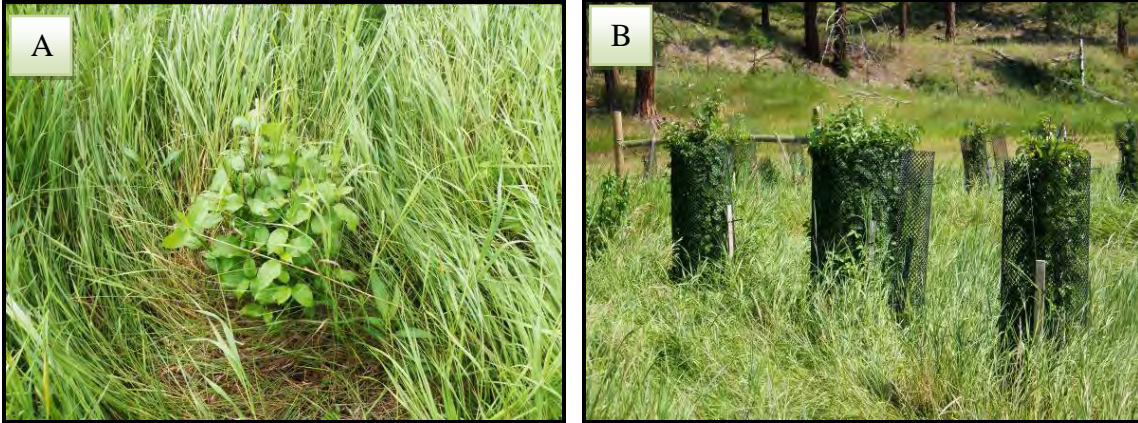
Figure 4. Photograph A shows the continued browse occurring on unprotected residual shrubs and the resulting suppressed growth form. Photograph B shows residual shrubs that have been protected from browse since 2007. The residual shrubs that were protected from browse have grown to the height of the browse protector (four feet) and in some cases have grown to the capacity of the browse protectors, which were expanded in 2009.

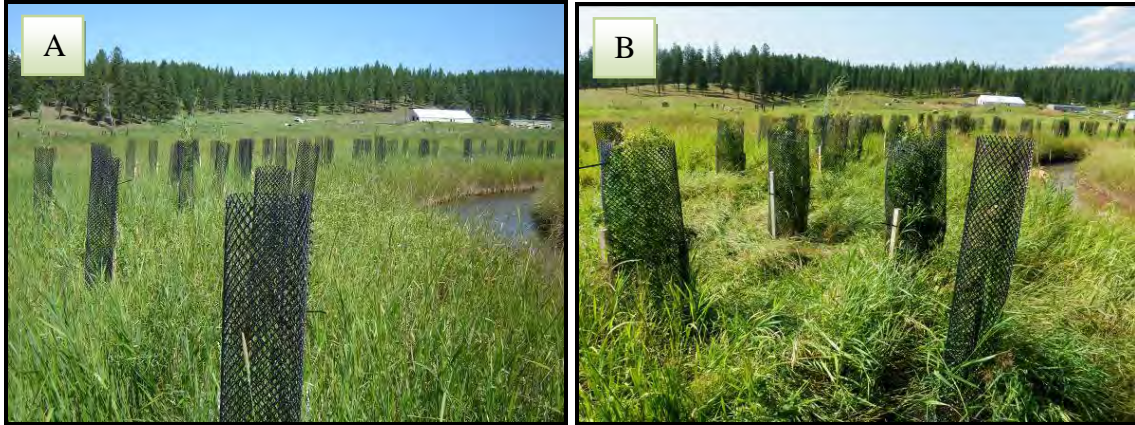
Figure 5. Photographs compare Planting Unit 7 in 2008 (A) and 2010 (B). Photographs were taken from the downstream end of the plot looking upstream.

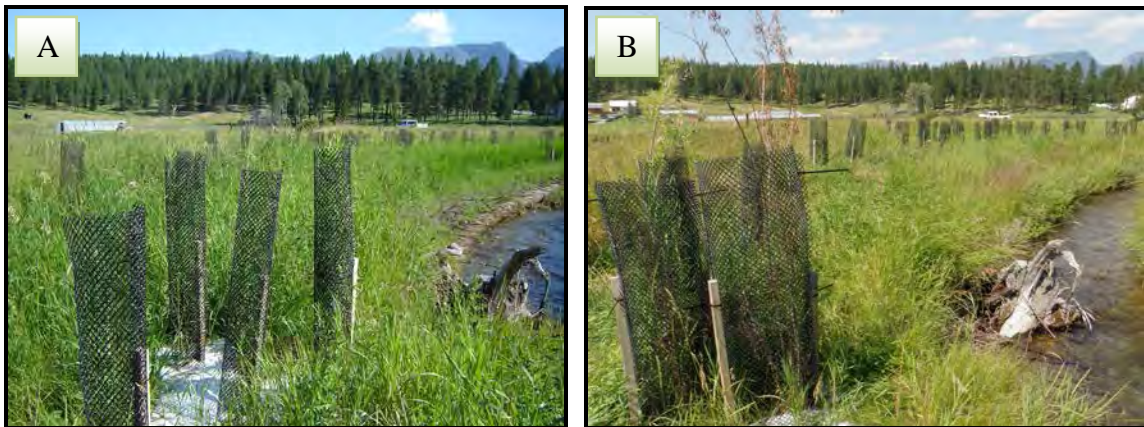
Figure 6. Photographs compare Planting Unit 1 in 2009 (A) and 2010 (B). Photographs were taken from the downstream end of the plot looking upstream.

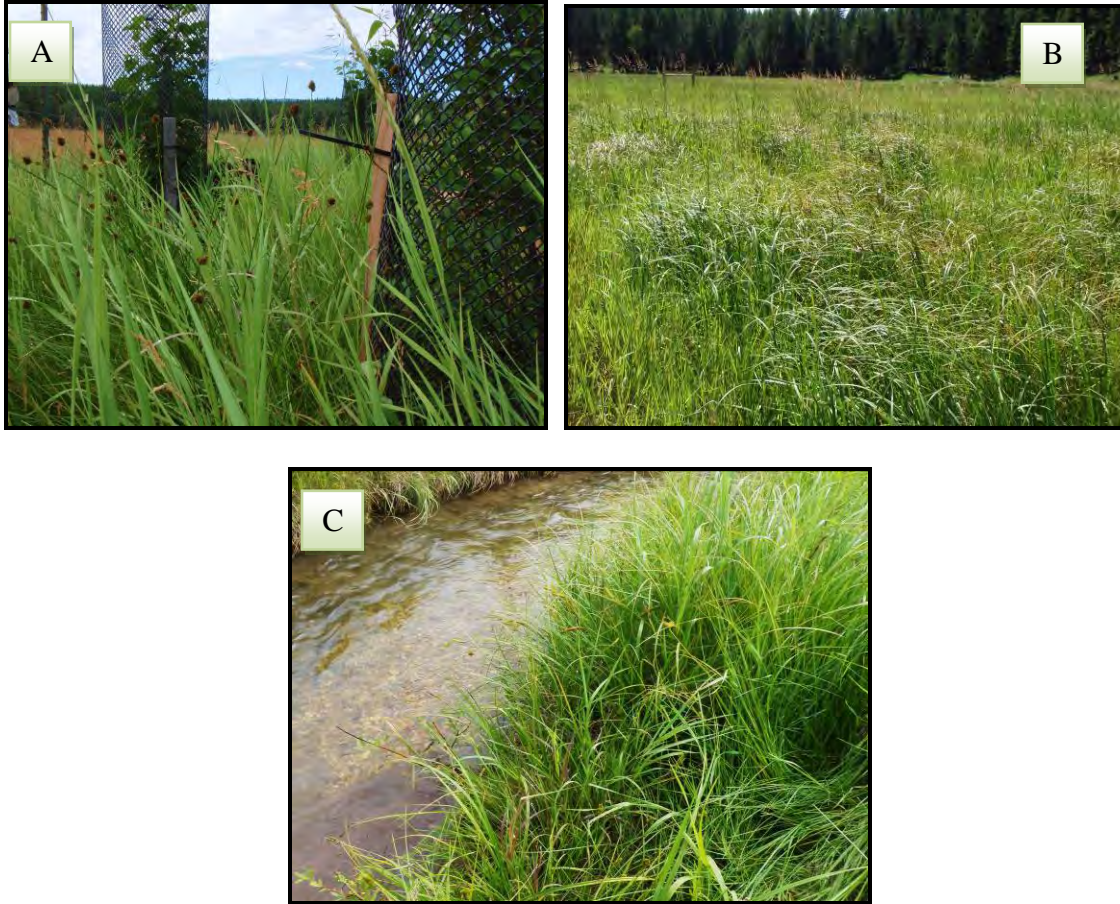
Pasture grasses remain the dominant understory species in most of the Phase I planting units but general observations of the entire project area suggest that the site is trending towards a wetter native community with higher percent cover of a range of sedge and rush species. There are new patches of sedge dominated communities throughout the planting units as well as in the hay field southeast of the channel (Figure 7). Percent cover and diversity of wetter species appears to have increased compared with observations made in 2009.

Figure 7. Photographs showing patches of sedge establishing in planting units along the creek (photographs A and C) as well as in the hayfield beyond the creek (Photo B).

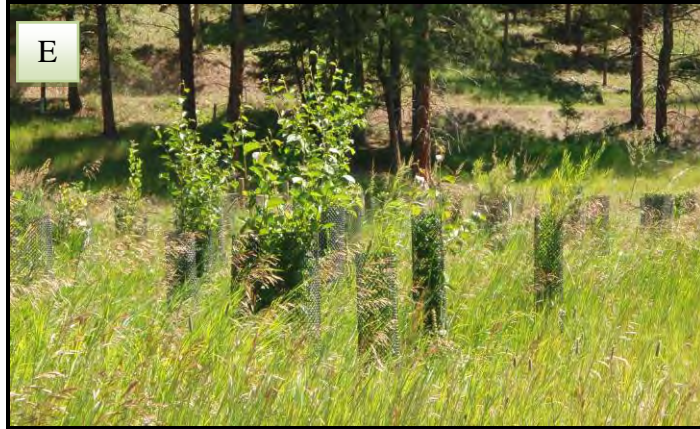
In 2009, most of the browse protectors originally installed in 2007 were expanded to provide additional capacity for plant growth. Despite this expansion, many plants had grown to maximum capacity of the expanded protectors by summer 2010. There were sign of elk use throughout the project reach. A number of browse protectors were damaged and many plants suffered severe hedging; defined as, browse of all growth above the height of the browse protector has been eaten (Figure 8). Although this may slow vegetative growth, given the size of the shrubs hedged, it is likely that the root systems of the surviving plants are established enough to withstand moderate browse pressure. The established root system coupled with protection of the lower half of the plant should enable the plant to survive browse pressure and eventually reach a height that is less vulnerable to browse. If heavy browse continues it may affect growth and survival of damaged shrubs.

Figure 8. Photographs show evidence of browse by ungulates. Photograph A shows tracks through a planted solarization plot. Many plants have been hedged to the top of browse protector (photographs B and D). Plants that have grown above browse height have been browsed at all reachable locations (photograph C). Photograph E provides an example of plant height in July, just one month prior to the August monitoring site visit. It appears that most of the browse observed during monitoring occurred sometime between the end of July and the beginning of August.

- Repair and re-secure damaged browse protectors during summer 2010.
- Water all planted shrubs and trees during August 2010.
- Install additional containerized plants in the lower half of the project reach during fall 2010.
- Install mulch mats, vole protectors and browse protectors around all containerized plants.
- Use shredded mulch instead of wood chips in vole protectors to reduce grass growth inside the vole protector.
- Install 16-inch diameter browse protectors to increase the area available to support plant growth.

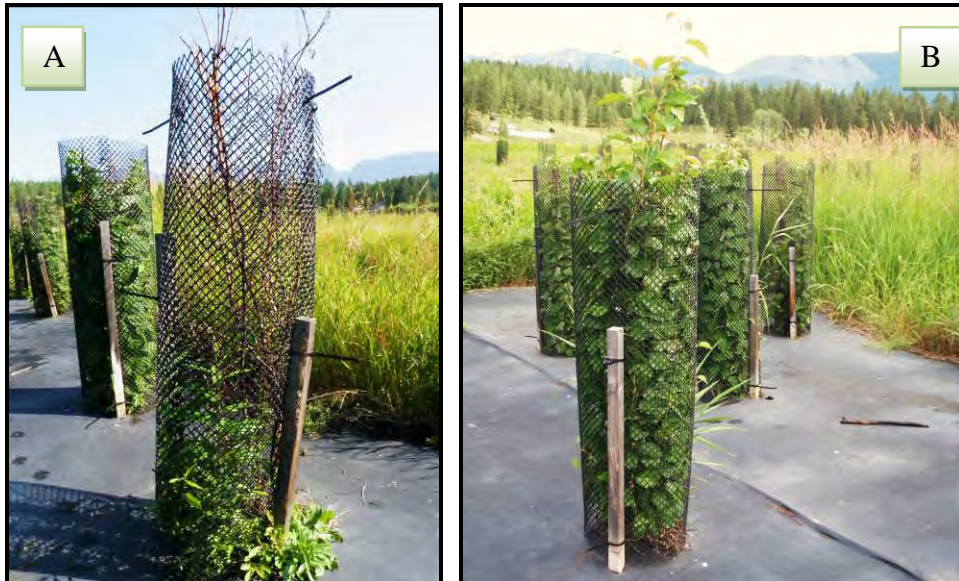
Figure 9. Photographs showing the various conditions found within the long-term planted solarization plots. Photograph A is an example of a containerized plant that has died back to the crown but is re-sprouting. Photograph B shows plants that have grown to the maximum capacity of the browse protector.

- Re-secure fabric at both long-term planted solarization plots in summer or fall 2010.
- Repair and re-secure browse protectors at both long-term planted plots in summer or fall 2010.

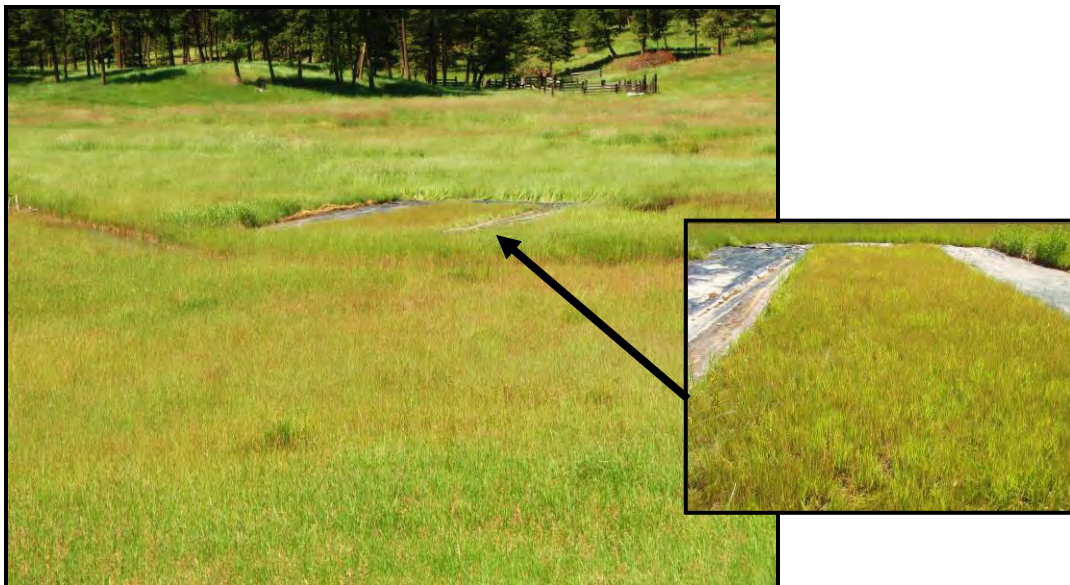
Figure 10. Photograph showing an overview and close-up (inset) of temporary solarization plot 3 during the first growing season after fabric removal.

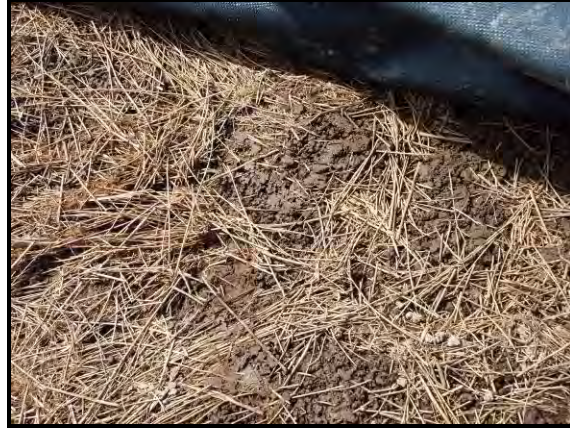
Figure 11. Photograph showing the condition of the soil in Temporary Solarization Plot 1. All the undesirable reed canarygrass has been killed and a layer of organic matter is all that remains on top of the bare mineral soil.

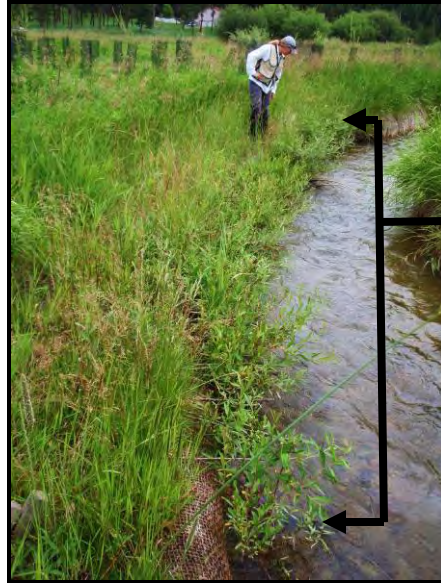
Both vegetated soil lifts were observed during the August 2010 monitoring site visit. General observations of vegetated soil lifts indicate a similar trend as observed in previous years. Willow (*Salix spp.*) survival is patchy at both sites. Survival of willow cuttings is much higher above the lift than below at both sites. Surviving willows continue to be browsed which is resulting in minimal shoot height. However, percent cover of the surviving willows has increased resulting in a dense band of cover immediately along the channel at both sites (Figure 12). Both sites were evaluated for the feasibility of installing browse control measures. Given the small size of the channel, which allows access to the willows from both sides of the channel, and the immediate location of the willows to flowing water, physical barriers to browse would not be effective without posing a risk during high flows. A variety of chemical barriers are available but would require frequent application to be effective, especially given the location of the willows next to flowing water. The frequency of application required does not seem feasible. Although browse is limiting vertical growth, root growth is likely unaffected, at least in the short-term.

Dense band of willows at vegetated soil lift 1. Shoot growth is suppressed by browse.

Figure 12. Photograph of vegetated soil lift 1 showing a dense but suppressed band of willow growth along the face of the lift.

- Hand-pull weeds at both vegetated soil lift sites in summer 2010.
- Re-secure exposed wooden stakes at both sites in summer or fall 2010.

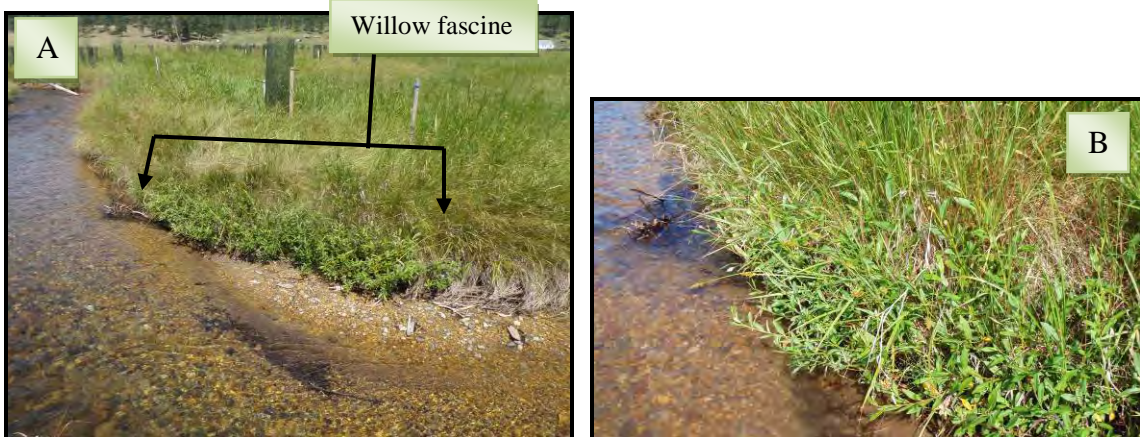
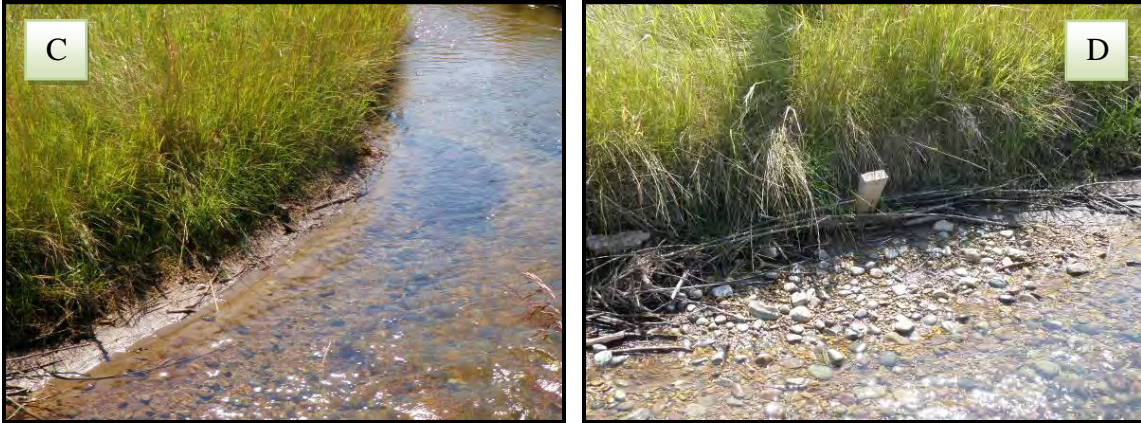
All willow fascine sites were observed in August 2010. Each site was photographed and general observations of treatment effectiveness were recorded. Survival of willows in willow fascines is highly variable (Figure 13). Most of the fascines continue to function for trapping debris and sediment. Some fascines have established into dense patches of vegetation within the channel margins. Other fascines have minimal willow growth, but are functioning for trapping debris and sediment to create roughness within the channel margins. Similar to other treatments where willow cuttings were installed, many willow fascines have been browsed resulting in limited shoot growth.

Figure 13. Photographs show the various conditions of willow fascines. Photographs A and B are examples of fascines where the willow cuttings have taken root and are becoming dense patches of vegetation within the channel margins. Photos C and D are examples of fascines where scour (D) and deposition (C) have occurred but minimal willow growth is occurring.

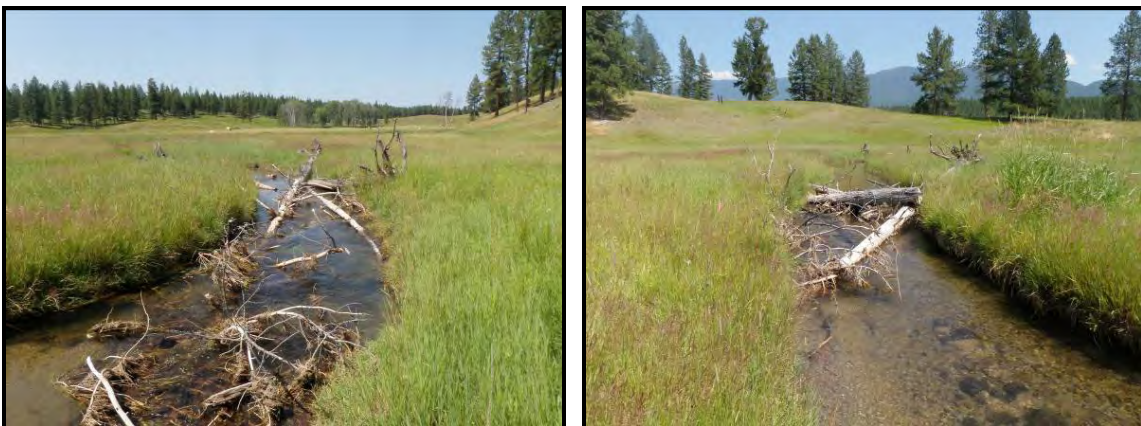
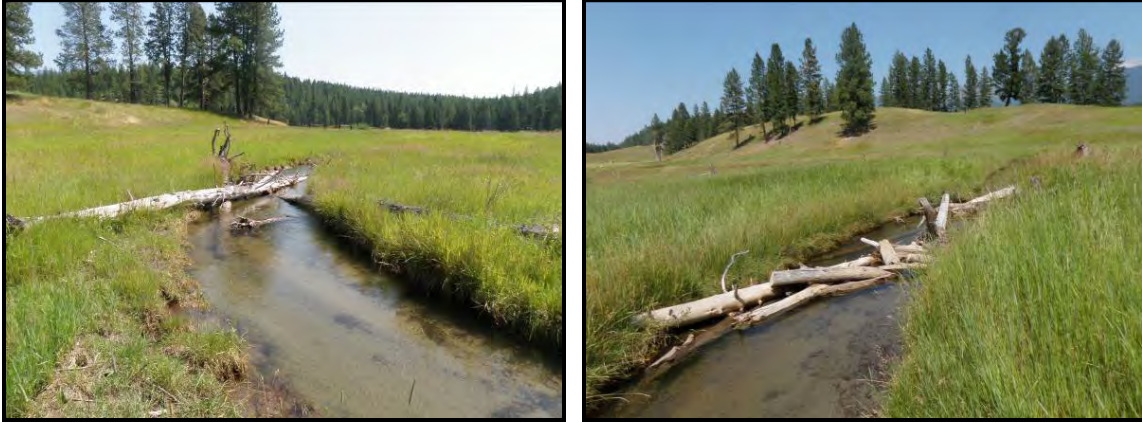
All woody debris structures were observed in August 2010. Each site was photographed and general observations of the condition and function of each large woody debris structure were made. Debris continues to accumulate in and around the structures (Figure 14). Colonization of willow seedlings was observed in deposition within two of the woody debris structures. The species composition of the surrounding floodplain remains dominated by non-native pasture grasses but there are patches of wetter vegetation such as sedges and rushes establishing. No obvious change in species composition has occurred since 2009 monitoring. Shifts in species composition are often slow changes that occur over time. Since native seed sources are present, it is expected that the site will continue to slowly convert to a wet meadow with more diverse native species over time.

Figure 14. Photographs showing the conditions at the large woody debris structure sites and the surrounding floodplain.

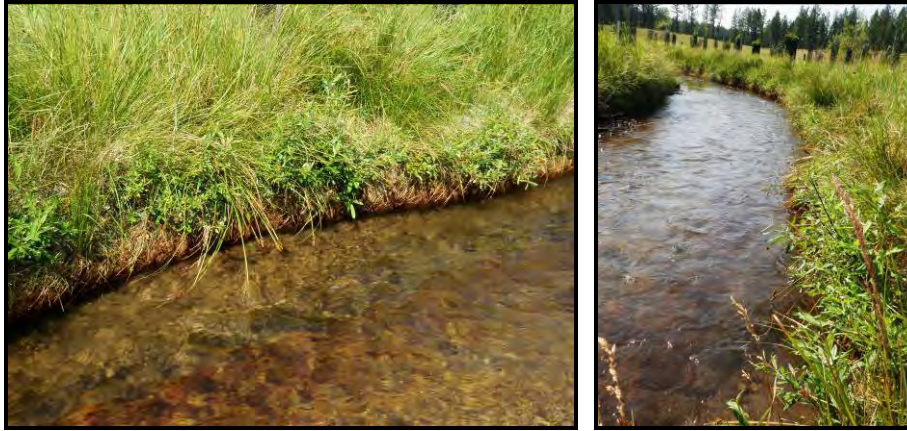
All coir log sites were observed in August 2010. Each site was photographed and observations of willow survival, growth and overall treatment effectiveness were recorded. Overall survival of willow cuttings appears to be consistent with data collected in 2009. Willow cutting growth is continuing but is slower than expected. Browse of willows was observed at almost every coir log site and this is likely a major factor affecting shoot growth on willows. Although top growth is being limited by browse, it is not likely affecting root development of the willow cuttings. Tall pasture grasses continue to dominate the banks adjacent to coir logs and may be limiting the availability of light reaching the willows. Similar to the vegetated soil lifts though, the surviving willow cuttings are beginning to form a dense band of woody vegetation along the streambanks (Figure 15). Potential measures for controlling browse on willow cuttings installed in coir logs were evaluated, but none were recommended for similar reasons as those described above for vegetated soil lift sites.

Although pasture grasses dominate the streambanks at these sites, it does appear that percent cover of wetter species, such as sedges are increasing immediately along the channel at these sites. This may indicate that coir logs are functioning to increase moisture in these banks late in the growing season resulting in a transition to wetter species.

Figure 15. Photographs show the short, but dense patches of willows growing from the coir logs. Sedge species have also started to dominate the streambank area immediately adjacent to the coir logs.

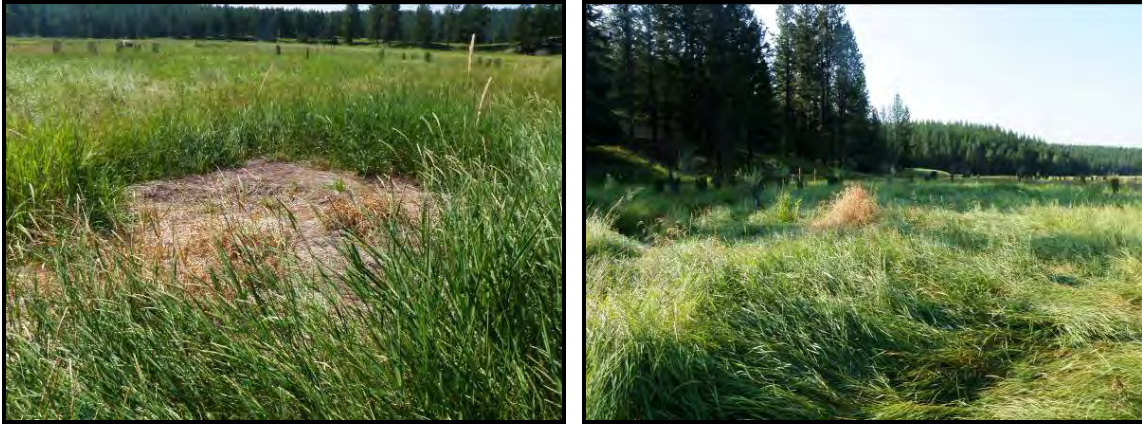
Figure 16. Photographs showing small patches of reed canarygrass after summer herbicide treatment.

- Complete herbicide application recommendations provided in the 2009 monitoring and maintenance report in summer and fall 2010.

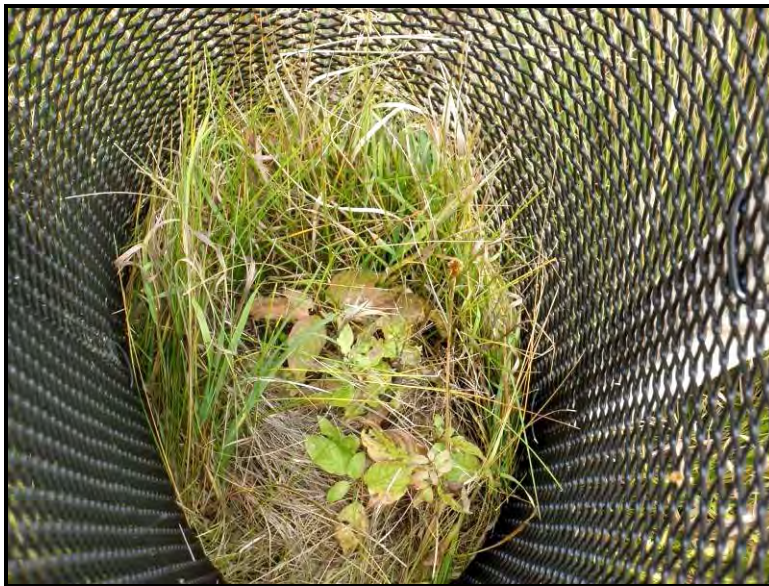
Residual shrubs selected for protection showed signs of heavy browse (Figure 18). All of the remaining surviving shrubs that could be located within the project reach were protected in 2010. The majority of residual shrubs are red-osier dogwood (*Cornus sericea*) and sandbar willow (*Salix exigua*).

Figure 18. Photograph showing the typical size of residual shrubs that were targeted for protection. Most shrubs were multi-stemmed and less than a foot tall.

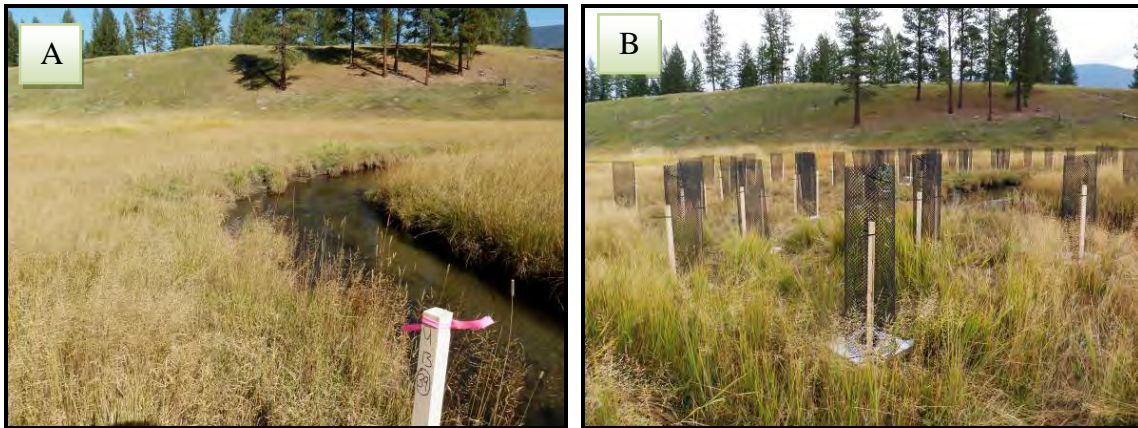
Figure 19. Photograph A shows Planting Unit 13 prior to plant installation. Photograph B shows Planting Unit 13 immediately after installation of containerized plants, browse protectors, vole protectors and brush blankets.

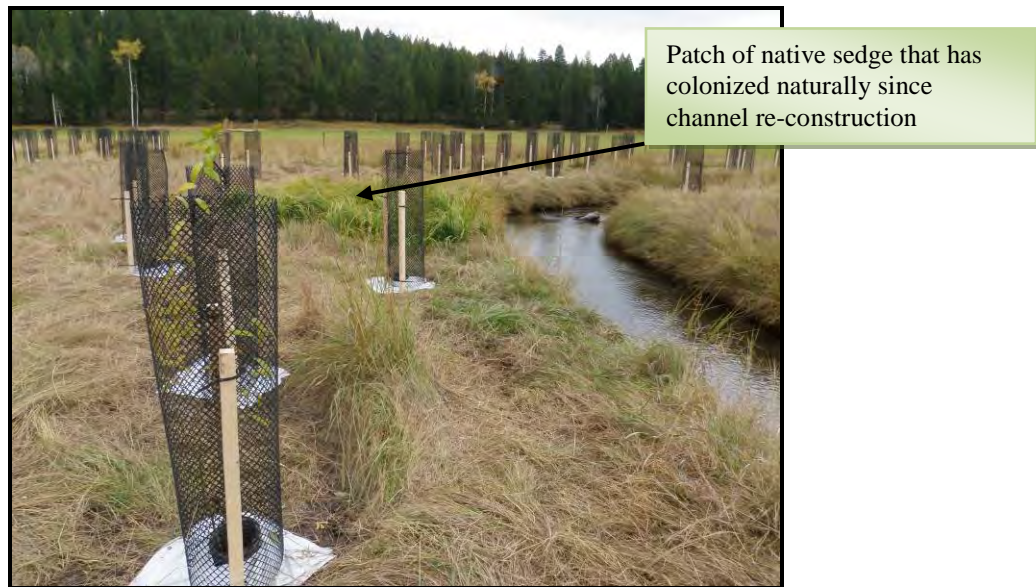
Figure 20. Photograph showing a typical Phase III planting unit along an outer meander. Note the patch of sedges that has colonized along the channel. Existing desired vegetation such as this was left undisturbed.
