# Therriault Creek Riparian Revegetation 2011 Monitoring and Maintenance Report

Contract #120001

**Prepared for:**

Geum Environmental Consulting, Inc.  
307 State Street  
Hamilton, MT 59840

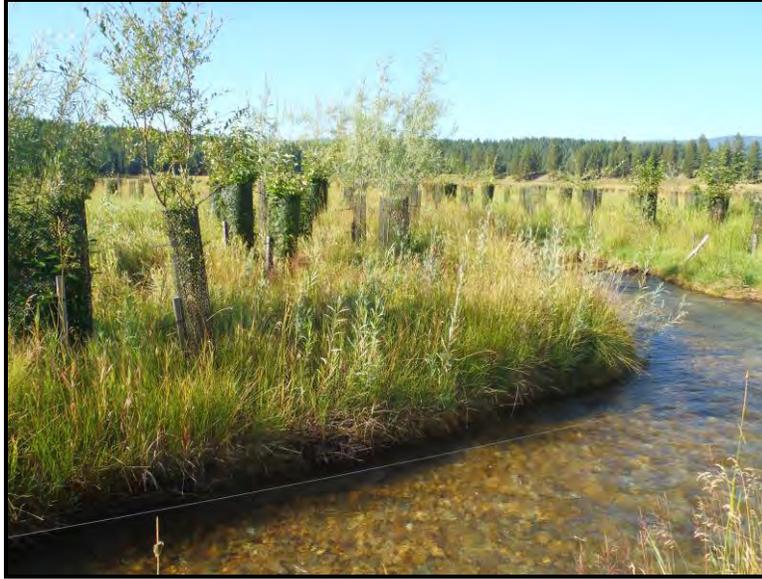
**Figure 3.** Photograph of previously planted (residual) shrubs protected with individual browse protectors located on an inside meander that have grown to a height where they are beginning to provide shade to the creek.

- Individual browse protectors were removed from sandbar willow shrubs growing more than three feet above the protector.
- Individual browse protectors were generally left in place on red-osier dogwood, alder, and birch shrubs that are not located near other protected shrubs.
- For residual shrubs that are found in clumps of multiple plants, individual browse protectors were removed and small exclosures were constructed around the group of shrubs. The purpose of the small exclosures is to continue to protect shrubs from browse and damage while reducing the need for continued annual expansion and removal of browse protectors and to allow multi-stemmed shrubs more growth freedom.

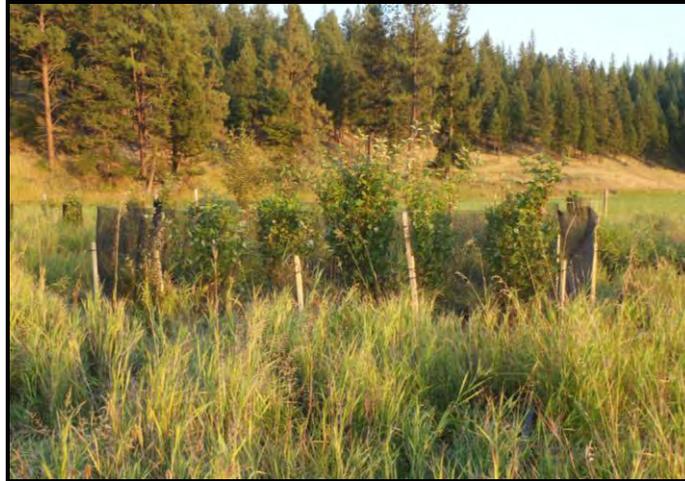
**Figure 5.** Photograph of a group of residual shrubs where individual protectors were removed and used to construct a small enclosure around the group.

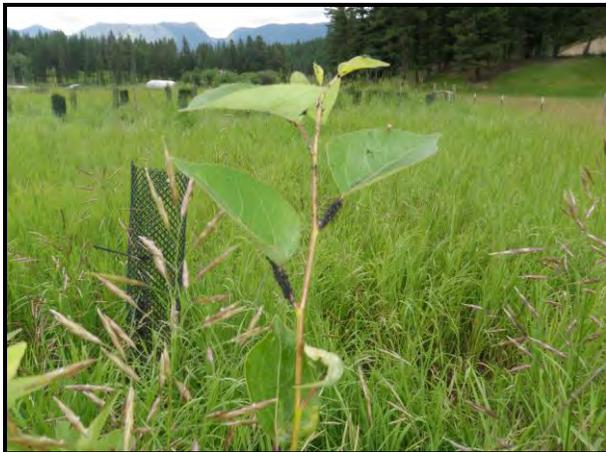
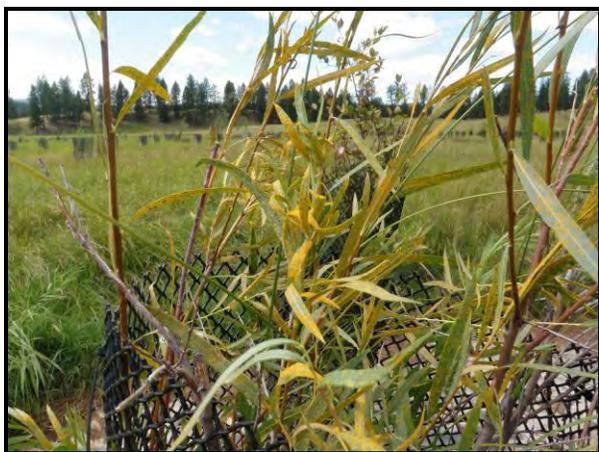
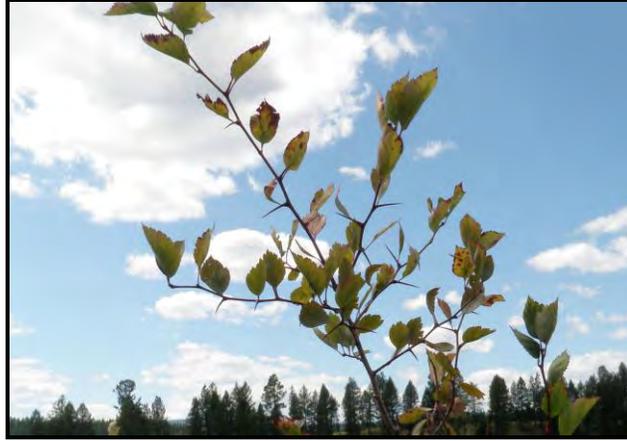
or insects has been observed on planted shrubs in the Phase I area. Evidence includes leaf spots, rust, cankers, or direct observations of insects (Figure 6). Leaf damage has also been observed each year, and can be caused by browse, herbicide drift, winter stress or leaf scorch, which occurs when the roots do not supply enough water to replace what is used by the leaves. This typically occurs during periods of drought. There has been adequate moisture in most years since and supplemental watering of the planted shrubs has occurred in years when moisture had not been adequate. The site is open with very little wind or sun protection which may also contribute to some leaf damage.

**Figure 6.** Photographs showing various factors that may be affecting plant survival in Phase I. Top left photo shows aphids on the stems of a planted aspen. Top right photograph shows rust fungus on a planted sandbar willow. The bottom photograph shows leaf spots and leaf damage from unknown causes on a planted hawthorne.

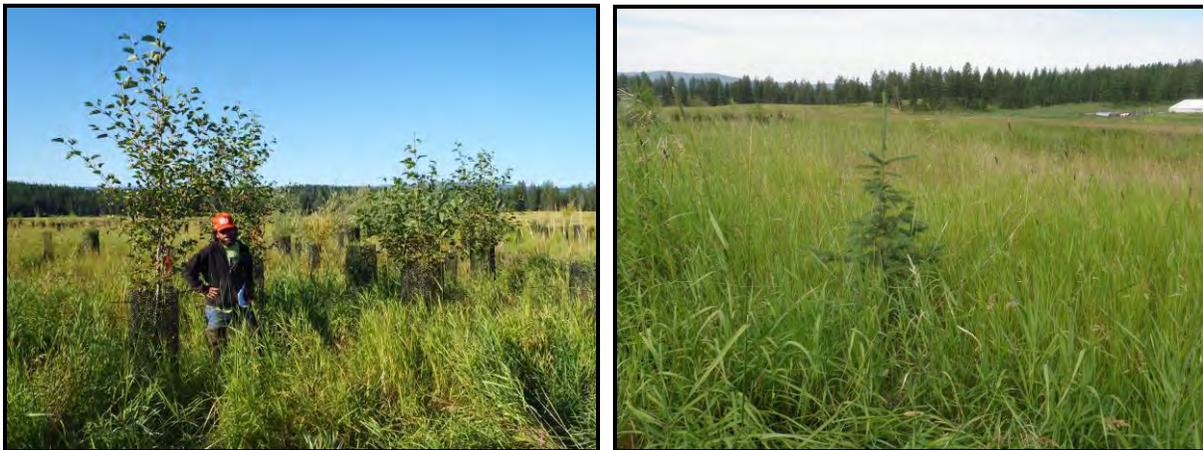
**Figure 7.** Typical growth of surviving shrubs in the Phase I area in 2011 which represents the fourth growing season for these plants. Photograph on the right shows new growth of more than one foot on a spruce planted in 2007.

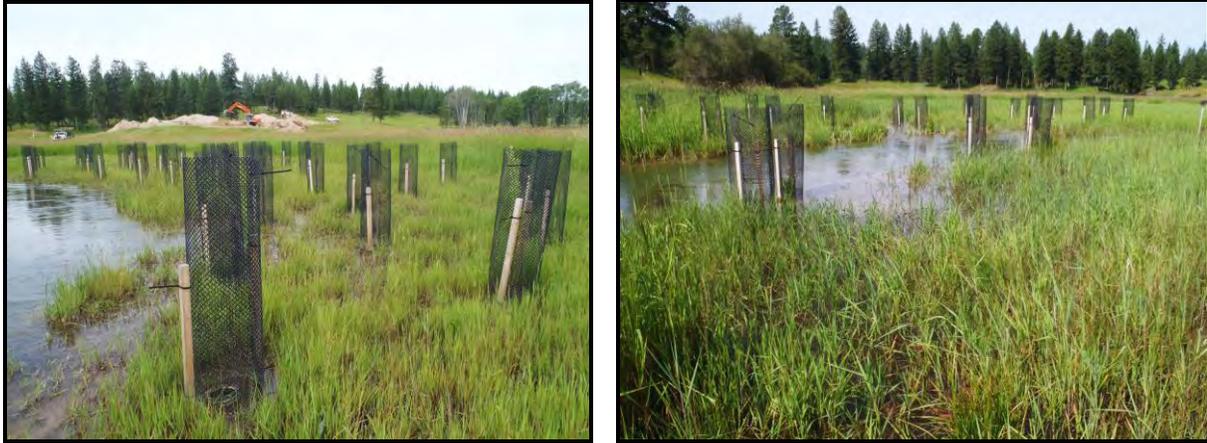
**Figure 8.** Photographs showing inundation in Phase III planting units taken during July 2011 monitoring.

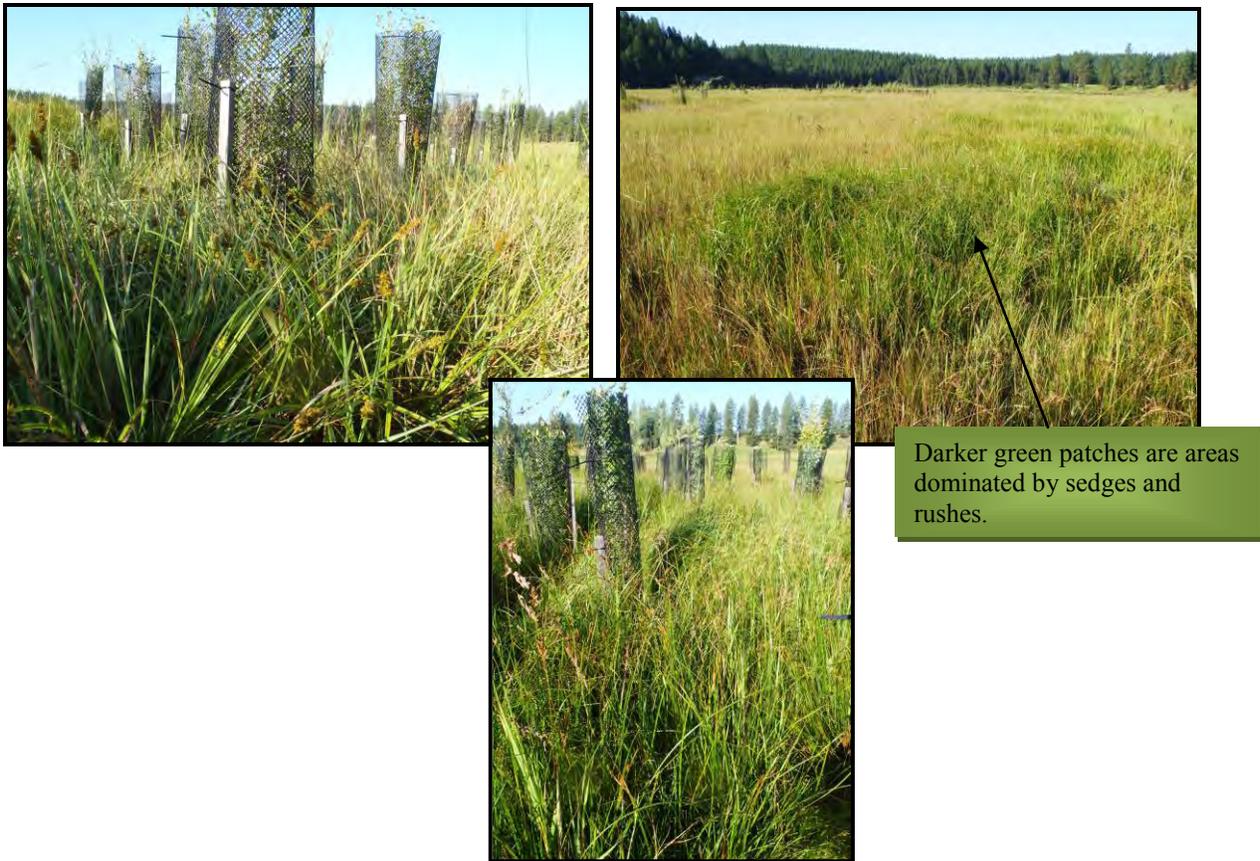
The herbaceous vegetation in both Phases I and III remains a mix of pasture grasses, sedges, rushes, and native grasses. The Phase III planting units support a greater diversity of sedges and rushes as these units tend to be wetter in general than the Phase I planting units. There was standing water throughout the floodplain in July 2011 in Phase III (Figure 8) and some areas of Phase I. In general the cover of native, wetter species appears to be increasing in both Phases I and III (Figure 9).

**Figure 9.** Photographs showing the abundance of sedge species in planting units and throughout the floodplain in Phases I and III.

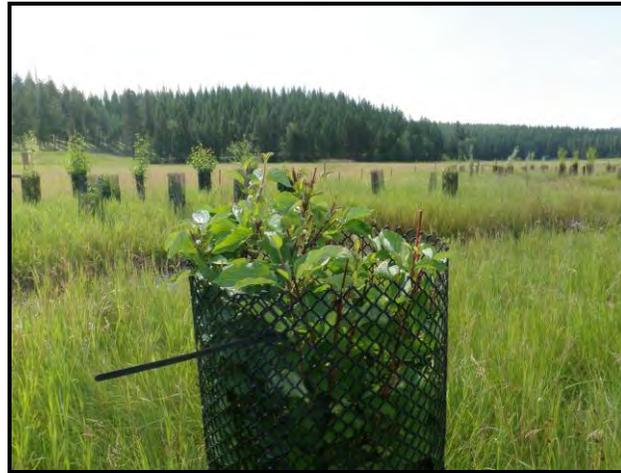
In Phase I, 2011 is the fourth growing season for planted shrubs and trees. Many of the surviving shrubs are very large and continue to outgrow the browse protectors, but other shrubs are being browsed down to the height of the browse protector (Figure 10). On many of the planted shrubs, the browse protectors are beginning to restrict horizontal growth of the shrubs. Some shrubs are still small and well contained within the existing browse protector.

**Figure 10.** Photograph of browse on planted red-osier dogwood to the height of the browse protector.

- In Phase I, for planting units where multiple shrubs were close to out-growing their browse protectors, individual browse protectors were removed and a small enclosure was constructed around the planting unit or a portion of the planting unit. Thirteen small enclosures were constructed. The purpose of the small enclosures is to continue to protect shrubs from browse and damage while reducing the need for continued annual expansion and removal of browse protectors and reducing growth restriction of multi-stemmed shrubs.

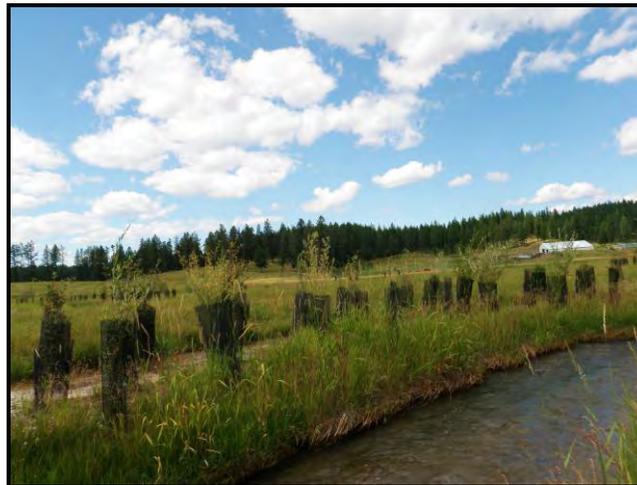
**Figure 11.** Photograph of planted solarization unit 2 in Phase I taken in August 2011. Most of the shrubs have outgrown their browse protectors and are large enough to withstand some browse pressure.

- Remove browse protectors on plants greater than three feet above browse protectors or robust enough to resist browse.
- Remove fabric from both planted solarization units and seed with a mix of native grasses, sedges and forbs. Most of the willows in the planted solarization units are mature and release seed each year. These sites should be observed for natural recruitment of willows on the exposed soils in summer 2012.

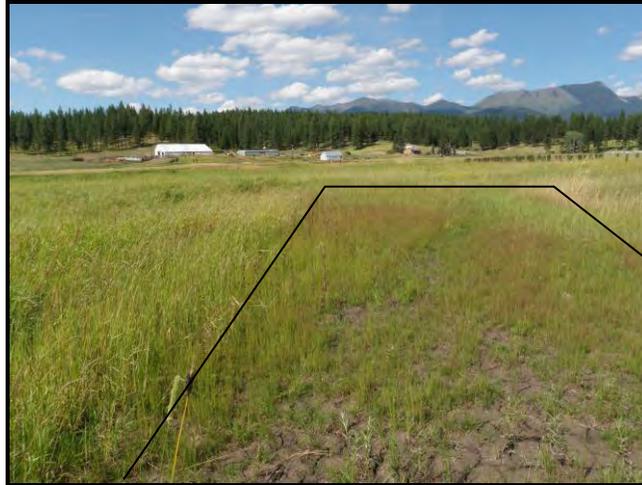
In plot 1, the bare mineral soil has been colonized by a range of species (Figure 12). Many of the colonizing grasses are too young to identify, but appear to consist of a mix of seeded species (tufted hairgrass, fowl mannagrass, and slender wheatgrass), and pasture grasses present adjacent to the plot (quackgrass, redtop, smooth brome, and timothy). Other seeded species observed in the plot include: red-osier dogwood, chokecherry, and Baltic rush. Sedge species were observed but were too young to identify. Other species observed in plot 1 include both native species (sandbar willow, field mint, violet, common willowherb, cattail and knotweed) and invasive species (reed canarygrass and Canada thistle). This plot had standing water in it until the middle of August 2011.

**Figure 12.** Photograph of temporary solarization plot 2 in July 2011, the second growing season after fabric removal. Black lines in the figure represent the approximate extents of where the solarization fabric covered the plot.

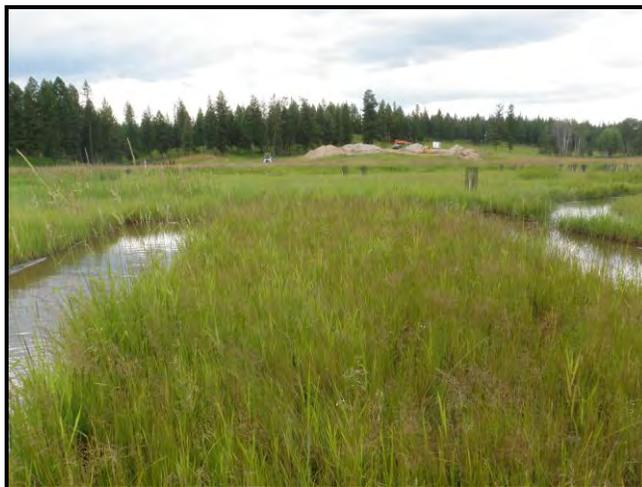
In plot 3, the bare mineral soil has been colonized by both seeded and non-seeded species. Some seeded species, such as fowl mannagrass, are a dominant species in the plot but the plot is dominated mostly by pasture grass species including reed canarygrass, timothy and quackgrass that dominate adjacent areas (Figure 13). Some other desirable species, such as sedges, rushes and wetland forbs are present in small amounts within the plot. In general, the species diversity of seeded species is lower in this plot compared with plot 1. This may indicate that an increase in pasture grasses will occur in plot 1 during the next growing season or it may indicate that the seed bank and root system of pasture grasses was more effectively killed in plot 3 due to the fabric staying in place for one additional growing season. There is little opportunity for colonization of woody vegetation in the plot similar to plot 1 due to the continuous cover of grasses and forbs.

**Figure 13.** Photograph of temporary solarization plot 3. The area between the standing water is the original plot location that was exposed and seeded in fall 2009. The areas of standing water have fabric under the water that was placed around the original plot.

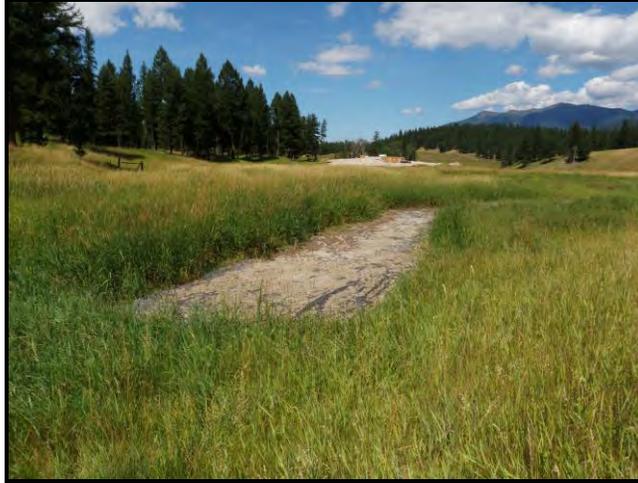
Plot 2 is surrounded by Canada thistle and reed canarygrass (Figure 14). This lower portion of the site has consistently been missed by herbicide applicators in past years and was not sprayed this year due to standing water at the time of application. The ground beneath the fabric consists of bare mineral soil.

**Figure 14.** Photograph of temporary solarization plot 2 located at the downstream end of the project site prior to fabric removal and seeding.

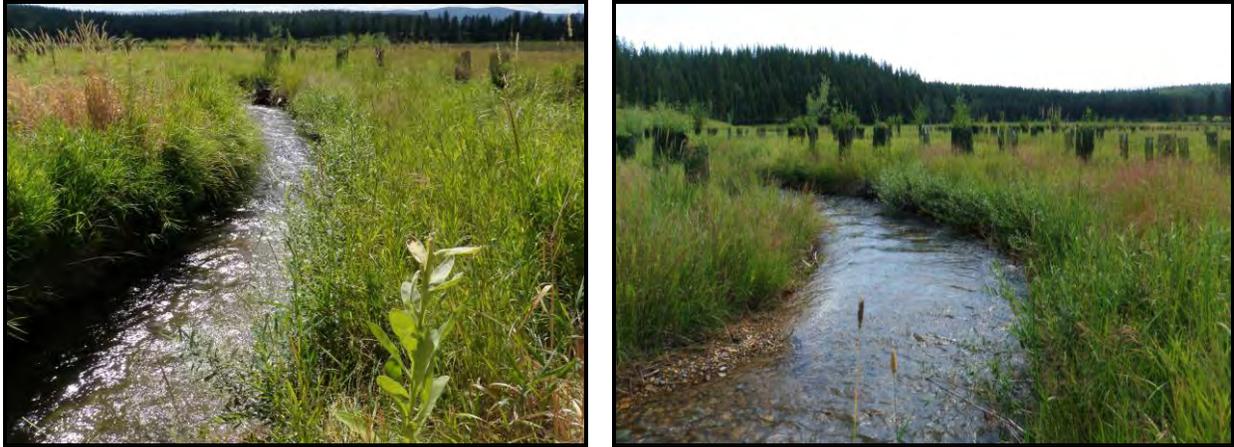
In 2011, general observations were made of both vegetated soil lifts. Percent cover of willows continues to increase resulting in a dense band of cover immediately along the channel at both sites (Figure 15). New growth on willows was greater than observed in previous years but willows at both sites continue to be restricted by browse. Appendix B provides a photo series for each site from 2008 through 2011.

**Figure 15.** Photograph of vegetated soil lift 1 (right bank in the left photo) and vegetated soil lift 2 (right bank in the right photo) showing dense but browsed bands of willows.

- Continue to observe function of the structures but no future maintenance or monitoring is anticipated because the dense growth and associated deep binding root mass is providing the desired function of bank stability.

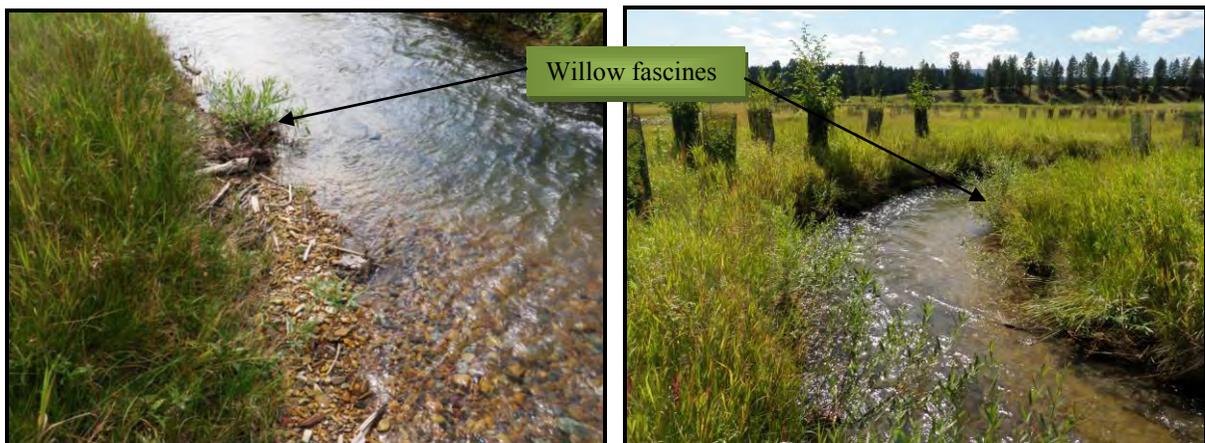
**Figure 16.** Photographs of buried willow fascines growing along inside meanders along the channel margins.

- No maintenance of structures is necessary. The fascines are functioning to trap sediment and debris and establish vegetation within the channel margins.
- Continue to observe the function of the willow fascines but no future maintenance or monitoring is anticipated.

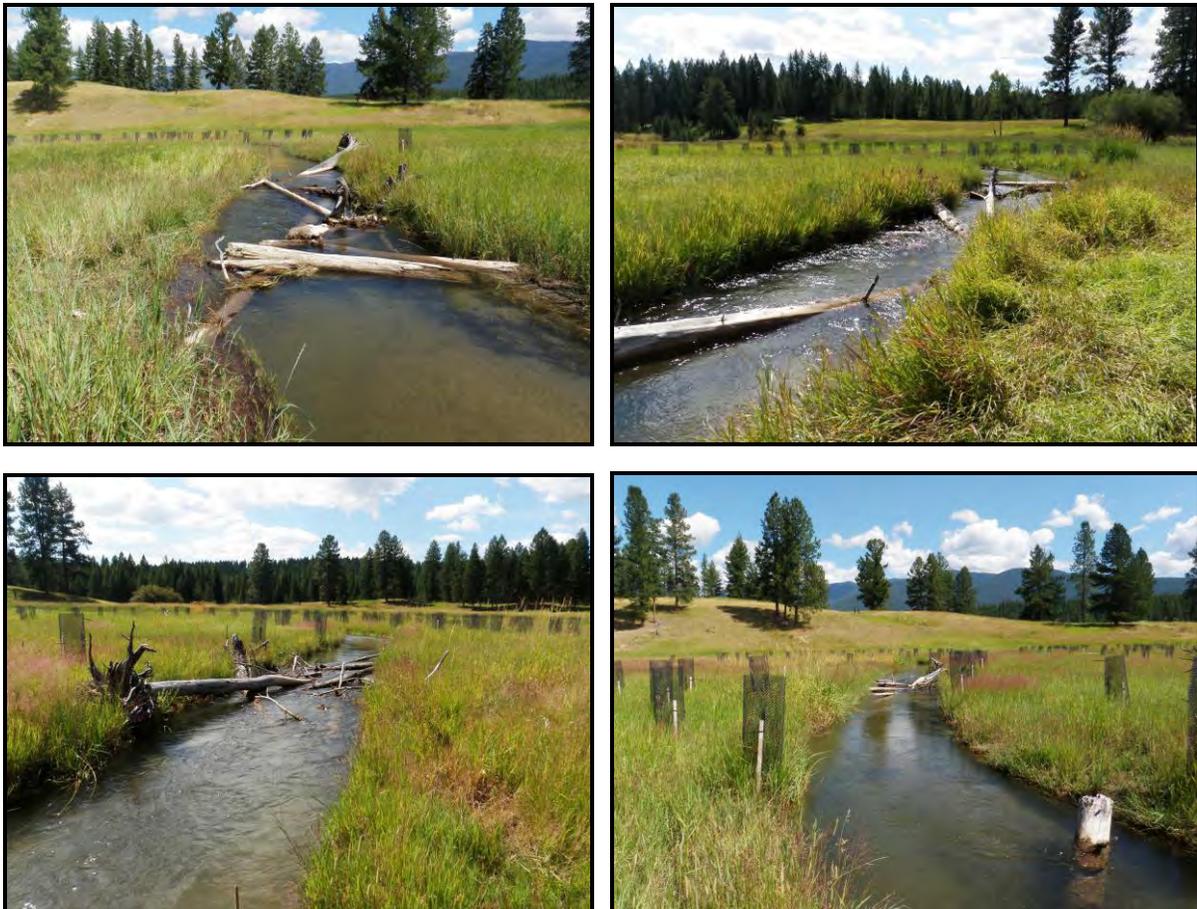
In 2011, general observations were made of all large woody debris structures. It was difficult to observe some of the intended functions of these structures, such as sediment, debris and seed recruitment, due to high flows. However, the large woody debris structures coupled with the high spring flows in 2011 resulted in extensive sustained floodplain inundation in the lower reach of the project area (Figure 17). An increase in native species and wetter species continues to be observed in floodplain areas adjacent to these structures. Large patches of sedges and rushes are now common within the floodplain which was not the case prior to installation of the structures.

**Figure 17.** Photographs of large woody debris structure sites and the surrounding floodplain in late July 2011. There was standing water in the floodplain adjacent to all sites.

- No maintenance of structures is necessary.
- Because shifts in species composition and percent cover occur slowly, transect monitoring at these sites has not occurred since August 2009. Collecting transect data should be considered for summer 2012 to document the shift in species composition at these sites.

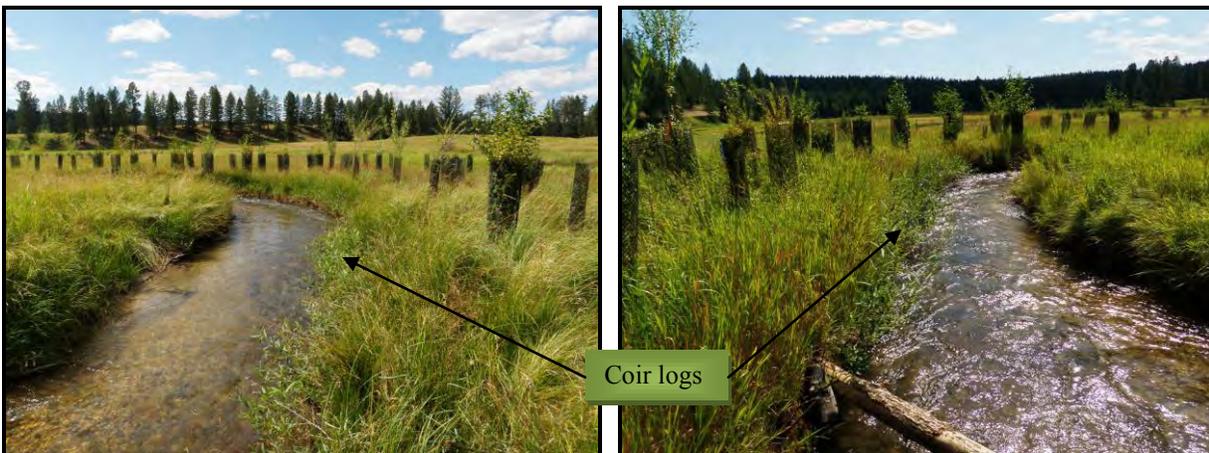
In 2011, general observations were made of all coir log structures. Overall survival of willow cuttings appears to be consistent with data collected in previous years. Percent cover of willows and willow height appears to be increasing at most sites. Coir logs are difficult to see at most sites due to the cover of willows. New growth on willows was approximately six to 12 inches in late July 2011. No browse of the current year's growth was observed during 2011 monitoring. Browse has been a limiting factor for the height of willow cuttings in past years. At many sites, willow cuttings are beginning to form a dense band of woody vegetation along the streambank (Figure 18). No lateral migration of the channel was observed at any of the coir log sites; however, deepening of the channel and an increase in undercut banks was observed at a number of the sites.

**Figure 18.** Photographs of coir log sites showing dense patches of willows growing from cuttings installed between the coir logs and pasture grass roots.

- No maintenance of structures is necessary.
- Continue to observe the function of coir logs but no future maintenance or monitoring is anticipated. Willow survival and percent cover is adequate at all sites to expect willows to maintain streambank and floodplain stability once the coir logs degrade.

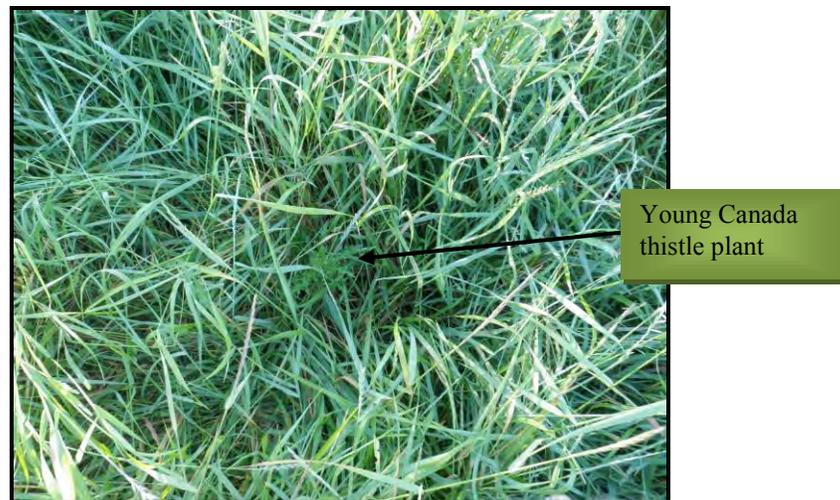
herbicide application. Reed canarygrass remains dense and widespread at the very downstream extent of the project site. These populations have not been treated due to their proximity to the channel and the extent of the infestation. Canada thistle remains the primary target species at the site. The large infestations of Canada thistle within project site have been significantly reduced and large, mature plants are now rare. In 2006, Canada thistle infestations consisting of mature, three to four foot tall plants were common throughout the project area. Although the large, mature infestations have been controlled, in 2011 small plants were found throughout the project area indicating that a significant residual seed bank remains at the site (Figure 19).

**Figure 19.** Typical size of thistle plants at the project site in 2011.

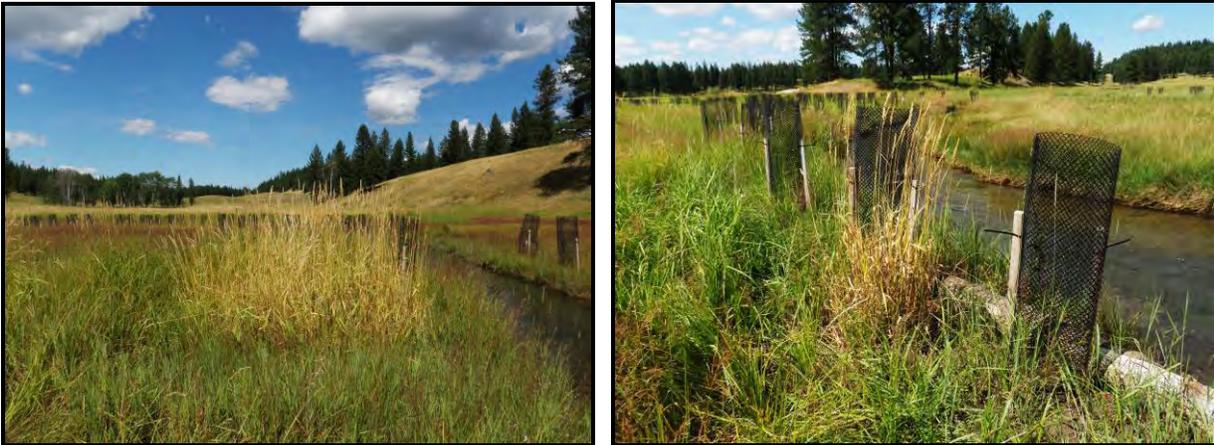
In 2011, weed control targeted all occurrences of Canada thistle, yellow toadflax, houndstongue and isolated patches of reed canarygrass. Figure 20 shows small isolated of reed canarygrass after treatment with herbicide. Figure 21 shows Canada thistle plants after treatment. Figure 22 shows the extents of 2011 herbicide application. A total of 28 acres were treated. Treatment in 2011 was very thorough with very few skips or missed plants observed three weeks after treatment. Transline® was applied at a rate of 0.5 ounces/gallon and 40 gallons per acre to treat thistle, toadflax and houndstongue. Roundup® was used to treat reed canarygrass.

**Figure 20.** Photographs of small clumps of reed canarygrass after summer 2011 herbicide treatment.

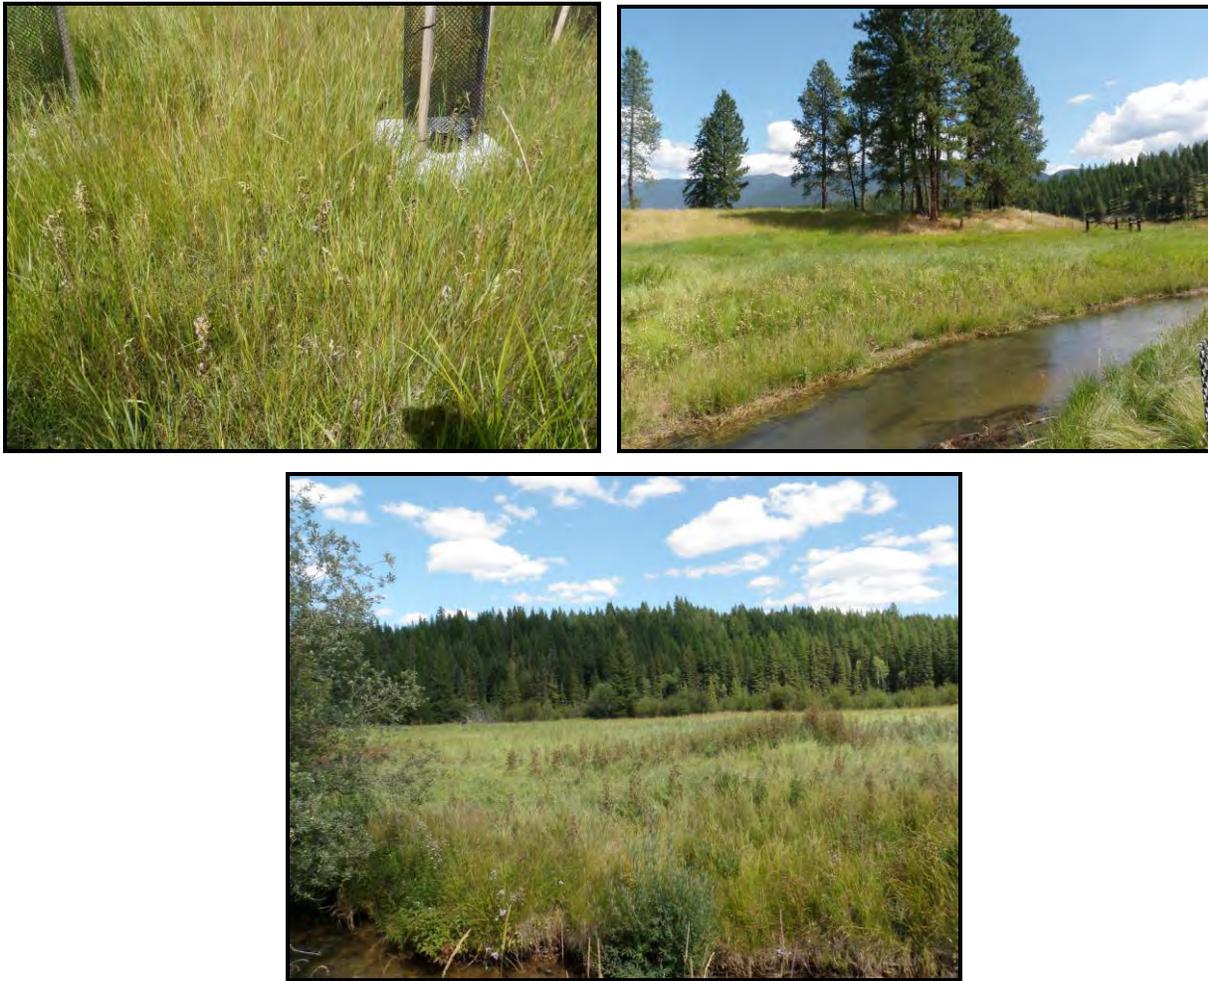
**Figure 21.** Areas treated for Canada thistle ranged from treating young plants in the Phase I area (upper left photograph) to denser infestations of older plants in the lower half of the Phase III area (upper right photograph) and upstream of the bridge, above the revegetation treatment area (lower photograph).
