GEUM ENVIRONMENTAL CONSULTING, INC.

December 22, 2015

Re: Therriault Creek 2015 Maintenance and Monitoring Summary

2015 Site Observations

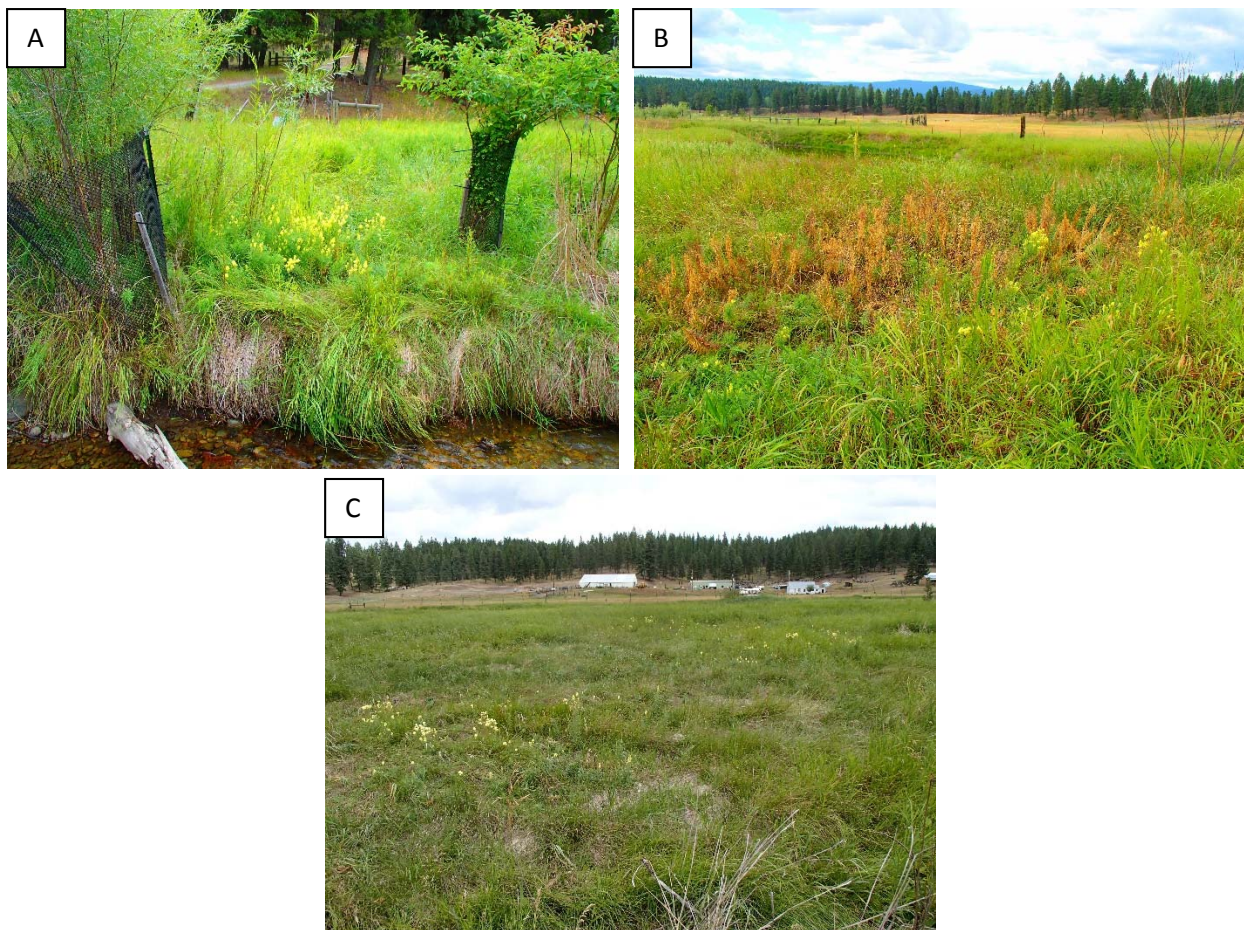
- The target weed species continue to be: common toadflax, Canada thistle, houndstongue and reed canarygrass.
- The abundance and distribution of common toadflax has increased in the project area (Figure 1). This species used to be localized to a few small patches near the bridge at the upstream end of the project but has expanded out from the channel and downstream. As this has been a target weed for numerous years, it is not clear why it is expanding in the project. It is difficult to see when it is not in flower, so it is possible that it has been missed in previous year's treatments.

Figure 1. Common toadflax along streambanks (A), treated near the ponds at the upstream end of the project (B) and expanding out from the original infestation (C).

- Maintenance recommendations based on site observations included: continue to treat all occurrences of noxious weeds within the project area; continue to treat isolated clumps of reed canarygrass in the project area; rake and seed treated patches of reed canarygrass where no other grasses have colonized; and continue to treat Canada thistle in the hayfield and ditch adjacent to the project area as budget allows.

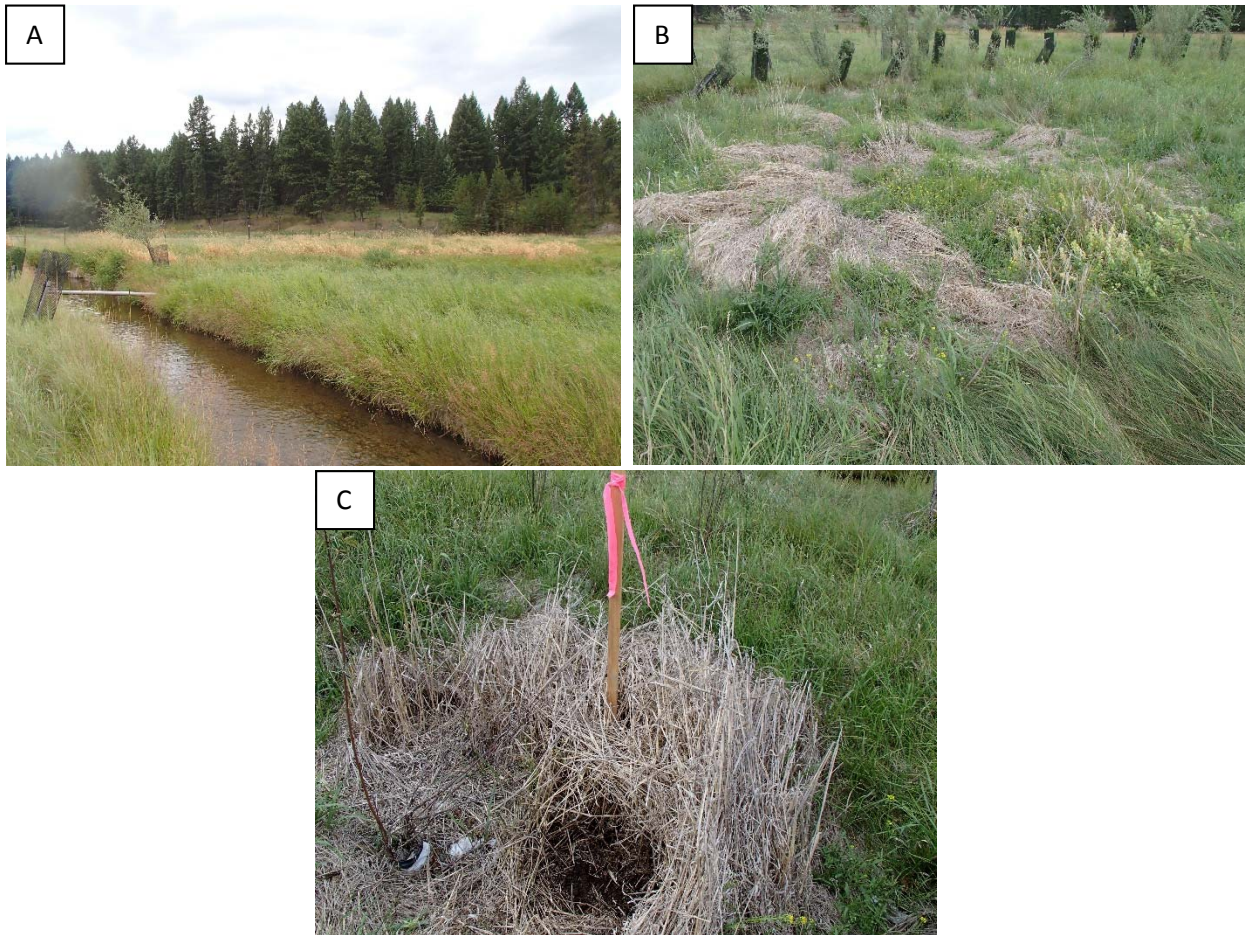
- Reed canarygrass is still widely distributed throughout the project area (Figure 2). Dense infestations are still present in the lower portion of the project where it remains the dominant species along the channel and ditches entering the project. In the upper portion of the project, isolated patches have generally been reduced and only some of the patches treated in 2013 and 2014 had re-growth. Some treated patches are being colonized by annual weeds, some by pasture grasses and others have nothing colonizing the bare ground under the dead vegetation. Reed canarygrass is still relative uncommon in the upper part of the project area but is increasing along the streambanks where it is difficult to control.

Figure 2. Large area of reed canarygrass treated in the Phase III project area (A); reed canarygrass clump previously treated and being colonized by annual weeds and pasture grasses (B); and treated clump that is not being re-colonized (C).

- Approximately 640 square feet of bare soil left after herbicide kill of isolated clumps of reed canarygrass were seeded with slender wheatgrass and fowl mannagrass. The areas were first raked to remove dead plant material.

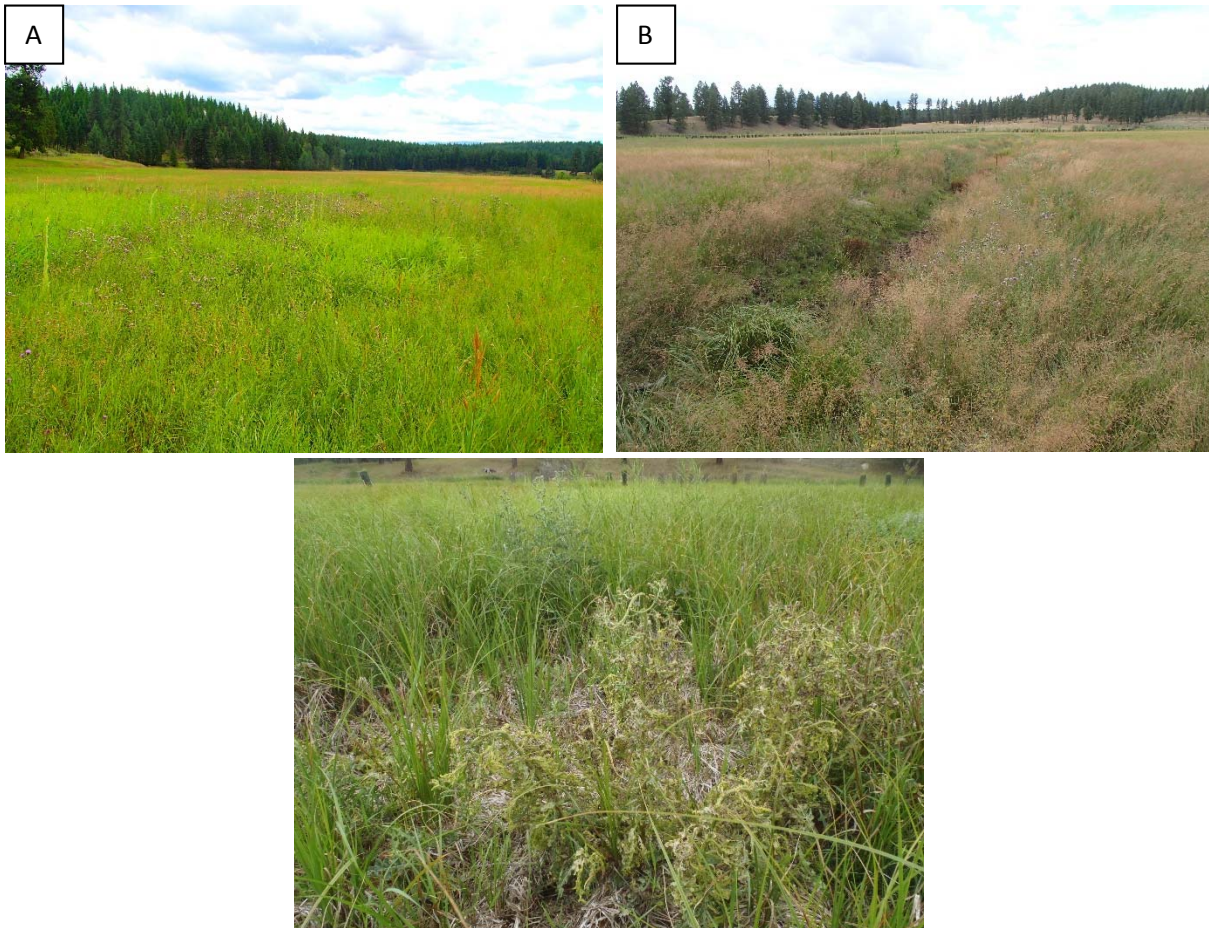
- Canada thistle within the project area has been greatly reduced but still occurs sporadically. Canada thistle is more widespread with higher densities in hayfield and drainage ditch adjacent to the project (Figure 3). This is likely due to inconsistent treatment of these areas in the past (treating this area has been a lower priority because it outside of the project area) and possibly due to drier conditions caused by the drainage ditch that lowers the water table in the hayfield.

Figure 3. Canada thistle in the hayfield (A), along the ditch (B) adjacent to the project and a large plant that was treated in the proejct area (C).

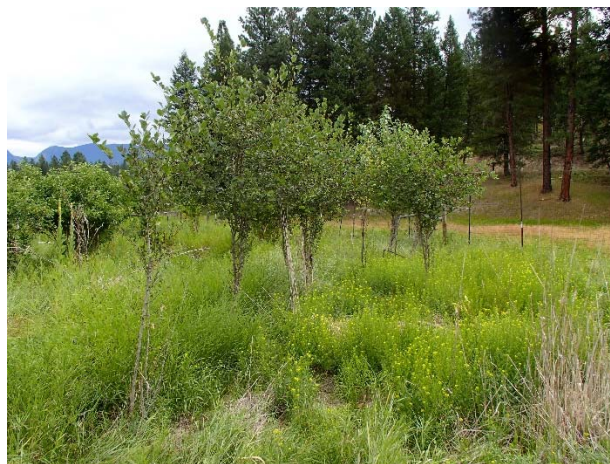
- There are a few areas where infestations of non-target species, such as mustard (*Brassica spp.*) were present in 2015 (Figure 4). This has not occurred in the past and may be a result of 2015 drought conditions. These infestations typically do not persist long-term.

Figure 4. Infestation of mustard in Planting Unit 16 in Phase 1.

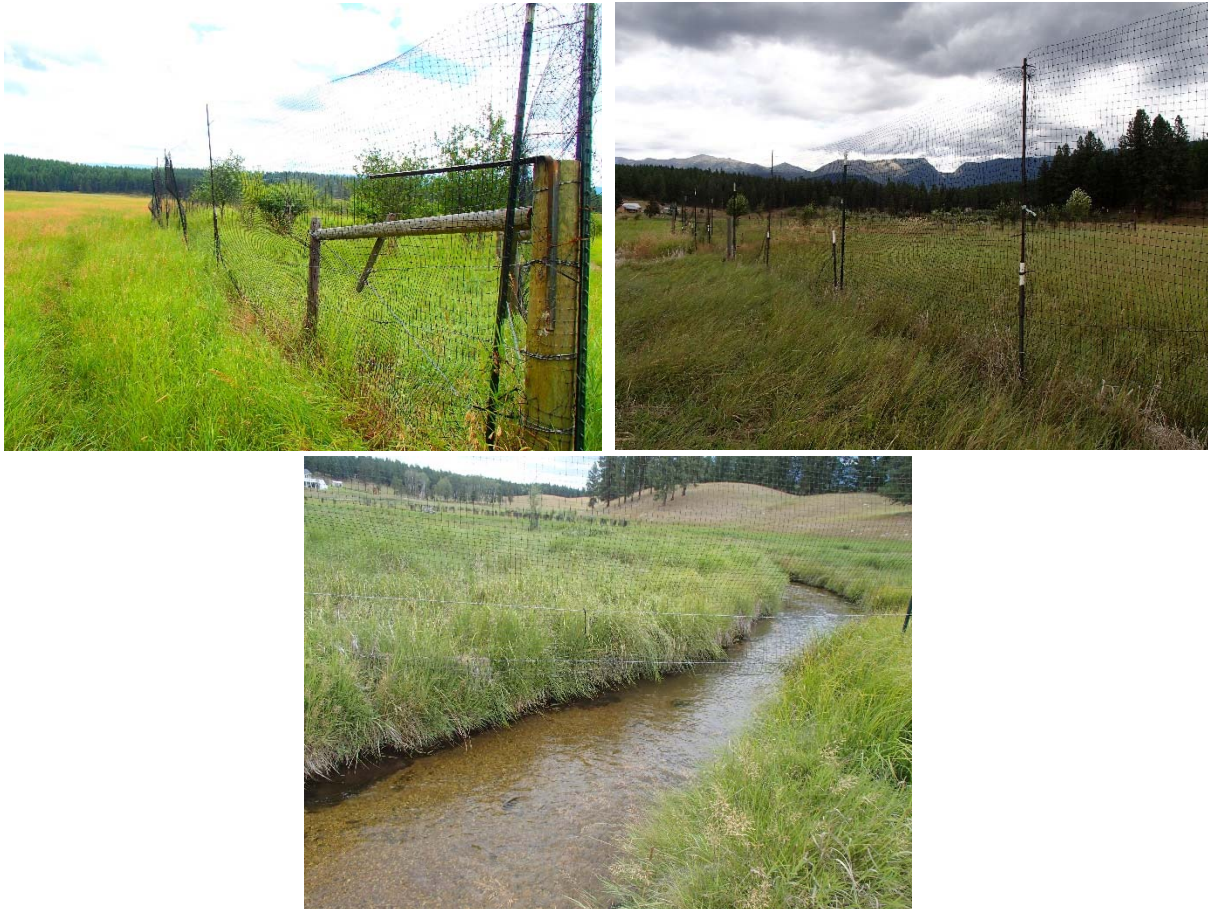
- The 10-foot t-posts installed in fall 2014 to re-inforce the iron extensions that were used to extend the height of the existing cattle fence to exclude wildlife exclusion were all intact and supporting the fence material (Figure 5).
- Two areas were identified where deer had torn through the fabric at the downstream end of the fenced area. There was also evidence that deer were entering the fenced area at the downstream channel crossing. Although at a much reduced level, browse was observed on planted shrubs throughout the Phase I and Phase III planting units.
- Maintenance recommendations based on site observations included: reinforcement of the two areas where deer damaged the fence and installation of additional fence material at channel crossing points.

Figure 5. Ten foot tall t-posts were installed in fall 2014 to re-inforce the original fence. In 2015, deer had broken through the fence in two locations but the only other observed damage was slight sagging of fence netting. There was also signs that deer were crossing under the fence at the channel crossings.

- The entire riparian protection fence was inspected and repairs were made at two locations where deer had torn the fence fabric and were accessing the project area.

- Additional fence fabric was installed at stream crossings to prevent deer from crawling under fence at low flows.
- Small exclosures were constructed around groups of residual shrubs at the upstream end of Phase I using recycled individual browse protectors.

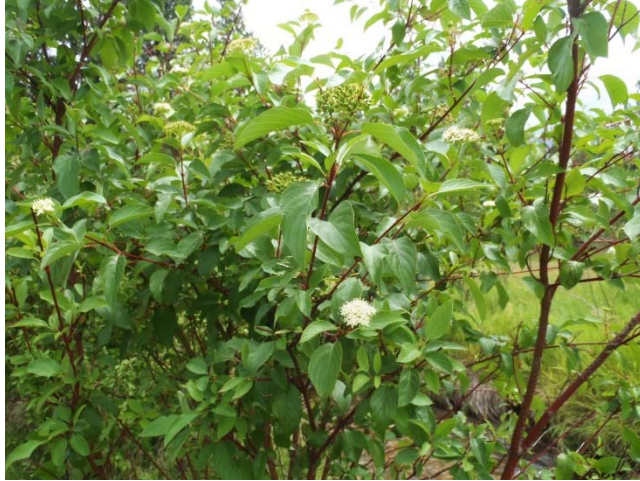
Figure 6. Photograph showing red-osier dogwood in Phase I with flowers and fruits.

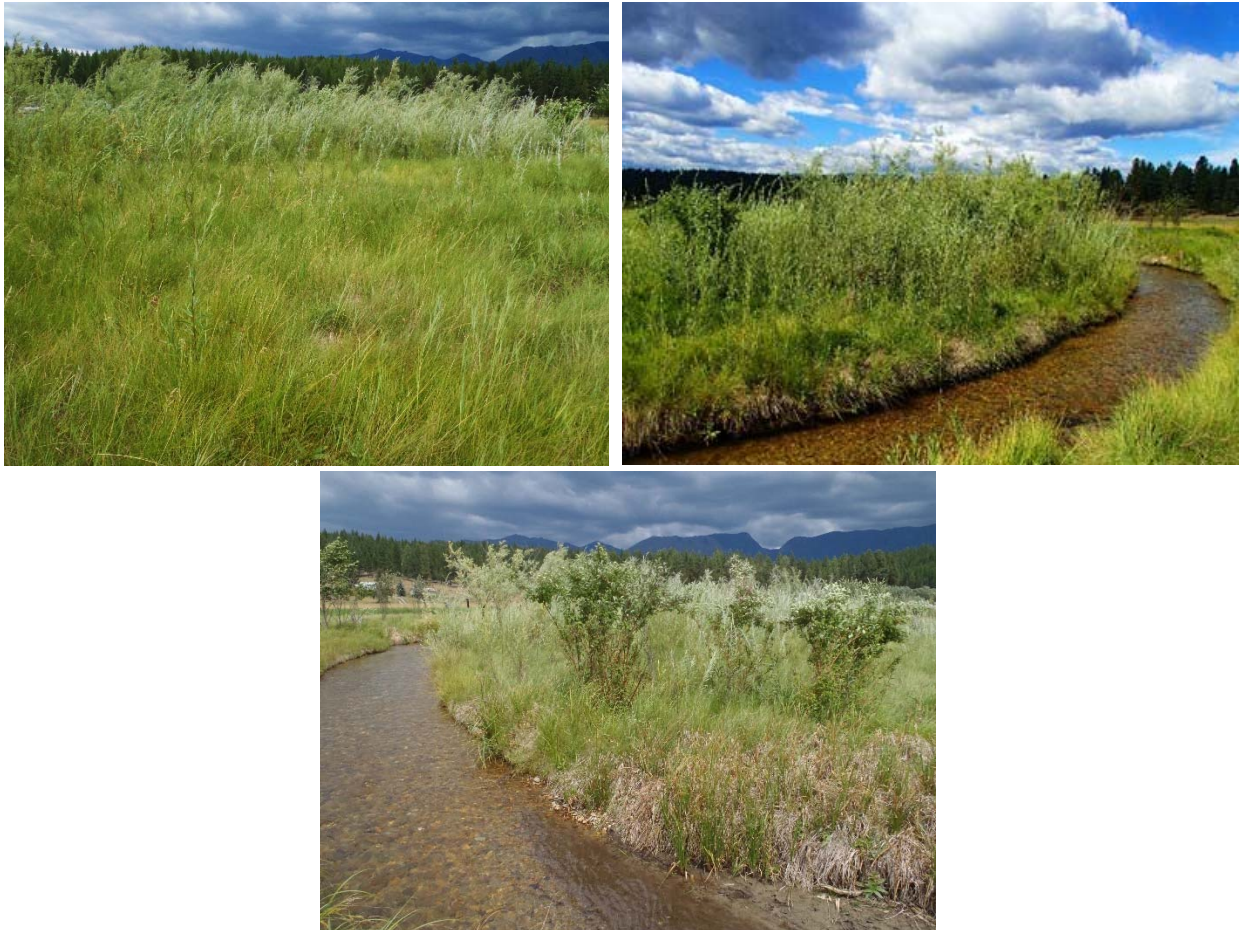
Figure 7. Photographs of naturally expanding sandbar willow and red-osier dogwood in Phase I as a result of installing the riparian protection fence.

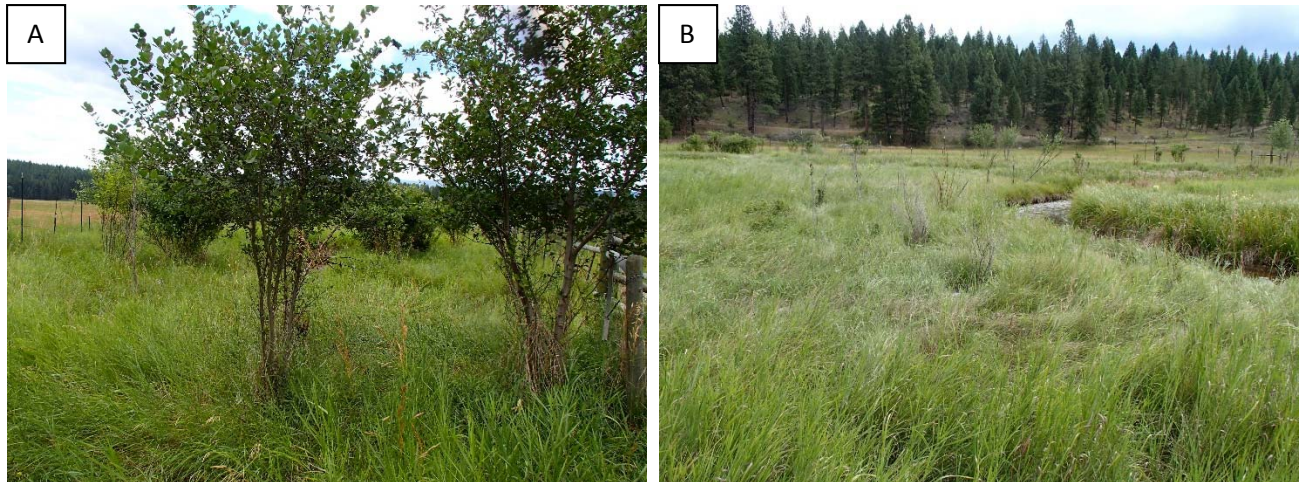
- Survival of planted shrubs and trees in Phase I remains variable and may have decreased slightly compared to observations made in 2014. Some planting units, such as Planting Unit 5 have very few, if any surviving shrubs (Figure 8). A few of the shrubs are re-sprouting from the base, but leaves showed signs of drought stress. Other units, such as Planting Unit 16 have high survival and shrubs that are over 15 feet tall (Figure 8). Plants in units with high survival have distorted growth forms from having individual browse protectors in place for multiple years. In general, the planting units on the west side of the channel and highest in elevation relative to the channel seem to have the lowest overall survival.

Figure 8. Photograph of variable survival in Phase I planting units, with high survival in Planting Unit 16 (A) and poor survival in Planting Unit 5 (B).

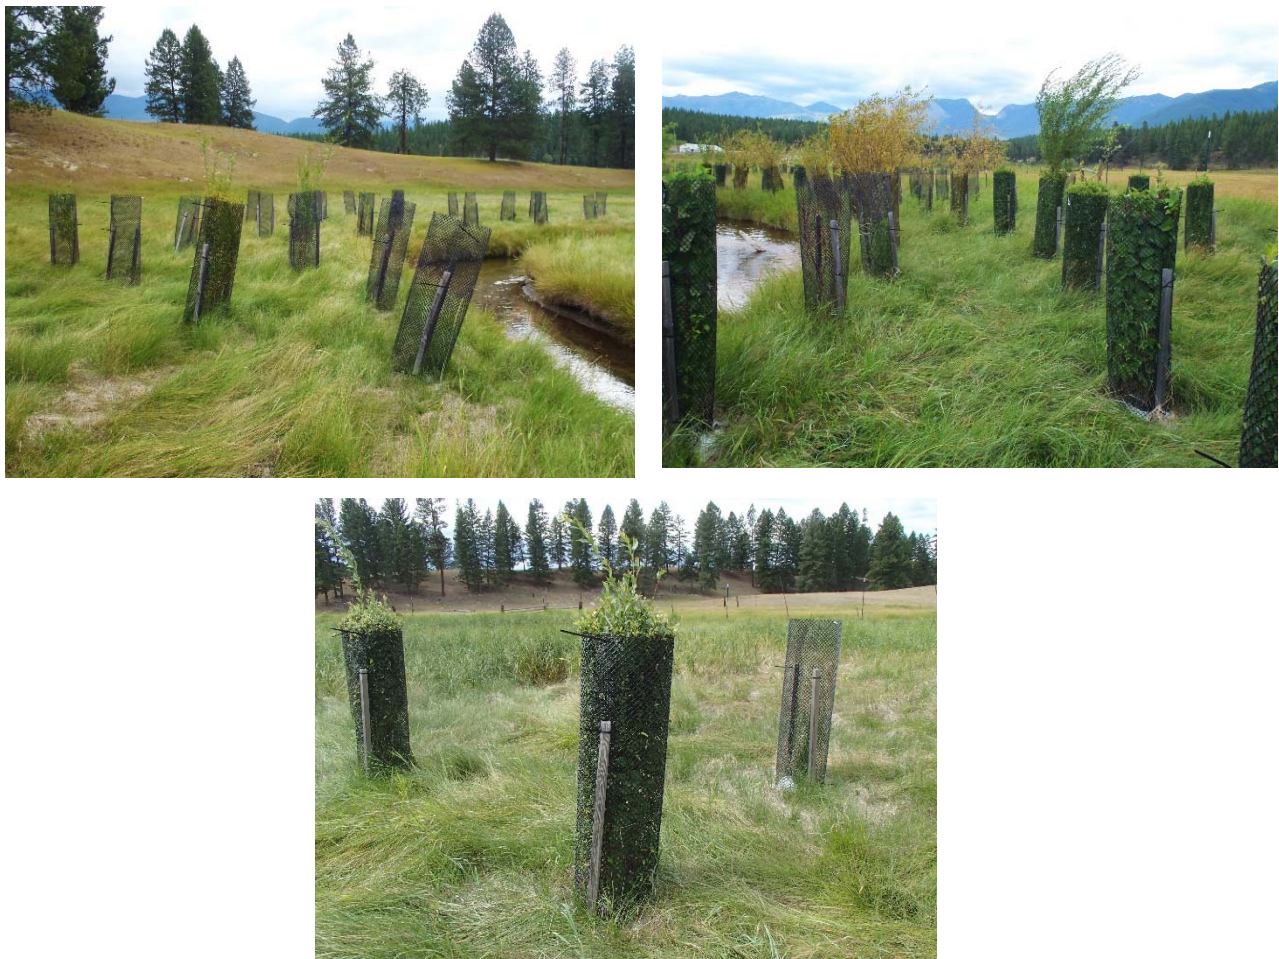
- Survival and growth of shrubs installed in Phase III planting units also remains variable. Units in the upstream portion of Phase III appear to have similar survival as observed in 2014. In these units surviving shrubs are outgrowing their individual browse protectors (Figure 9). Units in the downstream portion of Phase III appear to have lower survival compared to 2014 (Figure 9). In these units shrub growth is not as vigorous.

Figure 9. Photographs of Phase III planting units showing the difference in survival and growth between downstream (photograph left) and upstream (photograph right) units.

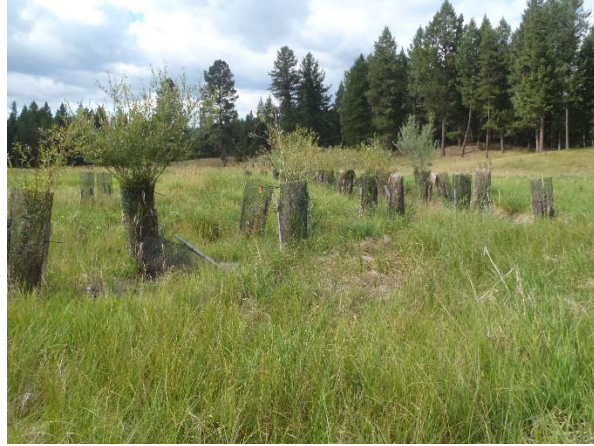
- Survival in Phase III Planting Unit 15, the planted solarization unit, remains high and plants have grown to 12-15 feet tall (Figure 10). This unit has the best growth compared to the other units in the downstream portion of Phase III. The planted solarization units in Phase I in comparison, have very poor survival of planted shrubs and trees (Figure 10). Plant growth and survival in Phase I planted solarization plots was initially vigorous too and it is possible that after the first couple of growing seasons the fabric actually prohibits root growth and suckering.

Figure 10. High survival and growth of shrubs planted in solarization Unit 15 in Phase III and poor survival of shrubs in .

- Solarization fabric was removed from around the base of plants in Planting Unit 15 in Phase III. Exposed mineral soil was seeded with a seed mix consisting of slender wheatgrass and fowl mannagrass.

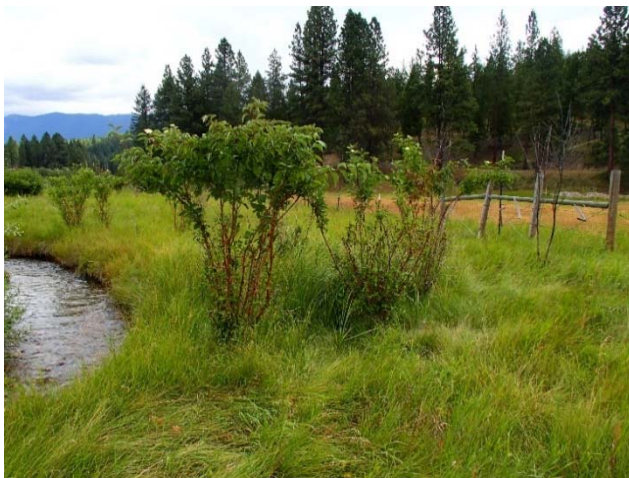
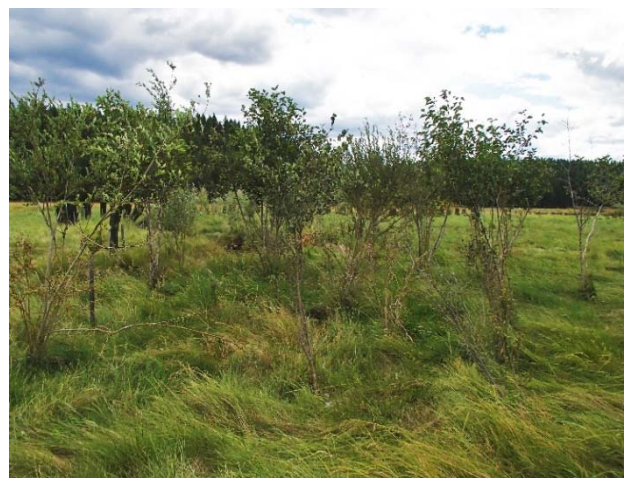
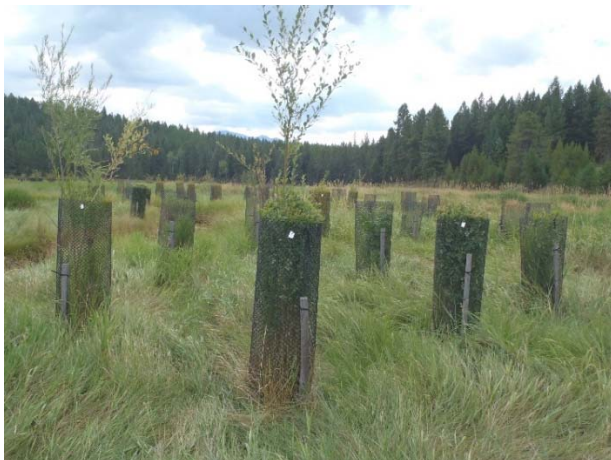
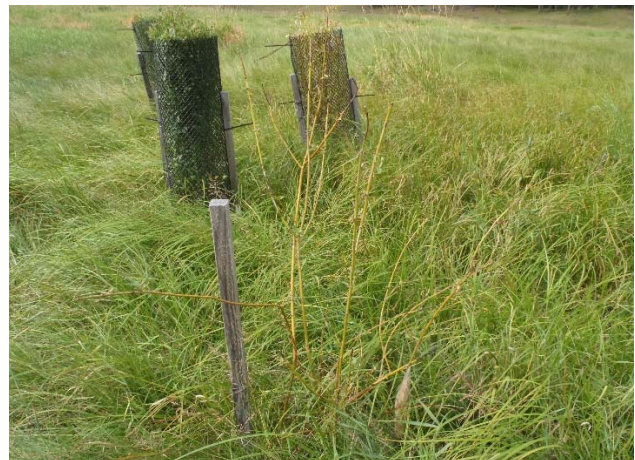
- The individual browse protectors restricted the growth of shrubs planted in Phase I. Most of the individual protectors in Phase I were removed in October 2014 and the shrubs are slowly expanding towards a more natural growth form (Figure 11). The lower branches of these shrubs continue to be browsed by deer. Outside of the riparian protection fence, plants continue to be browsed to the height of the individual browse protectors (Figure 11). Many of the shrubs in Phase III, both inside and outside of the fence have filled the capacity of the browse protector.

Figure 11. Photographs showing shrubs in Phase I that have been released from individual browse protectors and are transitioning to a more natural growth form (top photographs). Some shrubs still have an umbrella shape but branches and foliage are beginning to grow along the entire length of stems and trunks. Lower branches on these shrubs continue to be browsed inside the riparian protection fence. Outside of the riparian protection fence, shrubs are still being browsed down to the height of the individual browse protectors (bottom left photograph). Unprotected plants outside of the protection have extensive browse (bottom right photograph).

- Maintenance recommendations for planting areas based on site observations included: removal of individual protectors within the riparian protection fence, removal of select browse protectors outside of the riparian protection fence; repairs to the riparian protection fence; and removal of solarization fabric around the base of shrubs in Phase III Planting Unit 15 to allow better root growth and suckering.

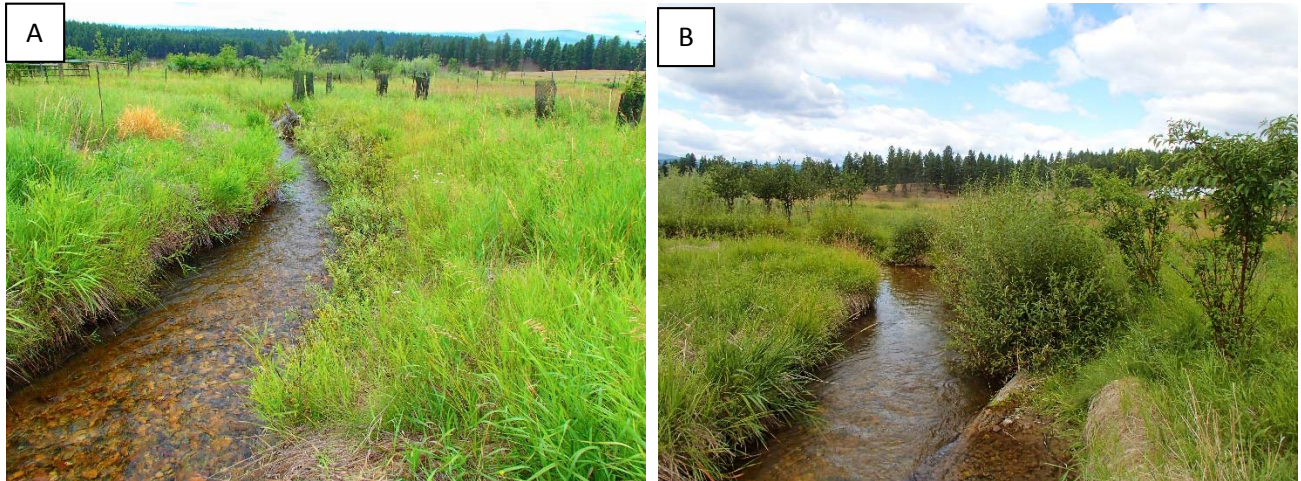
- Vegetated Soil Lift 2 is located within the riparian protection fence. This protection has reduced the amount of browse on the willows and in response willow height was significantly greater in 2015 compared to previous years and compared to Vegetated Soil Lift 1 which is located outside of the riparian protection fence (Figure 12).

Figure 12. Photographs showing the difference between willow growth on VSL 1 (A) and VSL 2 (B). VSL 1 is located outside of the riparian protection fence and VSL 2 is located inside the riparian protection fence.

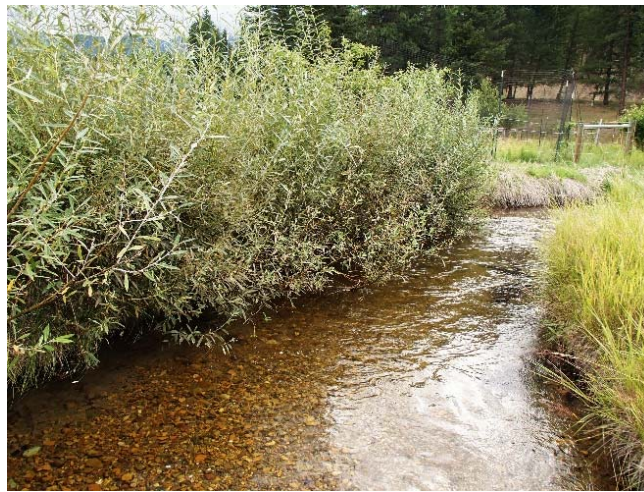
- Both soil lifts provide well-rooted vegetation that provide bank stability, but the additional growth of willows on Vegetated Soil Lift 2 is providing very good cover for the stream and willows at this site are expanding into the floodplain (Figure 13).

Figure 13. Vegetated Soil Lift 2 providing stream cover and shade.

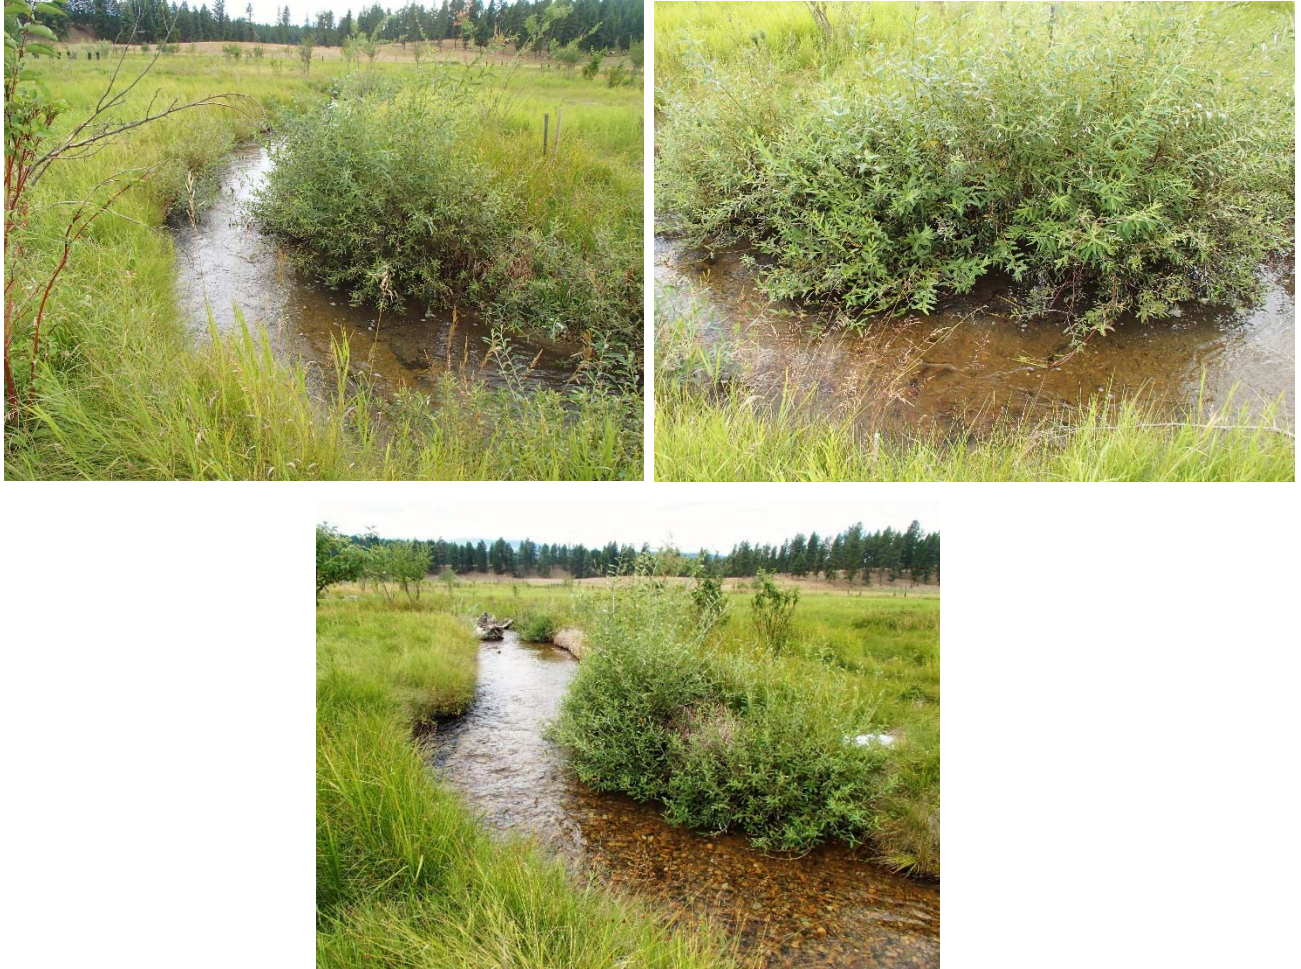
- Surviving willow fascines showed increased growth due to the installation of the riparian protection fence (Figure 14). Dense herbaceous vegetation on the streambanks is limiting suckering and spread of willows into the floodplain.

Figure 14. Photographs of willow fascines installed in Phase I. Willows in many fascines grew significantly in 2015 due to the installation of the riparian protection fence and many of these structures are providing cover and shade for the stream.

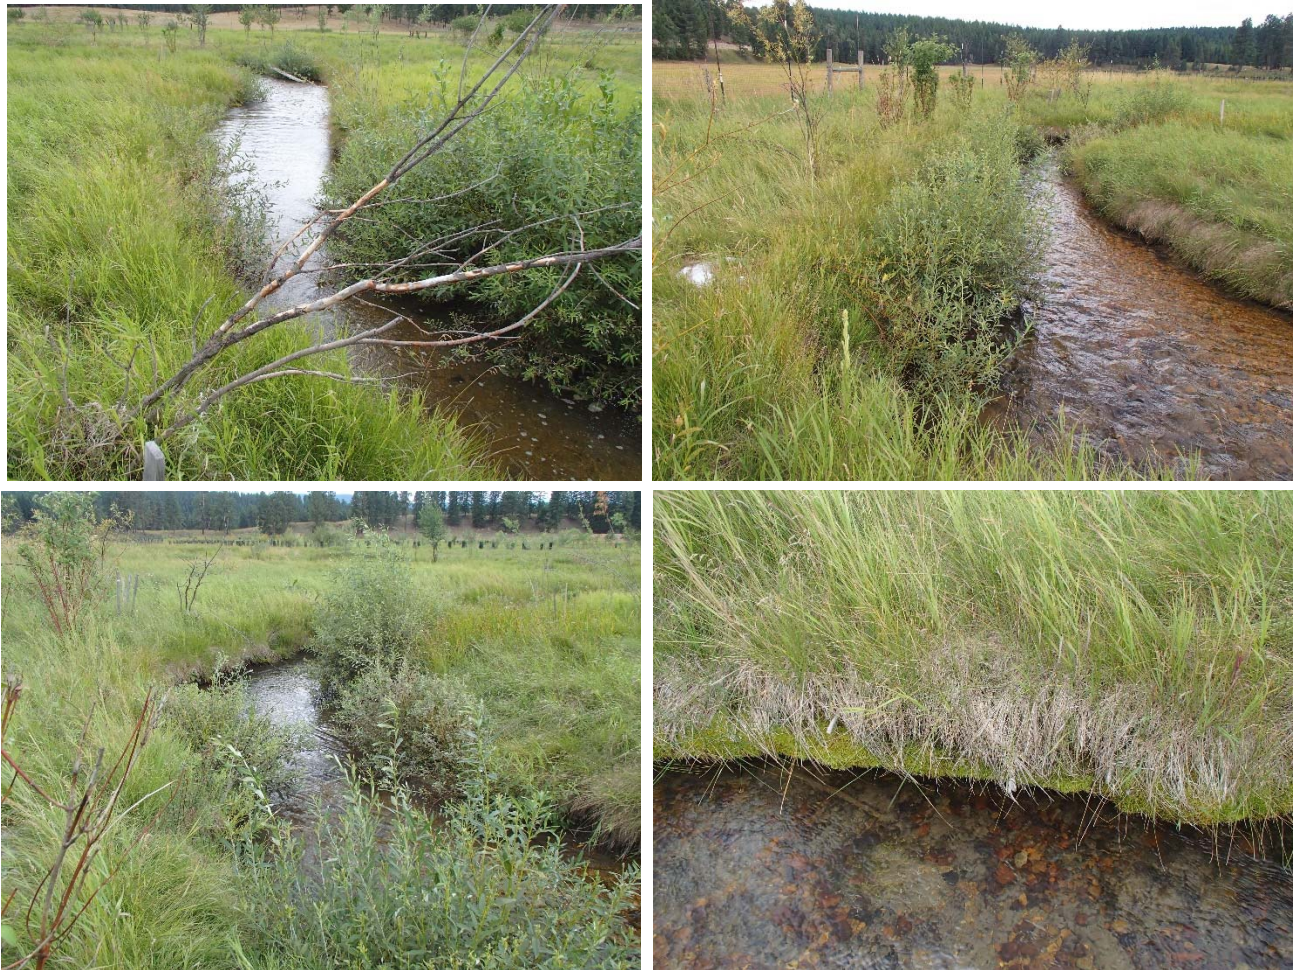
- Willow growth has also increased on coir log structures (Figure 15). Some coir log structures had poor survival of willows for unclear reasons. In general however, the logs are still functioning to support the streambank and provide cover habitat (Figure 15). Dense herbaceous vegetation on the streambanks is limiting suckering and spread of willows into the floodplain.

Figure 15. Photographs of coir logs installed in Phase I. In some areas, coir logs have formed dense bands of willows along the stream creating diverse habitat. In other areas, where willow survival was poor, the coir logs help support undercut banks (bottom right photograph).

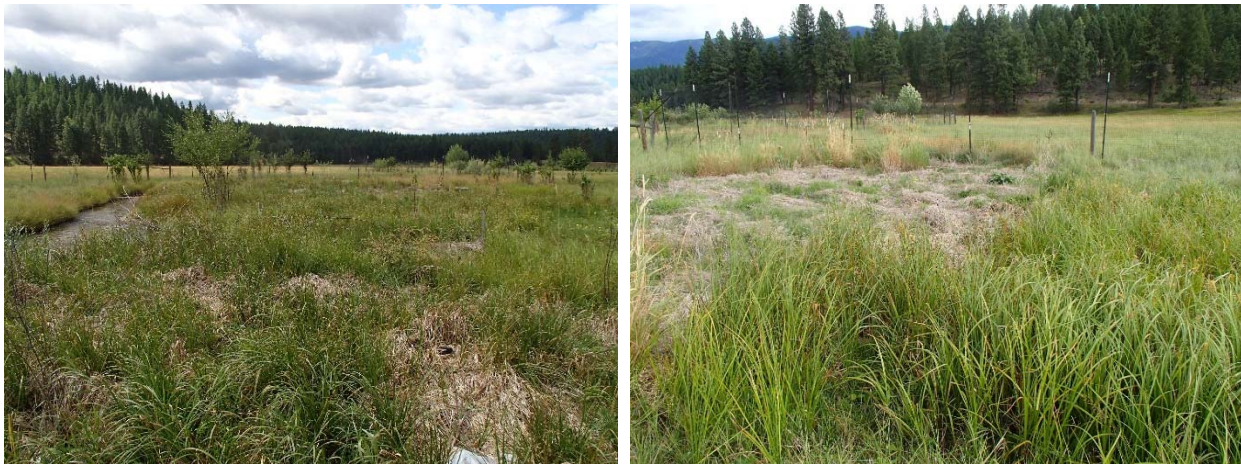
- In general, conditions at the site were much drier than previous years. Early season high temperatures and lack of moisture resulted in drought conditions leading to plant stress. Many of the sedge dominated areas in the floodplain had areas of vegetation dieback in response to drought conditions (Figure 16).

Figure 16. Photographs of sedge dominated vegetation communities within the project area where dieback of wetland vegetation was observed, likely in response to drought conditions that led to low streamflow and groundwater levels in 2015.

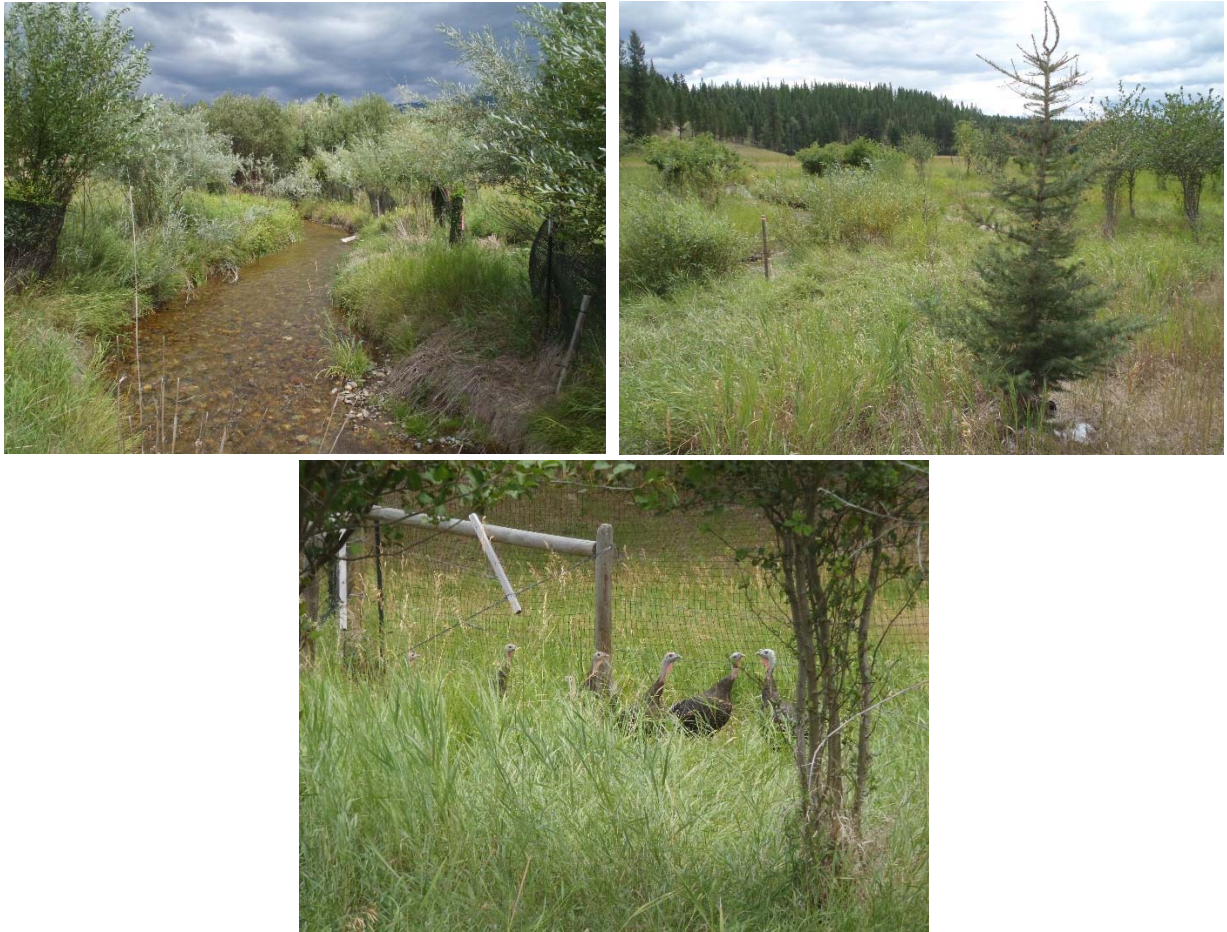
- Although survival of planted shrubs and trees is variable, surviving shrubs continue to grow and expand at the site (Figure 17). Survival and growth seems to be affected by a number of things including: competition with non-native pasture grasses, variable soil conditions (numerous pockets of clay were encountered during planting which some species may not tolerate), variable hydrology conditions (too wet and too dry), variable weather conditions that affect site moisture and influence insect and parasite populations, browse and potential off-target damage from multiple years of herbicide application.

Figure 17. Diversity of vegetation at the upstream end of the project reach and wild turkeys observed in the riparian vegetation.

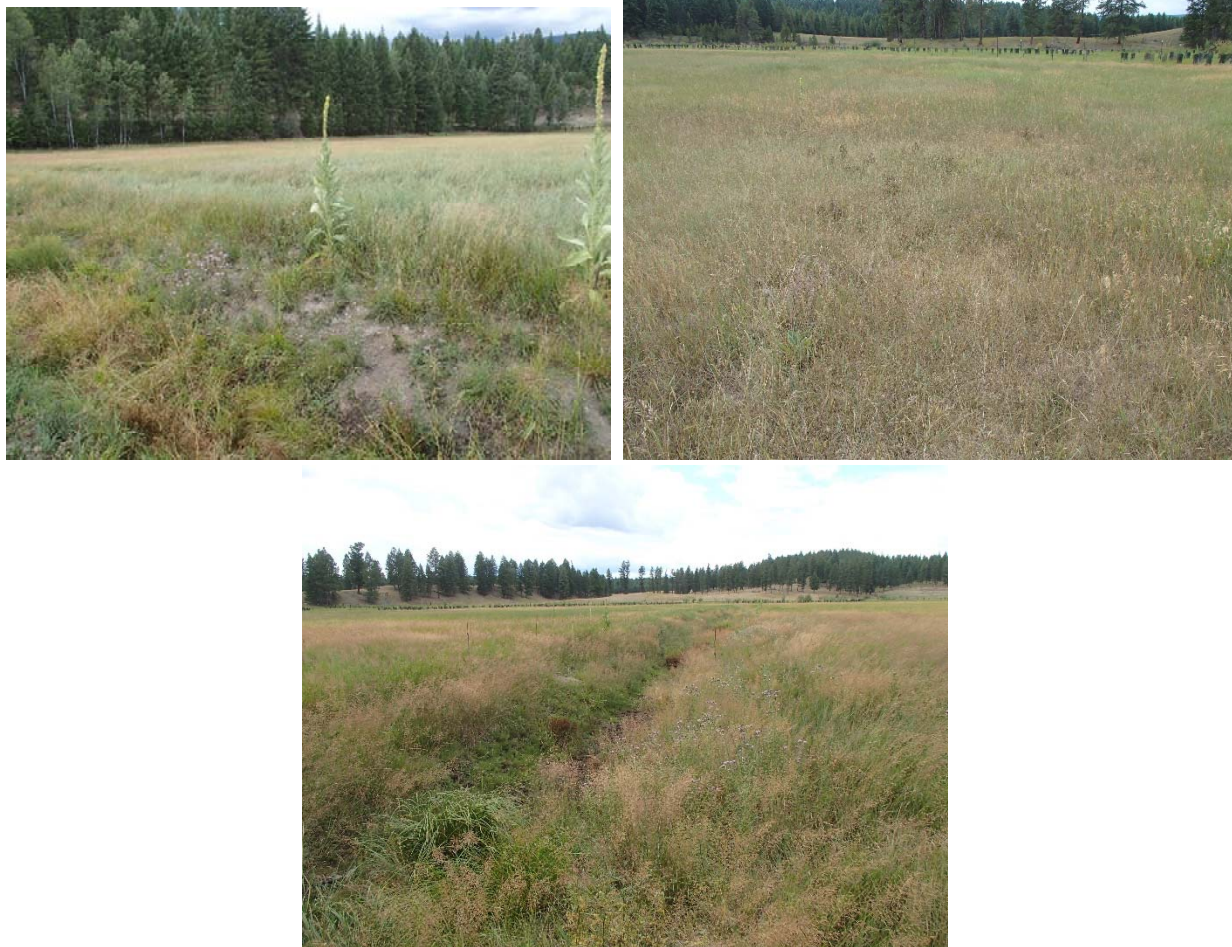
- The drainage ditch installed in the hayfield to the southeast of the project area continues to lower the water table in the hayfield resulting in a transition towards drier species (Figure 18). There was a noticeable shift towards drier vegetation in the vicinity of the ditch in 2015. Drought conditions also likely contributed to the observed shift in species composition. It is still unclear to what extent the drainage ditch may be affecting the hydrology of the floodplain and restored channel since much drier conditions were observed everywhere in the project area in 2015.

Figure 18. Drainage ditch in the hayfield southeast of the project area showing weeds colonizing the ditch and pasture grasses, rather than wetland species as the dominant vegetation adjacent to ditch.

- Management options that will create a more natural hydrograph through the project reach should be considered.
- Coordination with the landowner should occur to ensure that the hayfield drainage ditch is filled or fit with an outlet control structure to ensure no further drawdown of the water table in the project area occurs.

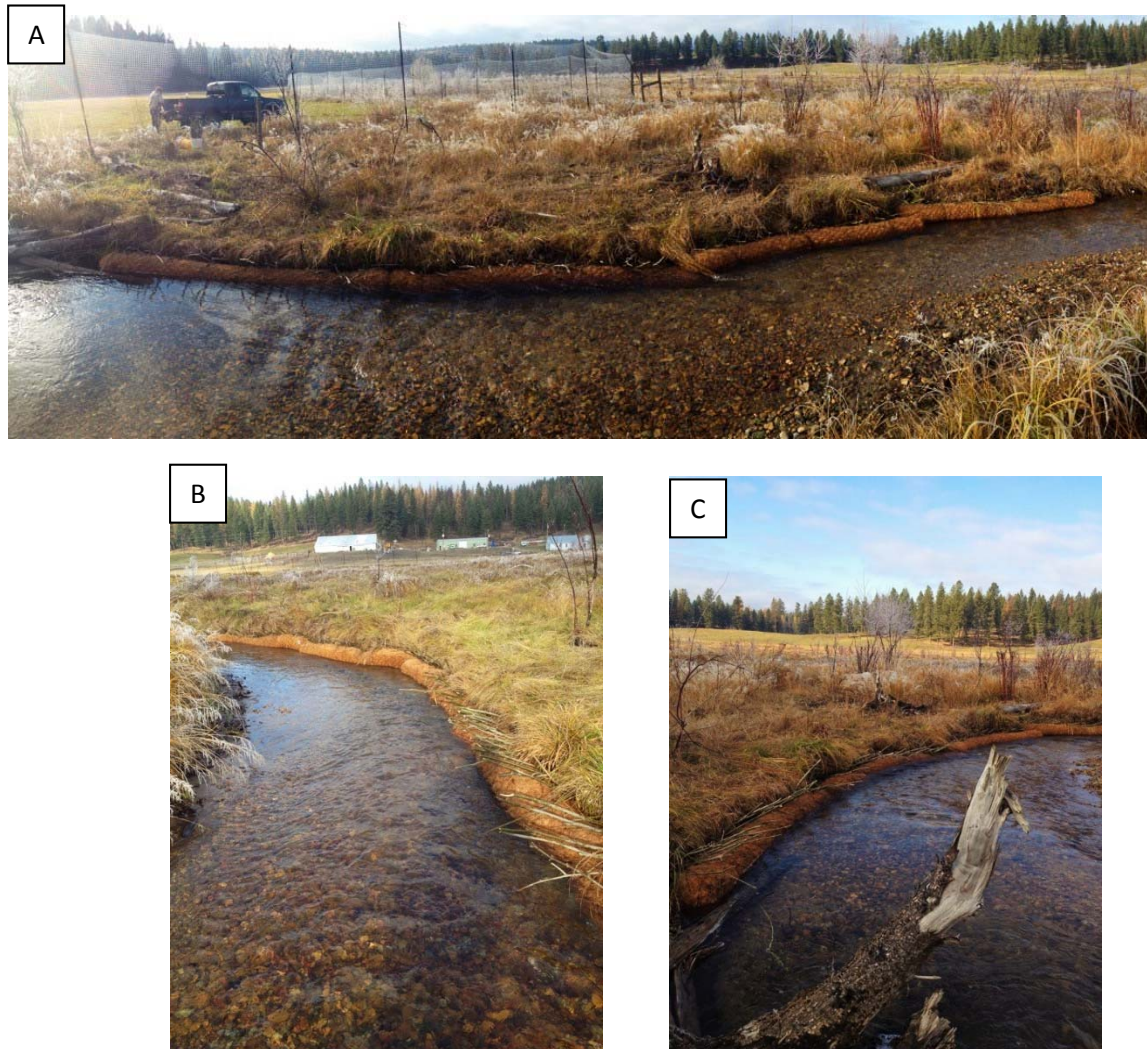
Figure 19. Photographs showing the 2015 coir log sites immediately after installation in November 2015. Photograph A is Coir Log Site 1. Photograph B is Coir Log Site 2. Photograph C is Coir Log Site 3.

- Installation of 100 feet of coir logs at three locations in Phase 1 (Attachment B, Figure 19). Coir logs were installed by hand and securing using duckbill earth anchors.
- Three hundred willow cuttings were collected from mature willows located at the upstream end of the project area. Cuttings measured 3 to 4 feet in length and were approximately ½-inch in diameter. Cuttings were installed at one foot spacing behind the coir logs, extending into the bank below the existing herbaceous sod mat.
