TO: Jim Dunnigan, Montana Fish, Wildlife and Parks  
FROM: Amy Sacry and Jesse Wallace, Geum Environmental Consulting, Inc.  
DATE: January 15, 2019  
RE: Therriault Creek 2018 Maintenance Summary

This memo describes maintenance work completed in 2018 at the Therriault Creek Restoration Project Site under Montana Fish, Wildlife and Parks (FWP) Task Order 19-0010. Maintenance tasks were identified by Geum Environmental Consulting (Geum). Maintenance work was completed by Westslope Forest Management (Westslope). Weed control activities were not completed in 2018, but the weed control contractor for Task Order 19-0010 is Mountain Valley Plant Management (MVPMP).

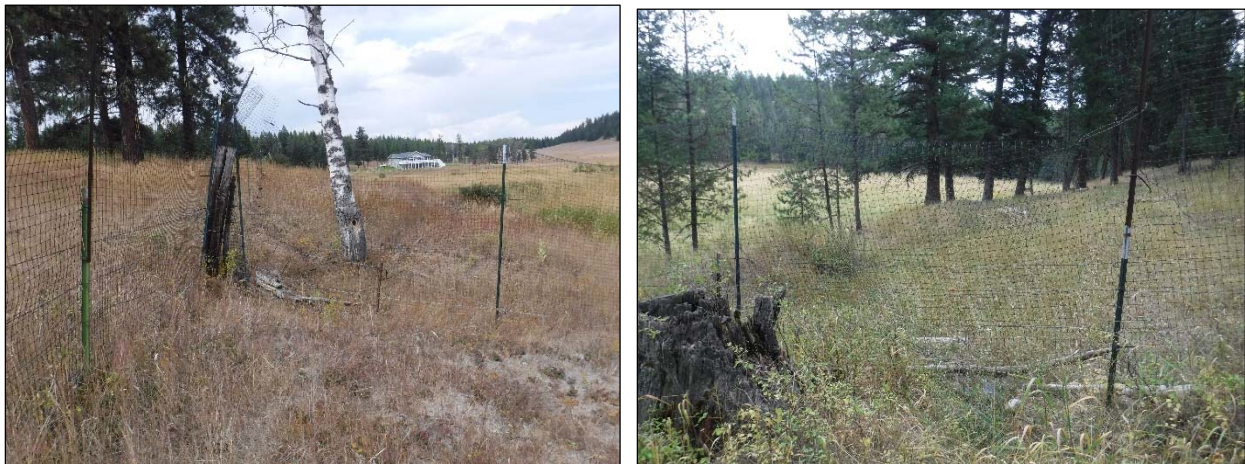
The perimeter of the riparian protection fence installed at the Site in 2013 and re-built in 2014 was walked on September 11, 2018. The southern end of the fence had the most damage from wildlife. The fence appeared to block a movement corridor as sign of deer, elk, and black bear were observed along a well-defined path immediately north of the livestock fence that was used as the southern boundary of the fence. There were tears in the east and west sides of the fence in this location (Figure 1). In addition, a large section of fence was down near the southwest corner near the toe of the hill slope near a dense patch of reed canarygrass (Figure 2). Several deer were spooked from this area and it is likely

**Figure 1. Damage to the riparian protection fence at the southern end of the project where the fence was blocking a wildlife movement corridor.**

deer use the reed canarygrass for cover and forage resulting in deer pushing through the fence to access the area. In response to these observations, Geum determined that relocating the southern end of the fence closer to the Therriault Creek channel (approximately 200 feet north of the current location) would allow animals to move through the area better and relieve pressure on the fence in this area. Geum identified approximately 750 linear feet of fence to be removed and approximately 350 linear feet of the removed material to be re-used to construct a new section of fence closer to the Therriault Creek channel (Figure 17).

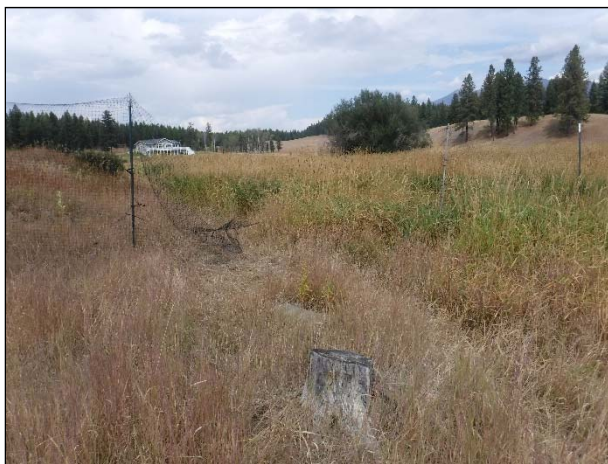
**Figure 2. Downed section of fence at toe of slope near dense infestation of reed canarygrass.**

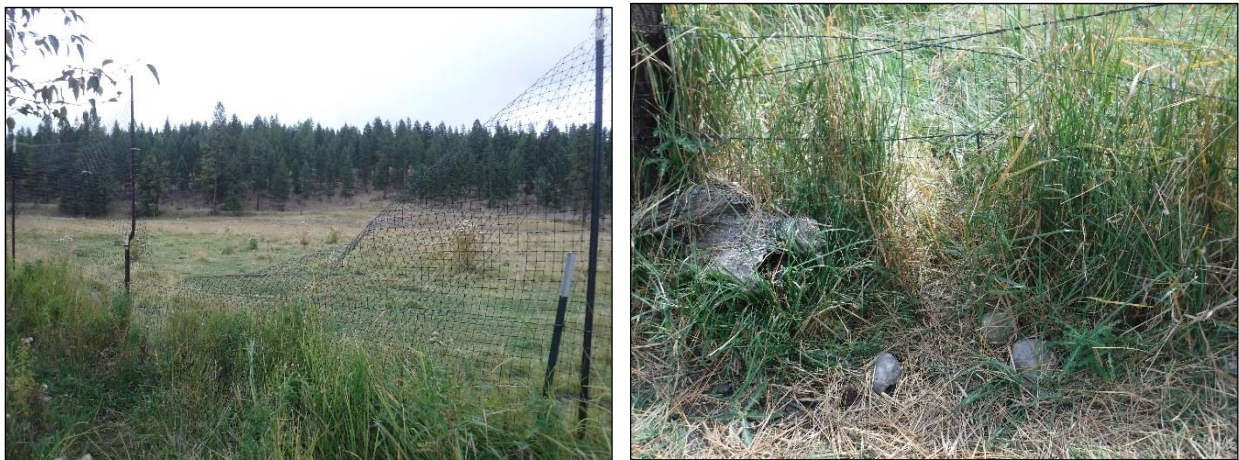
Several locations were identified where the riparian protection fence netting was sagging, ripped, or where deer had created holes underneath the fence (Figure 3). The locations where the fence crossed the channel have been entry points for deer in the past. Both of these crossings were evaluated and it did not appear that deer were entering the fence through those locations (Figure 4). In addition, a gate was left open in the southwest corner and the fence at this location was rolled up allowing easy access for deer to enter the Site (Figure 5). It is possible this was opened to allow deer inside the fence to leave. Relocating the fence netting from the outside of the livestock fence to the inside of the livestock fence was a work item in Task Order 19-0010 to prevent damage of the fence by livestock in adjacent

**Figure 3. Examples of riparian fence damage requiring maintenance. Hanging netting needs to be re-secured (left photo), and holes beneath the fence must be patched or stapled to the ground (right photo).**

- Patch larger rips and tears in the netting with zip ties, salvaged fence, and/or browse protector materials.
- Re-secure fencing to posts with zip ties, and straighten any damaged or leaning posts.
- Re-secure fence netting to the ground with ground staples.
- Repair holes under the fence with salvaged fence material and/or browse protector materials.
- Remove two small fences installed around solarization plots at the south end of the Site.

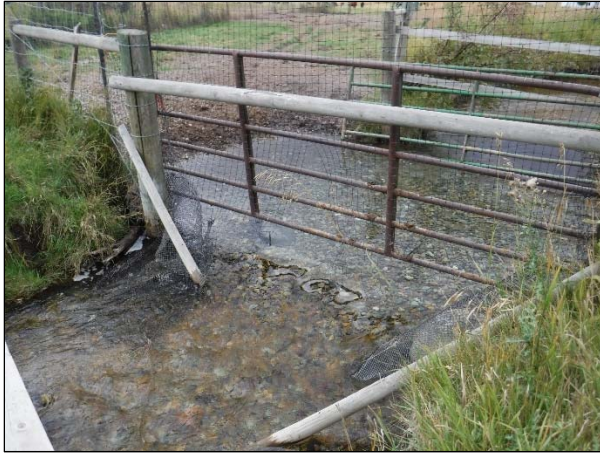
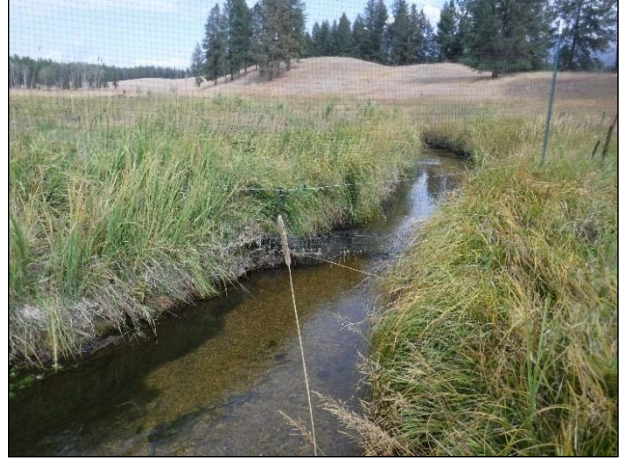
**Figure 4. Condition of riparian protection fence at upstream (left photo) and downstream (right photo) stream crossings.**

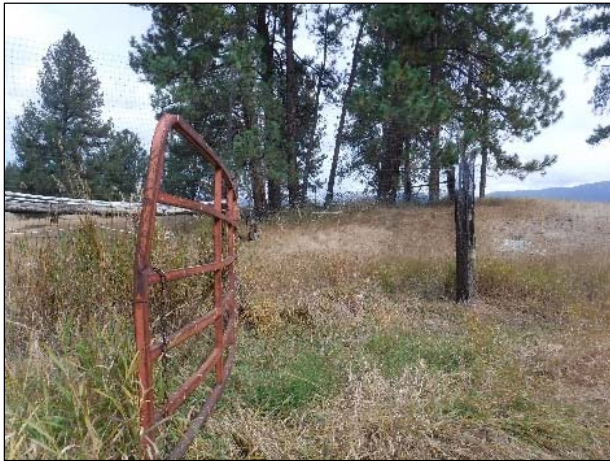
**Figure 5. Open gate with fence rolled up near downstream end of Site.**

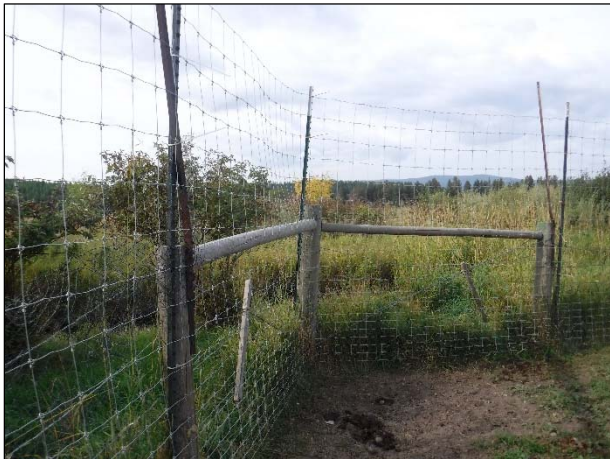
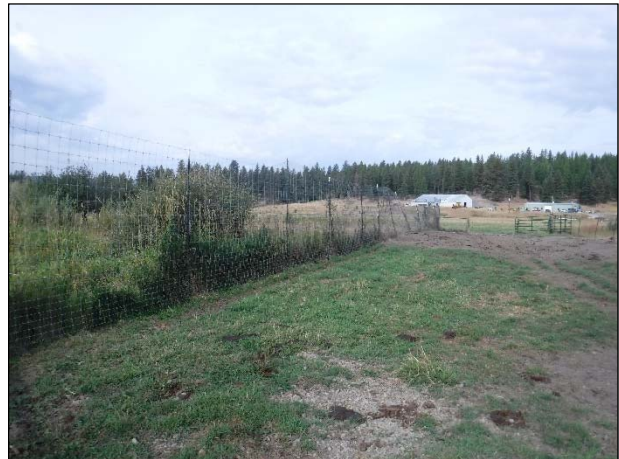
**Figure 6. Woven wire fencing installed by landowner on west side of livestock crossing at north end of riparian fence.**

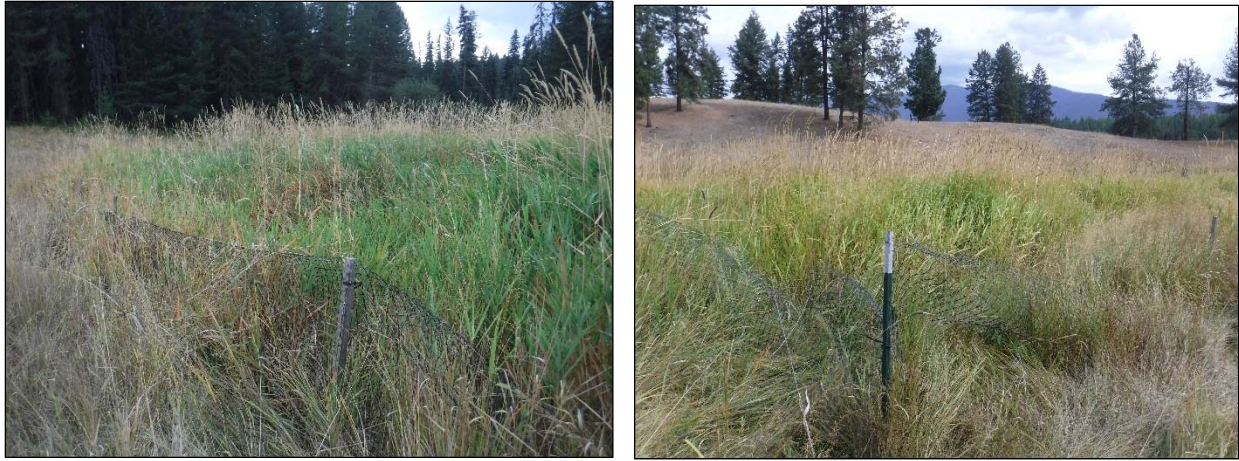
**Figure 7. Small fences built around solarization plots that are no longer functioning.**

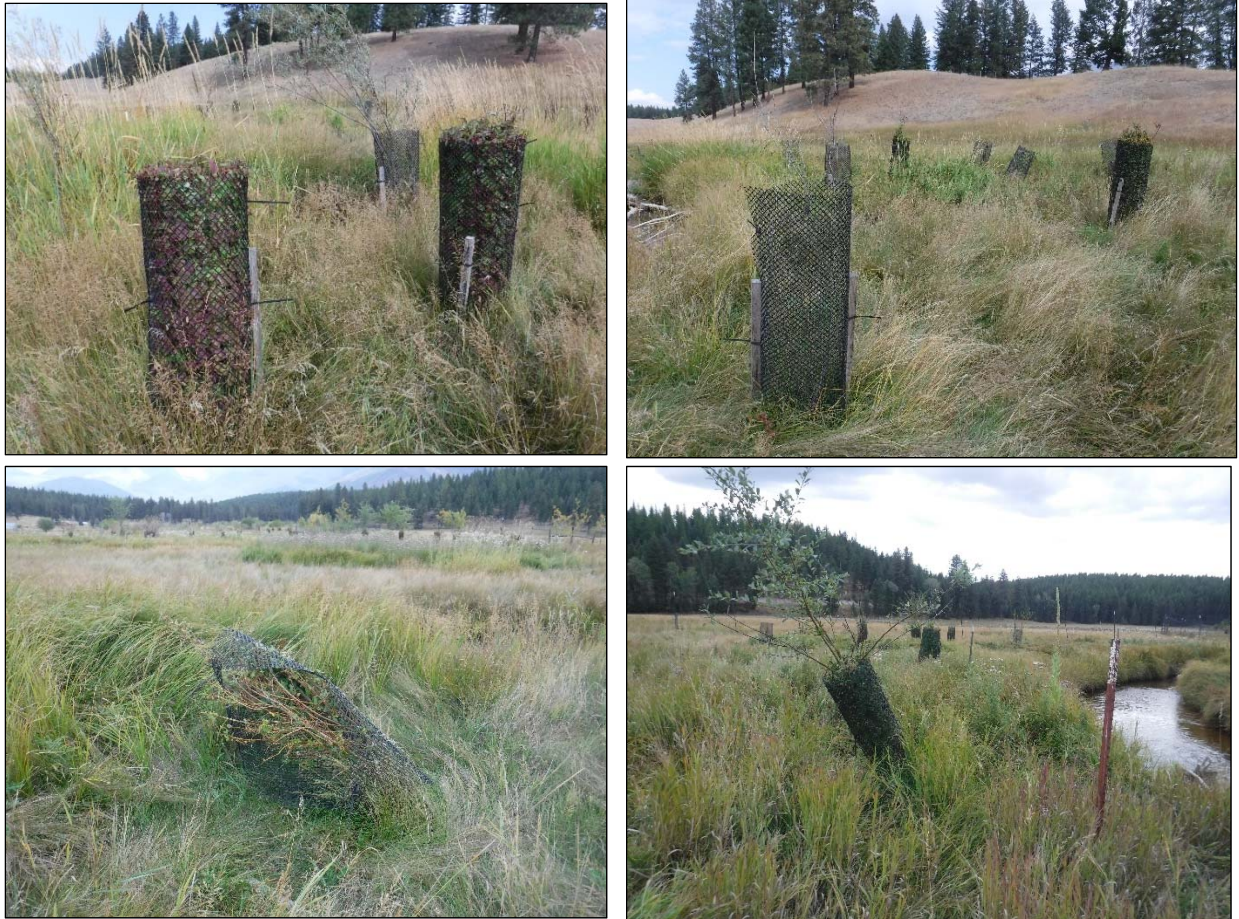
**Figure 8. Example of browse protectors that need to be expanded (top left photo), browse protector that needs to be removed from a dead shrub (top right photo), browse protector that needs to be removed and reinstalled (repaired) (left bottom photo), and browse protector that needs to be straightened and re-secured (right bottom photo).**

- Remove browse protectors from all dead plants and re-use protectors for the following two tasks.
- Enlarge protectors around plants that have outgrown the protector.
- Install new protectors on shrubs outside of the riparian protection fence with no existing browse protection.

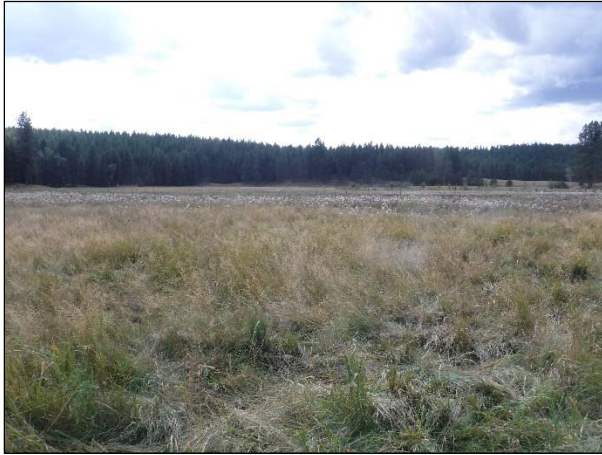
**Figure 9. Dense infestation of Canada thistle in hayfield east of the Site (thistle infestation is white band in middle of photo).**

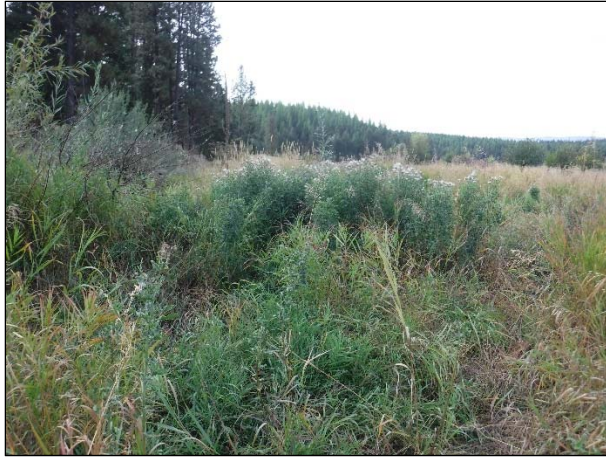
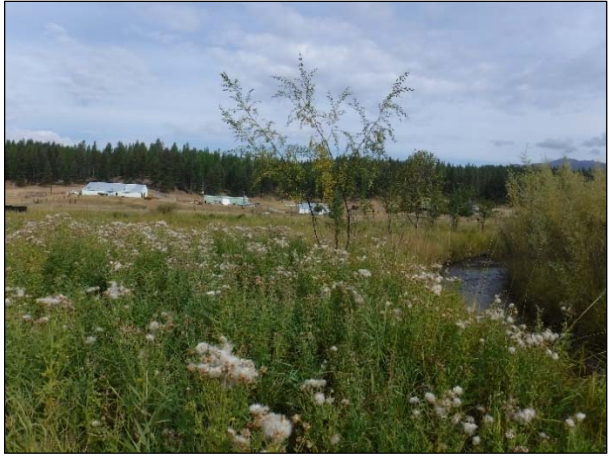
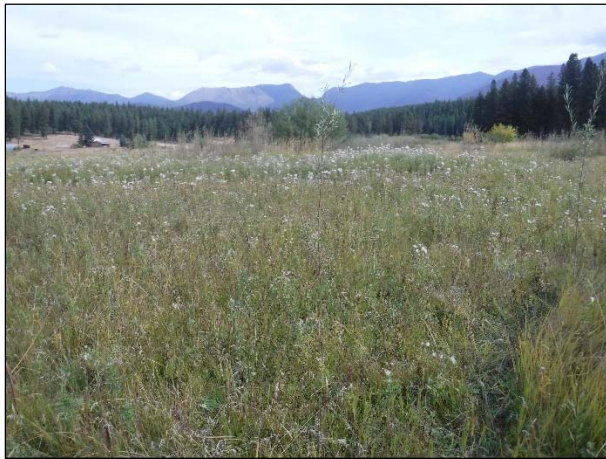
**Figure 10. Canada thistle infestations in the upstream portion of Site.**

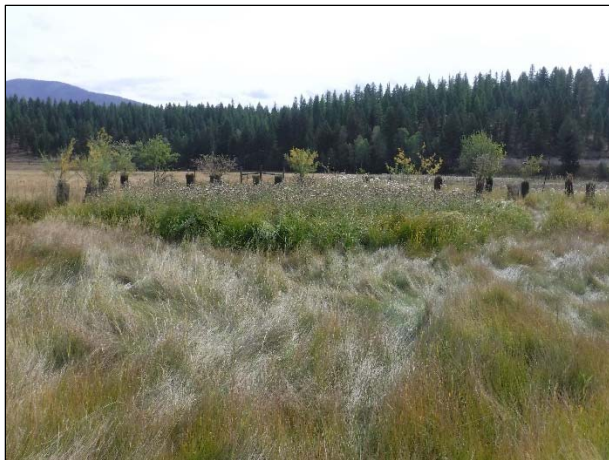
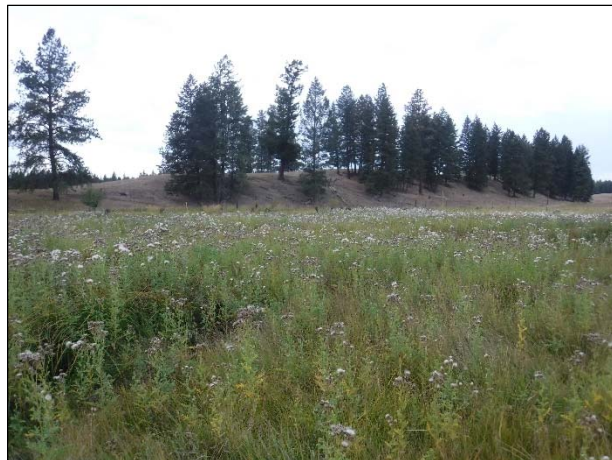
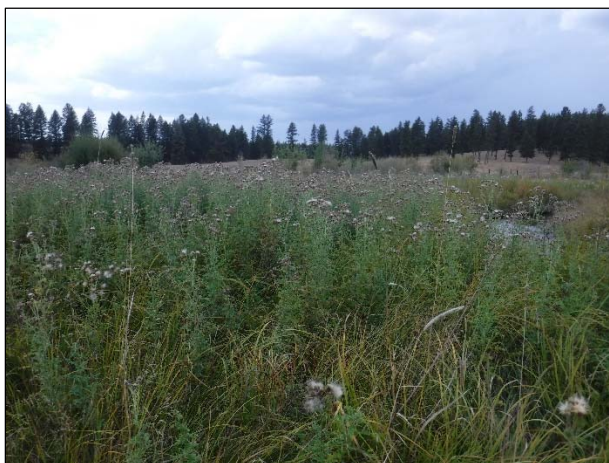
**Figure 11. Canada thistle infestations in the downstream portion of the Site.**

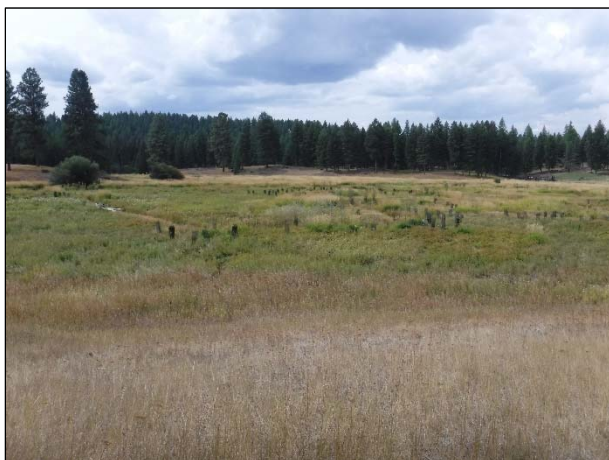
this area have allowed it to expand and dominate. In 2018, there were several new patches of reed canarygrass upstream of the large infestation (Figure 12). Reed canarygrass has always had much lower cover in the rest of the Site. It is primarily found on streambanks and in small patches away from the channel (Figure 13). Greater cover on both streambanks and areas further from the channel was observed in 2018 in response to the lack of Site-wide herbicide treatment in 2016 and 2017. Treating reed canarygrass along streambanks is difficult as it can lead to streambank instability. Continued treatment should focus on controlling the expansion from the downstream infestation and all clumps of reed canarygrass that can be effectively treated with herbicide throughout the rest of the Site (Figure 14).

**Figure 12. Expansion of reed canarygrass from large infestation at the downstream end of the Site. Reed canarygrass is the lighter yellow colored vegetation in the photograph.**

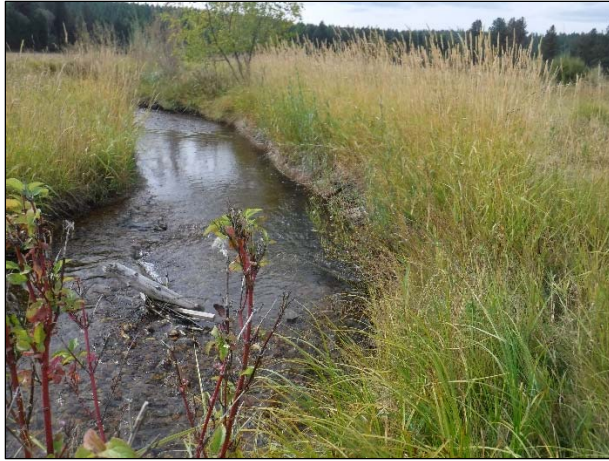
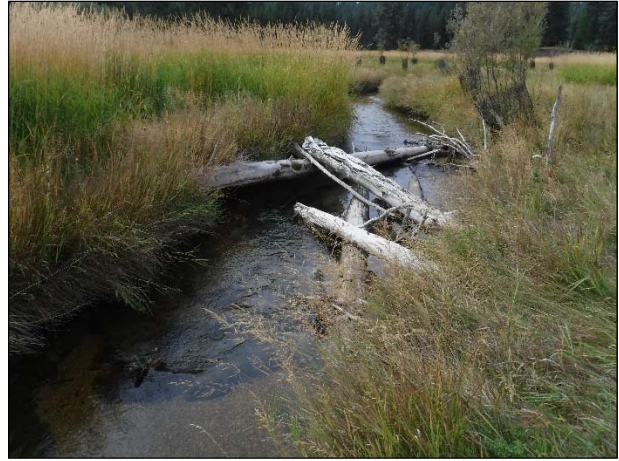
**Figure 13. Reed canarygrass along streambanks at the Site.**

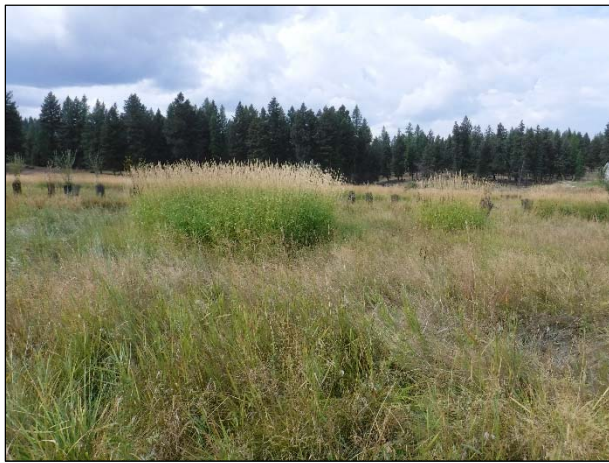
**Figure 14. Isolated clumps of reed canarygrass at downstream (southwest) end of Site.**

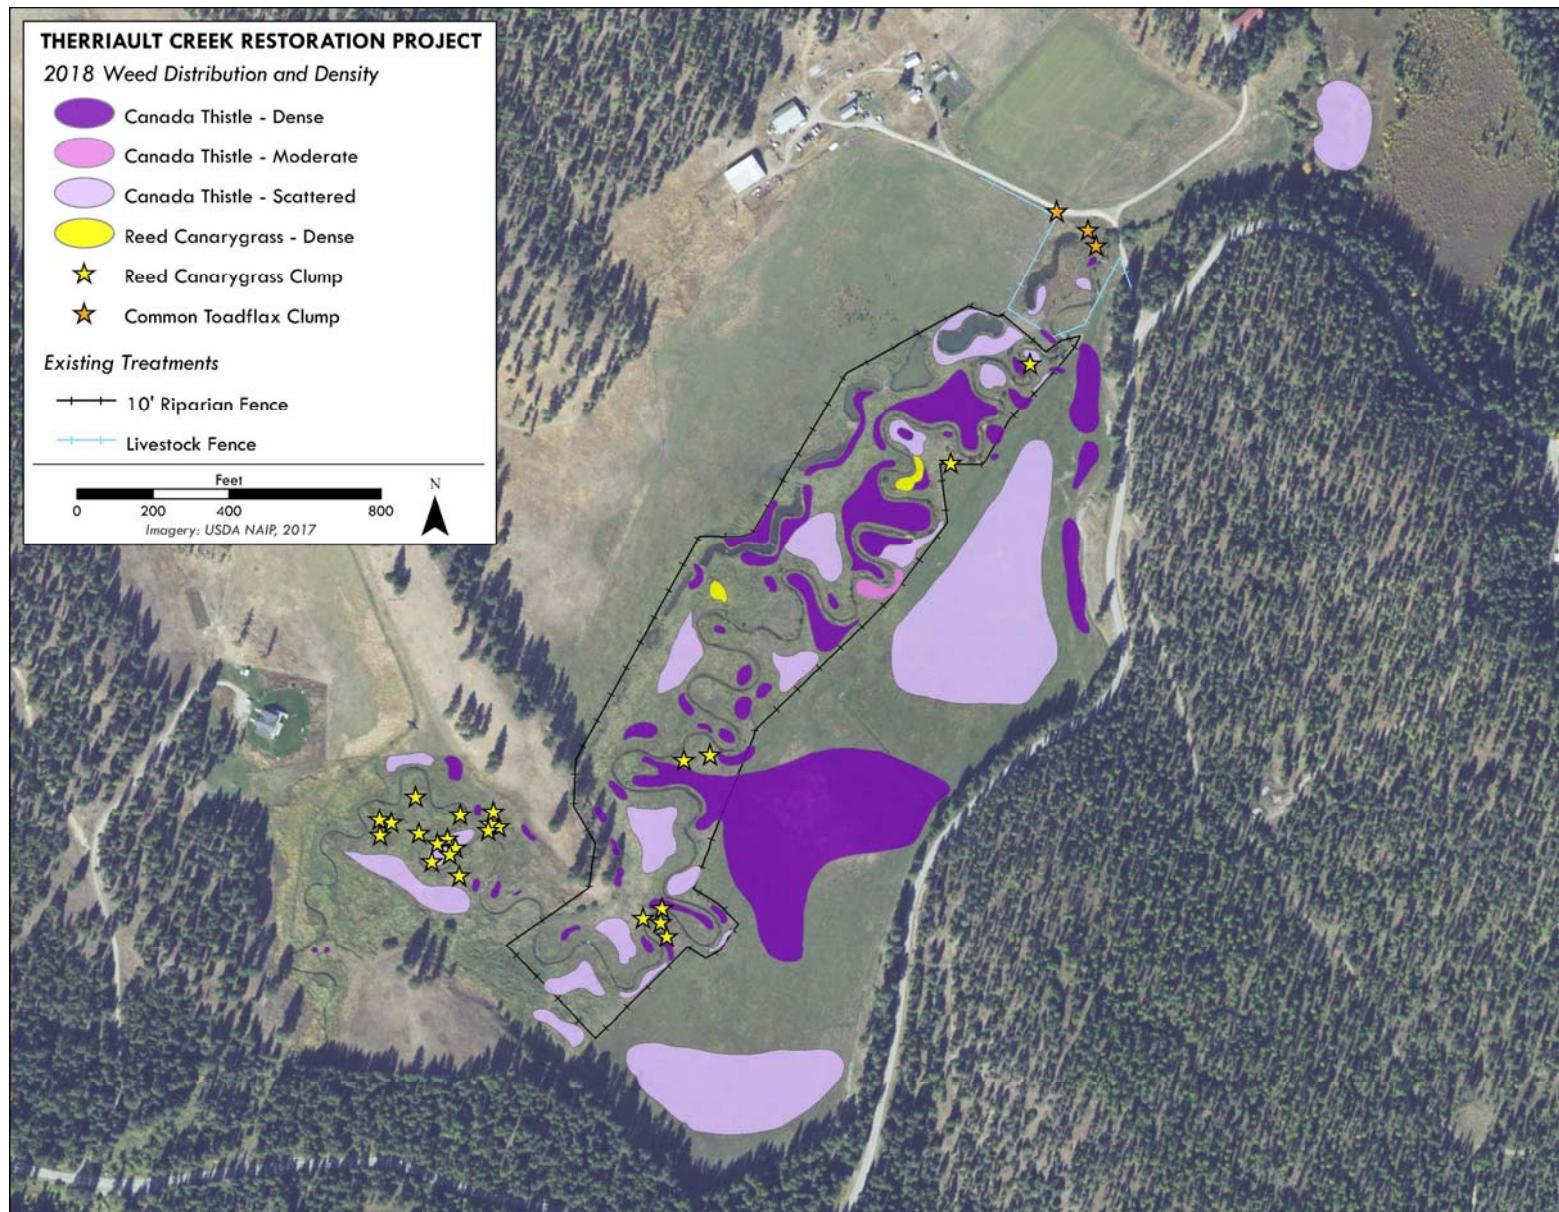
Figure 15. Weed species and densities mapped at the Site in 2018.

Figure 15 shows the distribution of weeds at the Site in 2018. A few dense patches of common toadflax were observed near the upstream end of the Site. Cover and density of Canada thistle has increased greatly at the site since the last Site-wide herbicide application in 2015 and here are several large, dense infestations of Canada thistle at the Site (Figure 10 and Figure 11). Within the Site itself, cover of Canada thistle was low in 2015, with few to no mature plants remaining. The hayfield south of the Site was treated several times, but also missed in some years allowing the Canada thistle infestations in this area to persist. These infestations have never been controlled completely and were likely a major contributor to reinfestation of the Site. Dewatering of this area combined with heavy grazing has created significant disturbance allowing thistle infestations to expand and become denser (Figure 9). Dense patches mostly occur along the channel or expand out from the edges of the channel or expand towards the channel from the dense infestations in the hayfield to the south of channel. Canada thistle is well distributed within planting units, within natural willow expansion areas, and throughout areas consisting of dense sedges and willows.

Figure 15 shows weed control needs identified during Geum's site evaluation on September 11, 2018. This guidance was provided to the herbicide applicator, Mountain Valley Plant Management (MVPM). MVPM visited the site in early October, 2018. At this time there had not been sufficient fall moisture for Canada thistle to grow so fall treatment would not have been effective. No weed control was completed in 2018. Weed control is planned for spring/summer 2019.

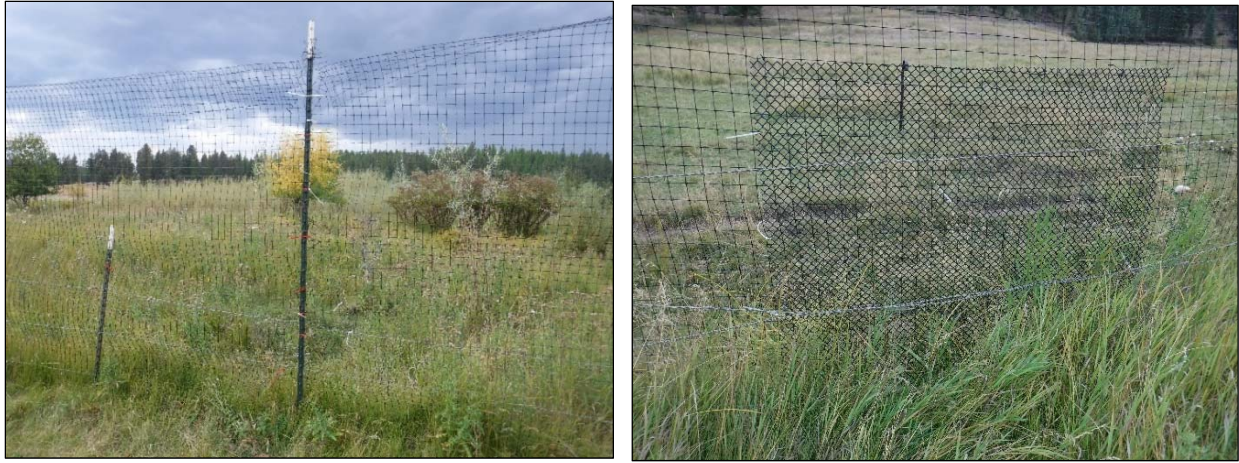
**Figure 16. Examples of riparian protection fence repairs: re-securing netting with zip ties (left photo) and using salvaged browse protector materials to patch fence holes (right photo).**

A total of 136 linear feet of riparian protection fence was repaired in 2018 (Table 1). Repair of the existing riparian fence included patching small holes and tears in the fence netting, straightening bent or damaged fence posts, re-securing fence netting to existing fence posts, re-securing fence netting to the ground, and patching holes under the fence. Salvaged fence netting and browse protector materials were used to patch holes and rips in and under the fence (Figure 16). Plastic zip ties were used to attach patches and re-secure netting to fence posts. Metal ground staples (18-inch) were used to re-secure fence netting to the ground. The repair locations identified by Geum are shown on Figure 17. Additional damage was located and repaired by Westslope during maintenance work. Fence repairs were measured in linear feet.
