# Grave Creek Riparian Revegetation 2011 Implementation Report

## Task Order #1008

Kootenai River Network  
P.O. Box 491  
Libby, MT 59923

Geum Environmental Consulting, Inc.  
307 State Street  
Hamilton, MT 59840

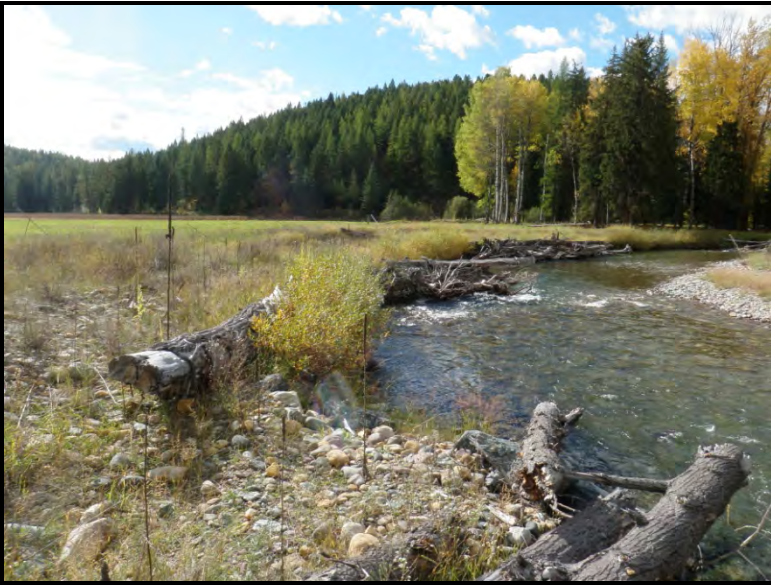
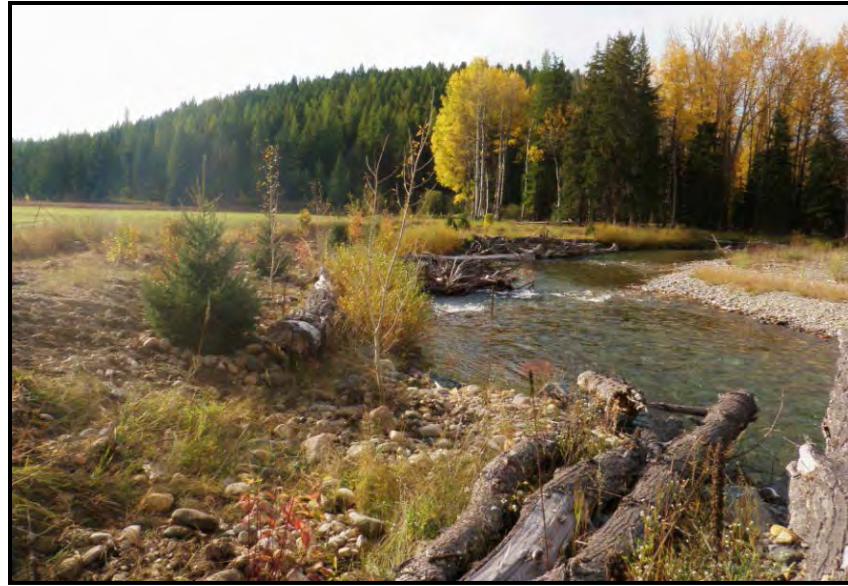
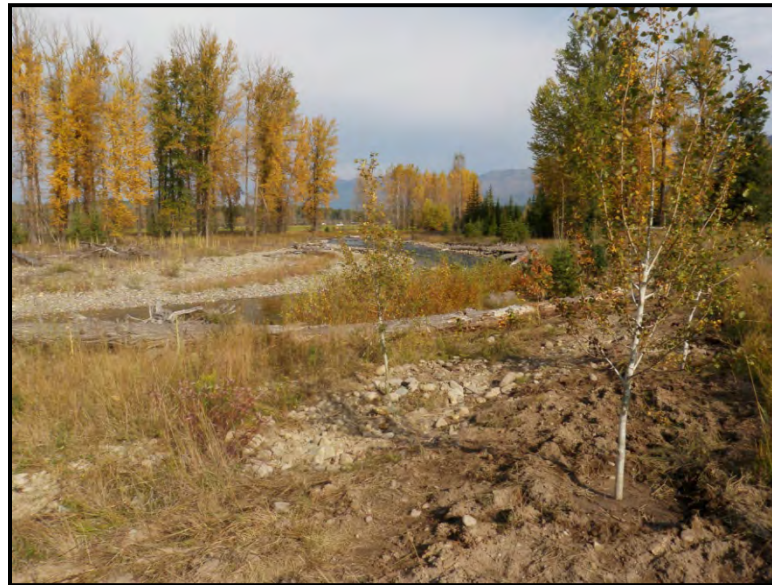
#### **Planting Site 4**

Top left photo shows the site prior to installation. Top right and bottom photo show the site after installation of trees and shrubs.

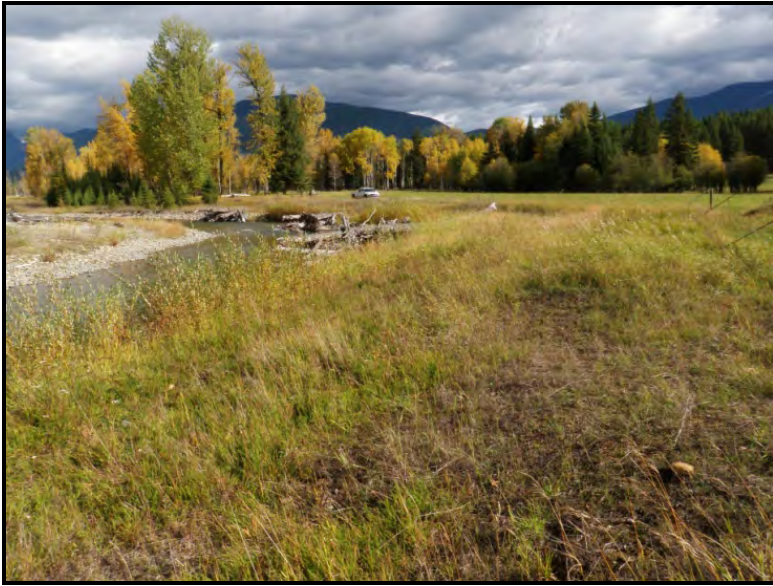
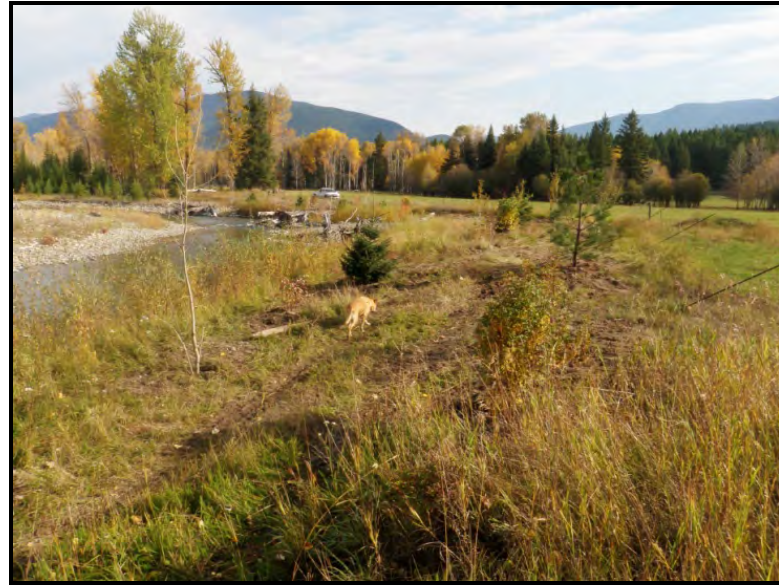
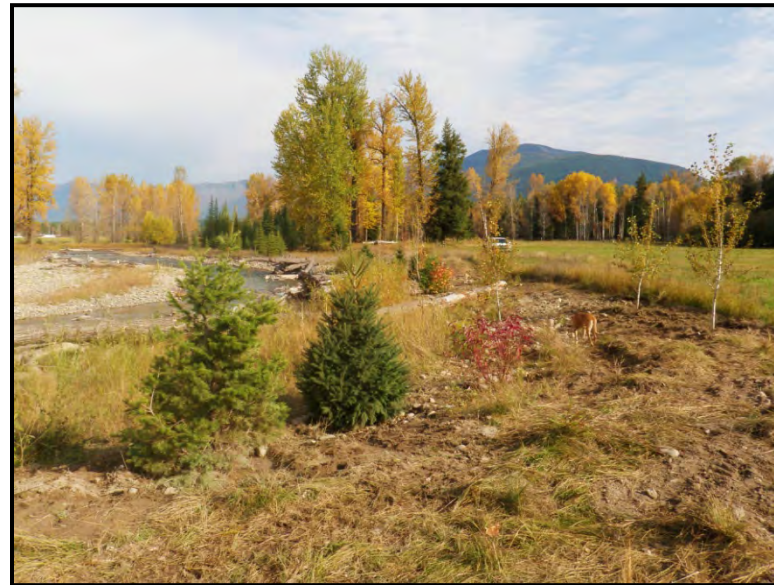
#### **Planting Site 4 Continued**

Top left photo shows the site prior to installation. Top right and bottom photo show the site after installation of trees and shrubs.

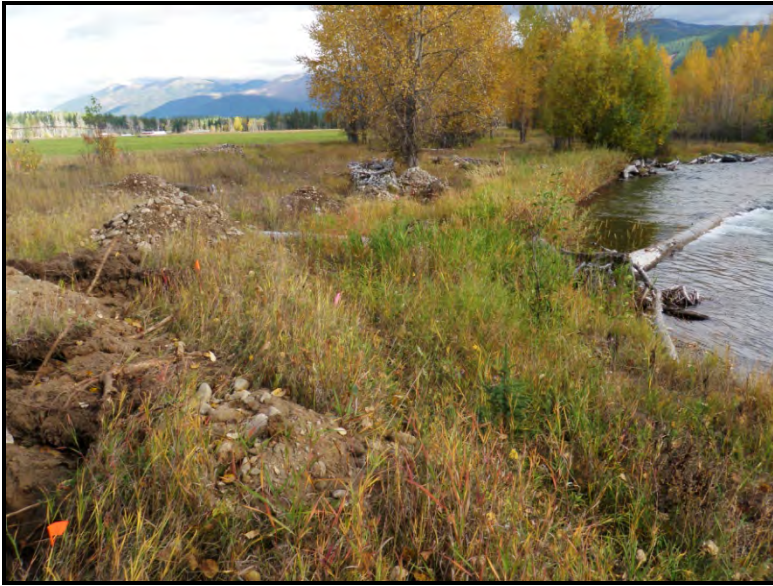
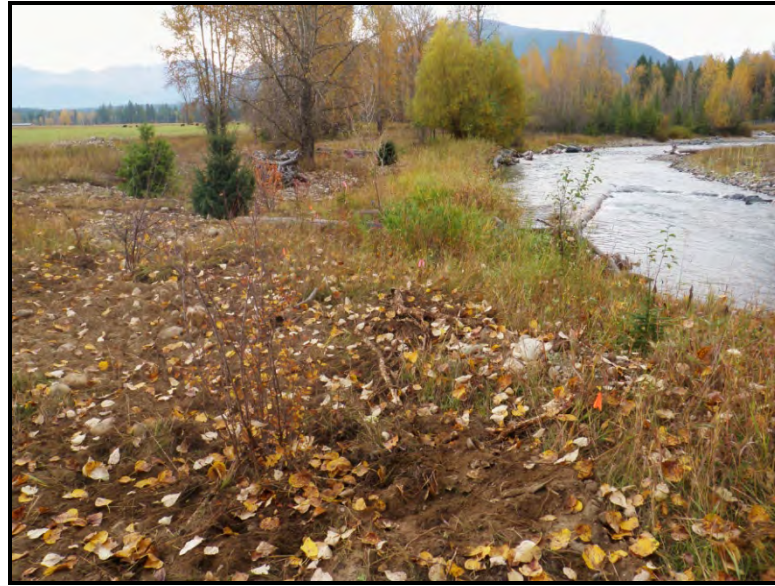
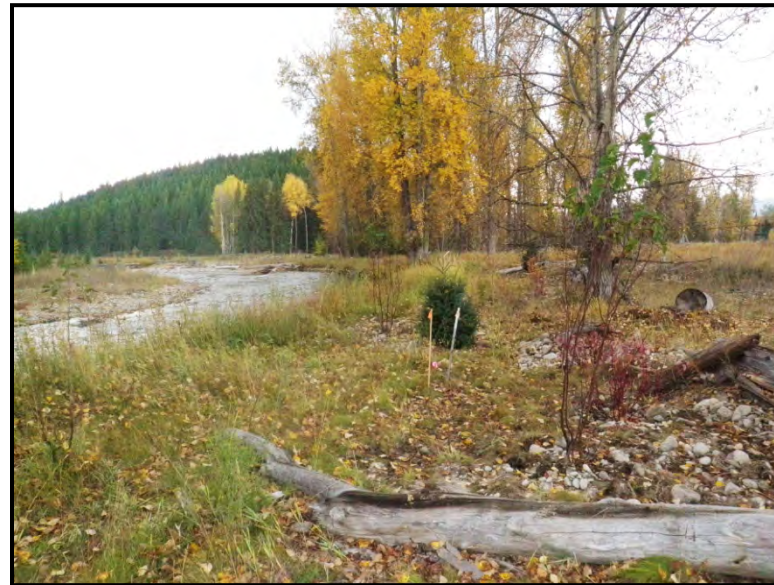
### **Planting Site 2**

Top left photo shows the site during installation. The top right and bottom photo show the site after installation. Many of the shrubs had already gone dormant and are difficult to decipher in the photo without their leaves.

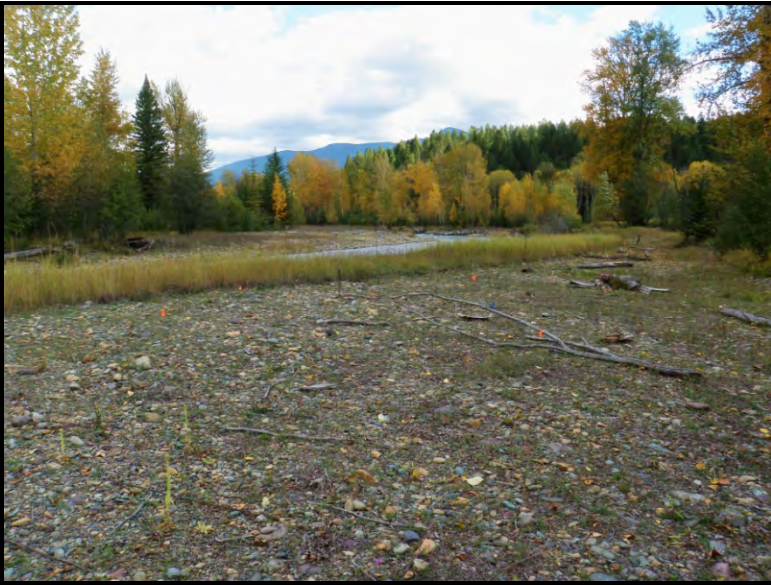
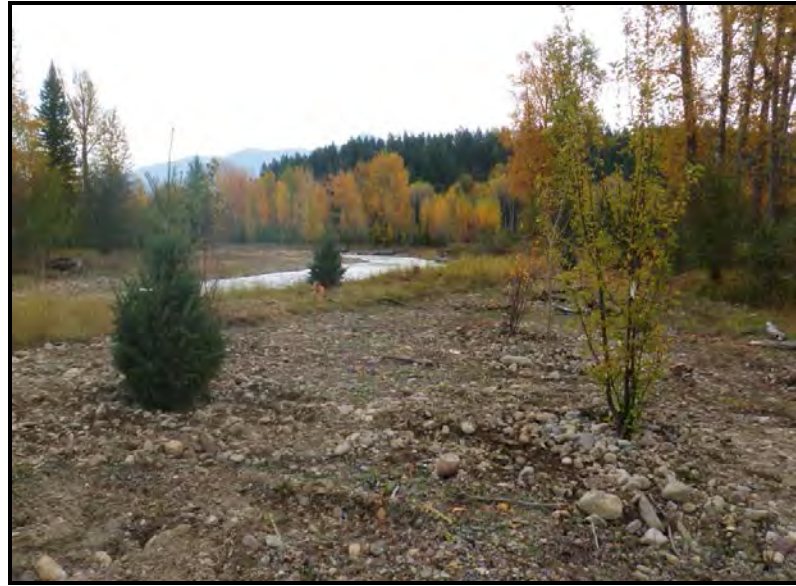
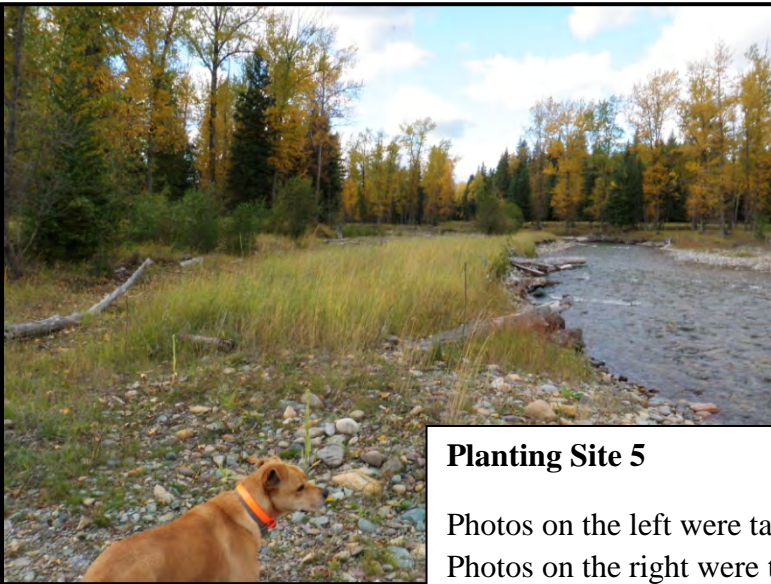
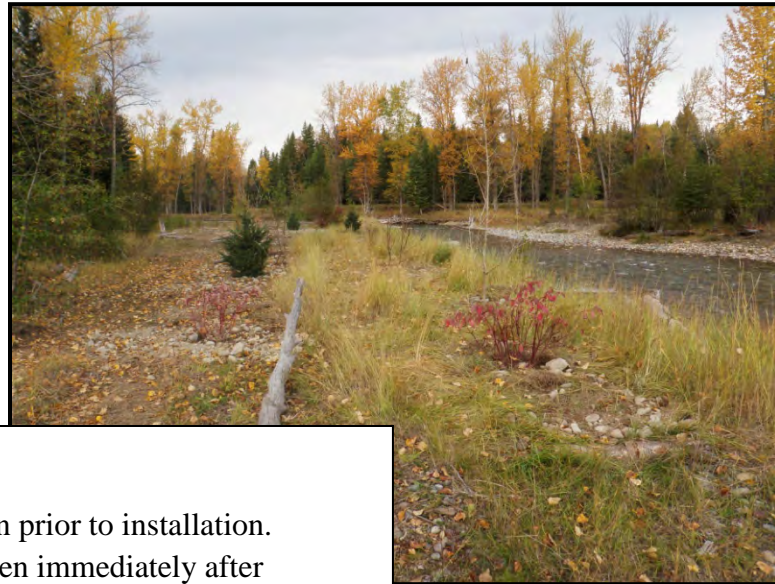
### **Planting Site 5**

Photos on the left were taken prior to installation.  
Photos on the right were taken immediately after  
installation.

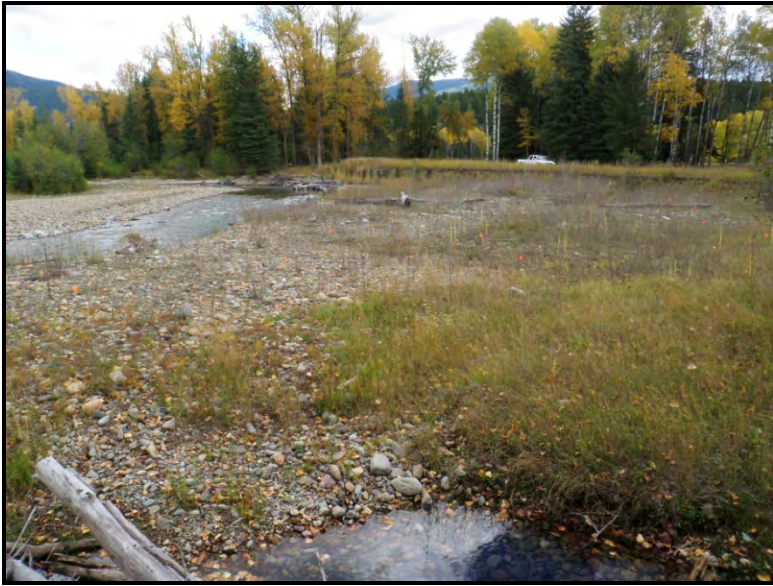
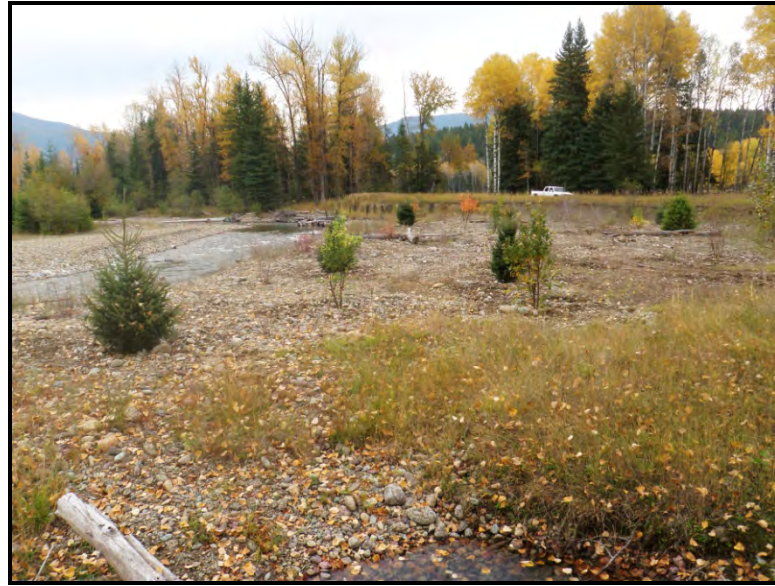
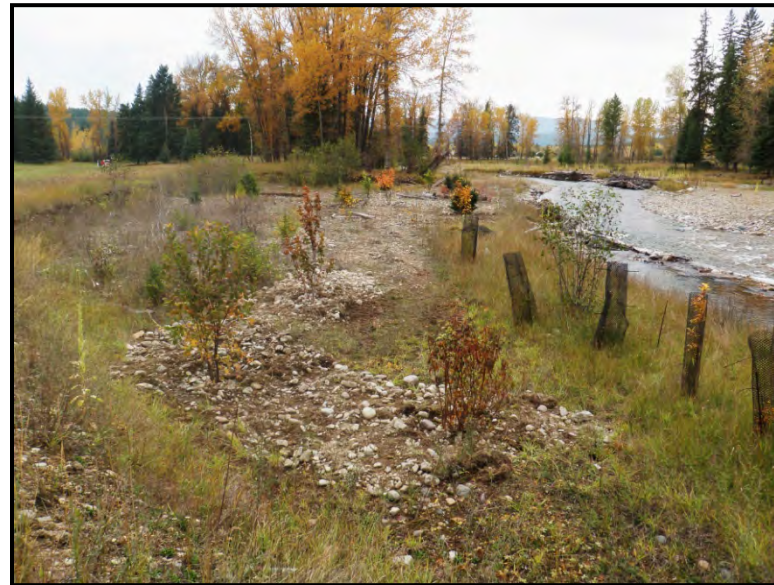
### **Planting Site 6**

The top left photo was taken prior to installation. The top right and bottom photo were taken after installation.

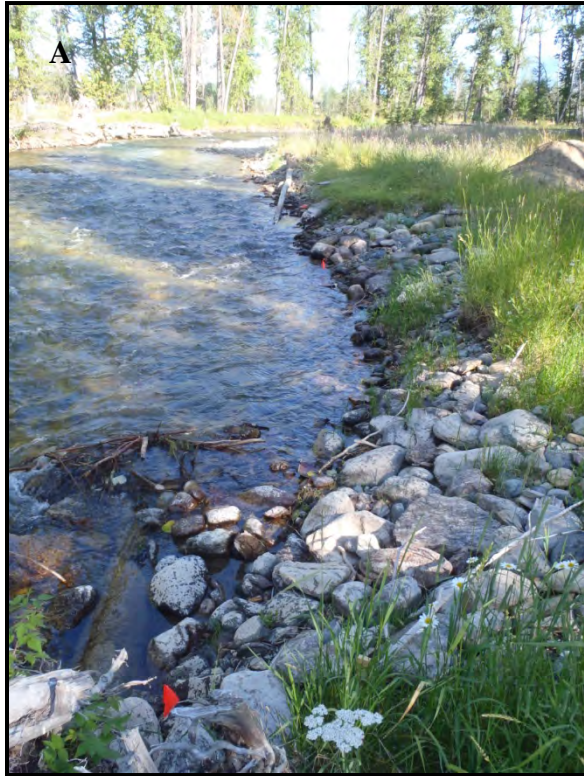
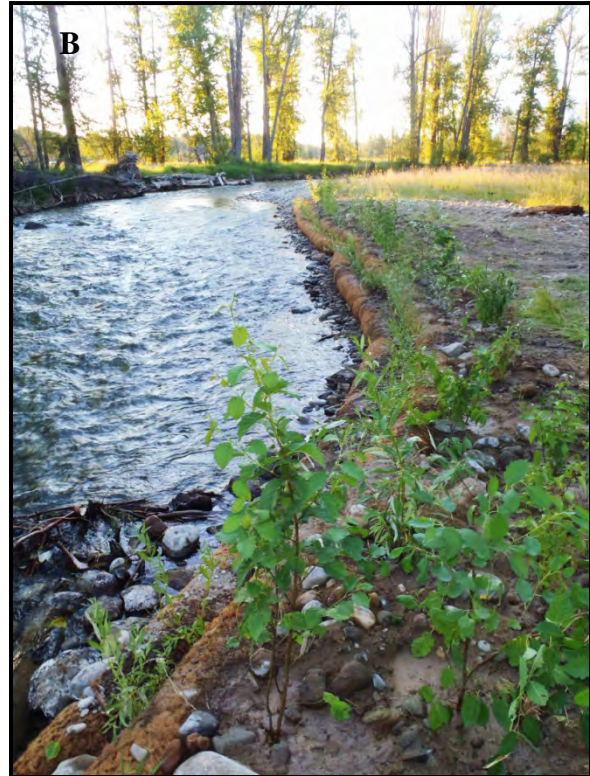
### Coir Log Site: Demo Reach

Photograph A shows Site 1 prior to construction in August 2011. Photograph B shows Site 1 immediately after coir log installation and planting.

- Evaluate erosion at the upstream and downstream ends and behind and between coir logs.
- Evaluate scour and erosion at the toe of the structure.
- Photo documentation during the growing season.
- Watering of containerized plants.

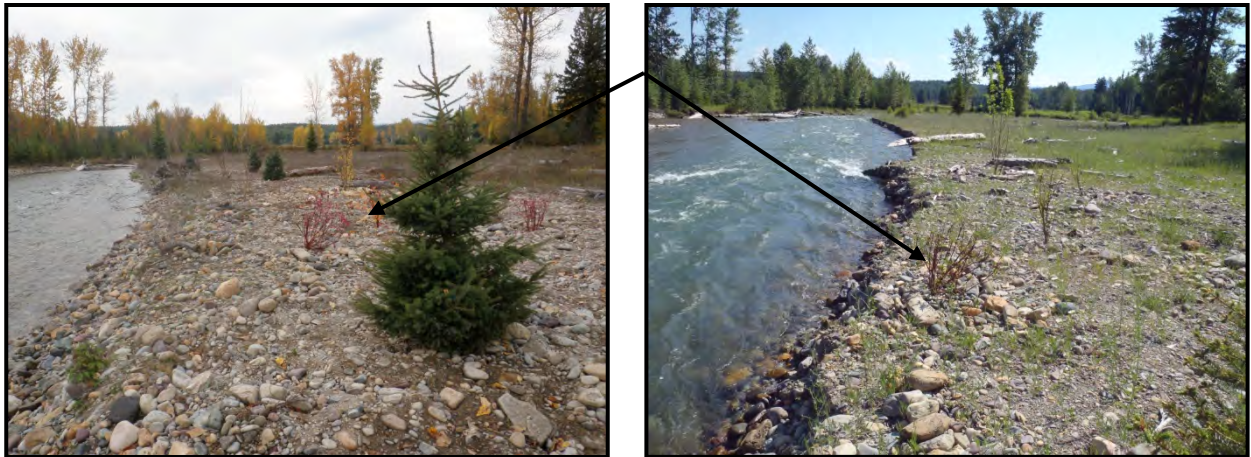
**Coir Log Site 7 (Not Installed)**

bank at this site eroded approximately 15 feet during the 2011 high flows and the originally planned treatment was determined to no longer be effective at the site. Photos of this site are included in Appendix B.

Coir Log site 7 in 2010 (photo left) and 2011 (photo right). Coir logs were not installed at this site because of the lateral and downstream extent of erosion that occurred during 2011 high flows. The arrows indicate the same planted dogwood in each photo.
