Therriault Creek Riparian Revegetation Maintenance and Monitoring 2009 Report

Task Order #0907

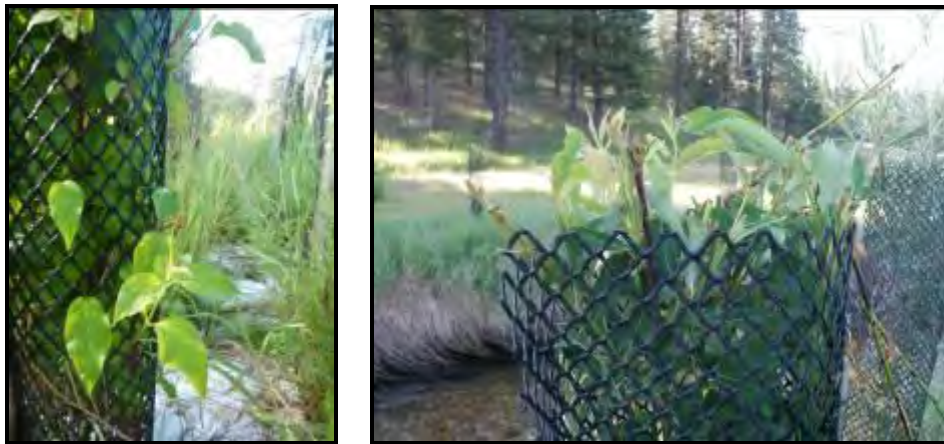
Figure 3. Photographs showing browse occurring on portions of protected plants extending beyond protectors.

- Browse is occurring on portions of protected shrubs growing outside of browse protectors (Figure 3). The long-term effect of this on survival and overall plant health is unclear. A similar situation was observed on a riparian revegetation project in the Thompson River drainage. Similar browse protectors were installed on planted shrubs in 2003 and 2004. Hedging to the height of the browse protectors was observed the three years following installation, but by 2008 the plants were able to put on so much new growth early in the season that hedging of new shoots was no longer an issue. This early season growth may have been the result of the establishment of an extensive root system during the first three years. These plants continue to be browsed, but it does not appear to be affecting survival or plant health. It is possible that a similar chain of events will occur at

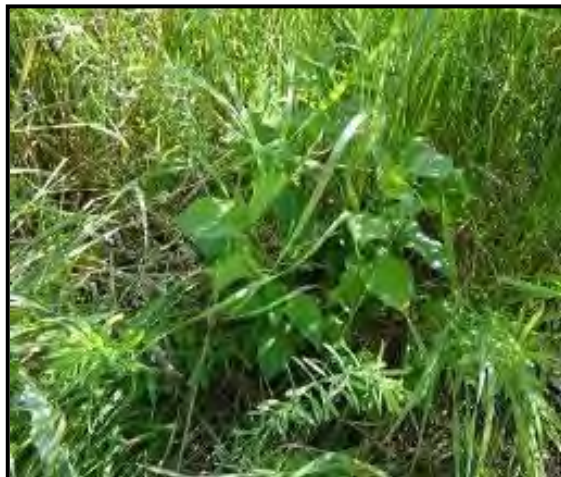
Figure 4. Photograph of unprotected residual shrub taken during July 2009 monitoring. Unprotected residual shrubs continue to be browsed and exhibit a suppressed growth form.

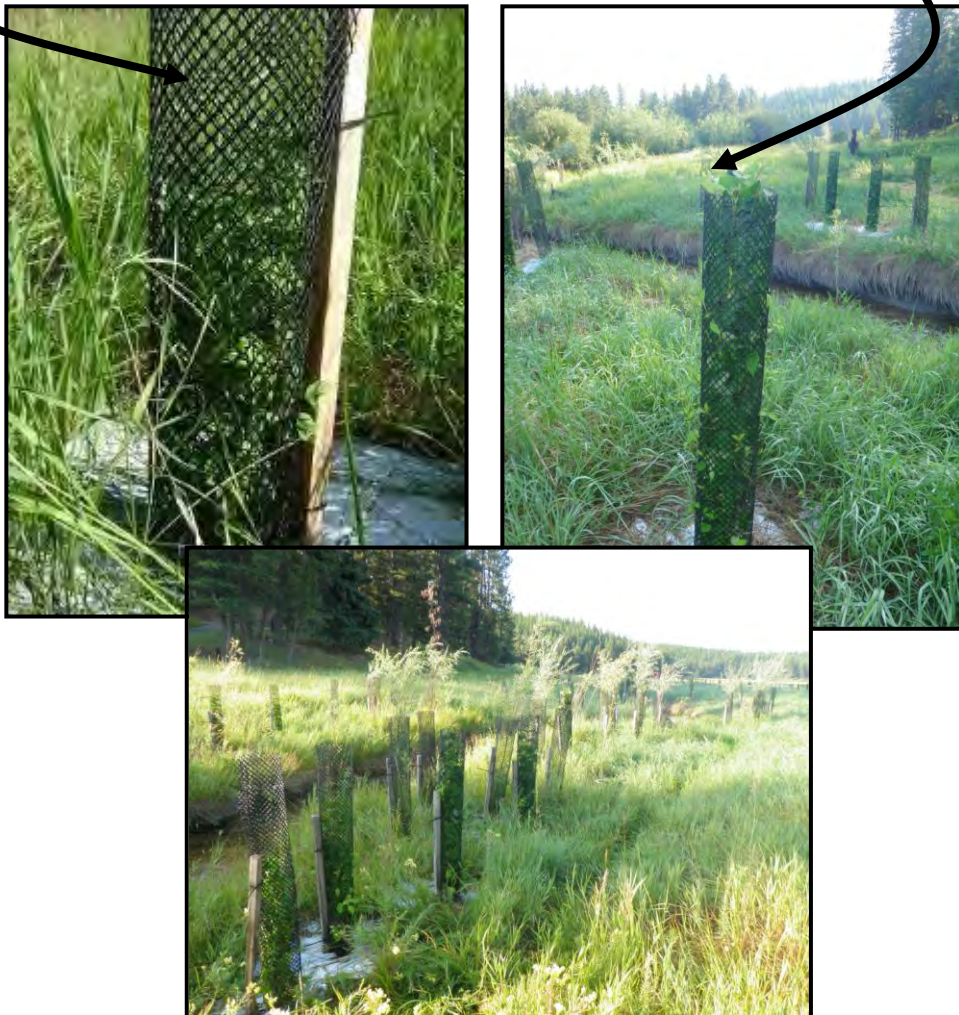
Figure 5. Photographs showing the difference in protected red-osier dogwood growth between 2008 (top photo left) and 2009 (top photo right) (the stake used to stabilize the netting is a good reference for the difference in height). Bottom photo shows the growth on protected sandbar willow plants monitored in 2009. Protected sandbar willows have grown approximately 3 feet between 2008 and 2009.

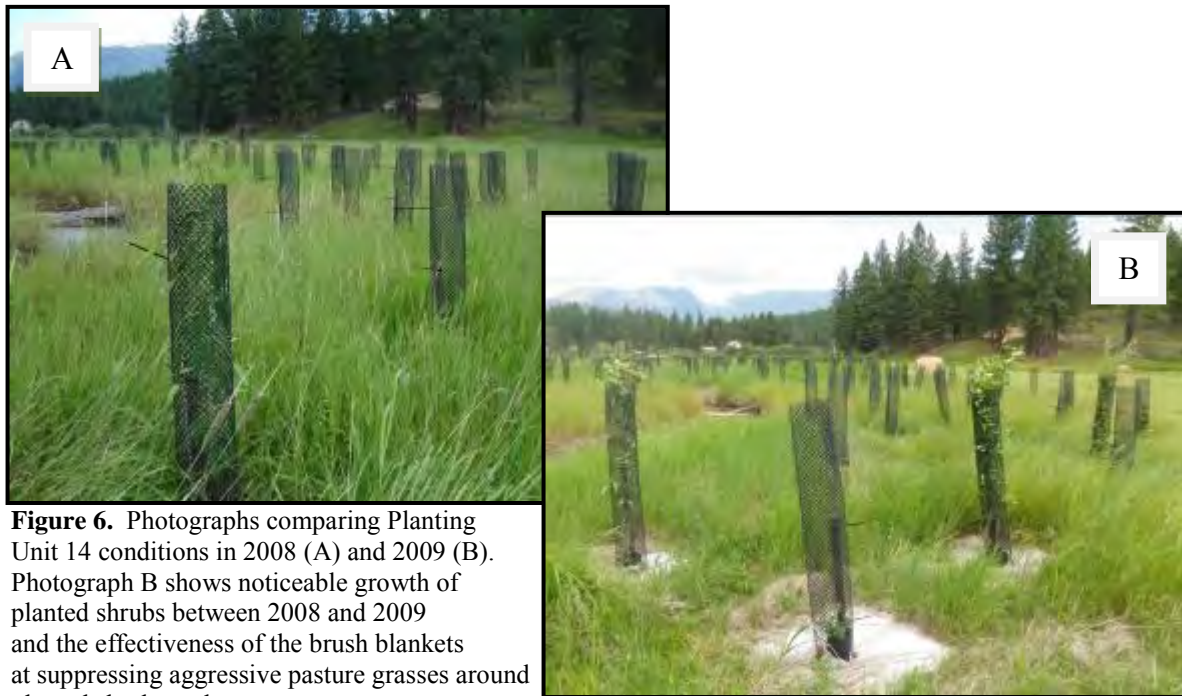
The common herbaceous species recorded in each monitored planting unit remained relatively unchanged between 2008 and 2009. Introduced pasture grasses remain common in all planting units. The dominant herbaceous species include: common timothy (*Phleum pretense*), smooth brome (*Bromus inermis*), redtop (*Agrostis stolonifera*), quackgrass (*Elymus repens*) and Kentucky bluegrass (*Poa pratensis*). Results of 2009 monitoring show that pasture grasses were less dominant in Planting Units 7 and 12 than they were in 2008, and that there was an increase in native sedge and forb species cover. The three foot by three foot brush blankets installed around planted shrubs and trees are eliminating cover of grasses near planted shrubs and trees (Figure 6).

Figure 6. Photographs comparing Planting Unit 14 conditions in 2008 (A) and 2009 (B). Photograph B shows noticeable growth of planted shrubs between 2008 and 2009 and the effectiveness of the brush blankets at suppressing aggressive pasture grasses around planted shrubs and trees.

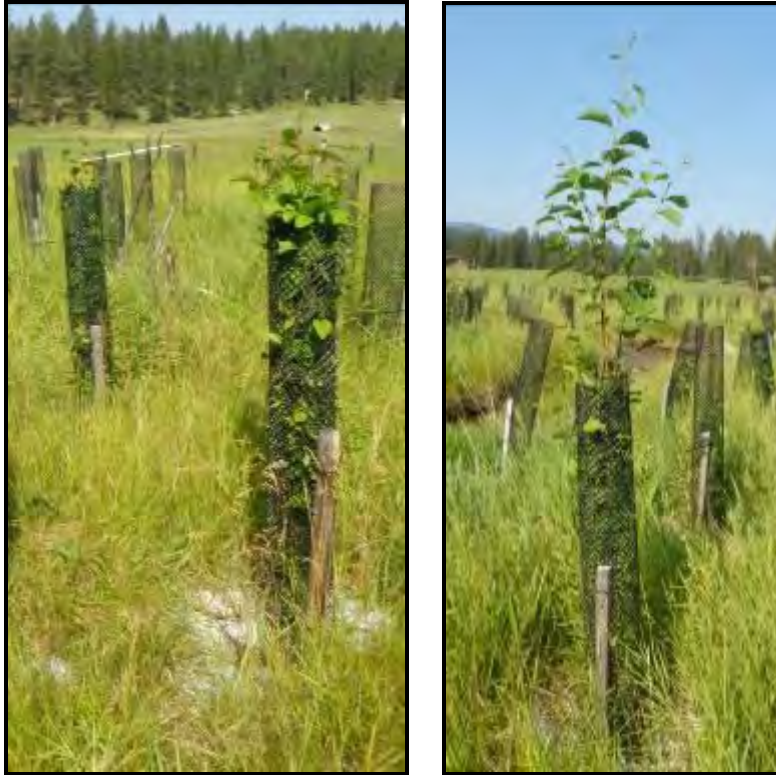
Figure 7. Photographs of plants that had out-grown their browse protectors by July 2009.

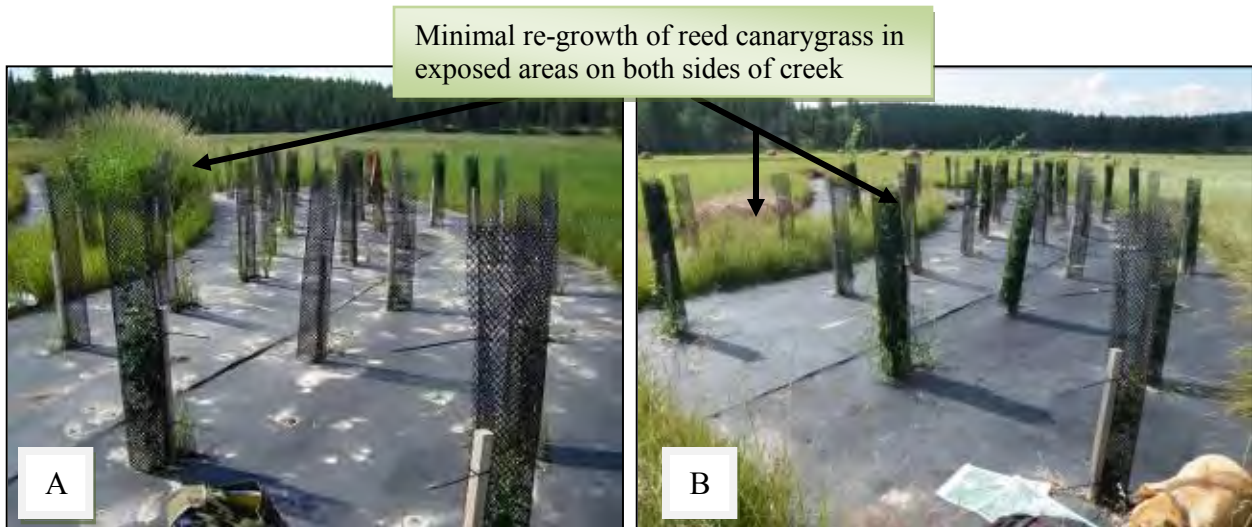
Figure 9. Planted solarization Plot 1 in 2008 (A) and 2009 (B). Most surviving plants out-grew their browse protectors in 2009. Photograph also shows the reduction in reed canarygrass adjacent to the solarization plot as a result of herbicide applications in 2008 and 2009.

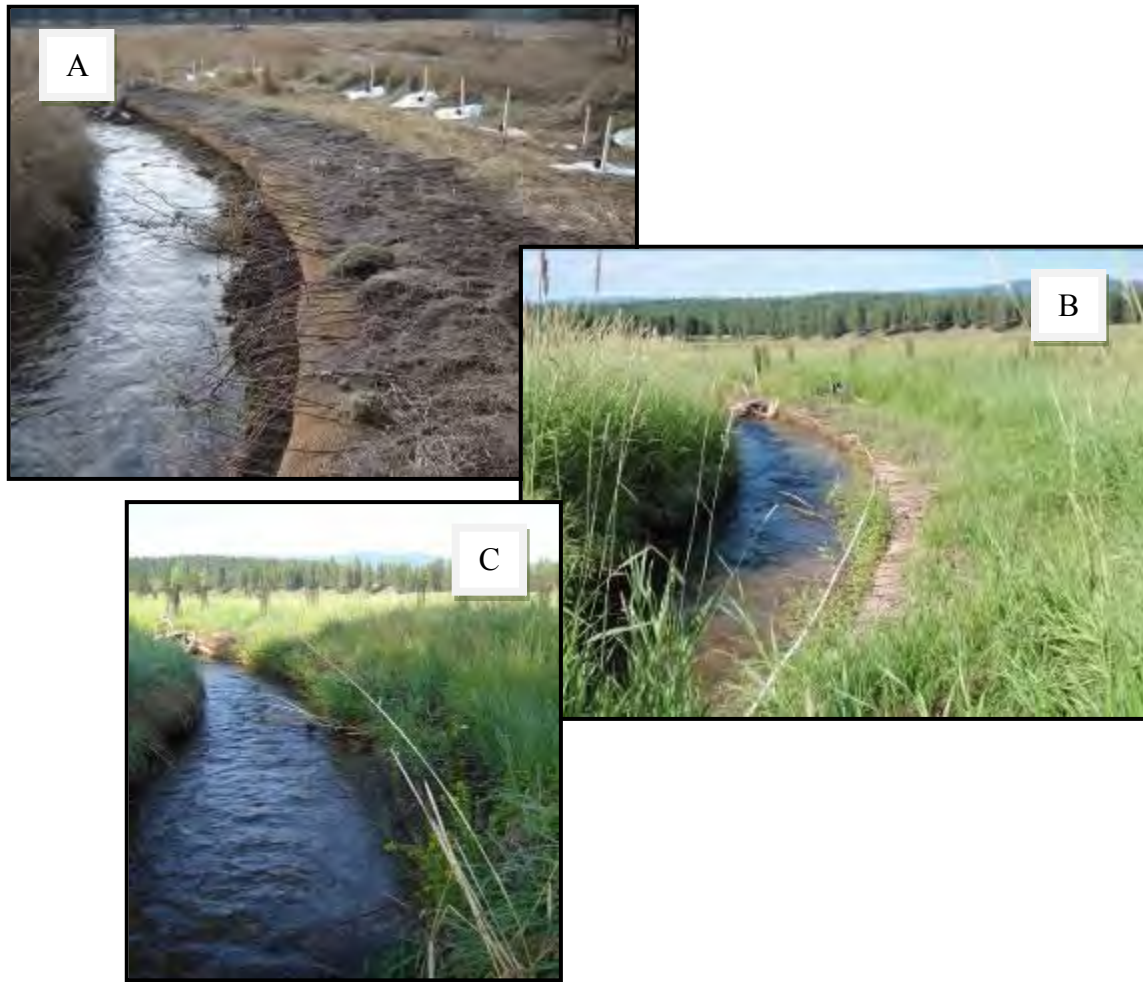
Figure 10. Photographs of Soil Lift 1 immediately after implementation (A), during July 2008 effectiveness monitoring (B), and during July 2009 effectiveness monitoring (C). Willow and herbaceous cover increased in 2009 on both the top and bottom layers of the lift.

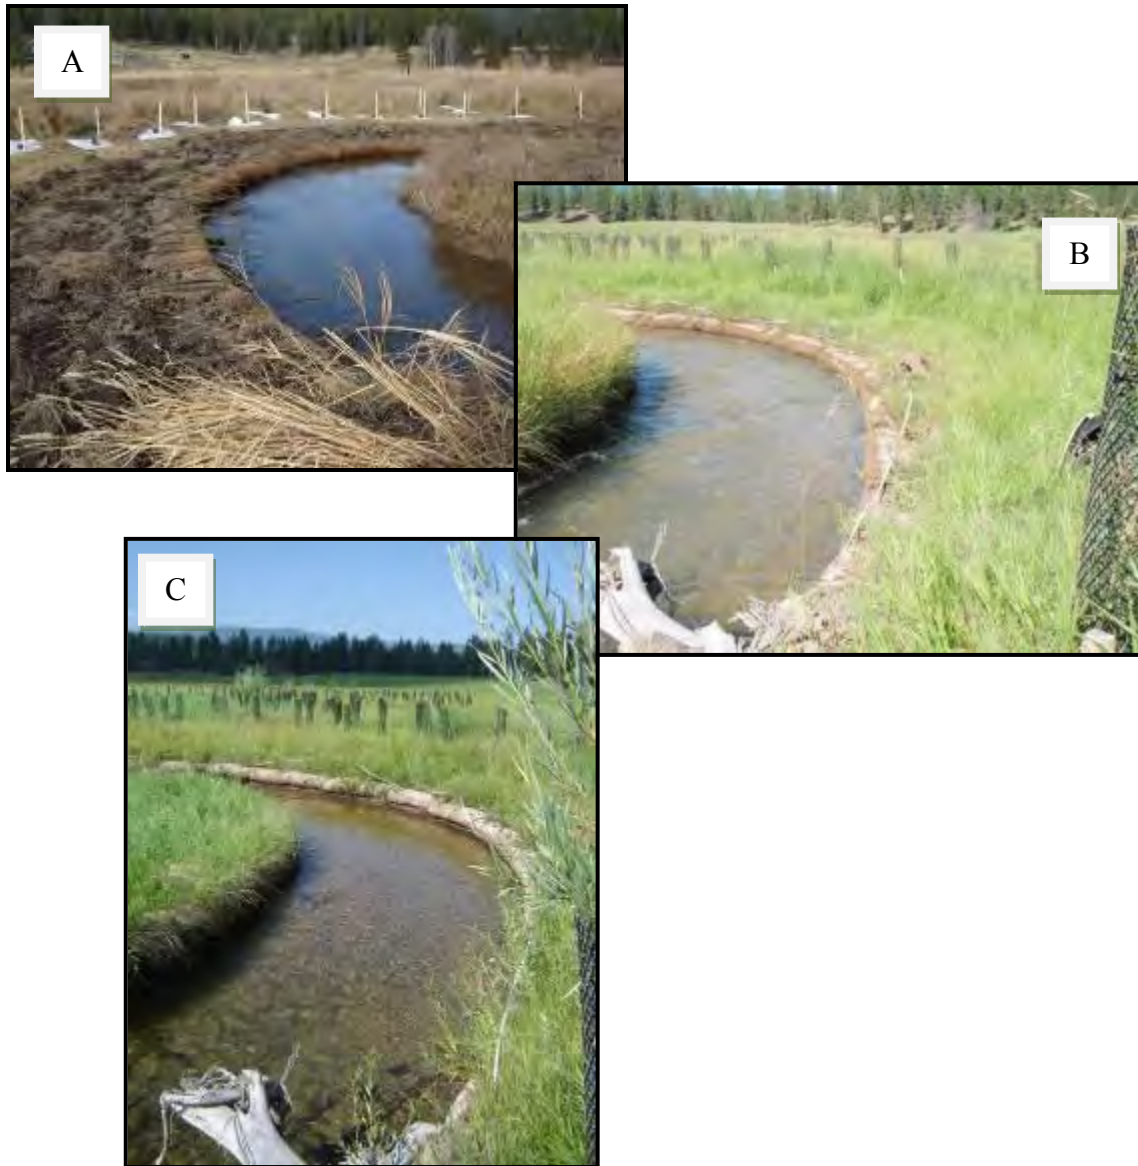
Figure 11. Photographs of Soil Lift 2 immediately after installation (A), during July 2008 effectiveness monitoring (B), and during July 2009 effectiveness monitoring (C). Willow and herbaceous cover increased in 2009 on both the top and bottom layers of the lift.

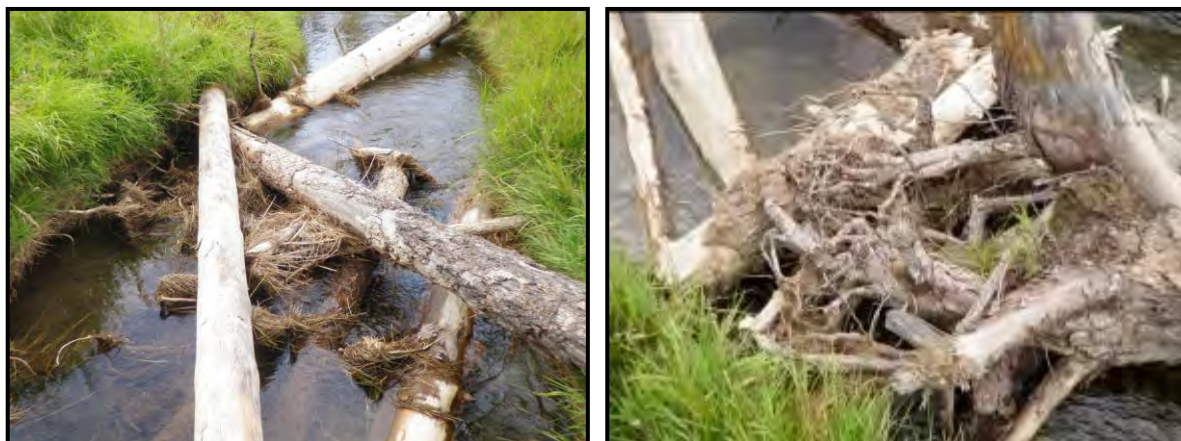
Figure 12. Photographs showing the accumulation of fine sediment and organic debris on large woody debris structure 1.

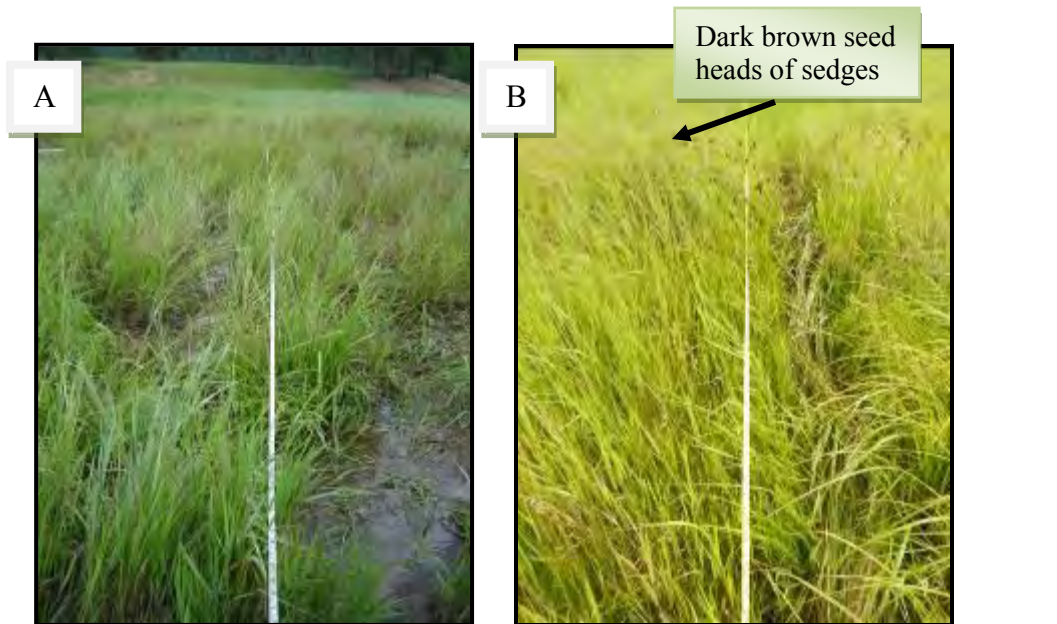
Figure 13. Photographs of Woody Debris Transect 1 at the 50-60' interval in 2008 (A) and 2009 (B). More standing water was recorded in 2008, but an increase in cover of sedges was recorded in 2009 (the dark brown in photo are sedge seed heads).

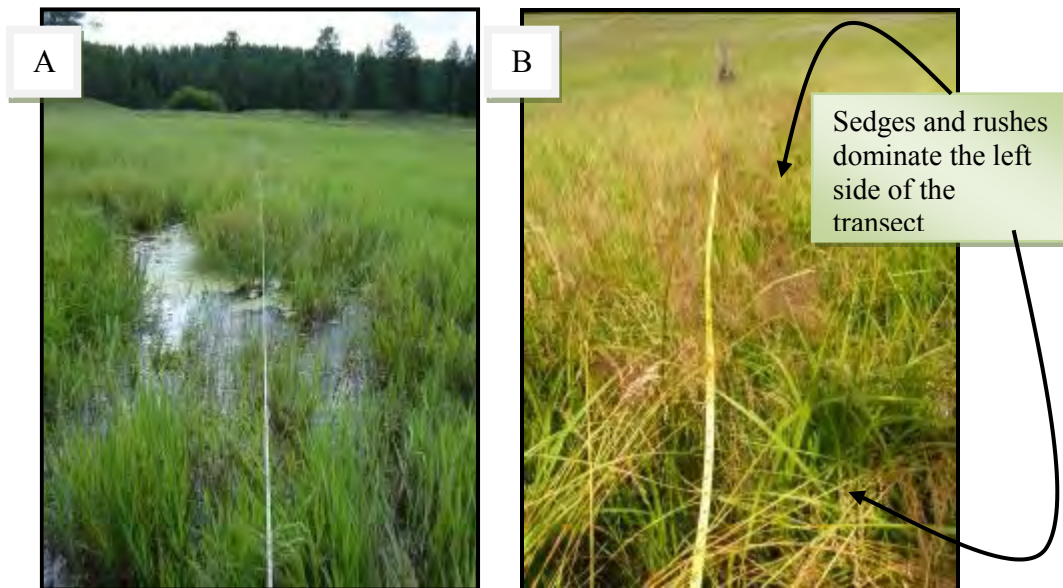
Figure 14. Photographs of Woody Debris Transect 2 at the 50-60' interval in 2008 (A) and 2009 (B). More standing water was recorded in 2008, but an increase in cover of sedges and rushes was recorded in 2009.

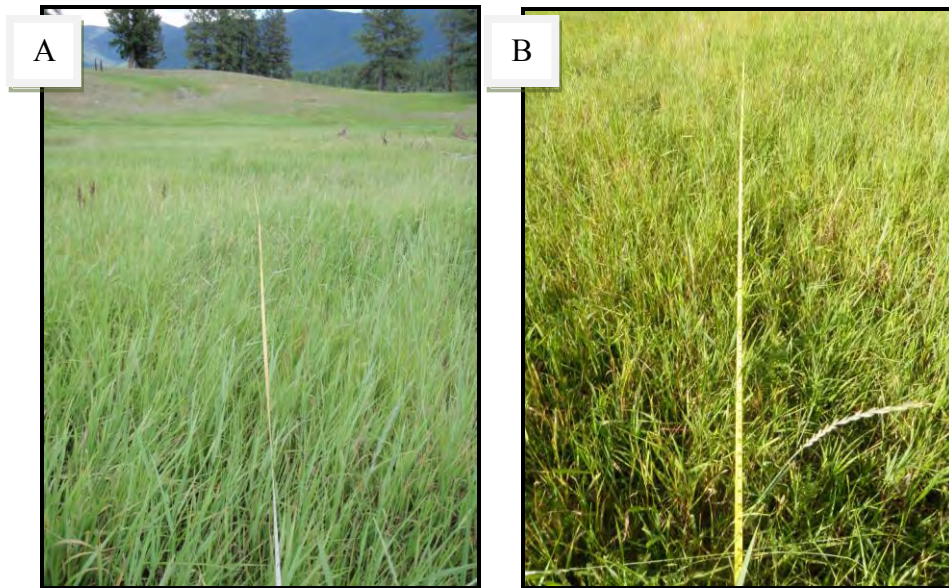
Figure 15. Photographs of Woody Debris Transect 3 at the 60-70' interval in 2008(a) and 2009(B). Species composition along this transect remained similar between 2008 and 2009.

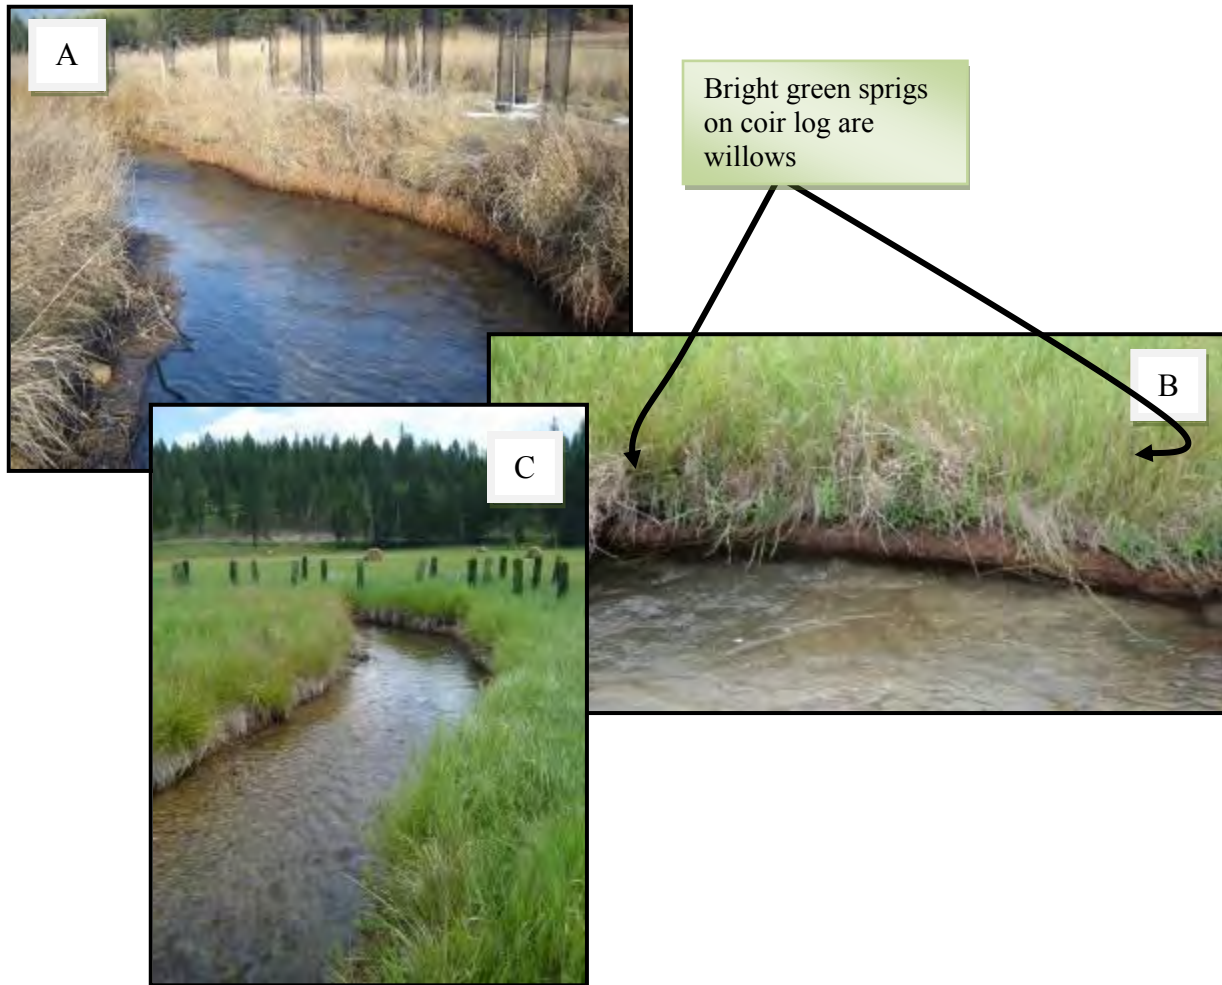
Figure 16. Coir log 5 immediately after implementation in October 2007 (A), during July 2008 effectiveness monitoring (B), and during July 2009 effectiveness monitoring (C).

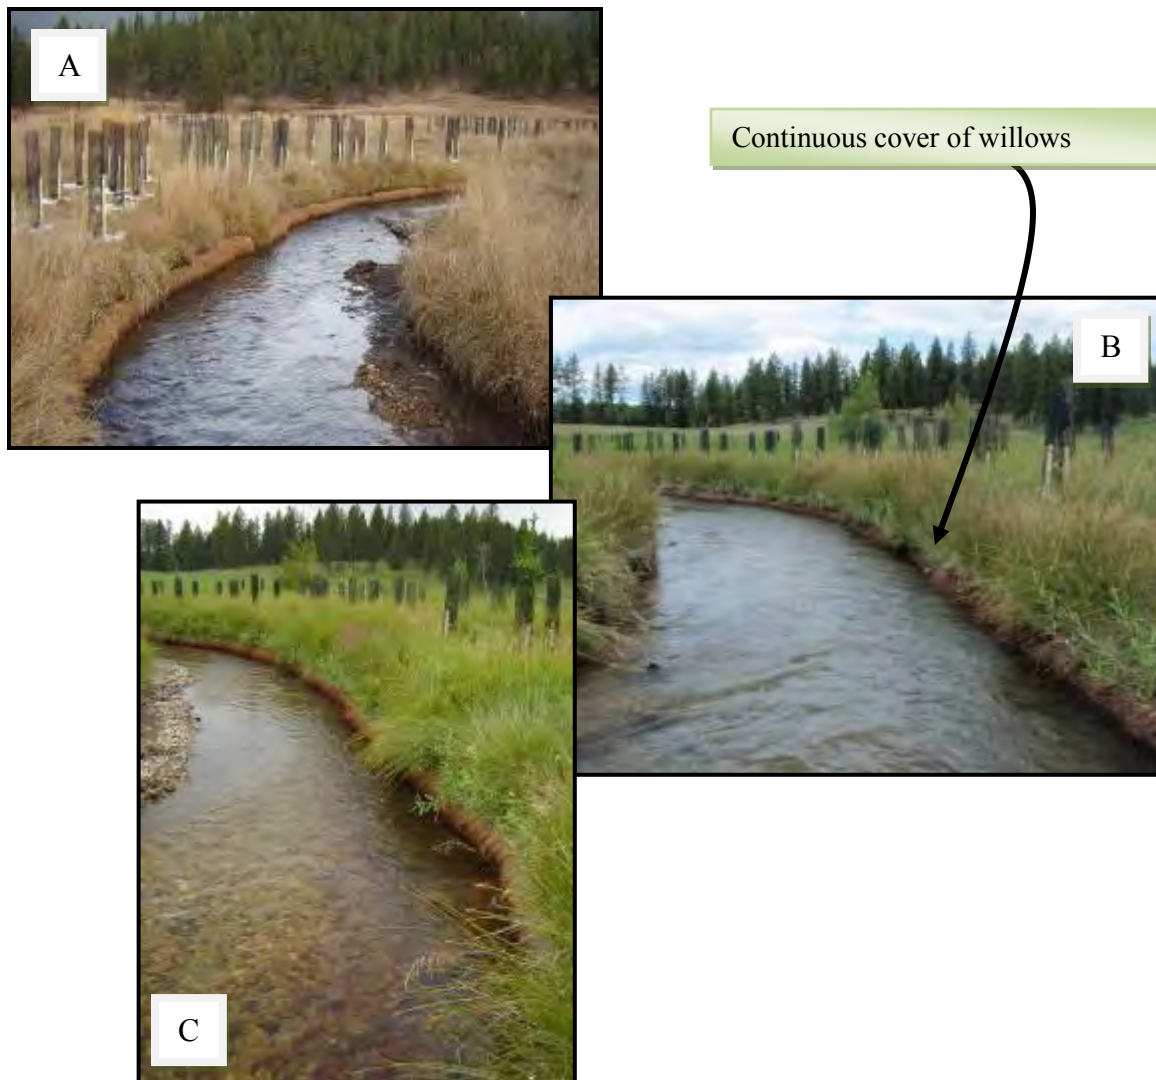
Figure 17. Coir Log 7 immediately after installation in October 2007 (A), during July 2008 effectiveness monitoring (B), and during July 2009 effectiveness monitoring (C). Willow survival on this structure is high, but cuttings are heavily browsed.

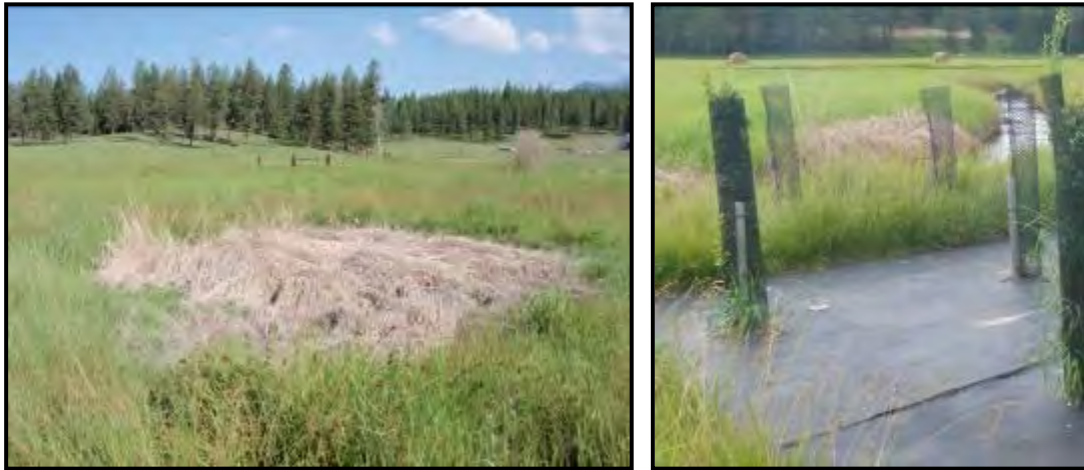
Figure 18. Photograph shows dead patches of reed canarygrass that were treated with herbicide in 2008.

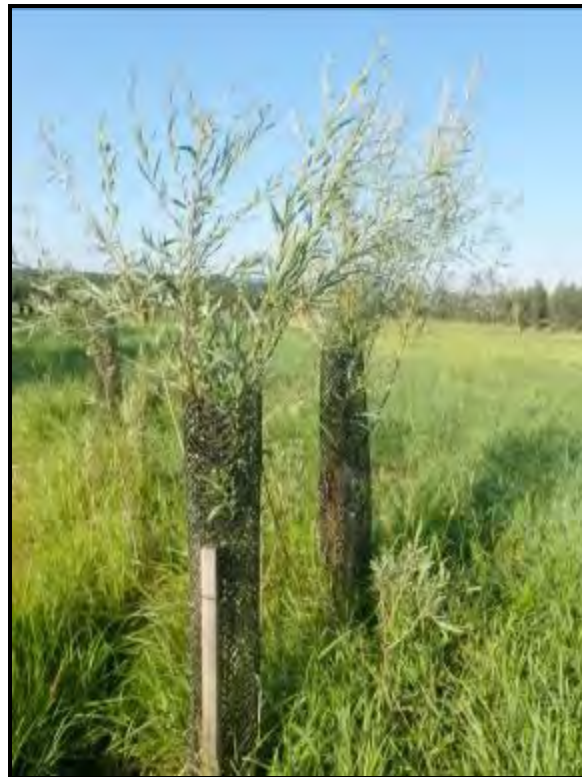
- Most protected residual shrubs continue to show increased new growth. New growth of more than three feet was observed on some protected shrubs (Figure 24). Since protection in 2007, most residual shrubs grew to the maximum capacity of the browse protectors. For this reason, expansion of browse protectors was identified as a maintenance need for this treatment. Approximately 200 of the 250 initially protected shrubs were expanded from eight-inch diameter to 16-inch diameter browse protectors in summer and fall 2009. For any browse protectors installed in the future, the diameter should be a minimum of 16-inches to allow room for plant growth and to reduce the amount of maintenance required.

Figure 24. Sandbar willow planted in 2004 that was fitted with browse protection in fall 2007. Approximately four feet of new growth occurred during the 2009 growing season (photograph was taken during July 2009 effectiveness monitoring).

Based on these results and observations, protection of additional residual shrubs with four-foot high by 16-inch diameter browse protectors should be part of Phase III revegetation efforts.

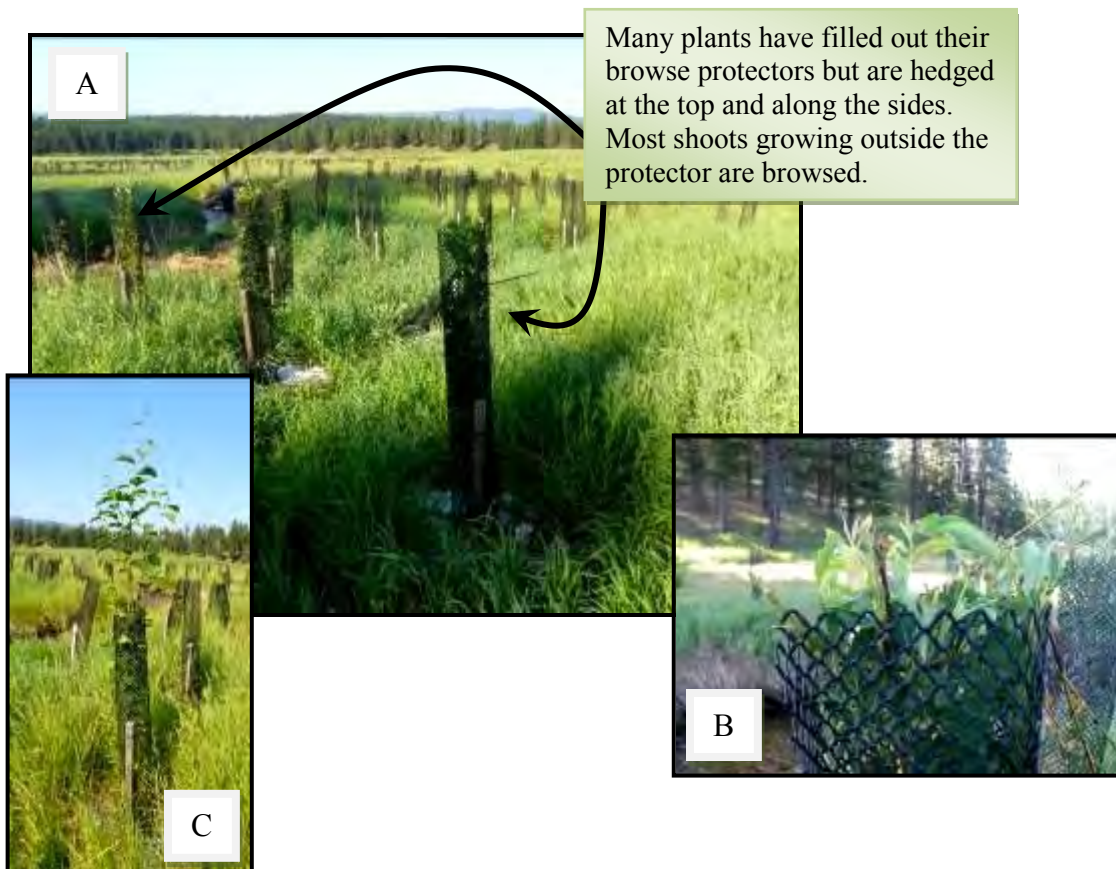
Figure 25. Photograph showing browse of new growth extending above browse protectors in containerized planting units (Photos A and B). Photo C shows an example of the height plants would be reaching after two full growing seasons if browse was eliminated.

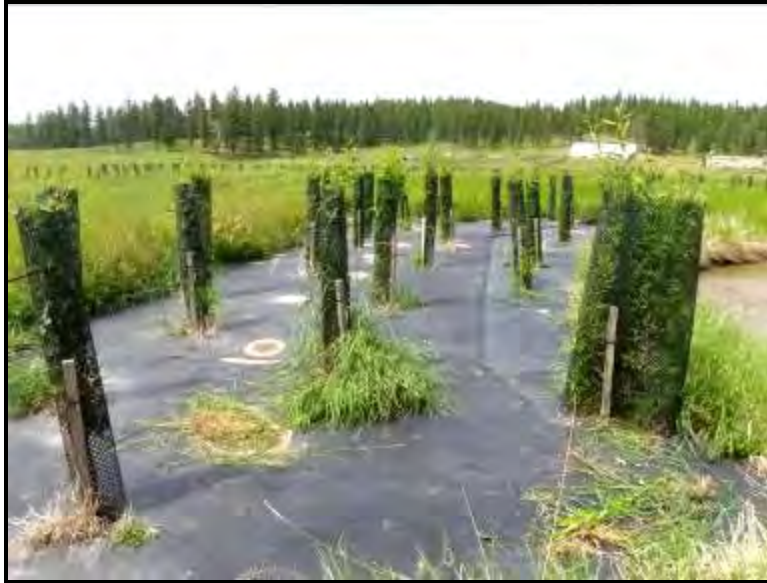
Figure 26. Photograph showing the vigorous growth of the containerized plants installed within solarization fabric. Most plants in this unit had out-grown browse protectors. Hand-pulling of grasses and expansion of browse protectors was completed in summer and fall 2009.

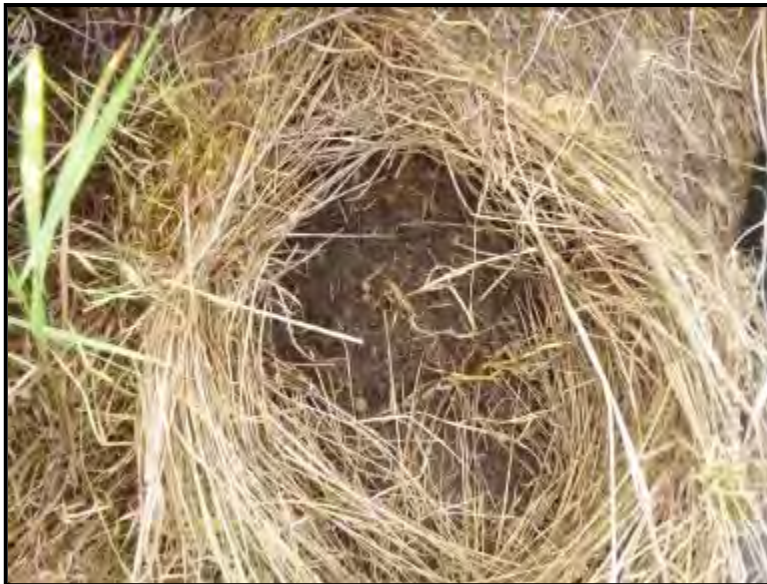
Figure 27. Photograph showing conditions under temporary solarization sites in July 2009 (after two growing seasons). When the fabric is removed dry leaf litter covers the bare mineral soil indicating the treatment has effectively heat-killed grasses.

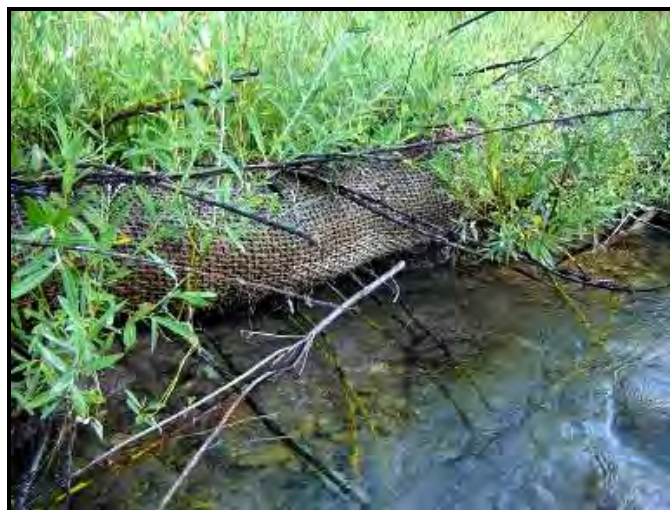
Figure 28. Photograph shows a soil lift in 2009 with good cover of willows above the lift but sparse cover below.

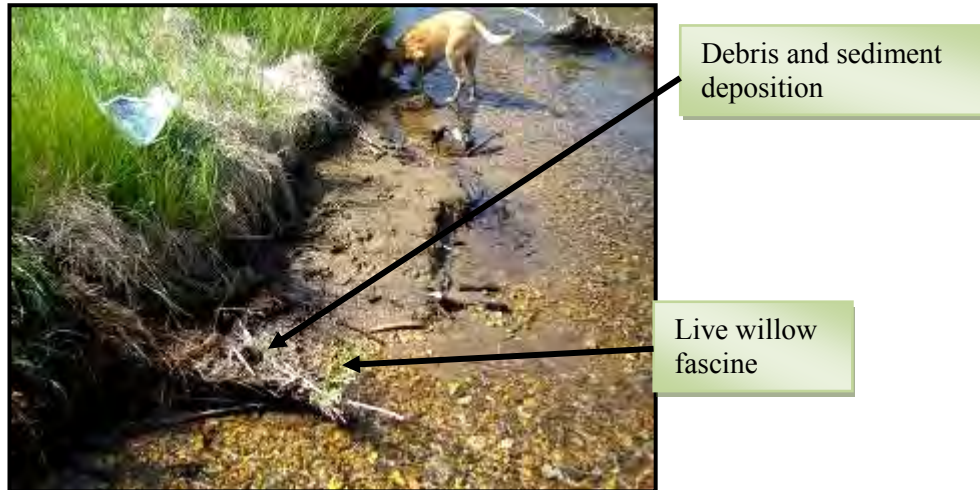
Figure 29. Photograph shows an example of sediment and debris deposition at the downstream end of a live willow fascine.

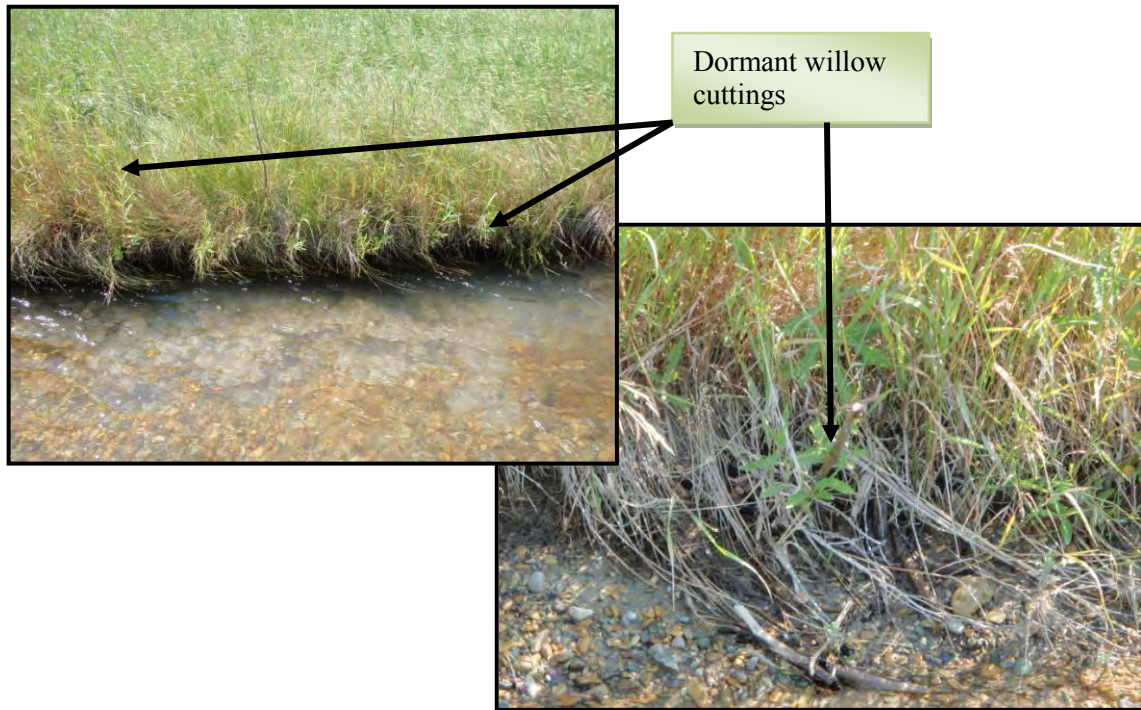
- In early spring 2008, a number of 24-inch dormant willow cuttings were directly installed into banks in the upper portion of the project reach by Eureka High School students. These cuttings were installed primarily along straight reaches of the channel. During monitoring of the willow fascine treatment sites many of these cuttings were observed. Where cuttings were observed, survival appears to be high and new growth averaging between six and 12 inches (Figure 30).

Figure 30. Photographs of dormant willow cuttings installed in early spring 2008.

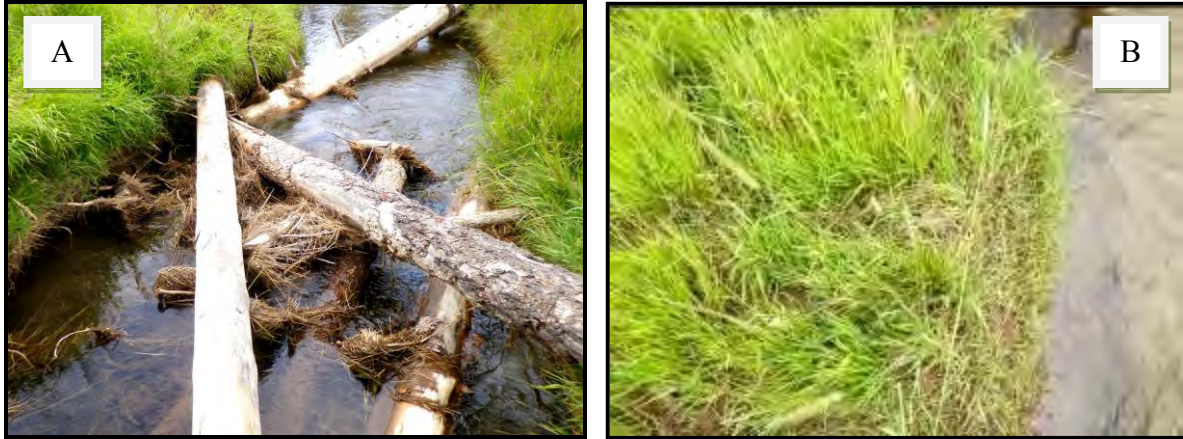
Figure 31. Photograph A shows debris and organic matter trapped by the large woody debris structures. Photograph B shows sediment trapped in the floodplain as a result of elevated water surfaces upstream of large woody debris structures.

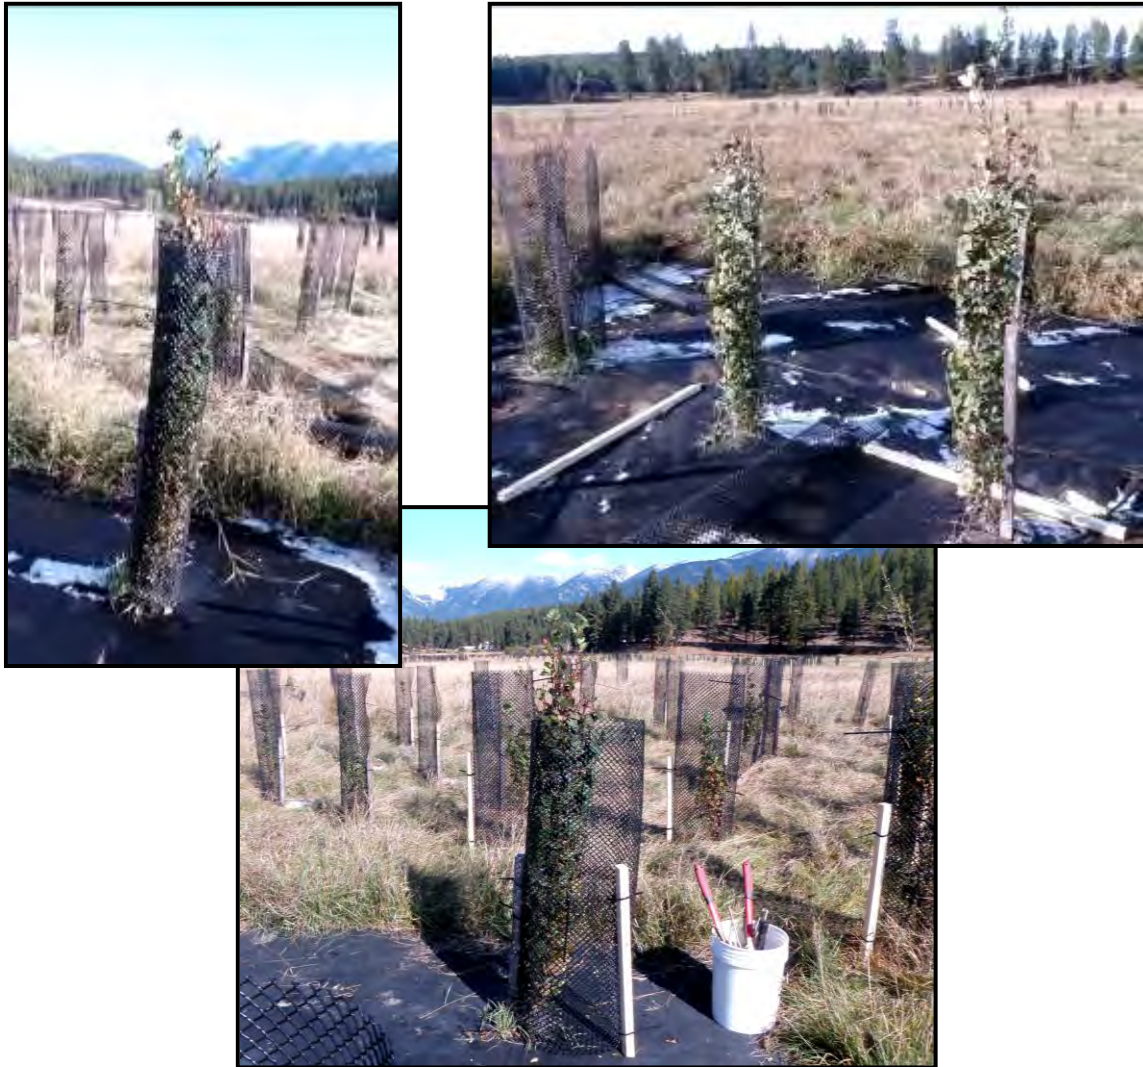
Figure 32. Photographs show the constricted growth form of plants after two full growing seasons in browse protectors (top photos) and the expanded protectors after fall 2009 maintenance (bottom photo).

- **Browse Protector Repair and Maintenance.** Browse protectors were expanded, re-secured and straightened in all planting units and residual shrub protection areas (Figure 32). For additional stability, a second four-foot wooden stake was added to each expanded browse protector. Browse protectors were enlarged for all shrubs that had out-grown the current browse protector. Approximately 700 of the 1,028 plants installed were retro-fitted with larger diameter browse protectors. Approximately 200 of the 250 residual shrubs were retro-fitted with larger browse protectors.

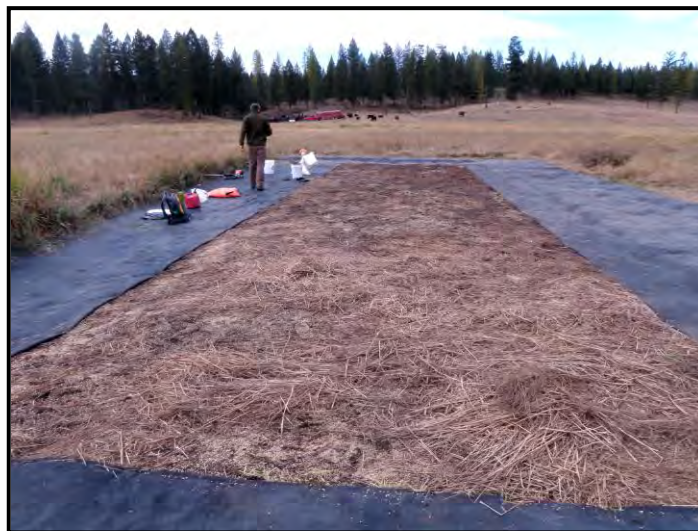
Figure 33. Photograph showing temporary solarization plot 3 after a portion of the fabric was removed and re-located to act as a buffer around the newly exposed surface. The buffer will limit the potential for seed from adjacent grass areas to colonize the newly exposed soil.
