Therriault Riparian Revegetation 2008 Monitoring Report

Task Order #0803

Geum Environmental Consulting, Inc.
307 State Street
Hamilton, MT 59840

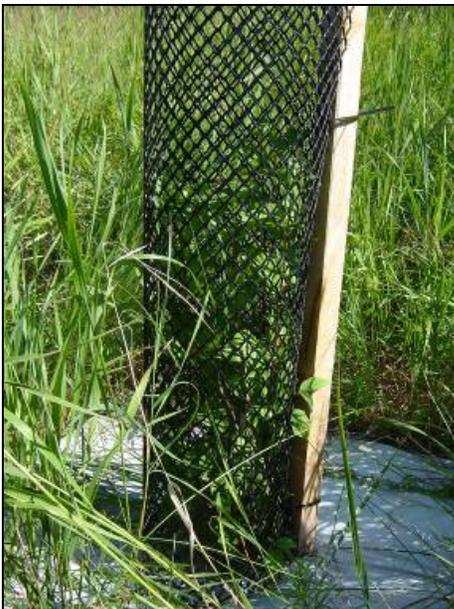
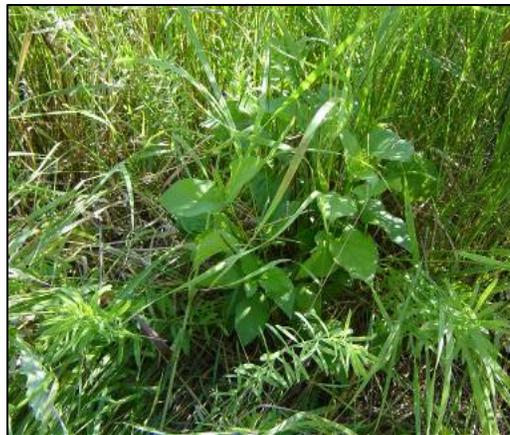
Figure 4. Comparison of residual shrub with browse and weed protection measures (left) and without (right).

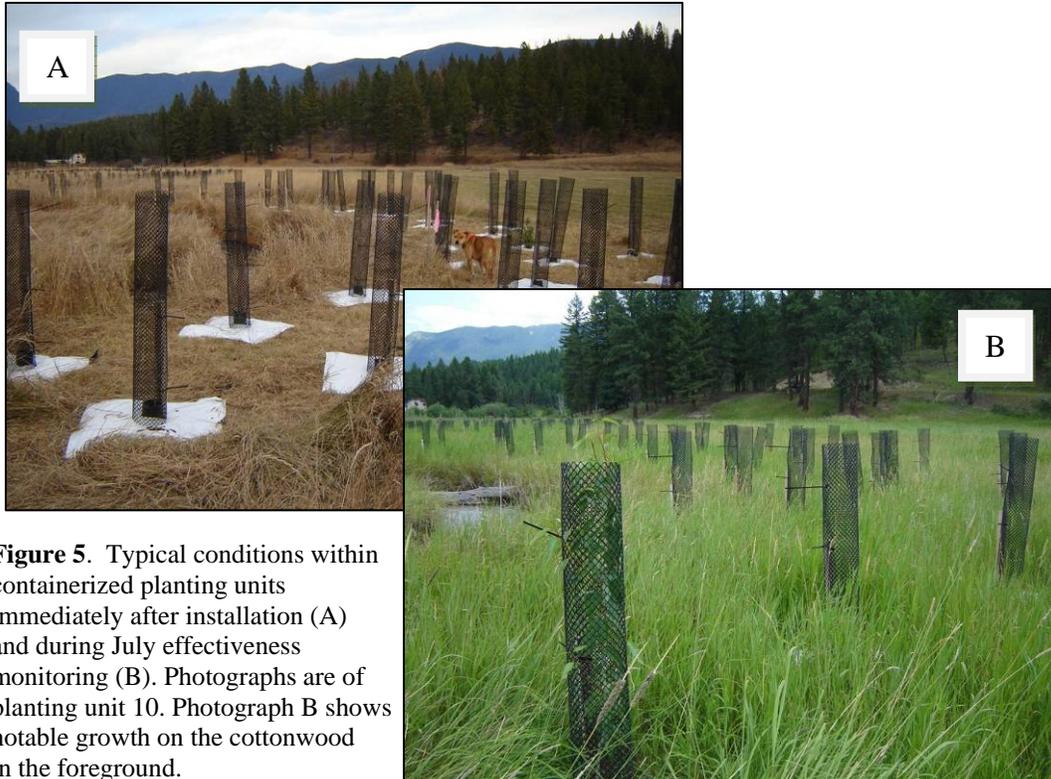
Figure 5. Typical conditions within containerized planting units immediately after installation (A) and during July effectiveness monitoring (B). Photographs are of planting unit 10. Photograph B shows notable growth on the cottonwood in the foreground.

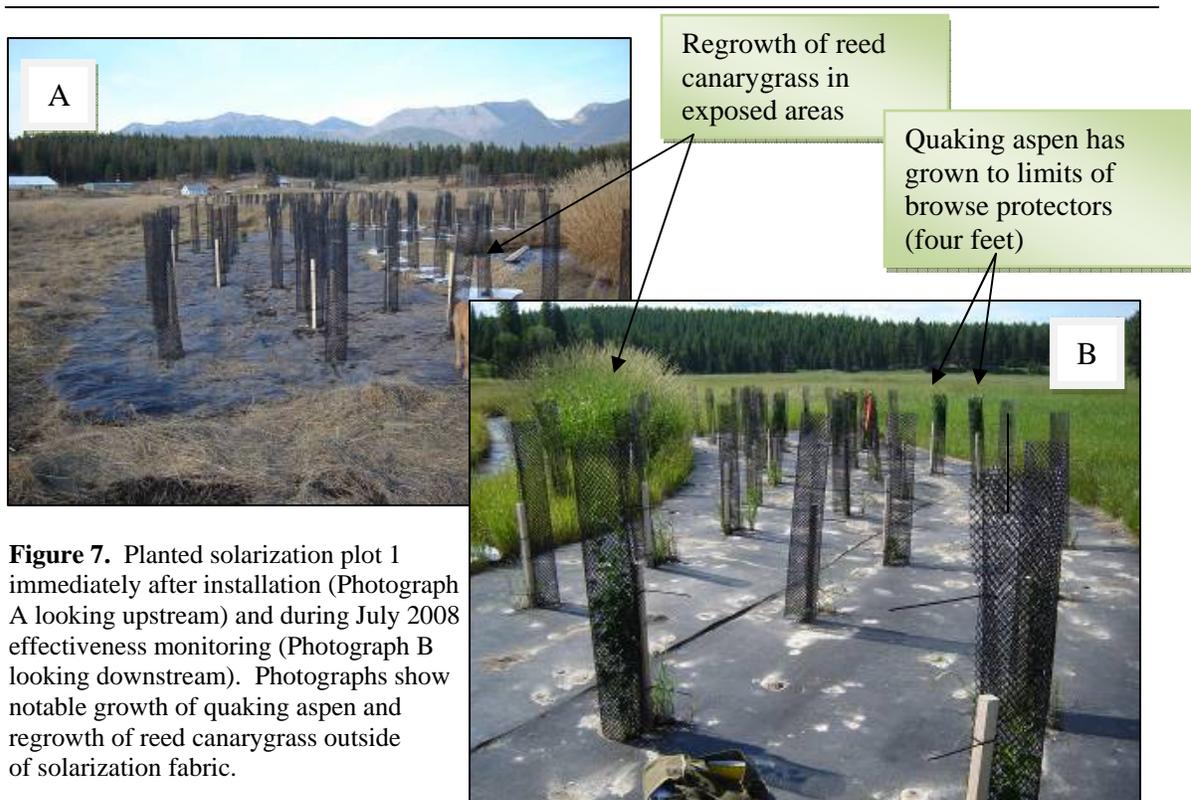
Figure 7. Planted solarization plot 1 immediately after installation (Photograph A looking upstream) and during July 2008 effectiveness monitoring (Photograph B looking downstream). Photographs show notable growth of quaking aspen and regrowth of reed canarygrass outside of solarization fabric.

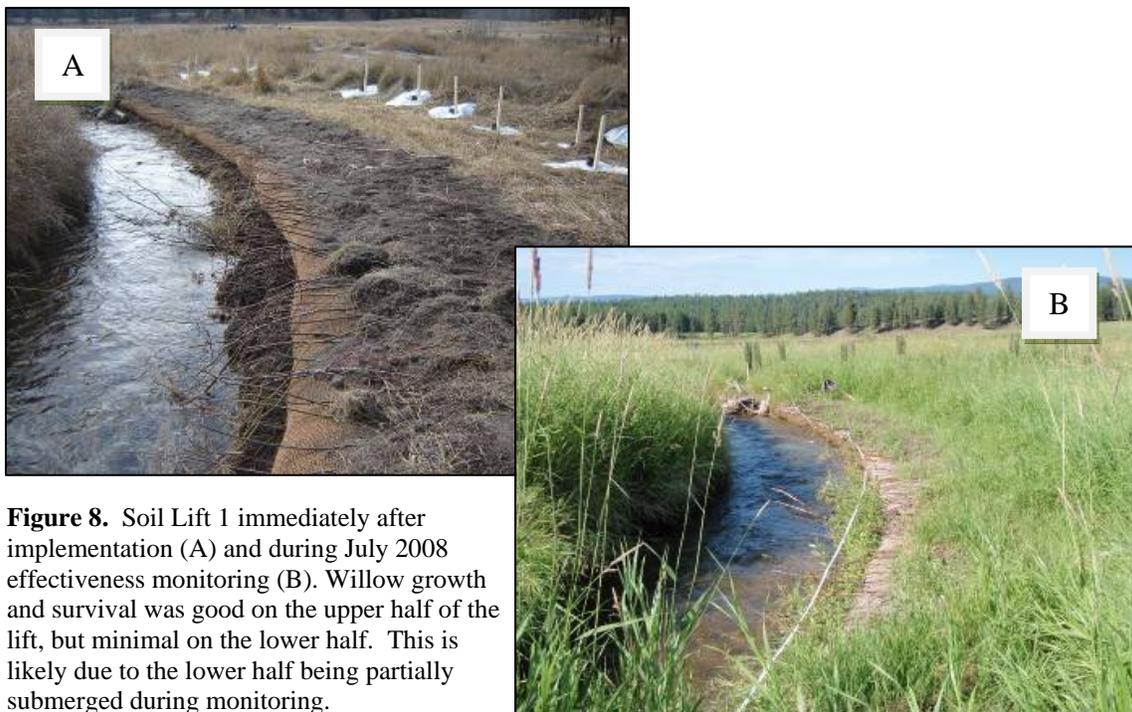
Percent cover of willows ranges from one to 15 per five foot increment for both Soil Lifts 1 and 2. Willow stem survival was generally high on both soil lifts, with the exception of willows placed under Soil Lift 1. There were no rips in the fabric and fabric degradation was estimated to be 10 percent for both lifts. The percent cover of herbaceous species was much higher on Soil Lift 2. Herbaceous species consisted mainly of non-native pasture grasses such as smooth brome (*Bromus inermis*), quackgrass, and orchard grass (*Dactylis glomerata*). Weed coverage, mainly Canada thistle and reed canarygrass, was slightly higher on Soil Lift 1.

Figure 8. Soil Lift 1 immediately after implementation (A) and during July 2008 effectiveness monitoring (B). Willow growth and survival was good on the upper half of the lift, but minimal on the lower half. This is likely due to the lower half being partially submerged during monitoring.

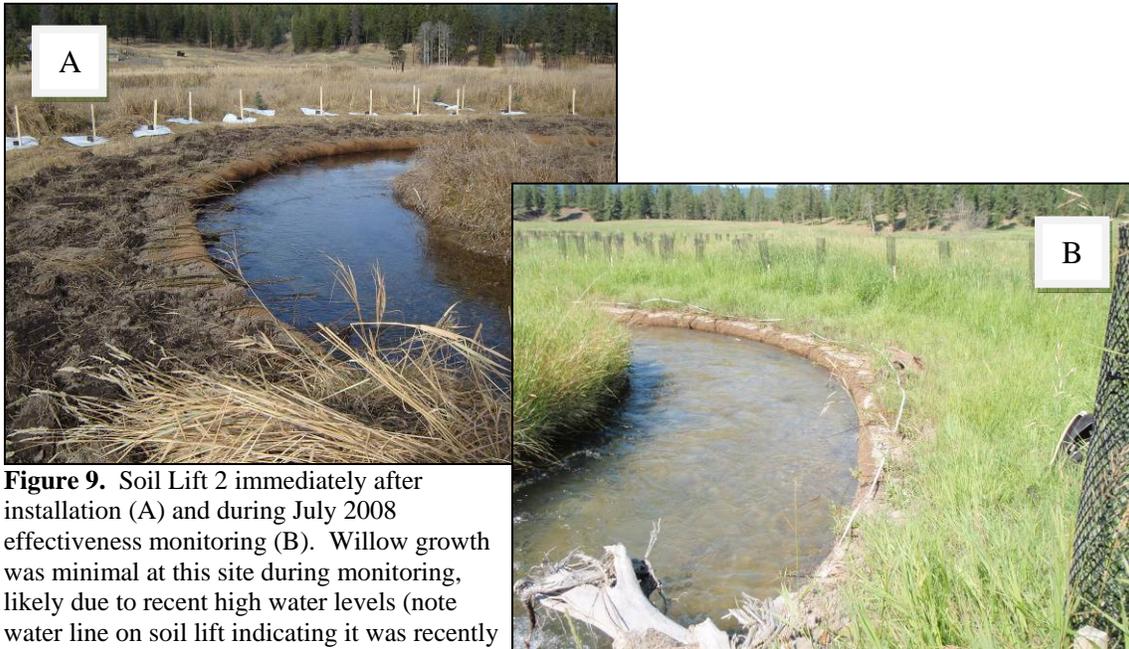
Figure 9. Soil Lift 2 immediately after installation (A) and during July 2008 effectiveness monitoring (B). Willow growth was minimal at this site during monitoring, likely due to recent high water levels (note water line on soil lift indicating it was recently under water).

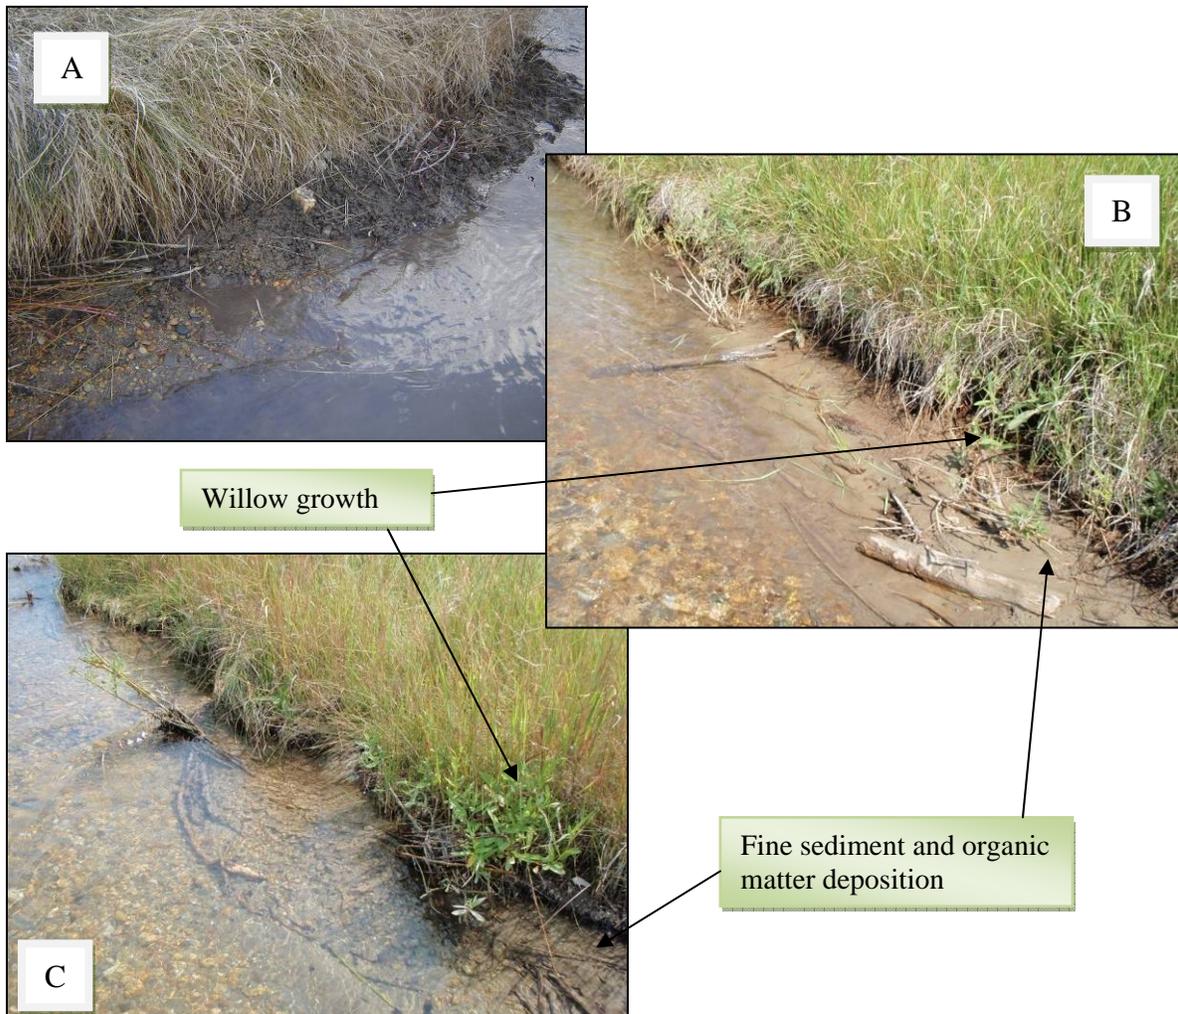
No scour occurred at any of the observed buried willow fascine sites. Fine sediment deposition was observed at almost all of the sites, either at the downstream end or throughout the entire site. Some of the willow fascines had trapped and retained organic matter or woody debris. Willow survival was generally high (between 75 and 100 percent), although many of the fascines were still under water and survival was not able to be determined at the time of monitoring.

Figure 10. Typical conditions of willow fascine sites immediately after installation (A) and during July 2008 effectiveness monitoring (B, C). Photographs B and C show examples of fine sediment deposition and willow growth on willow fascines.

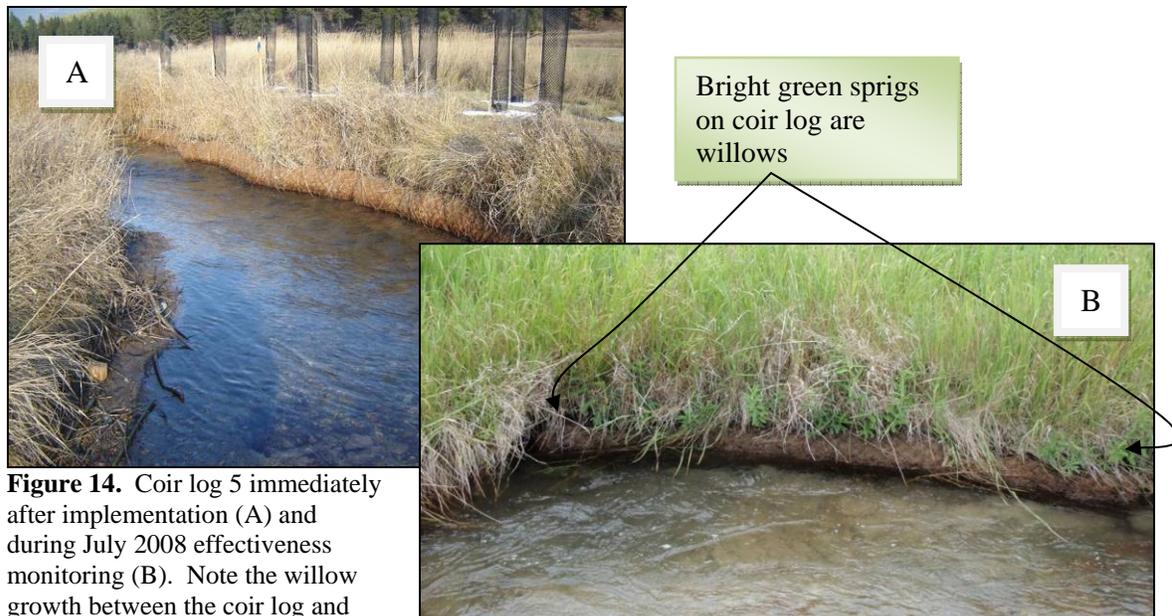
Figure 14. Coir log 5 immediately after implementation (A) and during July 2008 effectiveness monitoring (B). Note the willow growth between the coir log and existing pasture grass plant community in photograph B.

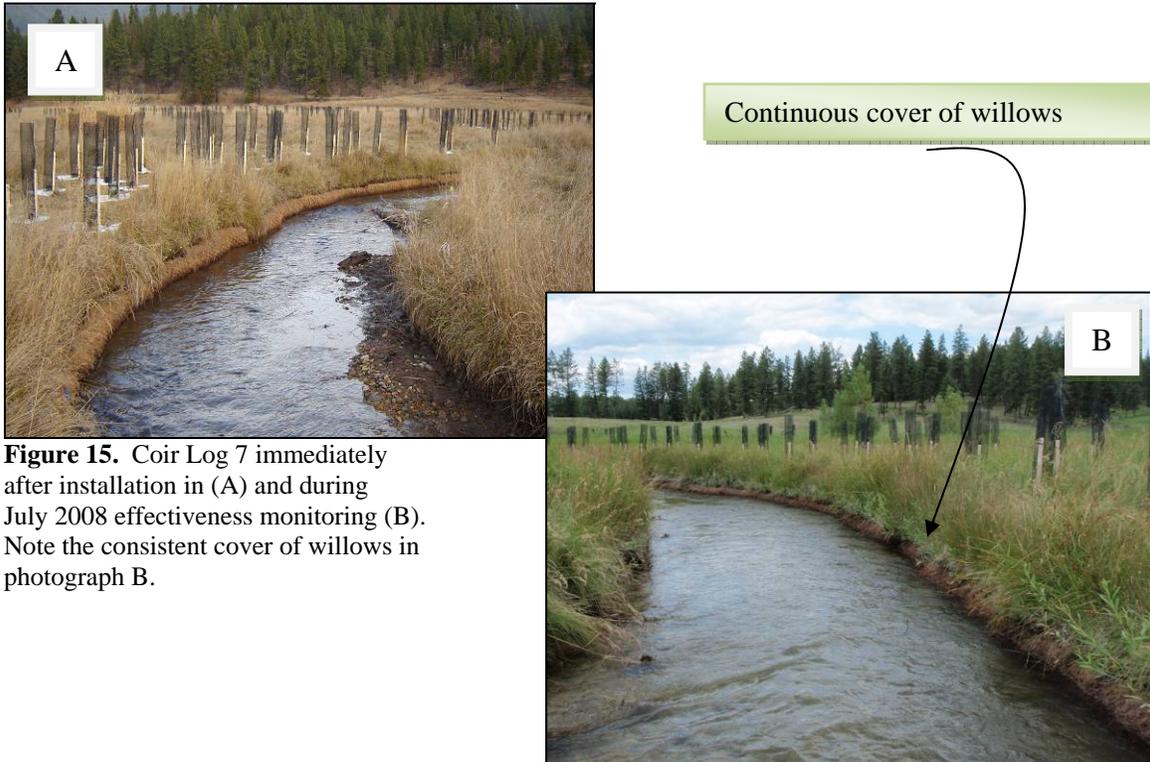
Figure 15. Coir Log 7 immediately after installation in (A) and during July 2008 effectiveness monitoring (B). Note the consistent cover of willows in photograph B.

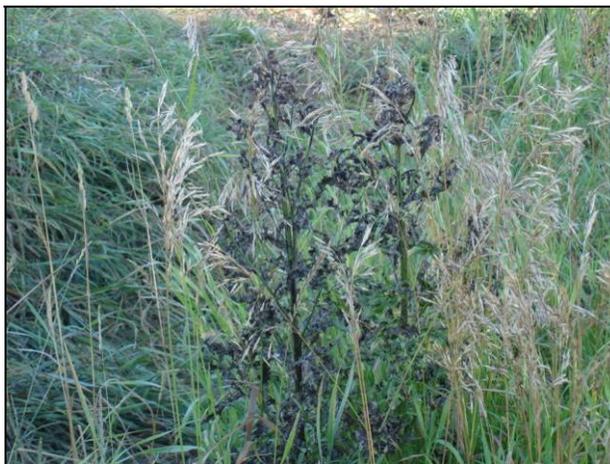
Figure 16. Photograph taken one week after July herbicide application of treated Canada thistle plant.

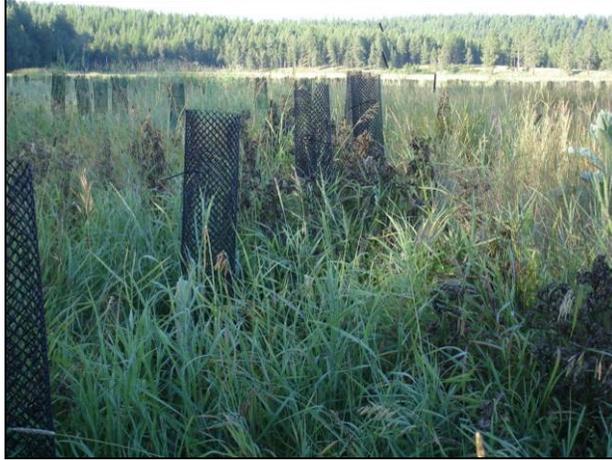
Figure 17. Photograph taken one week after July herbicide application of Canada thistle treated within a residual shrub protection area.

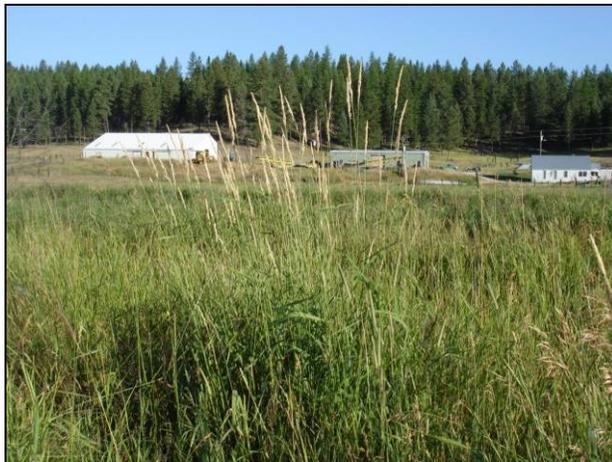
Figure 18. Photograph of reed canarygrass taken one week after July herbicide application. Applicators indicated the grass was not tall enough to be located in July and therefore not treated in the July application.

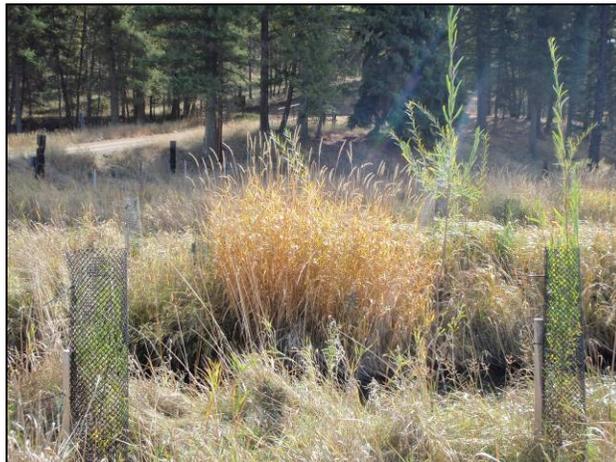
Figure 19. Photograph showing clump of reed canarygrass observed approximately 10 days after September herbicide application. Yellowing of grass indicates that herbicide was applied.

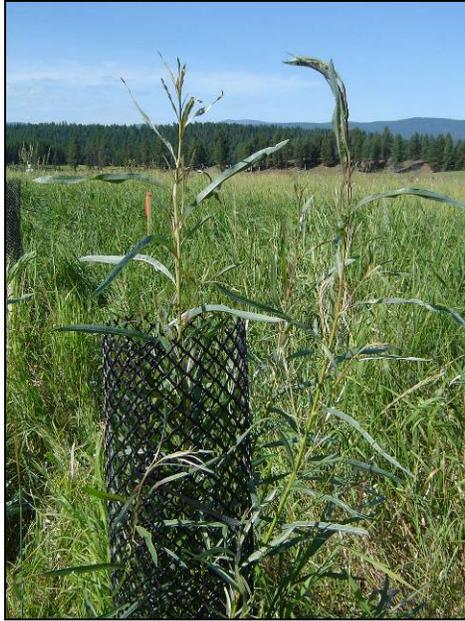
- Residual shrubs surviving from initial revegetation efforts had been subject to severe levels of annual browse. Protected shrubs now generally exhibit high vigor. This indicates that extensive root systems, needed to support healthy vegetative growth, are in place. New growth of more than two or three feet observed on some protected shrubs indicates this treatment is effective and that plants are healthy (Figure 20).

Figure 20. Previously planted sandbar willow fitted with browse protection and showing approximately two feet of new growth during the 2008 growing season (photograph was taken during July 2008 effectiveness monitoring).

- Protecting these plants is a relatively easy way to promote vegetative growth and ensure long-term survival of these plants. Installing browse protectors on the remaining residual shrubs will provide those shrubs the protection needed to grow above browse height and resist pressure from browse.

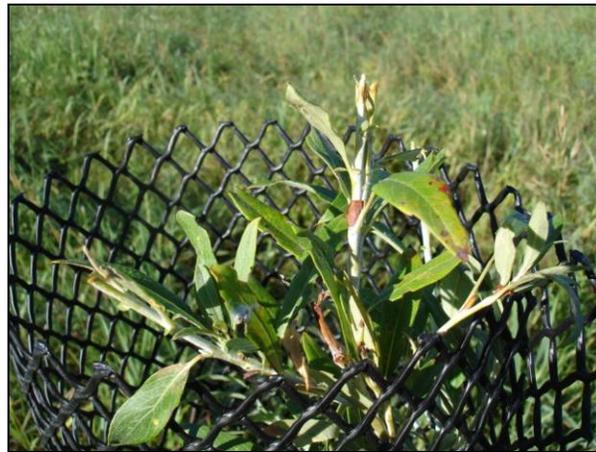
Figure 21. Photograph showing browse of new growth extending above browse protection net in containerized planting unit.

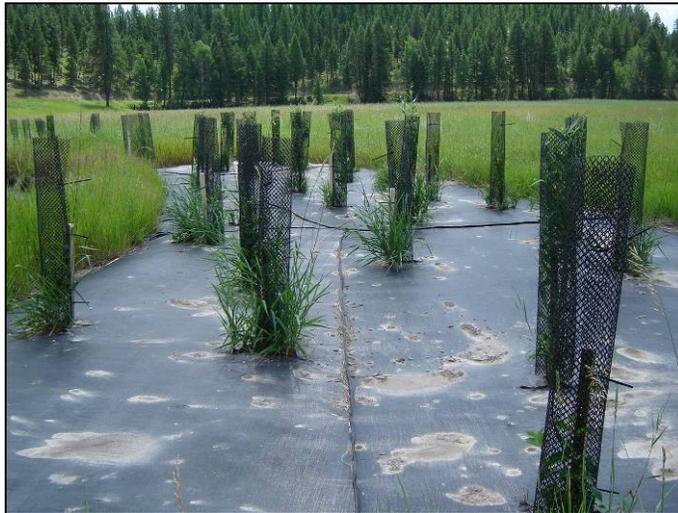
- Solarization fabric is effectively controlling growth of weeds and aggressive pasture grasses, with the exception of areas immediately around containerized plants where holes were cut in the fabric to install plants (Figure 22).
- Maintenance needs for this treatment include: hand pulling weeds and grasses growing through the fabric at the base of containerized plants; supplemental irrigation twice a month in August and September (depending on site conditions); and expanding browse protectors on species that have grown out of the current browse protector size.
- Although the temporary solarization plots were not monitored in 2008, no maintenance needs were observed at these sites. The extent to which reed canarygrass and other grasses have been killed at these sites should begin to be monitored in 2009.

Figure 22. Photograph of planted solarization plot showing growth of grass species through holes cut to plant containerized plants.

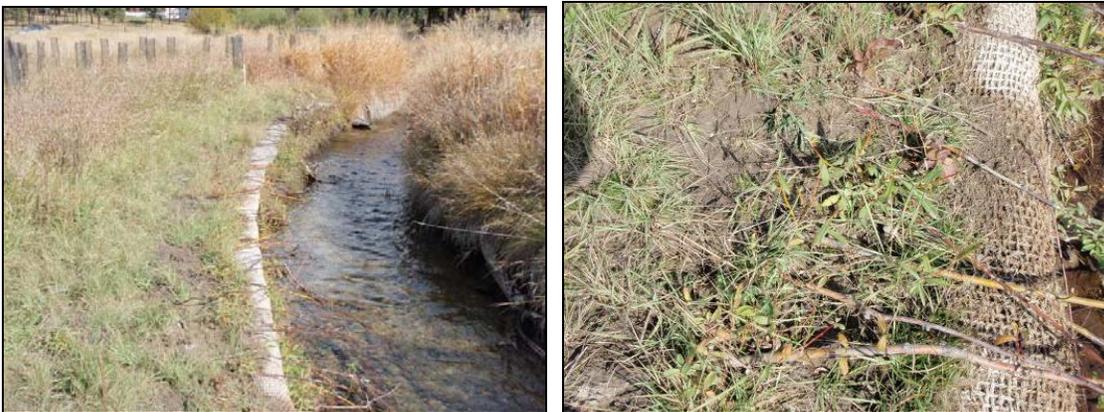
Figure 23. Soil lift site 1 observed in October 2008. Note the growth of willow cuttings installed under the soil lift (photograph left). These cuttings were under water during the July effectiveness monitoring. Photograph right shows willow growth further back on the stem.

- Maintenance needs for 2009 consist of hand pulling or spot spraying Canada thistle. Willow cuttings installed on the top layer often sprout further back on the stem, at the interface of the cutting with soil (Figure 23). Given the aggressive nature of the grasses and weeds colonizing this same area, it may be necessary to install some type of weed suppression mat along the back edge of the soil lifts until willow cuttings are tall enough to resist competition.

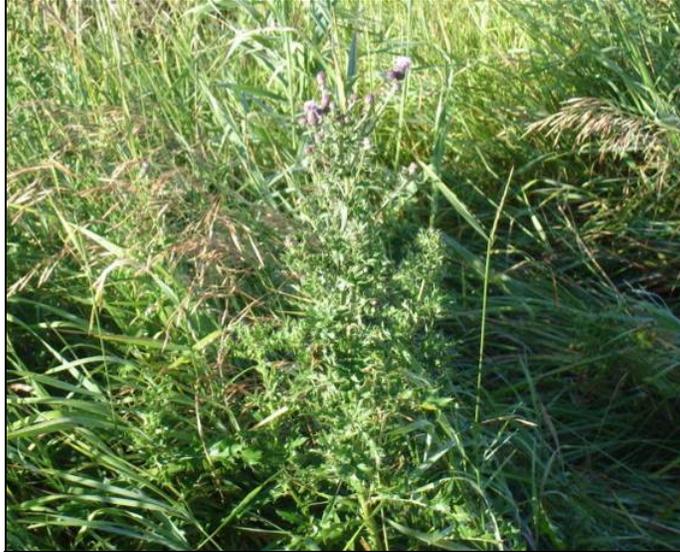
- Application was concentrated along the stream and within planting units. Numerous plants outside of this zone were observed indicating the target area should be expanded during future applications (Figure 24).

Figure 24. Photograph showing an example of target species Canada thistle that was missed during the initial herbicide application during July 2008. Target areas should be expanded for future herbicide applications.

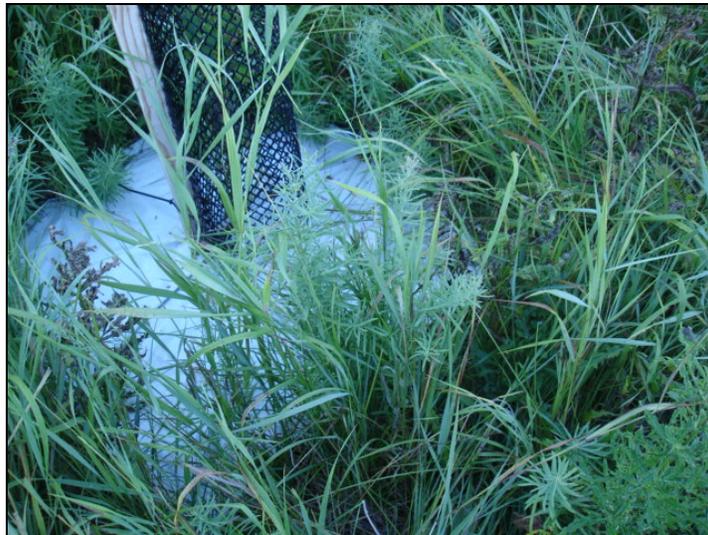
- Yellow toadflax has increased considerably since initial weed mapping. Although some plants were sprayed during the initial application, most were not (Figure 25). These expanded infestations should be included in future applications.

Figure 25. Photograph showing expanding infestation of yellow toadflax.
