Therriault Creek Riparian Revegetation 2013 Monitoring and Maintenance Report

Contract #140025

Geum Environmental Consulting, Inc.
307 State Street
Hamilton, MT 59840

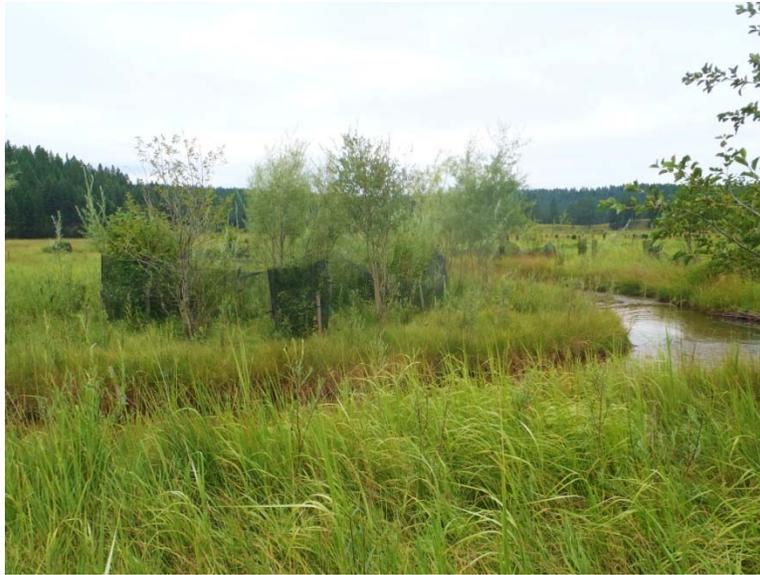
Figure 3. Residual shrubs on an inside meander that have outgrown individual protectors and small enclosure fencing. Naturally colonizing sandbar willow saplings can also be seen in the photo foreground. Wildlife perimeter fence will protect all planted and colonizing vegetation and allow for natural expansion.

- Remove all remaining browse protectors from within the newly fenced area. The landowner may be removing some of these protectors, but all remaining protectors should be removed.

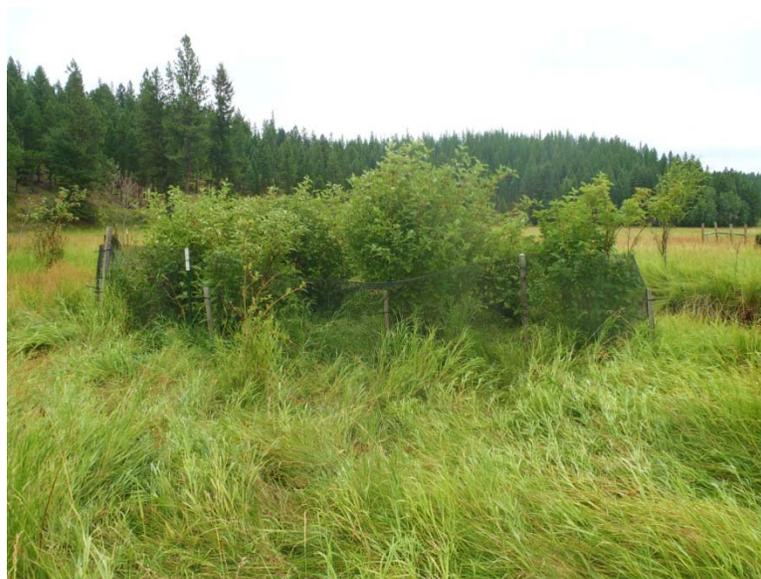
Figure 4. Residual dogwood shrubs within a small enclosure. Residual shrubs have responded so well to the browse protection that they outgrow individual and small enclosures within a growing season or two. The small enclosures allowed for the shrubs to maintain a more natural growth form since they are no longer restricted by individual browse protectors.

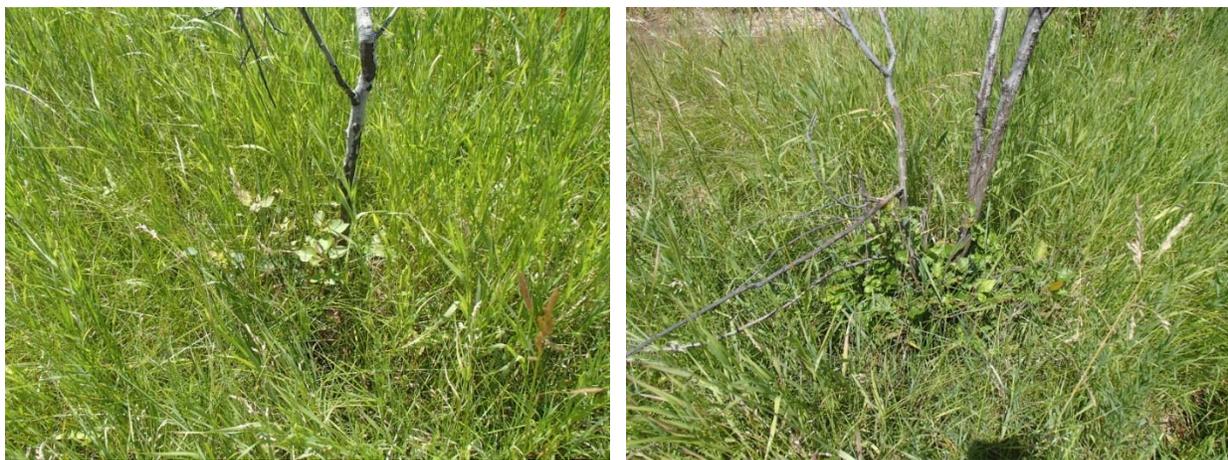
Figure 5. Planted shrubs in Phase 1 that were presumed dead but had new growth at the base in 2013.

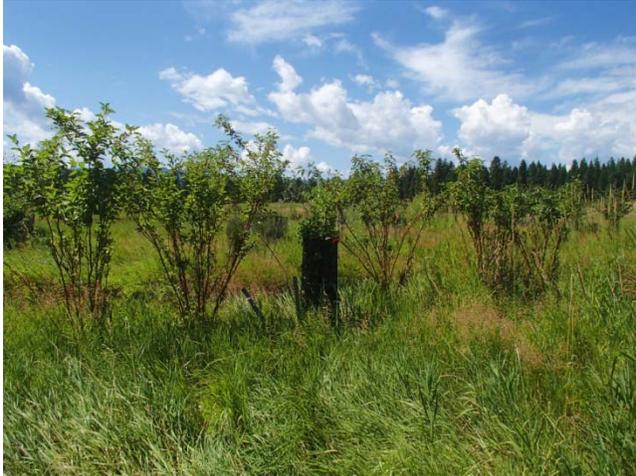
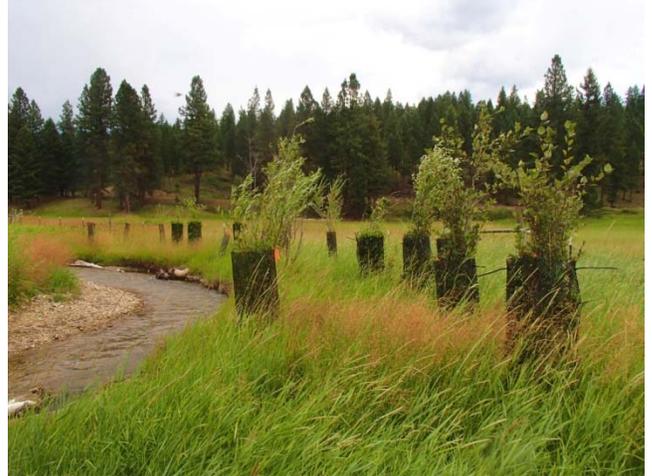
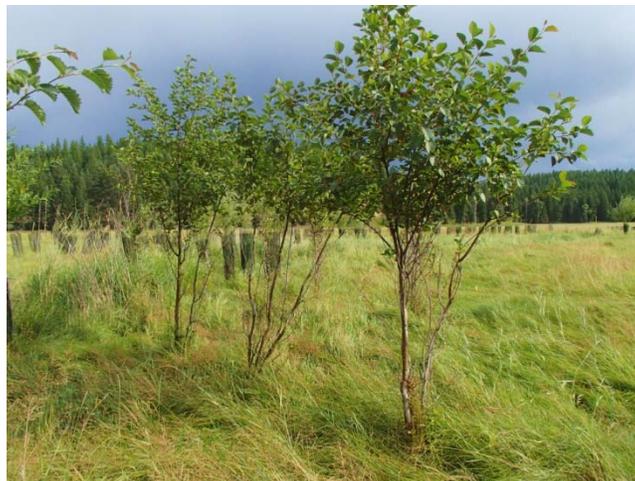
Figure 6. Shrub growth in Phase I planting area. Note the difference in growth form once the browse protectors are removed.

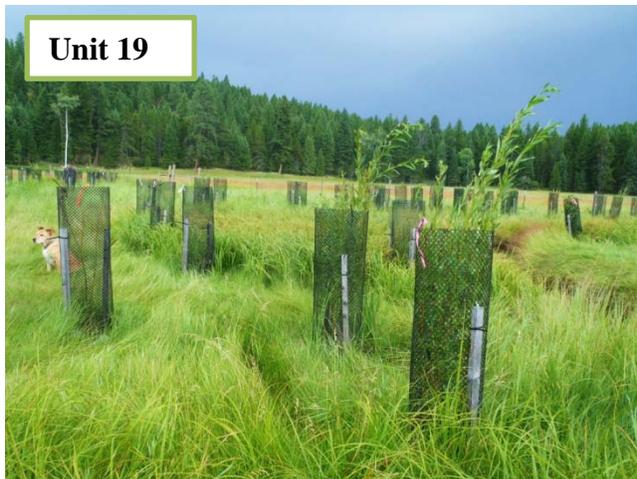
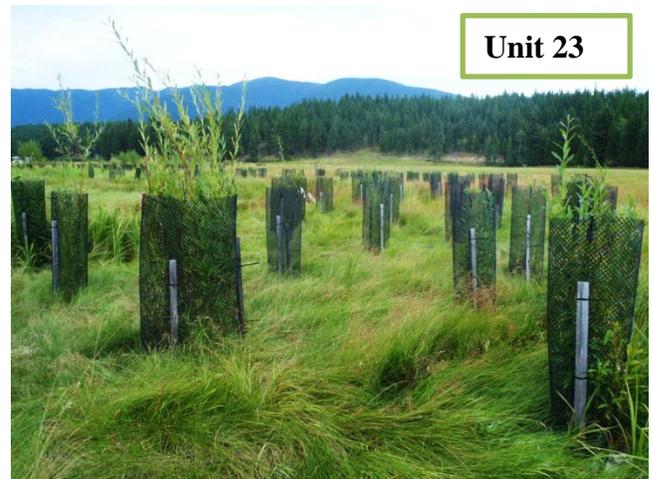
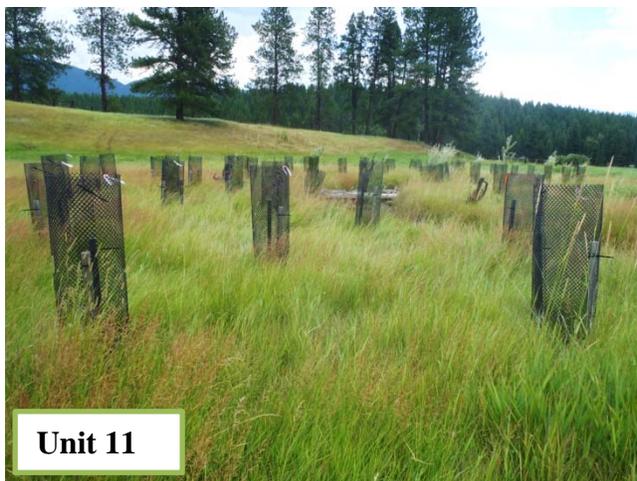
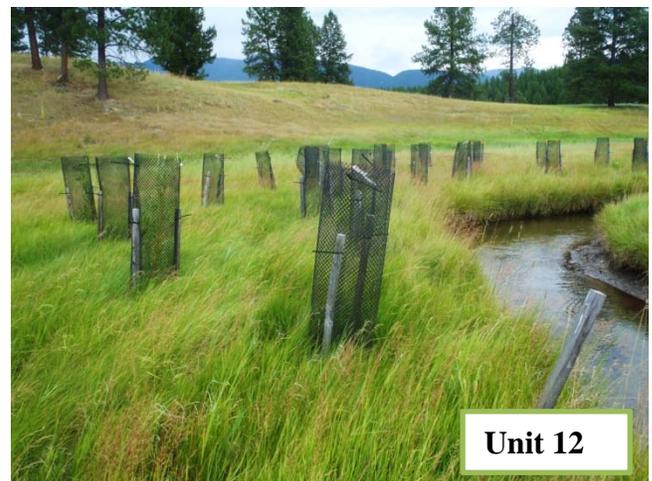
Figure 7. Shrubs in Phase III Planting Units 19 and 23 (top) compared with Units 11 and 12 (bottom). Units 19 and 23 are located upstream of Units 11 and 12.

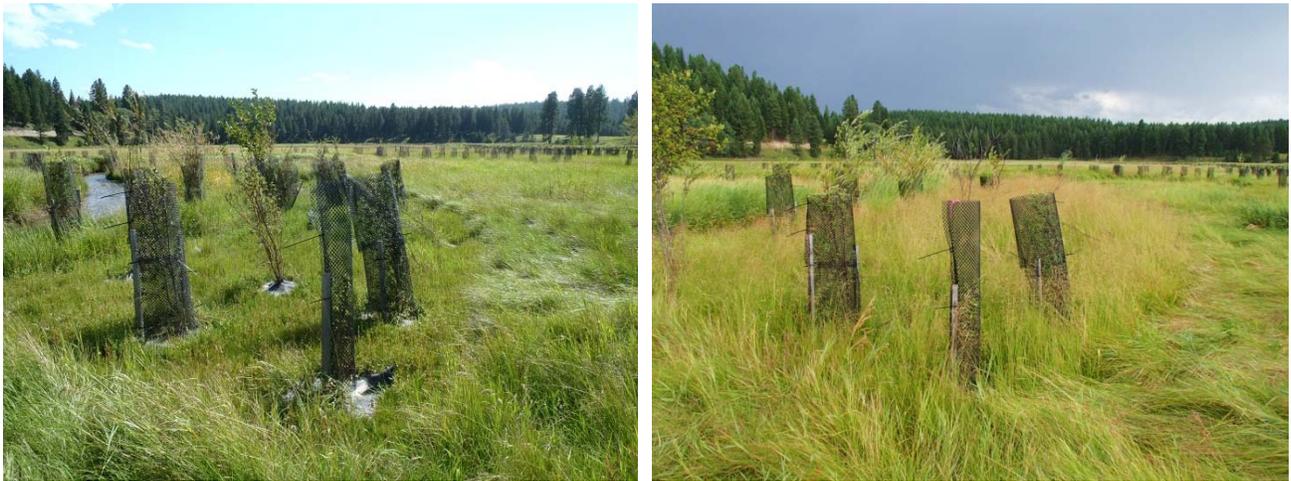
Figure 9. Planted solarization plot 1 in August 2012 (A) and August 2013 (B). Herbaceous species colonization is dominated by seeded species.

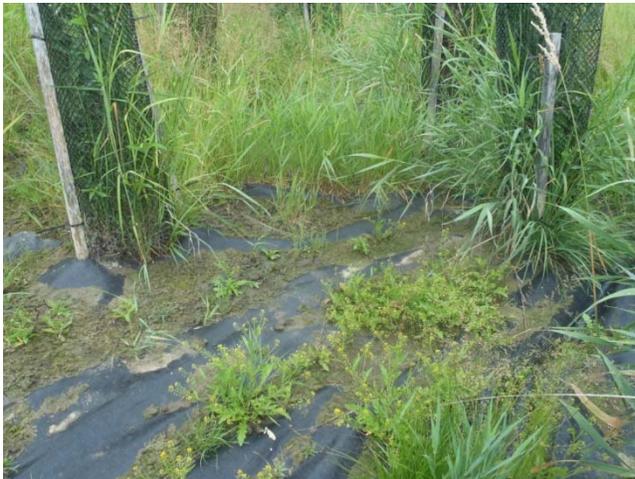
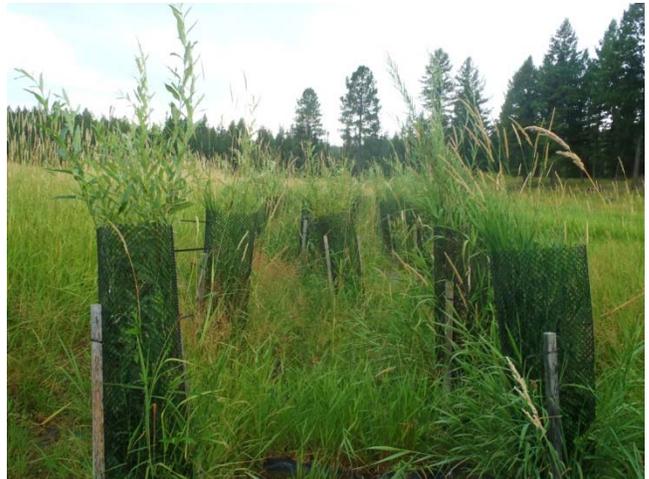
The planted solarization plot in Phase III (Unit 15) was installed in fall 2010 and has been in place for nearly three growing seasons. The reed canarygrass under the fabric has been killed. However, in spring 2012, fine sediments deposited on top of the fabric providing substrate for new reed canarygrass plants to grow in. Similar to much of the lower project area, this planting unit is surrounded by reed canarygrass and it will be difficult to eliminate this undesirable grass in this area. Figure 12 shows examples of the conditions in Planted Solarization Unit 15. The plants installed within this unit are thriving despite the patchy recolonization of reed canarygrass and are taller than most of the Phase III plants.

Figure 12. Phase III planted solarization plot showing colonization of undesirable species on top of the fabric and the recolonization of reed canarygrass. The fabric has however provided an advantage for shrub growth. The shrubs in this unit are some of the tallest in Phase III.

- Install 10-foot tall riparian protection fencing along existing fence line to protect establishing vegetation from continued browse and reduce annual maintenance costs.
- Continue to observe and monitor natural colonization in Phase I planted solarization plots.
- Remove reed canarygrass through use of herbicide or hand pulling from Phase 1 planted solarization plots.
- Continue to observe and monitor the Phase III planted solarization plot. If plants remain healthy and vigorous leave fabric in place until shrubs are well established.

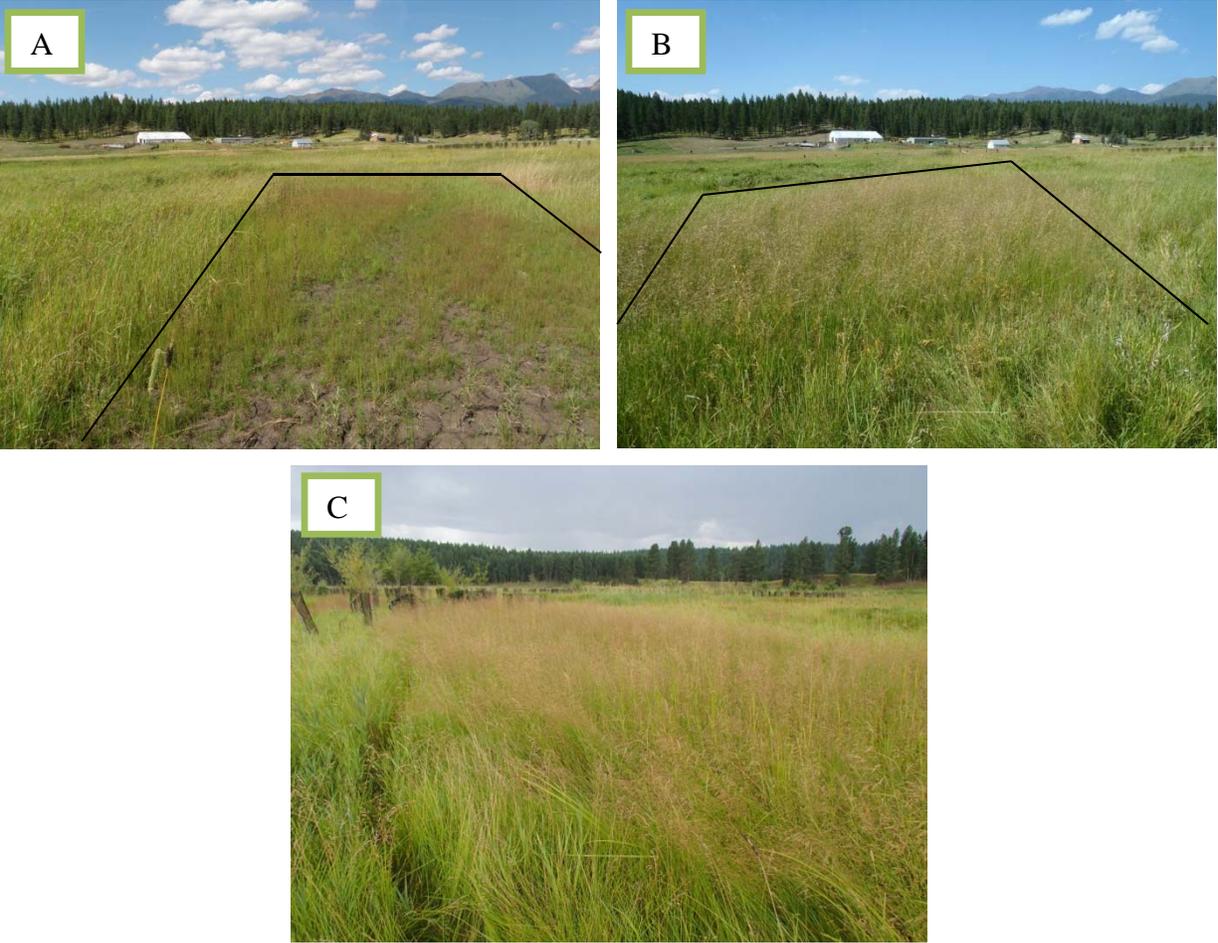
In Temporary Solarization Plot 1, the bare mineral soil has been colonized by a range of species (Figure 13). The plot is dominated by reedtop. Other species observed in plot 1 include both native species (sedges, sandbar willow, field mint, violet, common willowherb, and knotweed) and invasive species (reed canarygrass and Canada thistle).

Figure 13. Photograph of Temporary Solarization Plot 1 in July 2011 (A) and in August 2012 (B). Black lines in the figure represent the approximate extents of where the solarization fabric covered the plot. Photo C taken in 2013 (from the opposite direction) shows the dense cover of grasses dominating the plot.

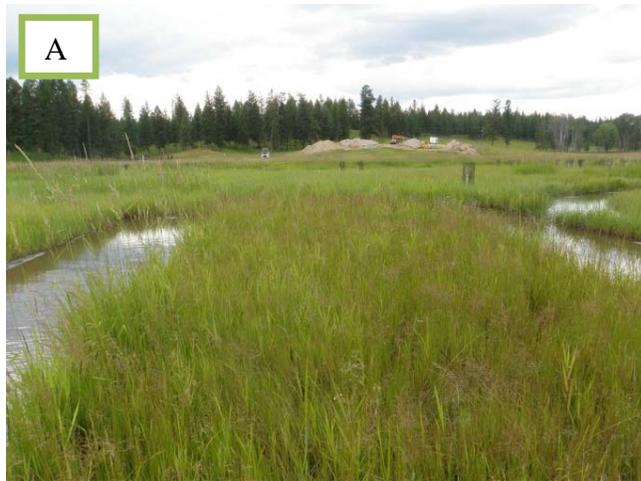
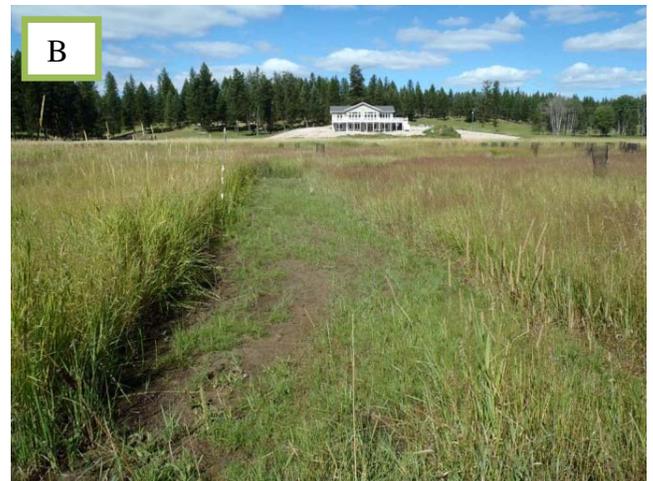
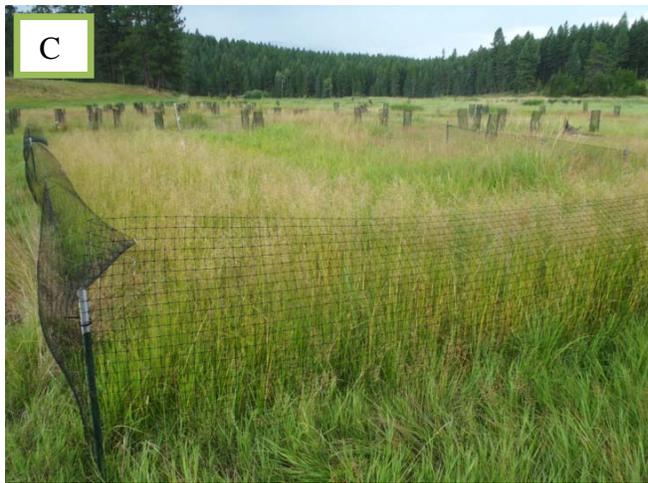
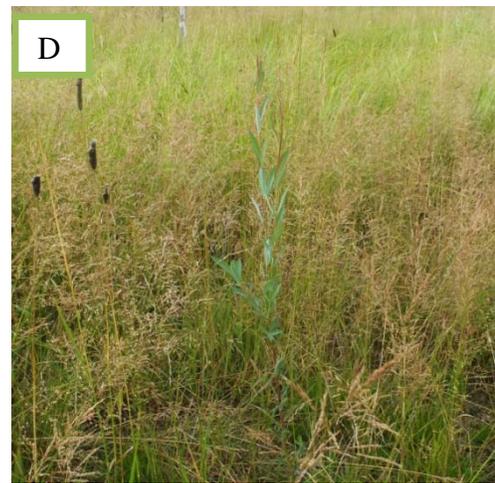
Figure 14. Photograph of Temporary Solarization Plot 3 in 2011 (A) and in 2012 (B). In photo A the area between the standing water is the original plot location that was exposed and seeded in fall 2009. The areas of standing water have fabric under the water that was placed around the original plot. This fabric was removed in fall 2011 and the exposed soil area is shown in photo B. Photo C taken in 2013 (from the opposite direction) and shows the browse enclosure and the fully vegetated plot. Photo D shows the growth of willow cuttings that were planted in fall 2012.

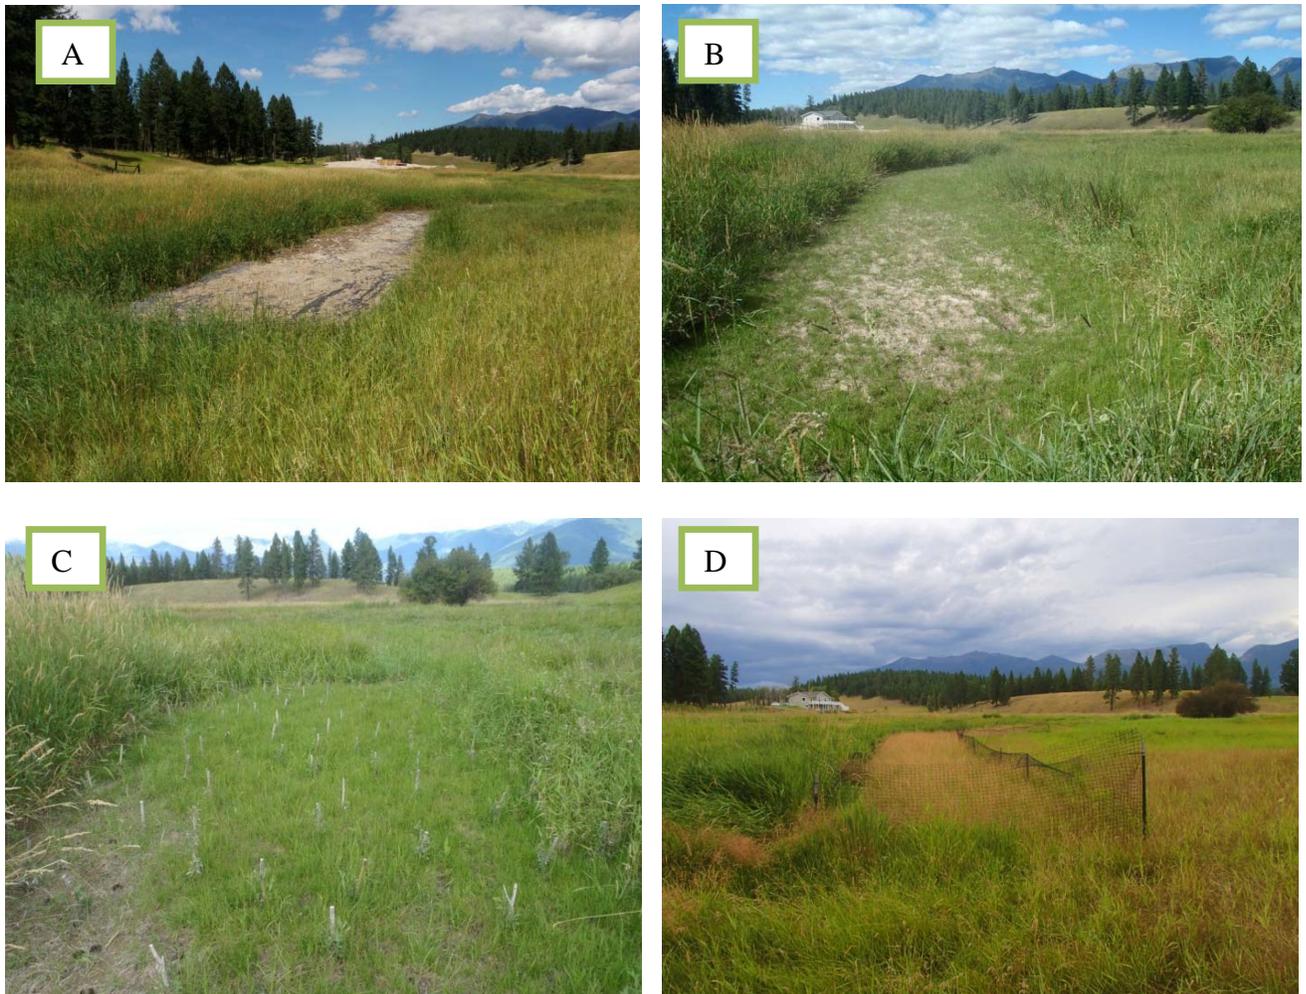
Figure 15. Photograph of Temporary Solarization Plot 2 prior to fabric removal and seeding in fall 2011 (A), in August 2012 one year after fabric removal (B), after willow cutting were planted in fall 2011(C), and showing grass cover observed in 2013 (D).

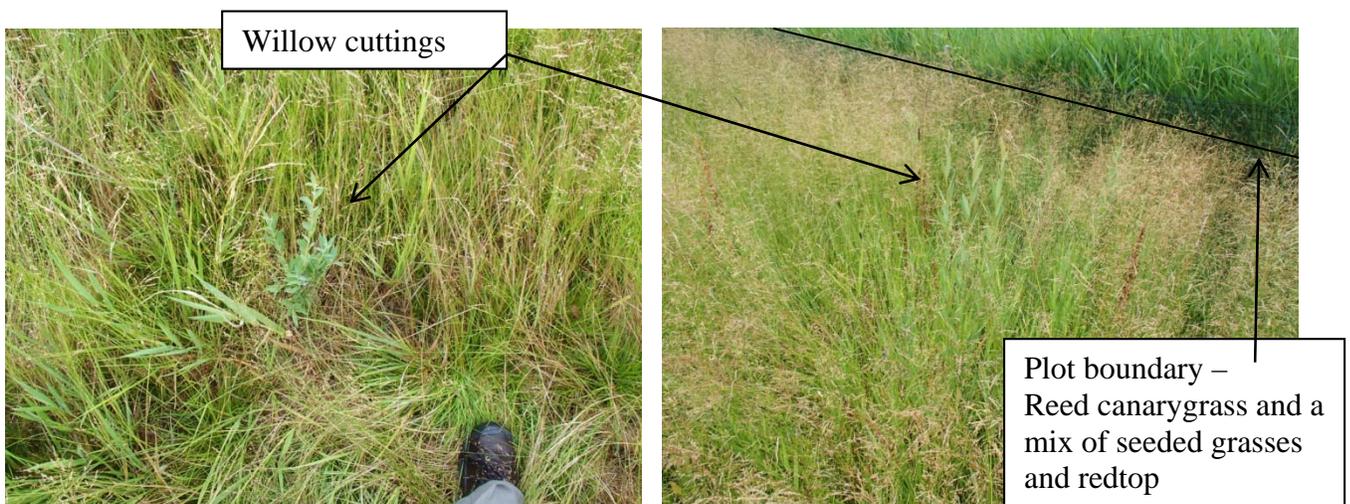
Figure 16. Willow cuttings installed in 2011 in Temporary Solarization Plot 2 have grown under the cover of seeded grasses and with the protection of the exclosure fencing. The photo on the right shows a clear line between the reed canarygrass and the grasses within the solarization plot.

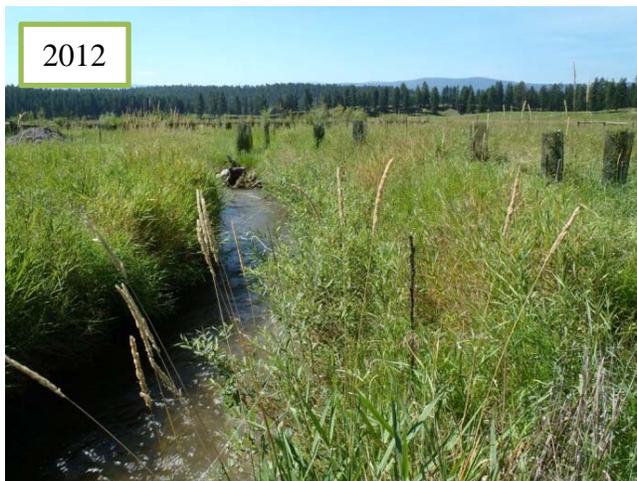
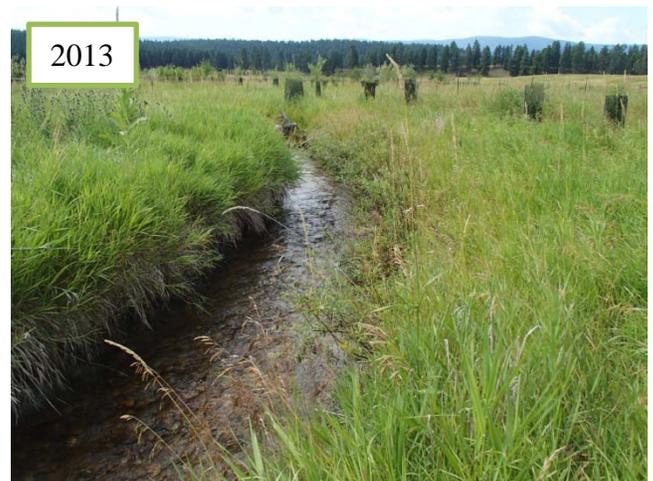
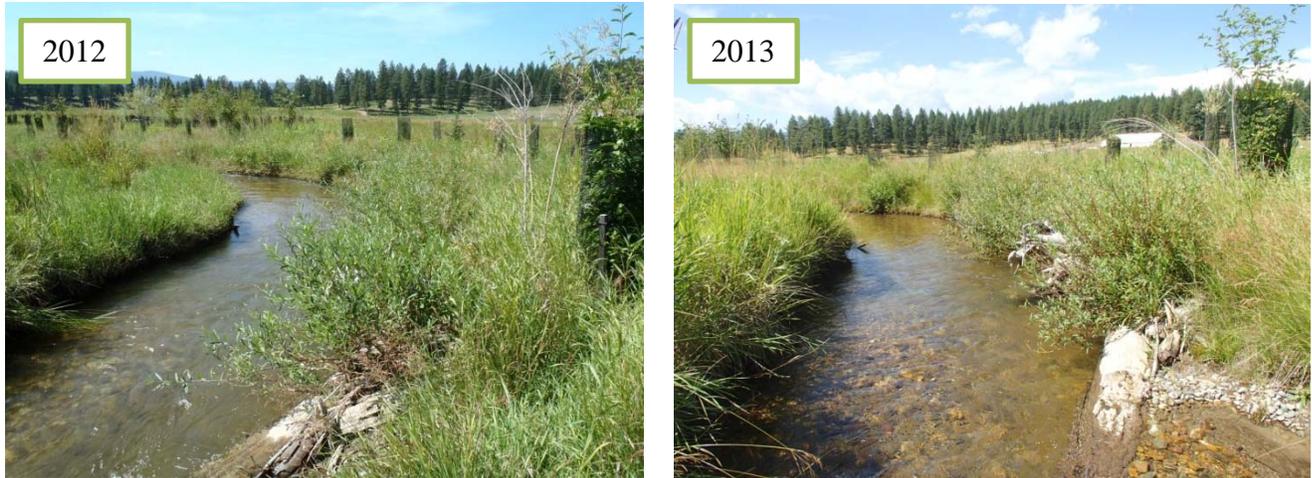
Figure 17. Photograph of vegetated soil lift 1 (top) and vegetated soil lift 2 (bottom) in 2012 and 2013 showing dense but browsed bands of willows.

- Install 10-foot tall riparian protection fencing along existing fence line to protect establishing vegetation from continued browse and reduce annual maintenance costs.
- Observe the response of these treatments to installation of riparian protection fence.
- No additional maintenance or monitoring of these structures is anticipated.

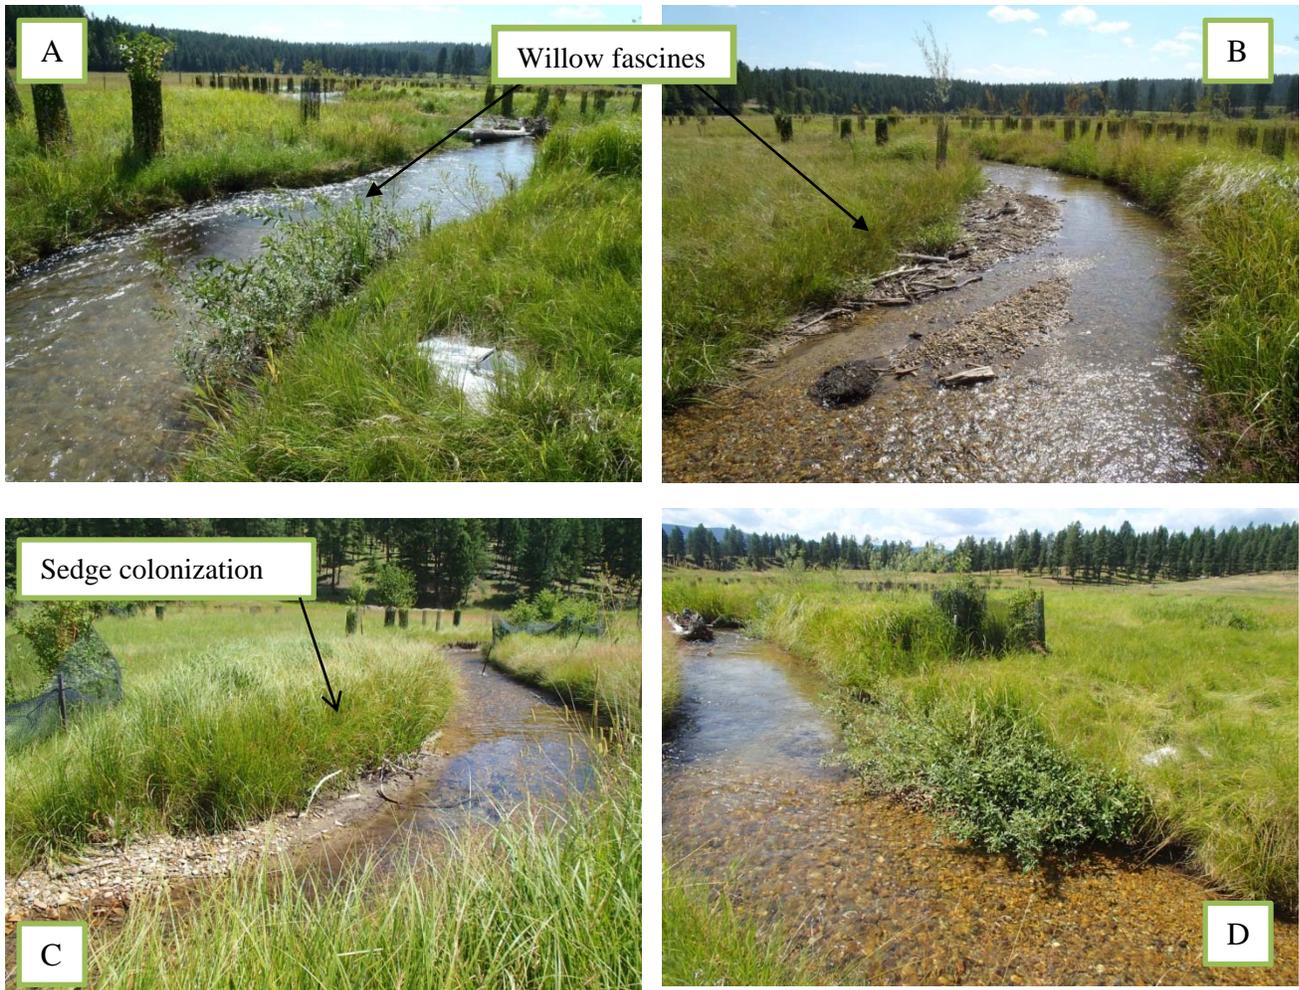
Figure 18. Photographs showing various conditions of willow fascines in 2012 (A and B) compared with 2013 (C and D).

- Install 10-foot tall riparian protection fencing along existing fence line to protect establishing vegetation from continued browse.
- Observe the response of these treatments to installation of riparian protection fence.
- No additional maintenance or monitoring of these structures is anticipated.

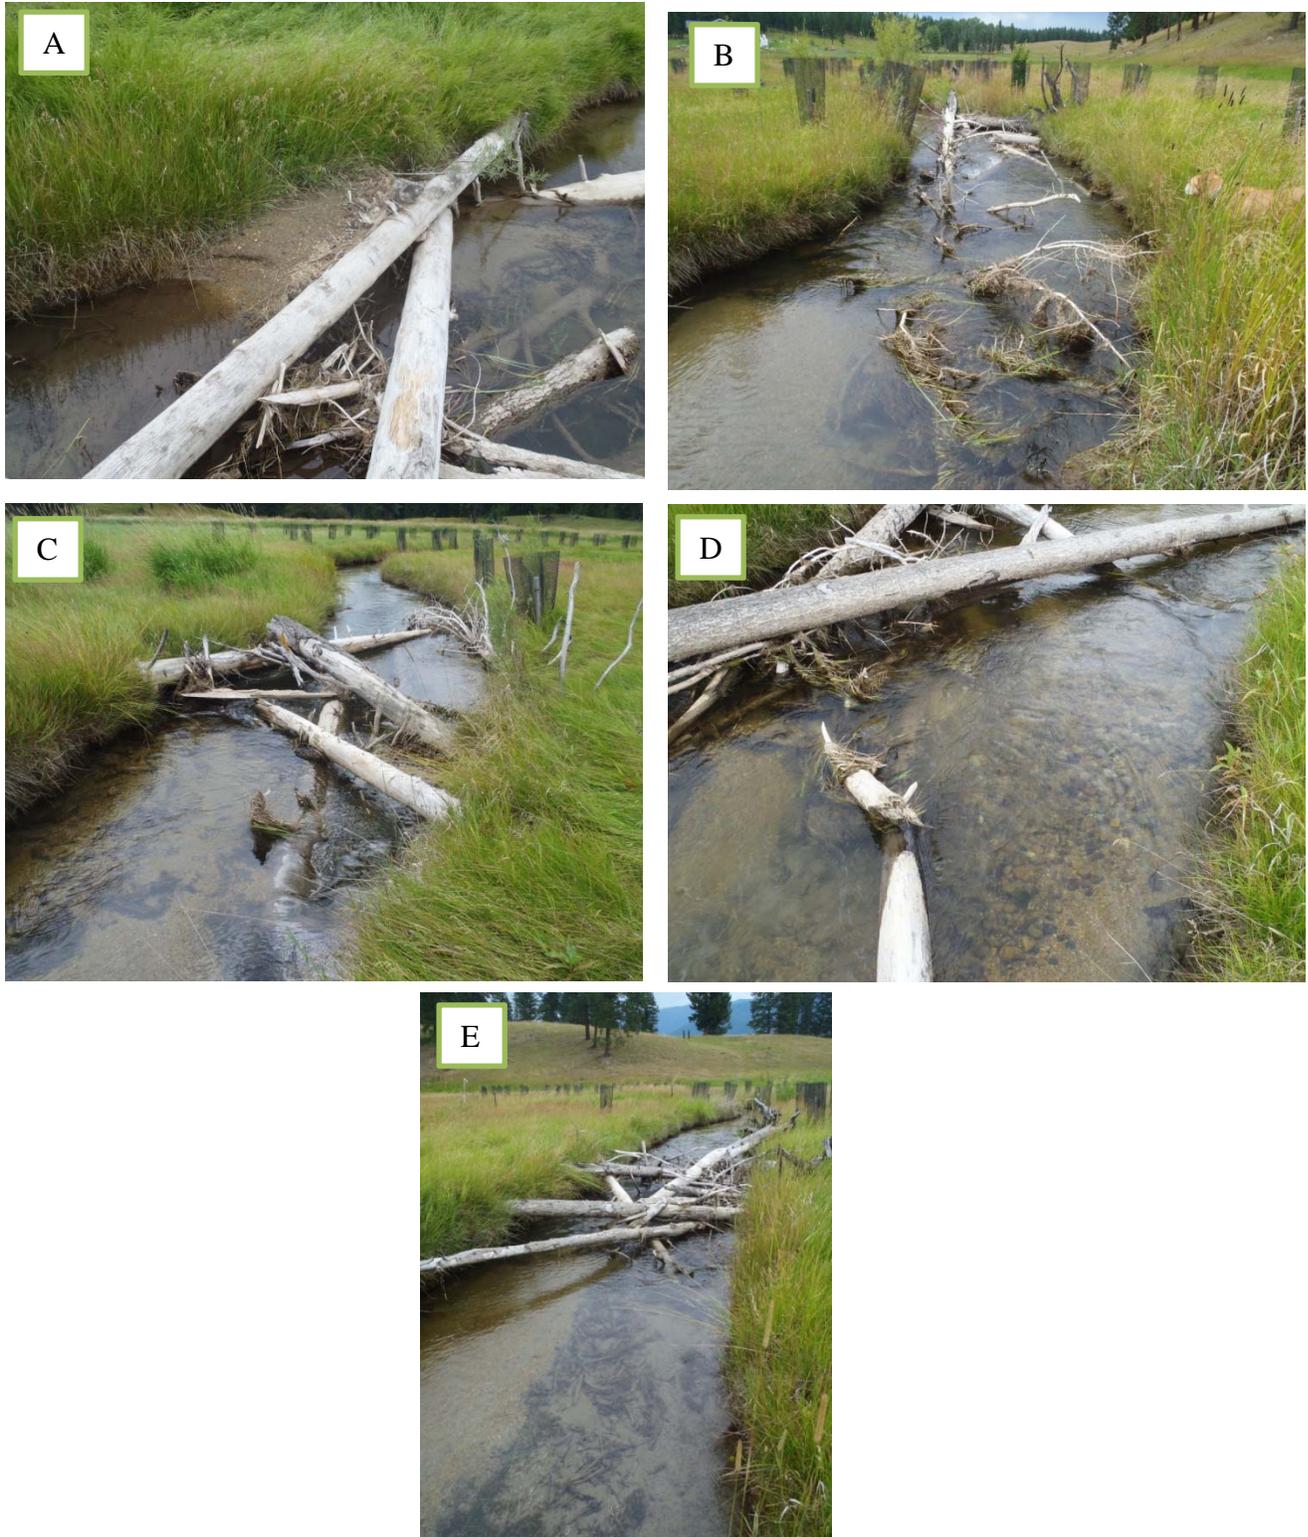
Figure 19. Large woody debris jams 1 through 5 (A through E). The various sediment, gravel and organic debris deposition patterns, both within the channel and along channel margins, can be seen in some of the photos. Smaller debris continues to accumulate on top of the structures.

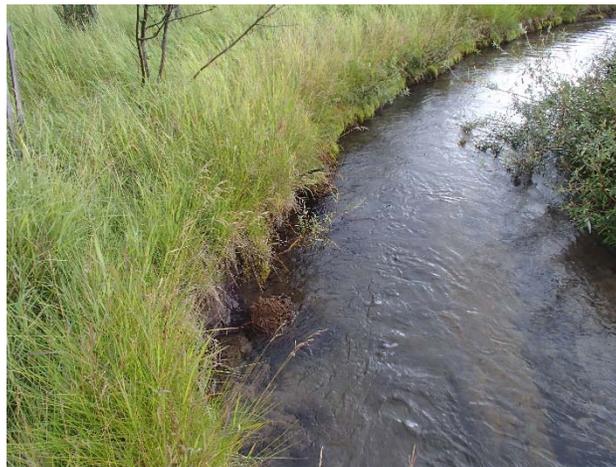
Figure 20. Coir log site where scour occurred at the upstream end of the structure during 2012 high flows. Bank erosion resulted in a vertical bank upstream of the coir log but the vegetated under-cut bank was maintained where coir logs were left intact.

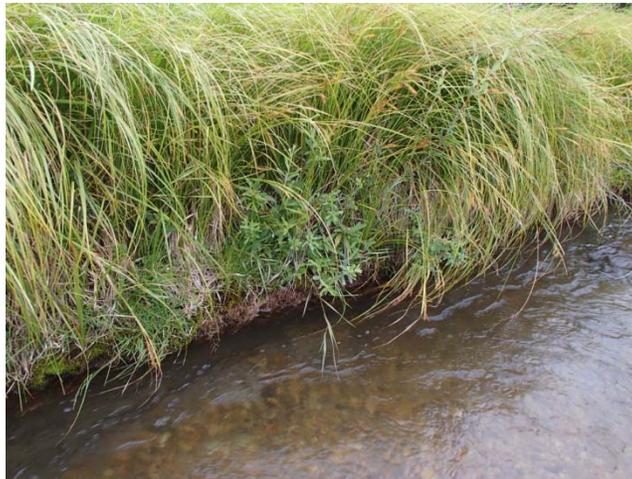
Figure 22. Coir Log 1 showing willow cover, dense growth of sedges on bank above and undercutting beneath log. Most willows showed some signs of browse.

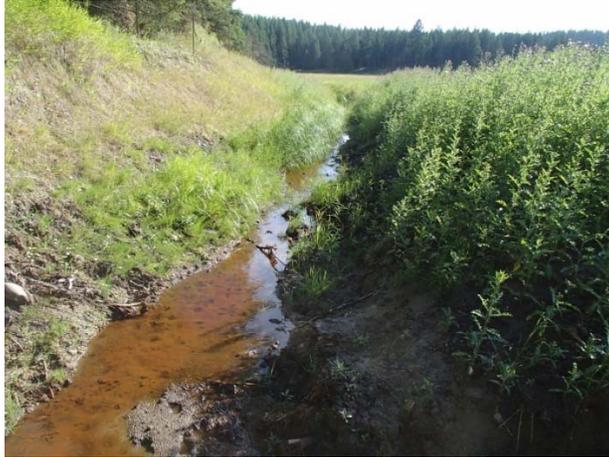
Figure 23. Canada thistle infestation along newly constructed drainage ditch.

- Complete weed control in August 2013 based on specific observations made at the site and using the detailed weed mapping completed in 2012.
- Continue to conduct annual weed control targeting Canada thistle and other noxious weeds. Canada thistle has been effectively controlled within the project area, but large, dense infestations in the adjacent hayfield continue to be a threat to re-infestation of the project area. Project partners should strongly encourage the landowner to implement weed control activities in areas adjacent to the project.
- Continue to treat isolated patches of reed canarygrass in the project area. Reed canarygrass cannot be eradicated from the site but selective control has prevented spread in the floodplain at the upstream end of the project area.

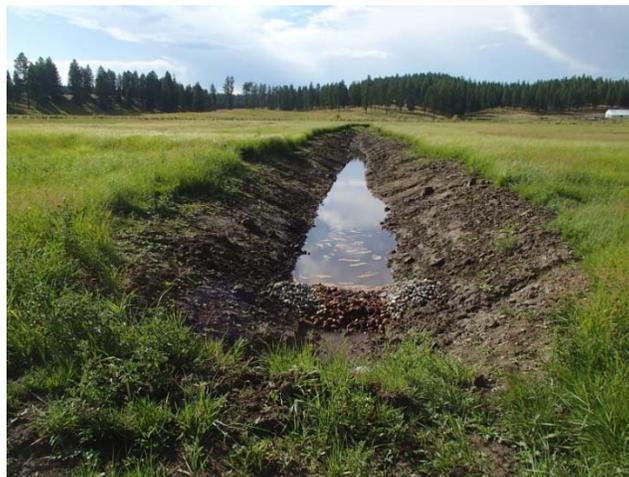
In spring 2013, a drainage ditch was constructed in the hayfield east of the project area (Figure 26). In August 2013, general observations of the effects of this ditch on wetlands in the project area were made. Based on observations made at the site over the last seven years portions of the hay field that have transitioned from predominantly pasture grasses (smooth brome, quackgrass) to wetter graminoids such as sedges and rushes due to reconnection of Therriault Creek with the historic floodplain. This same transition has occurred in much of the project area. This increase in wetland area and wetland species as a result of restored floodplain hydrology was the intent of the project and is necessary to achieve project goals and objectives and enhance ecological function of the site. The newly constructed drainage ditch appears to be effectively draining the hayfield and wetland that has developed (or re-developed) there. If the ditch remains in place, the wetland area will begin to transition to drier species over time. Although this wetland is not in the project area it is part of the Therriault Creek floodplain and therefore connected to the project area. This wetland is supporting a variety of desirable ecological functions that are helping achieve project goals and objectives including: ground water storage and recharge, amphibian and bird habitat, flood and erosion control, and filtering and storage of nutrients and sediments. Based on these observations, a recommendation was made to project partners that the ditch be filled and the area allowed to function as an emergent wetland component of the restored Therriault Creek floodplain. The landowner plans to install a headgate at the ditch outlet so that the drain will only be open the two weeks immediately prior to haying.

Figure 26. Drainage ditch constructed in spring 2013 in the hayfield adjacent to the project area.
