TERRIAULT CREEK RESTORATION PROJECT

FIVE-YEAR VEGETATION MANAGEMENT PLAN

JANUARY 2019

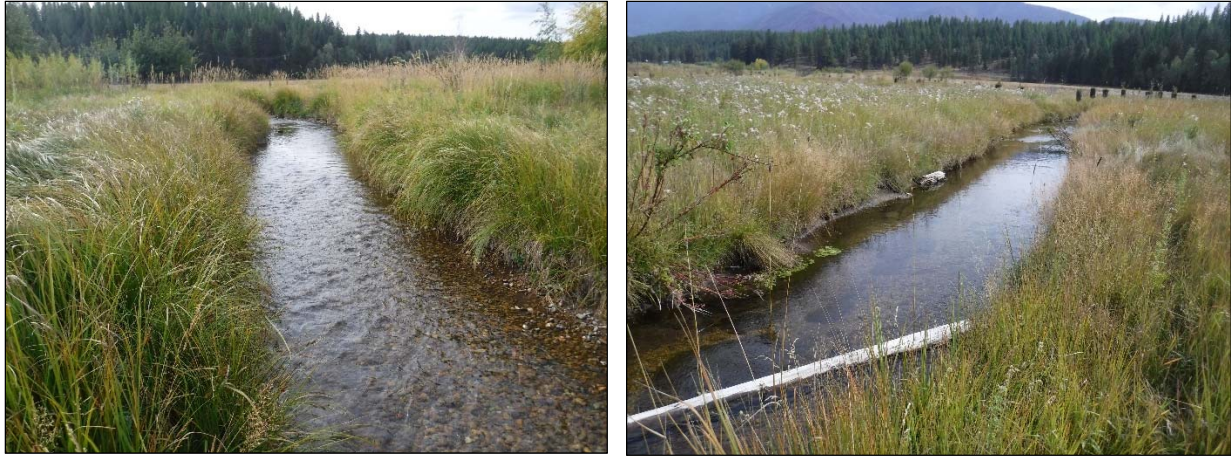
Figure 1. Uniform riffle with good floodplain connection resulting in dense sedges (left photo) compared with uniform riffle with less connection and domination by pasture grasses (right photo).

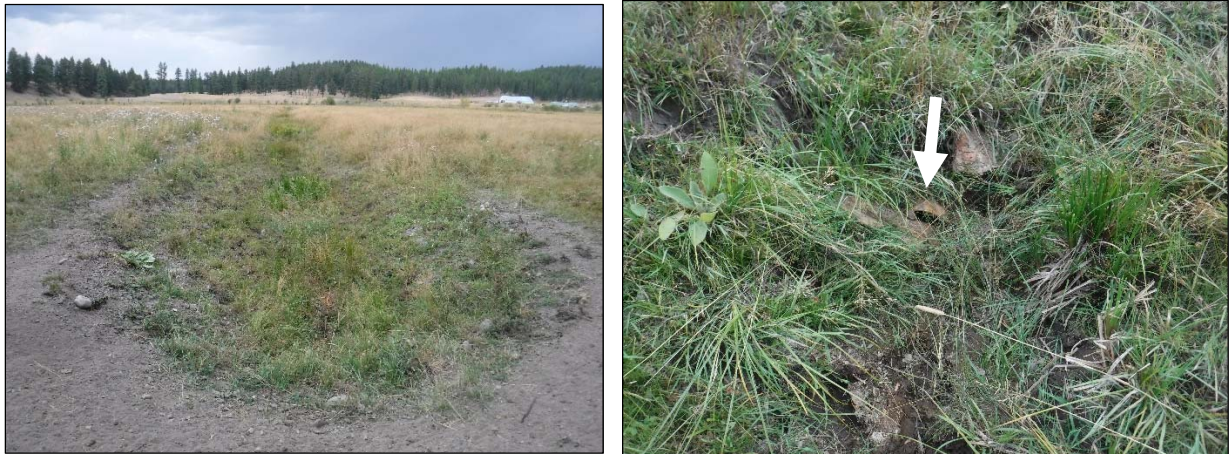
ducks, great blue herons, songbirds and muskrats. Also notable in 2013 was the construction of a drainage ditch in the hayfield adjacent to the Site that is converting this area to drier conditions.

Figure 2. Drainage ditch constructed in 2013 in hayfield east of Site showing heavy use by cattle (left photo). Culvert at end of ditch with no outlet gate but plugged with sediment (right photo).

Based on the results of 2014 monitoring, the 2014 report recommended that weed control and fence maintenance continue at the site. Recommendations also included no longer collecting effectiveness monitoring data for revegetation treatments and documented how the site was on a trajectory towards meeting revegetation objectives in many areas. The 2014 report recommended landowner outreach to ensure that weed infestations were controlled and the drainage ditch be filled in or a headgate installed to only allow drainage for a short period of time.

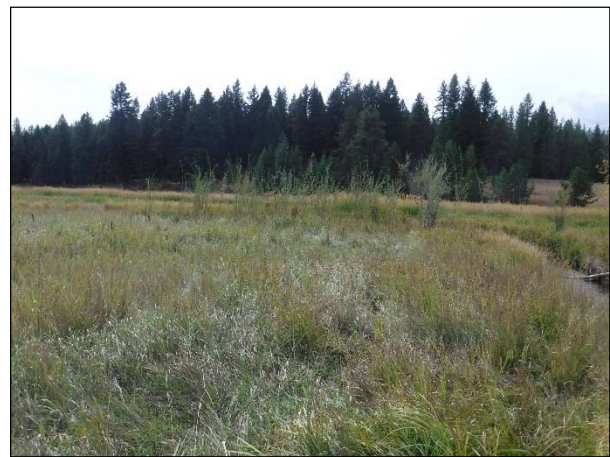
Figure 5. Left photo shows dense sandbar willow cover on well-connected inside meander bend near upstream end of Site. Right photo shows sandbar willow expansion from residual protected shrubs just downstream of where the channel turns northwest and leaves the riparian protection fence. This is one of the few downstream areas where willows have expanded naturally.

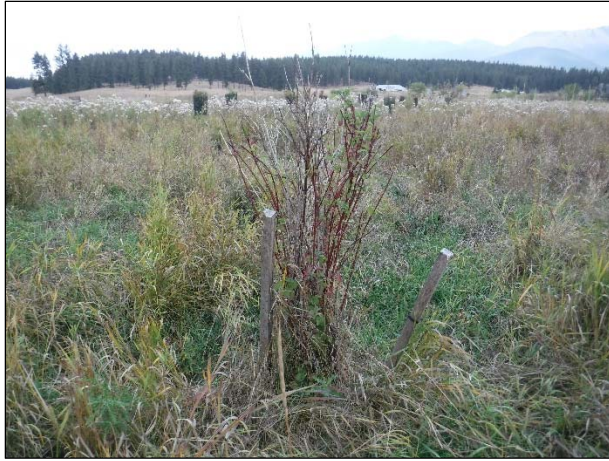
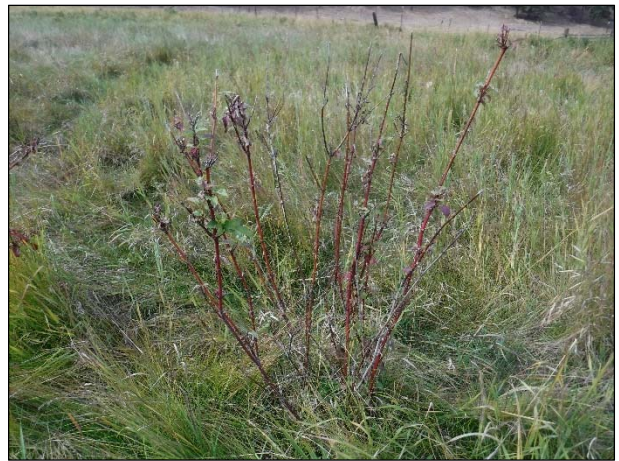
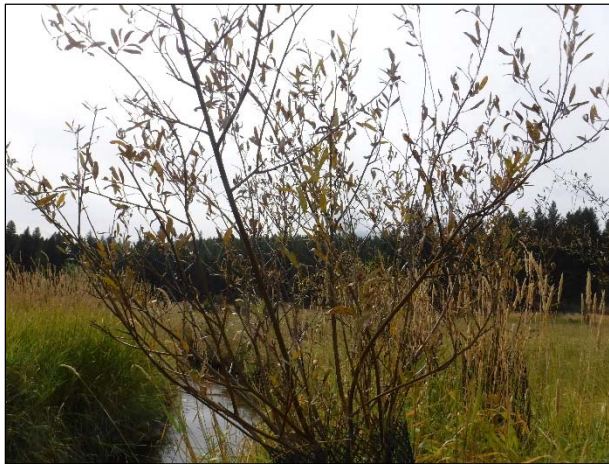
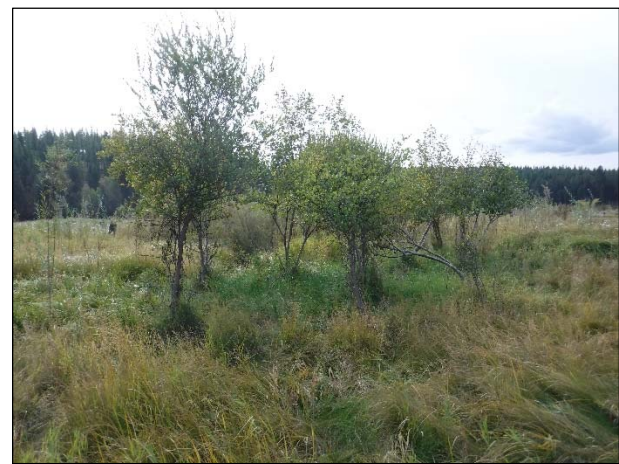
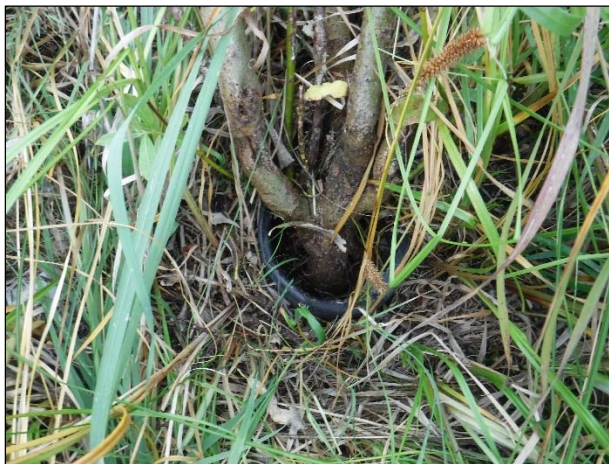
Figure 6. Surviving shrubs showing signs of stressed conditions resulting in poor vigor. Top photos show heavy browse on dogwoods and death of younger stems possibly from competing for resources with dense grasses. Middle left photo shows rust fungus on a willow, a common occurrence on willows throughout the Site. Middle right photo shows mature shrubs with altered growth forms from initial browse protection measures and then continued browse of lower stems. Bottom photo shows stem damage and rotting from vole protector.

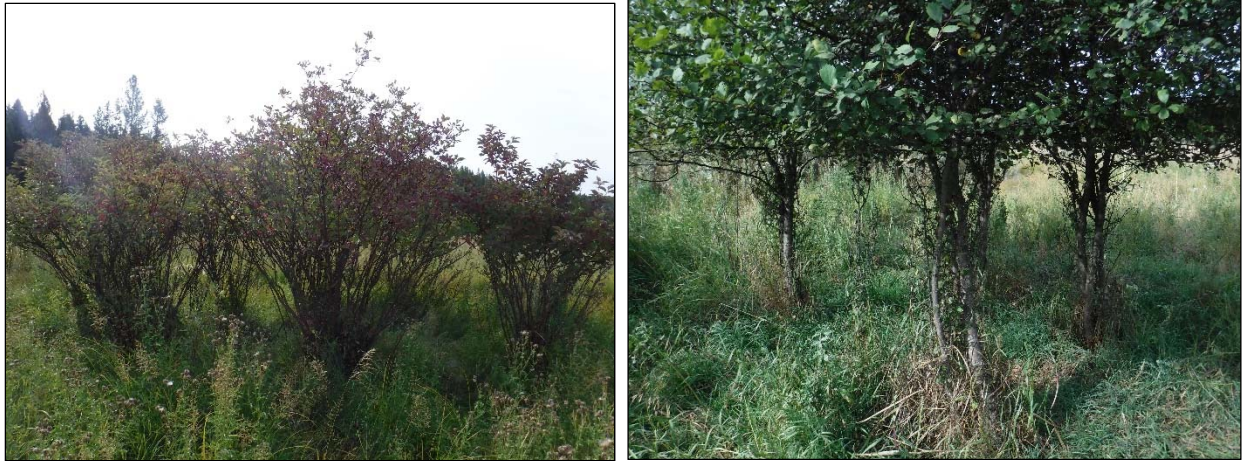
Figure 7. Dogwoods and hawthorns planted in 2007 that still exhibit altered growth forms from browse protection. The lower branches of these shrubs continue to be heavily browsed.

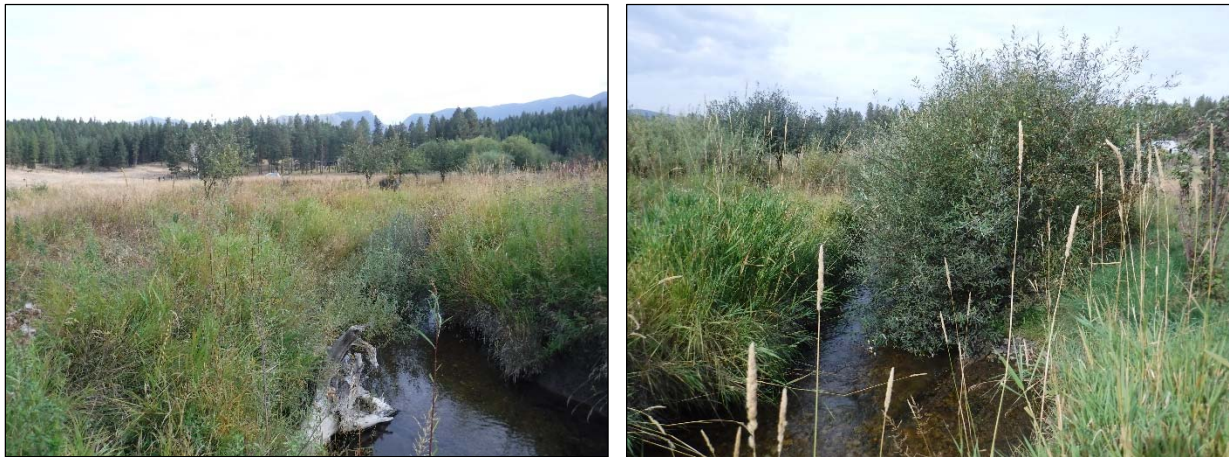
Figure 8. Willow height on soil lift 1 located outside of riparian protection fence (left photo) and willow height on soil lift 2 located inside of riparian protection fence (right photo).

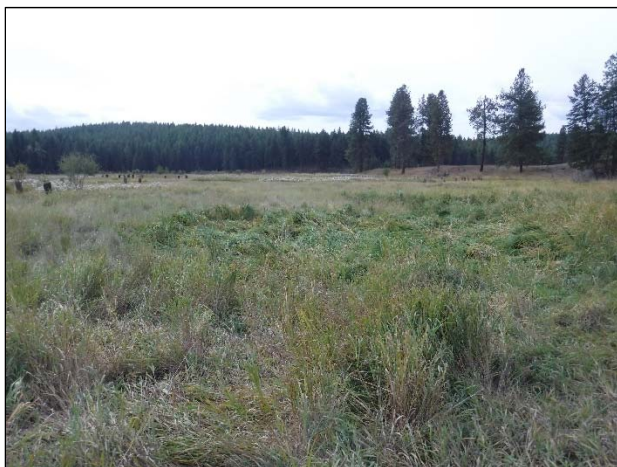
Figure 9. Large deer bed inside riparian protection fence at break between 2007 and 2010 work.

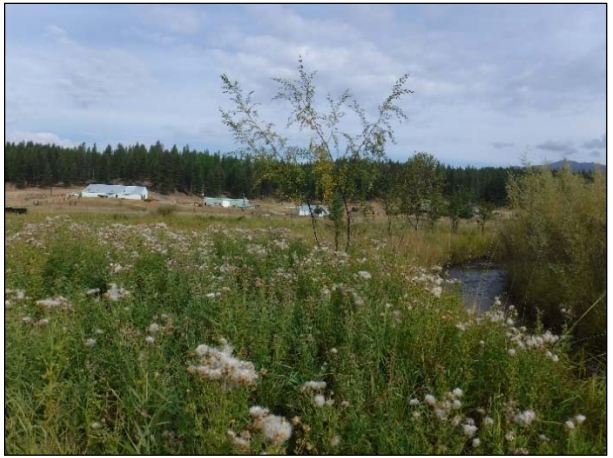
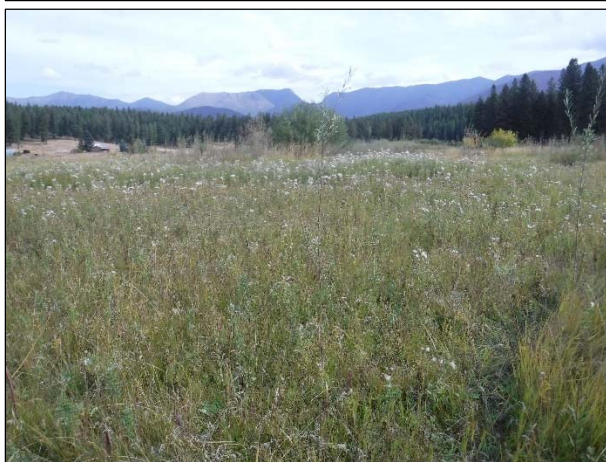
Figure 12. Canada thistle infestations in the upstream portion of Site.

Weed control is the highest priority vegetation management action for the Site. Weed control should be completed each year of the five-year management period. Due to the extensive infestations of Canada thistle at the site, treating weeds with herbicide is the only option to regain control. Some of the area can be treated with broadcast spraying but much of the area will need to be treated with handlines or backpacks to avoid damage to desired vegetation. Weed treatments should target all noxious weeds. To date the following noxious weeds have been identified at the Site: Canada thistle, sulfur cinquefoil, houndstongue, yellow toadflax, oxeye daisy, and perennial pepperweed. Only Canada thistle and yellow toadflax are widely distributed.

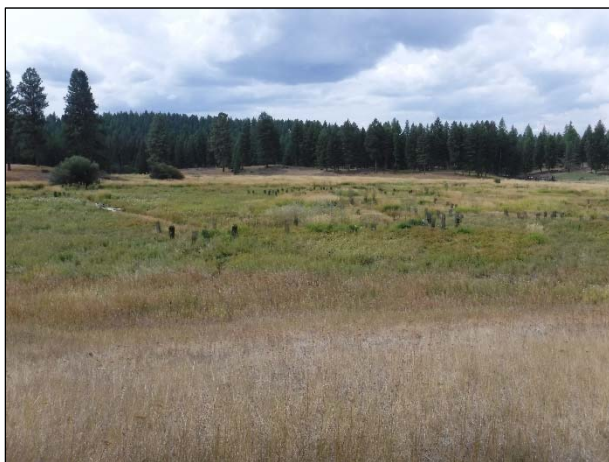
been very high. It appears to have spread to this area through old irrigation ditches and several old swales and channels in this area have allowed it to expand and dominate. In 2018, there were several new patches of reed canarygrass upstream of the large infestation (Figure 14). Reed canarygrass has always had much lower cover in the rest of the Site. It is primarily found on streambanks and in small patches away from the channel. Greater cover on both streambanks and areas further from the channel was observed in 2018 in response to the lack of herbicide treatment in 2016 and 2017. Attachment B provides a map of reed canarygrass distribution and density observed in 2018.

Figure 14. Expansion of reed canarygrass from large infestation at the downstream end of the Site. Reed canarygrass is the lighter yellow vegetation in the photograph.

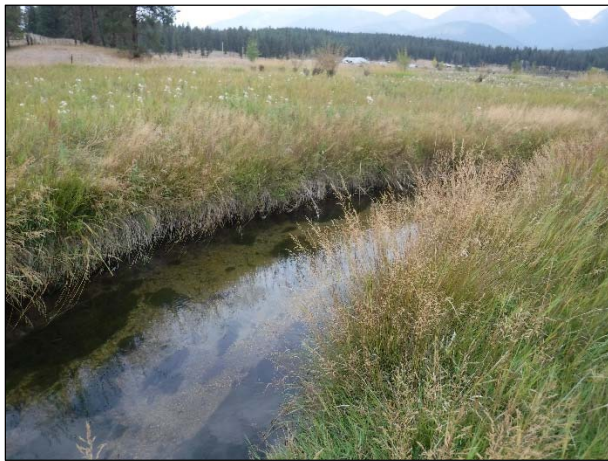
Table 2 summarizes the current status of vegetation objectives for the Therriault Creek Restoration Project. Overall, the site is characterized by a lack of natural flood disturbance necessary to create new surfaces and substrates for riparian shrubs to colonize, and to stimulate plants to sucker and expand. There are plenty of seed sources of desirable woody riparian species, but the conditions necessary for germination and establishment are lacking. Even the large magnitude flows that have occurred at the Site since 2007 resulted in little water outside of the active channel. This is further affected by a large irrigation diversion upstream of the Site which often reduces the peak flows that enter the project reach. The two floods that occurred in 2011 and 2012 activated the few low inside meander bends in the project area, allowing extensive expansion of riparian shrubs, particularly sandbar willow. Gravel deposition occurred on the floodplain in 2011 and was colonized by red-osier dogwood and some willows. The area quickly became infested with reed canarygrass and woody seedlings were suppressed by browse. Some red-osier dogwood seedlings were still present in 2018; but all were suppressed by browsed (Figure 15). The scarcity of disturbance processes to create new habitats, combined with a predominance of aggressive graminoids and ungulate browse have created static conditions at the Site which greatly limit the potential for the Site to naturally convert to woody riparian vegetation (Figure 16).

Figure 16. Stagnant channel with static floodplain vegetation (dense pasture grasses) near middle of Site.

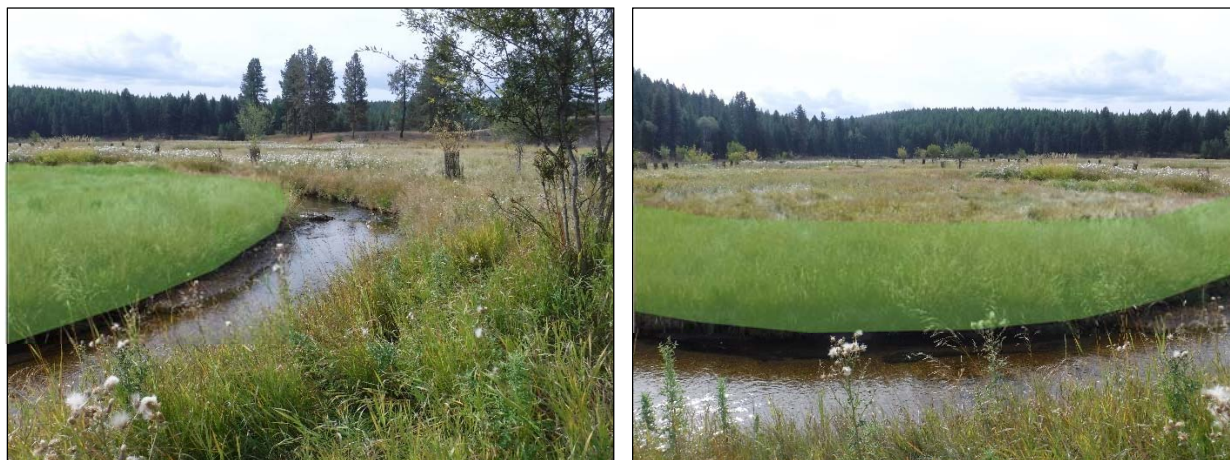
Figure 18. Example of an inside meander bend areas dominated by dense cover of introduced pasture grasses that could be lowered to increase floodplain connectivity and create a surface capable of supporting woody riparian shrubs. Areas highlighted in green are approximate extents of surface lowering.

Point bar expansion is a treatment that would increase the low elevation area along the channel. Point bar expansion involves lowering the existing ground on the inside of meander bends in select areas. These areas are almost all dominated by dense cover of aggressive grasses. No planting of riparian shrubs and trees has been done in these areas. The size of the lowered area can vary. Areas would be lowered between one and two feet and gently slope from the channel bed to existing ground. This treatment would remove the dense pasture grasses, exposing bare substrates and creating areas that can be colonized by woody riparian shrubs, primarily willows, alder, and dogwood. In addition, these areas would increase connectivity with the channel, allowing high flows to create natural disturbances necessary for riparian vegetation community initiation. These surfaces would also be closer to the late season water table supporting riparian shrub expansion. This treatment would attempt to mimic the conditions where sandbar willow expansion has occurred in the upstream portion of the Site. Willow fascines (bundles of 5-ft long ½-inch diameter willow cuttings) could be buried in the lowered surface to jump start woody vegetation establishment. Figure 18 shows examples of inside bends where point bar expansion would apply.

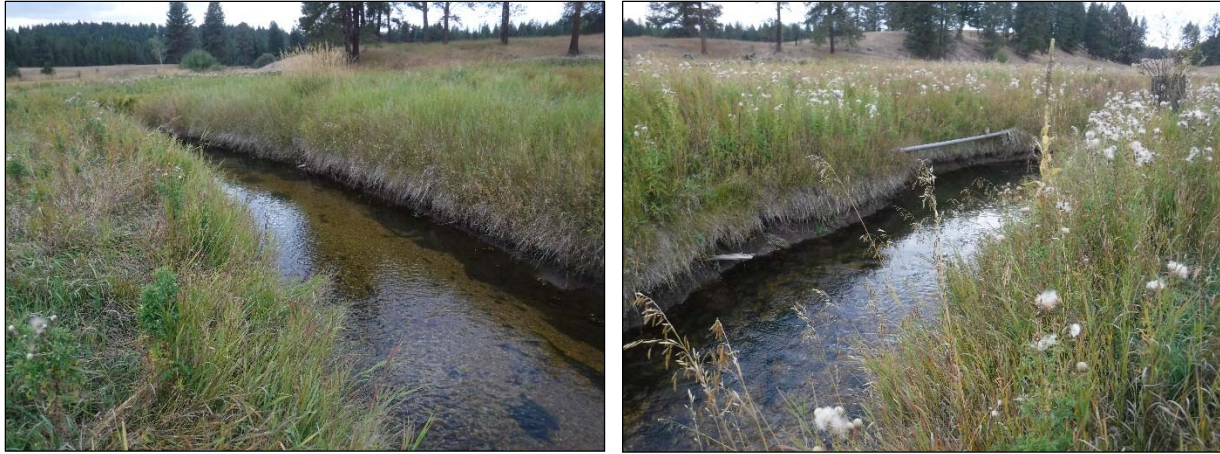
Figure 20. Example of streambanks where brush matrix streambank treatment would greatly increase aquatic habitat and vegetation conditions.

The vegetated soil lift, coir log, and willow fascines treatments have all worked well at the Site because they either replace aggressive grasses (vegetated soil lifts) or add willows below the dense sod mats (coir logs and willow fascines). The densest streambank woody vegetation cover occurs where these treatments were installed. For this reason, additional streambank treatments are proposed for the lower portion of the reach to establish more woody vegetation cover in this area. Streambank treatments should be located within the riparian protection fence so they are protected from browse. To increase aquatic habitat and mimic natural streambank conditions (in addition to increasing woody vegetation), a streambank treatment that incorporates woody brush material is proposed. This treatment will remove aggressive pasture grasses on the streambank and re-build the bank using a mix of brush, excavated materials and dormant willow cuttings. Figure 19 shows a photo of a constructed brush matrix streambank treatment. Figure 20 shows the types of streambanks that could be rebuilt using this treatment at the Site.

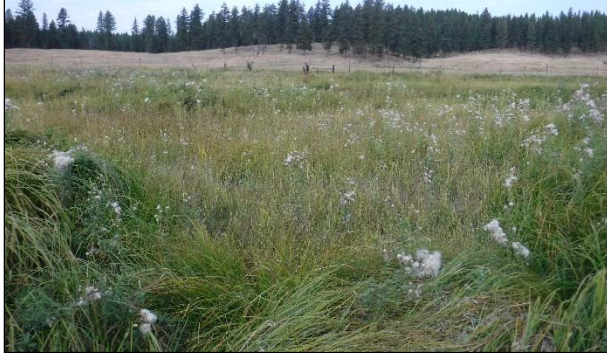
Plot 2 has been recolonized by reed canarygrass. No living willow cuttings were found.

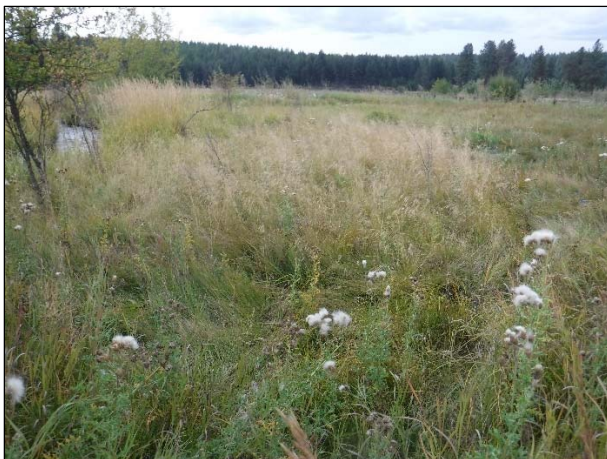
Planted Solarization Plot 1 is dominated by bluejoint reedgrass. There are very few surviving shrubs despite high survival and vigorous growth prior to fabric removal.

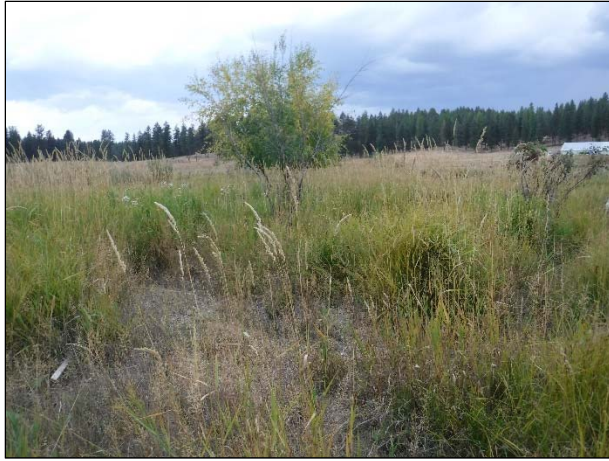
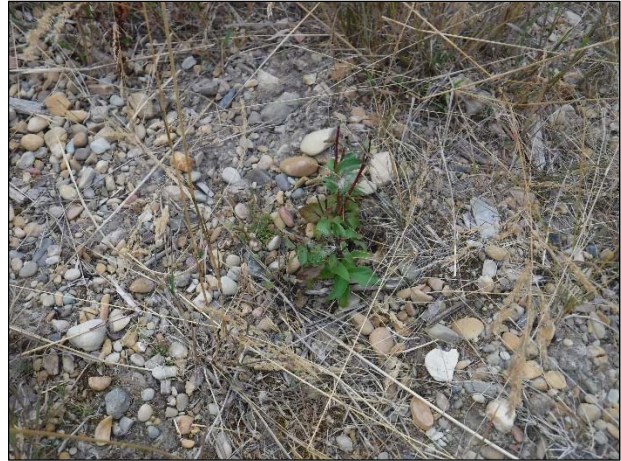
Planted Solarization Plot 2 is where the channel filled with gravels and flowed across the floodplain. The gravel plug was removed and the channel put back into its constructed alignment. This is the only location in the project where gravels have deposited on the floodplain surface. The gravel was colonized by numerous red-osier dogwood seedlings but few willows. These seedlings are still present but suppressed by browse. The gravels have been colonized by reed canarygrass and pasture grasses.
