GRAVE CREEK RIPARIAN REVEGETATION AND MONITORING PLAN

FEBRUARY, 2008

KOOTENAI RIVER NETWORK
P.O. BOX 491
LIBBY, MT 59923

GEUM ENVIRONMENTAL CONSULTING, INC.
307 STATE STREET, P.O. BOX 1956
HAMILTON, MT 59840

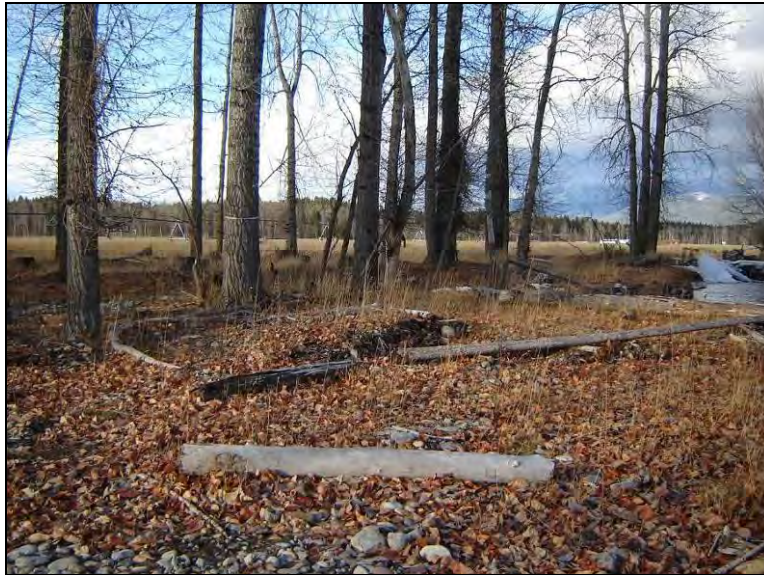
Figure 8. Black cottonwood plant community illustrating the dominance of even-aged cottonwoods and a lack of understory woody vegetation.

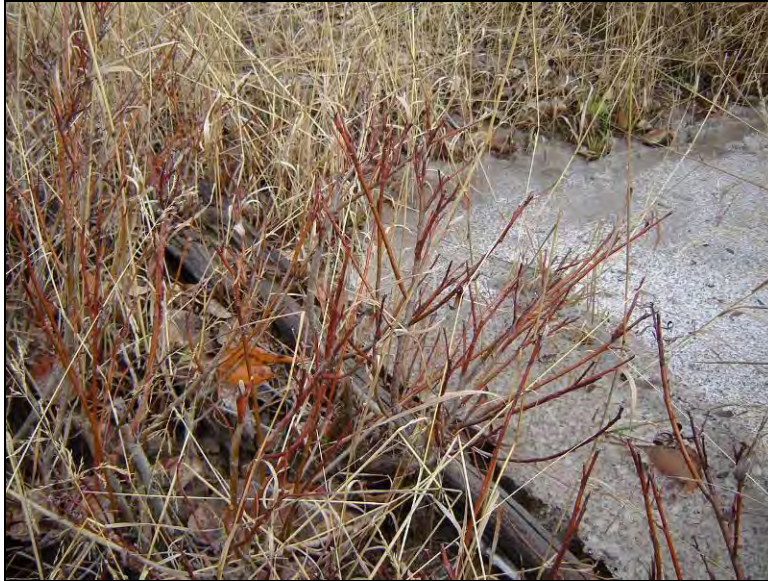
Figure 9. Suppressed willow growth due to browse showing arrested growth structure.

The level of browsing intensity at the site is intense, with intense defined as browse resulting in a complete annual stem segment being killed (Keigley and Frisina 1998). Most shrubs within the project reach exhibit an arrested-type architecture indicative of intense browsing. Herbivory is uniform throughout the project reach, with all individuals within the young age class exhibiting this arrested-type architecture. The existing stands of cottonwoods and willows are likely relic of an early period of light-to-moderate browsing and are often the parents of the short, heavily browsed plants.

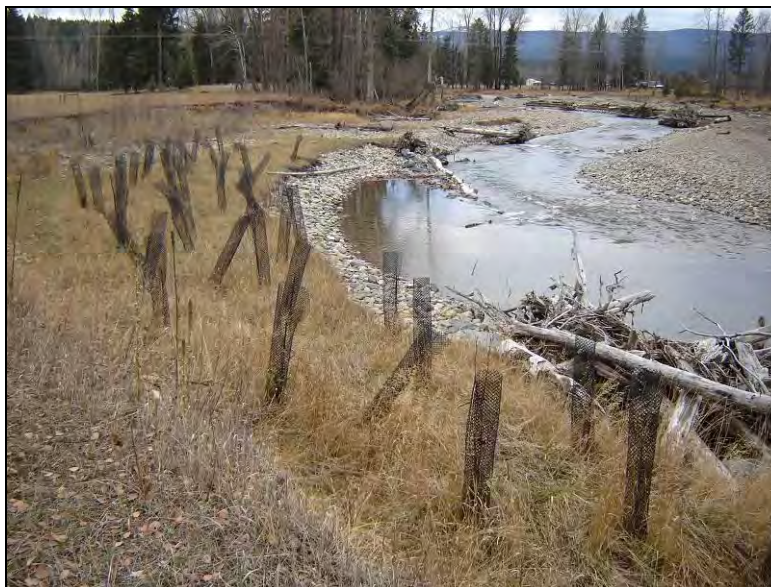
Figure 10. Photograph of existing conditions along the project reach, where banks lack mature riparian vegetation. Past land uses resulting in removal or riparian vegetation led to an increase in lateral bank erosion, often into secondary terraces (photo left). Channel reconstruction moved the channel away from these eroding terraces through the creation of bankfull benches. Some of these benches were planted with containerized shrubs in 2005.

Some portions of the project reach lack mature woody vegetation along the banks (Figure 10). This is primarily due to past land uses that resulted in the removal of riparian vegetation communities. This is also due to the short time since channel restoration was completed. Restoring the channel from braided to single thread resulted in large areas of newly constructed surfaces, which require a long period for desired, mature vegetation to develop.

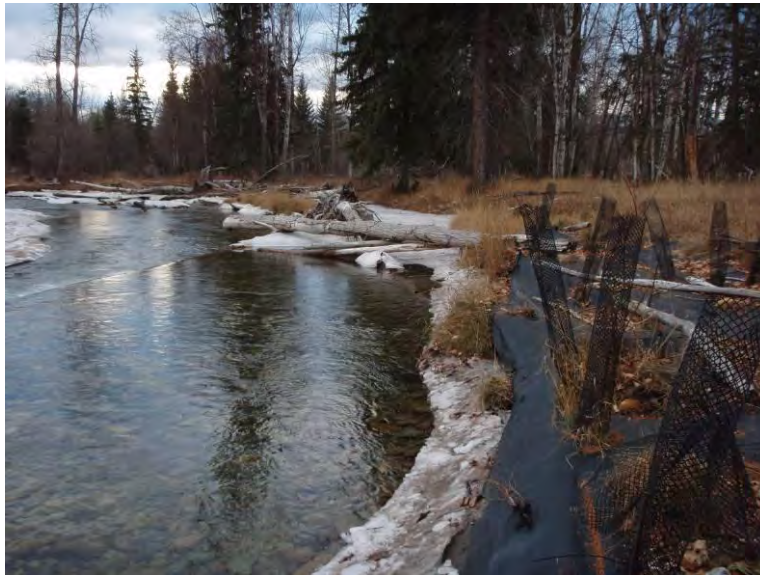
Figure 11. Photograph of Fall 2005 planting site. Photograph shows the extent of lateral erosion that occurs on outer banks within the reach. The black plastic weed mat was placed approximately three feet from the edge of the stream bank in 2005 and in December, 2007 one and a half feet of weed mat had slumped into the channel, indicating at least four feet of lateral erosion occurred along this bank.

Within the project reach, some accelerated bank erosion is occurring in areas where mature woody vegetation is lacking. Some outer banks have migrated approximately four feet or more since 2005 (Figure 11). Most of this erosion probably occurred during one large run-off event in the late winter of 2005, but stream bank and point bar stability are also being affected by scour from anchor ice formation and break up (Figure 12).

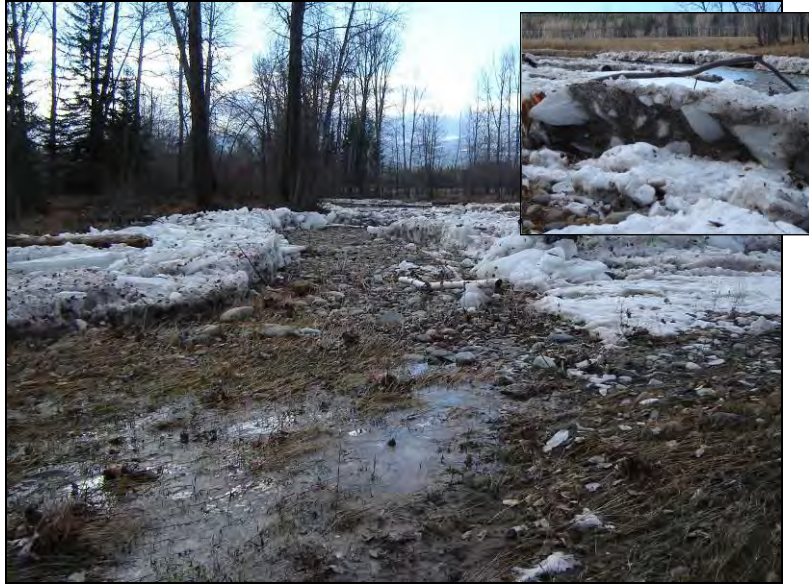
Figure 12. Ice accumulation along the project reach affects channel stability. Ice formation results in diverting flows onto adjacent floodplain surfaces and ice break up may result in lateral shearing and vertical scour.

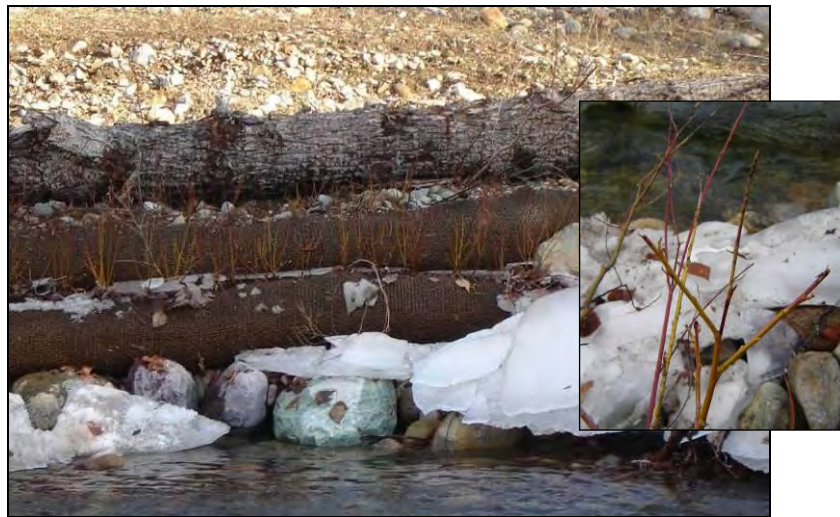
Figure 13. Photograph of vegetated soil lift bioengineered stream bank. Willows are surviving in these structures, but heavy browse (inset photo) is limiting growth and continued browse pressure could reduce survival.

The one exception is bioengineered stream banks, where woody vegetation is still developing but lateral erosion rates appear to be lower. This is apparent at sites where soil lifts were constructed in 2005. The channel at the toe of these structures scoured, but little to no lateral migration occur. This may indicate that if soil lifts had not been constructed at these sites, bank erosion rates in these areas would have been much higher during the winter 2005 flood. Data collected in December 2007 indicates willows are surviving in the vegetated soil lifts installed during 2005 and 2006 but have been heavily browsed (Figure 13). Continued browse pressure will result in poor long-term survival of willows in vegetated soil lifts, and reduce success of these structures at improving long-term stability.

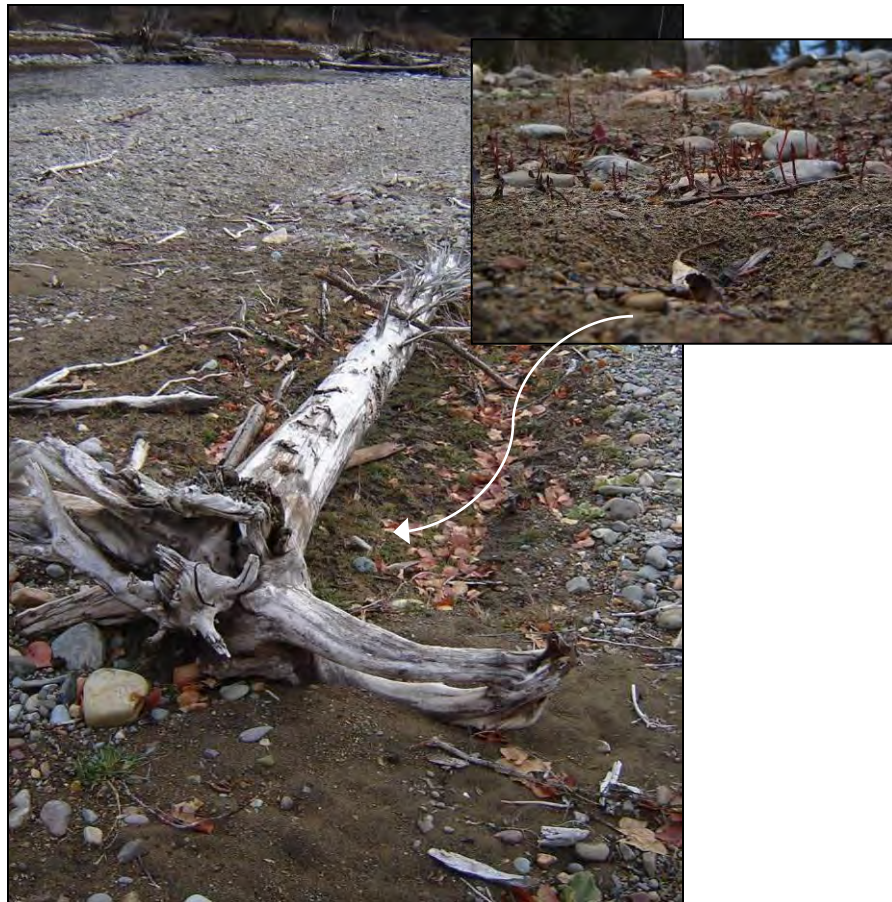
Figure 14. Photograph of constructed point bar illustrating flood deposited fine sediments and organic matter accumulation around placed large woody debris. Colonization of woody species is occurring in the fine sediments deposited around the woody debris (inset photo).

Results of monitoring data collected on point bars in December 2007 indicate that cottonwood recruitment occurs in very select areas of constructed point bars. Point bars with more surface area at an overall lower elevation (between one and two feet above the baseflow water elevation) and with gradual slopes may be more suitable for natural woody vegetation recruitment. This indicates that flood duration, timing, and access to depositional areas are all factors affecting the rate of woody species recruitment on constructed point bars. Point bars closer to low flow water surface elevations may retain flood waters longer and recession of flood waters from these areas may be slower and therefore a wider window of conditions needed for colonization of desired woody species is present.

Winter anchor ice that regularly forms and breaks apart in this reach of Grave Creek may limit achieving the desired future condition. The main limitation resulting from the development of ice is the potential for bank, bed and floodplain scour to occur as ice breaks apart. Anchor ice can result in significant amounts of erosion and scour and has damaged planted shrubs and bioengineering structures installed along the reach. However, ice jams also function to increase water depths upstream of the jam which often results in water flowing onto adjacent floodplain surfaces during winter months. While it is not likely that viable seed is transported during winter months, the water flowing over point bars does result in deposition of organic material and fine sediments which create ideal sites for deposited seed to germinate and grow during the growing season (Figure 14).

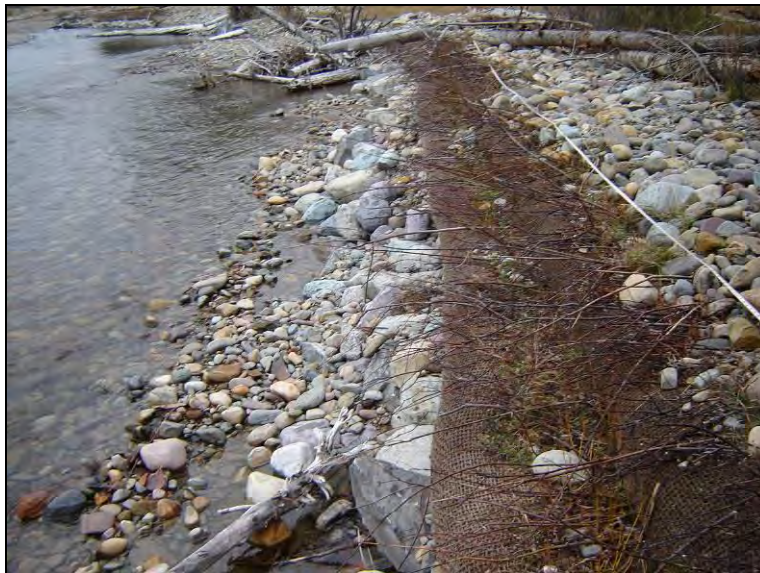
Figure 16. Photograph showing how tape is laid across top layer of soil lift to record data in five-foot increments.

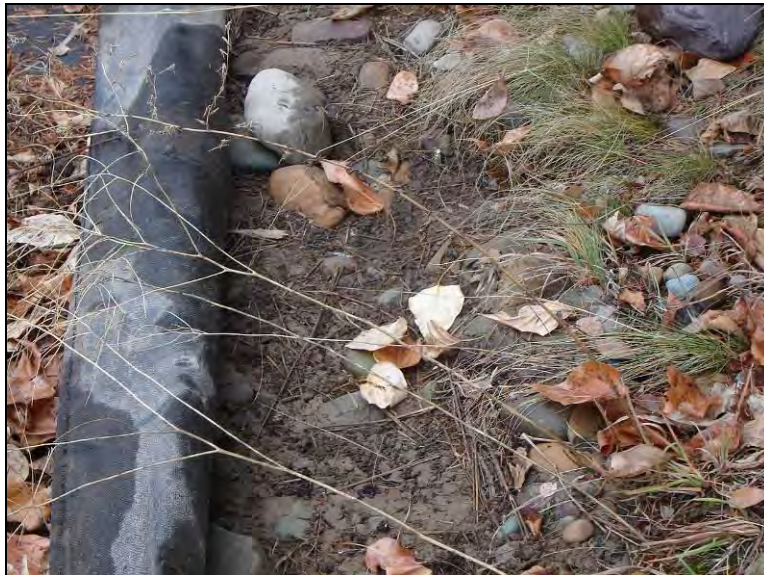
Figure 17. Solarization fabric treatment showing heat killed grasses under treated area.

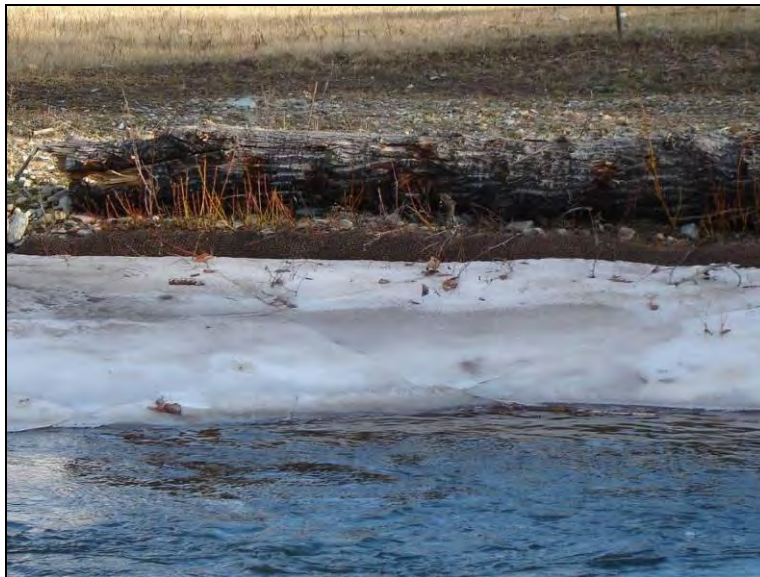
Figure 18. Photograph of soil lift 2 illustrating log barrier placed behind the structure to prevent browse. Willows are surviving but heavily browsed down to the height of the barrier.

- Average shoot growth on surviving willows is between three and 24 inches and average growth was higher on lifts where woody debris was placed as a browse barrier.

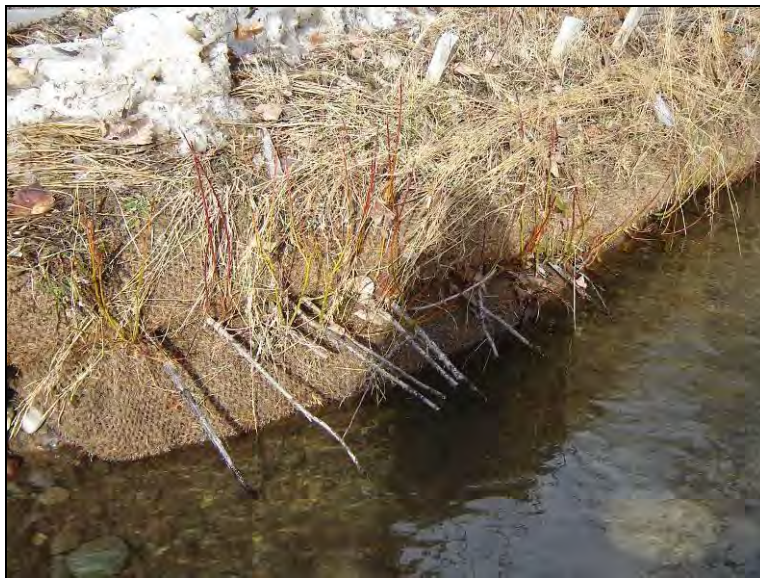
Figure 19. Toe scour and slumping of soil lift installed in 2005, but new willow shoot growth on decadent stems and good herbaceous cover of seeded species on top lift.

The most notable results of monitoring were the difference between soil lifts installed in 2005 compared with those installed in 2006. Soil lifts installed in 2006 were improved by implementing the following changes:

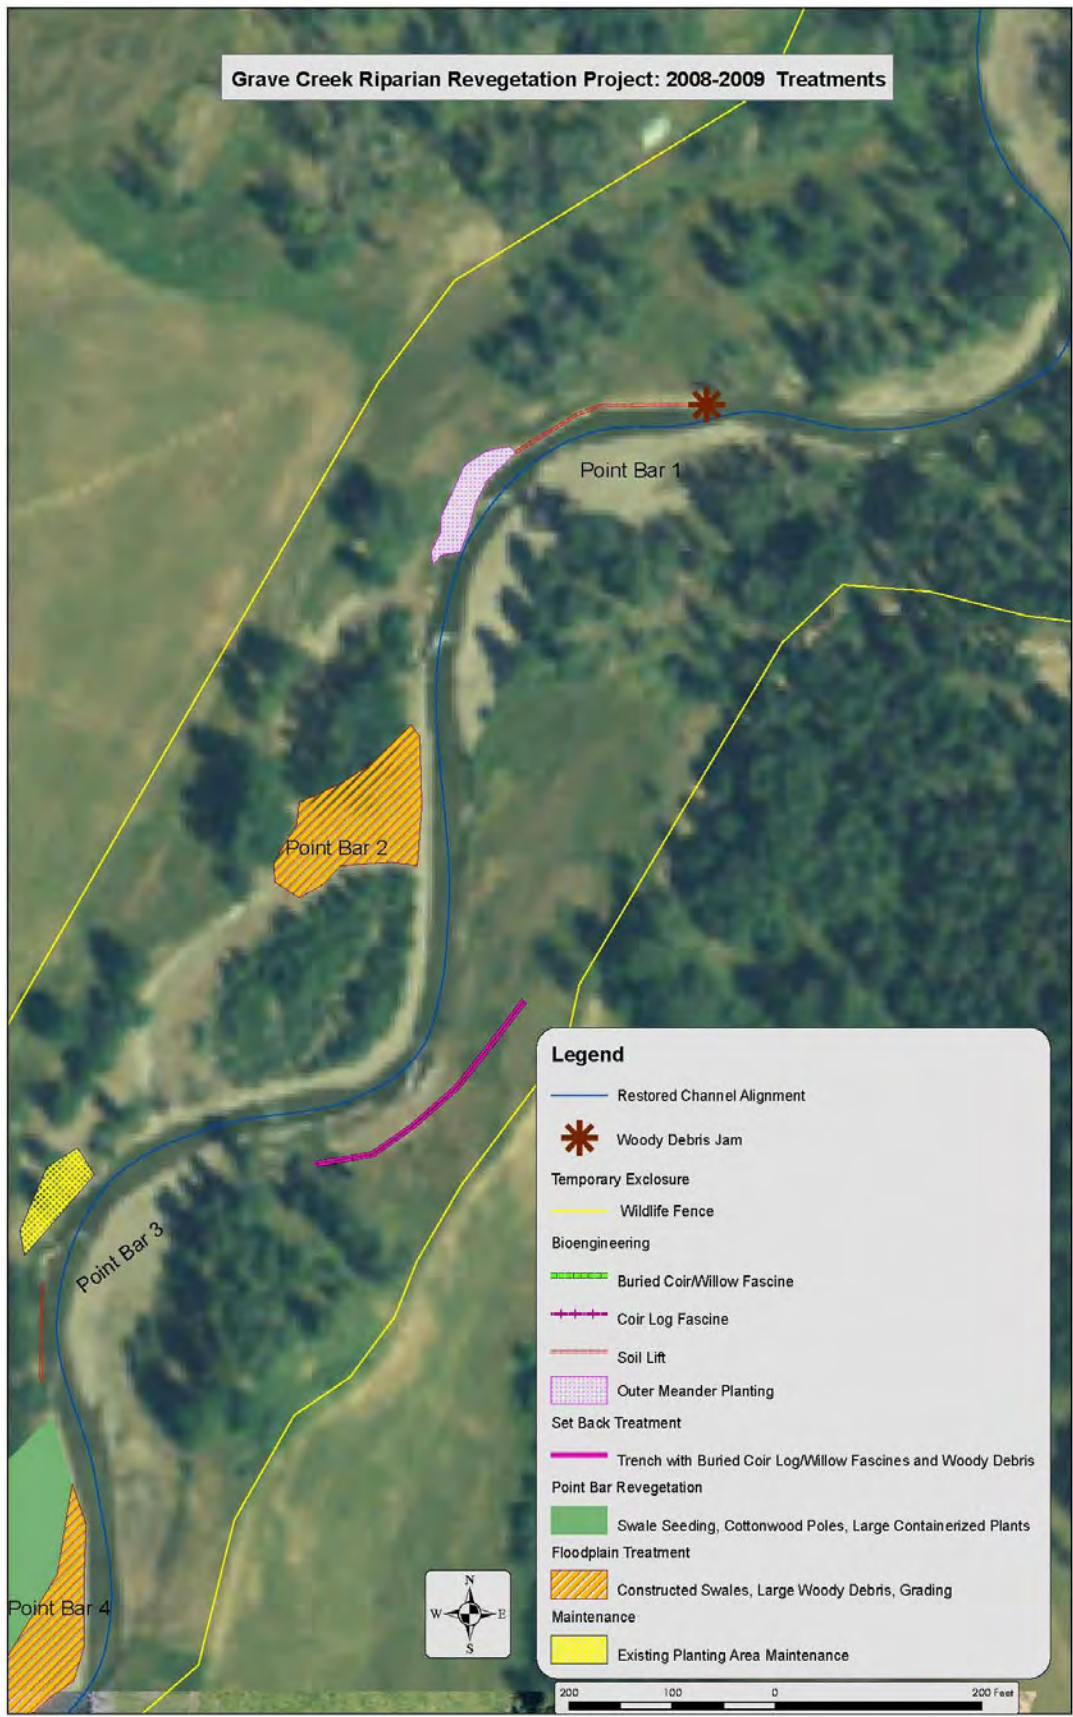
Figure A-1. Grave Creek riparian revegetation treatments, point bars 1-4.

Set back vegetated trench: This treatment consists of digging a 10-foot wide trench parallel to the channel approximately 20 feet away from the existing stream bank. The trench is then filled with woody debris, coir logs, and willow bundles to create a dense hedge of vegetation set back from the existing channel. The excavated fill is then replaced, leaving only the tips of the willow bundles exposed. The coir logs and woody debris will create stability and promote establishment of the willow cuttings by retaining moisture in the rooting zone and promoting soil development. The placement of this trench is in anticipation of continued lateral channel migration at the site. Because it appears the channel is attempting to increase its radius of curvature at this site via lateral channel erosion it would not be desirable to construct vegetation treatments directly along the bank to reduce erosion rates (John Muhlfeld, personal communication, 2008). The intent of this treatment is to create a stable hedge of desired vegetation for the channel to migrate into. The trench would extend between 200 and 400 feet along the existing channel. Figure A -14 shows the area chosen for the set back treatment. The trench location is shown on Figure A-1.

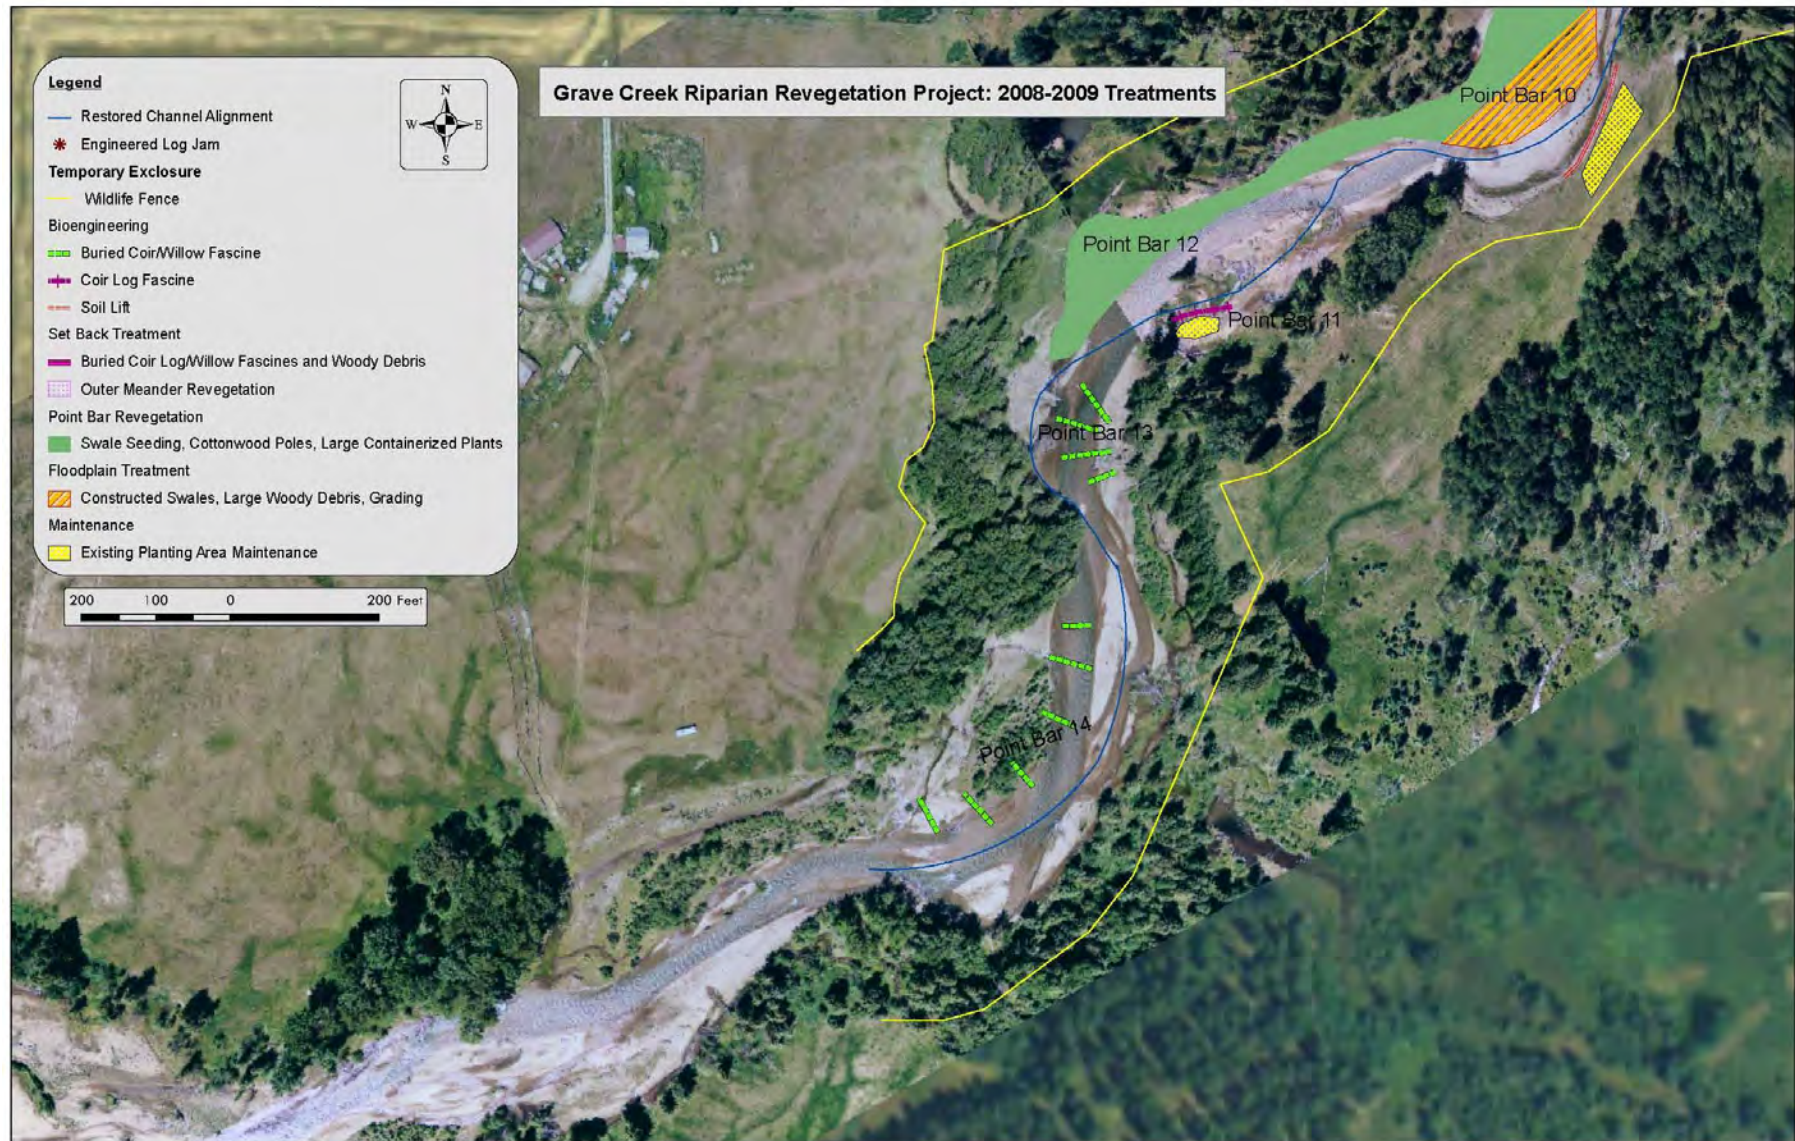
Figure A-3. Grave Creek riparian revegetation 2008-2009 treatments for point bars 10-14.

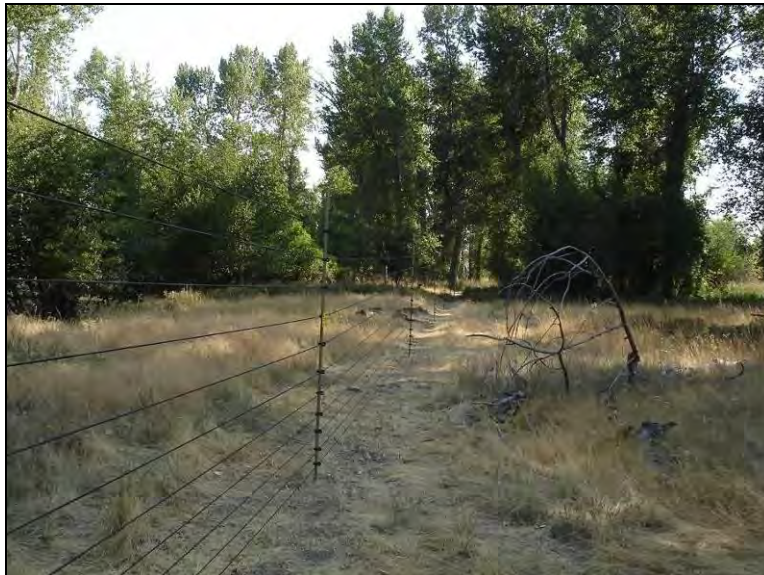
Figure A-4. Photograph of ElectroBraid electric wildlife fencing.

ElectroBraid is a brand of electric fence that is durable and has been proven to be an effective deer barrier (Figure A-4). Fencing can be installed using posts, strapped to existing trees, or tied into the existing fence line. A 2002 study conducted by the USDA National Wildlife Center found ElectroBraid to be a 99% effective deer barrier (USDA 2002). This treatment will not only protect the containerized plants installed in 2005, but also allow natural regeneration of woody species to occur throughout the entire riparian area. Maintenance for this type of fence may include: checking the energizer and the fence voltage on a regular schedule; walking the fence line and visually inspecting for possible damage or shifted brace posts; cutting weeds and grass (generally once per year); and removing fallen branches.

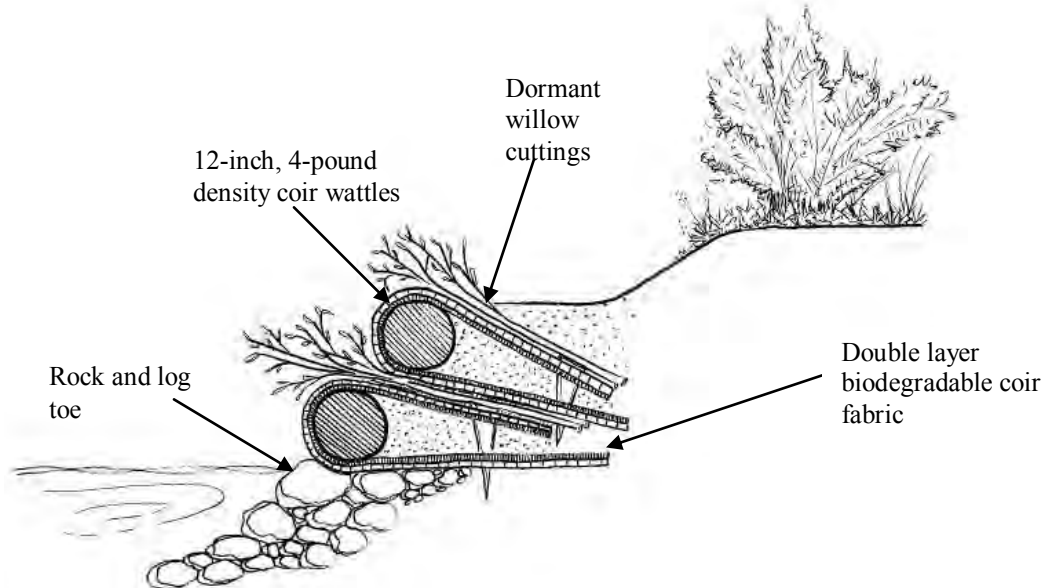
Figure A-5. Profile view drawing of vegetated soil lift treatment.

Vegetated soil lifts: Vegetated soil lifts are a revegetation and bank construction technique that combines layers of dormant willow cuttings with fabric-wrapped soil to revegetate and stabilize stream banks (Figures A-5 and A- 6). Soil is wrapped within two layers of biodegradable coconut fiber (coir) fabric to hold the soil in place while vegetation becomes established. Soil lifts, combined with a bankfull bench, will result in near bank areas where native woody vegetation can become established. To increase success, the face of the bottom soil lift should be reinforced with a coir wattle to help maintain the lift shape, keep fine soil particles from filtering out through the lift face, and maintain surface tension. The uppermost soil lift should be filled with salvaged sod or seeded with the seed mix developed for the reach. These structures should be tied into bank structures such as engineered log jams. Within the project reach, five outer meander bends have been identified for vegetated soil lift construction.

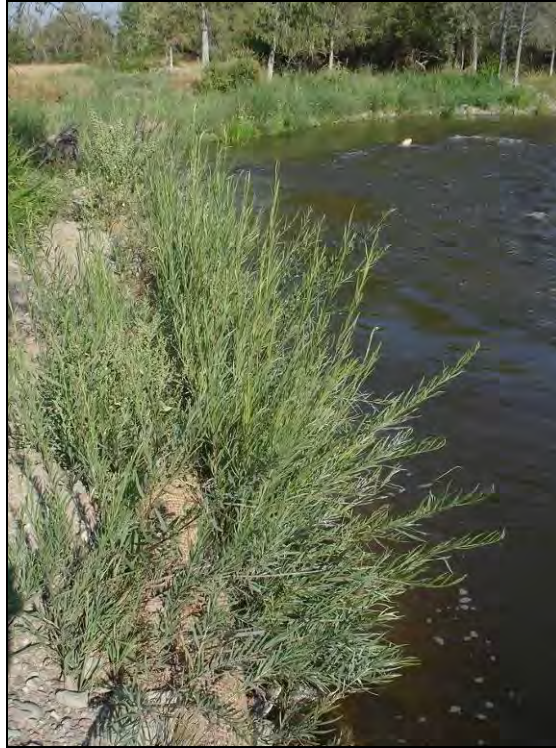
Figure A-6. Photograph showing vegetated soil lift five months after construction.

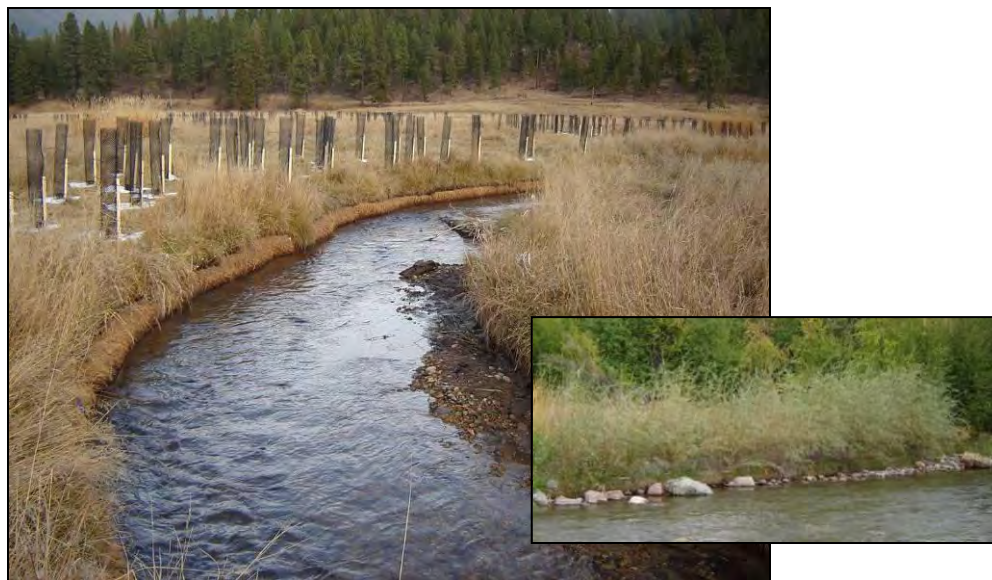
Figure A-8. Photograph of coir log immediately after installation and with willow growth after three years (inset).

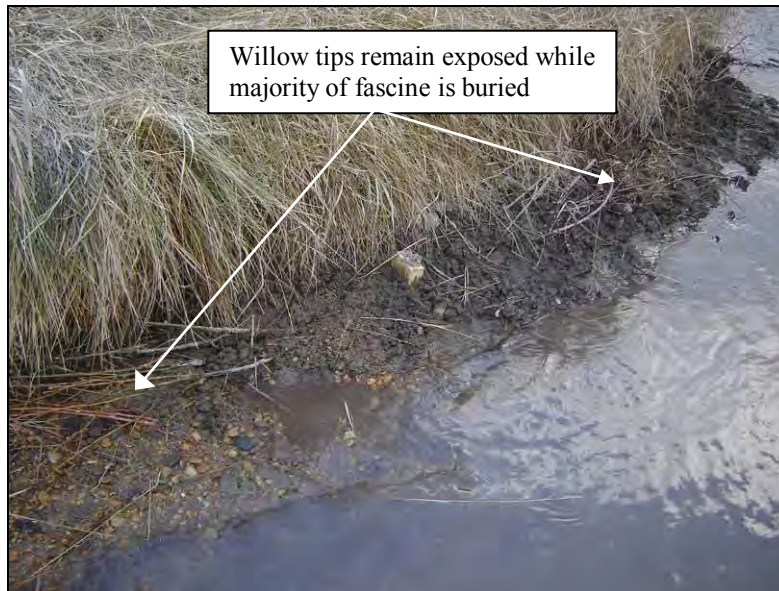
Figure A-9. Photograph of buried willow fascine treatment.

Buried Coir Log Fascines: This treatment consists of digging a narrow trench (approximately 12-16 inches wide and 16 inches deep) and placing coir logs and dormant willow cuttings into the trench. In lieu of individual dormant willow cuttings, willow fascines (bundles) can also be incorporated into this treatment. Willow fascines consist of willow cuttings tied together in bundles and bundles tied together end to end to form linear rows of desired lengths (Figure A-9). This treatment is proposed for use in constructed point bars to promote establishment of cottonwoods and willows. Buried coir log fascines are constructed perpendicular to the channel to encourage point bar stability. To further anchor the treatment, coir logs and willow bundles in each trench are laced together and the ends tied to rope buried three feet below the trench. Each linked length of coir logs is between 30 and 50 feet. This treatment will be used on point bars 13 and 14.

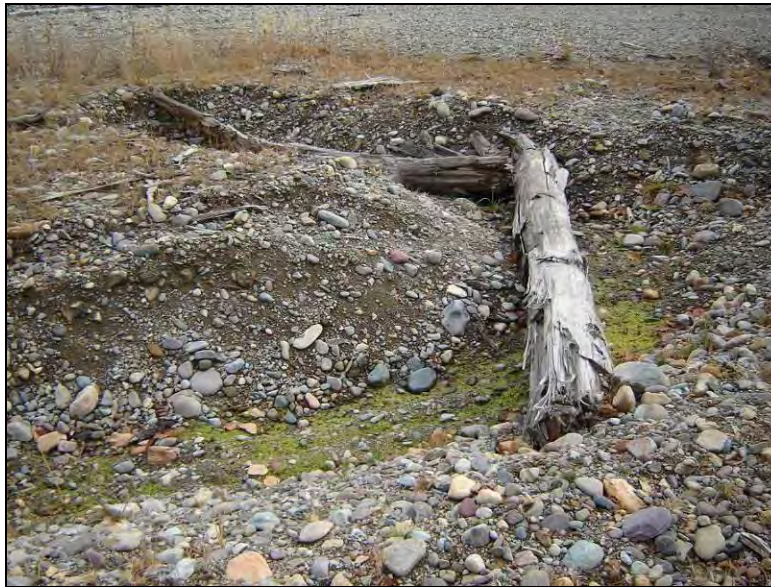
Figure A-10. Photograph of constructed swale with conditions, such as late season moisture retention and large woody debris creating microsites, appropriate for supporting woody vegetation establishment.

Swale Seeding: This treatment consists of broadcast seeding in constructed swales that have conditions favorable for seedling development (Figure A-10). This treatment will accelerate the natural process of vegetation development in swales. Table A-2 provides the recommended seed mix for the reach.

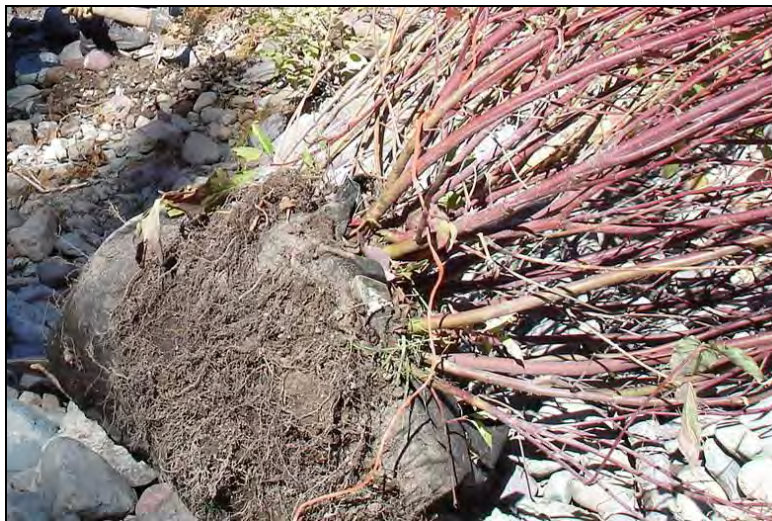
Figure A-11. Photograph of large containerized plant material with well developed root system and large diameter stems.

Large Containerized Plant Material: This treatment consists of installing small numbers of shrubs grown in 16 gallon grow bags. This sized plant material will have a well developed root system and large diameter stems better able to withstand browse pressure and provide immediate root stability to the site (Figure A-11). This treatment will be concentrated in the swales connecting point bars 10 and 12. Willow, cottonwood, and alder are the desired species for use in these areas, however, exact species will depend on plant availability.

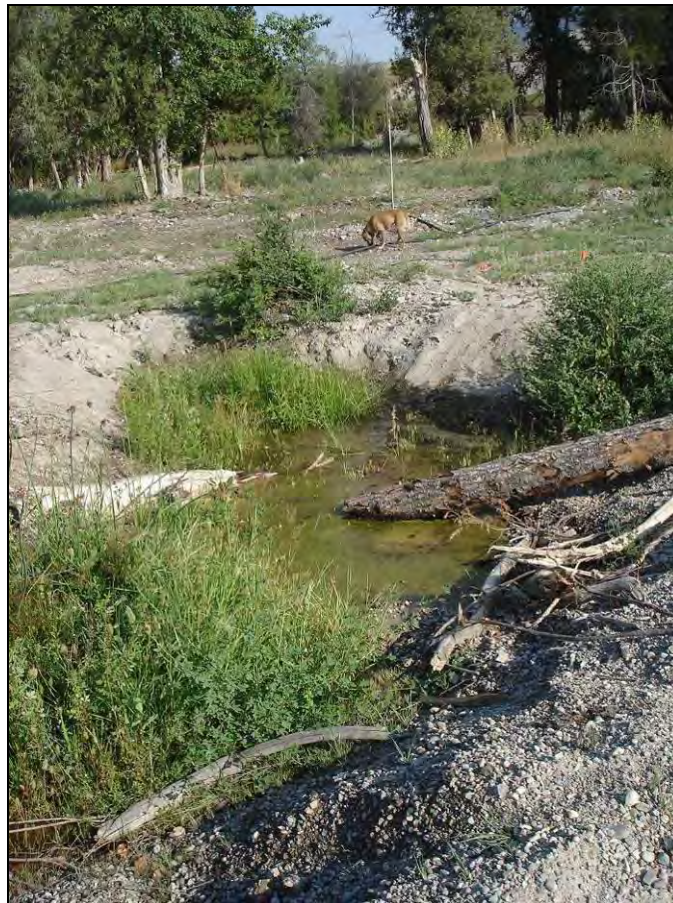
Figure A-12. Photograph of constructed floodplain swale five months after construction.

between the edge of the channel and excavated swales. Material excavated for swale construction can be spread throughout the area to further enhance microtopography. Large woody debris will be placed along created swales, and/or partially buried adjacent to these swales to provide additional shade, create microsites, retain moisture and stimulate biological development within the soil. Adding roughness to floodplain surfaces will increase the ability of these surfaces to trap cottonwood and willow seed that naturally colonize exposed alluvial material.

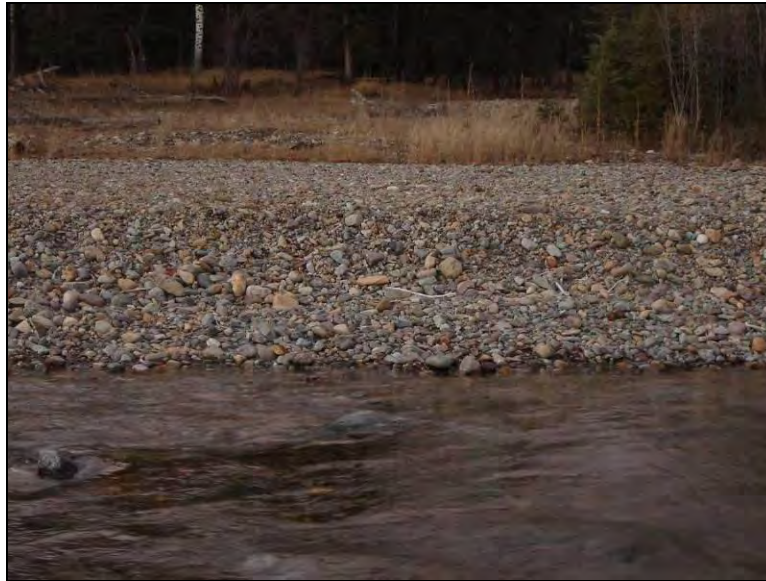
Figure A- 13. Photograph of steep bank on point bar 10 and flat, uniform floodplain surface.

Grading: This treatment includes minor grading of point bars 4, 8 and 10, where channel incision has resulted in a loss of connectivity with the floodplain (Figure A- 13). Floodplain grading will consists of removal of floodplain material or re-configuring of floodplain materials with the purpose of lowering select areas of the point bar to allow overbank flows to access a larger surface area. All material removed from point bar areas will be deposited in an established waste site on the landowner's property.

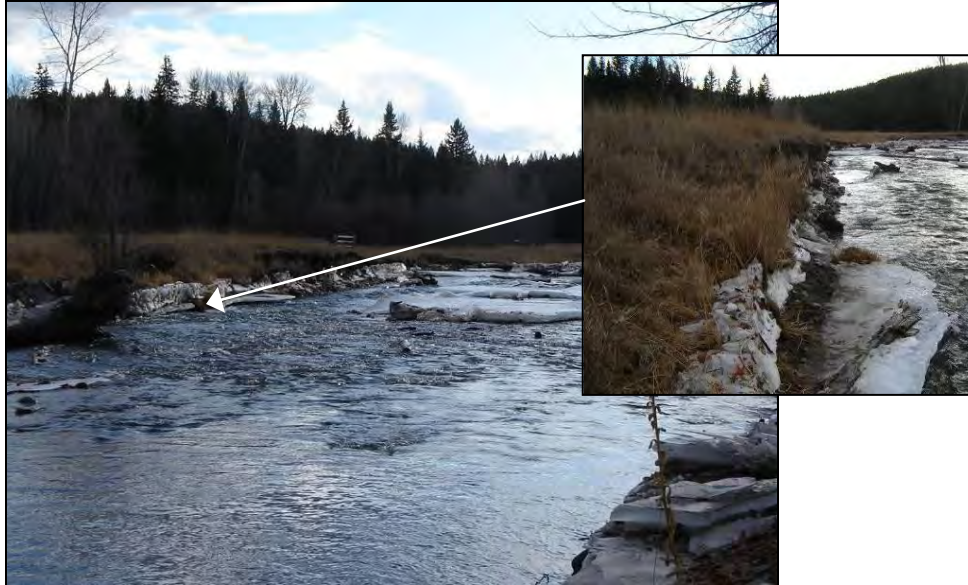
Figure A-14. Photograph showing area selected for set back treatment. Inset photograph shows vertically eroding bank.

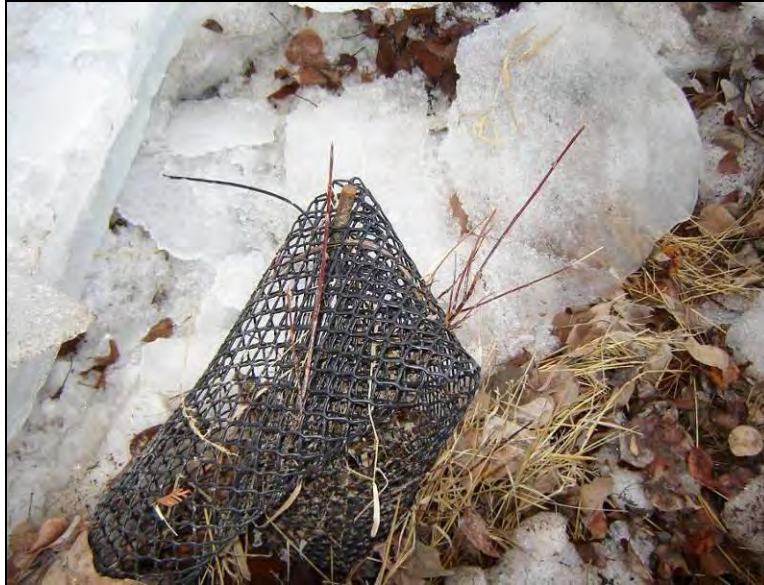
Figure A-15. Photograph showing browse protector damaged by ice. Willow has survived, but is browsed and constrained by the browse protector.

Browse Protection: Browse protectors that have fallen over or are no longer protecting the plant should be repaired, replaced, or re-installed so that they serve their intended purpose. Browse protectors should be removed from plants that have grown too large for the protector to be effective. Browse protector maintenance should be done with care so as to not damage the plant during removal. Plants that have reached the height of the browse protector should be protected by stacking two browse protectors together so as to create taller and wider browse protection. Browse protectors should be removed from planting areas along banks affected by ice flows in the winter and spring (Figure A-15).

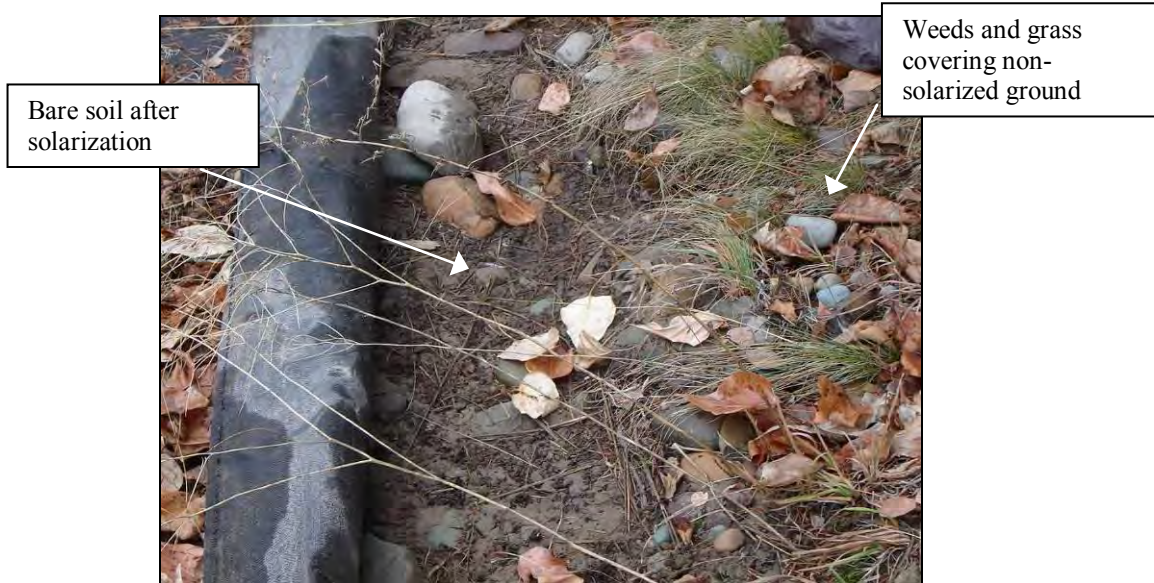
Figure A-16. Bare soil under solarization fabric after three years compared with grass and weed cover just beyond the fabric.

Solarization: Solarization fabric has proven effective in killing undesired grass and weed species. Figure A-16 shows bare soil after two years under the fabric. Solarization fabric should be removed from the entire plot, except immediately around planted shrubs, without disturbing the containerized plantings. The bare soil can then be seeded with a native grass and forb mix to further enhance plant community structure and prevent weed species colonization. An example seed mix is shown in Table A-2.
