# GRAVE CREEK DEMONSTRATION PHASE RIPARIAN REVEGETATION PLAN

**DECEMBER, 2008**

KOOTENAI RIVER NETWORK  
P.O. BOX 491  
LIBBY, MT 59923

GEUM ENVIRONMENTAL CONSULTING, INC.  
307 STATE STREET, P.O. BOX 1956  
HAMILTON, MT 59840

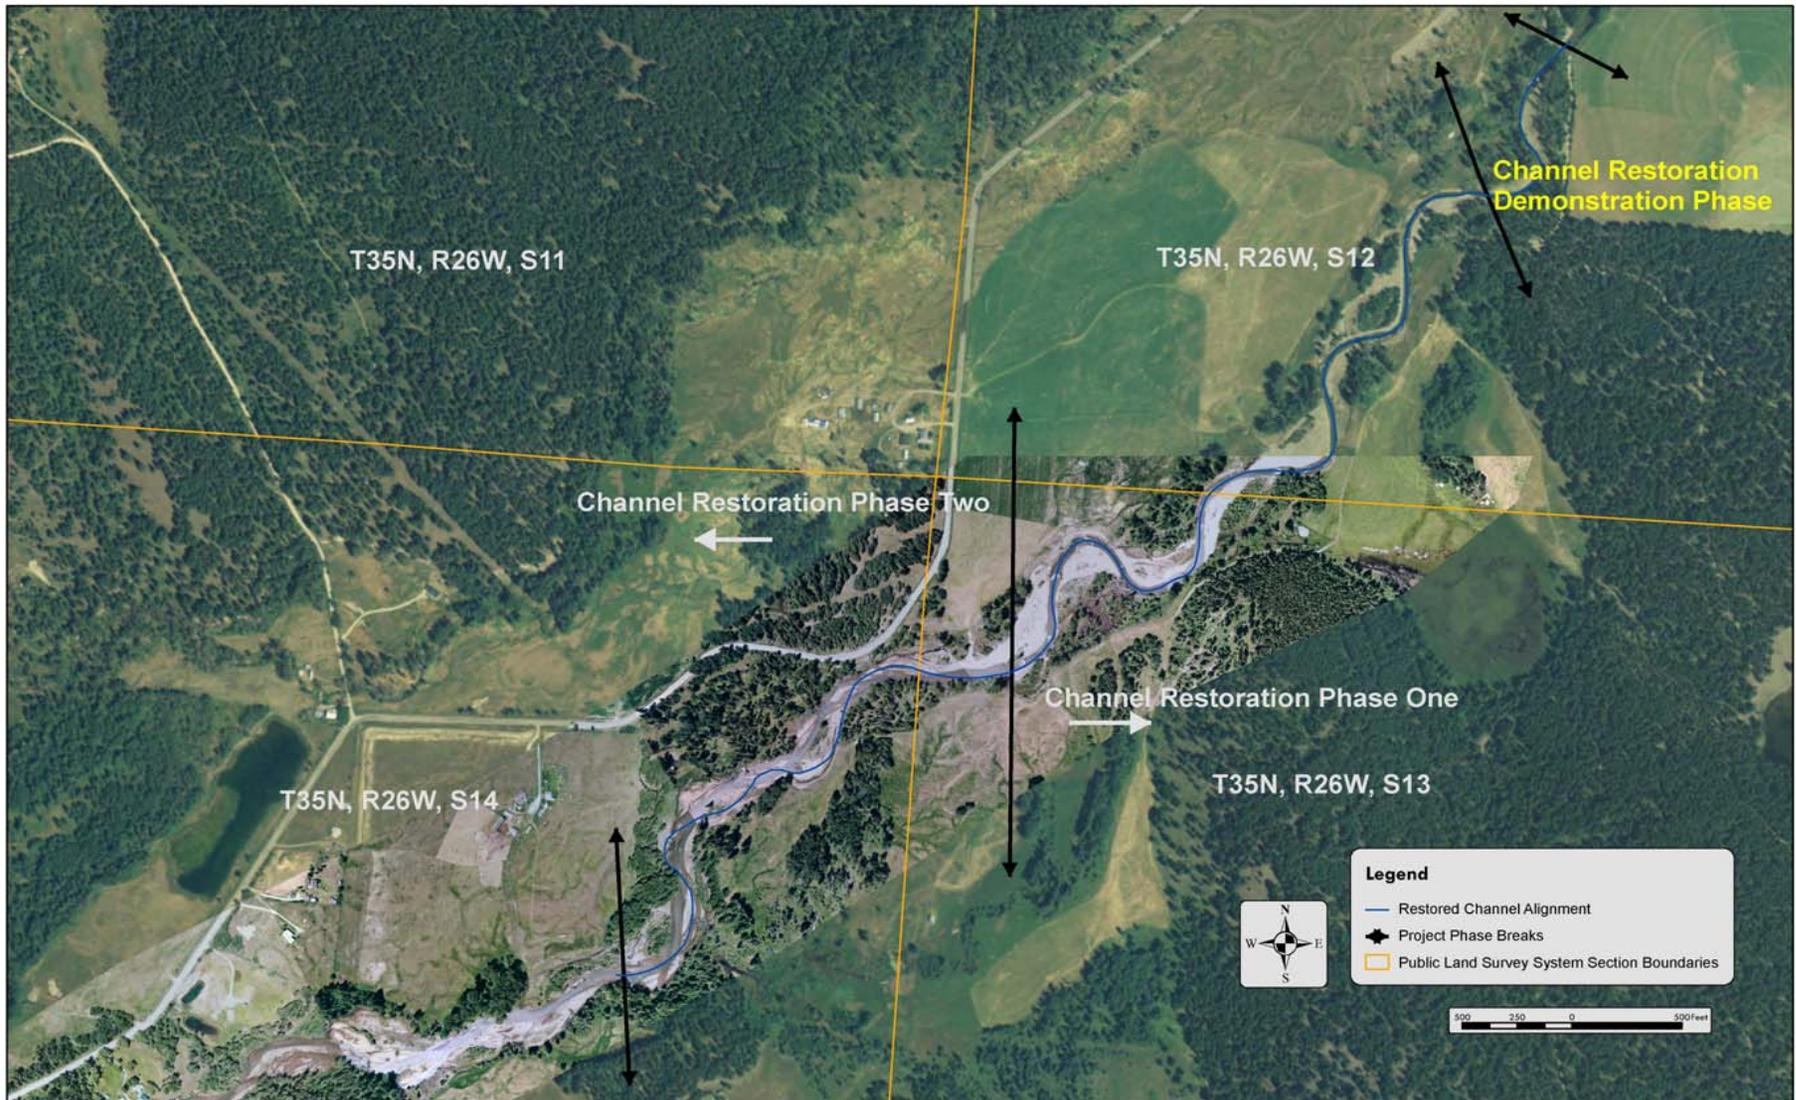
**Figure 2.** Overview of Grave Creek restoration project area. This riparian revegetation plan includes the channel restoration Demonstration Phase (highlighted in yellow).

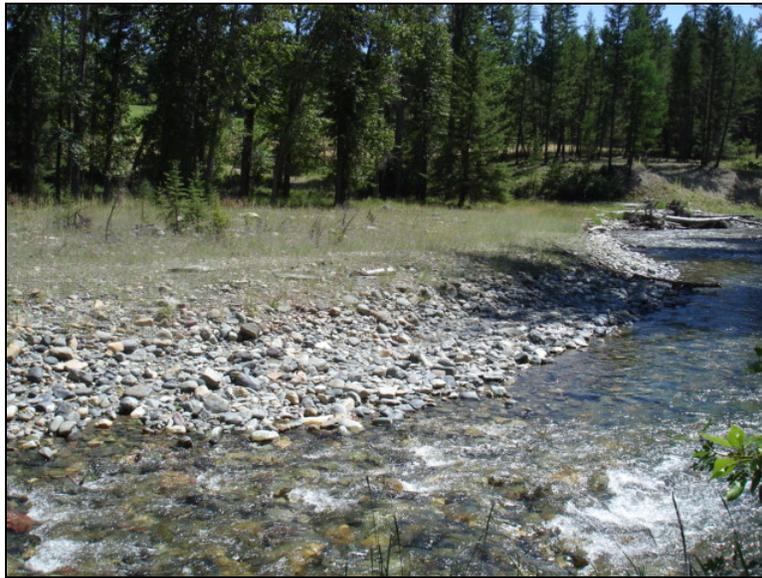
**Figure 3.** Example of Spruce/red-osier dogwood habitat type encroaching on a point bar within the Demo reach. Young spruce are growing under the cover of mature cottonwood trees (photo background).

Examples of vegetation community types and successional stages occurring within the Demo reach at Grave Creek are shown in Figures 3, 4 and 5 below.

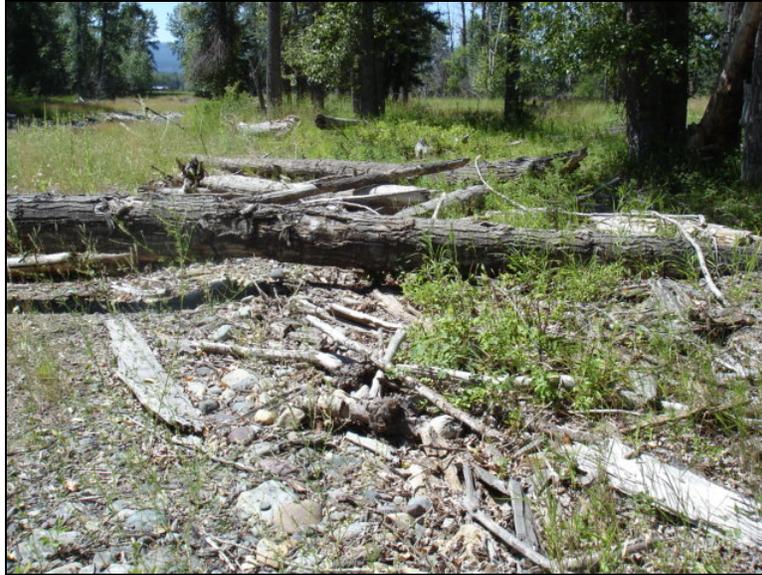
**Figure 4.** Example of black cottonwood/recent alluvial bar community type colonizing a point bar within the Demo reach.

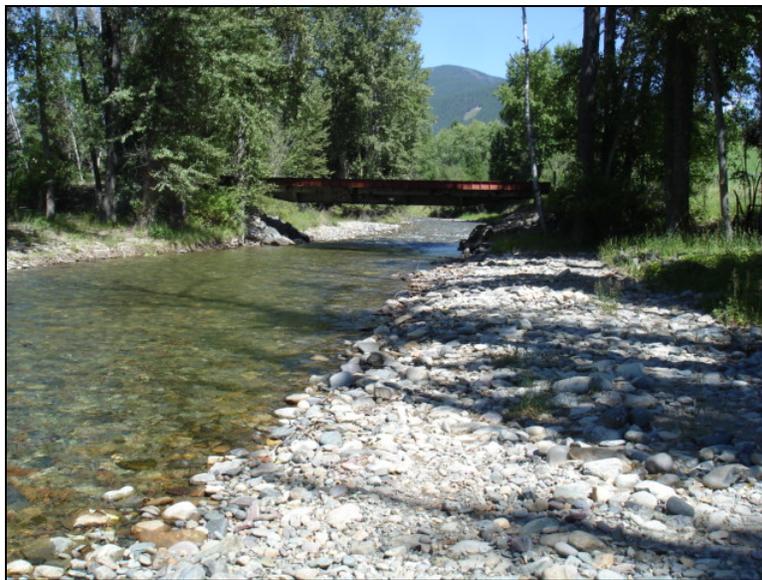
**Figure 5.** Example of black cottonwood/red-osier dogwood community type within the Demo reach.

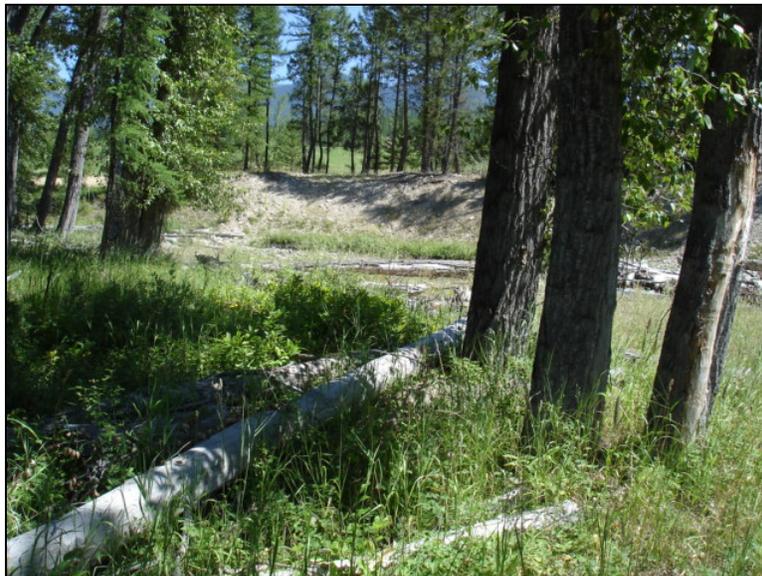
**Figure 6.** Black cottonwood plant community illustrating the dominance of older age class cottonwoods and a lack of understory woody vegetation within the Demo reach.

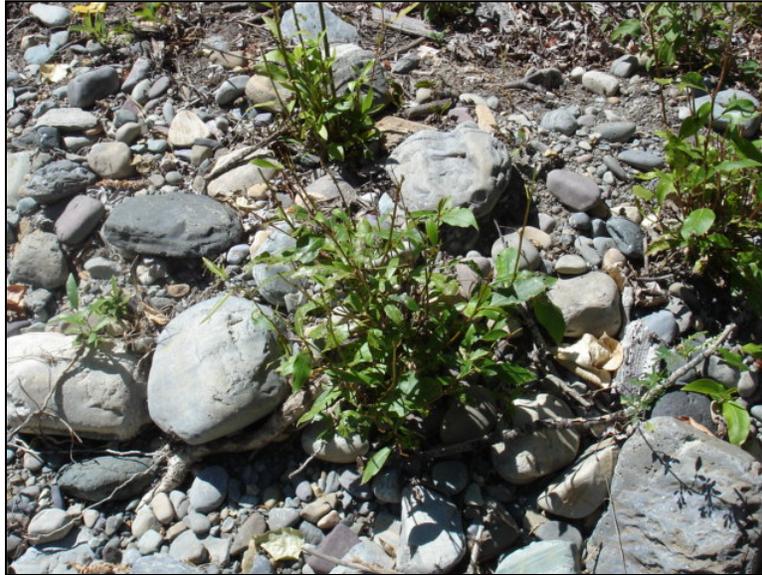
**Figure 7.** Photograph showing suppressed cottonwood seedling growth due to browse.

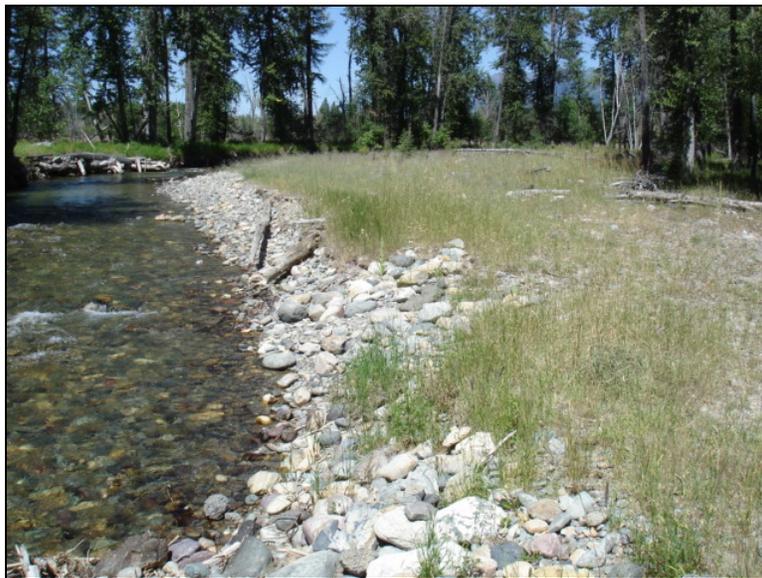
**Figure 8.** Photograph of existing conditions within the Demo reach, where banks lack mature riparian vegetation. During initial channel construction in 2001, concerns of possible avulsions or headcutting resulted in the construction of floodplain surfaces that are uniform and at elevations that are less frequently accessed by high flows.

Some portions of the Demo reach lack mature woody vegetation along the banks (Figure 8). This is primarily due to past land uses that resulted in the removal of riparian vegetation communities. This is also due to the short time since channel restoration was completed. Restoring the channel from braided to single thread resulted in large areas of newly constructed surfaces, which require a long period of time for desired, mature vegetation to develop. Another possible cause for the lack of woody vegetation along the stream banks, primarily the left bank, is the construction of flat, uniform floodplain

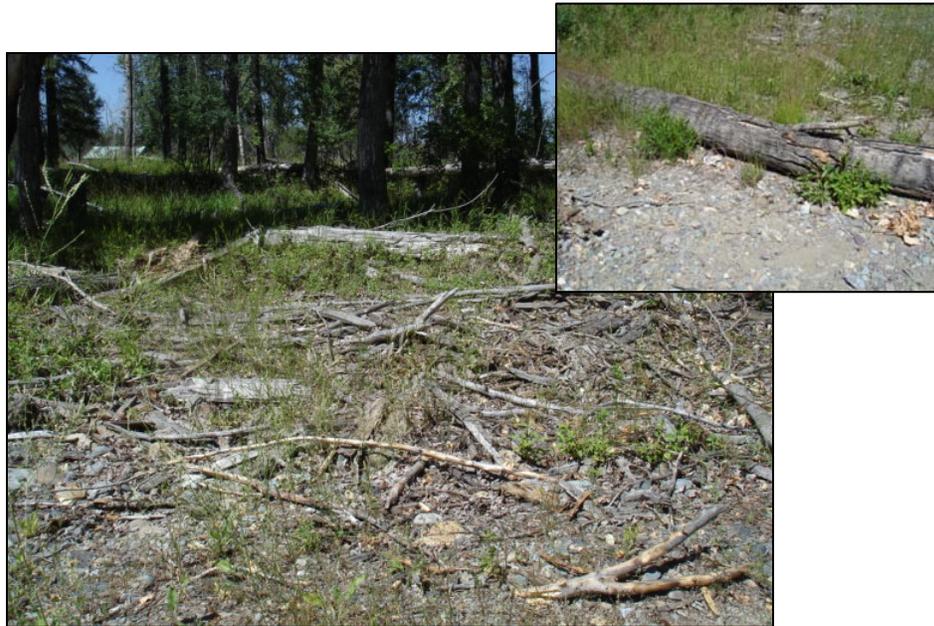
**Figure 9.** Photograph shows flood deposited woody debris accumulating on a point bar surface in the Demo reach. Inset photo shows native species are colonizing around the woody debris.

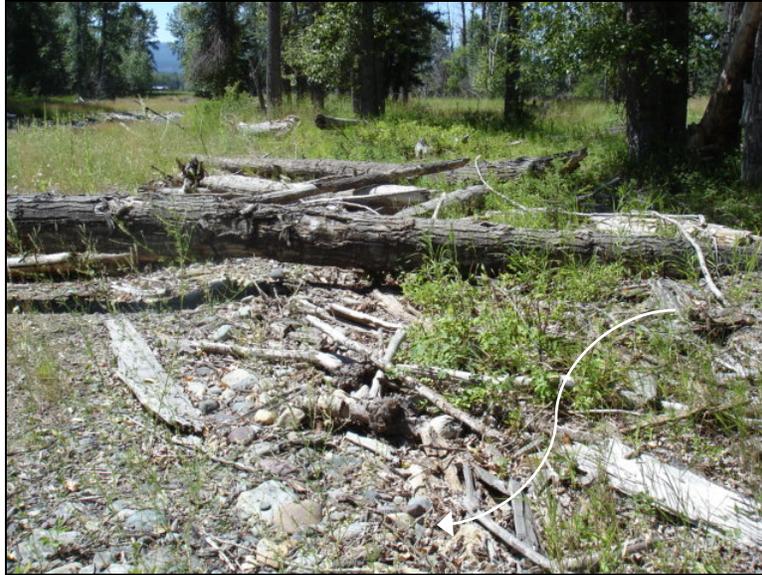
**Figure 10.** Photograph of point bar illustrating flood deposited coarse woody debris and organic matter accumulation around large woody debris. Colonization of woody species is occurring in the sediments and organic matter deposited around the woody debris.

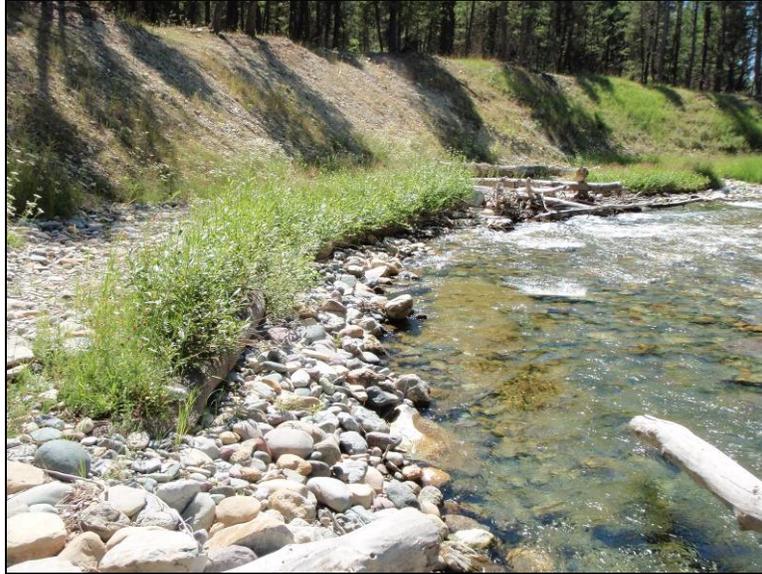
**Figure 11.** The downstream outer meander of the Demo reach is occupied by a steep slope, a bankfull bench, and two vegetated soil lifts.

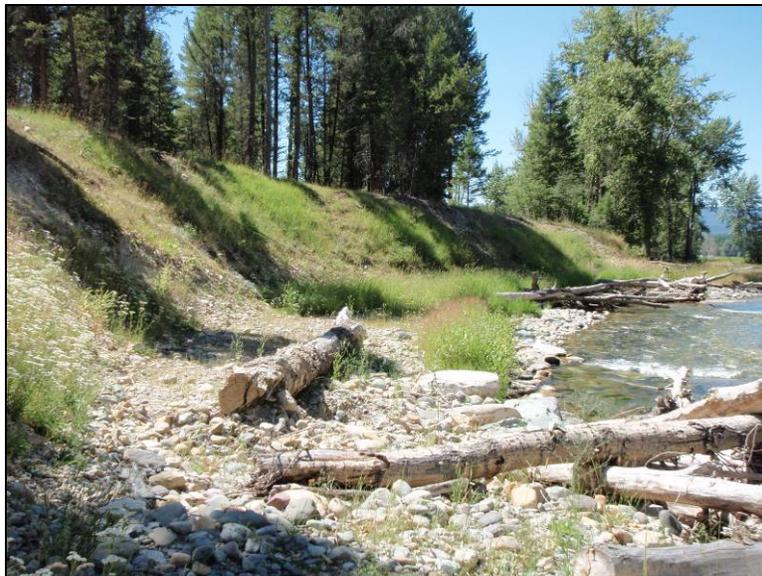
**Figure 12.** Photograph shows the slope, bankfull bench, and vegetated soil lift in the Demo reach. Grasses and forbs (both seeded and naturally recruited) are colonizing the slope and bench, but bare soil areas are still present.

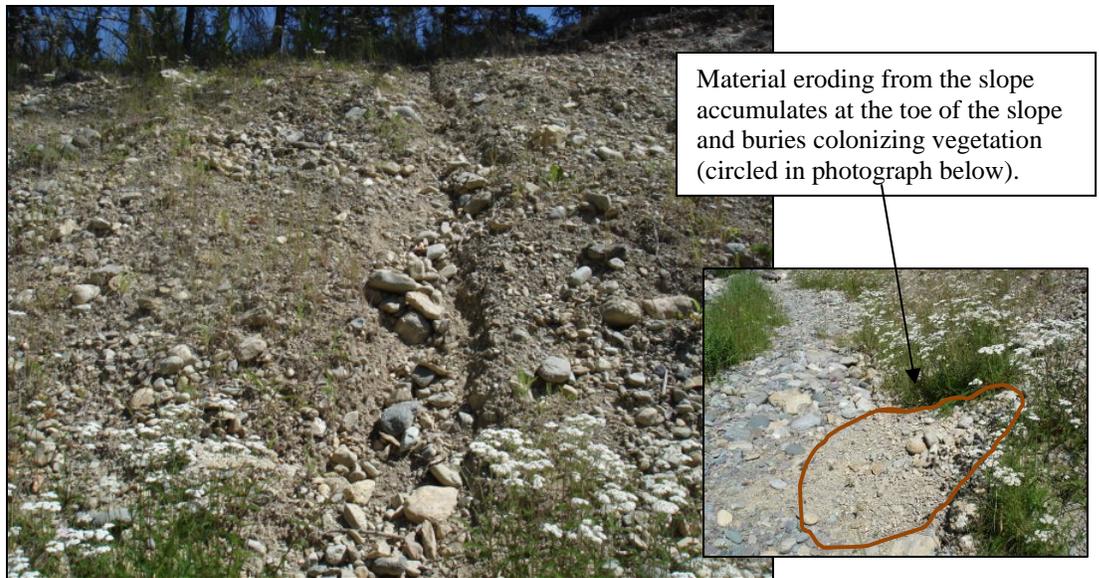
**Figure 13.** Photograph shows evidence of rilling and erosion on the upper portions of the steep slope within the Demo reach. Note the yarrow that has colonized the bottom of the slope. Inset photo shows the eroding material accumulating at the toe of the slope and covering a patch of yarrow.

The left bank at the downstream end of the Demo reach is adjacent to a high, steep eroding slope. A bankfull bench and woody debris jams were installed along this bank during initial channel restoration activities. A significant flood event that occurred during 2005 resulted in erosion between the debris jams. In response to this erosion, vegetated soil lifts and a bankfull bench were constructed along this bank in 2006 to establish woody vegetation and limit scour and erosion of the slope toe (Figure 11). Monitoring of these treatments in August 2008 indicated that willow survival in the soil lift is high and seeded species such as *Achillea millefolium* (common yarrow) and *Trifolium* spp. (clover) are colonizing the bankfull bench, although total percent cover is relatively low on the bench (Figure 12). Colonization of the bankfull bench is limited by the predominantly large sized cobble substrate (Figures 13 and 14).

Observations of the eroding slope made during August 2008 indicate that although there is evidence of rilling and erosion (Figure 13), the risk of major sediment inputs to the stream is not severe because the constructed bankfull bench separates the slope from most flows. The slope is being colonized by a mix of native and non-native early successional species. Species colonizing the toe and lower portions of the slope include: *Bromus inermis* (smooth brome), *Phleum pratense* (common timothy), *Agrostis stolonifera* (redtop), *Elymus trachycaulus* (slender wheatgrass), *Festuca* spp. (fescue), *Agropyron riparium* (streambank wheatgrass), *Dactylis glomerata* (orchardgrass), *Poa pratensis* (Kentucky bluegrass), Wood's rose, red raspberry, snowberry, and other *Bromus* spp. (brome species) (Figure 14). Species colonizing the upper portions of the slope include common yarrow, *Aster* spp. (aster), *Galium* spp. (bedstraw), *Fragaria virginiana* (strawberry), *Taraxacum officinale* (common dandelion), *Cynoglossum officinale* (houndstongue), Kentucky bluegrass, common timothy, and *Medicago lupulina* (black medic). Shrub species are present only on the lower portions of the slope. The steepest portions of the upper slope do not support any vegetation because of frequent

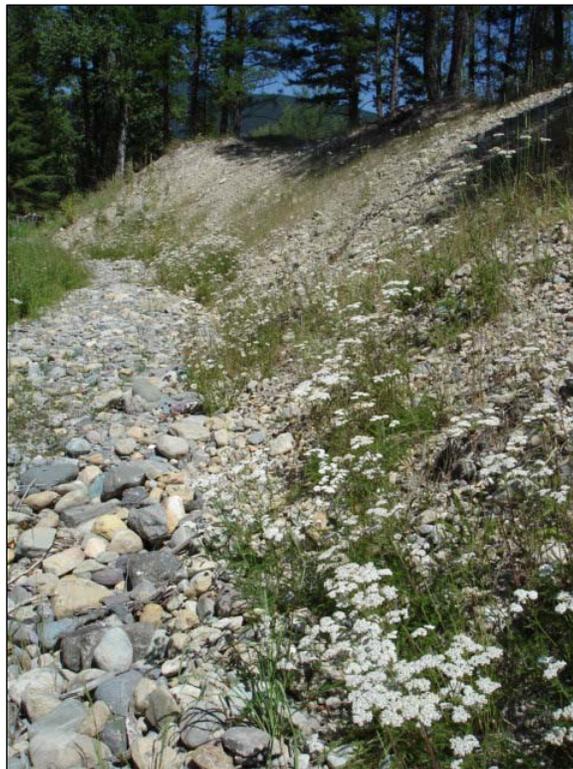
**Figure 14.** The slope located along the left bank of the downstream end of the Demo reach is colonized by a patchy distribution of native and non-native species.

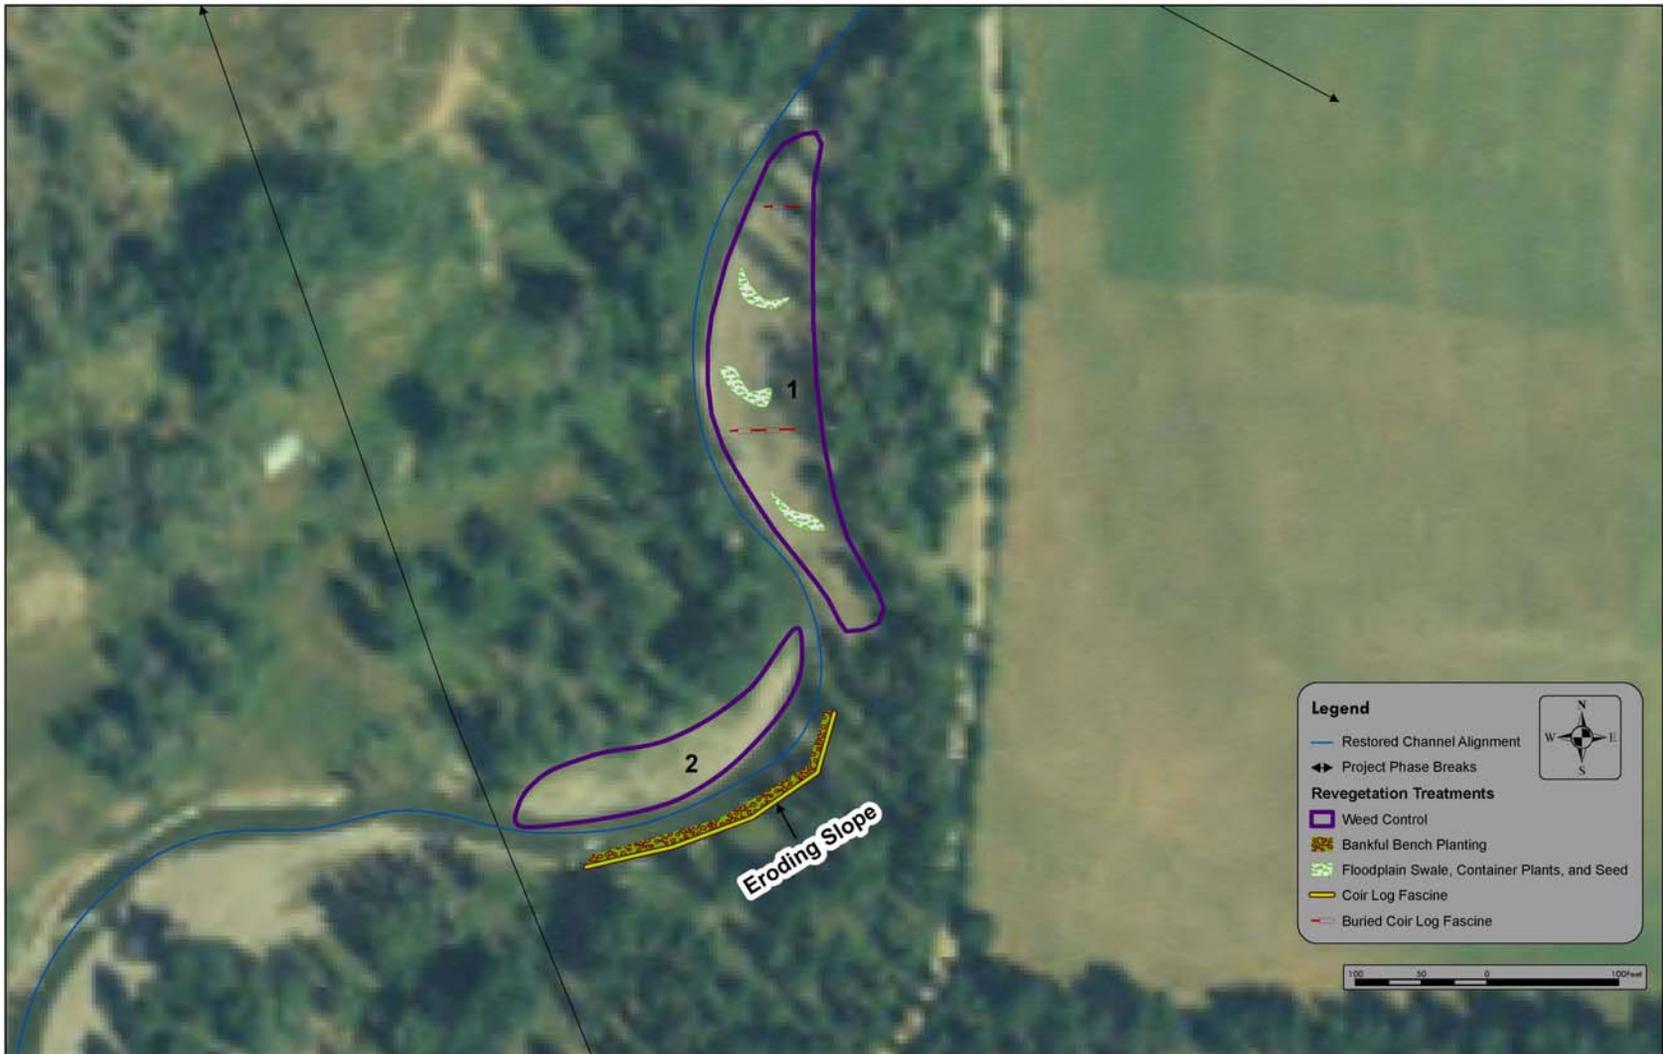
**Figure 15.** Locations of Grave Creek Demonstration Phase reach 2009 revegetation treatments.

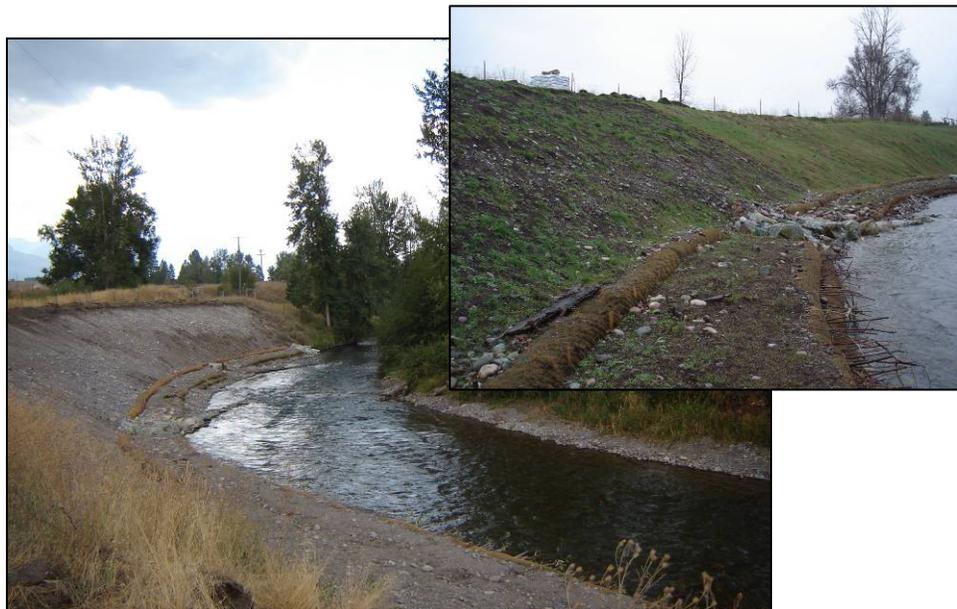
**Figure A-1.** Photograph of coir logs immediately after installation along the toe of an eroding slope and eight months after installation (inset). Plant material was not incorporated into the coir logs at this project site.

**Coir log fascines:** This technique includes placement of coir logs, combined with dormant willow cuttings in areas where it is difficult to establish vegetation. The purpose of this treatment is to establish woody vegetation along the toe of the eroding slope. Both the coir log and the vegetation that establishes will catch and filter sediment eroding from the slope. Coir logs consist of high density coir (coconut fiber) bales wrapped in a natural fiber netting. Coir is used for bioengineering because it stores water for long periods, and its durable fibers trap sediment and mimic soil matrices formed by living roots. Coir fibers biodegrade over approximately five to seven years, thus providing a short-term stable growing medium while native riparian plants establish. This treatment is proposed for one site in the project reach, along the toe of the eroding slope. The coir log fascine should filter sediment eroding from the slope and promote woody vegetation to establish and stabilize the toe of the slope over the long-term. Figure A-1 shows an example of this treatment used under similar conditions as proposed in this plan.

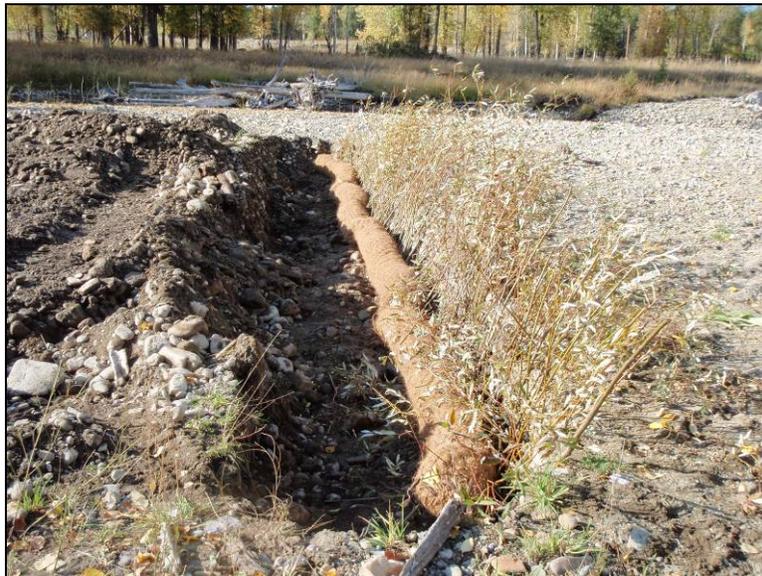
**Figure A-2.** Photograph of buried coir log fascine floodplain treatment during construction.

**Buried Coir Log Fascines:** This treatment consists of digging a narrow trench (approximately 2-4 feet wide and 1-4 feet deep) and installing coir and plant materials within the trench. The target depth for the trench is to intercept shallow groundwater, therefore, trench depths will vary. Dormant willow or cottonwood cuttings are placed vertically inside the trench along either one or both sides at a spacing of approximately 5 per foot. Medium density coir logs are then placed in the trench bottom near the base of

the willow cuttings to retain moisture in the rooting zone (Figures A-2 and A-3). Coir logs may or may not require anchoring based on the trench depth (i.e. shallower trenches may require anchoring coir logs with stakes or duck-billed earth anchors). The trench is backfilled with enough fill so the coir log is buried completely and approximately  $\frac{3}{4}$  of the willow cutting lengths are in contact with soil. Depending on the results of final design, this treatment may be used on Floodplain surface 1 to promote establishment of cottonwoods and willows by retaining moisture longer into the growing season.

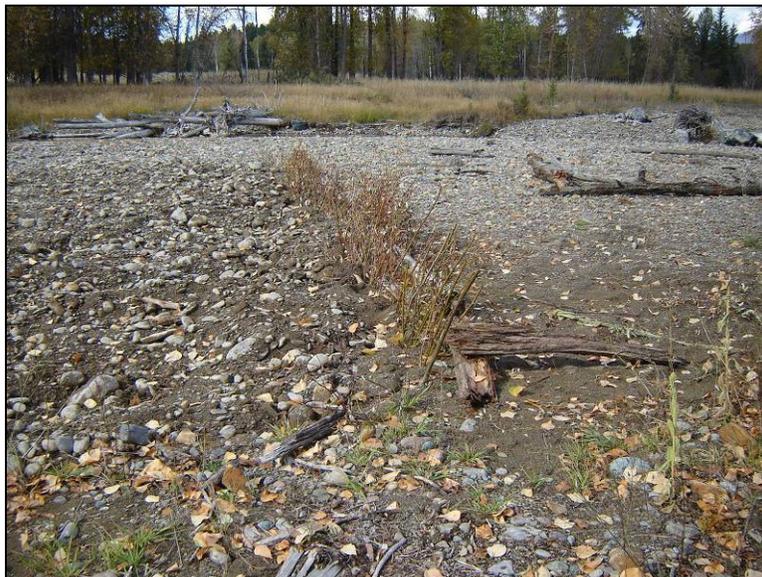
**Figure A-3.** Photograph of buried coir log fascine floodplain treatment immediately after construction.

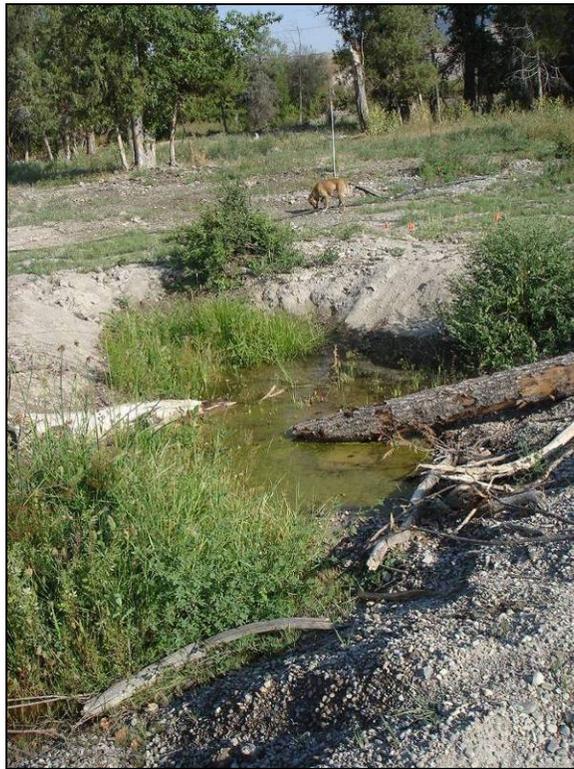
**Figure A-4.** Photograph of constructed floodplain swale five months after construction.

**Constructed Swales:** This treatment includes constructing depressions perpendicular to the channel, which minimizes the risk of depressions capturing and transporting flood waters (Figure A-4). Swales should be excavated to a depth of one to three feet depending on the surface elevation relative to channel features and swales should be approximately 10 feet wide and 20 feet long. A minimum buffer of 20 feet will be left between the edge of the channel and excavated swales. Material excavated for swale construction can be spread throughout the area to further enhance microtopography. Large woody debris will be placed within created swales, and/or partially buried adjacent to these swales to provide additional shade, create microsites, retain moisture and stimulate biological development within the soil. Adding roughness to floodplain surfaces will increase the ability of these surfaces to trap cottonwood and willow seed that naturally colonize exposed alluvial material.

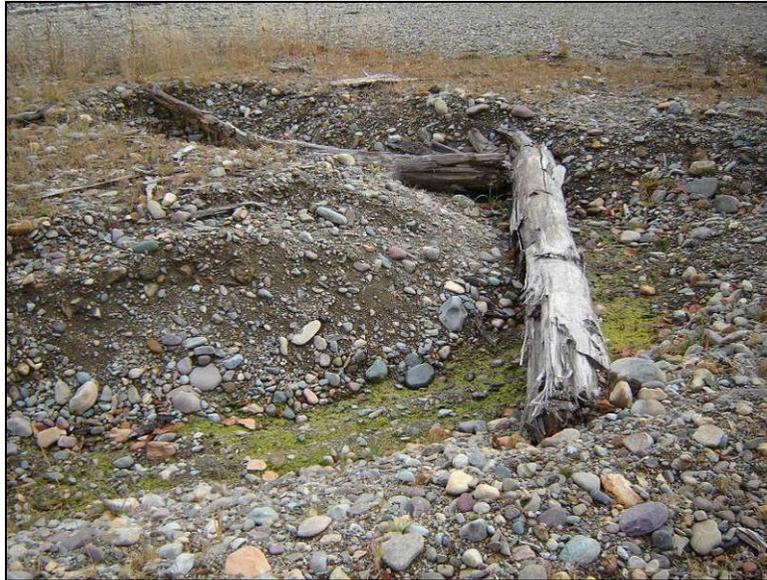
**Figure A-5.** Photograph of constructed swale with conditions, such as late season moisture retention and large woody debris creating microsites, appropriate for supporting woody vegetation establishment.

**Swale Seeding:** This treatment consists of broadcast seeding in constructed swales that have conditions favorable for seedling development (Figure A-5). This treatment will accelerate the natural process of vegetation development in swales. Table A-3 provides the recommended floodplain swale seed mix for the reach.

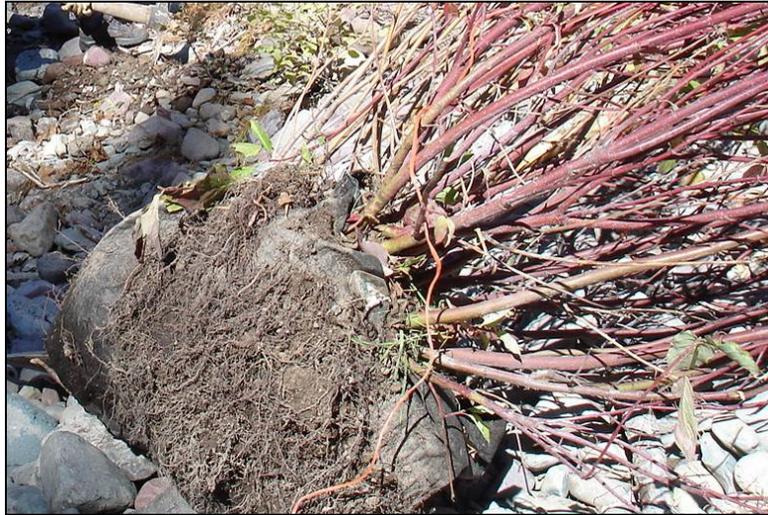
**Figure A- 6.** Photograph of large containerized plant material with well developed root system and large diameter stems.

**Large Containerized Plant Material:** This treatment consists of installing small numbers of shrubs grown in 5-10 gallon containers. This sized plant material will have a well developed root system and large diameter stems better able to withstand browse pressure

and provide immediate root stability to the site (Figure A-6). This treatment will be concentrated in the swales and behind the vegetated soil lifts below the terrace slope. Willow, cottonwood, and alder are the desired species for use in these areas; however, exact species will depend on plant availability. Table A-1 provides a suitable mix of species for Floodplain 1.

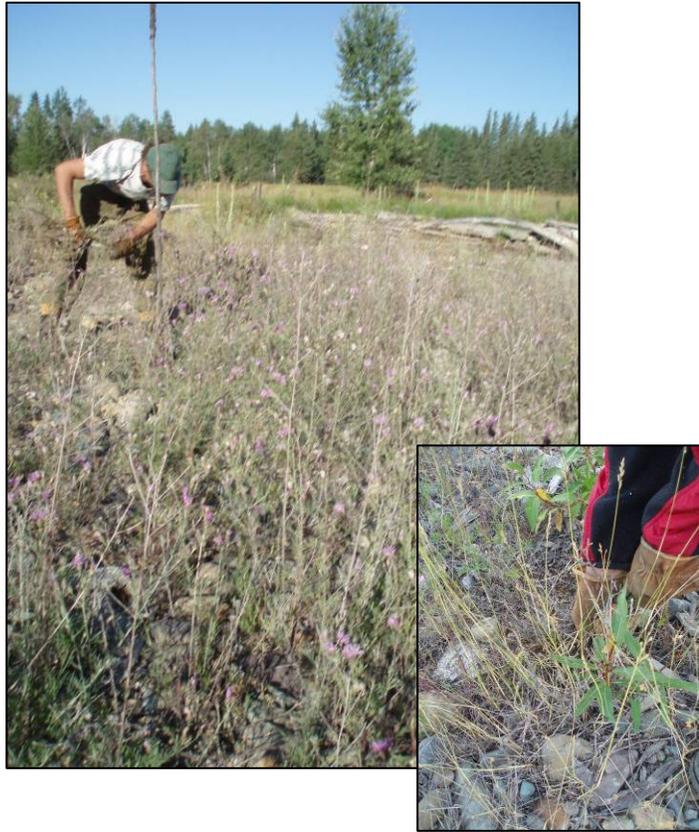
**Figure A-7.** Photographs showing a knapweed infested point bar and hand removal of knapweed from around cottonwood seedlings (inset).

Weed control includes the development and implementation of a weed control program. This program should include all project phase reaches. Exact timing and weed removal methods will depend on the targeted species. For example, in sensitive areas, such as point bars where cottonwood seedlings are establishing, weed removal should be done by hand pulling. In other areas, such as floodplain terraces with high densities of weeds, herbicide application may be more effective and appropriate. Figure A-7 provides an example of hand removal of weeds in a sensitive floodplain area in the Phase Two project reach where cottonwood seedlings are present. Because the Demo Reach includes relatively small areas of infestation, hand pulling or digging of rosettes in the early spring is recommended.

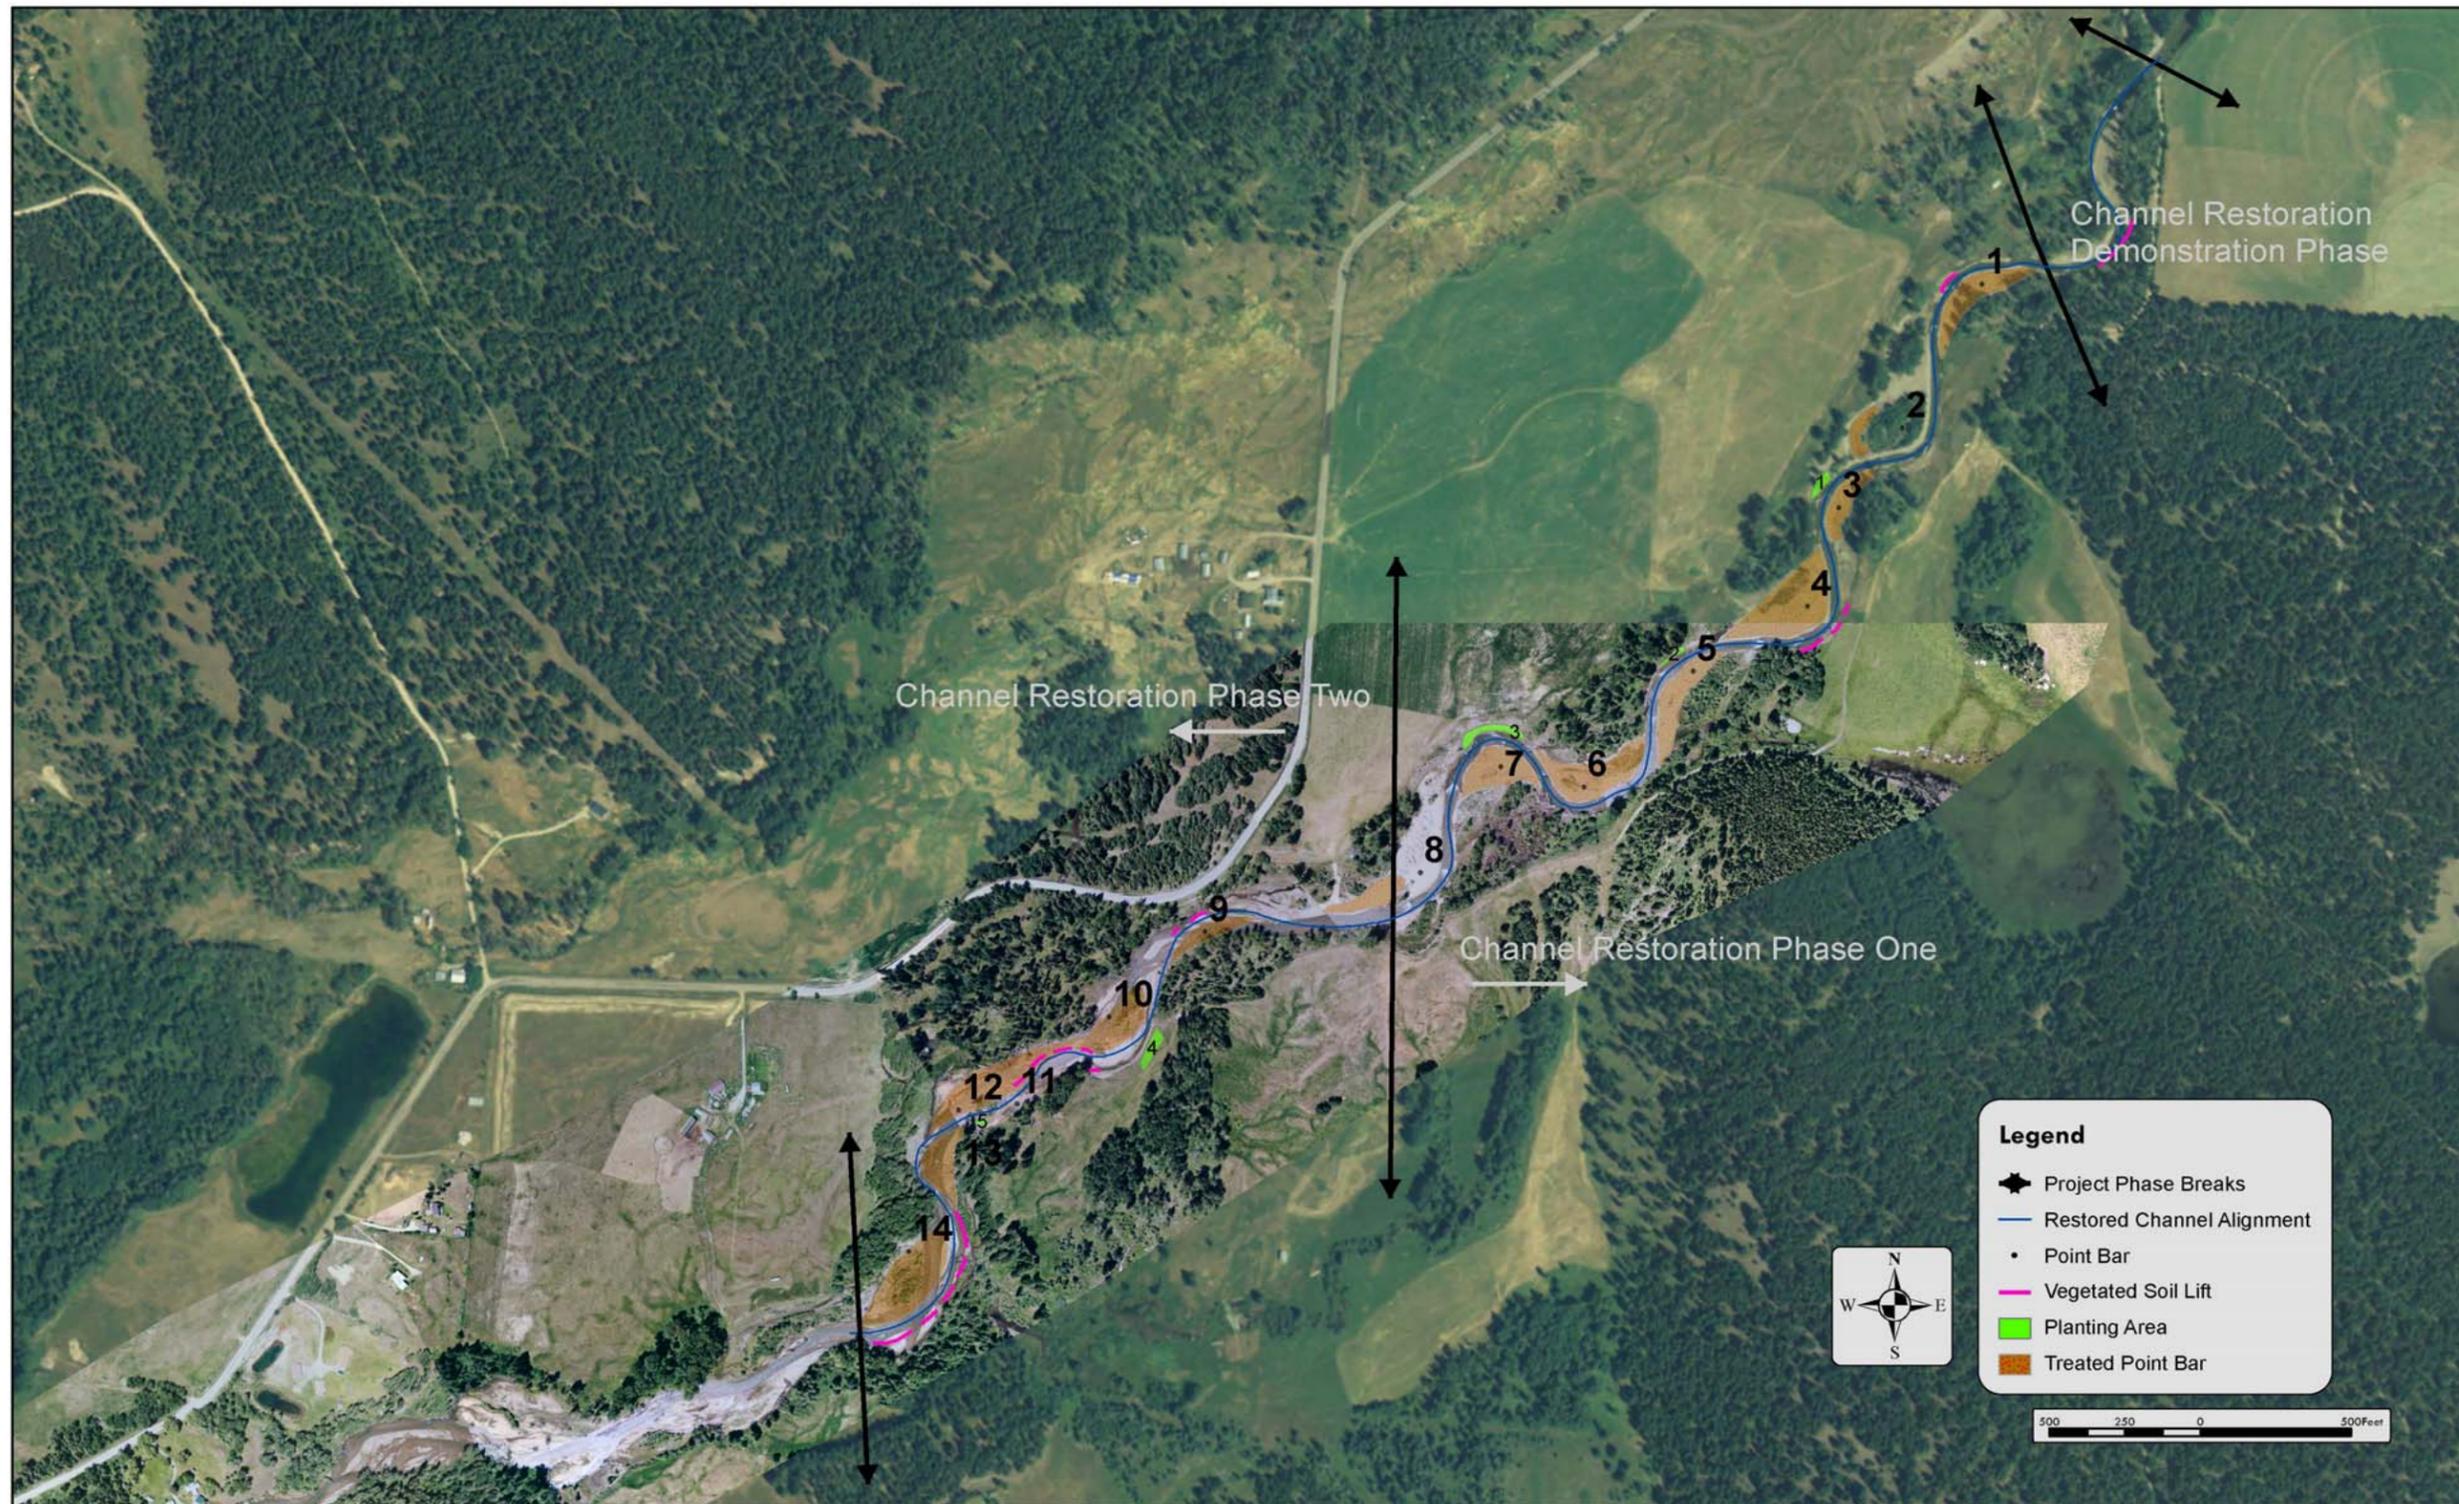
**Figure B- 1.** Locations of revegetation treatments in the Grave Creek project reaches implemented between Fall 2005 and Winter 2006.
