# GRAVE CREEK DEMONSTRATION PHASE RIPARIAN REVEGETATION PLAN

**DECEMBER, 2008**

KOOTENAI RIVER NETWORK  
P.O. BOX 491  
LIBBY, MT 59923

GEUM ENVIRONMENTAL CONSULTING, INC.  
307 STATE STREET, P.O. BOX 1956  
HAMILTON, MT 59840

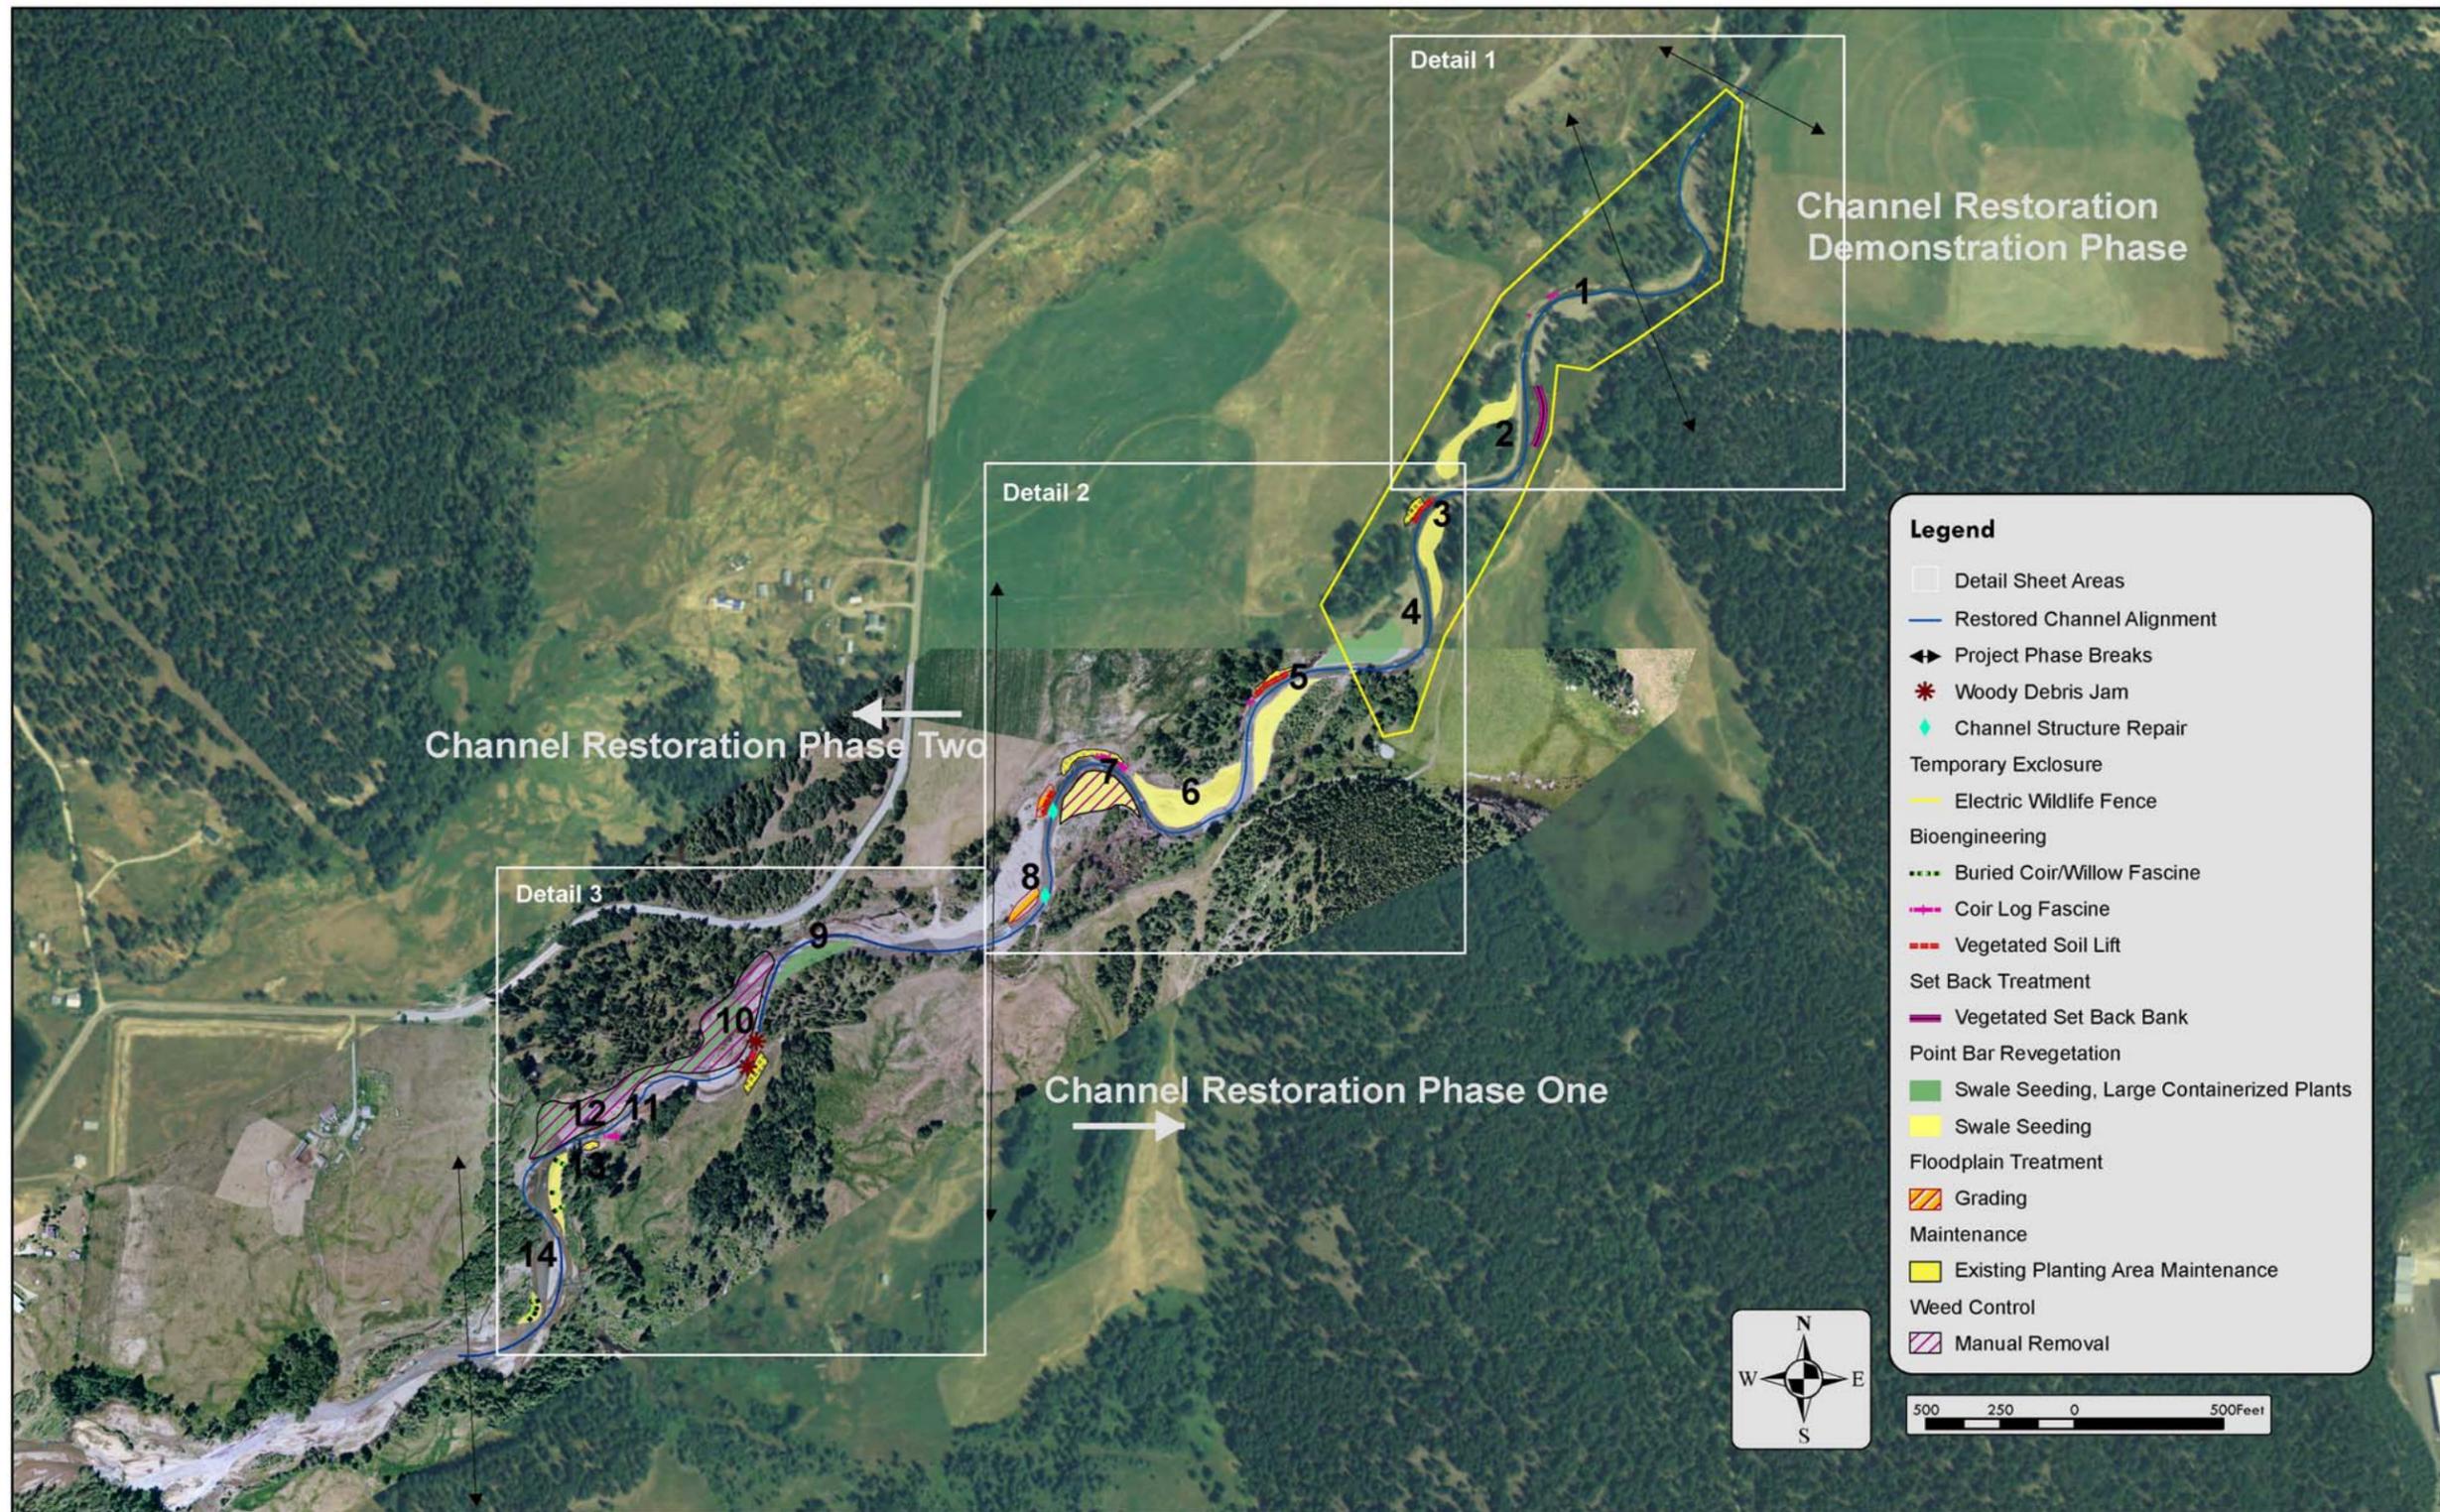
Figure B- 2. Locations of revegetation treatments in the Grave Creek Project reaches implemented during October 2008.
