# TERRIAULT CREEK RIPARIAN REVEGETATION PLAN

KOOTENAI RIVER NETWORK  
P.O. BOX 491  
LIBBY, MT 59923

GEUM ENVIRONMENTAL CONSULTING, INC.  
307 STATE STREET, P.O. BOX 1956  
HAMILTON, MT 59840

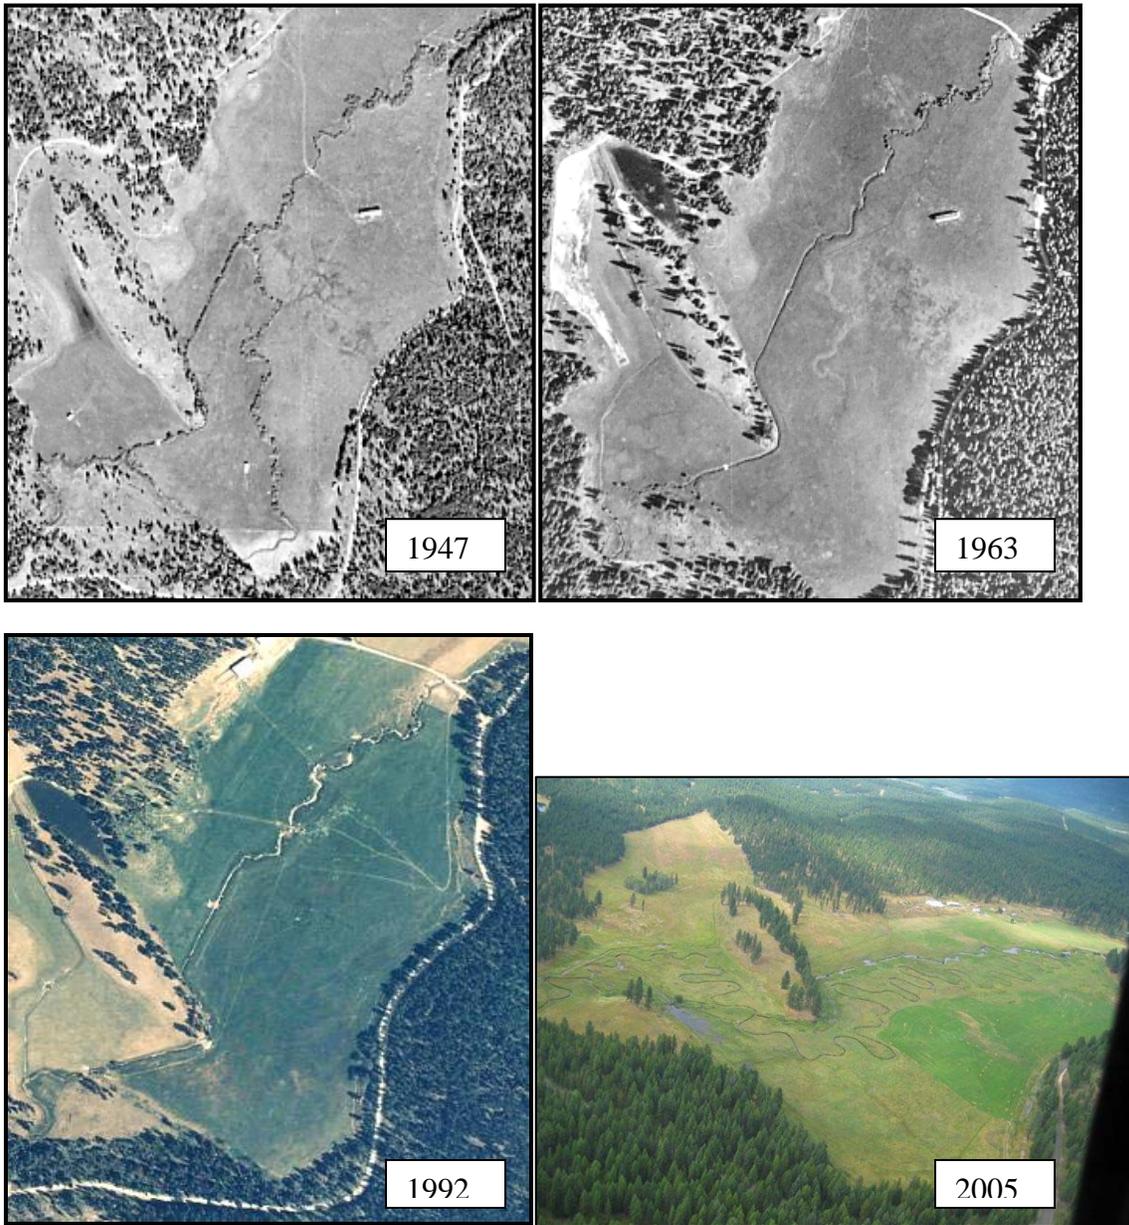
**Figure 1.** Aerial photos of Therriault Creek restoration project reach dated 1947 (upper left), 1963 (upper right), 1992 (lower left) and 2005 (lower right).

Based on data collected in 1999 and 2000 by NRCS, it was estimated that at least 80 percent of the 68 acre meadow within the project reach was historically wetland dominated by willow, alder, and other woody plant communities with wetter inclusions of sedges (NRCS 2000). Restoring this type of diverse riparian and wetland system is the desired future condition of the project reach.

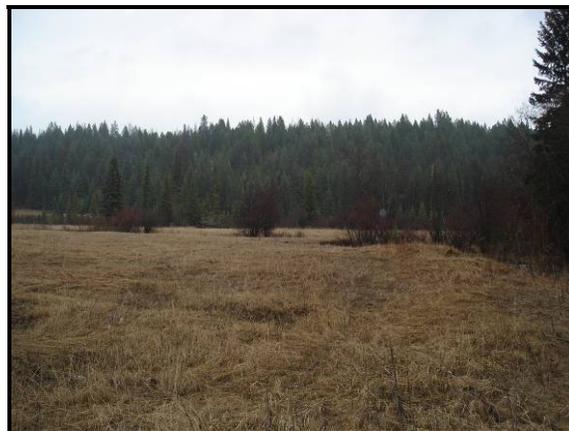
**Figure 2.** Bebb willow plant community along Therriault Creek at upstream end of project reach. Plant community occurs directly along channel (photo right and center) on floodplain benches.

The Bebb willow plant community occurs directly adjacent to the channel at the upstream end of the project reach (upstream of the property access road) (Figure 2). The Bebb willow community type is a common riparian plant community in northwestern Montana (Hansen et al. 1995). Bebb willow (*Salix bebbiana*) is the dominant shrub species in this plant community with lesser amounts of Geyer willow (*Salix geyeriana*) and sandbar willow (*Salix exigua*). Bebb willow communities often represent a browsing/grazing disclimax of the Geyer willow dominant habitat type (Hansen et al. 1995). A Geyer willow habitat type may represent the potential natural community for the upstream portions of the project reach. The stream channel appears to have incised through this reach resulting in loss of connectivity with the floodplain and reduced the extent of riparian vegetation. The plant community occurs on low elevation benches that have formed along the channel at the incised elevation. These benches are supporting willows and other native shrubs, sedges, forbs and grasses. In addition, this section of channel was planted with containerized shrubs and dormant willow cuttings during initial restoration efforts. Planted shrubs are surviving where they were installed on the low floodplain benches along the channel.

Overall, this plant community consists of desired species directly along the stream channel; containerized plants and willow cuttings are surviving; and riparian maintenance processes such as deposition and scour, natural recruitment and sufficient hydroperiod are present. Residual surviving shrubs that were planted during initial restoration should be protected from browse and vole predation and competition from grasses and weeds to the extent possible.

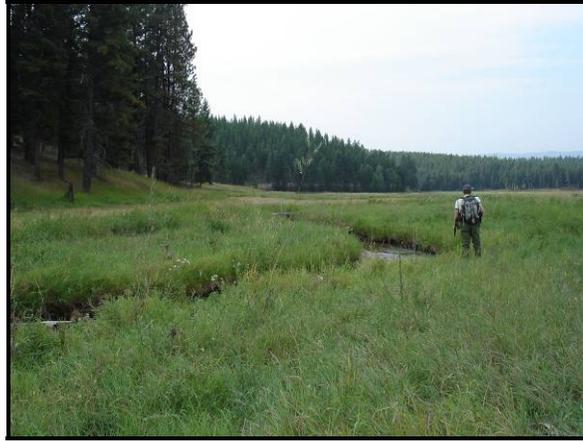
**Figure 3.** Pasture grass plant community along Therriault Creek at upstream end of project reach. Photo shows drier pasture grasses and invasive species that occur on the higher terrace elevation.

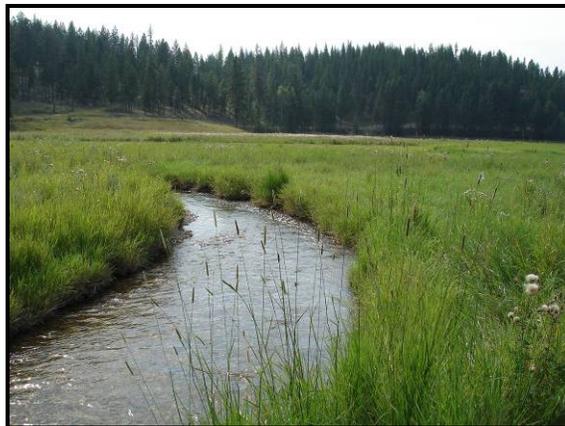
**Figure 4.** Pasture grass plant community along Therriault Creek at upstream end of project reach. Photo shows wetter pasture grass plant community that occurs in floodplain depressions and along the channel.

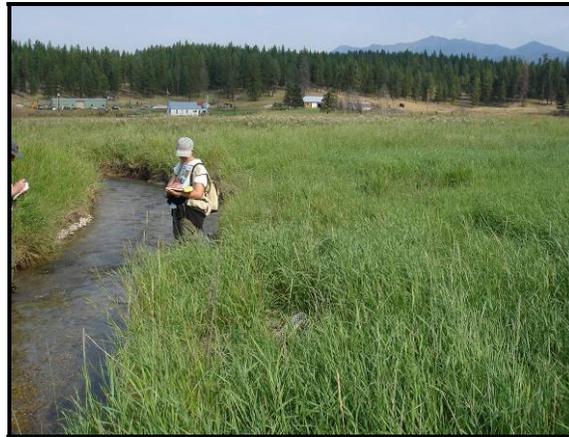
**Figure 5.** Quackgrass plant community along Therriault Creek at upstream end of project reach.

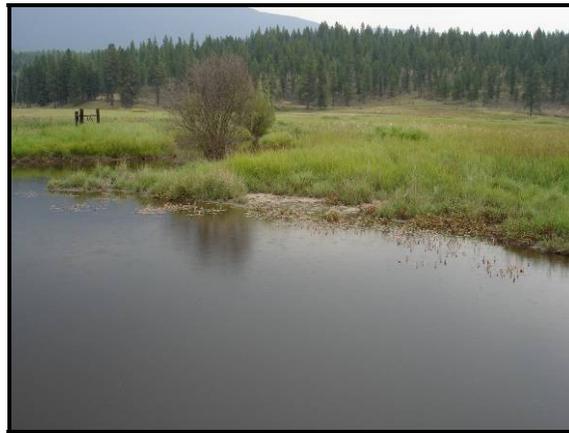
**Figure 6.** Pond plant communities associated with former Therriault Creek channel location.

Various plant communities are associated with the former channel location that has been abandoned and plugged at various intervals, resulting in seasonally and perennially ponded water (Figure 6). The hydroperiod resulting from fluctuations in water levels will determine if these plant communities persist overtime. Plant species occurring in pond plant communities include American mannagrass (*Glyceria grandis*), common cattail (*Typha latifolia*) and softstem bulrush (*Scirpus validus*). Species such as smartweed (*Polygonum spp.*) and common willow-herb were observed growing on downed logs

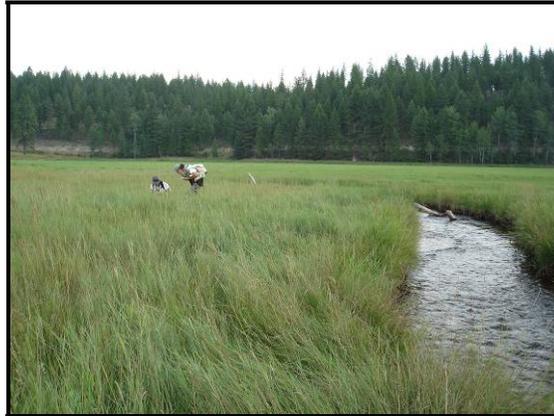
**Figure 7.** Wetter quackgrass plant community along Therriault Creek.

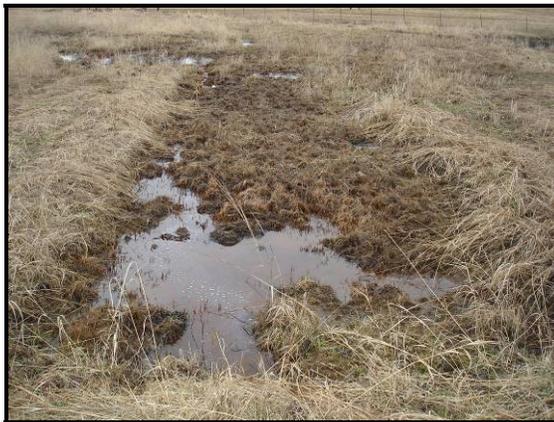
**Figure 8.** Sod excavation area within 'Wetter Quackgrass' plant community observed in winter 2005.

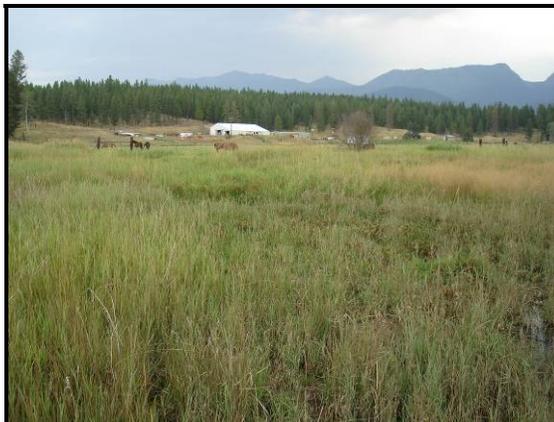
**Figure 9.** Sod excavation area within 'Wetter Quackgrass' plant community where native wet species are colonizing observed in summer 2006.

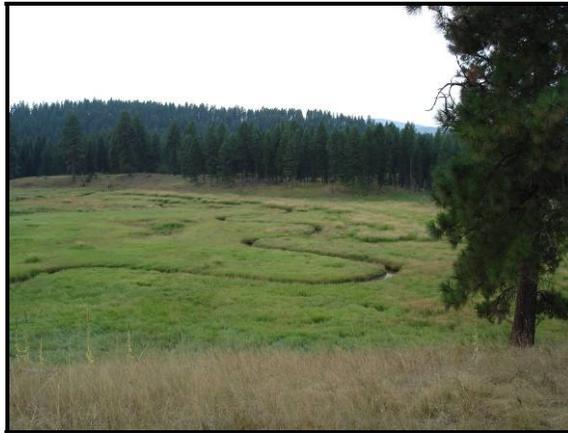
**Figure 10.** Overview of lower portion of reach showing primarily 'Wetter Quackgrass' plant community with inclusions of 'Drier pasture grass' (dull brown) and reed canarygrass (brighter green and slightly taller clumps).

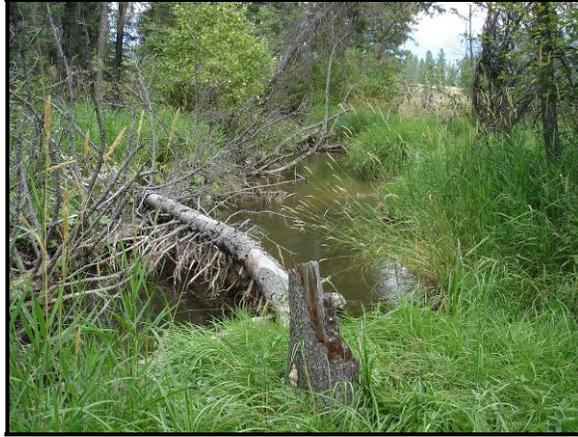
**Figure 11.** Spruce/red-osier dogwood plant community downstream of the project reach.

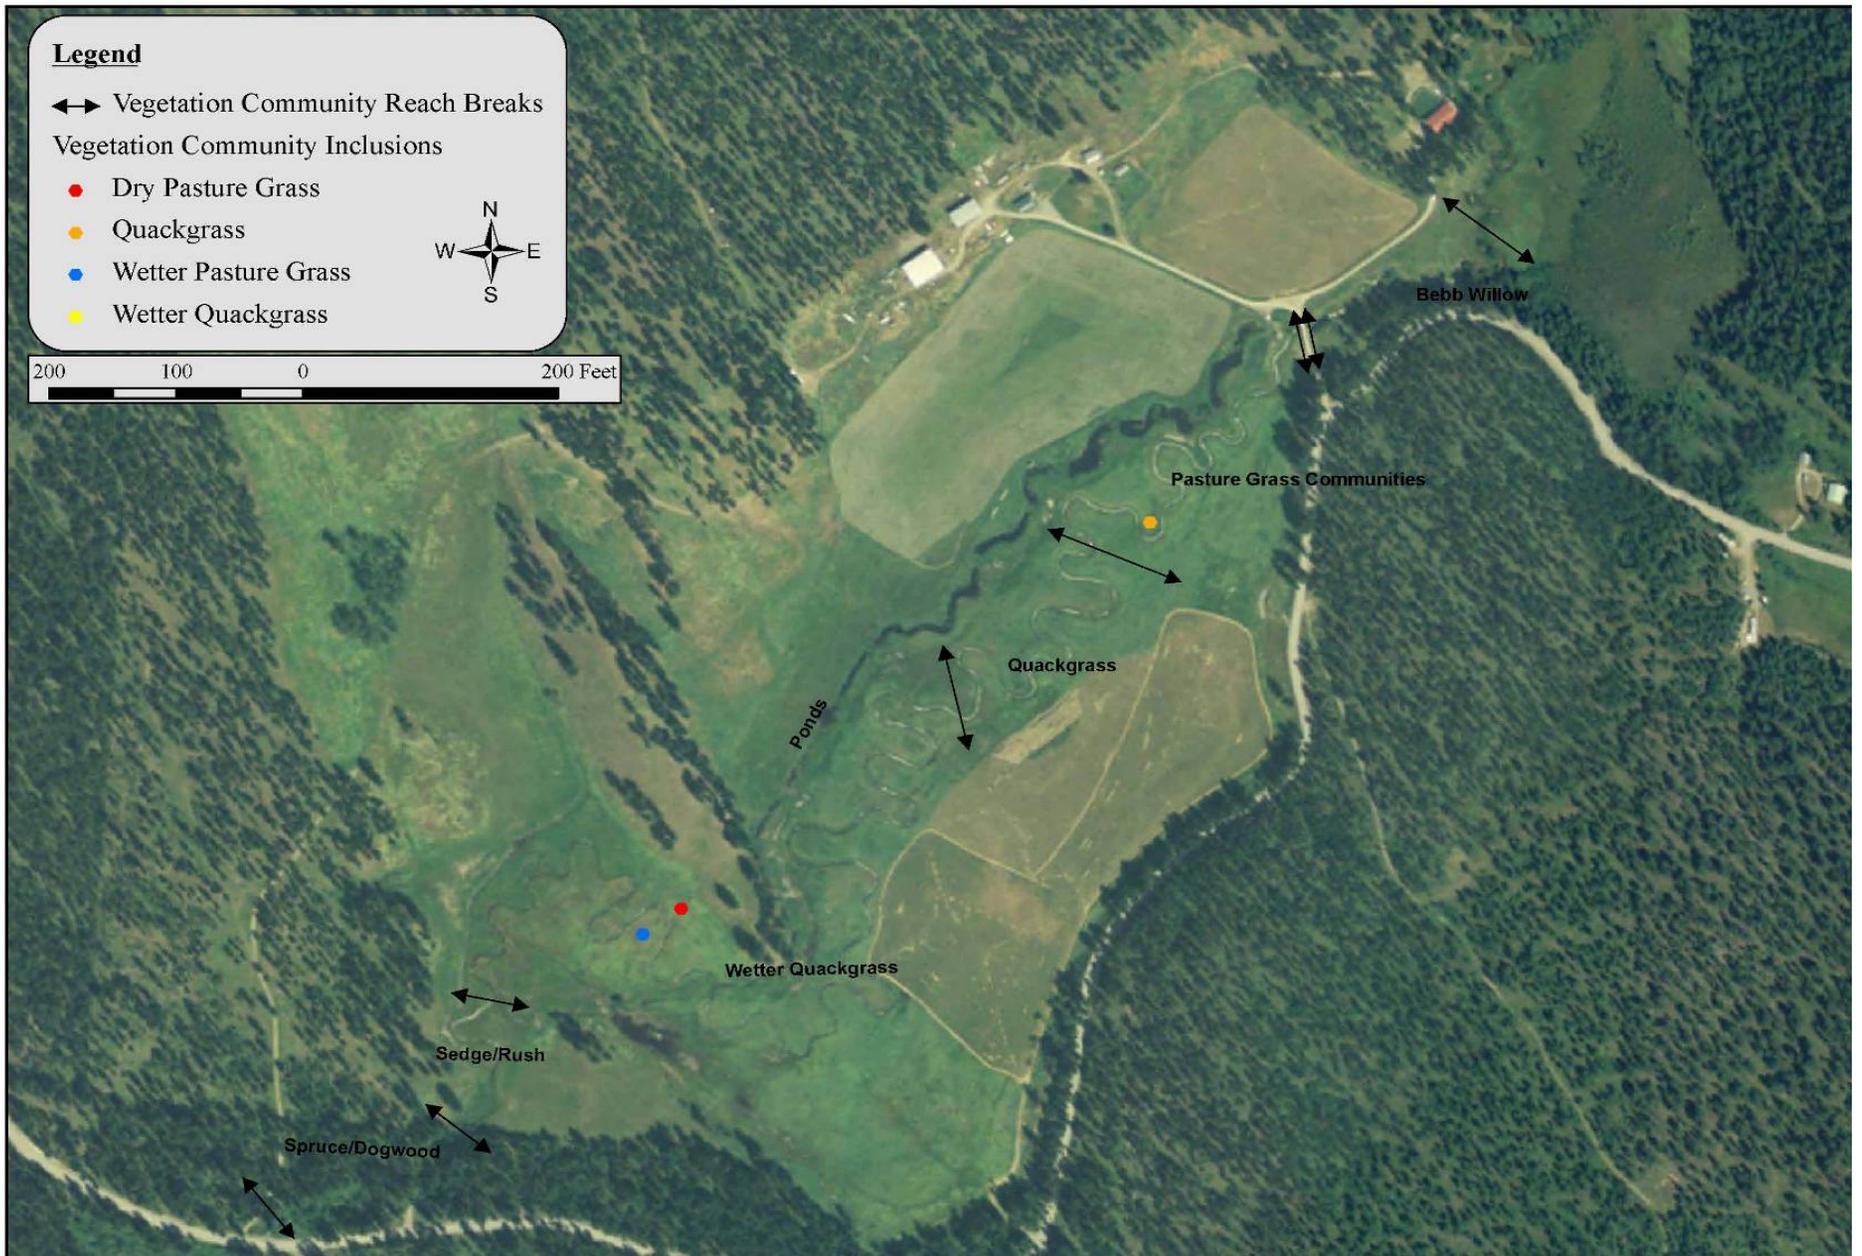
**Figure A-1.** Overview of Therriault Creek project reach showing approximate locations of vegetation community breaks. Colored dots represent inclusions of a different plant community within an areas predominantly another plant community.

This section describes the existing plant communities within the project reach and the restoration strategies and techniques recommended for each plant community. Plant community distribution through the project reach is shown on Figure A-1 in Appendix A. Revegetation treatments for the project reach are shown on Figure C-1 in Appendix C and described in detail in Appendix B.

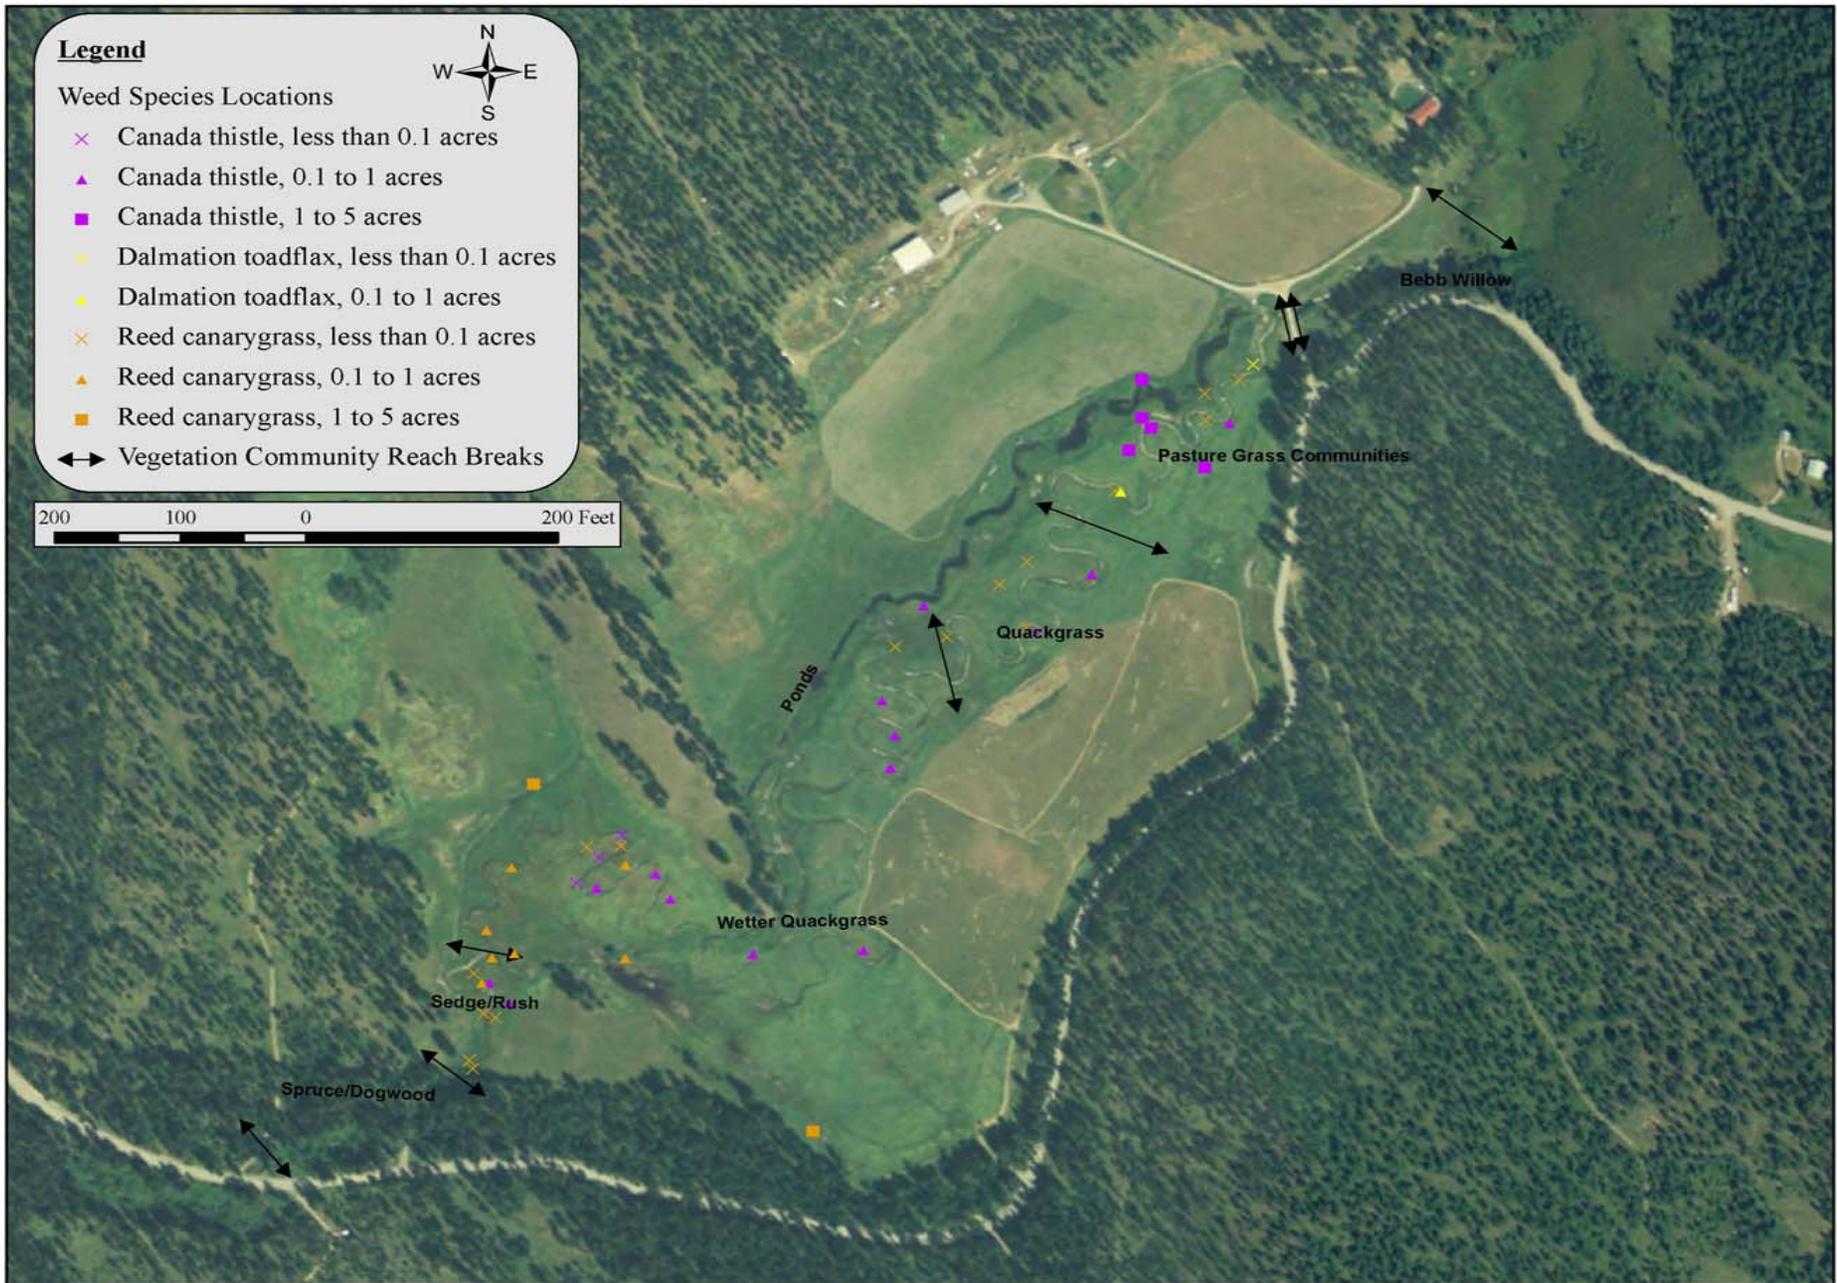
Figure A-2. Overview of Therriault Creek project reach showing approximate locations of weed infestations to target with herbicide application.

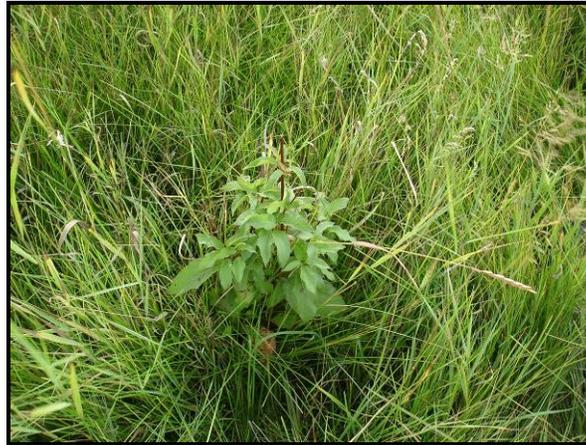
**Figure B-1.** Ungulate browse and grass competition on residual planted shrub.

This treatment includes protecting surviving shrubs planted during initial restoration activities at the site. Many of these surviving shrubs show signs of heavy browse by ungulates (Figure B-1) or girdling by voles. In addition, most shrubs are subject to high levels of competition from aggressive grasses or other invasive species. All residual shrubs that can be located will be protected from browse by securing rigid plastic mesh browse protectors and vole protectors around each plant. In addition, plants will be protected from competition by installing 2' x 2' brush blankets around the base of each plant (Figures B-2 and B-3). These techniques are described in more detailed in the *Containerized Planting* section below. Some containerized willow plants and willow cuttings installed in 2004 and 2005 are exhibiting vigorous growth, and exhibit minimal impact from browse and girdling. These individuals do not need to be protected. All other shrubs and trees that can be located (estimated to be approximately 500) will be protected.

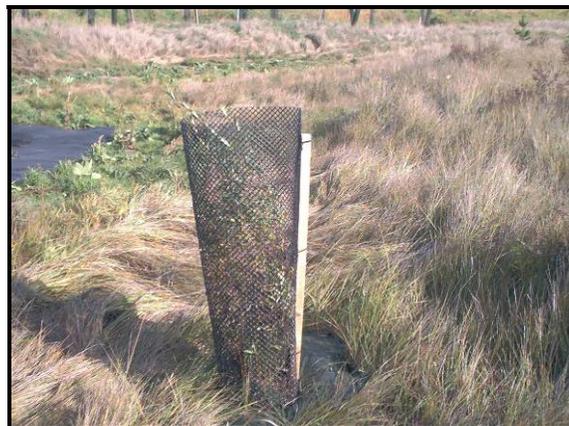
**Photo B-2.** Photo illustrating one gallon shrub installed with mulch mat and browse protection.

Each one-gallon shrub will receive a rigid plastic mesh browse protector and Tubex® vole guard to protect the shrub from browse and girdling. Browse protectors are 4 feet in height and constructed from rigid plastic netting. Netting is secured in place with 2-inch square by 4-foot tall wooden posts and UV stabilized zip ties (Photo 2). Tubex® vole guards are solid rigid plastic tubes that are approximately 8 inches high and whose diameter can be adjusted. Vole guards are pushed or trenched into the ground to ensure that rodents cannot burrow under them. Vole guards will be placed inside of each larger browse protector (Figure B-3). Due to the aggressive grasses present throughout the project reach, approximately 3 inches of bark mulch will be placed within each vole guard to provide protection from weeds at the base of the plant. Bark mulch will also function to create a favorable microclimate for plant growth by retaining soil moisture, moderating soil temperature, and providing organic material which may be lacking in upper layers of the soil due to the agricultural history of the site. In addition to browse protection, a two-foot by two-foot plastic mulch mat will be installed around the base of each one gallon shrub to reduce competition from aggressive grasses and other invasive species (Figure B-2). Five gallon plants should be large enough to resist browse and competition so these plants will not require protection.

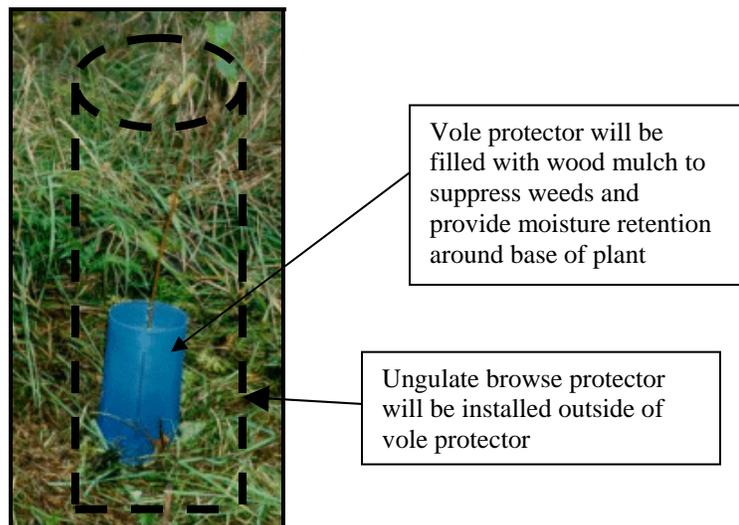
**Figure B-3.** Vole guard protecting base of plant installed inside of a larger ungulate browse protector.

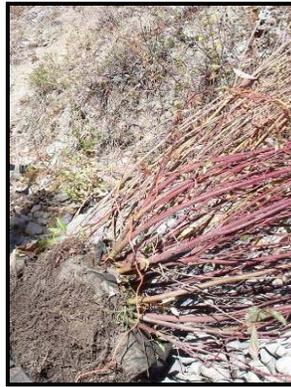
**Figure B-4.** Larger sized plant material, such as this Red-osier dogwood, will be used in select areas along the channel if plant material is available.

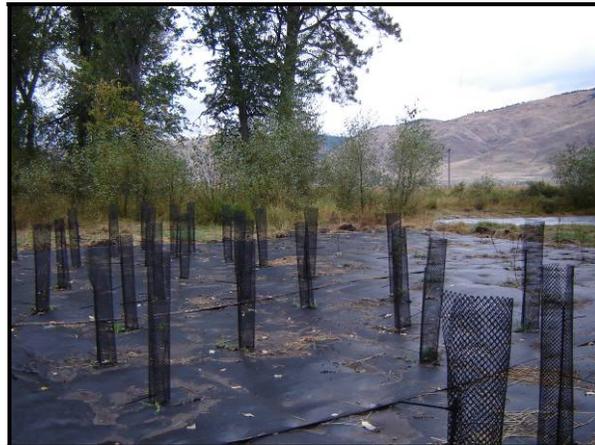
**Figure B-5.** Example of long-term solarization weed barrier treatment planted with containerized shrubs.

The treatment will be used as either a pre-planting treatment (temporary) or as barrier treatment where plants will be installed through the material (long-term) (Figure B-5). A total of 0.5 acres (0.4 acres temporary and 0.1 acres long-term) within the project reach will be treated with solarization. Long-term solarization planting sites, functioning as a weed barrier treatment, will be located on outer meanders and planted through using one-gallon shrubs. Within long-term solarization areas, shade cloth should remain for up to three growing seasons or until shrubs have become established. When shade cloth is removed, the area should be seeded with the seed mix provided in Table B-2. Five temporary and two long-term solarization areas will be installed as a pre-planting treatment or as a weed barrier treatment to completely eradicate small areas of invasive species. If used as a pre-planting treatment, the fabric should be left on the ground for at least half of the growing season before removing the fabric. Only temporary solarization sites should be seeded with native wetland forbs and grasses prior to placement of shade cloth.

Treatment sites should be covered with two side-by-side strips of 15-foot wide fabric laid out on the floodplain, with three feet of the fabric overlapping. Each strip will be approximately 50 feet long. It may be necessary to mow the sites prior to placing the fabric to ensure the fabric can be effectively secured to the ground. Fabric is typically secured using eight inch by two inch metal staples. For long-term, planted, sites, the outside edges of the fabric will need to be buried or trenched into the ground with at least one foot of the fabric buried or trenched. For temporary sites, the fabric should not be trenched to make moving fabric to new locations easier.

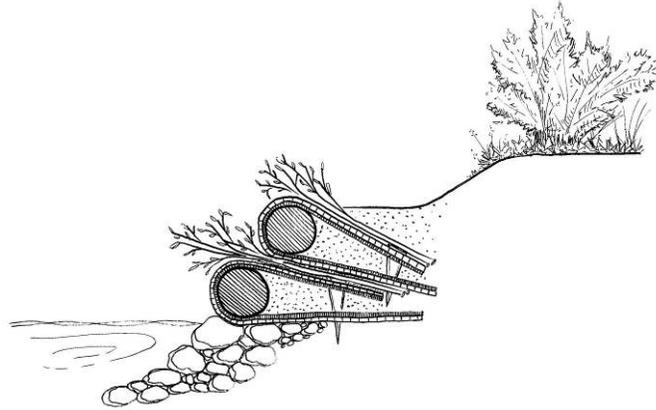
**Figure B-6.** Profile view drawing of vegetated soil lift treatment.

Vegetated soil lifts are proposed at two sites along outer meander bends near the upstream end of the project where there is risk of channel avulsion into the abandoned Therriault Creek channel. Vegetated soil lifts are a revegetation and bank construction technique that combines layers of dormant willow cuttings with fabric-wrapped soil to revegetate and stabilize stream banks (Figures B-6 and B-7). Soil is wrapped within two layers of biodegradable coconut fiber (coir) fabric, to hold the soil in place while vegetation becomes established in the relatively high stress land/water interface. Soil lifts, combined with a bankfull bench, will result in near bank areas where native woody vegetation can become established. To increase success, the face of the bottom soil lift should be reinforced with an aspen excelsior log or other suitable material to help maintain the lift shape, keep fine soil particles from filtering out through the lift face, and maintain surface tension. The uppermost soil lift should be filled with salvaged sod or seeded with the seed mix developed for the site.

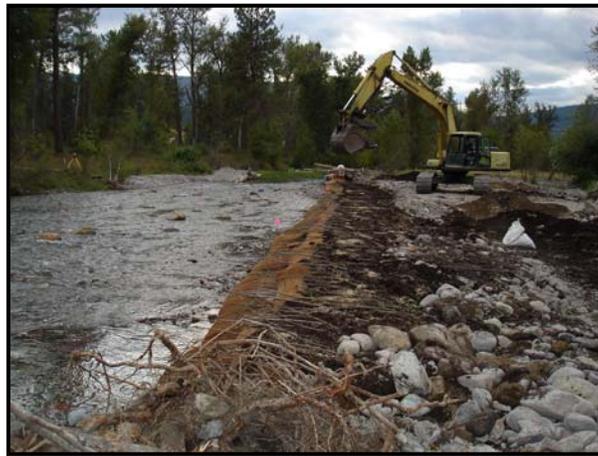
**Figure B-7.** Photograph showing vegetated soil lift treatment immediately after installation.

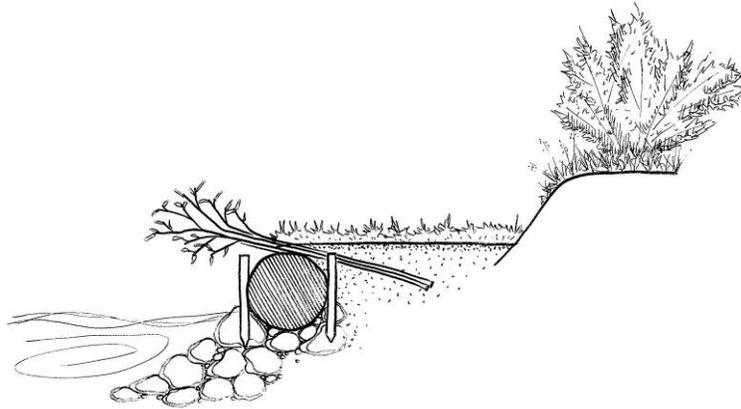
**Figure B-8.** Profile view drawing of coir log treatment.

This technique includes placement of coir logs, combined with dormant willow cuttings, at the toe of stream banks along selected outer meander bends. The purpose of this treatment is to establish woody vegetation along the channel in areas where competition from invasive species is less; in this case, below the bankfull water elevation. Coir log fascines are pre-constructed bioengineering components designed for use at the land/water interface (Figures B-8 and B-9). Coir log fascines have a synthetic (polyethylene) mesh or natural fiber netting that contains high-density coir (coconut fiber) bales. Coir is used for bioengineering because it stores water for long periods, and its durable fibers trap sediment and mimic soil matrices formed by living roots. Coir biodegrades over approximately five to seven years, thus providing a stable growing medium while native riparian plants become established. Coir log fascines can be placed within the existing channel to create the toe of new channel banks and allow a narrower channel to be created. New banks are created behind the coir log fascines by filling the area with cobble and soil. These areas can then be planted with woody vegetation.

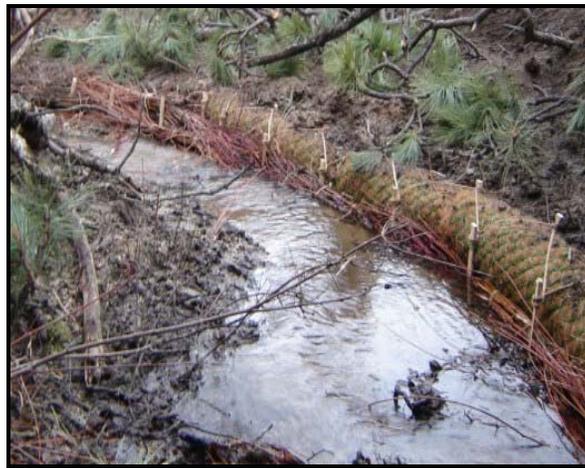
**Figure B-9.** Photo of installed coir log installed at the toe of a slope in conjunction with willow fascines (bottom).

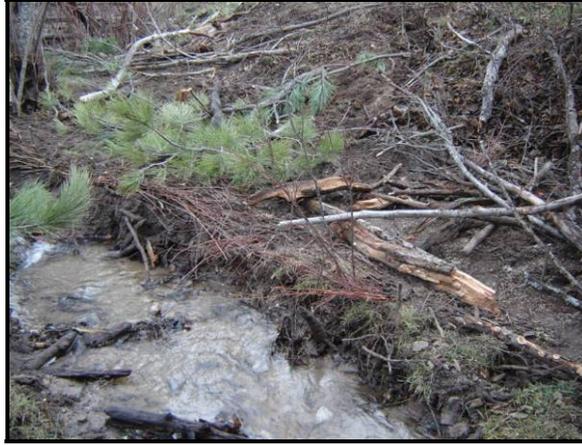
**Figure B-10.** Example of live willow fascines buried in the floodplain parallel to the stream. The ends of the fascines hang over the newly constructed bank.

Live willow fascines are willow cuttings tied together to form a linear bundle. This treatment is proposed for recent depositional areas within the channel. Due to the mobility of sediments in these areas, it will be necessary to bury or otherwise anchor the fascines. Live willow fascines can be buried parallel to the stream in depositional areas (Figure B-10), perpendicular to the stream in floodplain areas, or used in conjunction with coir log treatments.

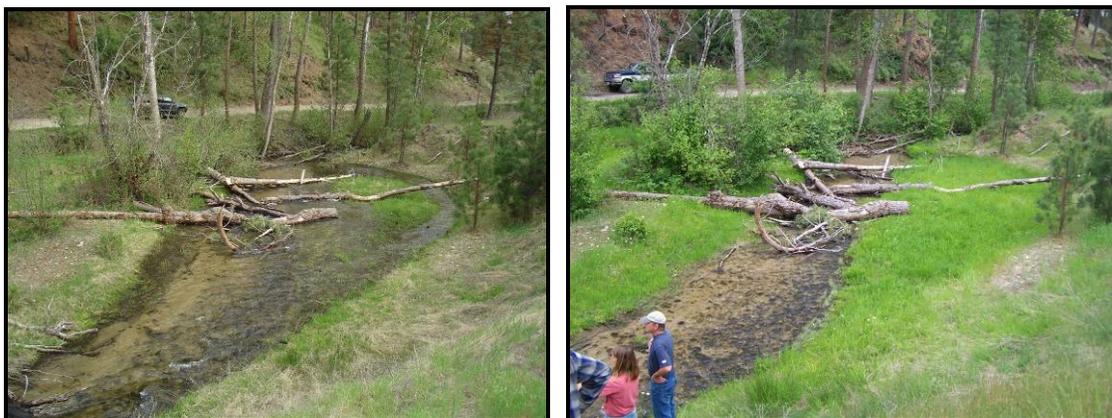
**Figure B-11.** Example of large woody debris placed in stream channel resulting in increased inundation of adjacent floodplain during high flows (left) to stimulate natural riparian revegetation processes and during low flows (right) to provide habitat. Willow seedlings recruited naturally into high flow side channel after one spring.

This technique includes placing large woody debris in select locations of the channel to enhance habitat and provide roughness features to encourage over-bank flooding and retention of flood waters in adjacent floodplain and riparian areas. This technique can be used as a method to restore riparian and wetland hydrology, thereby creating conditions that will better support native riparian vegetation (Figures B-11 and B-12). Ideal materials for this project are whole logs and trees with limbs, branches and root wads attached. Only portions of the whole trees are placed in the channel, mimicking the natural process of trees falling into a stream, and reducing the need to either anchor or bury trees to keep them in place. This will also maximize habitat benefits because portions of each structure will interact with all stages of streamflow and extend into adjacent riparian habitat.

Between three and five woody debris structures, with four to six trees each, are proposed for Therriault Creek. Approximate structure locations are shown on Figure C-1 in Appendix C. Structures will be placed between 50 and 100 feet apart in a short reach near the downstream end of the project. This reach is located within the ‘Wetter Quackgrass’ plant community. Within this reach, small patches of reed canarygrass and other invasive species are colonizing drier microsites, and desirable species, such as sedges and rushes, are colonizing wetter microsites within the floodplain. At the same time, very little natural recruitment of woody plants is occurring. The purpose of this technique will be to increase floodplain wetness to encourage establishment of sedge and rush communities and create conditions within and along the channel for natural recruitment of desirable woody shrubs.

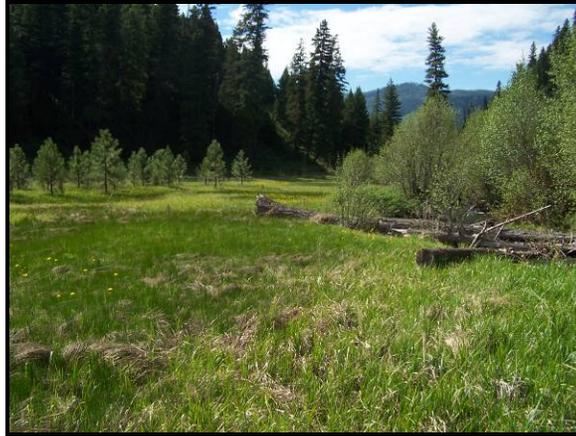
**Figure B-12.** Example of conversion from agricultural grasses and invasive species including timothy, Red top, tansy and Canada thistle to diverse sedge and rush meadow in response to placement of large woody debris in the channel (photo right) and resulting increased floodplain inundation.

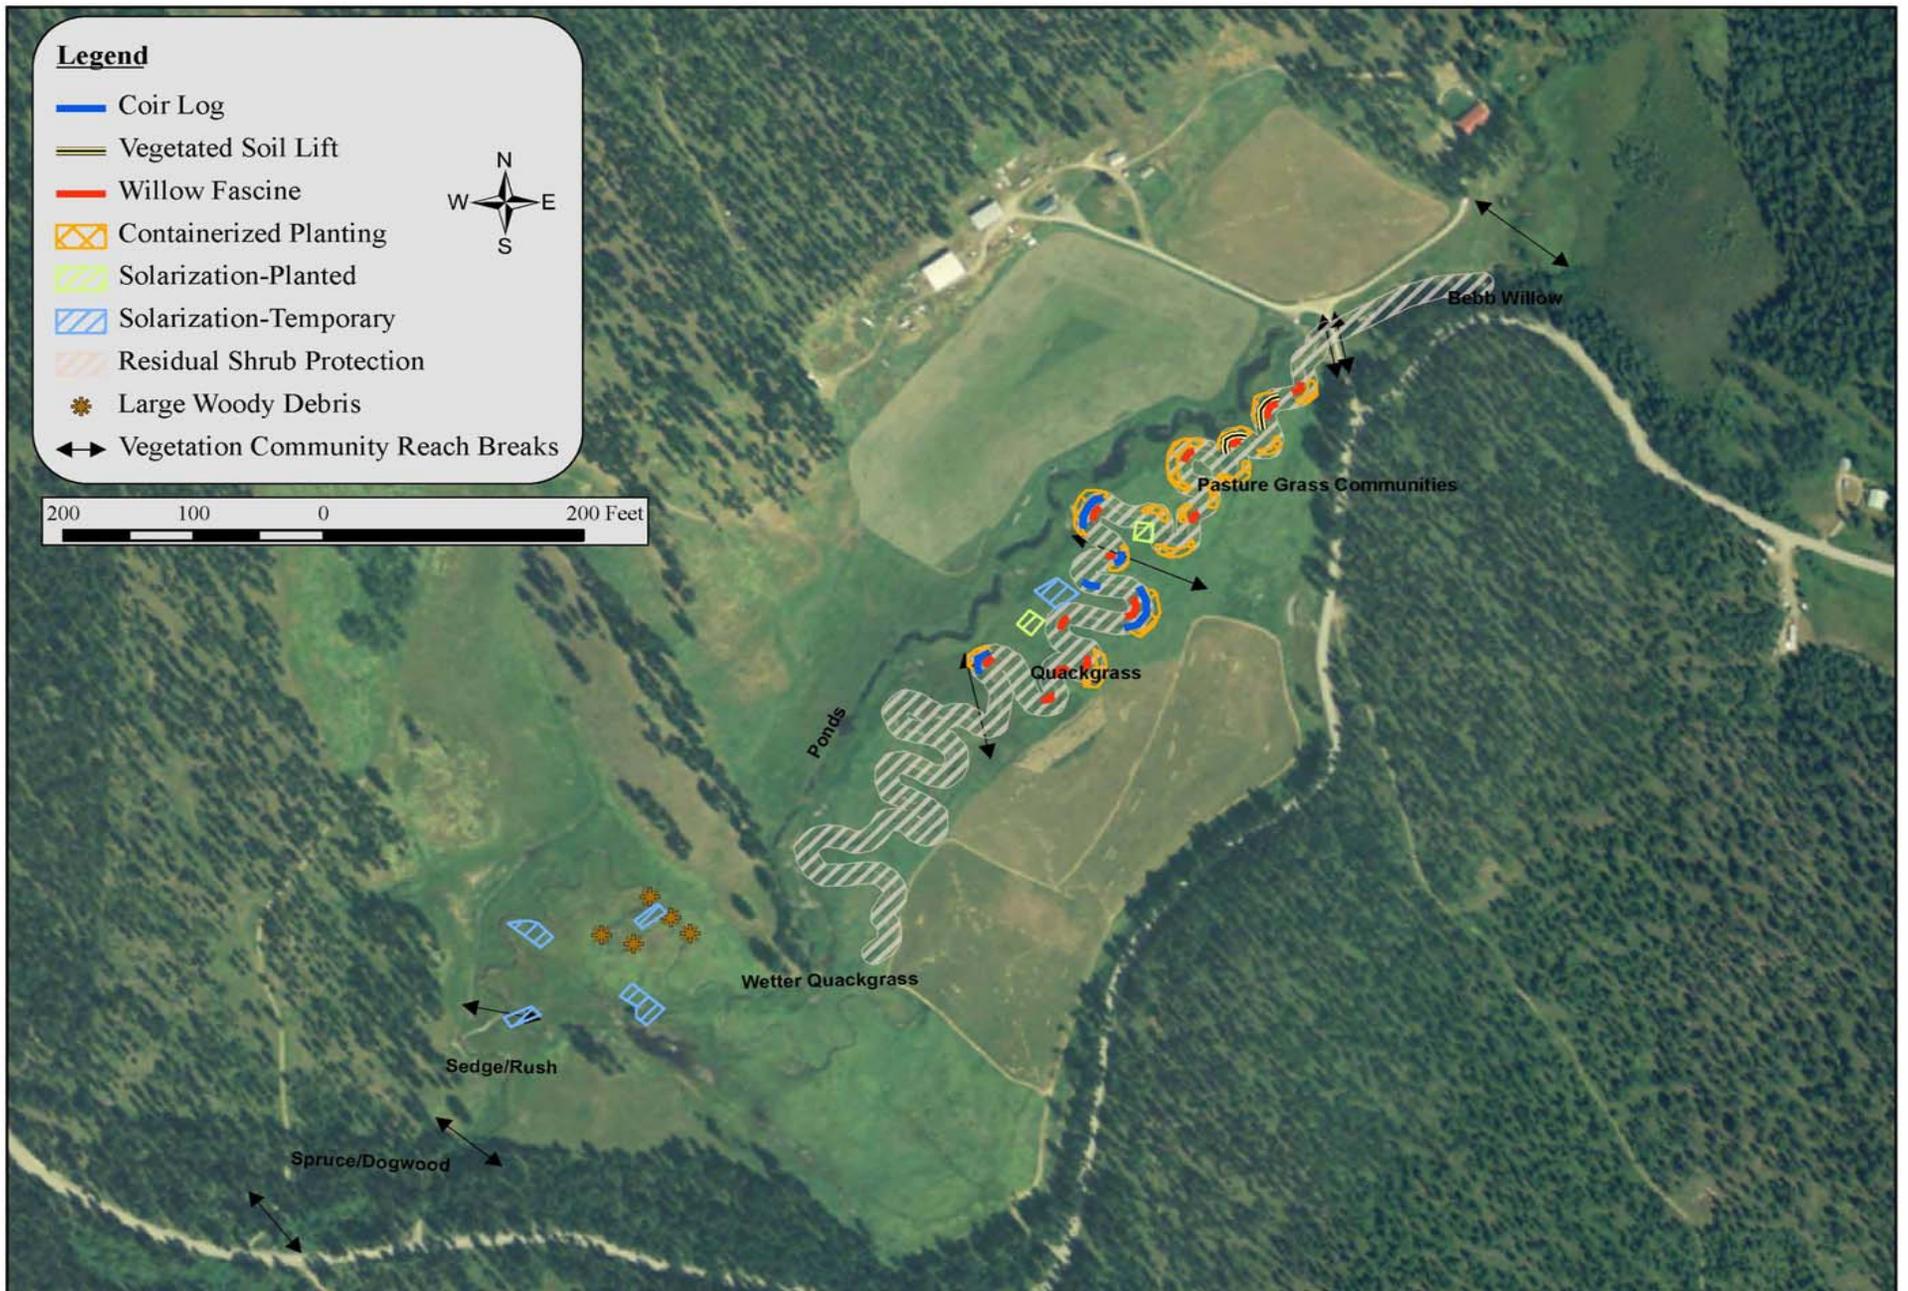
Figure C-1. Overview of Therriault Creek project reach showing locations of revegetation treatment.
