# Milltown Dam Floodplain Restoration – Status Update

**Amy Sacry, Restoration Ecologist**  
**Geum Environmental Consulting**  
**Hamilton, Montana**

### Restoration Plan for the Clark Fork River and Blackfoot River near Milltown Dam

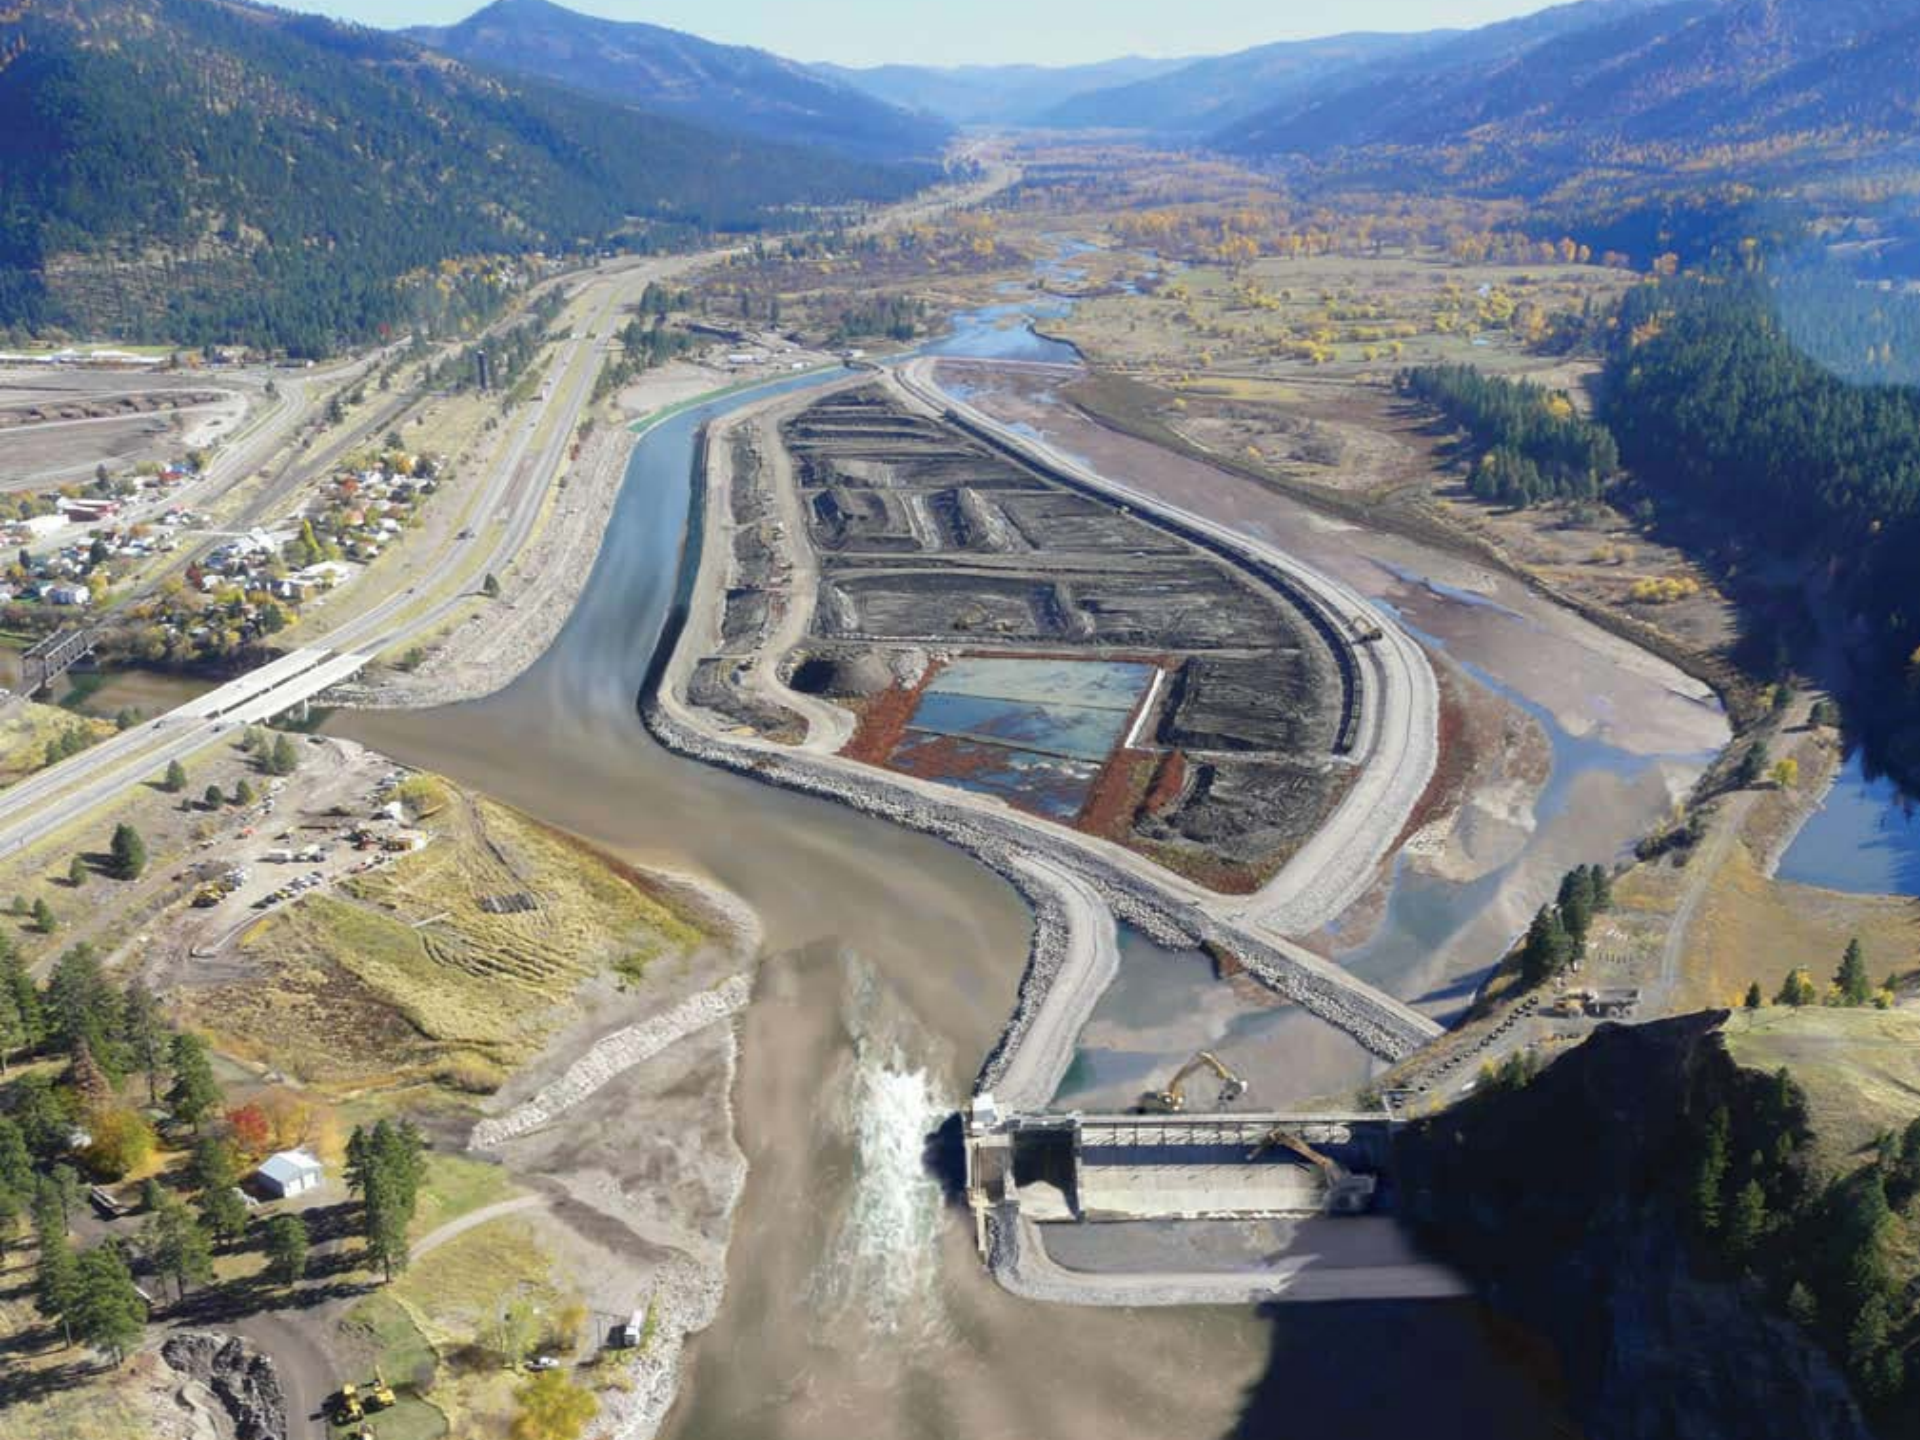
## Grading Plan

- Main Channel
- Secondary Channel
- Point Bar
- Wetland
- Bankfull Floodplain (bankfull elevation to 2 ft. above bankfull)
- Low Terrace (2 to 3 ft. above bankfull)
- High Terrace (greater than 3 ft. above bankfull\*)
- Existing Floodplain Surface (to remain undisturbed)
- Deer Creek Tributary (pending final design)
- Existing Spring
- Existing Secondary Channel

\*Final elevation to be determined based on final cut/fill quantities.

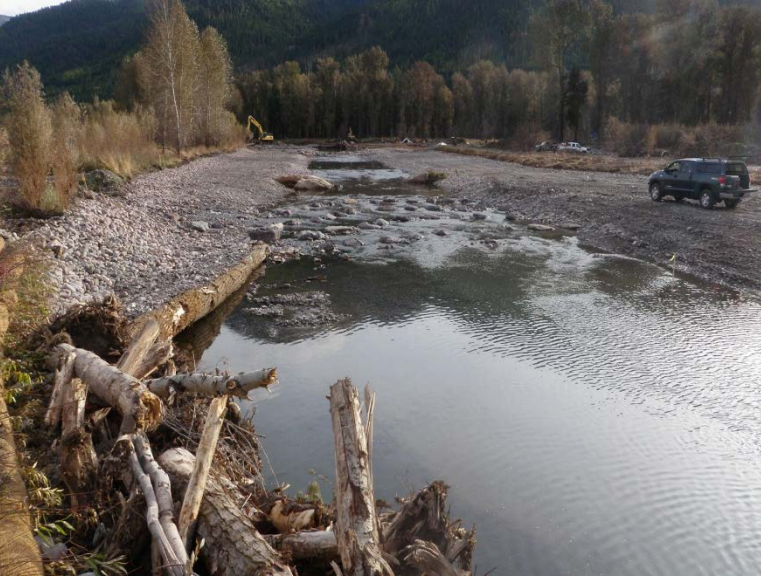
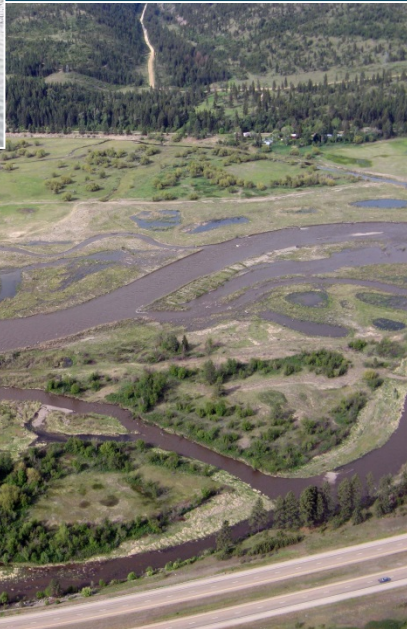
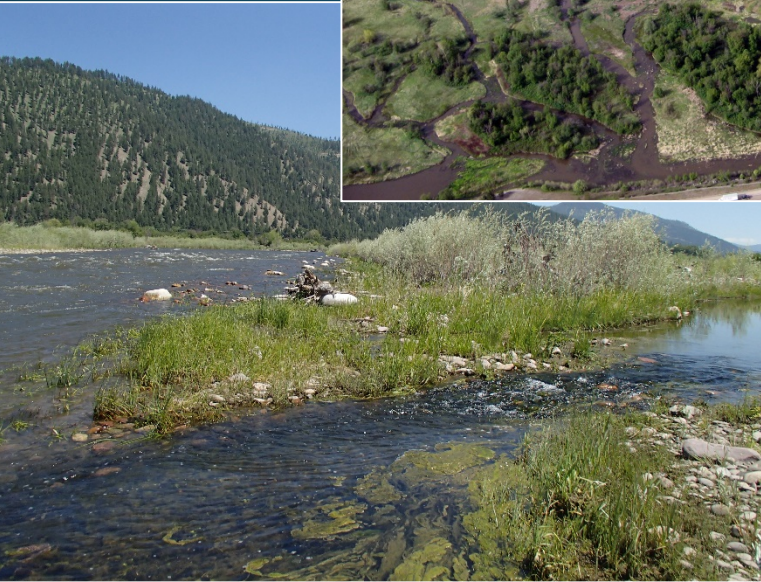
# Design for Deformability

- Select hydraulic criteria from flood events less than 100-yr
- Design bank toe protection at depths less than scour
- Use biodegradable fabrics, plant material and wood
- Use round v. angular rock
- Allow bed mobility
- Integrate side channels
- Maintain floodplain connectivity at less than  $Q_2$

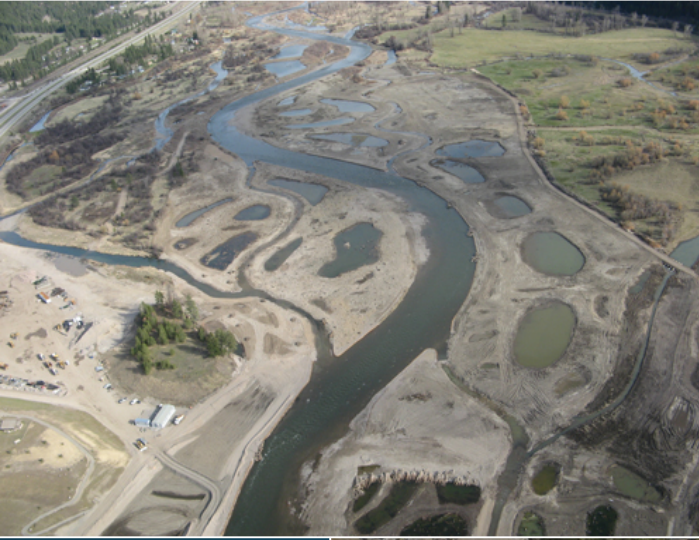
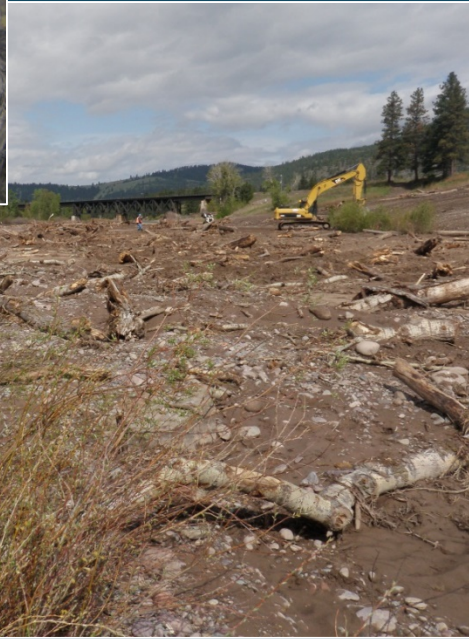
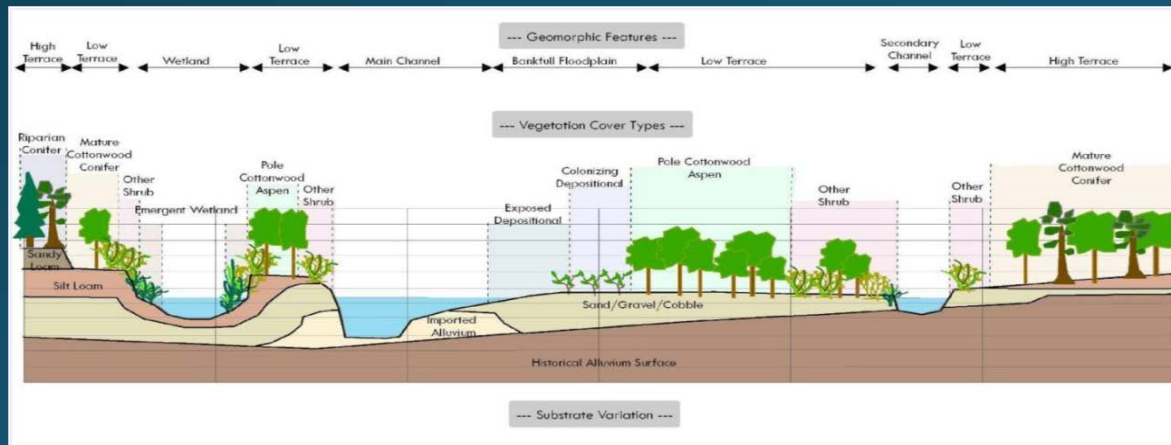
# Design for Floodplain Diversity

- Vary geomorphic surfaces
- Vary substrates to mimic floodplain stratigraphy
- Maximize floodplain surface roughness
- Construct large and small depression features
- Maintain floodplain connectivity at less than  $Q_2$

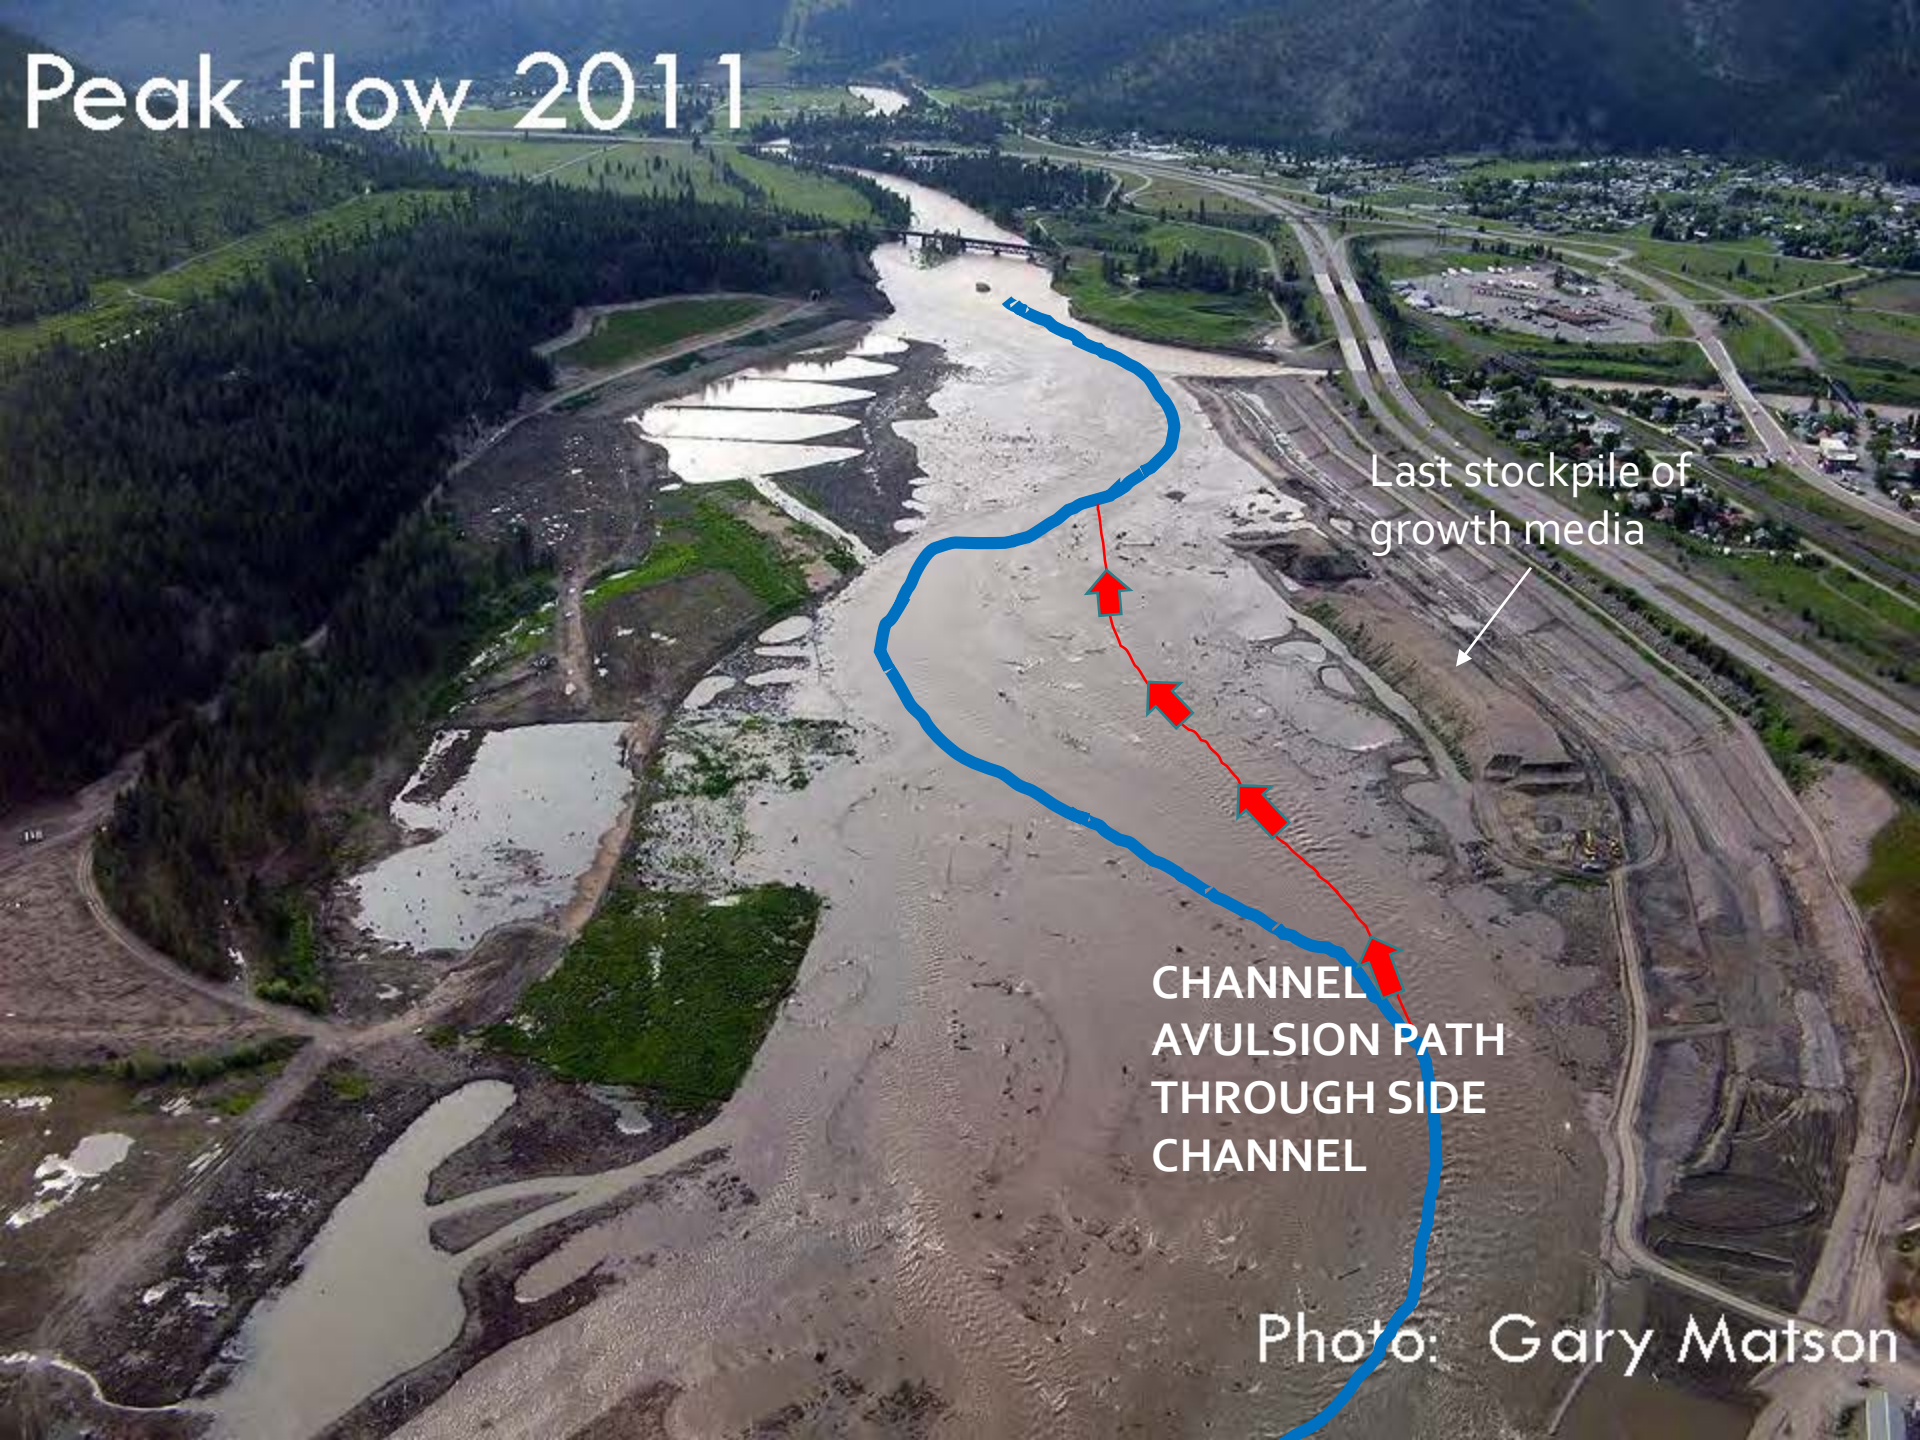
Last stockpile of  
growth media

CHANNEL  
AVULSION PATH  
THROUGH SIDE  
CHANNEL

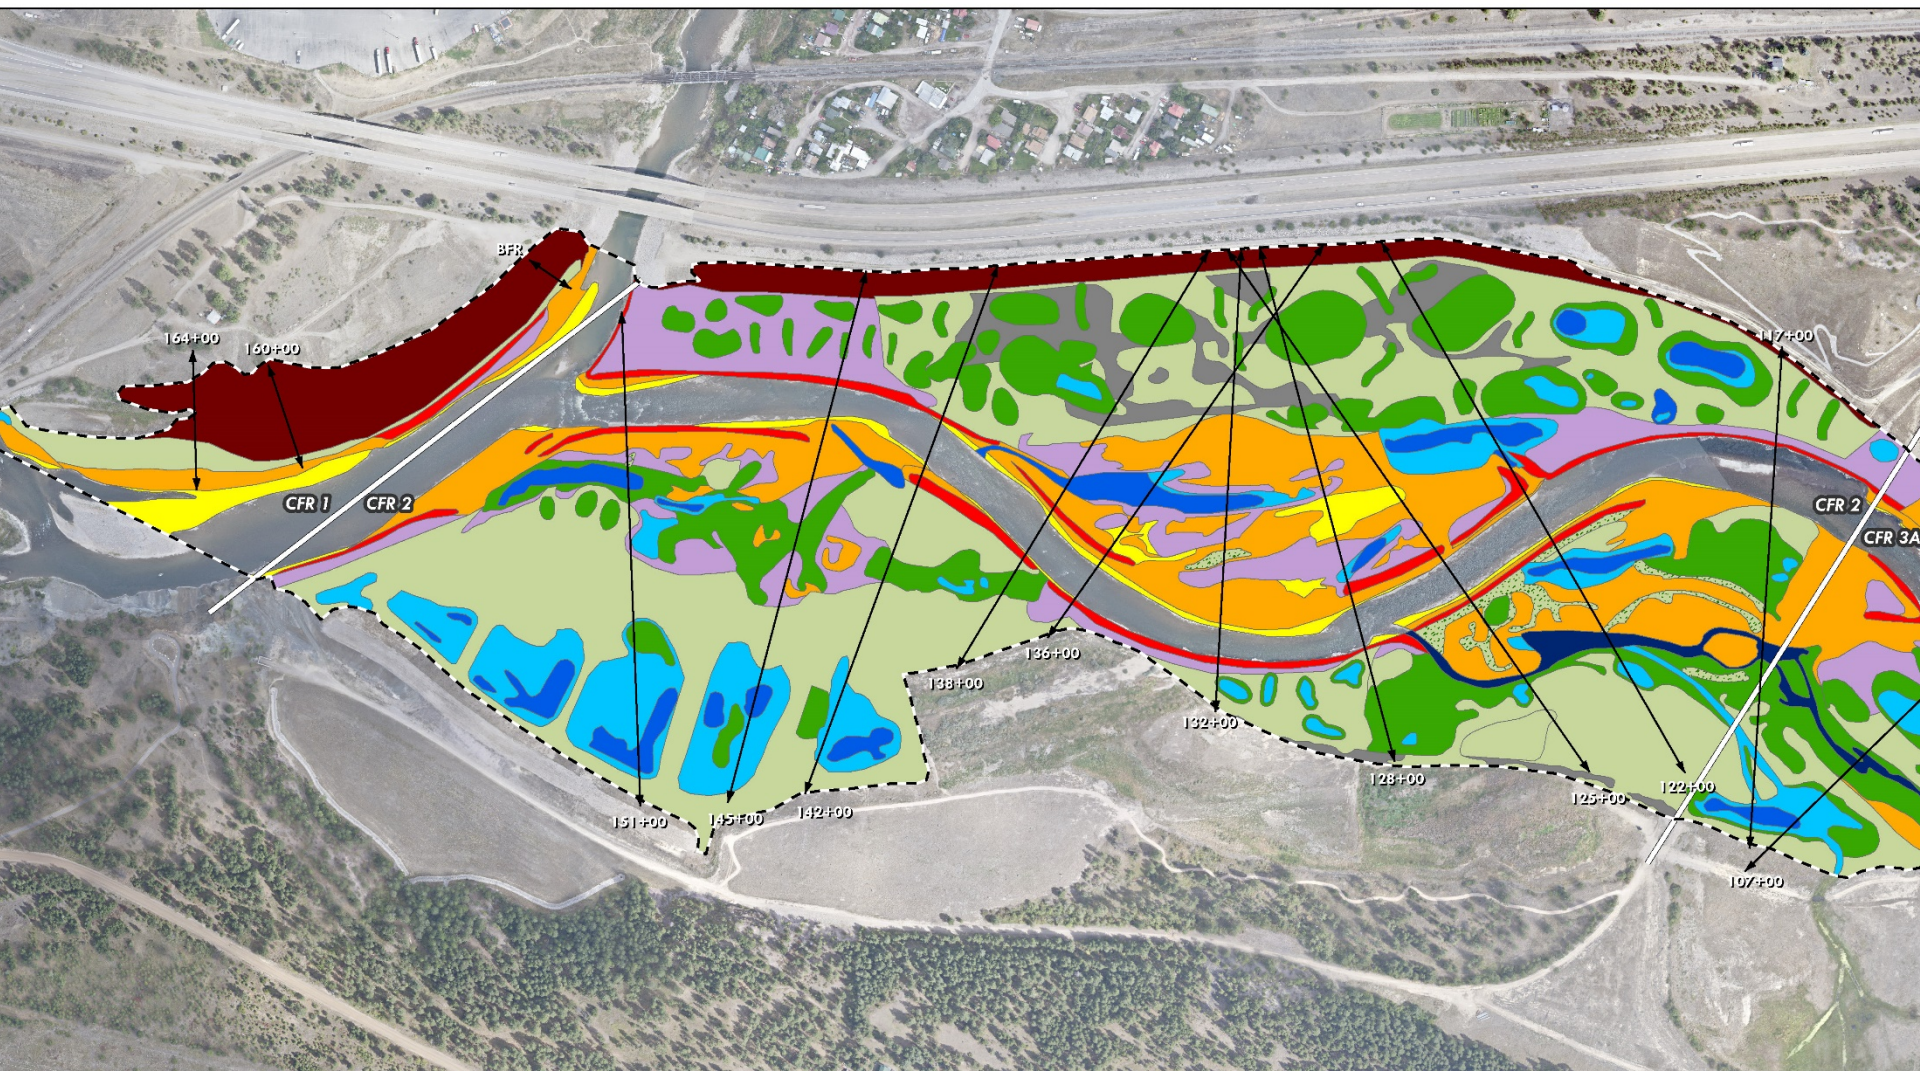
# FLOODPLAIN TRANSECTS

FLOODPLAIN VEGETATION TRANSECT

PROJECT REACH BREAK

CONSTRUCTION EXTENTS

MILLTOWN - CFR 1 & 2
