# Grave Creek Riparian Revegetation 2011 Implementation Report

## Task Order #1008

Kootenai River Network  
P.O. Box 491  
Libby, MT 59923

Geum Environmental Consulting, Inc.  
307 State Street  
Hamilton, MT 59840

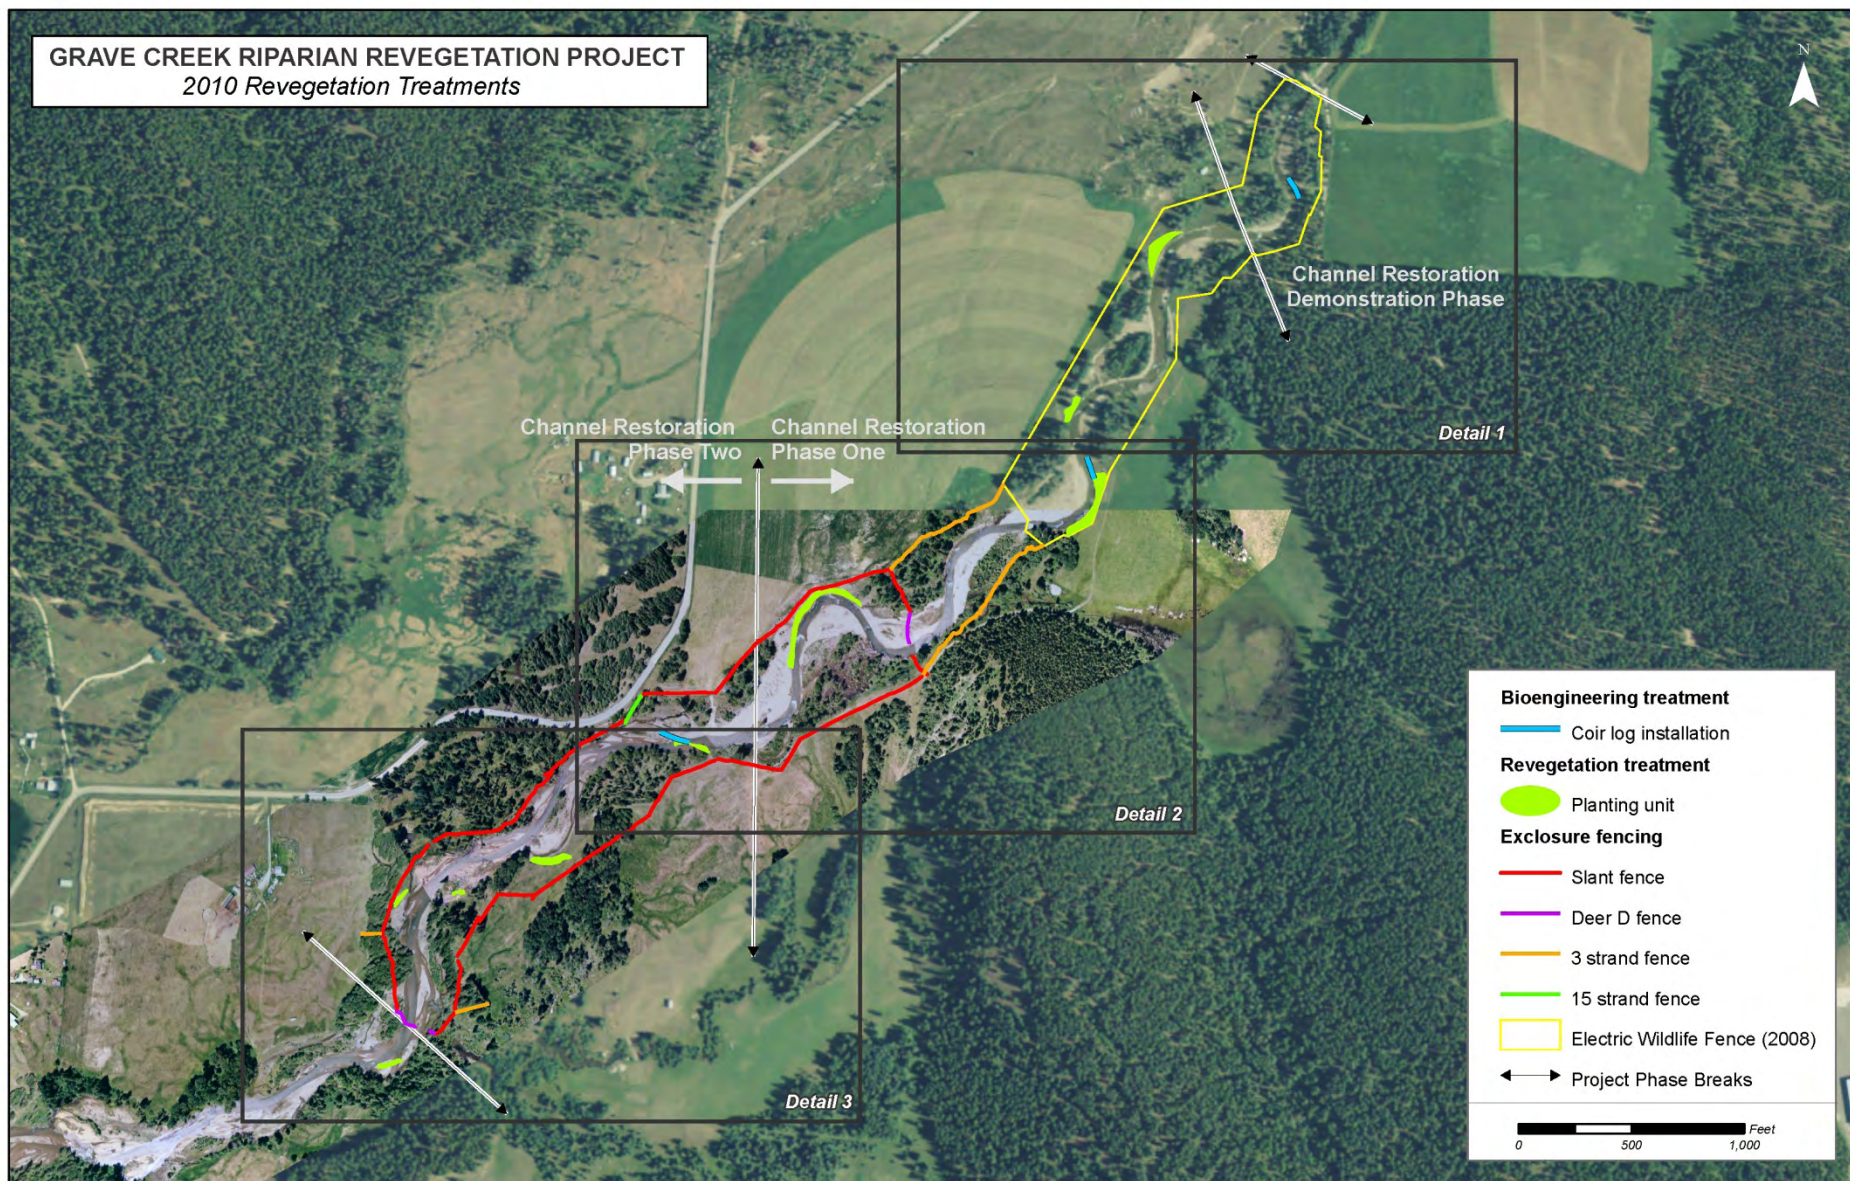
**Figure 1.** Overview figure showing the locations of the 2010 planting sites and electric wildlife fence.

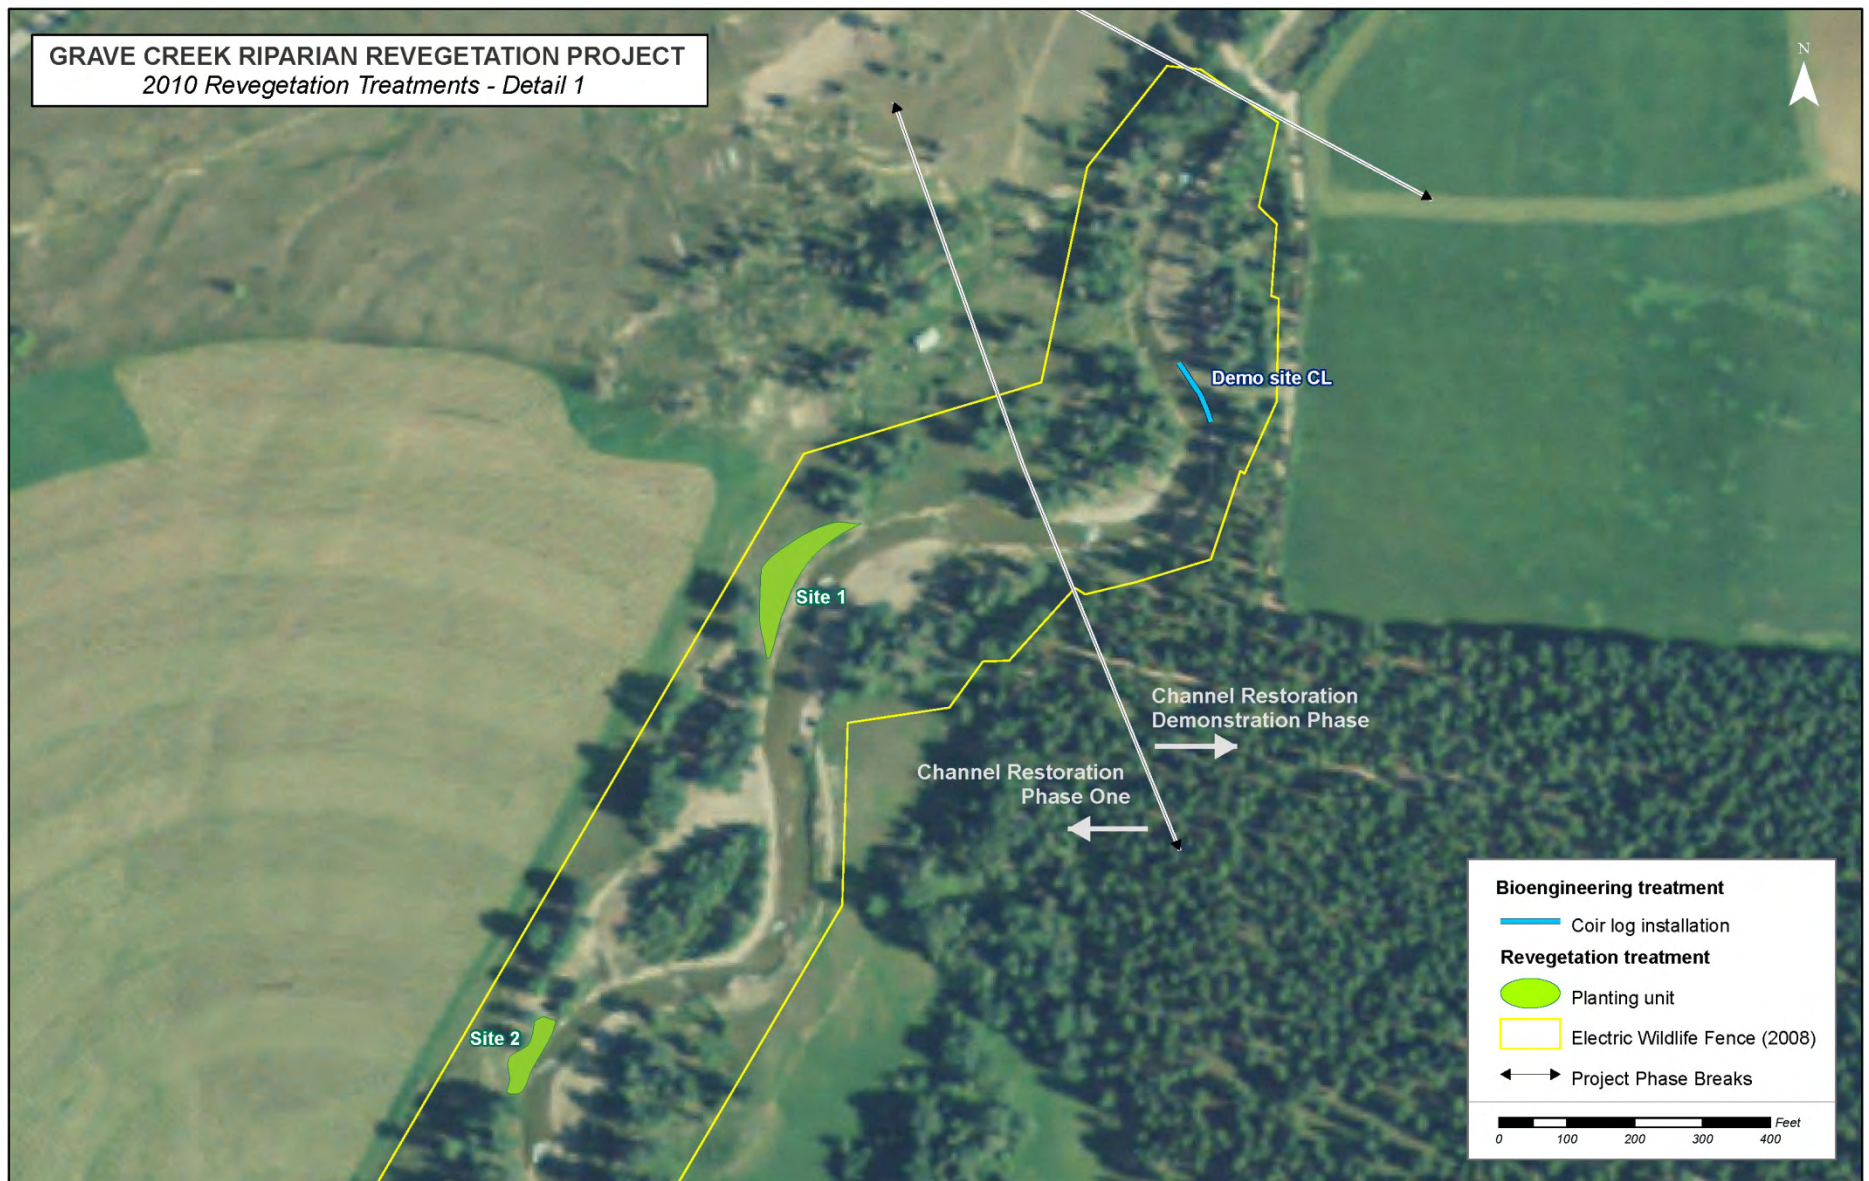
**Figure 2.** Detail figure showing the locations of planting sites 1 and 2 and coir log site Demo.

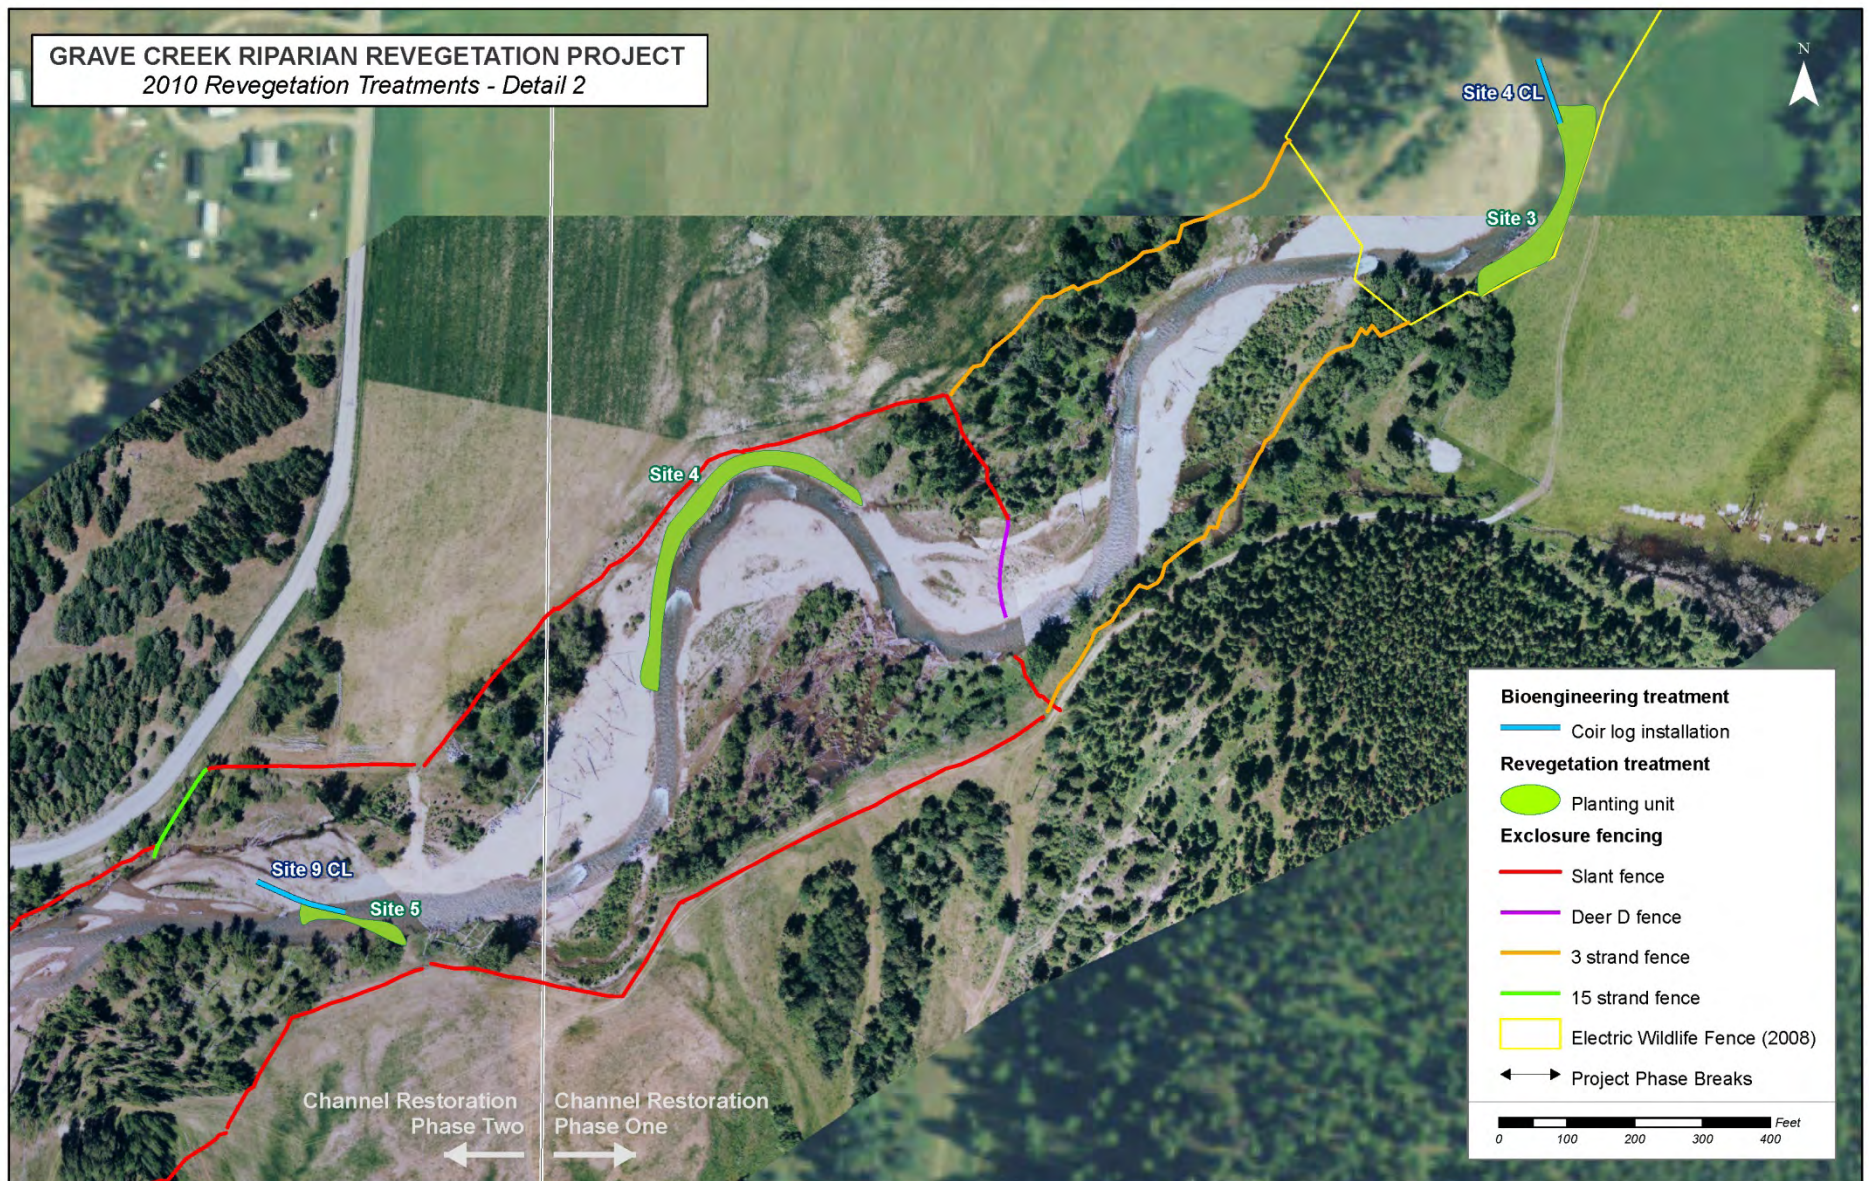
**Figure 3.** Detail figure showing the locations of planting areas 3 through 5 coir log sites 4 and 9 and exclosure fence types and locations.

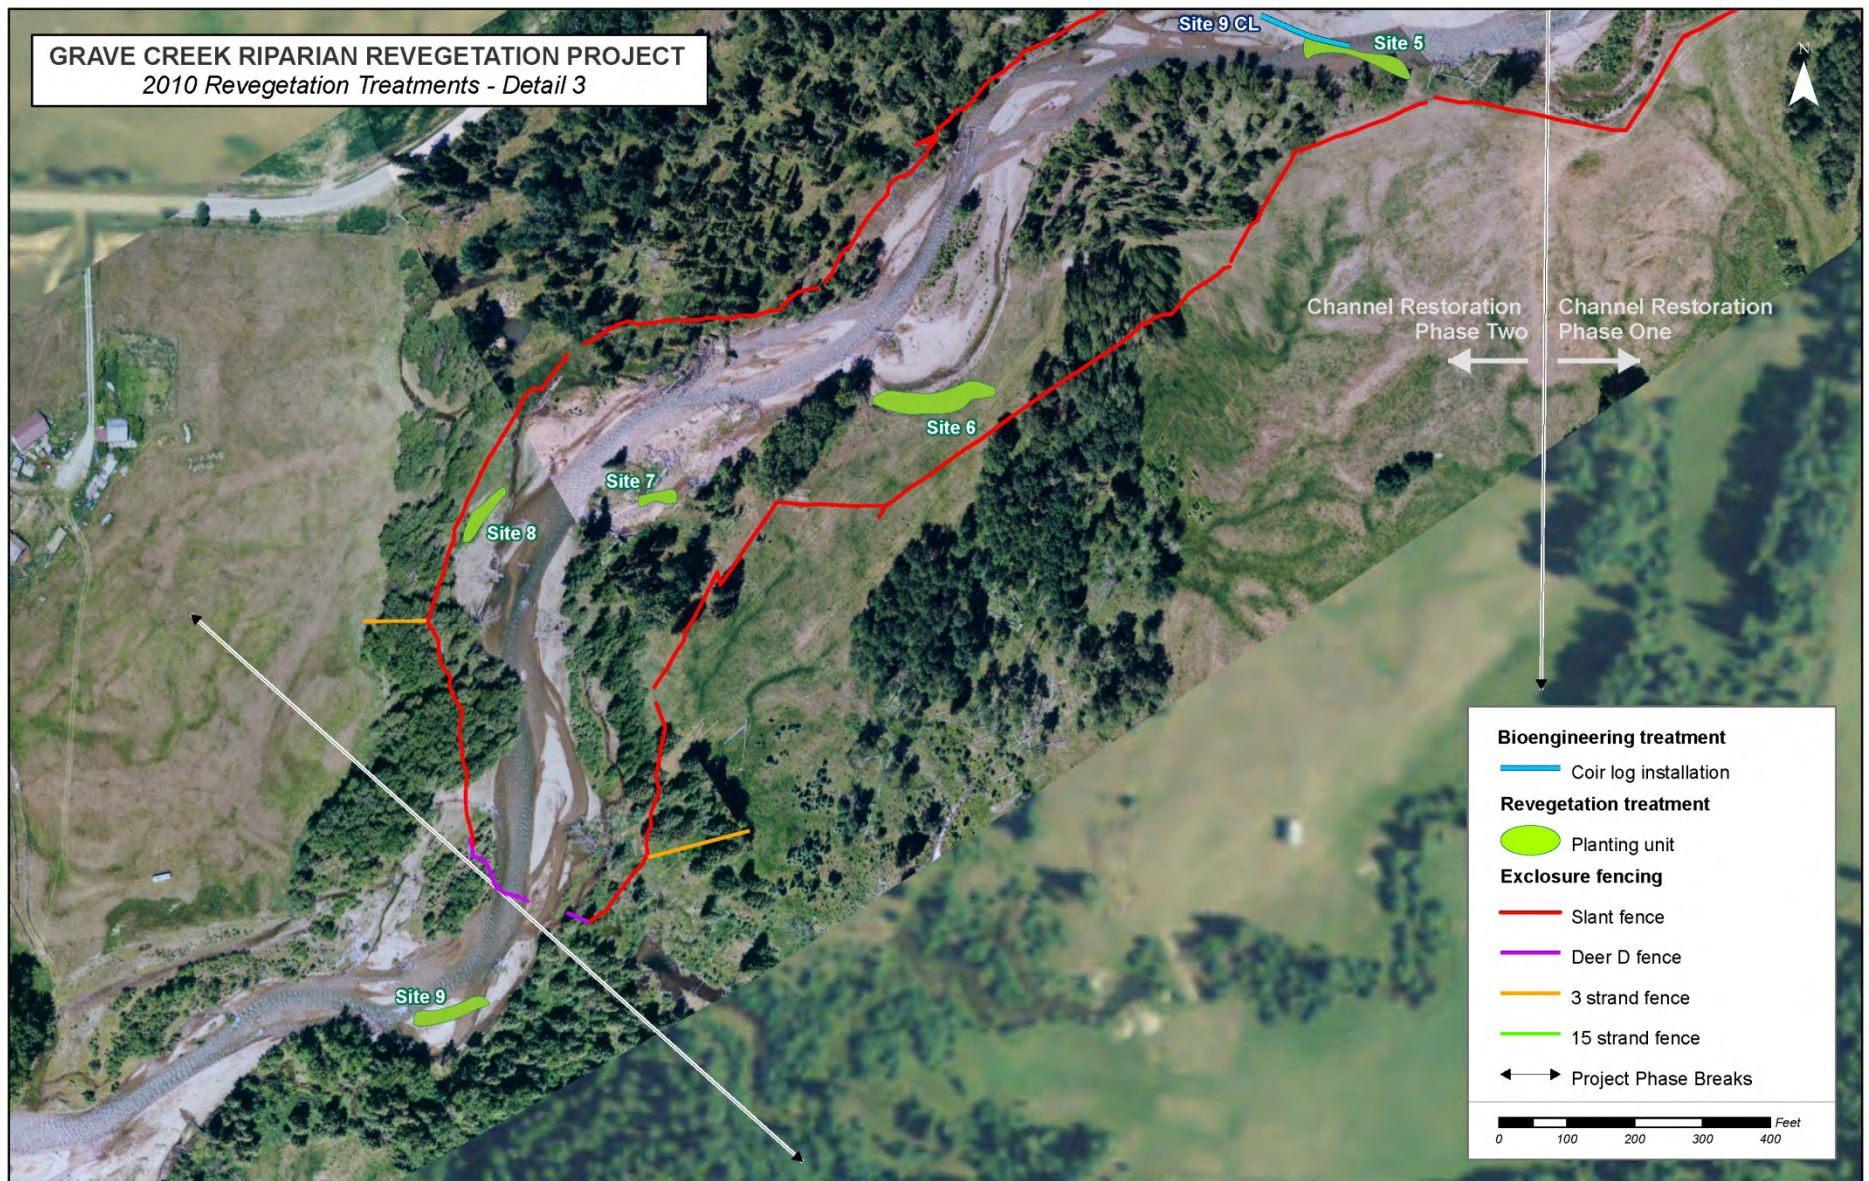
**Figure 4.** Detail figure showing the locations of planting sites 5 through 9 and exclosure fence types and locations.
