# Grave Creek Restoration Project

## Phase 1 and Phase 2 Monitoring Report

River Design Group, Inc.  
5098 US Highway 93 South  
Whitefish, MT 59937

June 2011

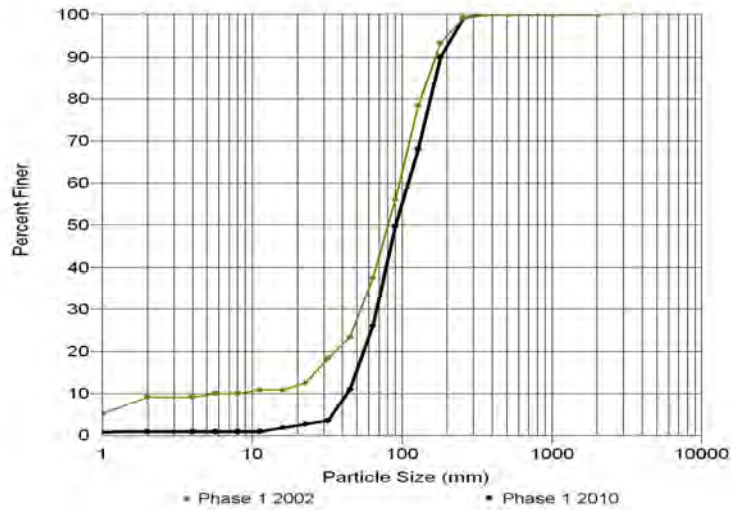
**Figure 2-13.** Riffle substrate particle size distribution for pre and post-restoration conditions within Phase 1.

Results of the particle size distribution analysis indicate a coarsening trend for all size classes except the  $D_{100}$ . The coarsening trend may be attributed to a reduction in fine sediments contributed to the channel from bed and streambank erosion.

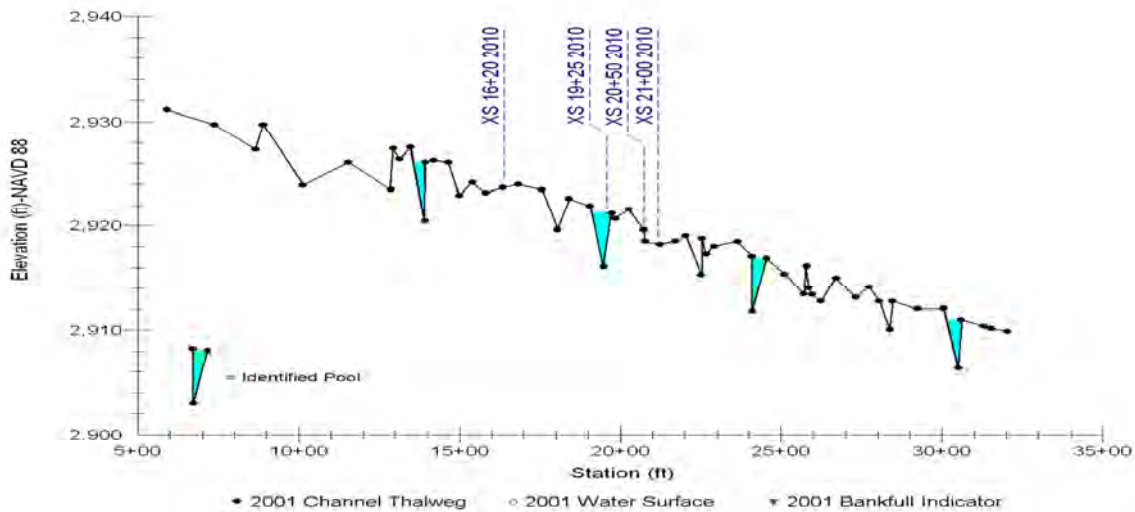
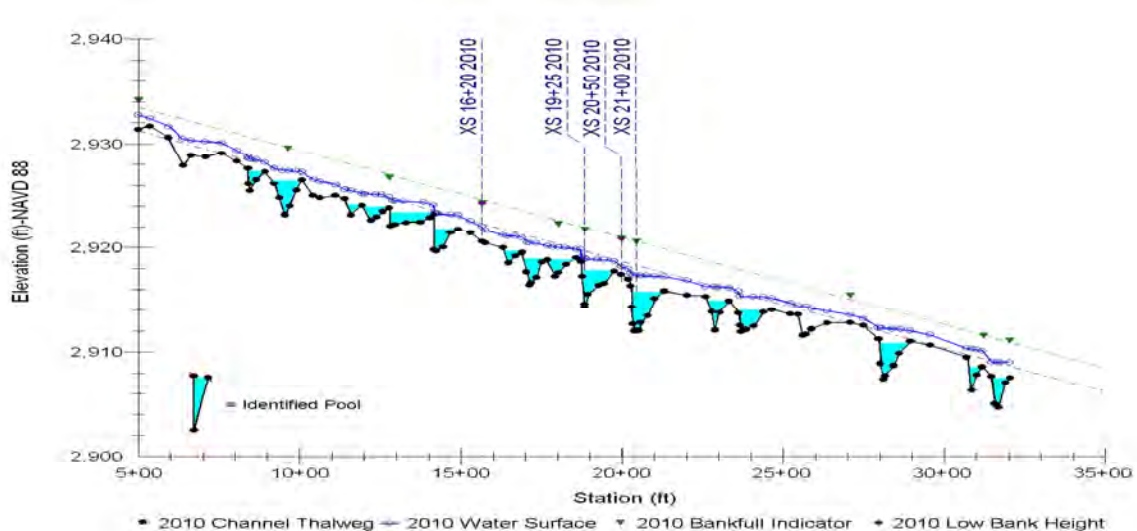
An evaluation of available aquatic habitat was completed for the pre and post-restoration conditions in Phase 1. Pool habitats were identified and evaluated during the 2001 and 2010 monitoring surveys. Figure 2-14 displays the longitudinal distribution of pool habitat features prior to restoration in 2001. Figure 2-15 displays the longitudinal distribution of pool habitat features eight years following construction in 2010.

Table 2-11 includes the results of the aquatic habitat evaluation. The number of pools increased from four identified in 2001 to 16 identified in 2010, a 300% increase. The pool spacing averaged 552 ft in 2001 and 179 ft in 2010. Average residual pool volume in Reach 1 increase 136% compared to 2001 pre-restoration conditions.

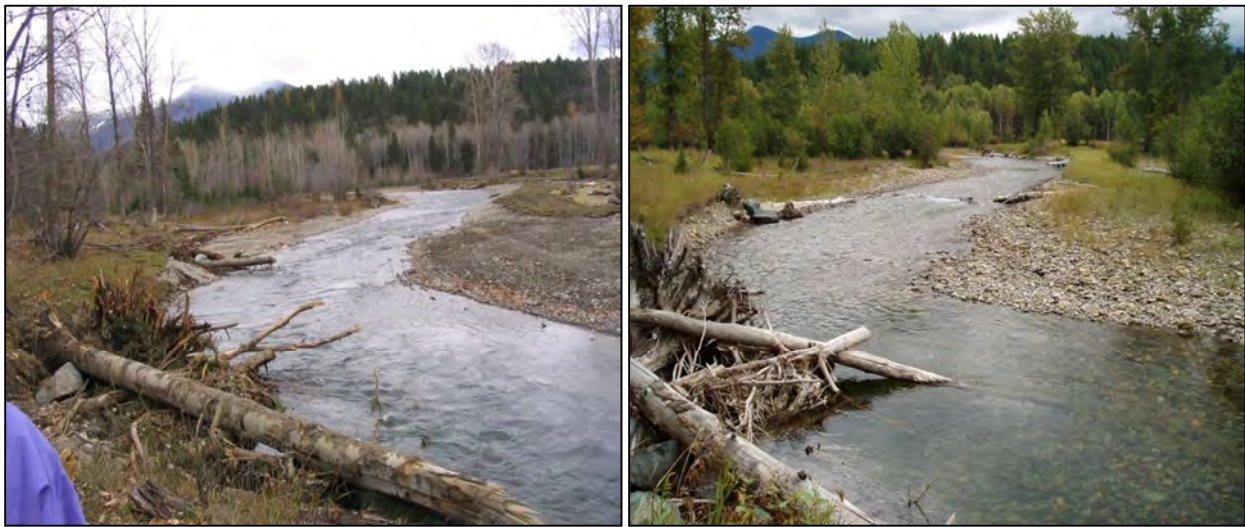
**Figure 3-4.** Photos of Phase 2 in 2004 (left) and 2010 (right).

The longitudinal spacing of pools decreased from 725 ft in 2001 to 208 ft in 2010. A 333% increase in the number of pools was observed with a decrease in the longitudinal distribution of riffle habitat types. Maximum depths for all channel units increased throughout the project area.

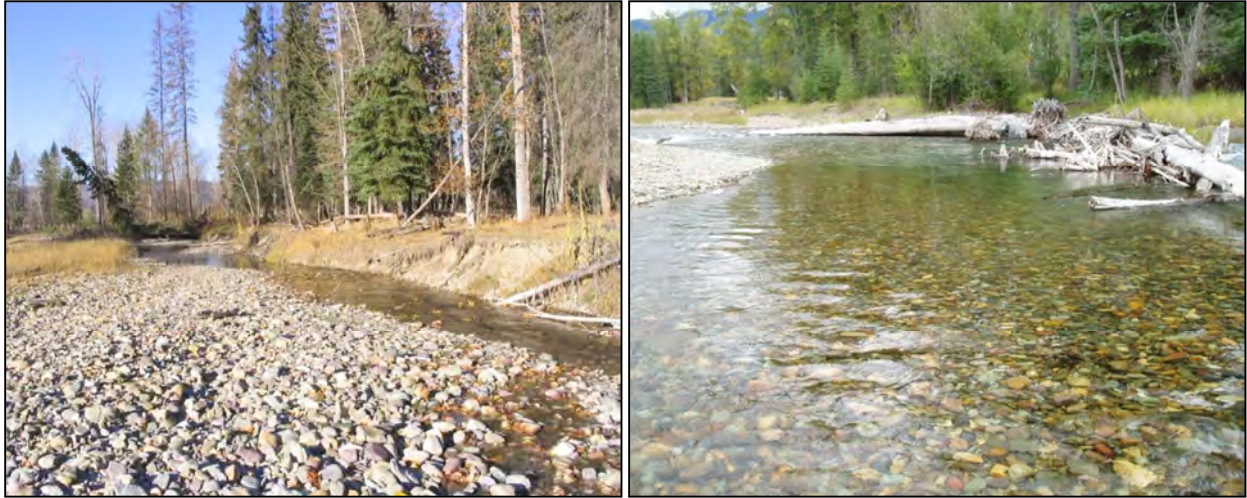
**Figure 3-10.** Photos of the pool cross-section at Station 17+25, in 2001 (left) and 2010 (right).

Figure 3-10 contains photographs of the cross-section location at Station 17+25 for the pre and post-restoration conditions. A multiple channel condition characterized by mid-channel and transverse bar deposits characterized the morphology in 2001. The 2010 post-restoration photograph shows the constructed pool feature, large wood habitat structure, and the improved channel geometry that functions to consolidate base flows.

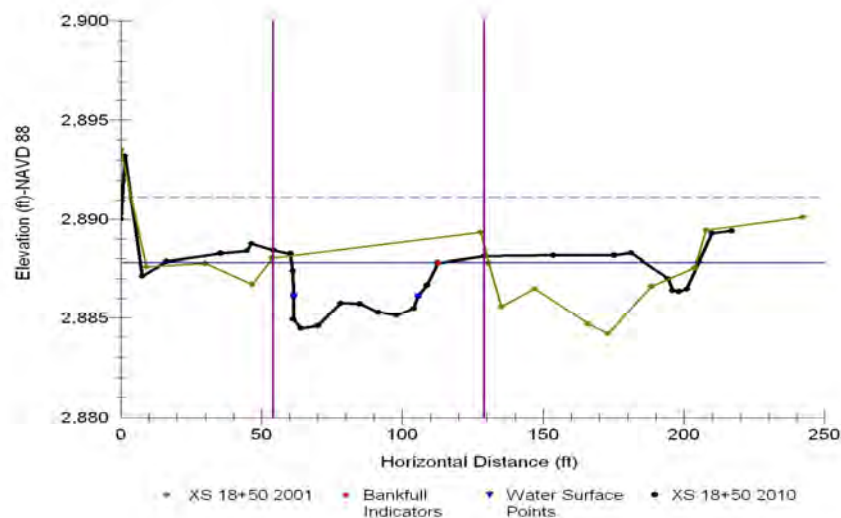
**Figure 3-11.** Riffle cross-section at Station 18+50, displaying pre and post-restoration conditions.

Figure 3-11 displays the 2001 and 2010 channel conditions at Station 18+50. An extensive mid-channel bar is evident in the 2001 channel reflecting the high width to depth ratio condition and depositional channel regime. The restoration project converted the multi-channel geometry to a dominant channel with secondary side channels on the active floodplain surface.

The pre-restoration and post-restoration data are compared in Table 3-7. The 2010 floodprone width remained unchanged compared to 2001 and averaged 250 ft. The bankfull channel width decreased from 201 ft to 52.1 ft through consolidation of multiple channels into one dominant channel. Mean depth has increased 21.1% and maximum depth decreased 35.3%. The width to depth ratio decreased from 104 in 2001 to 22.6 in 2010. Channel cross-sectional area is 70% less than the 2001 pre-restoration conditions.

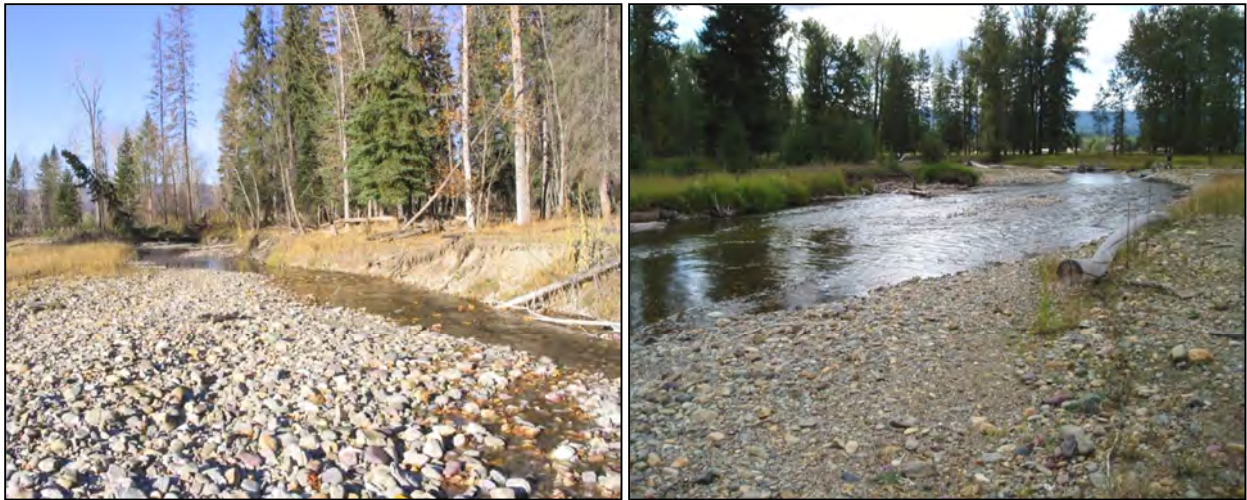
**Figure 3-12.** Photos of the riffle cross-section at station 18+50 ft, in 2001 (left) and 2010 (right).

Figure 3-12 contains photographs of a riffle channel unit at Station 18+50 ft for the pre and post-restoration conditions. Recent deposition is evident in the 2001 photograph. This depositional feature occupies a large percentage of the channel cross-sectional area. The 2010 post-restoration photograph shows the dominant channel and adjacent floodplain surfaces.

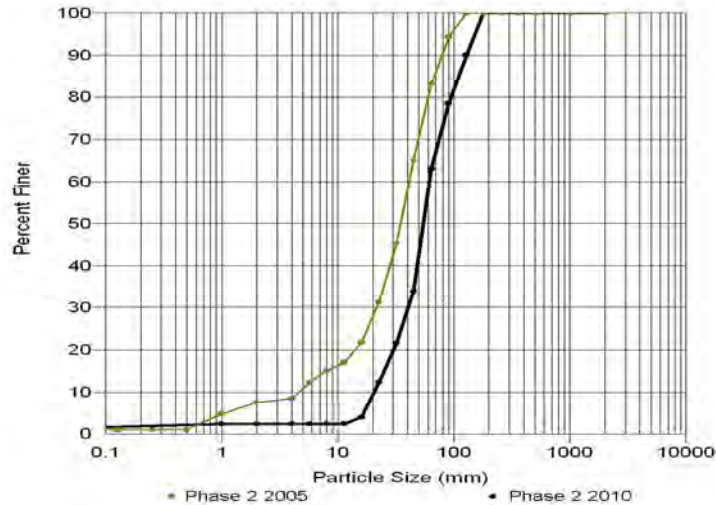
**Figure 3-13.** Riffle substrate particle size distribution for pre and post-restoration conditions within Phase 2.

Results of the particle size distribution analysis indicate a coarsening trend for all size classes. The coarsening trend may be attributed to a reduction in fine sediments contributed to the channel from bed and streambank erosion.

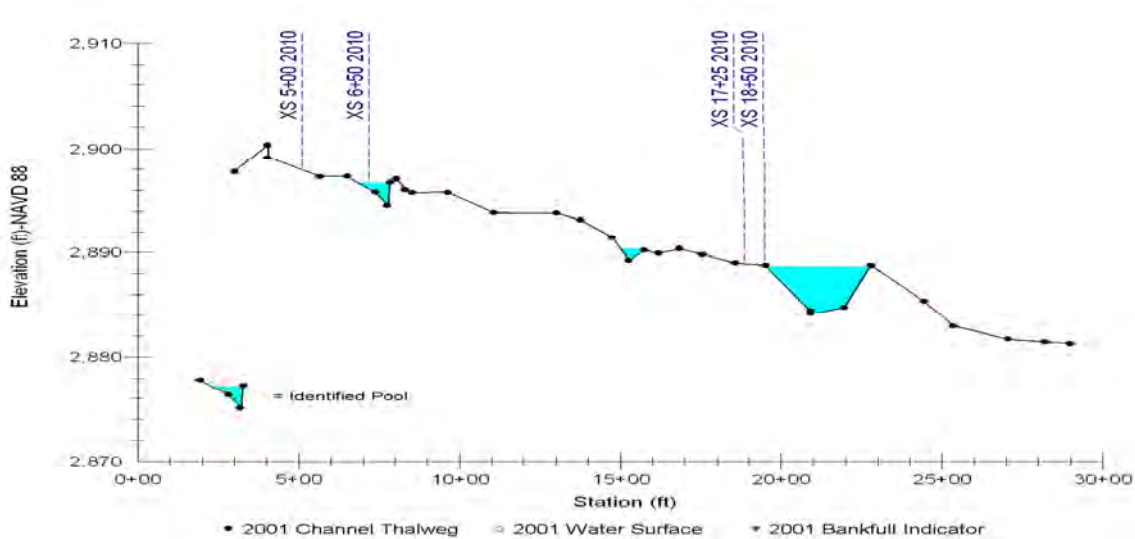
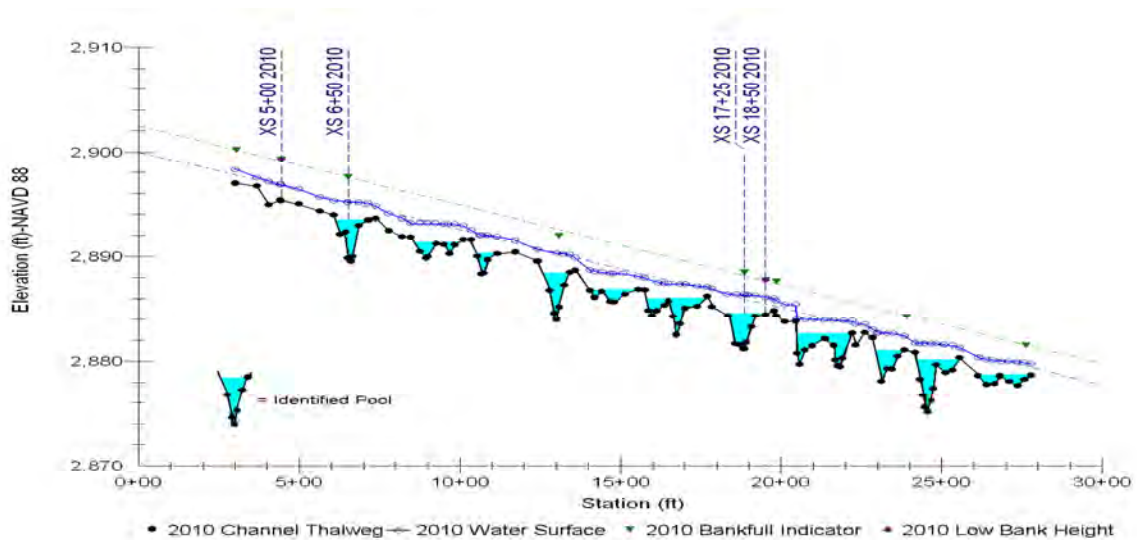
An evaluation of available aquatic habitat was completed for the pre and post-restoration conditions in Phase 2. Pool habitats were identified and evaluated during the 2001 and 2010 monitoring surveys. Figure 3-14 displays the longitudinal distribution of pool habitat features prior to restoration in 2001. Figure 3-15 displays the longitudinal distribution of pool habitat features six years following construction in 2010.

Table 3-11 includes the results of the aquatic habitat evaluation. The number of pools increased from three in 2001 to 13 in 2010, an increase of 333%. Pool spacing averaged

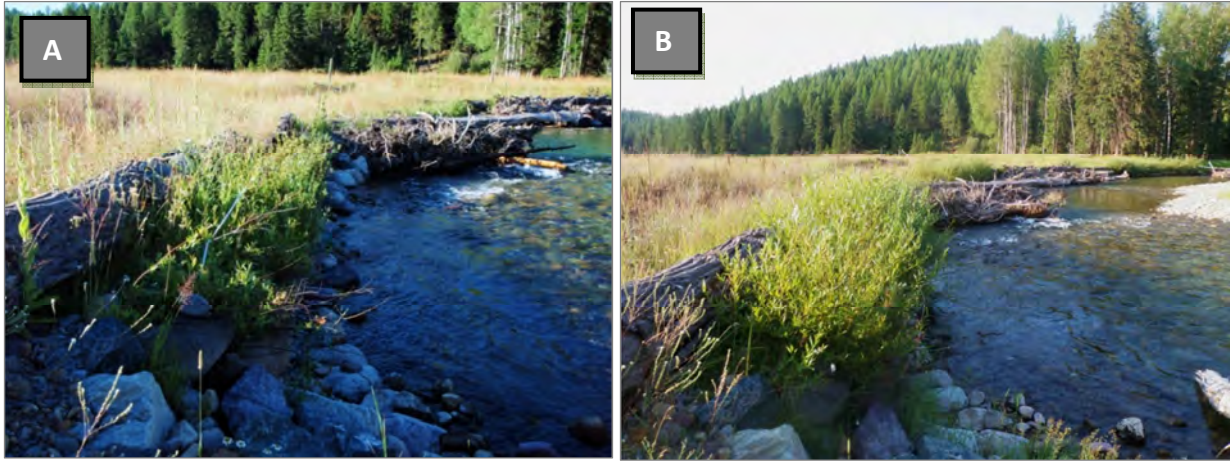
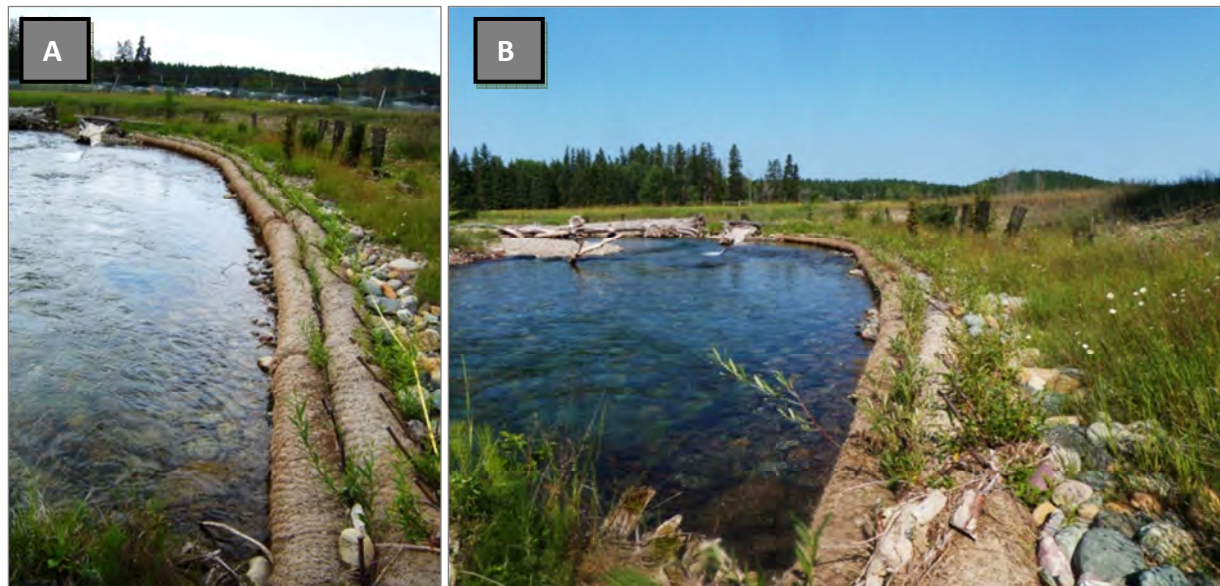
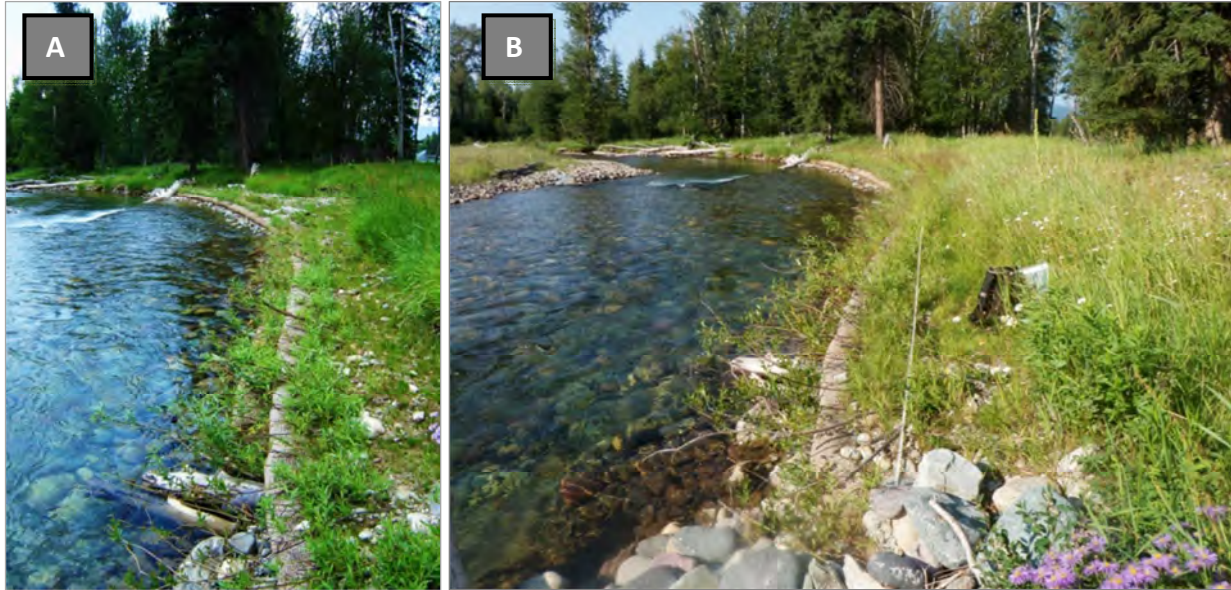
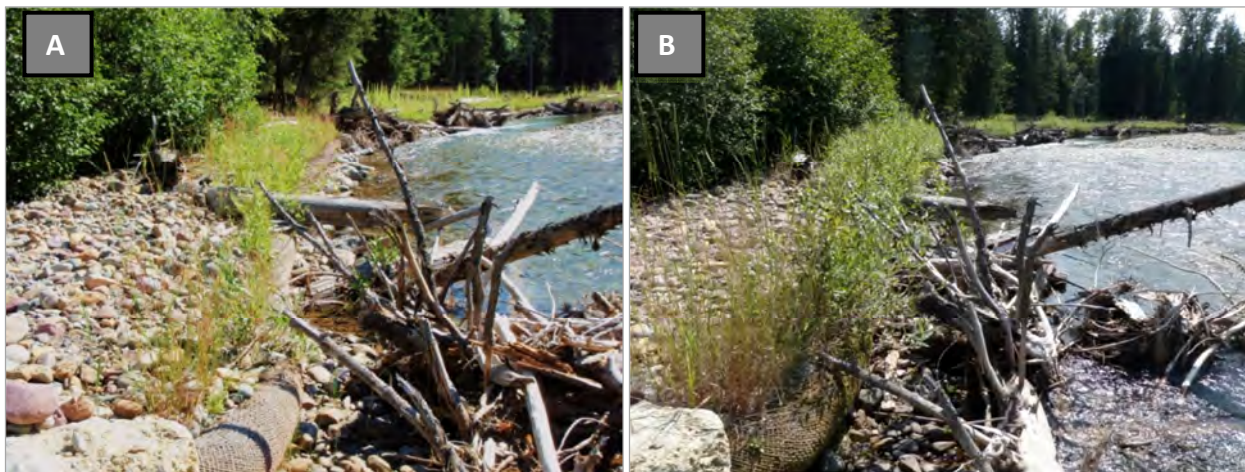
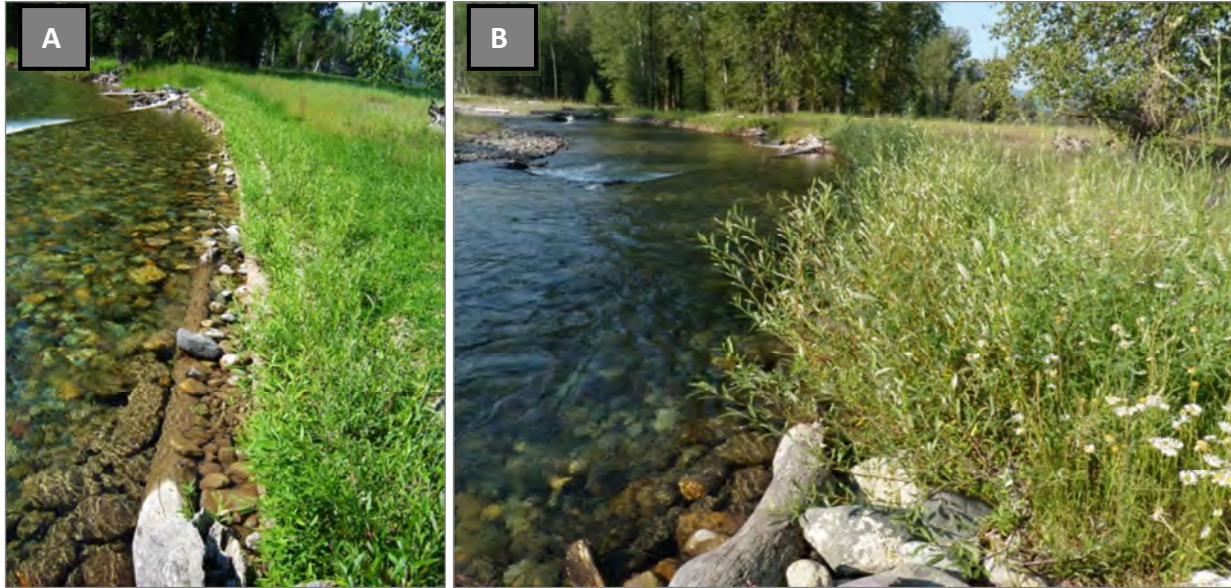
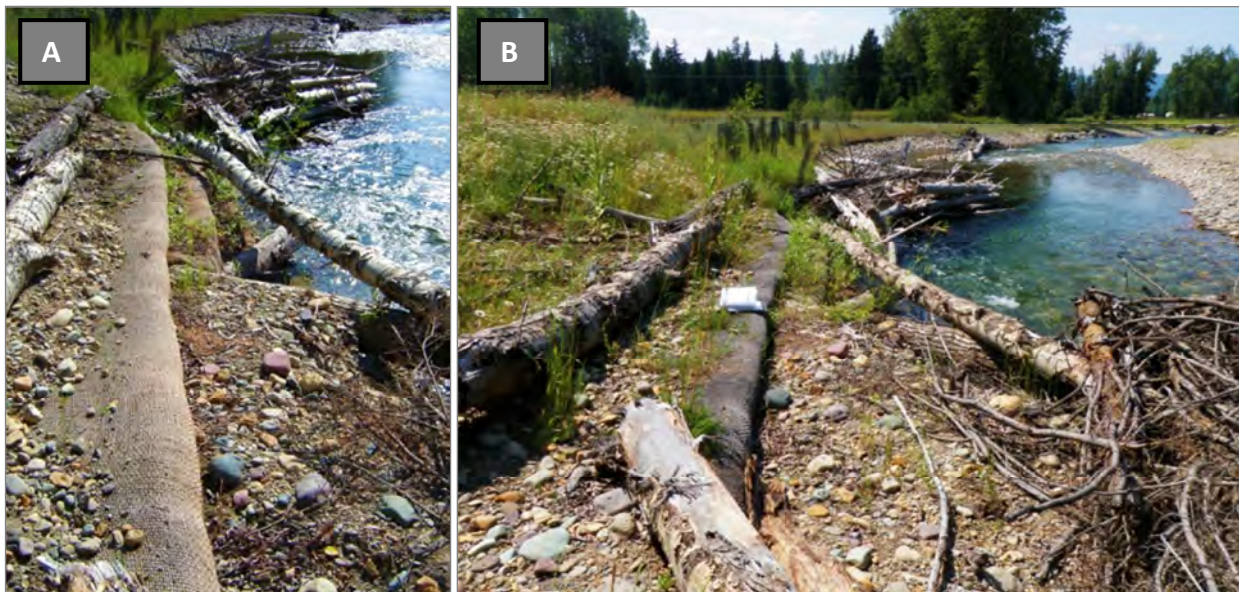
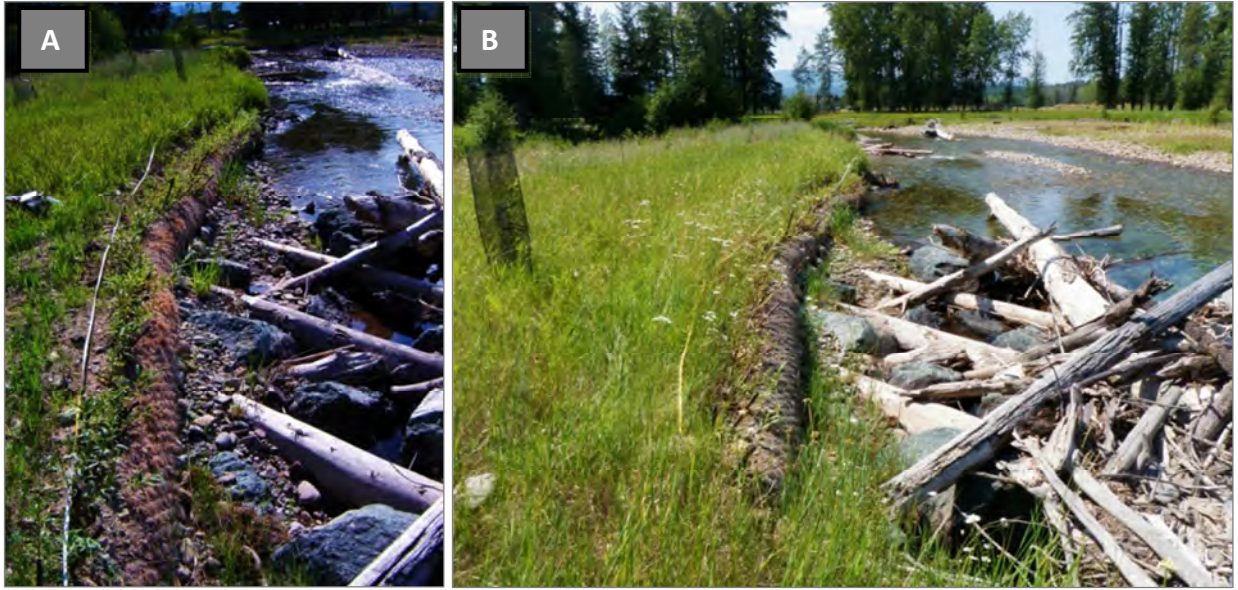
In general, bioengineering structures have remained stable since 2006. As shown in Tables 4-5 and 4-6 most of the structures have greater than 60% cover of woody vegetation. Figures 4-6 through 4-12 show each of the monitored soil lifts in 2008 or 2009 and in 2010.

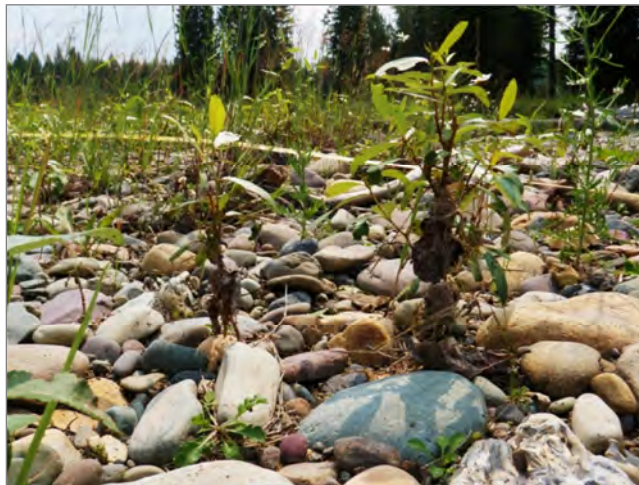
**Figure 4-15.** Photograph of flood deposited debris on constructed point bar surface.

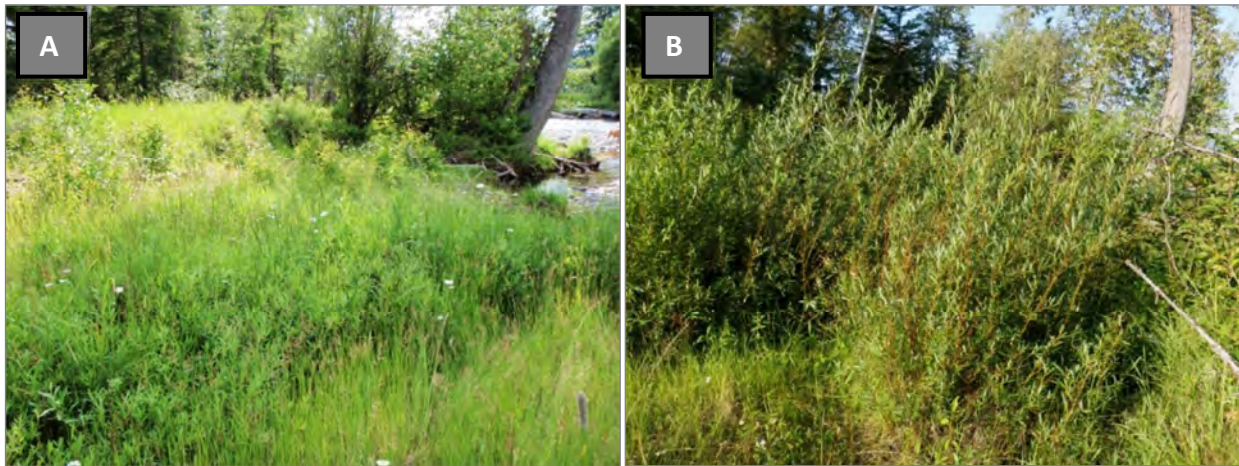
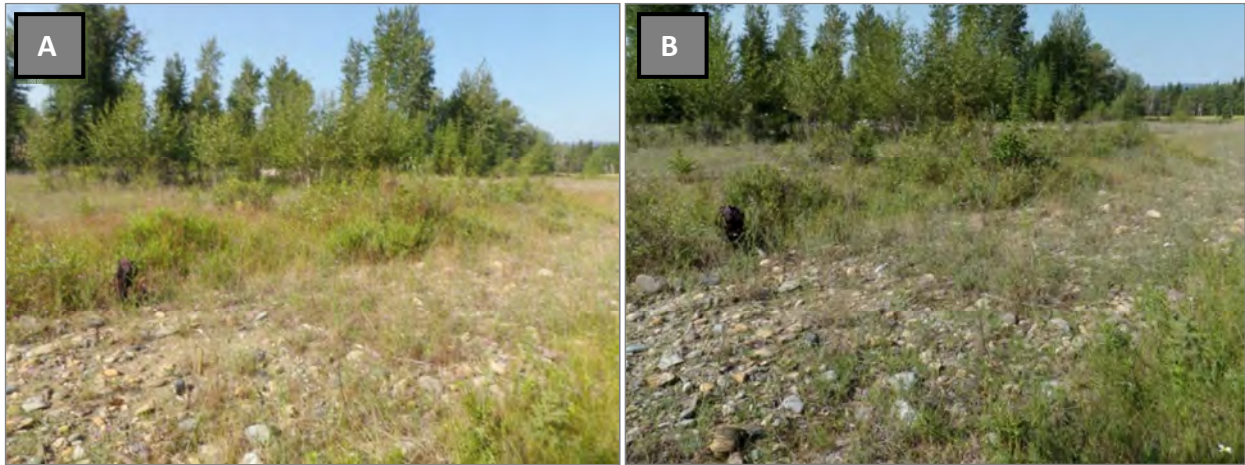
Plots located within the electric fence show signs of release from browse as indicated by the absence of browse on current year's growth and the presence of previously browsed older stems. Willow stands have expanded and percent cover has increased from 30 to 50 percent. Plants in plots located outside of the electric fence continue to show signs of moderate to severe browse as indicated by the presence of browse on current and older growth. Figure 4-16 compares shrubs within the browse evaluation point located within the fenced area prior to fence installation and two growing seasons after fence installation. Willow height, percent cover and distribution has increased. Figure 4-17 compares shrubs within the browse evaluation point located outside the fenced area in 2009 and 2010. Figure 4-18 compares the difference in shrub growth form for shrubs within the fenced and outside of the fenced area.

**Figure 4-16.** Photographs of vegetation in Browse Evaluation Plot B Inside Fence (shrub) in July 2008 (A) prior to fence installation and in August 2010 (B) two growing seasons after fence installation.

**Figure 4-17.** Photographs of vegetation in Browse Evaluation Plot B Outside Fence in July 2009 (A) and in August 2010 (B).

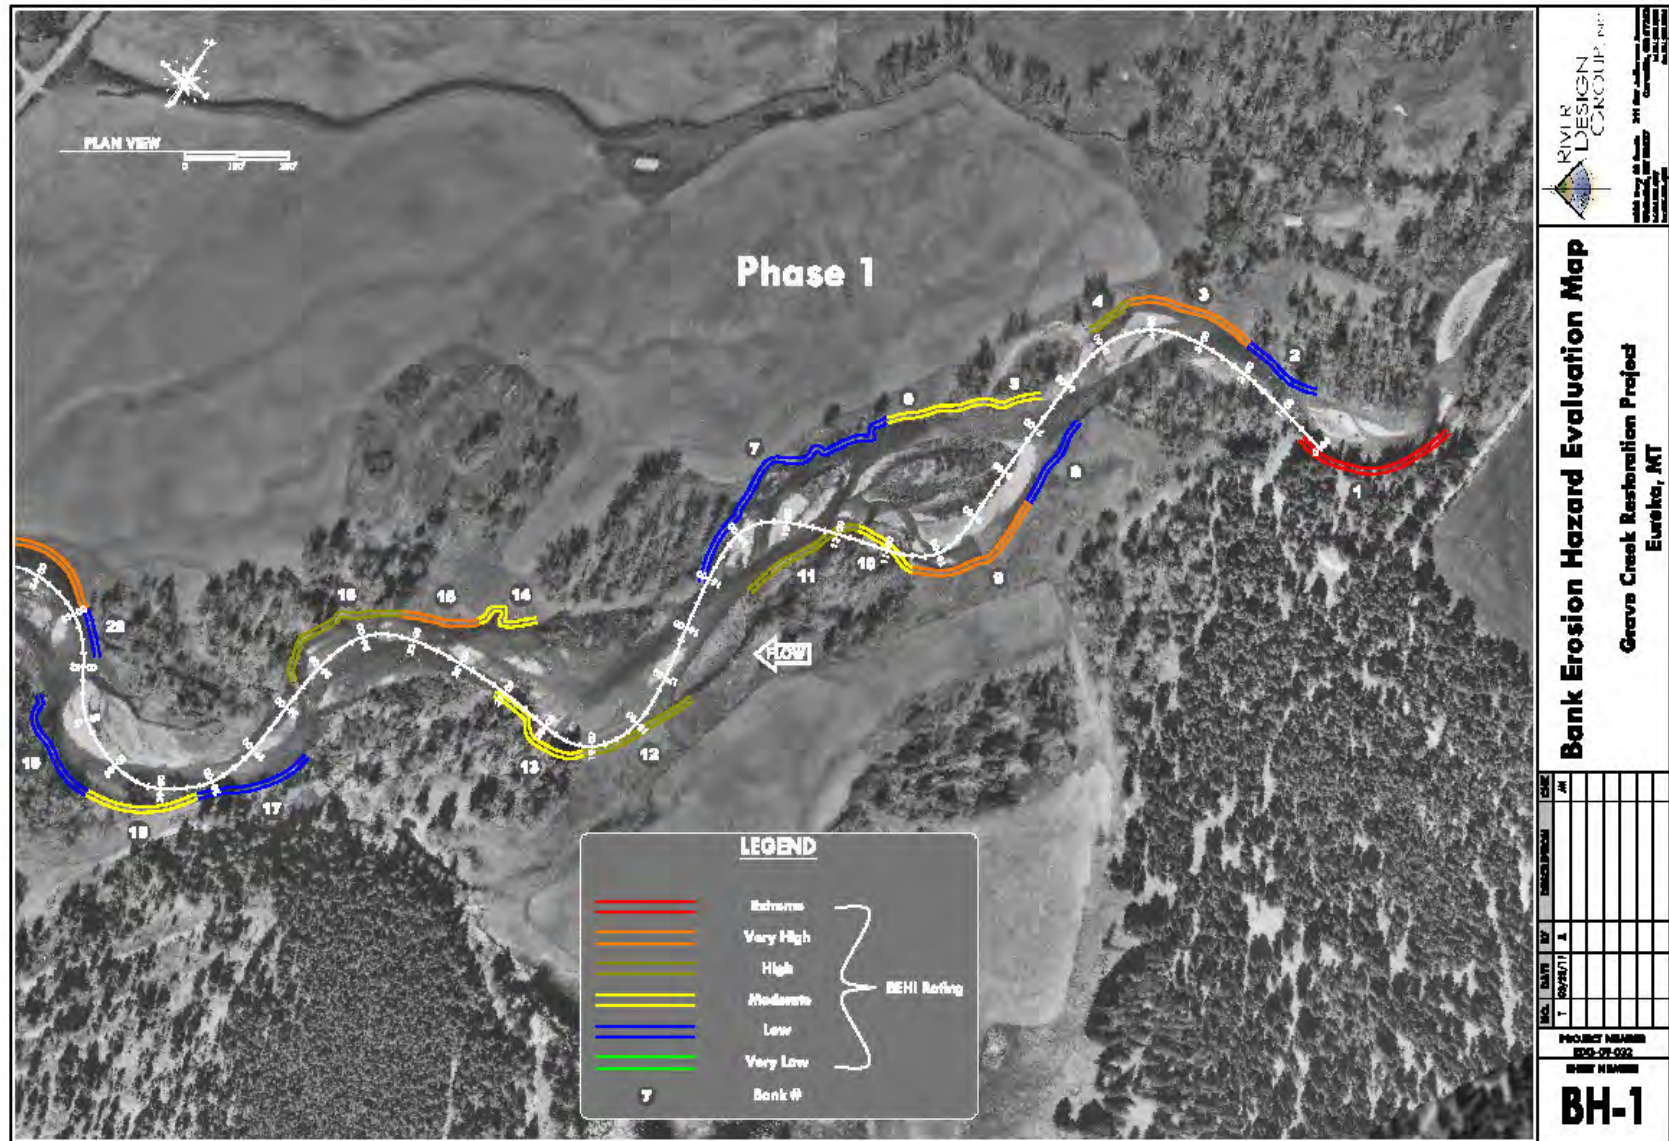
Figure A-1. Distribution of the bank erosion hazard in upper Phase 1 before restoration.

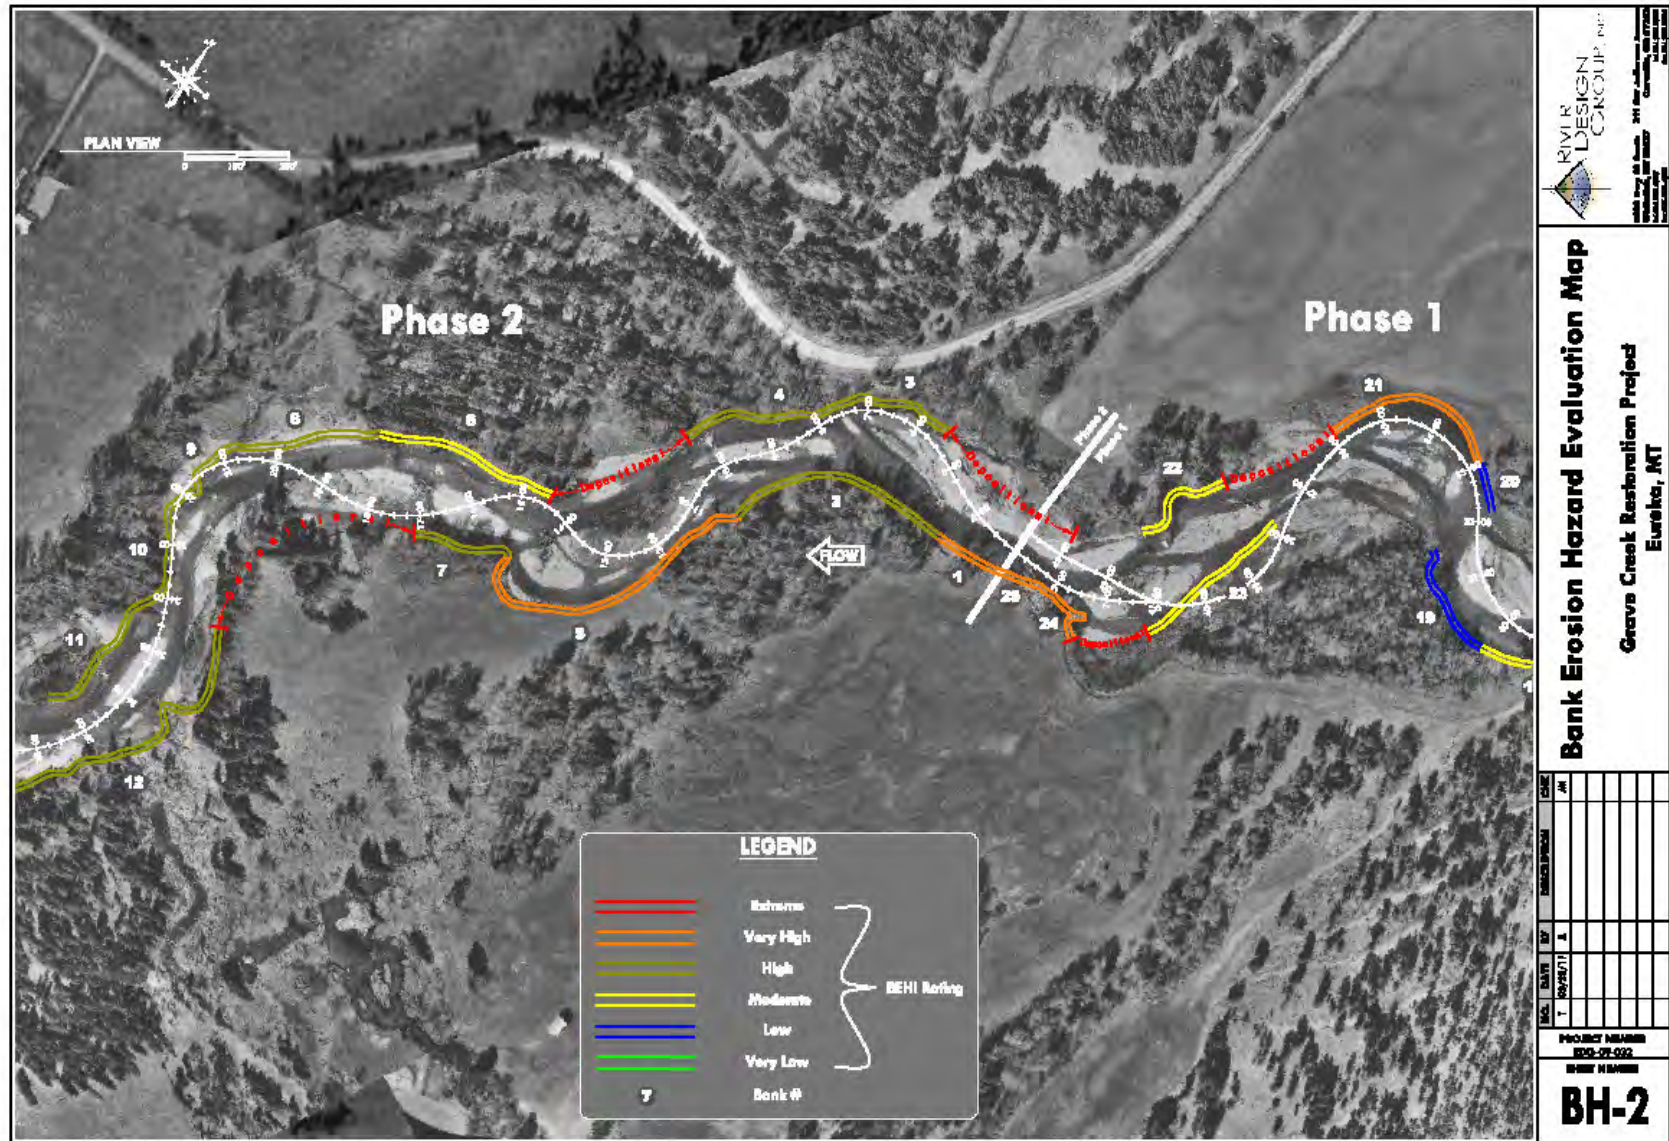
Figure A-2. Distribution of the bank erosion hazard in lower Phase 1 before restoration.

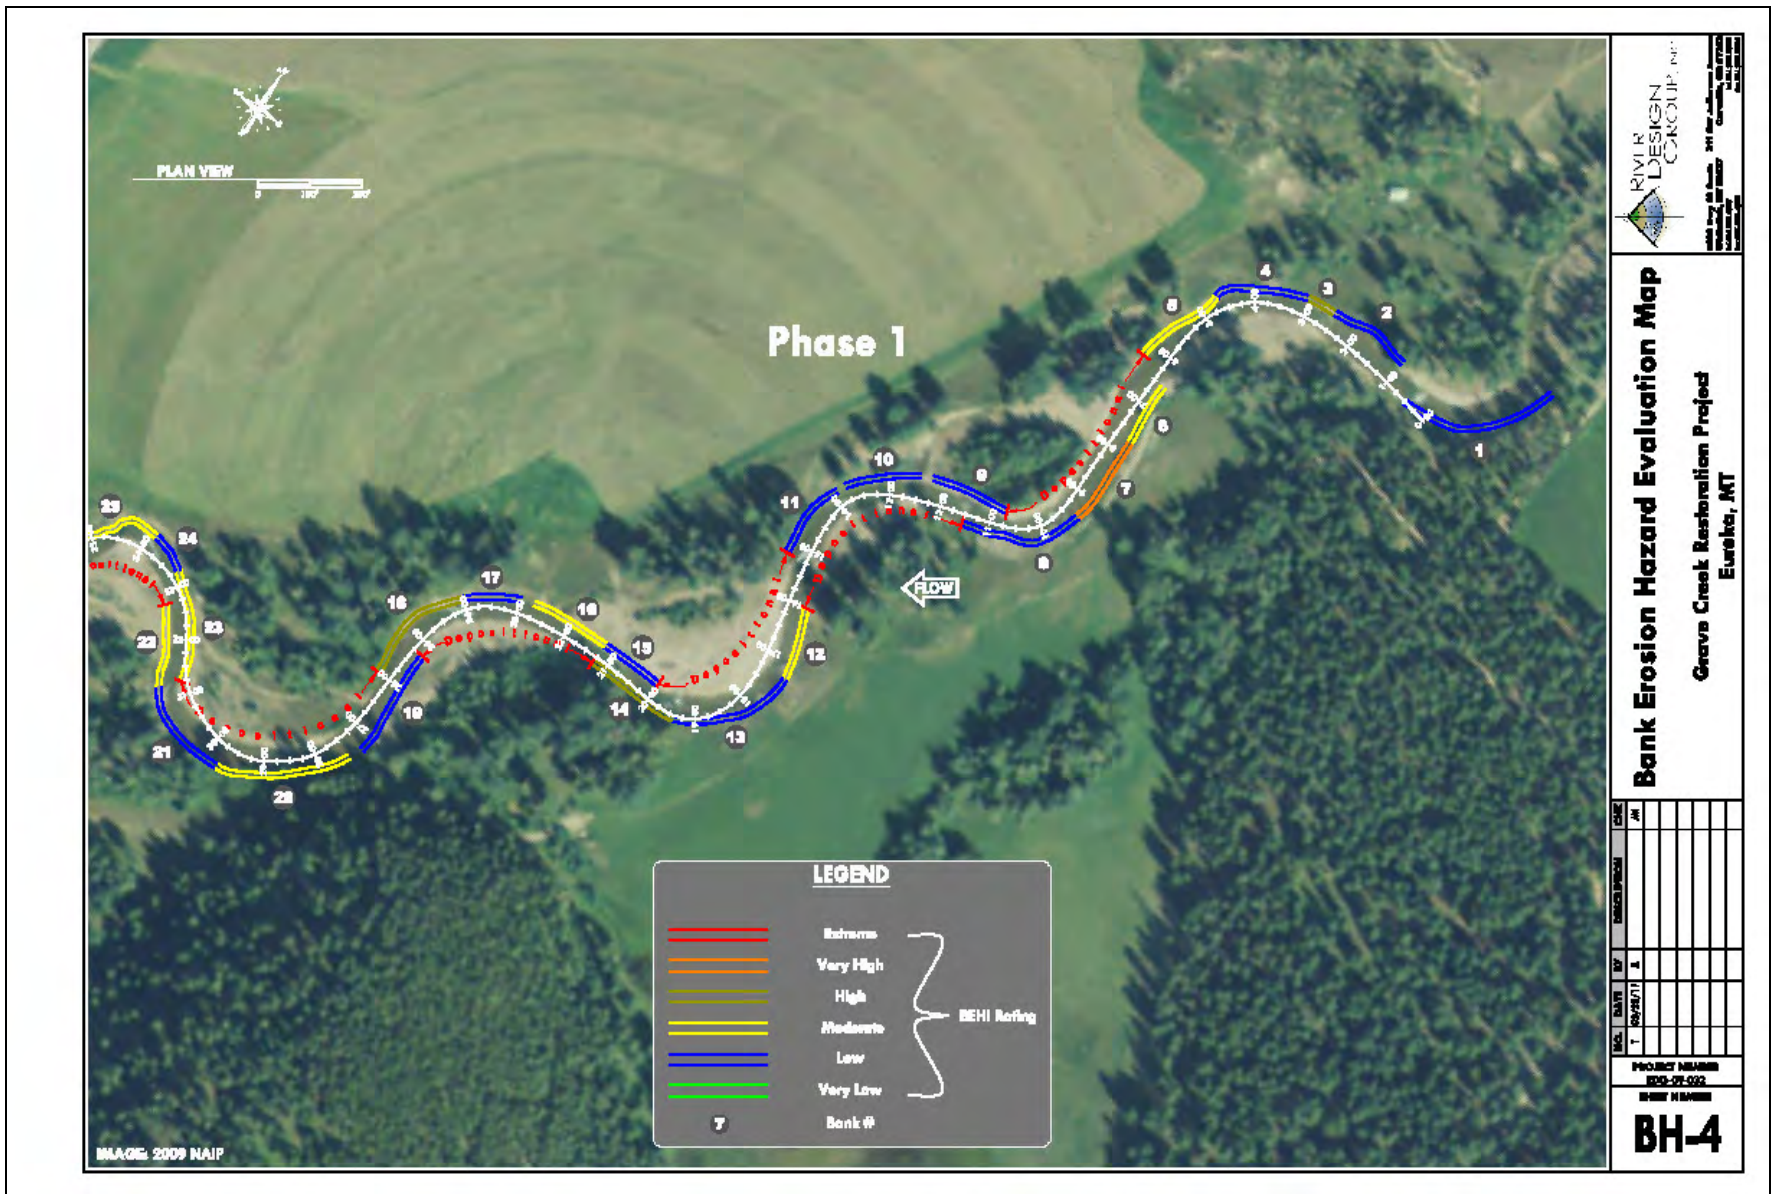
Figure A-3. Distribution of the bank erosion hazard in upper Phase 1 after restoration.

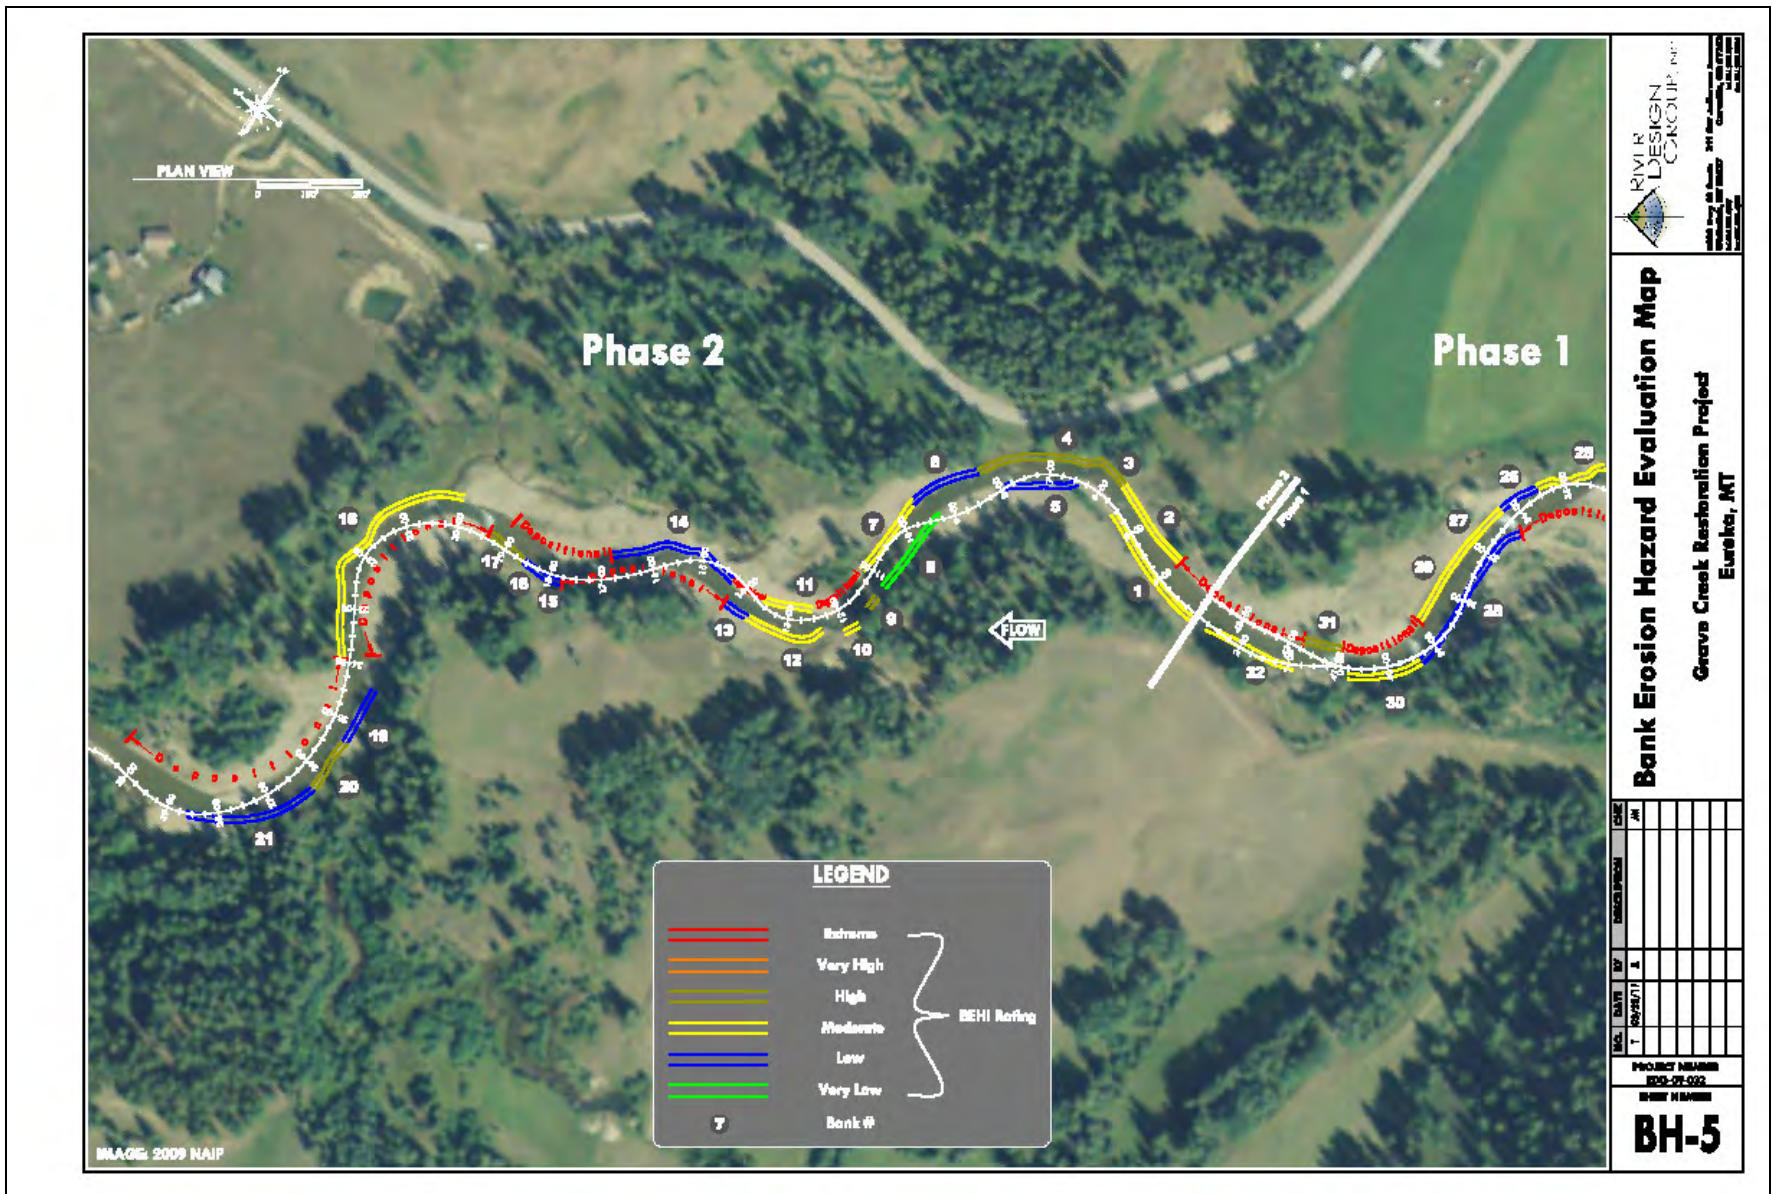
Figure A-4. Distribution of the bank erosion hazard in lower Phase 1 after restoration.
