# Grave Creek Restoration Project

## Phase 1 and Phase 2 Monitoring Report

River Design Group, Inc.  
5098 US Highway 93 South  
Whitefish, MT 59937

June 2011

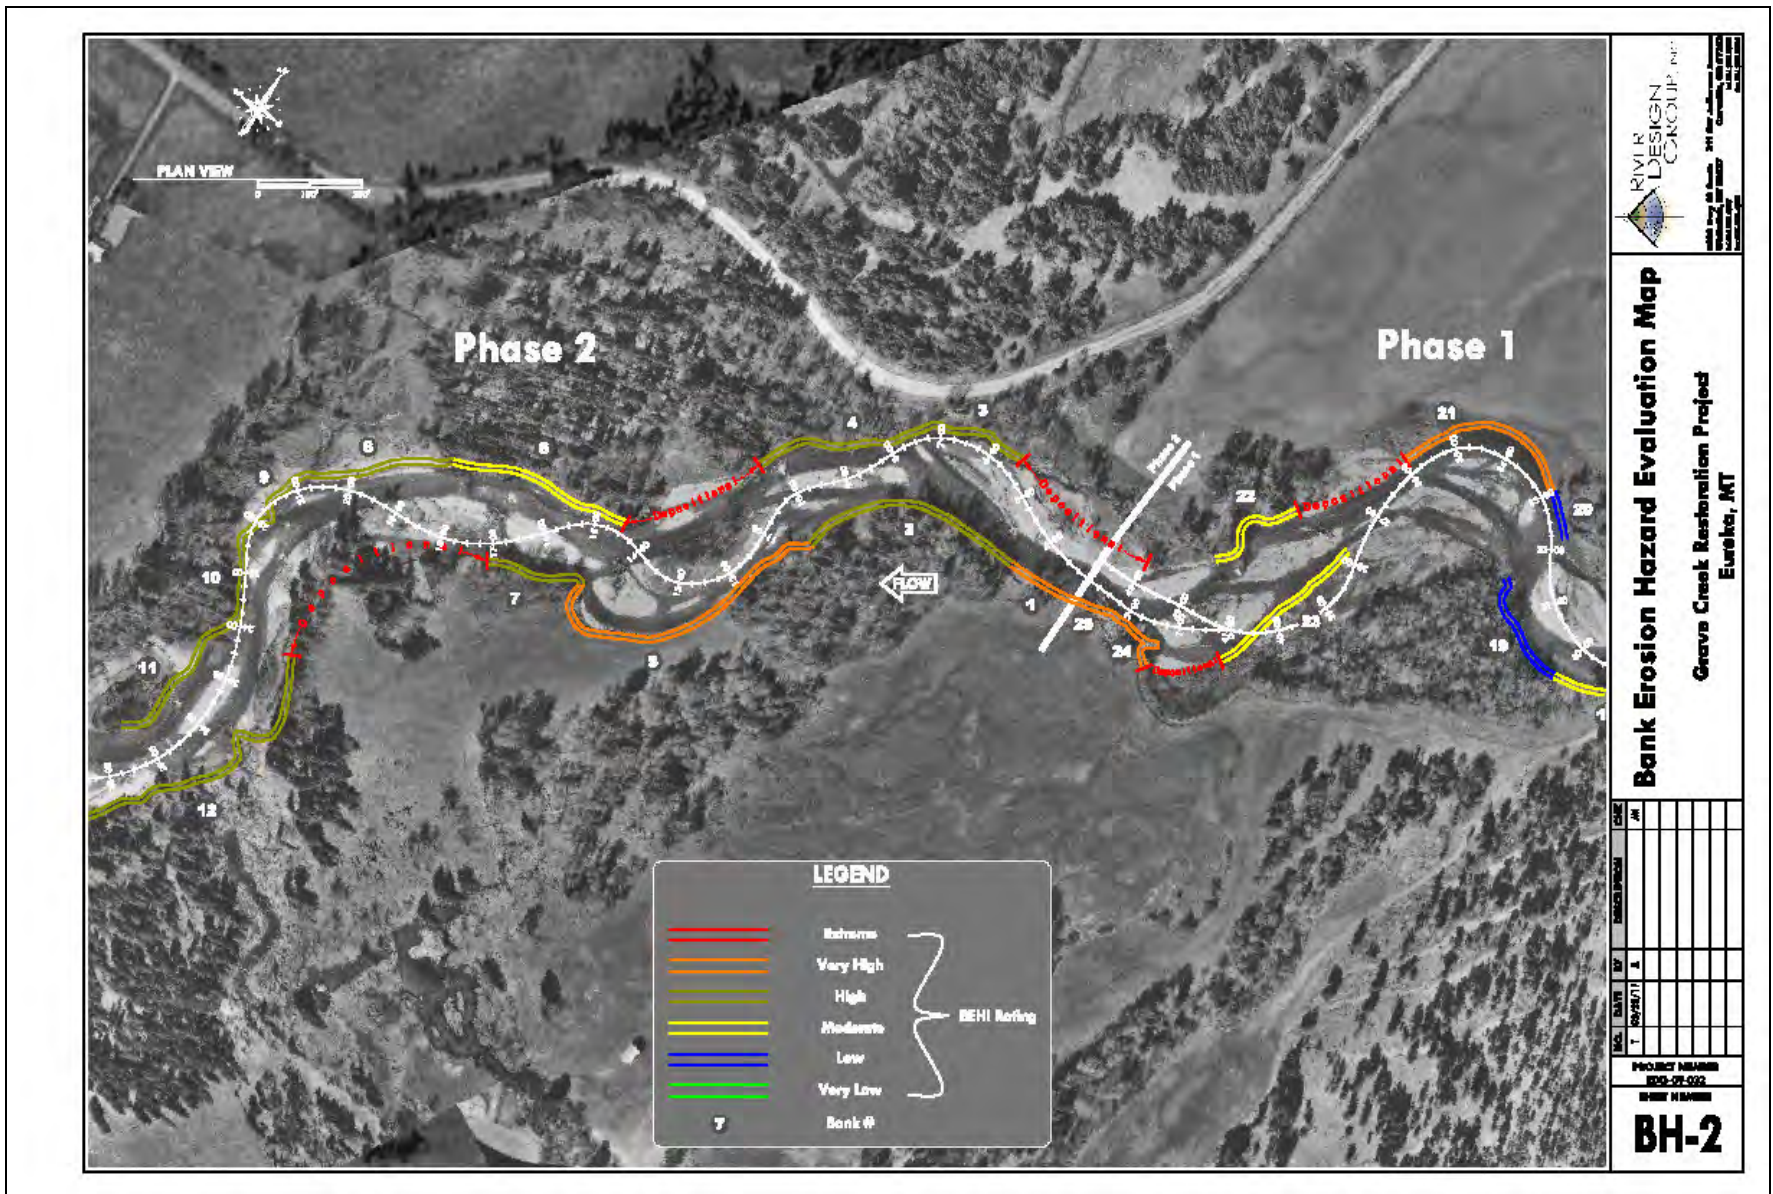
Figure A-5. Distribution of the bank erosion hazard in upper Phase 2 before restoration.

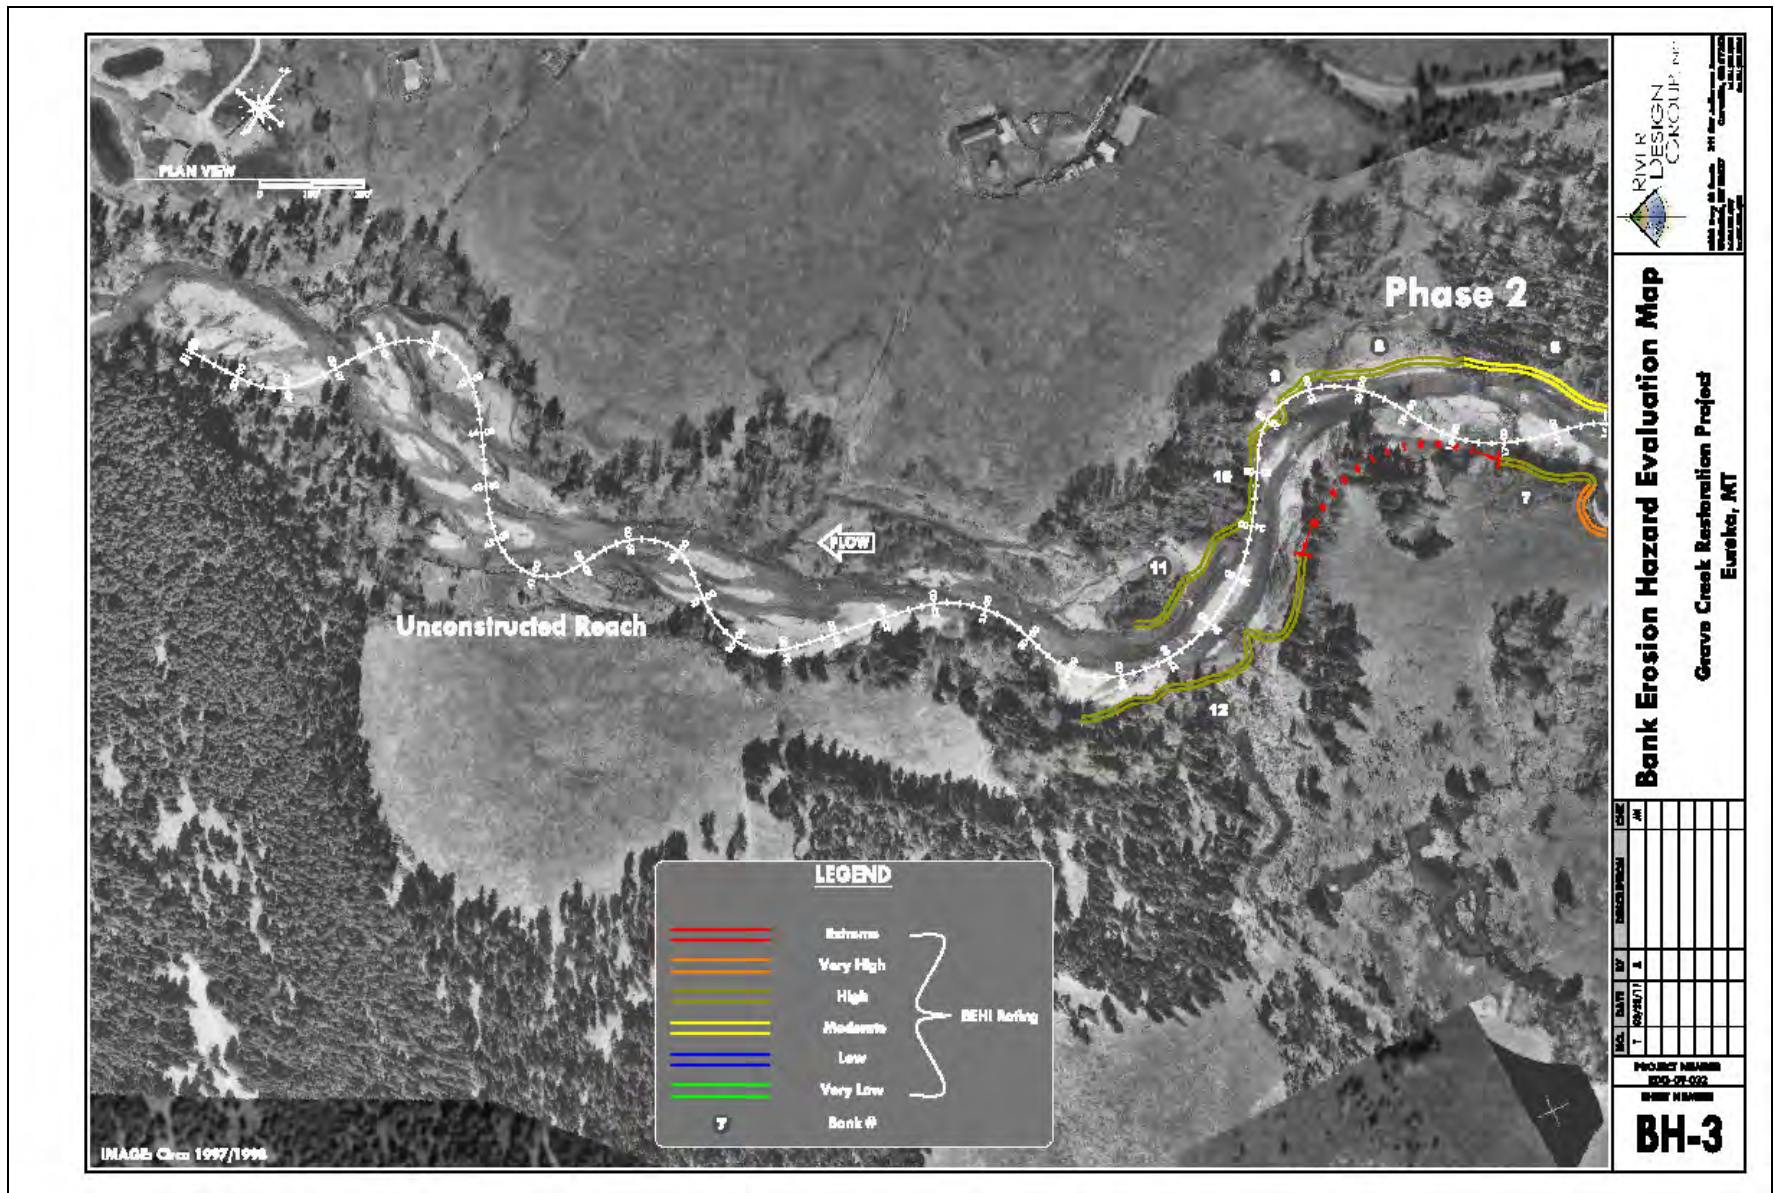
Figure A-6. Distribution of the bank erosion hazard in Lower Phase 2 before restoration.

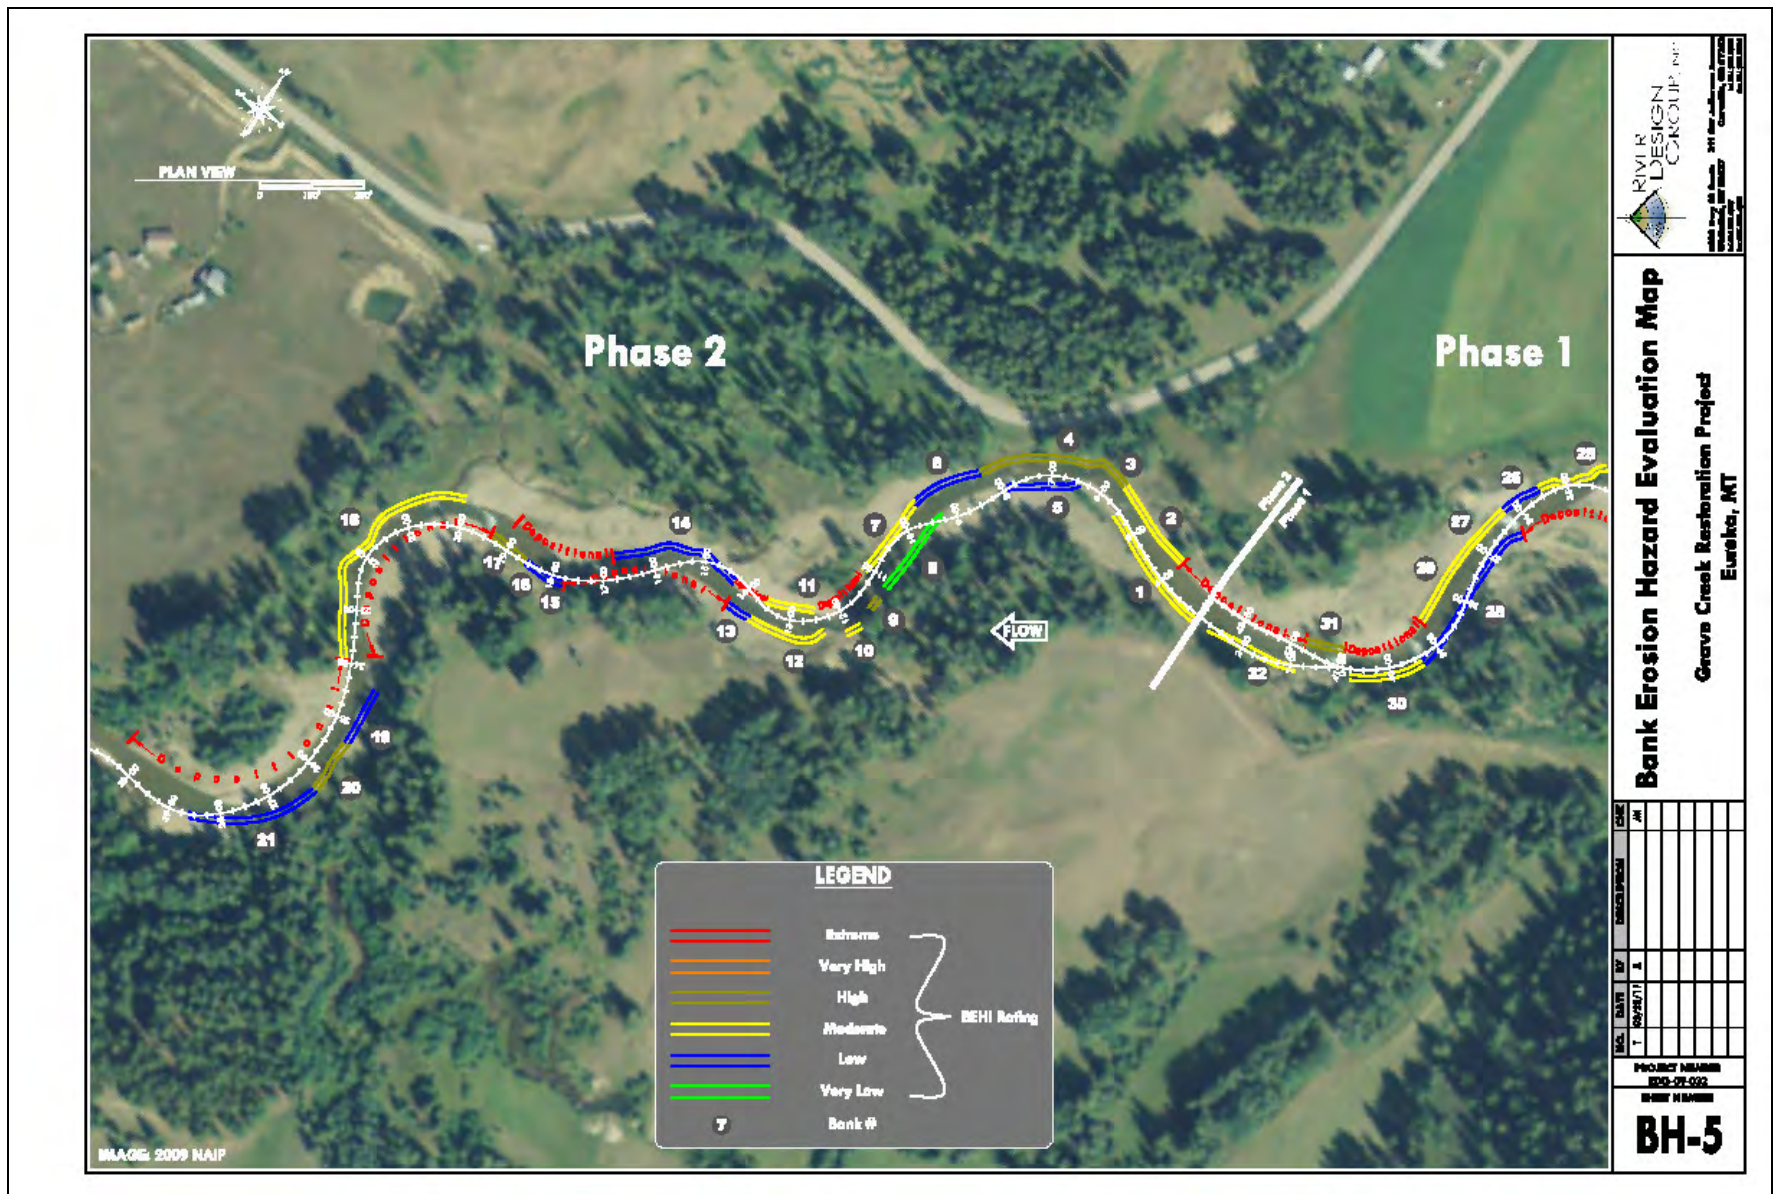
Figure A-7. Distribution of the bank erosion hazard in upper Phase 2 after restoration.

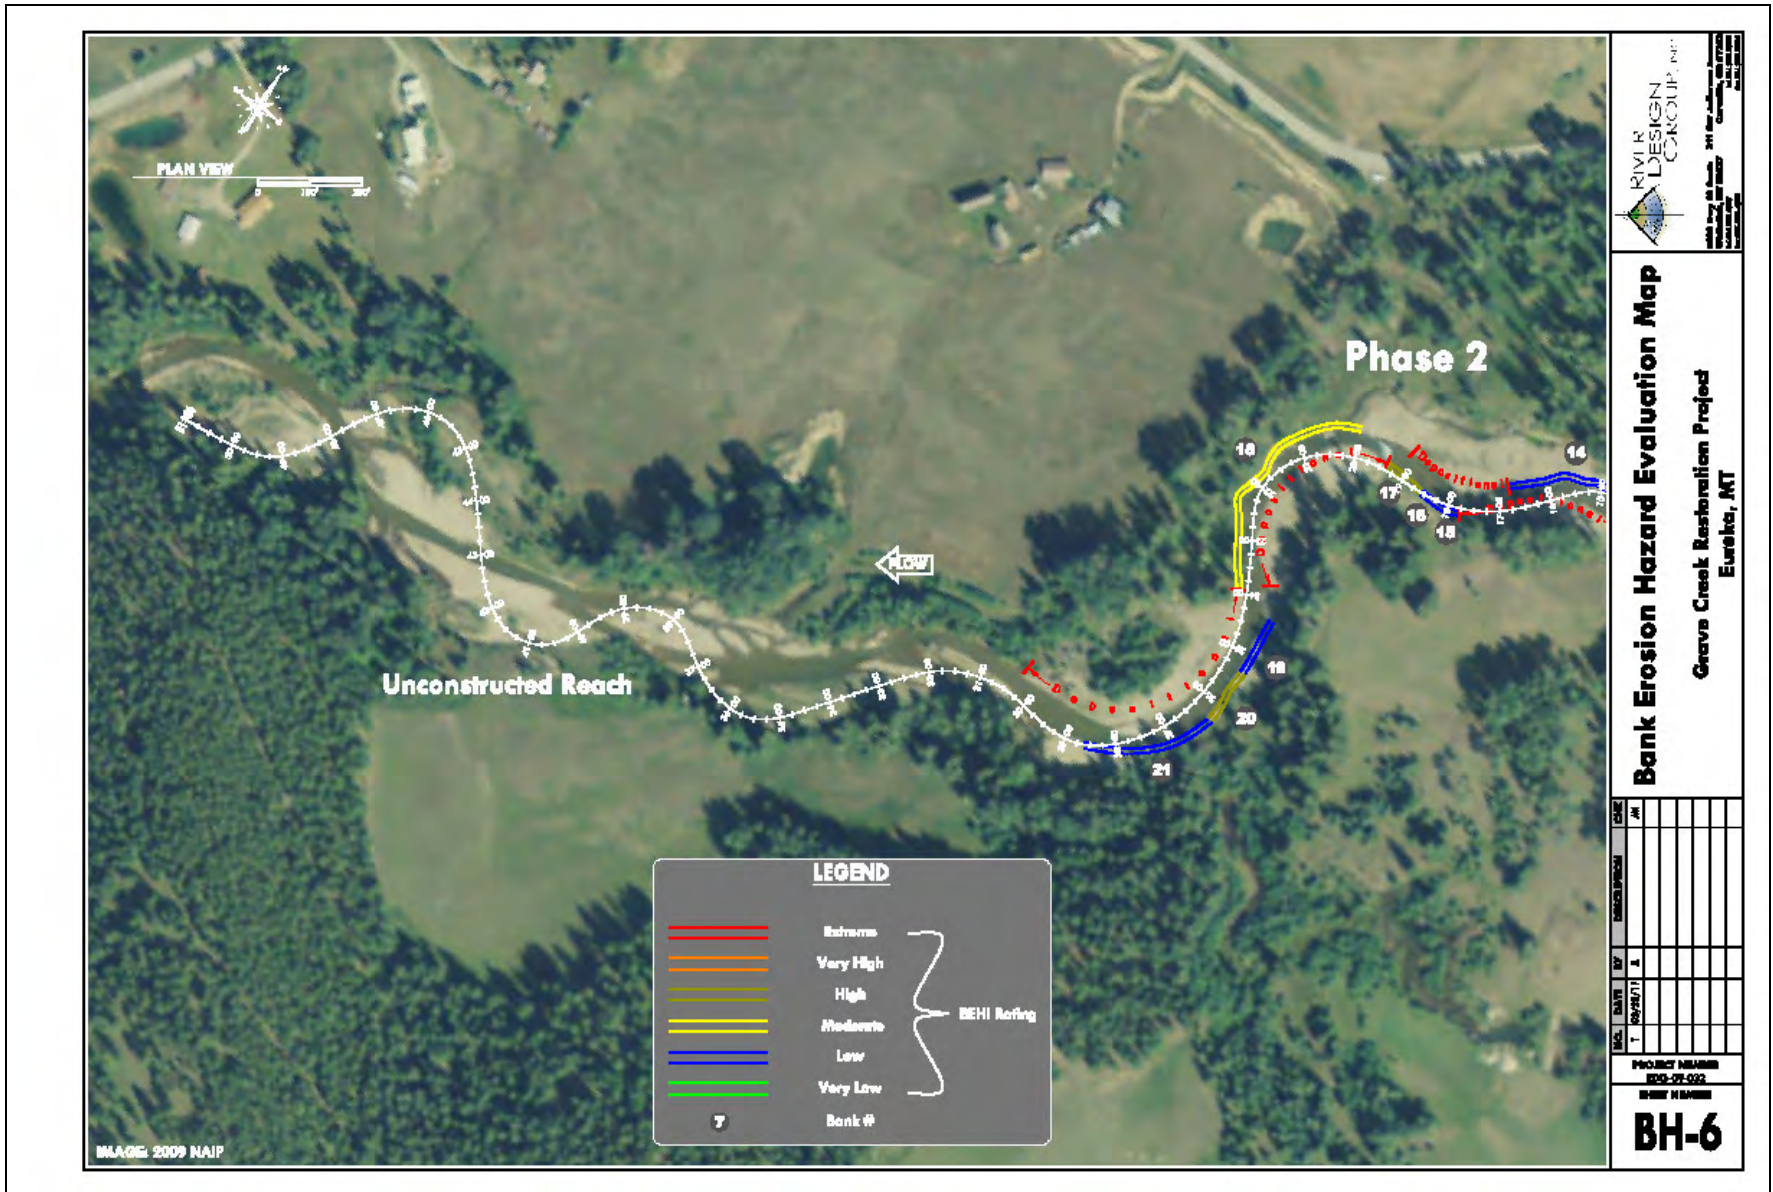
**Figure A-8.** Distribution of the bank erosion hazard in Lower Phase 2 after restoration.
