Therriault Creek Riparian Revegetation Maintenance and Monitoring 2009 Report

Task Order #0907

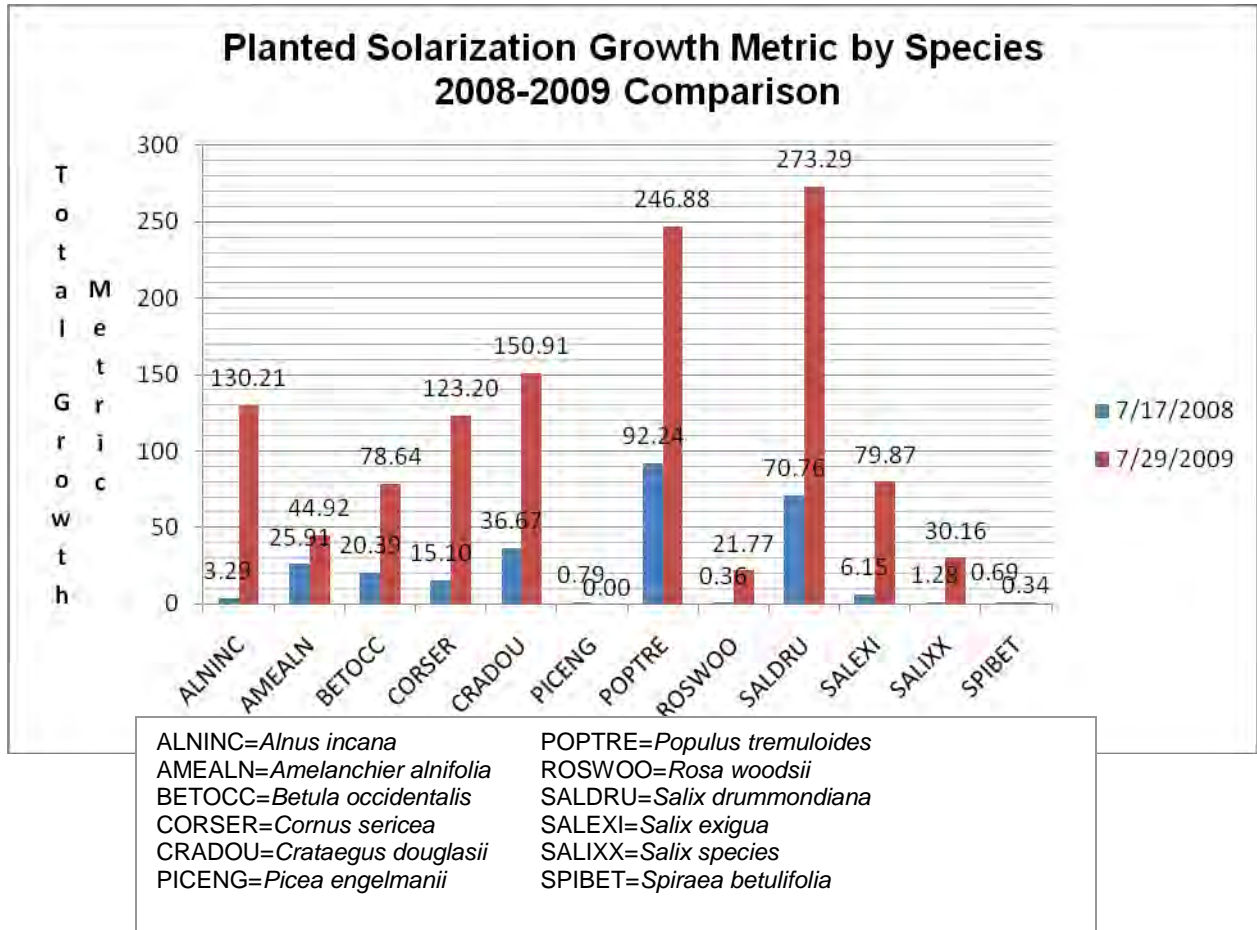
Table 6 and Figure 8 provide summaries of the total growth metric (height x πr^2) compared between 2008 and 2009. Total values for the growth metric varied widely by species. In general, quaking aspen (*Populus tremuloides*) and Drummond's willow (*Salix drummondiana*) showed the highest growth metric value, which is consistent with 2008 data. Engelmann spruce, white spirea and serviceberry (*Amelanchier alnifolia*) showed the lowest growth metric values. Mountain alder (*Alnus incana*), Black hawthorn (*Crataegus douglasii*), quaking aspen, and Drummond's willow had the biggest change in growth metric between 2008 and 2009.

Figure 8. Comparison of growth metric values between species in planted solarization plots 1 and 2 in 2008 and 2009. Total represents the sum of growth metric values (height x πr^2) for each species.

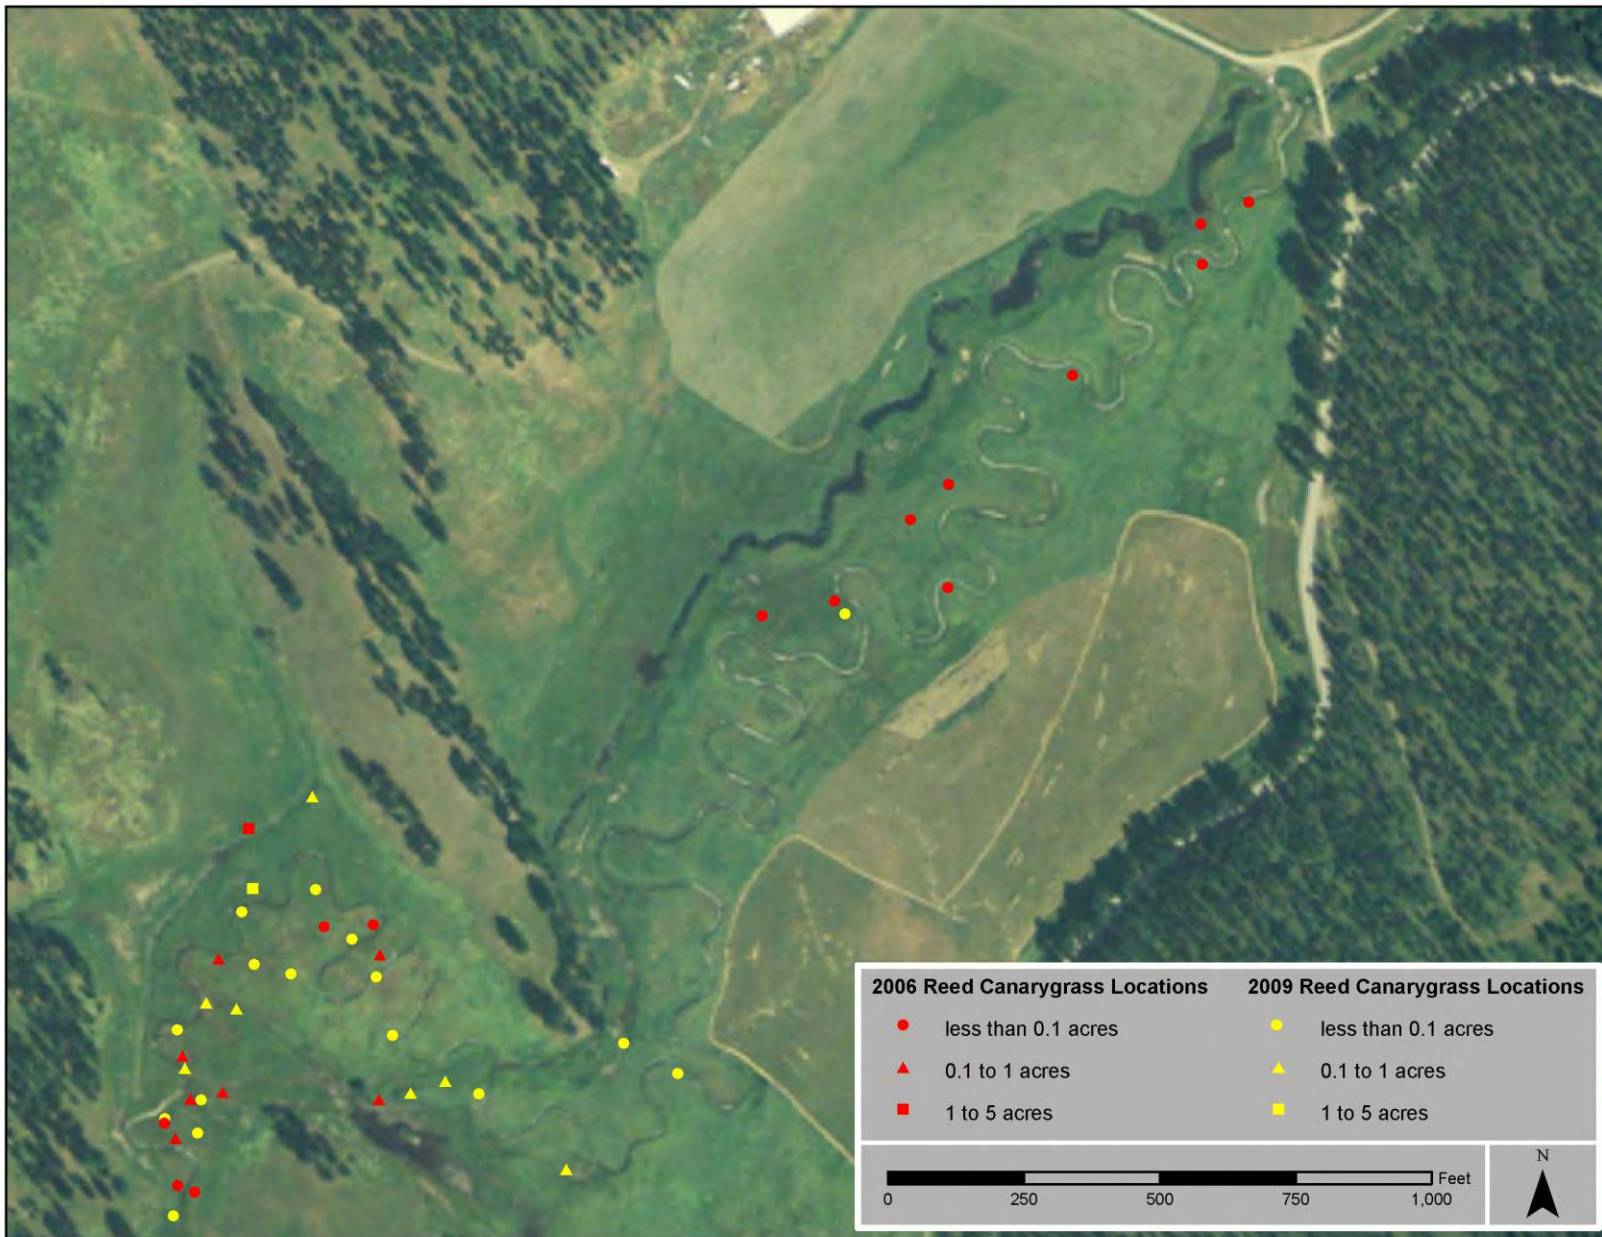
Reed canarygrass and Canada thistle continue to make up the largest infestations at the site, both in terms of density and distribution (Figures 19 through 22). The density of Canada thistle along the creek in the upper portion of the project site has decreased since 2006 (Figure 20). New and

increased density infestations have appeared at the downstream end of the project reach in areas that were not treated with herbicide (Figures 20 and 22). As a result of 2009 effectiveness monitoring, herbicide treatment of these new infestations was begun in fall 2009. Herbicide treatment of discrete reed canarygrass patches appears to be effective (Figures 18 and 19). Reed canarygrass distribution has been greatly reduced in the upper half of the project reach where it was targeted for control by herbicide (Figure 19).

Figure 19. Therriault Creek restoration project site reed canarygrass distribution mapped in 2006 and 2009.

- Treating small patches of reed canarygrass has been effective (Figure 19). This treatment should be expanded to other discrete patches in the downstream portion of the project reach.

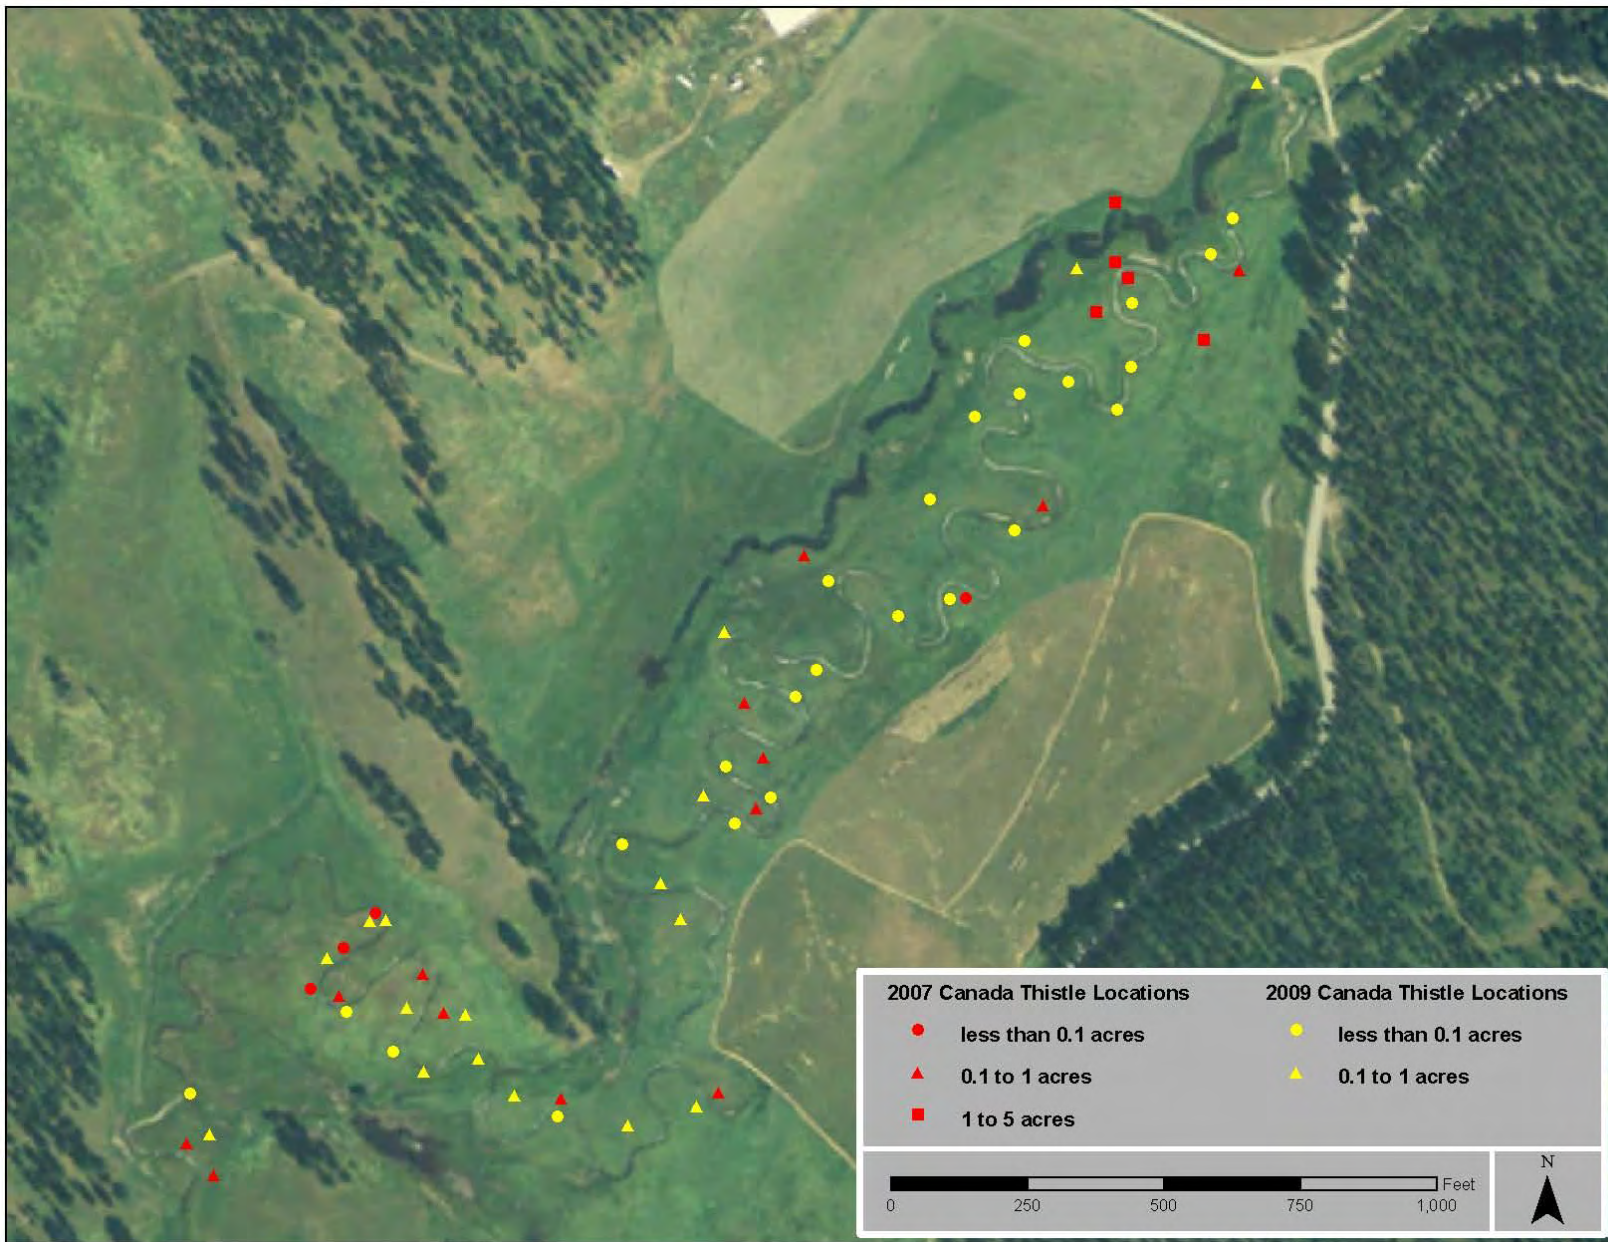
Figure 20. Therriault Creek restoration project site Canada thistle distribution mapped in 2006 and 2009.

- Herbicide applications are effectively decreasing the density of Canada thistle at the project site. The applicator missed downstream infestations of Canada thistle in 2008. This infestation increased in both size and density between 2007 and 2009 (Figures 20 and 22). This infestation was treated in the fall of 2009.

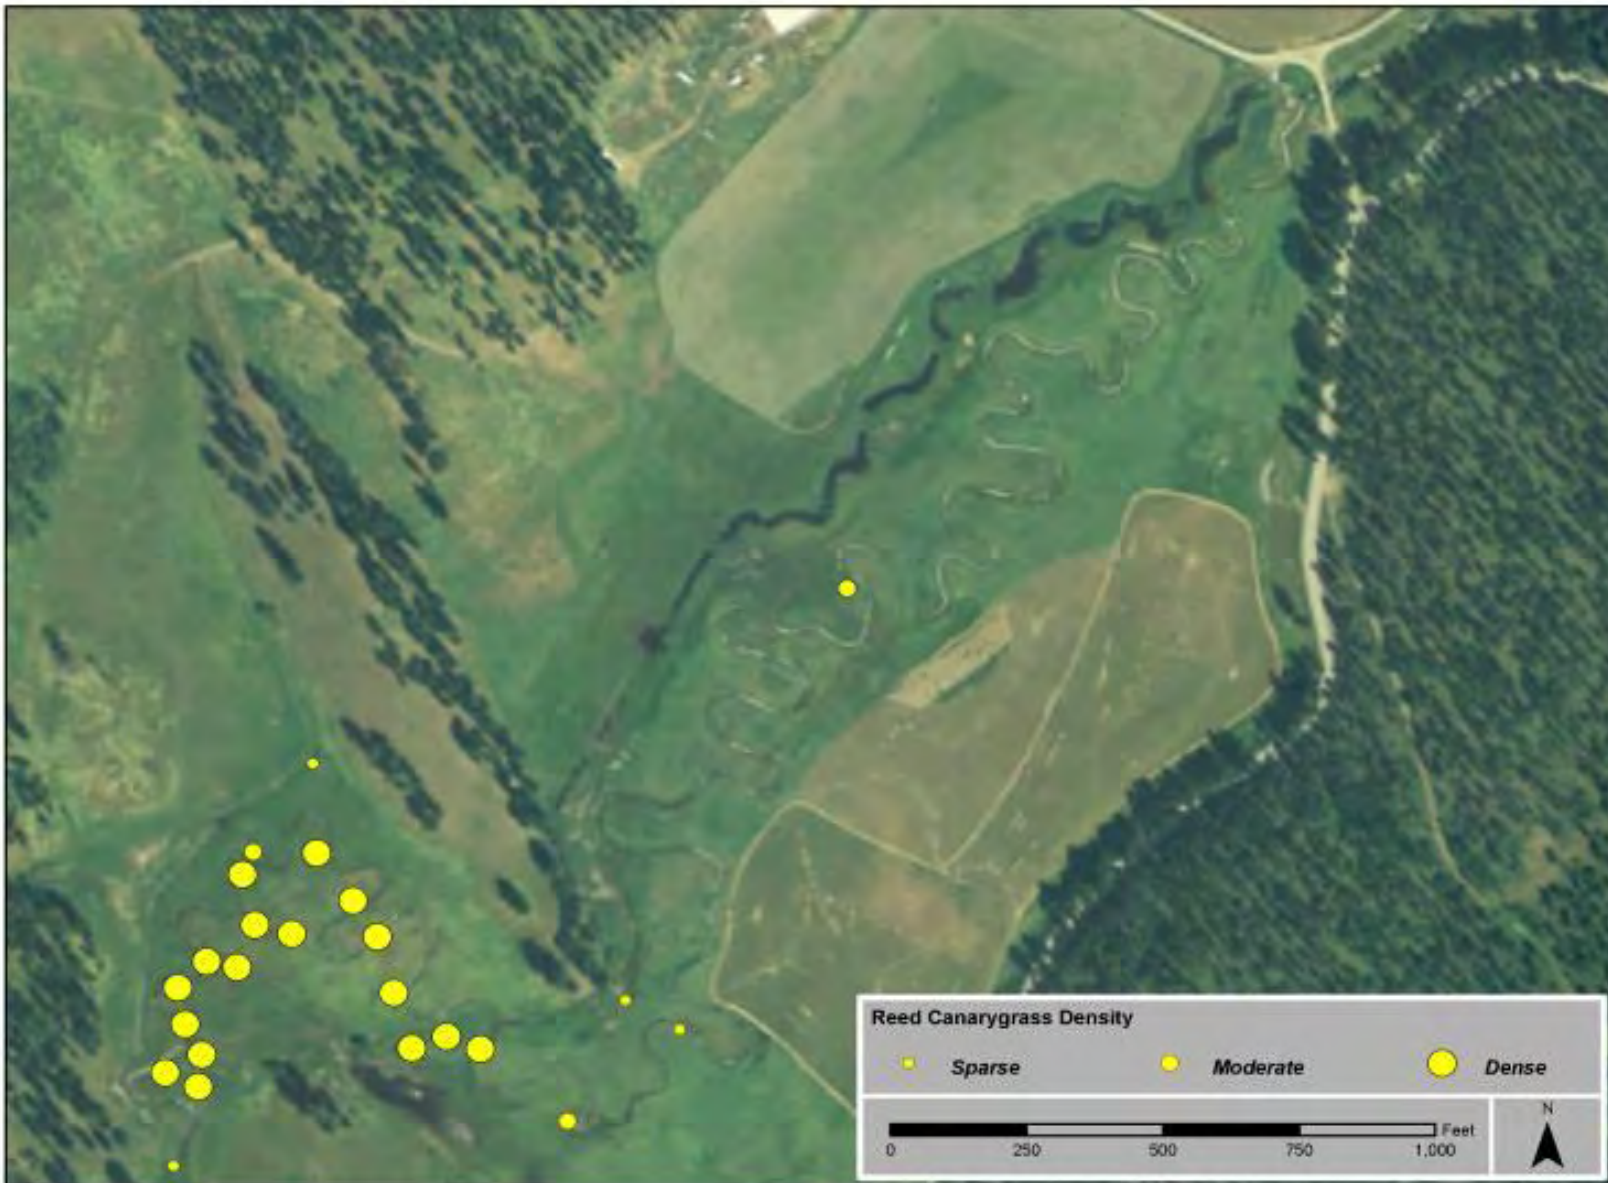
Figure 21. Therriault Creek restoration project reed canarygrass infestation densities mapped in July 2009.

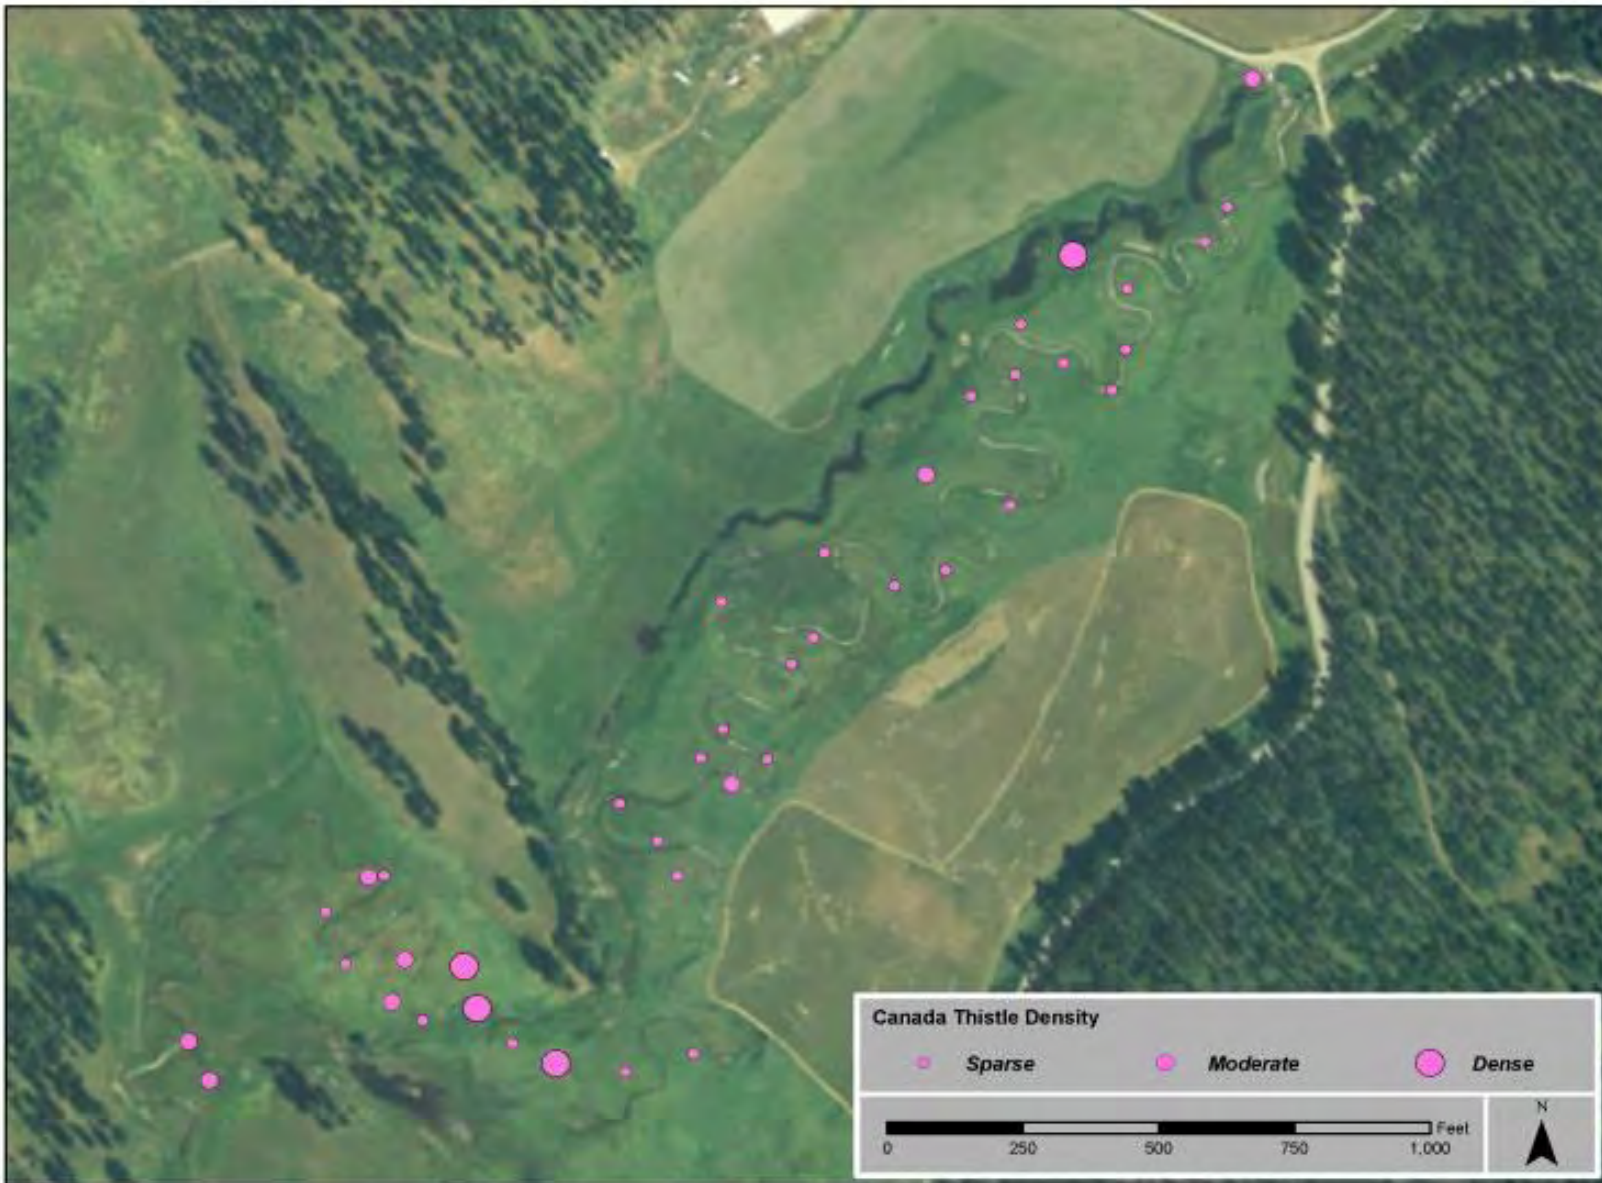
Figure 22. Therriault Creek restoration project site Canada thistle infestation densities mapped in July 2009.

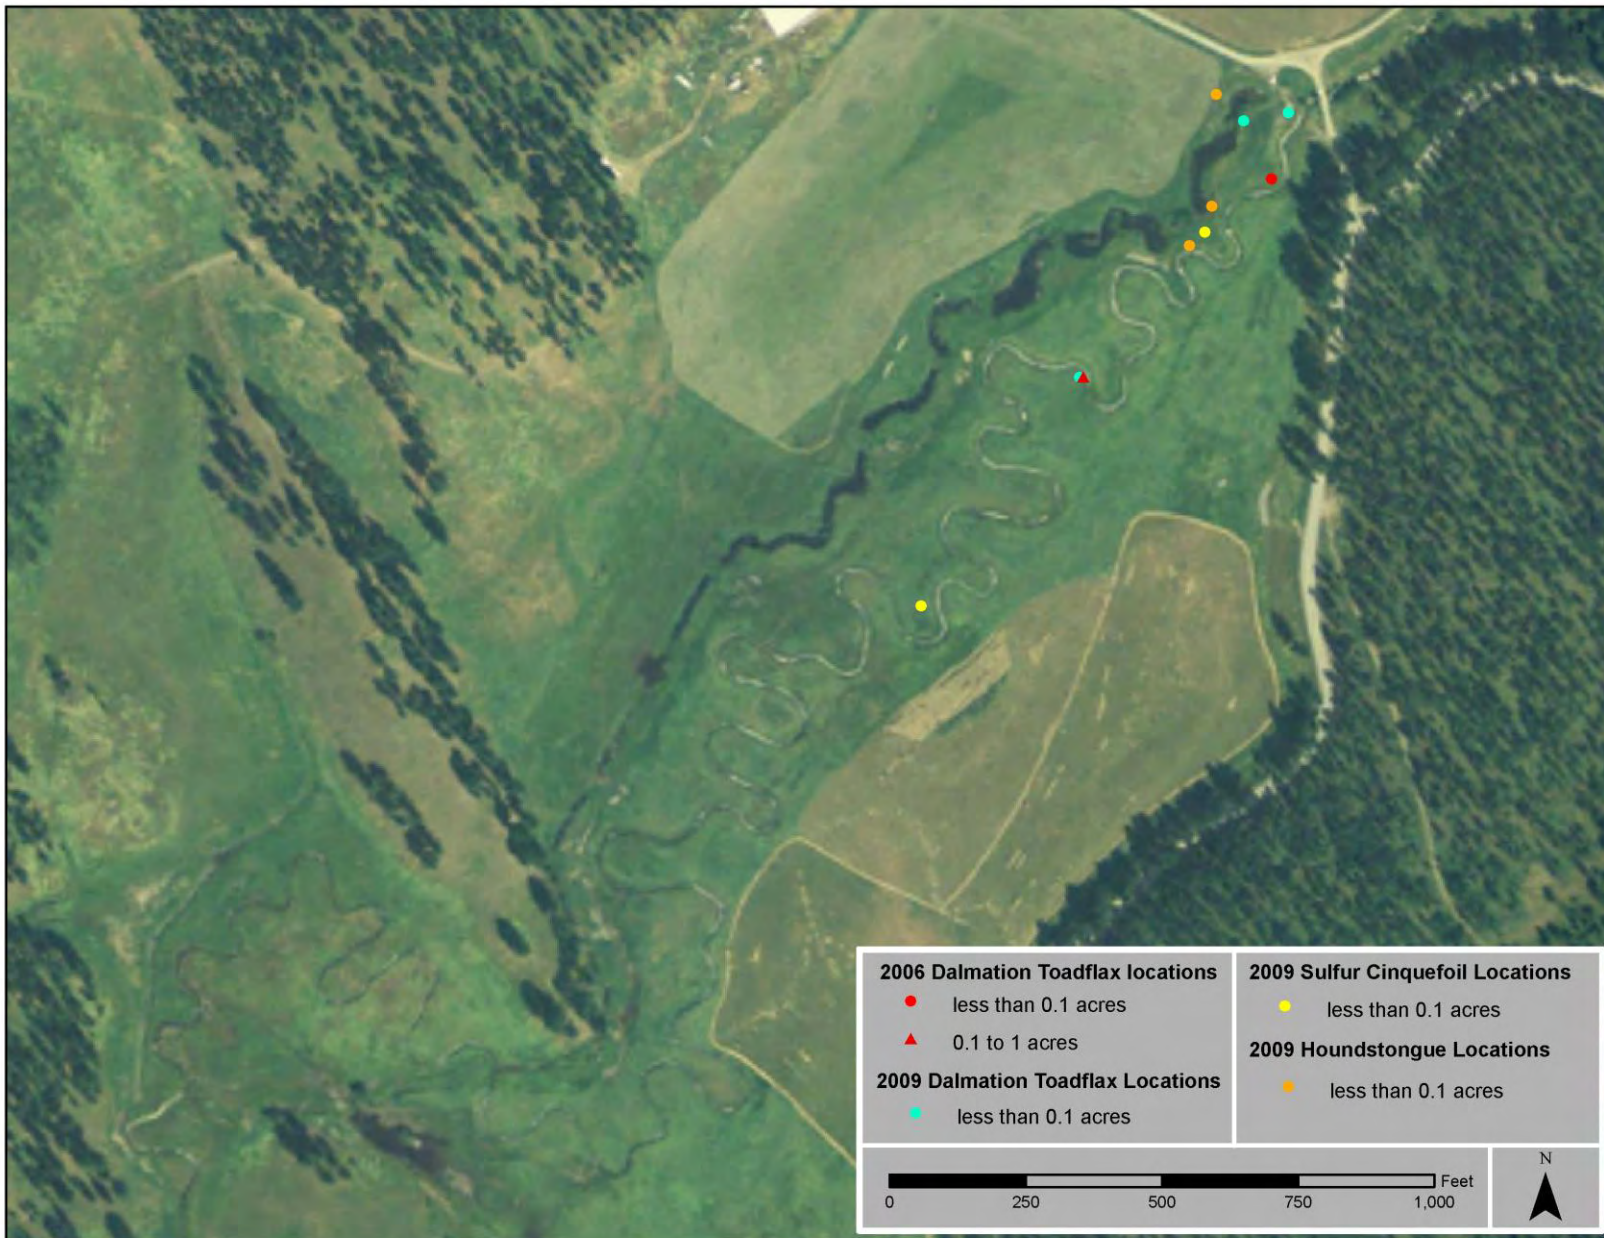
Yellow toadflax (*Linaria vulgaris*) continues to be present at the project site but to a lesser extent compared with thistle and canarygrass (Figure 23). Two new weed species were discovered in 2009 that were not present in 2006, sulphur cinquefoil (*Potentilla recta*) and houndstongue (Figure 23). The distribution and densities of these infestations is currently low (Figure 23).

Figure 23. Therriault Creek restoration project site toadflax, sulfur cinquefoil, and houndstongue infestation and densities mapped in July 2009.

- The distribution of yellow toadflax has increased since 2007 (Figure 23). Because overall distribution remains low, this species should be treated in 2010.
