TO: Jim Dunnigan, Montana Fish, Wildlife and Parks
FROM: Amy Sacry and Jesse Wallace, Geum Environmental Consulting, Inc.
DATE: November 27, 2019
RE: Therriault Creek 2019 As-built and Maintenance Summary

This memo describes restoration treatment installation and revegetation maintenance work completed in 2019 at the Therriault Creek Restoration Project Site under Montana Fish, Wildlife and Parks (FWP) Task Order 19-0010. Restoration treatments and maintenance tasks were identified by Geum Environmental Consulting (Geum). Installation of restoration treatments and maintenance tasks was completed by Westslope Forest Management (Westslope) and Geum. Weed control was completed by Mountain Valley Plant Management (MVPM).

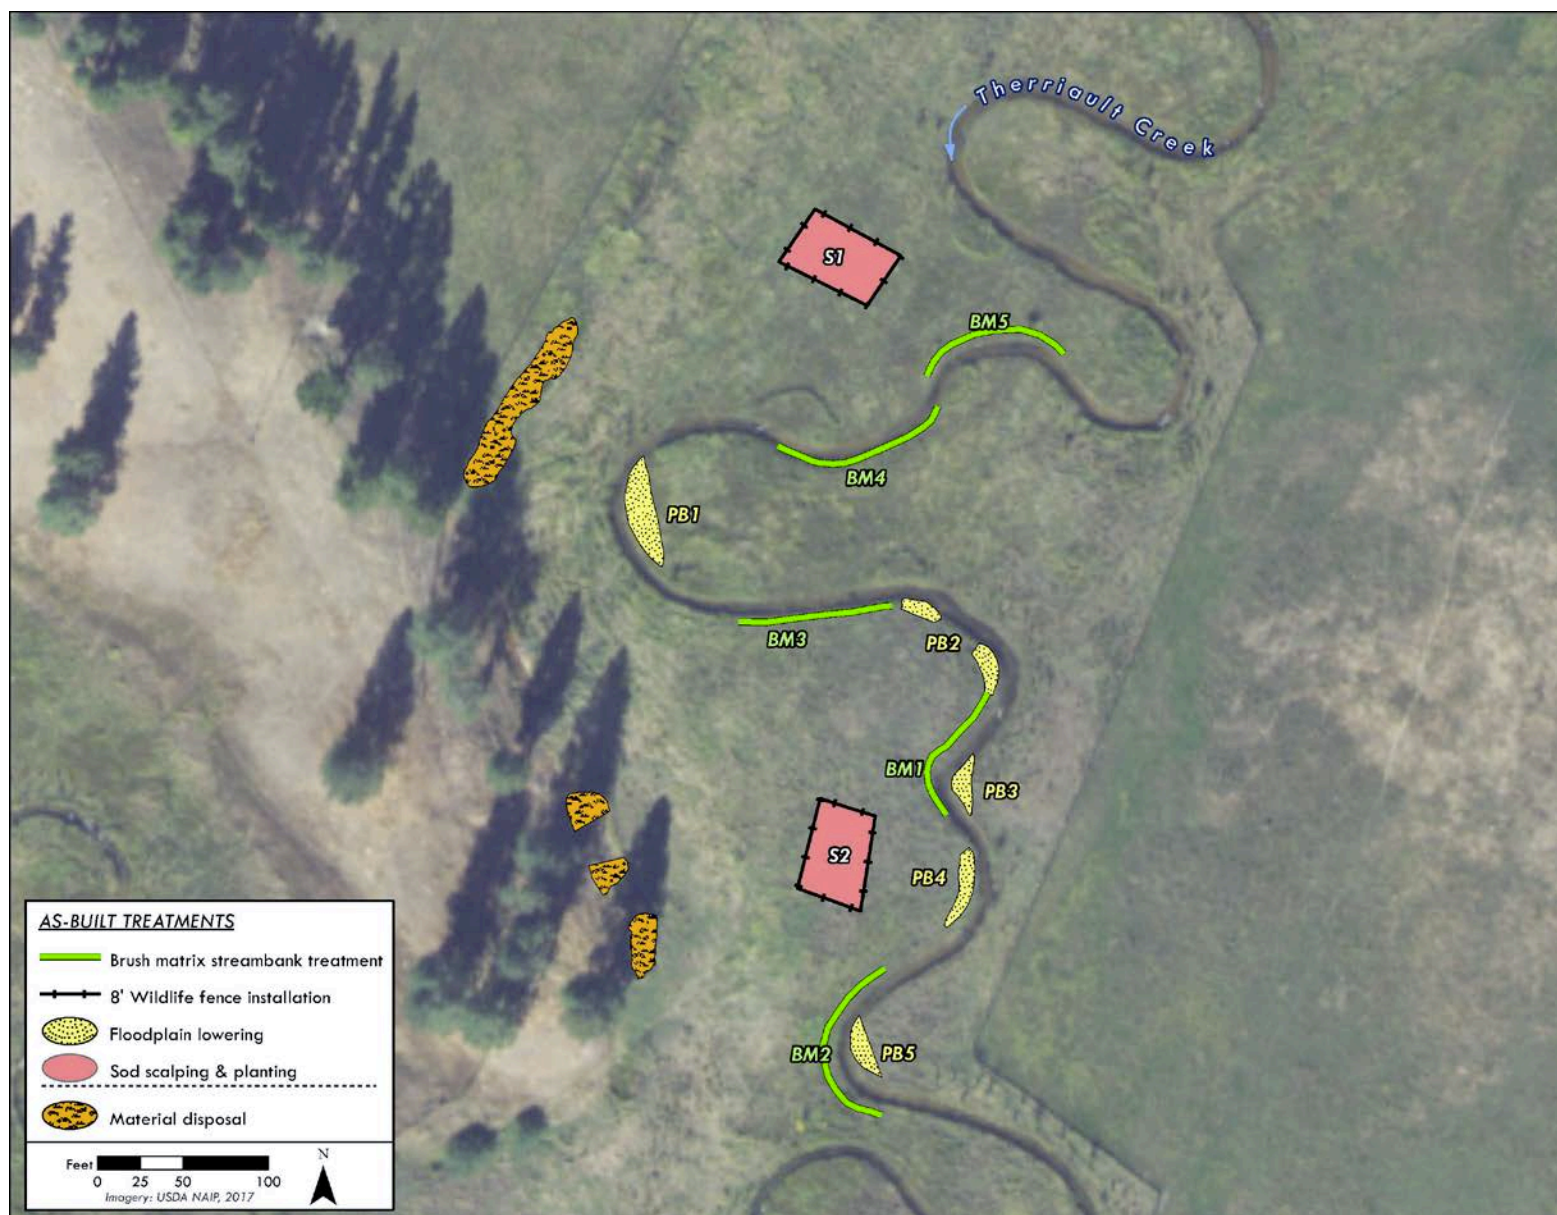
Five locations were lowered to expand point bars and increase floodplain connectivity on inside meander bends (Figure 1, Table 1). These areas were almost all dominated by dense cover of aggressive, introduced, pasture grasses and were previously disturbed during the original stream channel construction in 2004-2005. No previous planting of riparian shrubs and trees had been done in

Figure 1. Therriault Creek Restoration Project Fall 2019 As-built treatment locations.

these areas. This treatment removed the dense pasture grasses, exposing bare substrates that can be colonized by woody riparian shrubs; and lowered the floodplain elevation, creating areas of increased connectivity with the channel that will allow high flows to create natural disturbances necessary for riparian vegetation community initiation. Willows were installed in a trench approximately 1 foot above the low flow water surface elevation at each point bar expansion location. A total of 350 willow cuttings were installed in these treatments. Each point bar expansion area was seeded with a mix of native wetland grasses (Table 2). Before and after photographs of each treatment location are shown in Figure 2 through Figure 6. Excess material generated from point bar lowering treatments was placed in ponds shown on Figure 1.

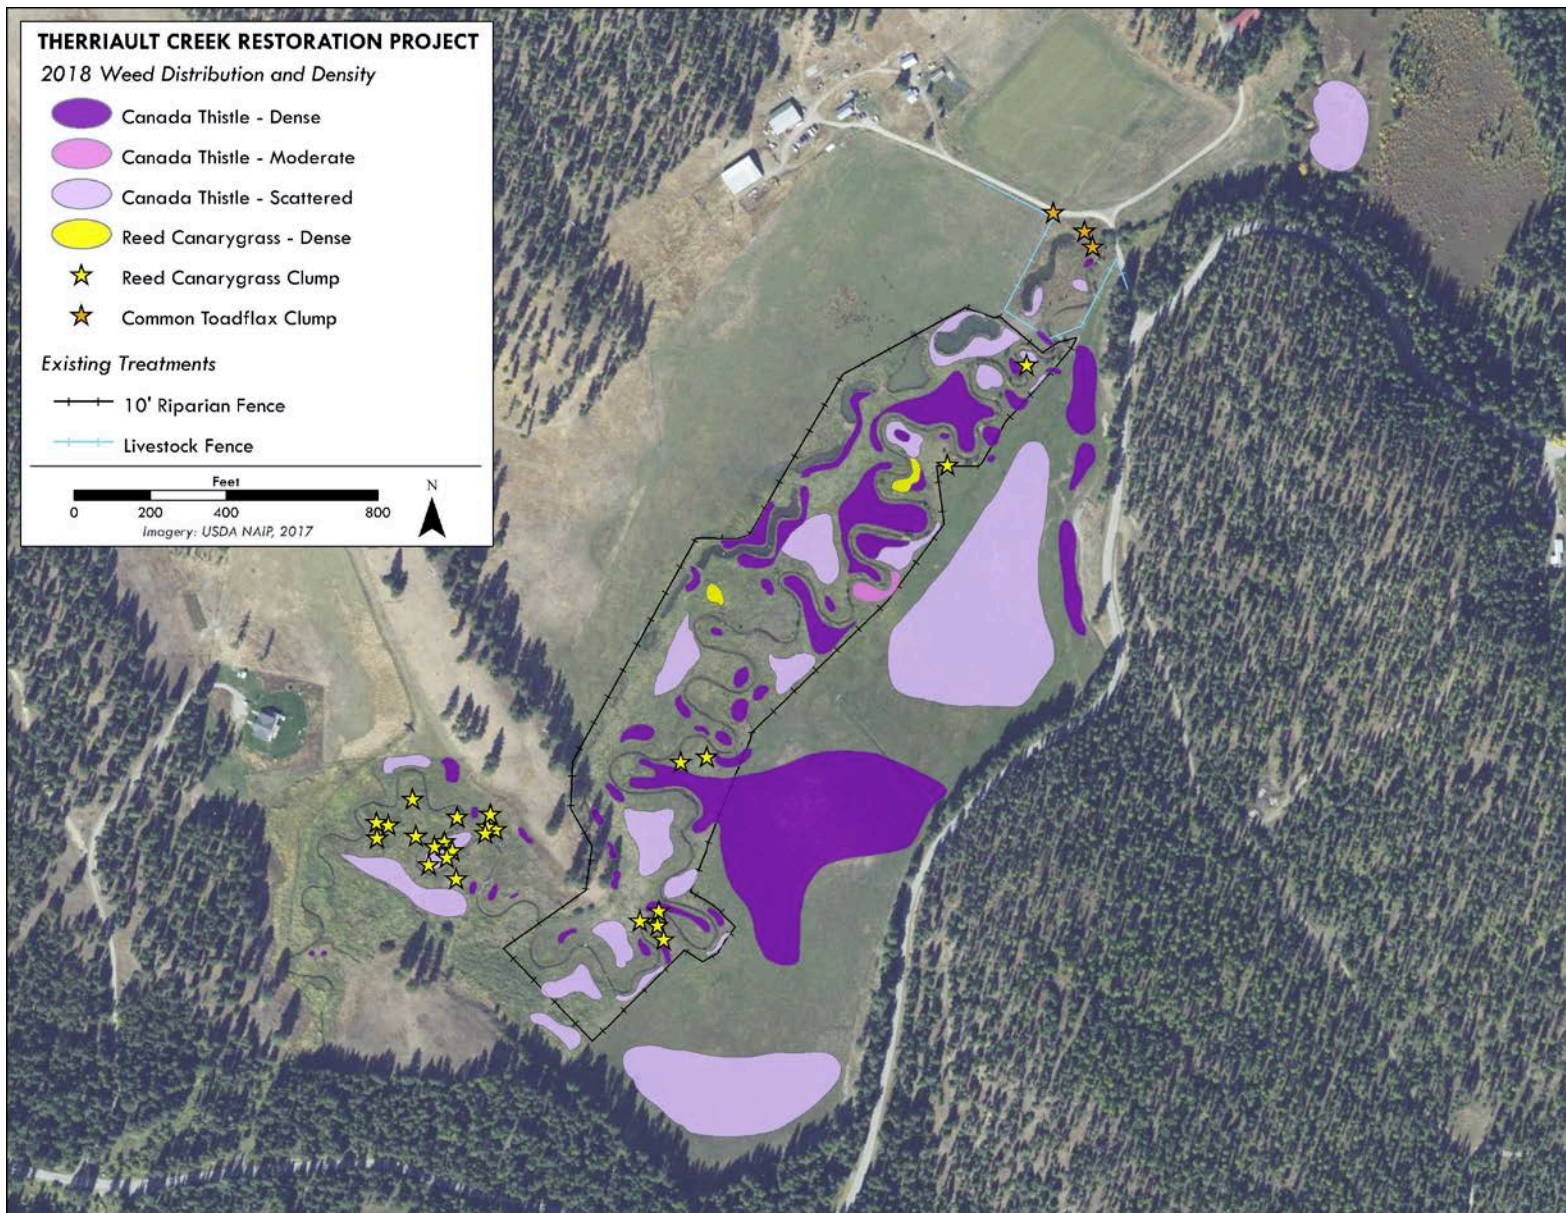
Figure 17 shows the distribution of weeds at the Site in 2018. No weed control was completed in 2018 and the distribution and density of weeds observed during the May 2019 site review was similar to 2018. 2018 weed observations are described in the 2018 Management Plan and a separate memo, *Therriault Creek 2018 Maintenance Summary* (Geum, January 15, 2019).

The weed distribution map shown on Figure 17 was provided to the weed control contractor to direct 2019 weed control activities. Weed control was completed by MVP on July 15 through July 18, 2019. Canada thistle (*Cirsium arvense*) was the primary weed targeted. Musk thistle (*Carduus nutans*), houndstongue (*Cynoglossum officinale*), and yellow toadflax (*Linaria vulgaris*) were also treated. Approximately 26 acres were treated at the site. Herbicide application records are provided in Attachment 2. Weed control activities in the hayfield east of the project area were completed by the landowner.

Figure 17. Weed species and densities mapped at the Site in 2018. This information was used to guide weed control treatment in 2019.
