TO: Jim Dunnigan, Montana Fish, Wildlife and Parks
FROM: Amy Sacry, Geum Environmental Consulting, Inc.
DATE: January 28, 2021
RE: Therriault Creek 2020 Maintenance Summary

This memo describes observations made and maintenance work completed in 2020 at the Therriault Creek Restoration Project Site under Montana Fish, Wildlife and Parks (FWP) Task Order 19-0010. Maintenance tasks were identified and completed by Geum Environmental Consulting (Geum). Weed control was completed by Mountain Valley Plant Management (MVPM). This memo also provides a budget status update for Task Order 19-0010 and a list of recommended next steps.

The Therriault Creek Restoration Project was evaluated by Geum on June 23, 2020. Stream flows were at bankfull during the site visit. The purpose of the site evaluation was to determine revegetation treatment maintenance needs, determine weed control needs, and evaluate restoration treatments installed in 2020. A detailed description of observations related to the overall condition of the site is provided in a separate document, *Therriault Creek Restoration Project – Five-year Vegetation Management Plan* (Geum, 2019). This plan identified restoration treatmen

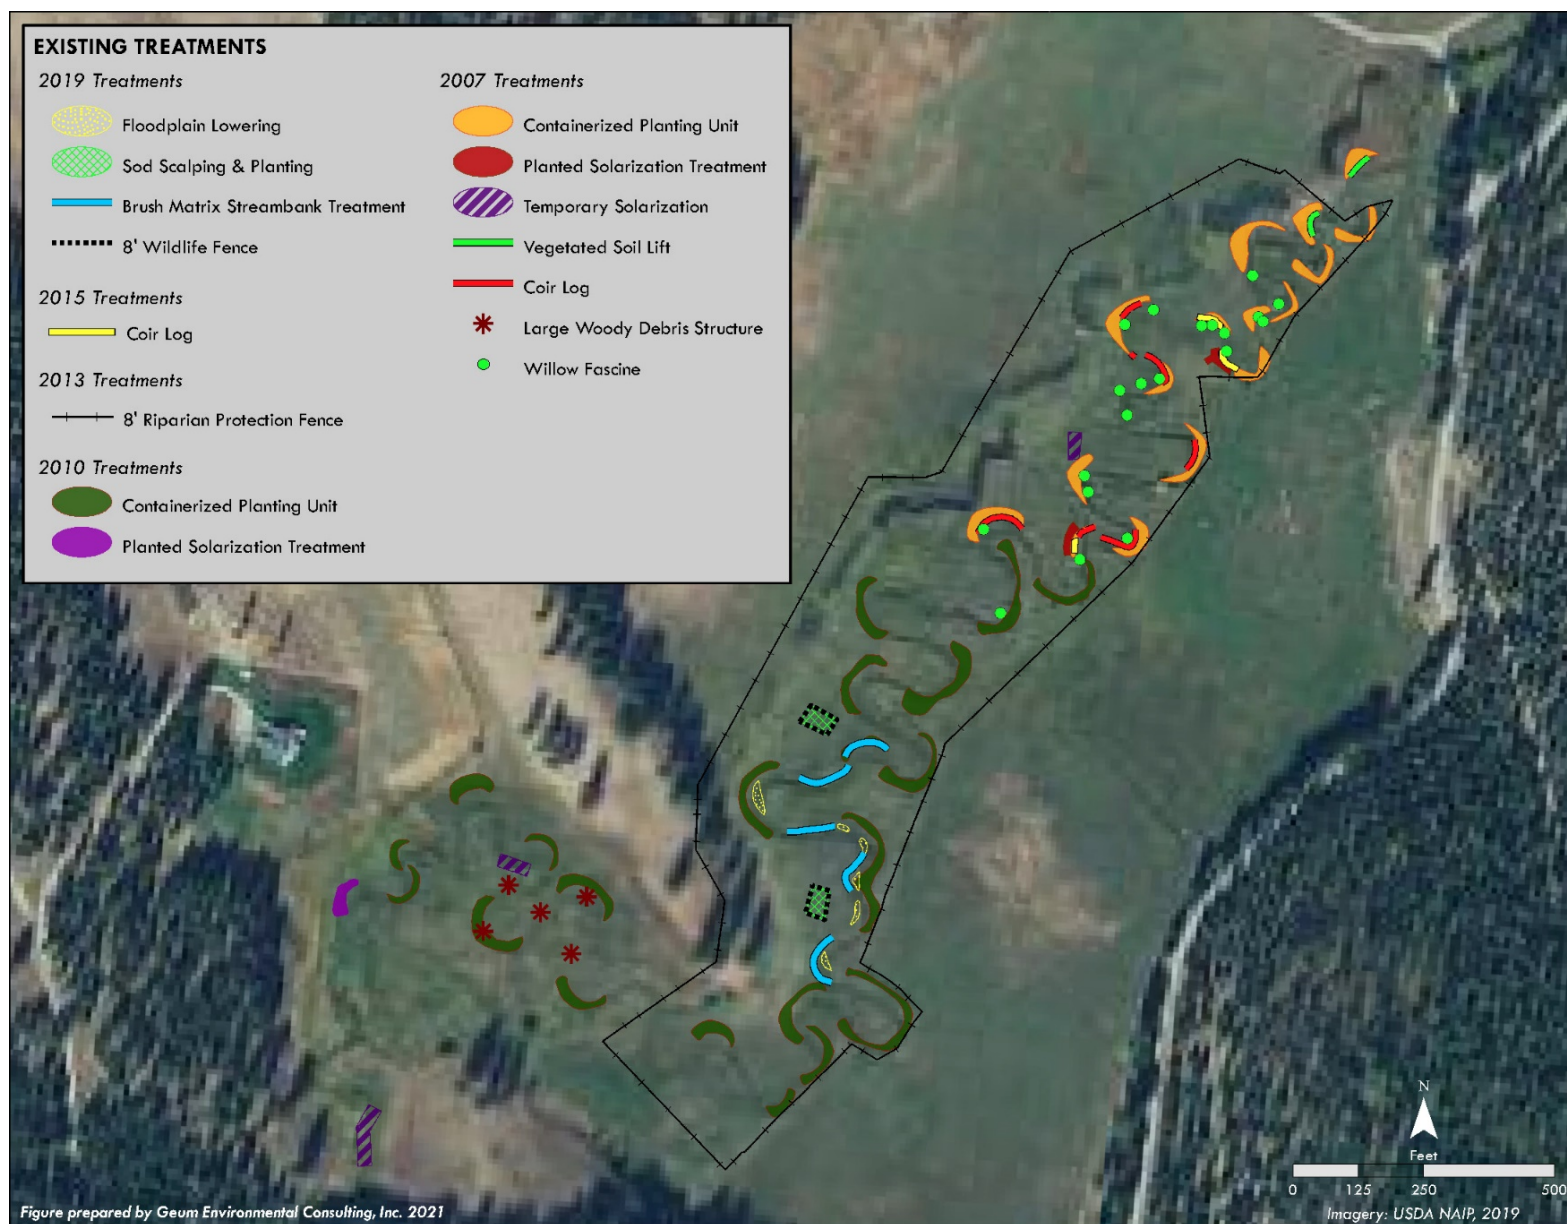
Figure 1. Overview of current treatment locations.

Sod scalping and planting occurred in two locations at the Site in Fall 2019 (Figure 1). The purpose of this treatment was to remove the aggressive introduced grass species and expose the bare mineral soil underneath to allow desirable species to establish. The exposed soil was seeded with native grasses, forbs and sedges and planted with a mix of container willow species. Willows were planted at a very tight spacing (approximately 2 to 3 feet on center) to allow rapid expansion and cover of willows. The two planted areas were fenced with 8-foot tall heavy duty elk net fencing to prevent browse and damage by ungulates and rodents.

Five locations were lowered to expand point bars and increase floodplain connectivity on inside meander bends (Figure 1 and Figure 9 through Figure 14). These areas were almost all dominated by dense cover of aggressive, introduced, pasture grasses and were previously disturbed during the original stream channel construction in 2004-2005. The point bar expansion treatment removed the dense pasture grasses and lowered the floodplain elevation, exposing bare substrates to be colonized by woody riparian shrubs and increase hydrologic connectivity between the channel and floodplain to create natural disturbances necessary for riparian vegetation community initiation. Willows were installed in a trench approximately 1 foot above the low flow water surface elevation at each point bar expansion location. A total of 350 willow cuttings were installed in these treatments. Each point bar expansion area was seeded with a mix of native wetland grasses.

Brush matrix streambank treatments were installed at five locations at the Site in Fall 2019 (Figure 1 and Figure 9, Figure 11, Figure 13, Figure 15, and Figure 16). The purpose of this treatment was to increase riparian woody vegetation cover along the stream and increase aquatic habitat cover. This treatment used small logs and woody brush material combined with dormant willow cuttings. A total of 499 linear feet of brush matrix streambank treatment was installed. A total of 1,500 6- to 8-foot long and ½" to 1" diameter willow cuttings were installed in brush matrix streambank treatments.
