GRAVE CREEK RIPARIAN REVEGETATION 2008 AS-BUILT AND 2009 MONITORING REPORT

KOOTENAI RIVER NETWORK
P.O. BOX 491
LIBBY, MT 59923

GEUM ENVIRONMENTAL CONSULTING, INC.
307 STATE STREET, P.O. BOX 1956
HAMILTON, MT 59840

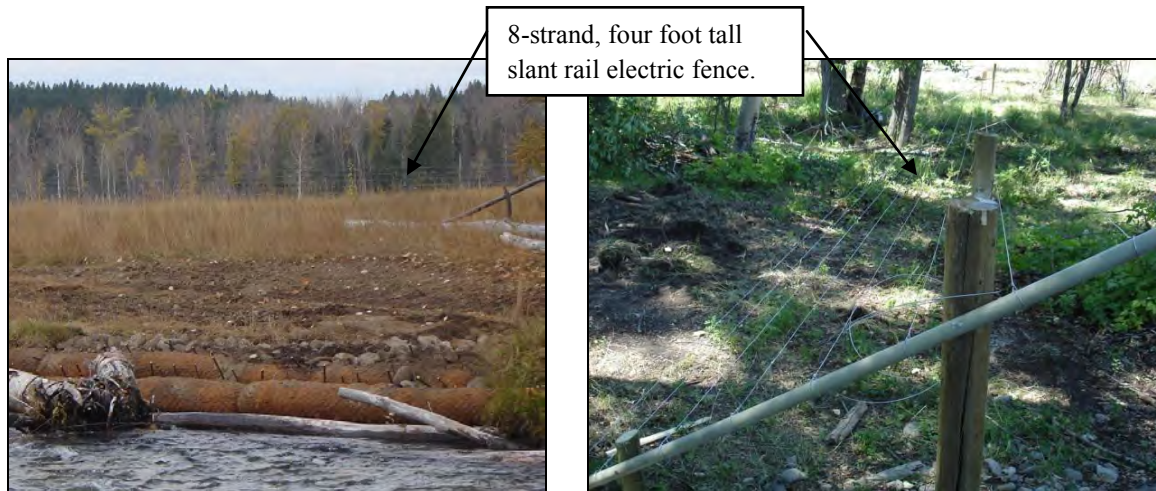
Approximately 4,000 feet of fence enclosing 20 acres of riparian vegetation was constructed in August 2008. The fence is an eight strand electric slant rail fence (Figure 10). The fence encloses the riparian area within the Demonstration reach and extends downstream to Site 4 within the Phase I project reach. The location of the fence is shown in Figure 9.

Figure 10. Photographs showing the electric slant rail fence installed during August 2008 to reduce wildlife browse within the project reach.

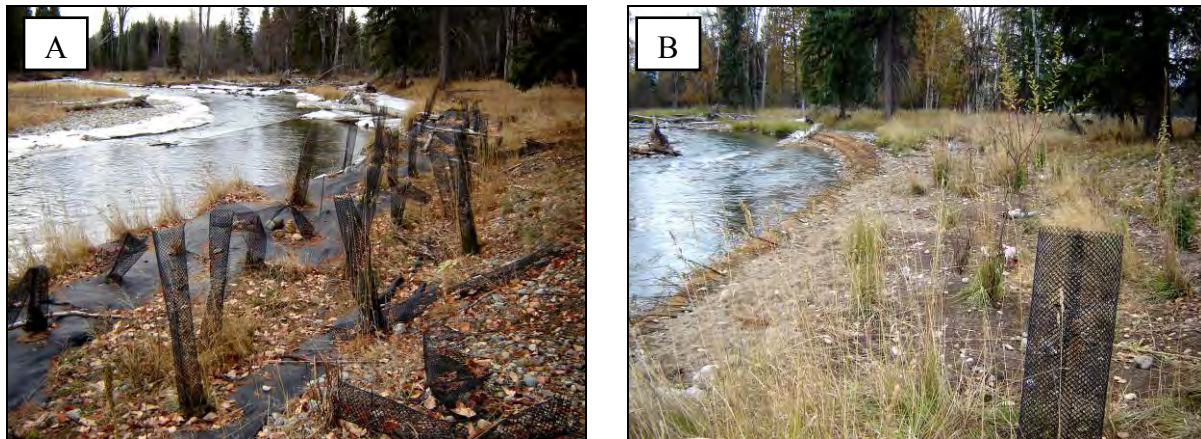
Figure 12. Photograph A shows Planting Area 3 before 2008 maintenance. Photograph B shows Planting Area 3 after maintenance and construction of a vegetated soil lift.

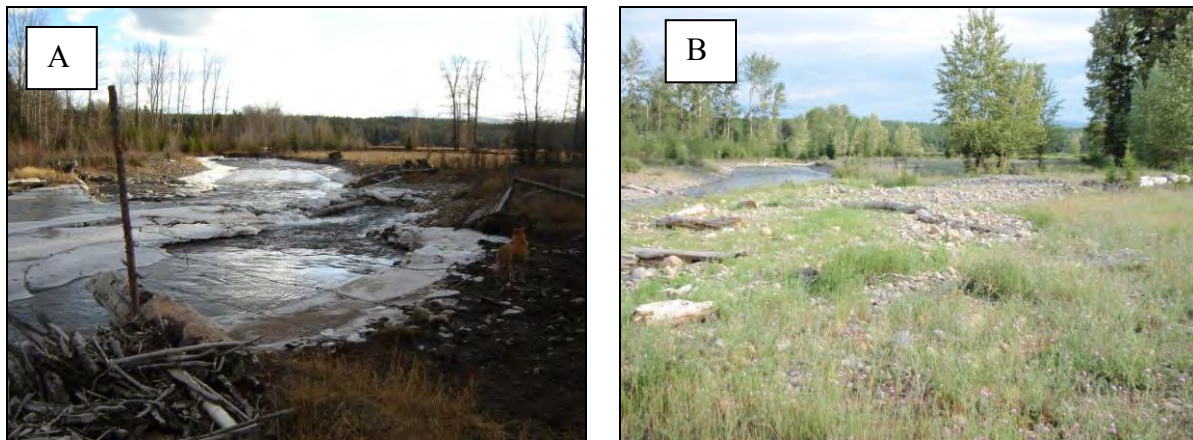
Figure 14. Photograph A shows the cattle water gap prior to construction. Photograph B shows the site the summer following construction of a soil lift and back-filling the access ramp. Material removed from Site 8 shown in Figure 13 was used at this site.

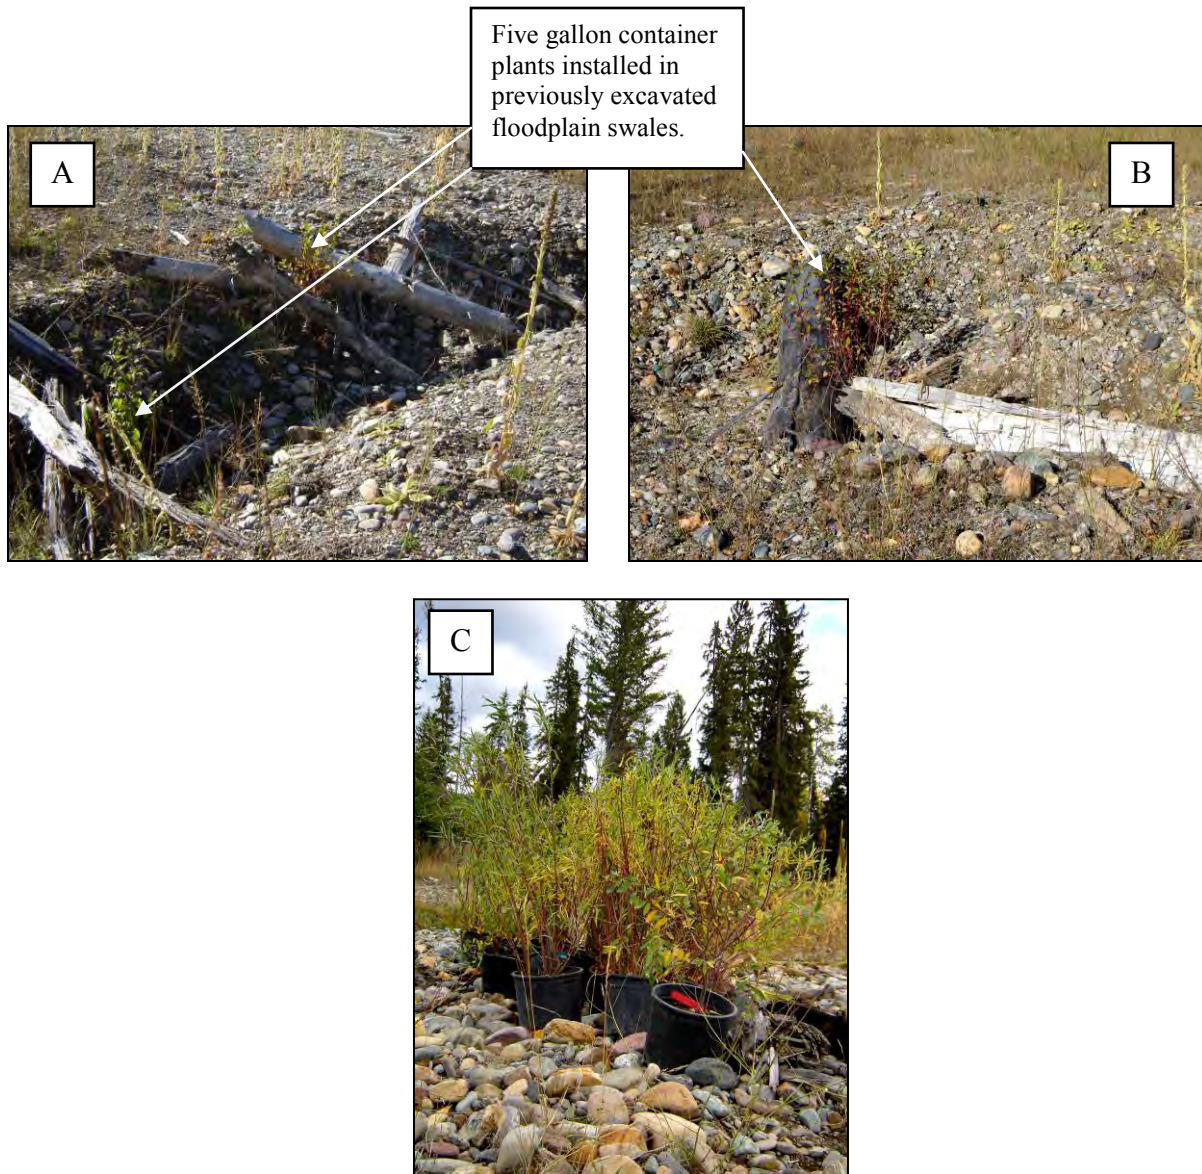
Figure 15. Two and five gallon container plants (Photograph C) were installed within previously excavated floodplain swales at Sites 4, 9, 10, and 12. Photographs A and B illustrate how woody debris was placed around plants to create moisture and shaded microsites as well as to protect the base of shrubs from browse.

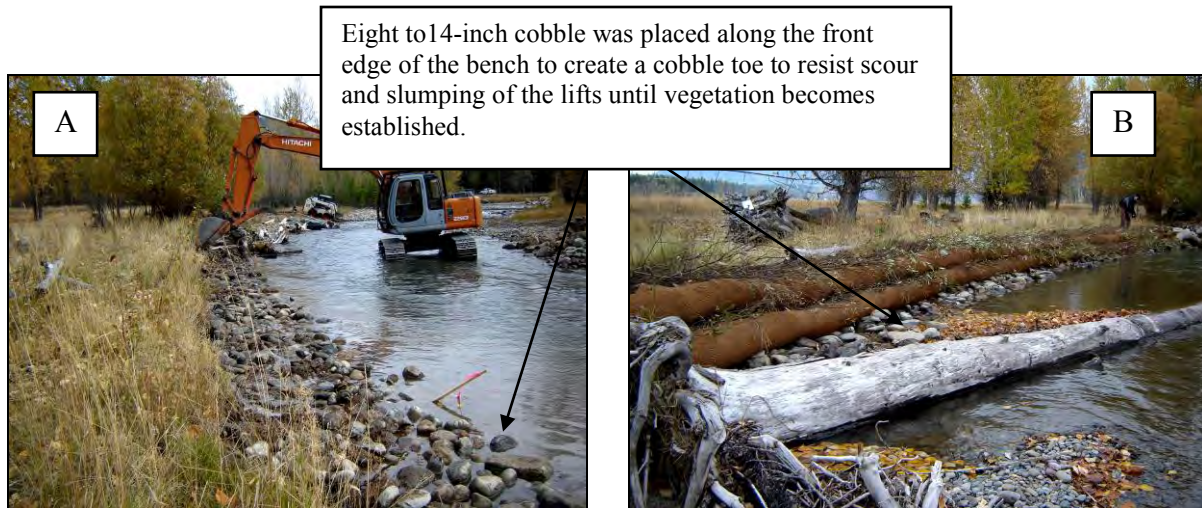
Figure 16. Vegetated soil lift at Site 3 during (Photograph A) and after (Photograph B) construction.

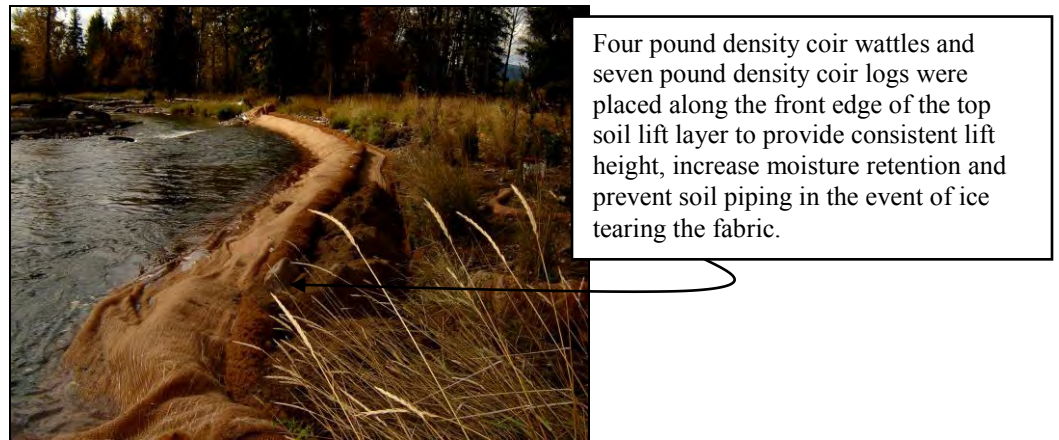
Figure 17. Photograph shows the vegetated soil lift at Site 5 during construction.

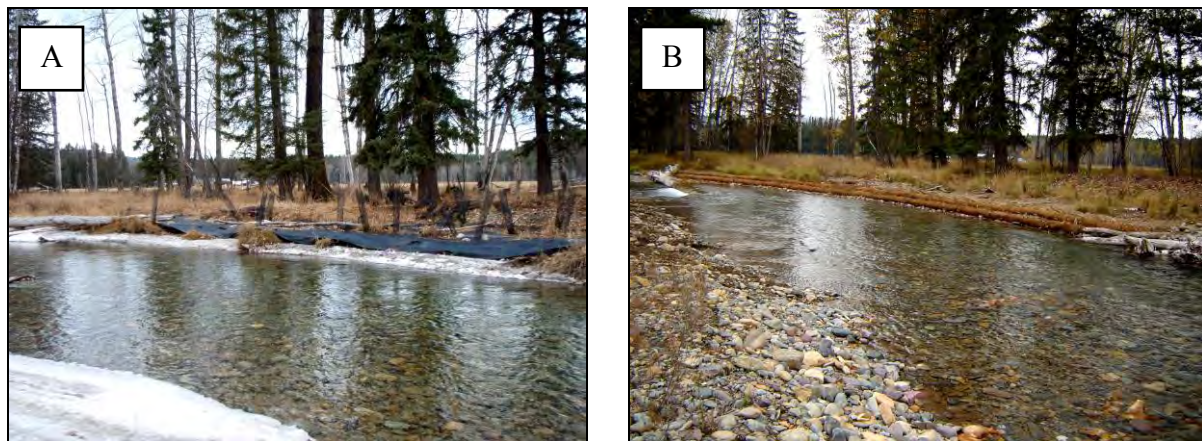
Figure 18. Photographs showing Site 5 vegetated soil lift and planting area before (Photograph A) and after (Photograph B) construction and maintenance.

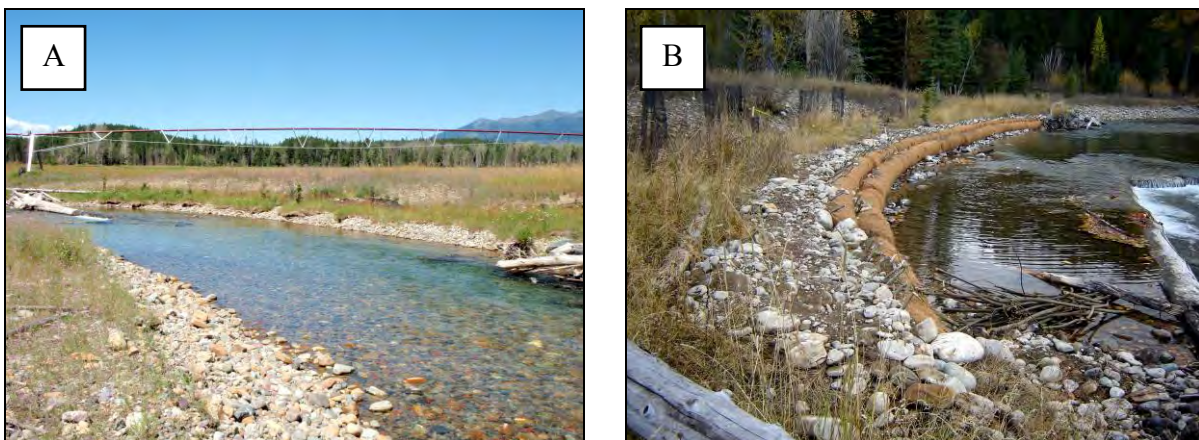
Figure 20. Photographs show Site 7 before (Photograph A) and after (Photograph B) construction of coir log fascine. Photograph A is taken from the left bank looking downstream. Photograph B is taken from the right bank looking upstream.

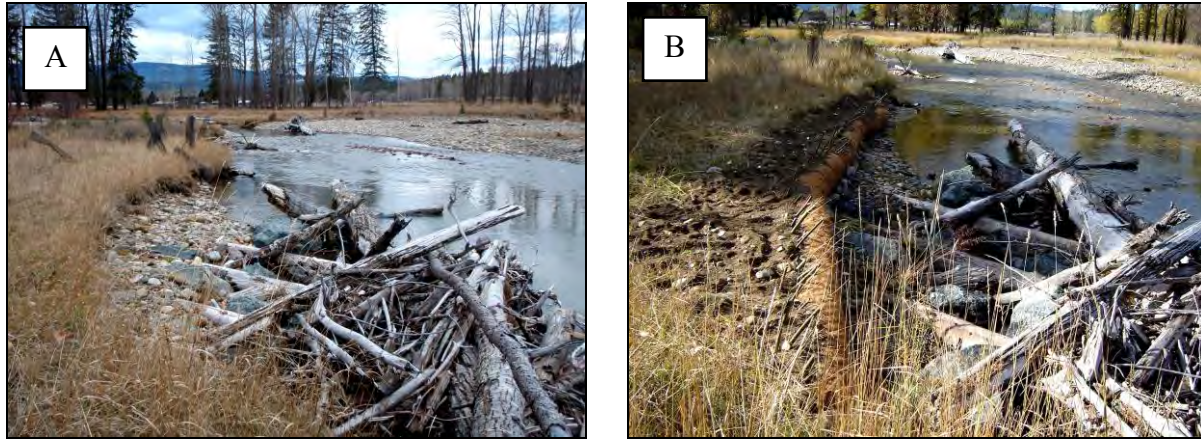
Figure 21. Photographs show Site 12 before (Photograph A) and after (Photograph B) construction of coir log fascine.

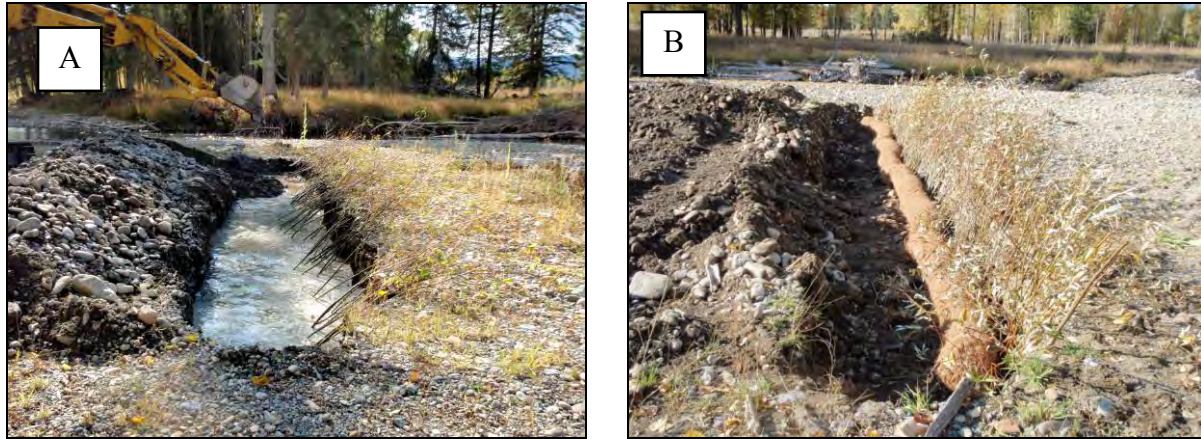
Figure 22. Photographs show the construction process for the installation of buried coir log fascines at Sites 13 and 14. Photographs A and B provide examples of the variation in the amount of ground water encountered during construction. The trench shown in Photograph A was located closer to the channel and further upstream on the point bar compared with the trench shown in Photograph B.

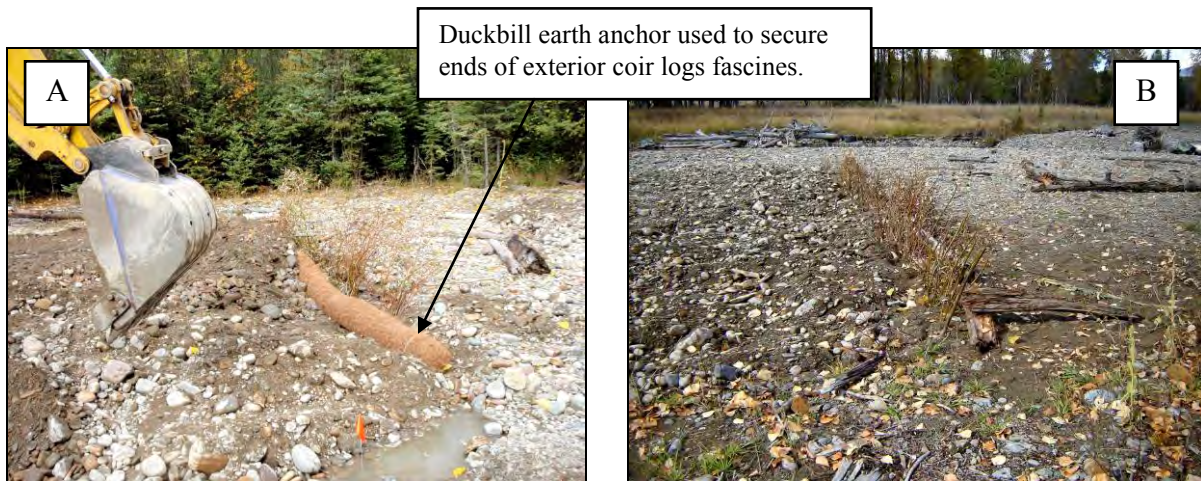
Figure 23. Photograph A shows a buried coir log fascine during final stages of construction. Photograph B shows a completed buried coir log fascine.

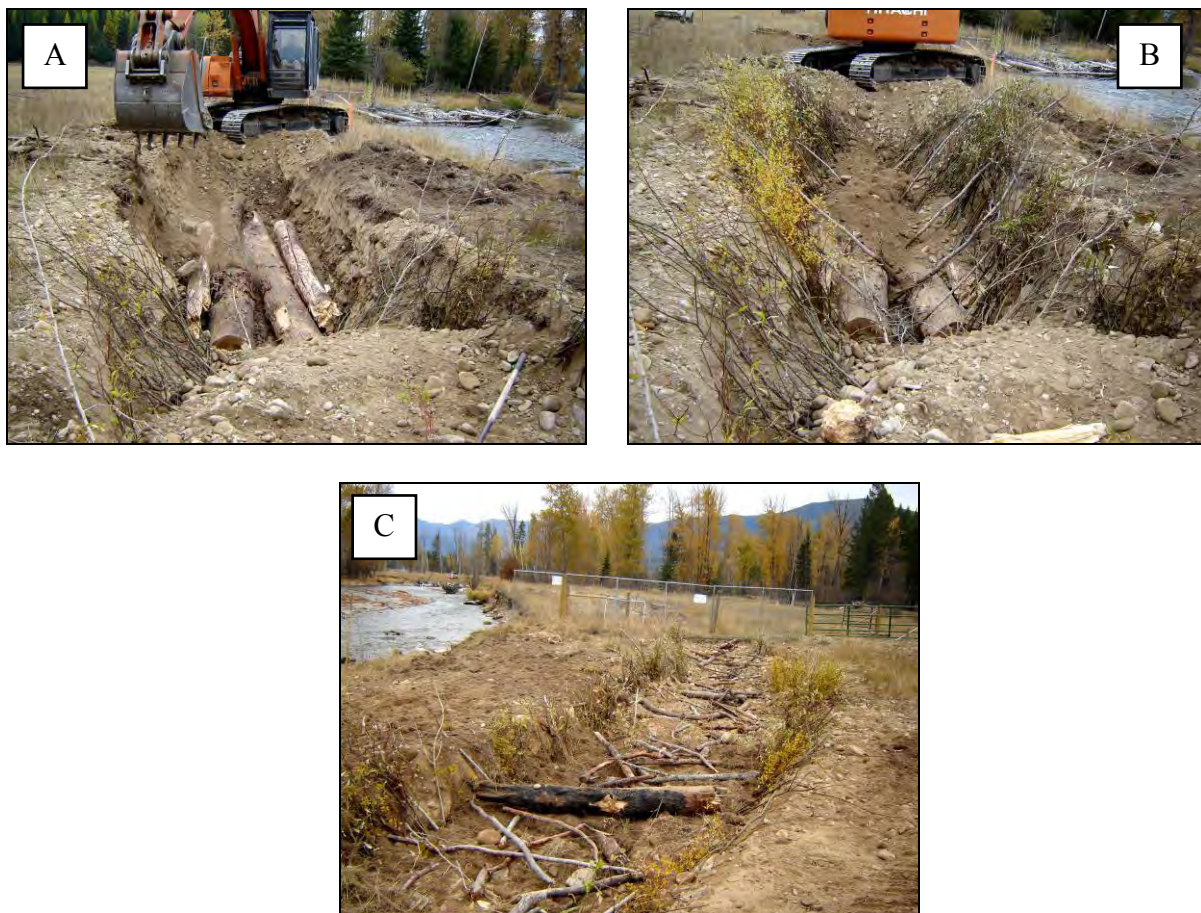
Figure 25. Photographs A through C show the sequence of constructing the vegetated set back bank at Site 2. The trench is excavated to the desired depth, woody debris is placed in the bottom of the trench for structure (Photograph A) and dormant and live plants placed in the trench (Photograph B). The trench is then back-filled to approximately bankfull elevation of the existing channel and container plants are installed and woody debris and seed scattered on the top surface (Photograph C).

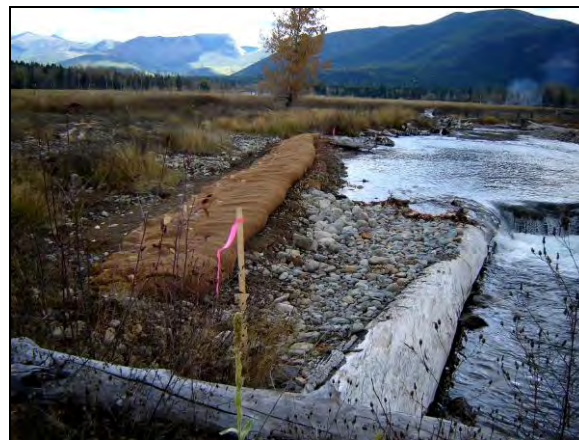
Figure 26. Vane at Site 7 after repairs showing the filled vane arm and reconstruction of the bank line along the decommissioned cattle water gap.

Two existing channel structures were repaired and two new woody debris jams were constructed as part of the 2008 phase of the riparian revegetation project. Existing log J-hook structures at Sites 7 (Figure 26) and 8 were repaired by back-filling the flanked vane arms and adjusting the height of the riffle downstream of the scour pool below each structure. Figure 27 shows the woody debris jams installed at Site 10.

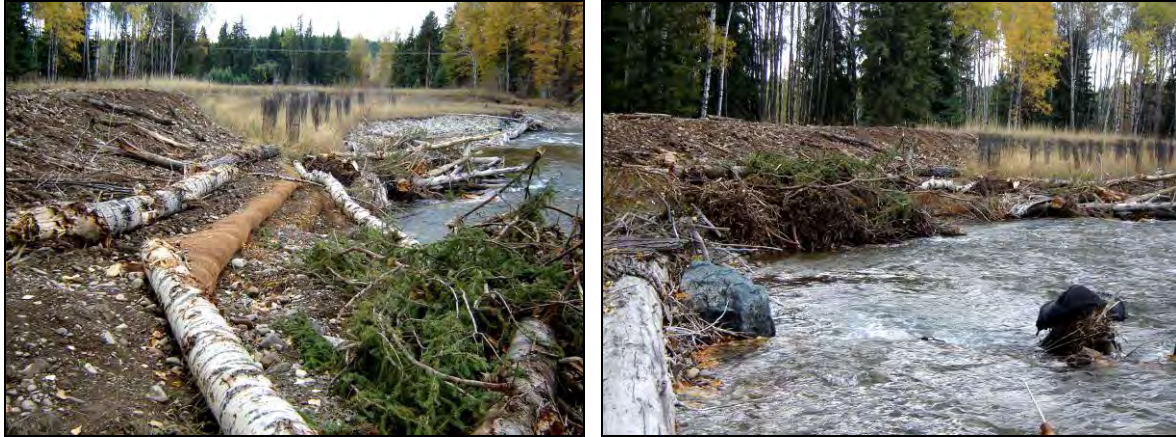
Figure 27. Woody debris jams constructed at Site 10 to reduce bank erosion at the site and allow willow cuttings in the soil lift establish.

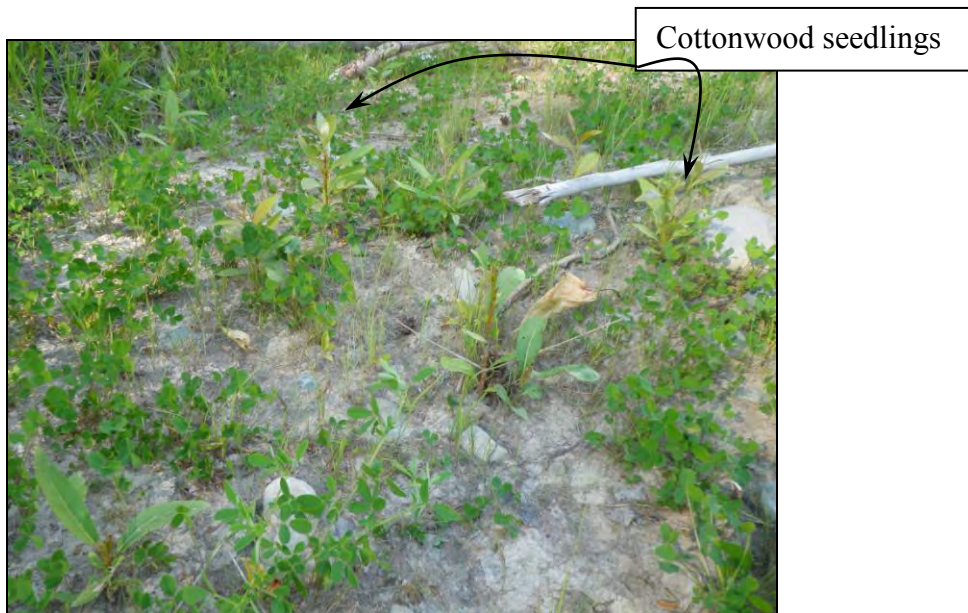
Figure 29. Photograph of mineral soil at Planting Area Monitoring Plot 2 exposed and seeded after removal of solarization fabric installed in this plot in 2005. Young grass shoots, assumed to be seeded species, are establishing along with naturally recruited cottonwood seedlings.

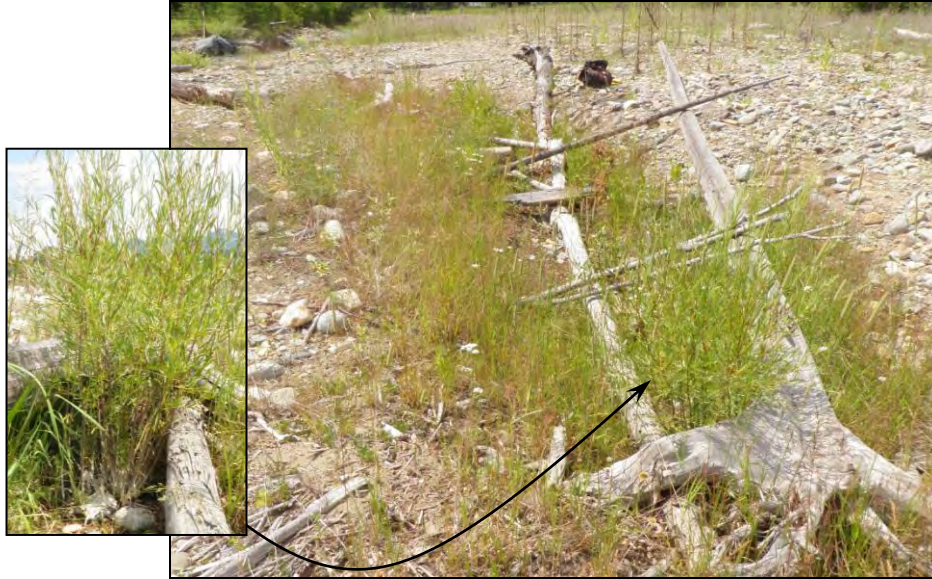
Figure 31. Photograph of a planted swale at Site 4 (inside the electric fence). Inset photo shows a five gallon container plant installed during fall 2008 that has been protected from browse and exhibits an uninterrupted growth form.

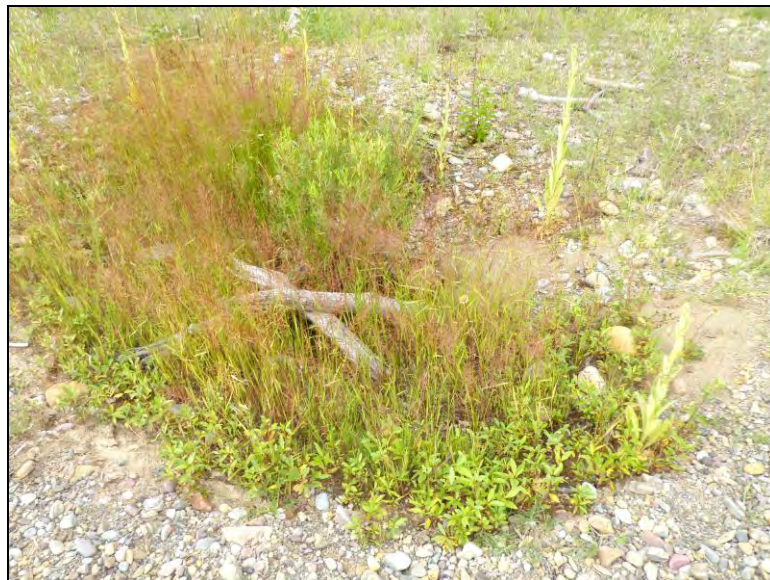
Figure 32. Photograph showing naturally recruited cottonwood seedlings surrounding a constructed floodplain swale. Grasses and forbs cover the bottom of the swale and planted shrubs are protected from browse by hand placed woody debris.

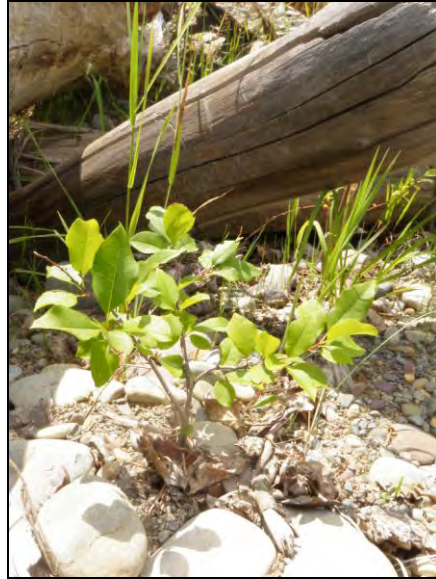
Figure 33. Photograph showing a chokecherry seedling growing in a constructed swale at Site 4. The chokecherry germinated from seed applied during fall 2008.

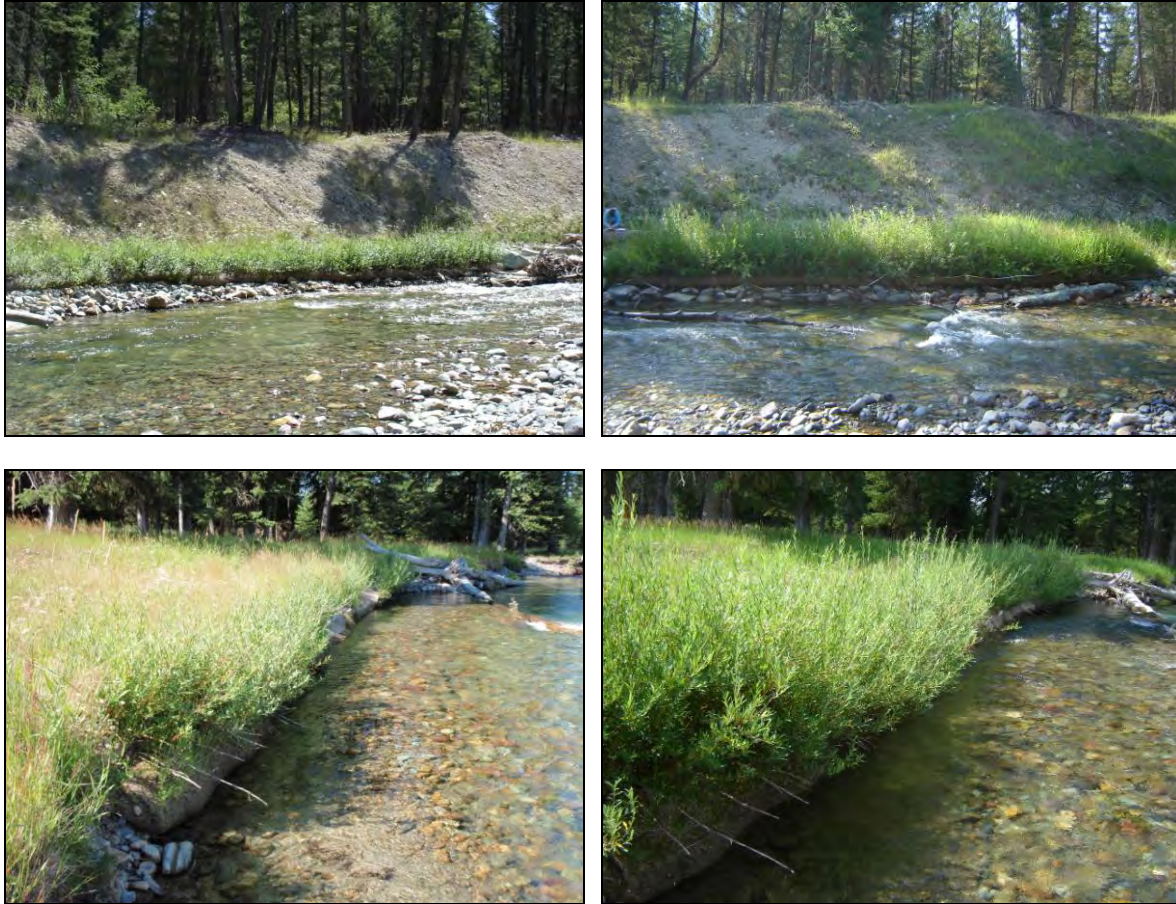
Figure 35. Photographs show Demo SL-2 in 2008 (top left) and in 2009 (top right) and SL-4 in 2008 (bottom left) and 2009 (bottom right). Both the Demo SL-2 and SL-4 are located within the electric wildlife fence.

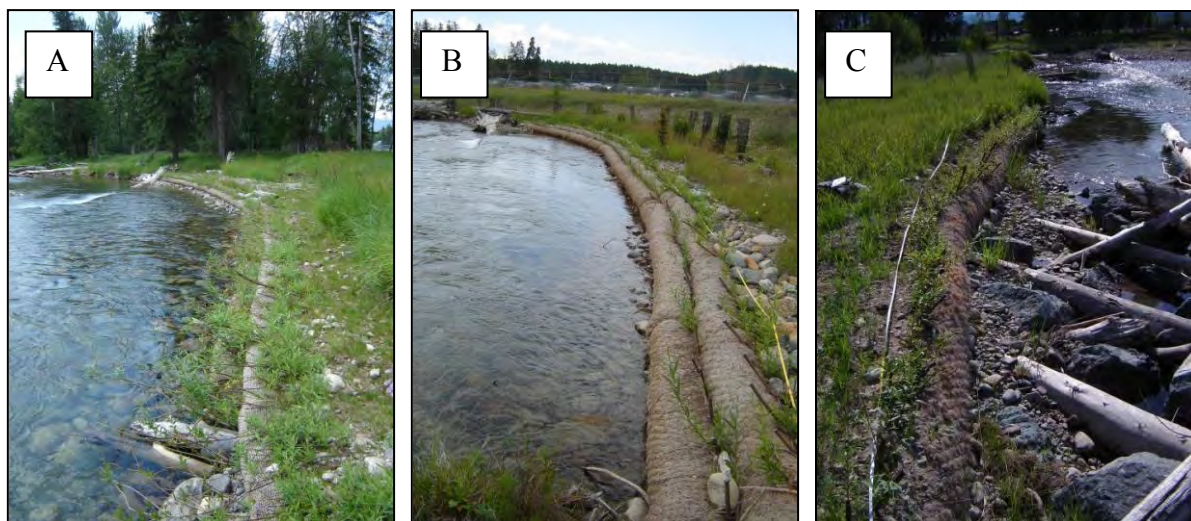
Structure ID	CL-7 (2008)		CL-12 (2008)	SL-5 (2008)	
	2009		2009	2009	
Monitoring Year	2009		2009	2009	
Layer	1	2	all	1	2
Metric¹					
Average percent cover willow	9	28	46	52	57
Average percent cover other	2	6	15	0	10
Average percent cover weeds	0	0	1	0	0
Total number dead stems	20	2	2	14	10
Average percent browsed	0	10	98	10	25
Average shoot height (inches)	10	14	14	12	10

Figure 40. Photographs showing bioengineering structures installed in October 2008 and included in July 2009 effectiveness monitoring. Photograph A is SL-5 (2008), Photograph B is CL-7 (2008) and Photograph C is CL-12 (2008).

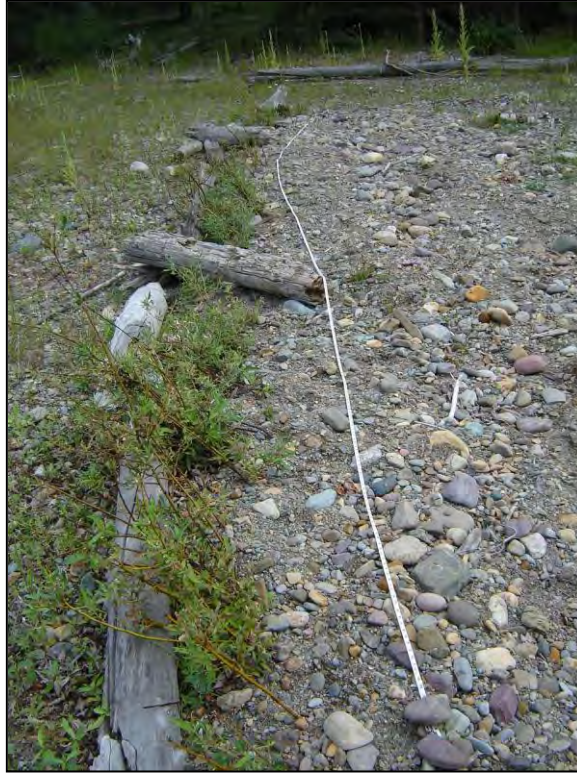
Effectiveness monitoring methods for buried coir log fascines are similar to those for other bioengineering structures. Data were collected in five-foot increments along the length of each buried coir/willow fascine (Figure 41). Data collected for each five-foot increment included: general willow survival (number of obvious dead stems), percent cover of willows, average height of new willow growth; percent of willows with signs of browse; and percent cover of herbaceous species (recorded for the area of trench back-fill which includes the line of willows and extends approximately four feet in a downstream direction). In addition to these data, general observations of the amount and type of debris accumulating at each structure, colonization of cottonwoods or other woody species in the substrate around each structure and general condition of willows was recorded. A summary of the results of July 2009 effectiveness

Figure 41. Photograph showing buried coir/willow fascine at Site 13. Effectiveness monitoring data were collected in five-foot increments along each structure.

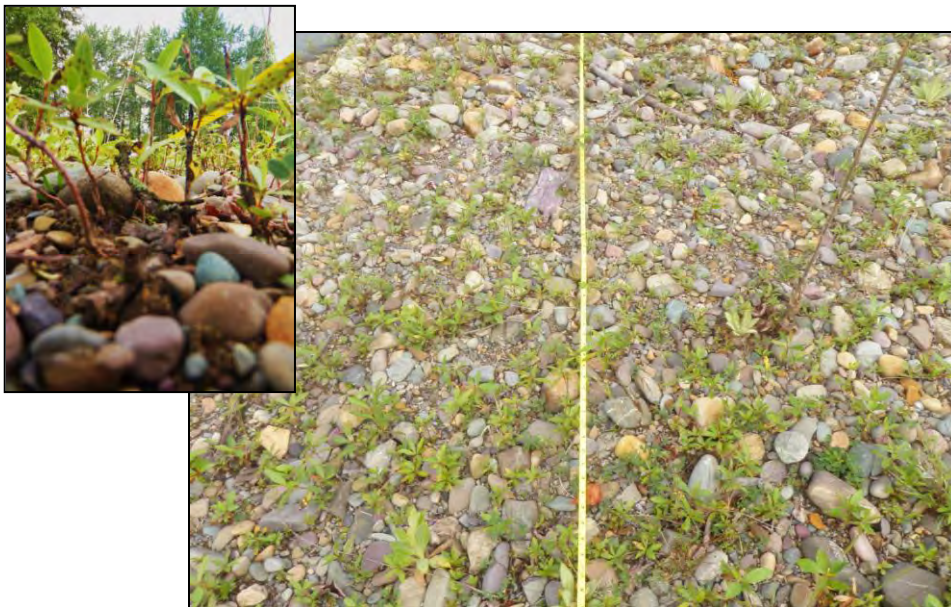
- Cottonwood recruitment was lower in 2009 than in 2008, but survival of the 2008 recruited seedlings is high, with some seedlings growing up to eight inches (Figure 42).

Figure 42. Photograph of surviving cottonwood seedlings on Point Bar 13 Transect 1.

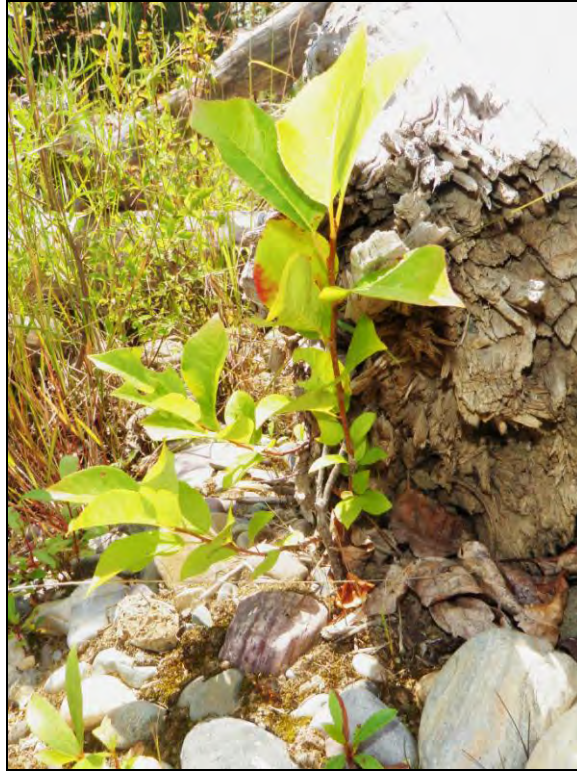
Figure 43. Photograph shows a seeded chokecherry in a woody debris microsite within a constructed swale on Point Bar 4 Transect 1.

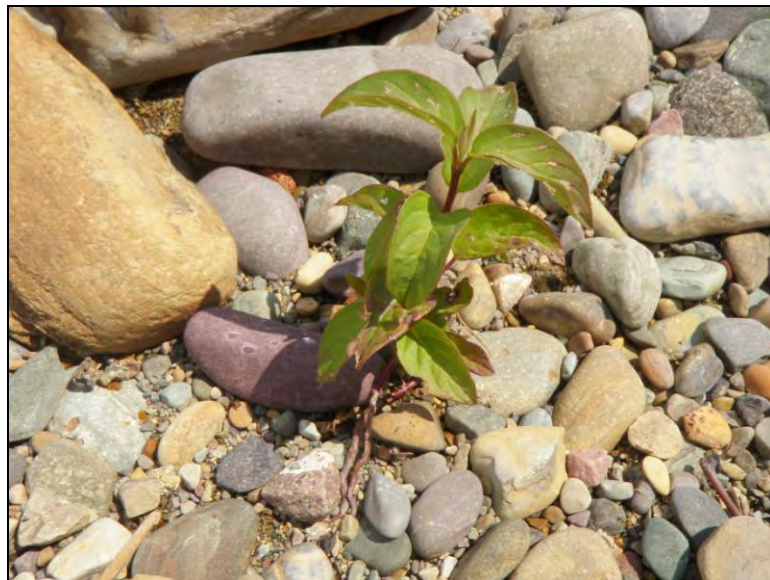
Figure 44. Photograph shows dogwood shrubs on at Site 13 that germinated from seed.

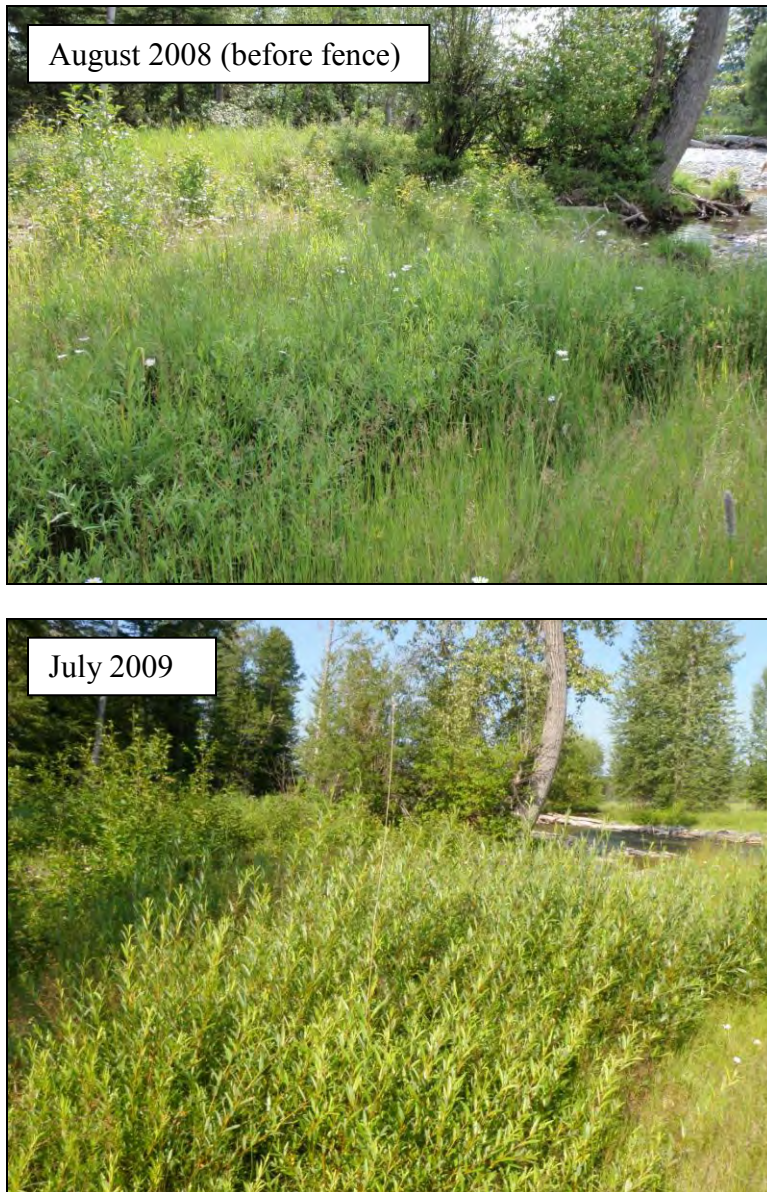
Figure 45 compares the difference in shrub growth form for shrubs within the fence and outside of the fence. Shrubs within the fence have un-browsed new shoot growth while plants outside the fence still exhibit an arrested-type architecture. Figure 46 provides a comparison of the shrub browse evaluation point located within the perimeter of the fence before the fence was installed and one season after the fence was installed. Willows have grown vertically and appear to be expanding horizontally as well at this point.

Figure 46. Photographs of browse monitoring plot B inside electric fence comparing the change in willow growth between August 2008 and July 2009.

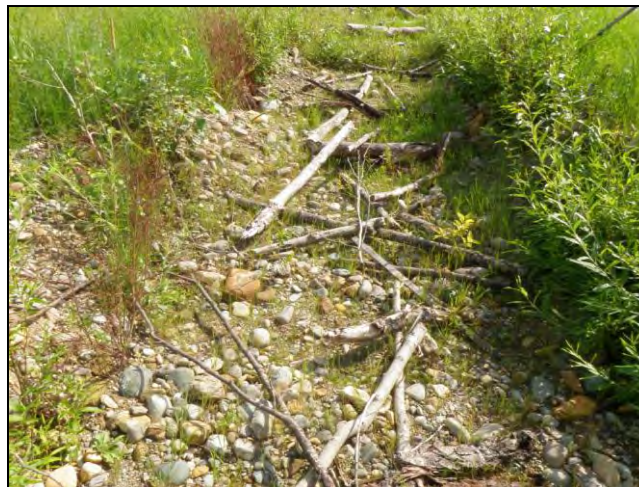
- Willow survival along the edges of the trench was estimated to be between 80 and 90 percent. There are a few sparse patches but these may fill in over time depending on overall survival (Figure 47).
- Containerized plant survival also appears to be high and is estimated to be greater than 80 percent.
- The majority of the cottonwood pole cuttings installed in the trench are re-sprouting from the base while others have new growth along the entire pole (Figure 48).
- Weed cover within the trench is low, but the surrounding area has high densities of knapweed and oxeye daisy.
- Seeded grass cover is low, but grasses were beginning to germinate in the bottom of the trench. Pasture grasses are also present.
- Herbaceous species found within the trench include yarrow and clover.

Figure 47. Photograph showing the downstream portion of the vegetated set back bank treatment. Willow growth along the side closest to the channel is dense and seeded grasses are establishing on the bottom of the trench.

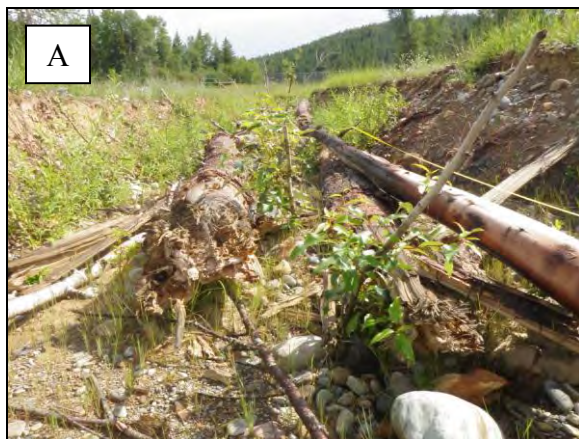
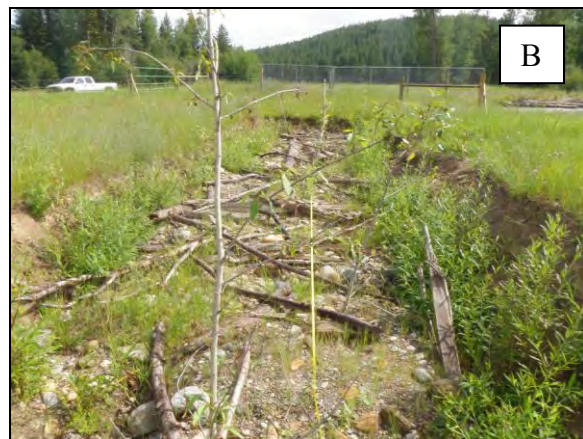
Figure 48. Photographs showing the conditions within the vegetated set back bank. Photograph A shows a cottonwood pole sprouting from the base and Photograph B shows a cottonwood pole sprouting from the top.
