Grave Creek Demonstration Project Area Riparian Revegetation and Vane Maintenance As-built Report

Task Order #0906

GEUM
ENVIRONMENTAL
CONSULTING, INC

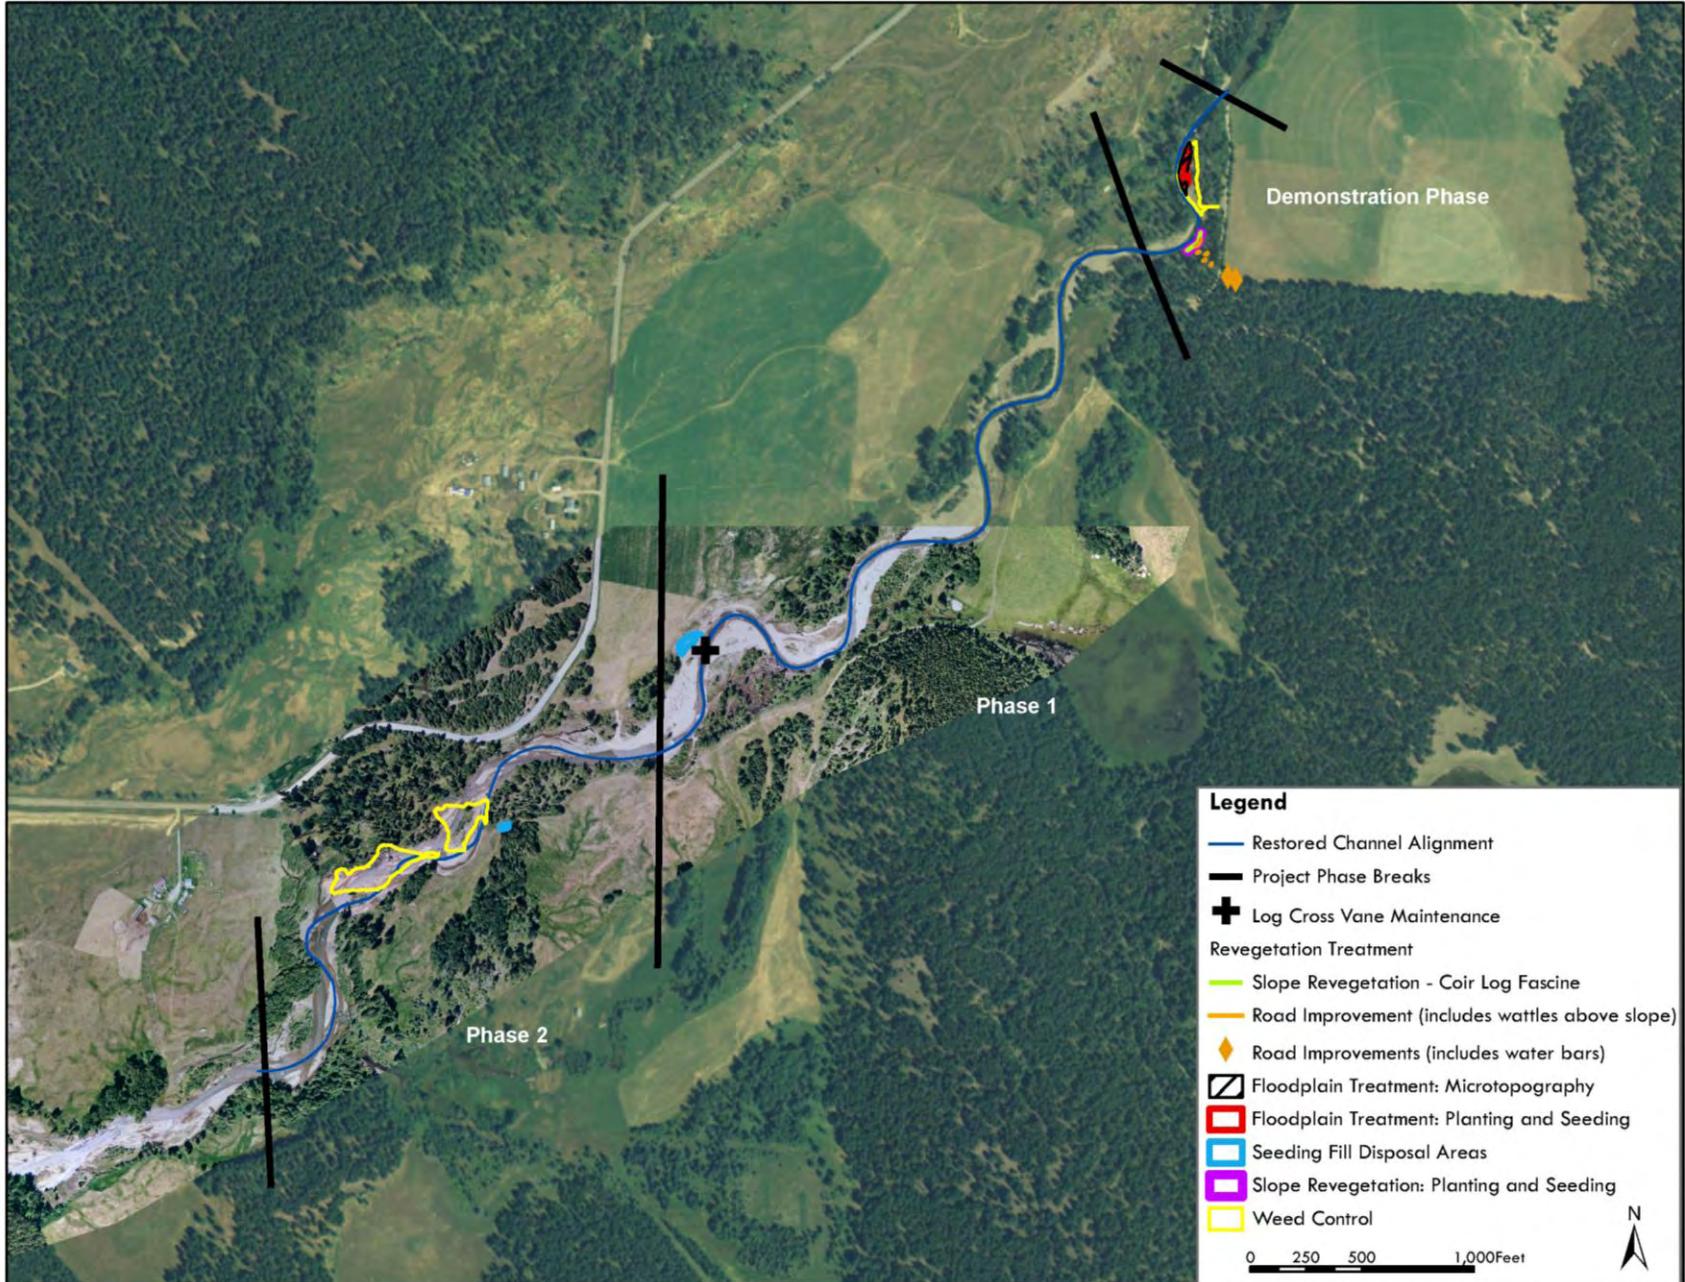
Figure 1. Overview of Grave Creek Restoration project area showing locations of work completed under Task Order #0906.

In addition to the Demonstration Phase floodplain, weeds were also removed by hand-pulling from two other floodplain surfaces in the project area (Figure 1). These areas are the same locations where weeds were hand-pulled in August 2008. A total of 1.5 acres of floodplain surfaces were treated. All weeds removed were placed in a location outside of the floodplain and buried with material removed from the Demonstration Phase floodplain (Figure 7).

In addition to work completed in the Demonstration Phase, described above, maintenance work was completed on one log vane structure located in Phase 2 (Figure 1). As a result of flows scouring the cobble placed over the arm of the structure in 2004, the riffle downstream of this structure down-cut leaving a drop over the vane throat in excess of two feet (Figure 8). This drop may have prevented upstream passage of juvenile fish. To address this issue, a boulder grade control structure was installed at the glide/top of riffle transition downstream of the vane. This reduced the total drop over the log vane throat at base flow to less than 0.5 feet. Cobble needed for the vane repair work was generated during re-shaping of the floodplain surface in the Demonstration Phase reach. Vane maintenance was completed by River Design Group on August 31 2009.

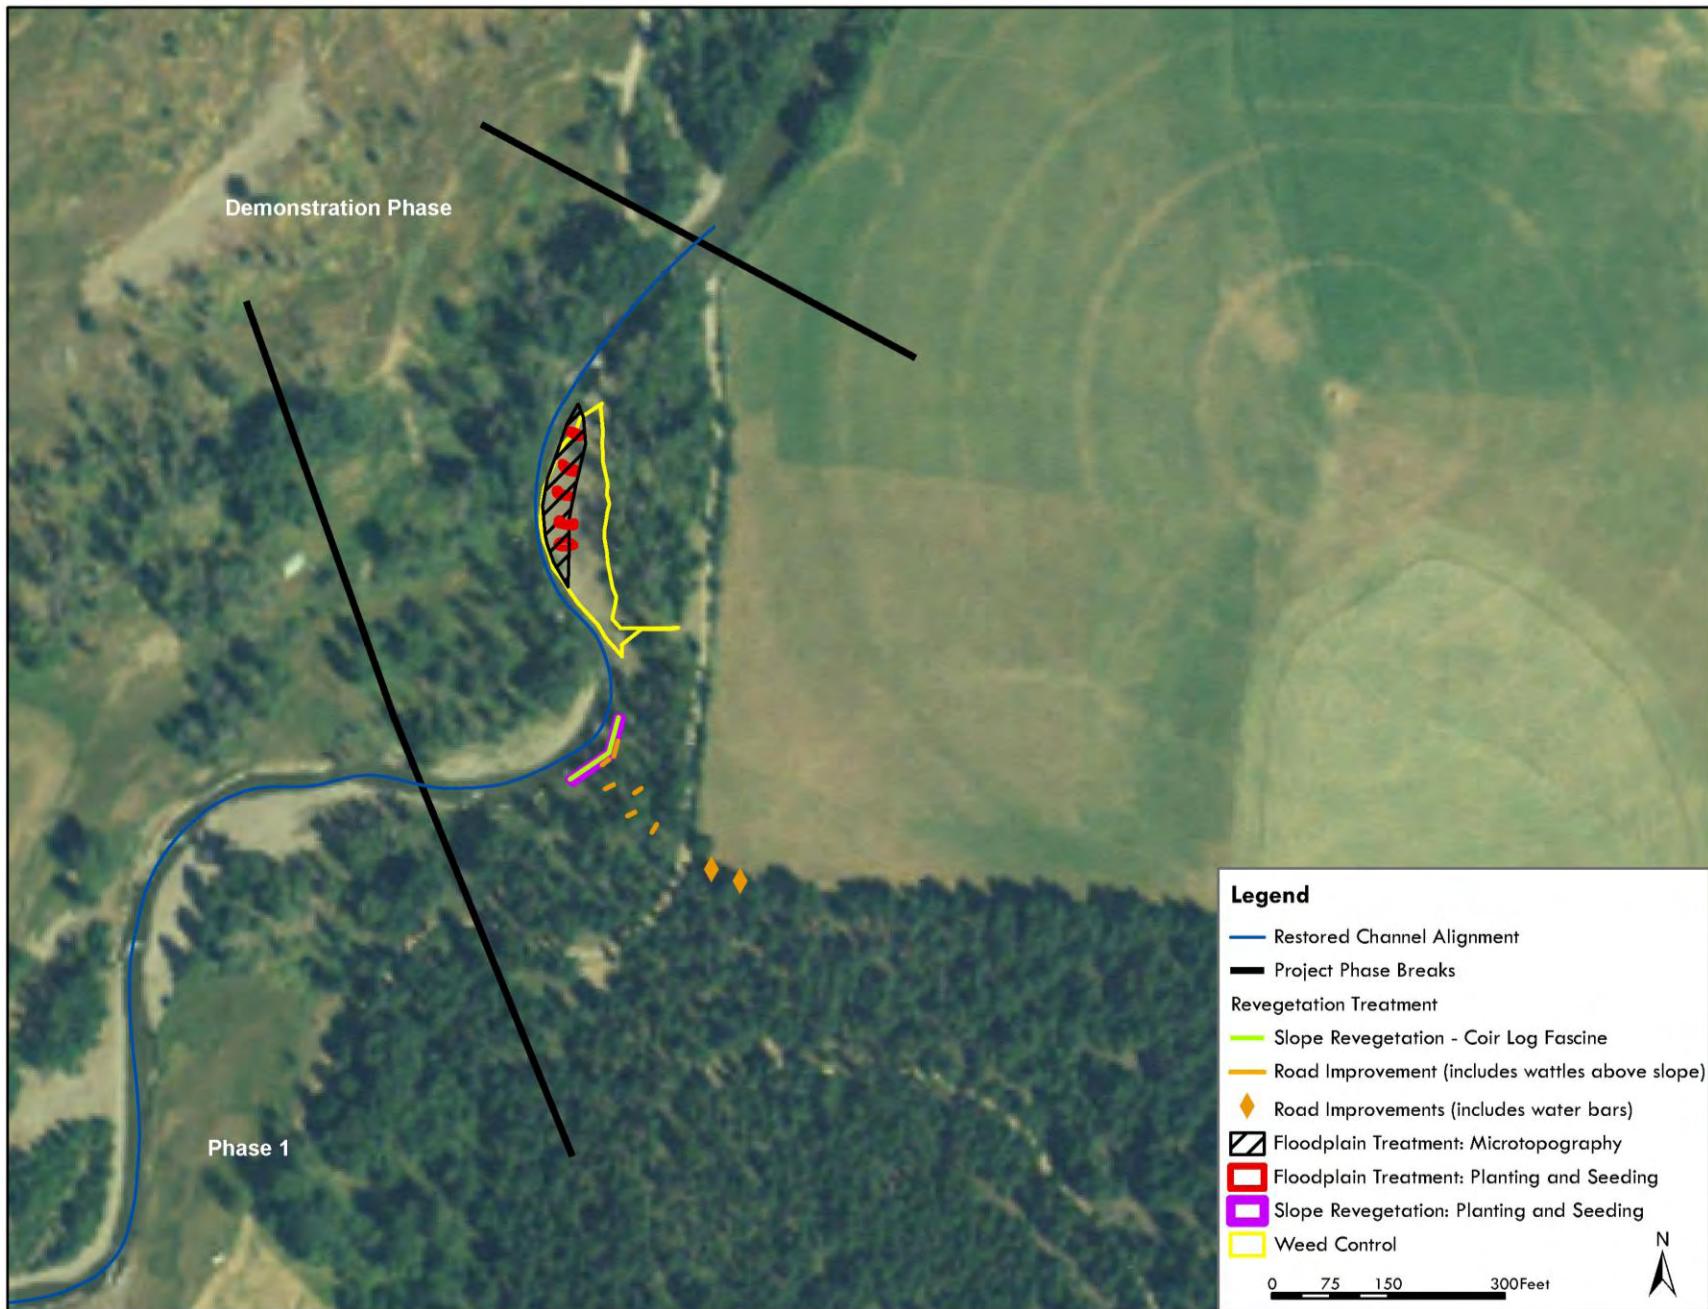
Figure 2. Aerial photograph of Demonstration Phase showing locations of treatments implemented in Summer and Fall 2009 under Task Order #0906.

Another limiting factor identified for the Demonstration Phase floodplain in the revegetation plan was the increasing density of noxious weeds and other invasive species on floodplain surfaces. The flat, uniform floodplain surfaces constructed during channel restoration resulted in a dense cover of spotted knapweed and other noxious weeds. To address this limiting factor, weeds were pulled by hand prior to removal of floodplain material to reduce the canopy cover and potential spread of weeds by seed. Weeds were hand-pulled by a Montana Conservation Corps (MCC) crew on August 17, and 18, 2009 (Figure 6). A total of 0.4 acres of knapweed and houndstongue were hand-pulled in the Demonstration Phase (Figure 2).
