Therriault Creek Riparian Revegetation 2012 Monitoring and Maintenance Report

Contract #130013

Geum Environmental Consulting, Inc.
307 State Street
Hamilton, MT 59840

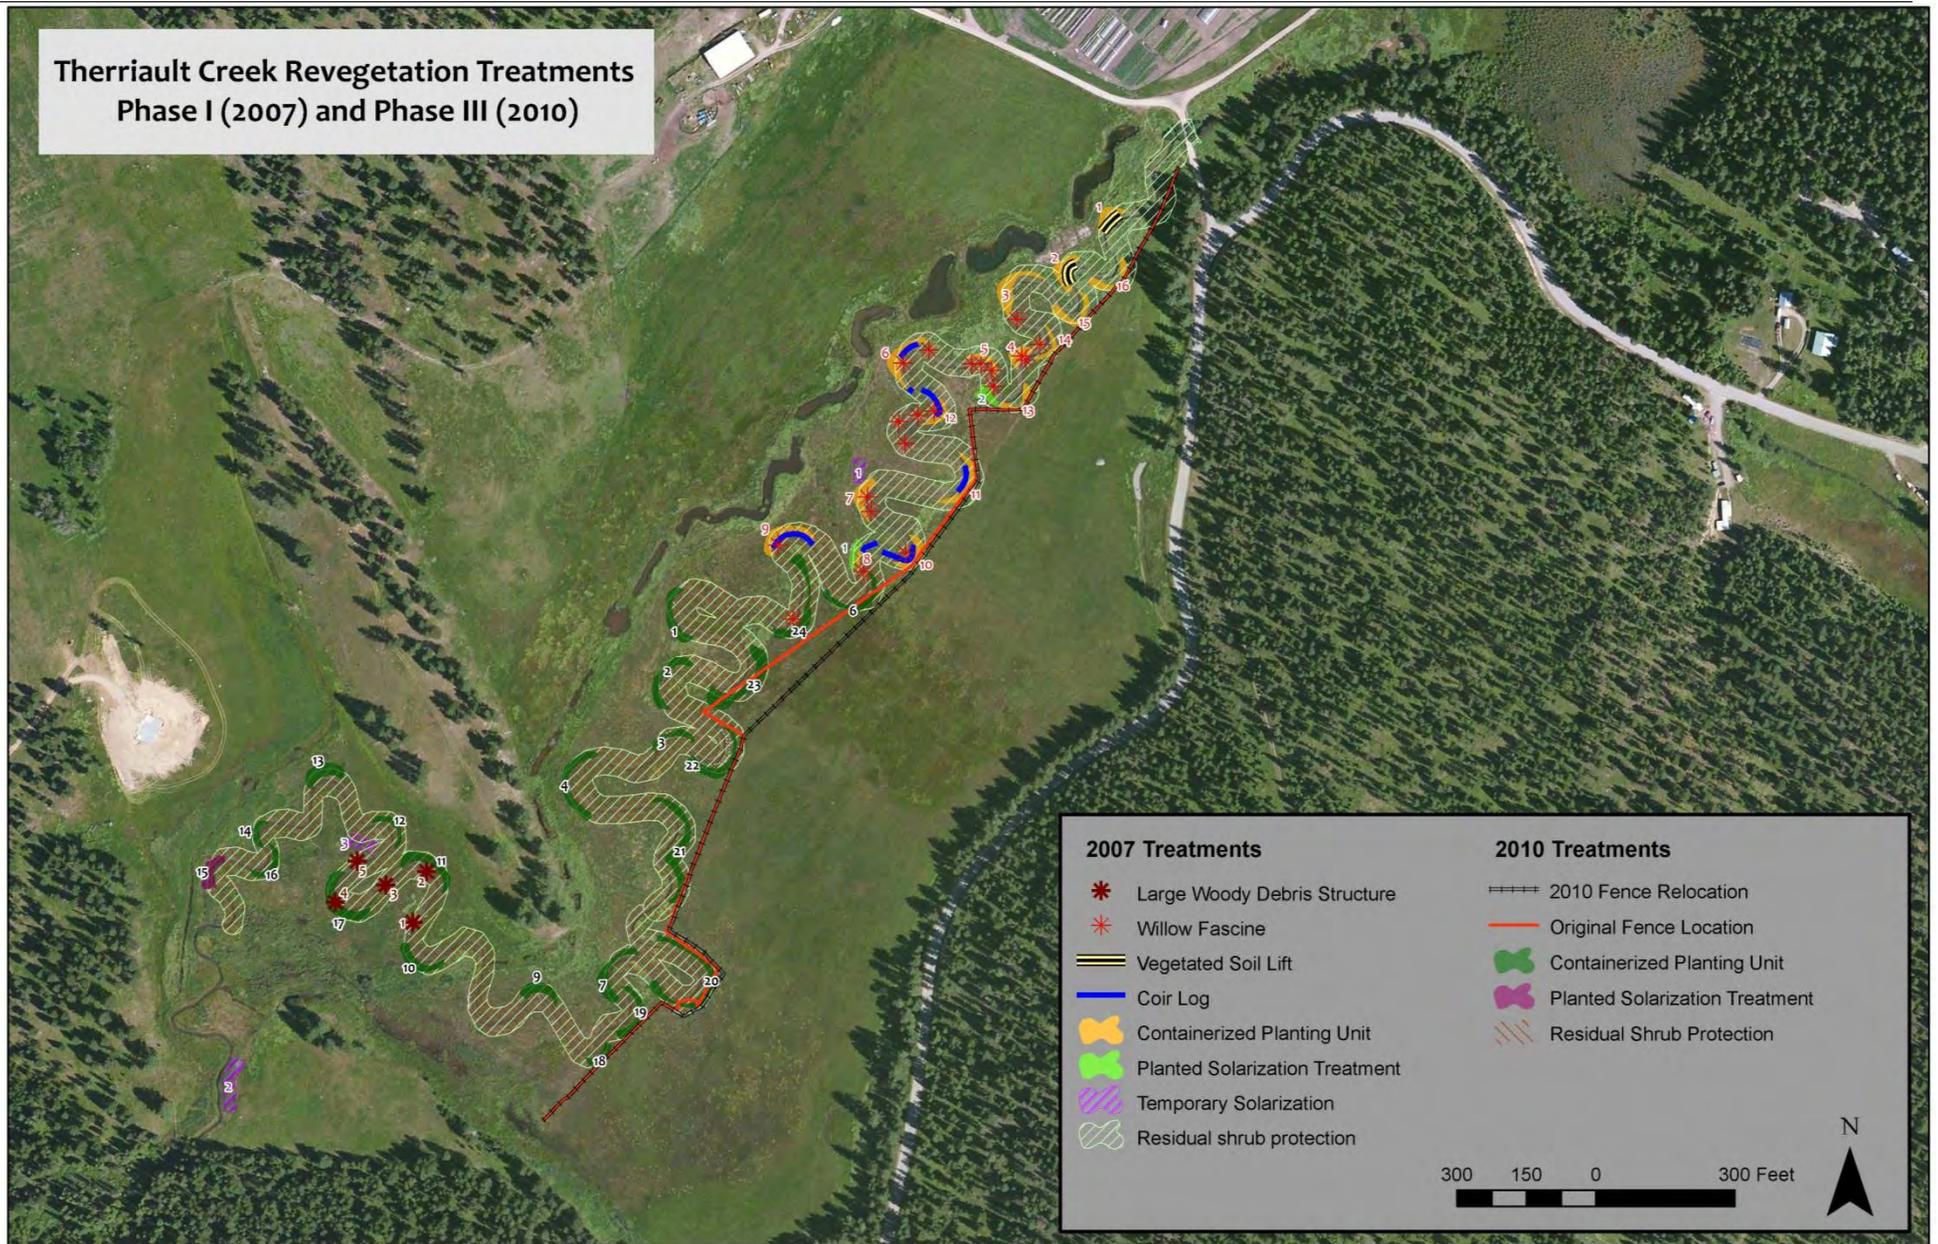
Figure 1. Overview figure showing riparian revegetation treatments installed in 2007 and 2010 at the Therriault Creek Riparian Revegetation project site.

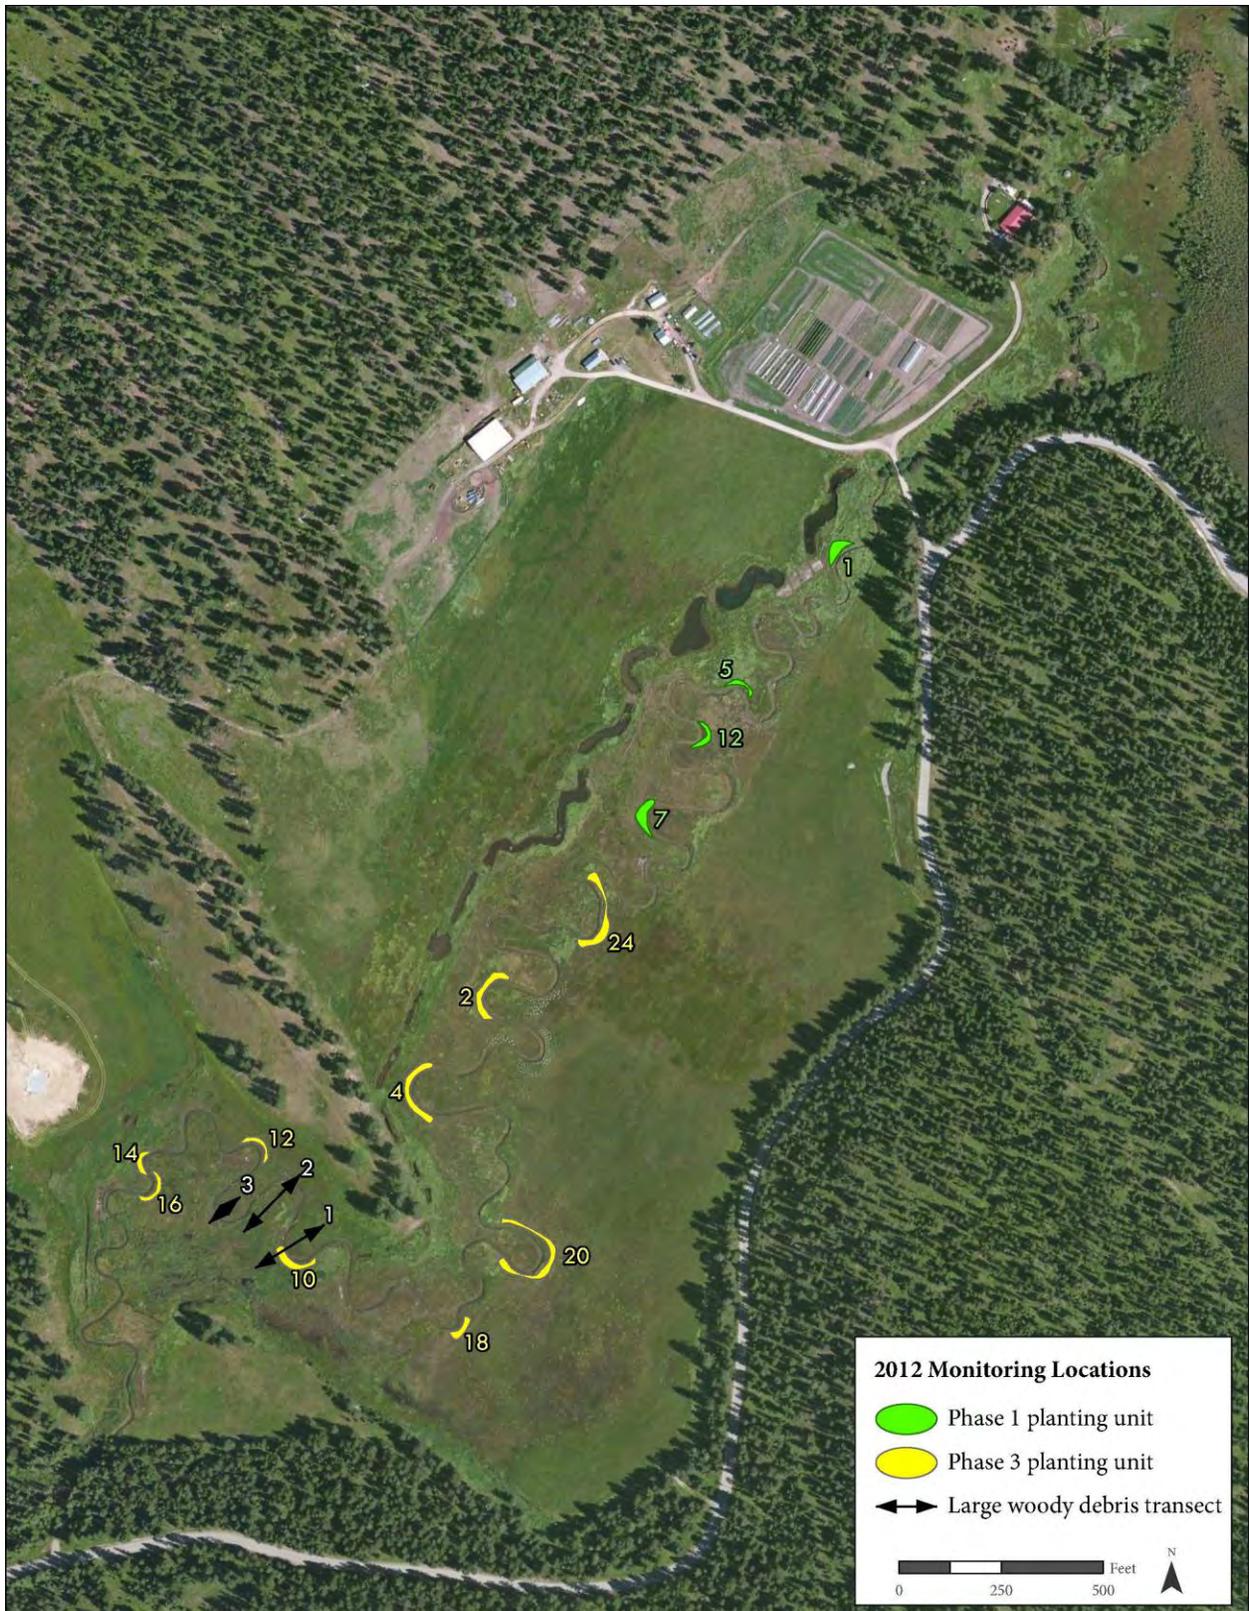
Figure 2. Effectiveness monitoring overview figure showing the locations of planting units monitored in 2012 at the Therriault Creek Riparian Revegetation project site.

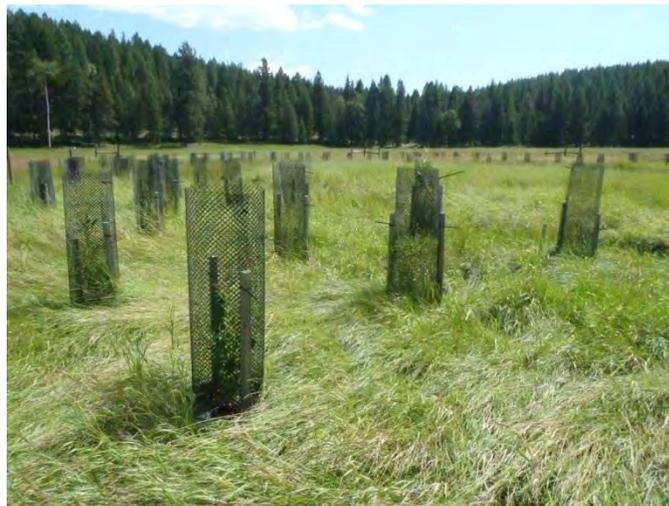
data by species. Serviceberry had the lowest survival at 0 percent. Mountain alder and river birch both showed significant declines in survival between 2011 and 2012. Both wet and dry species showed decreased survival between 2011 and 2012. Some of the shrubs in Phase III have grown 2 to 3 feet since installation but most shrubs remain very small and contained completely within browse protectors (Figure 8). Appendix D provides a photo series of Phase III planting units between 2010 and 2012.

Figure 8. Shrubs in Phase III planting area.

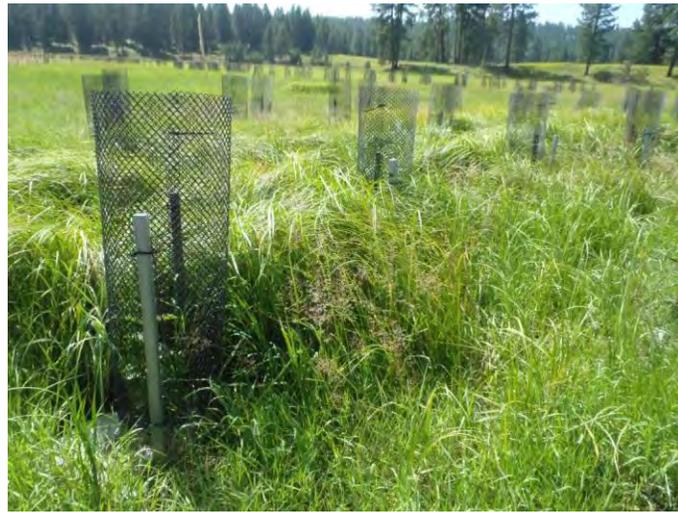
The herbaceous vegetation in both Phases I and III remains a mix of pasture grasses, sedges, rushes, native grasses, and native forbs. The lower end of Phase I and upstream portion of Phase III support large areas dominated by sedges and wetter species continue to increase in planting areas (Figure 10). The cover of native, wetter species is increasing in both Phases I and III.

Figure 10. Expansion of sedges in Phase III planting area.

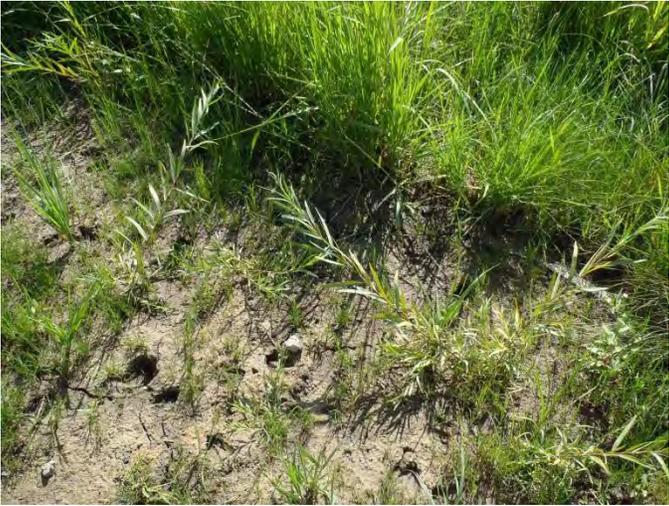
Figure 13. Sandbar willow colonization in Planted Solarization Plot 1.

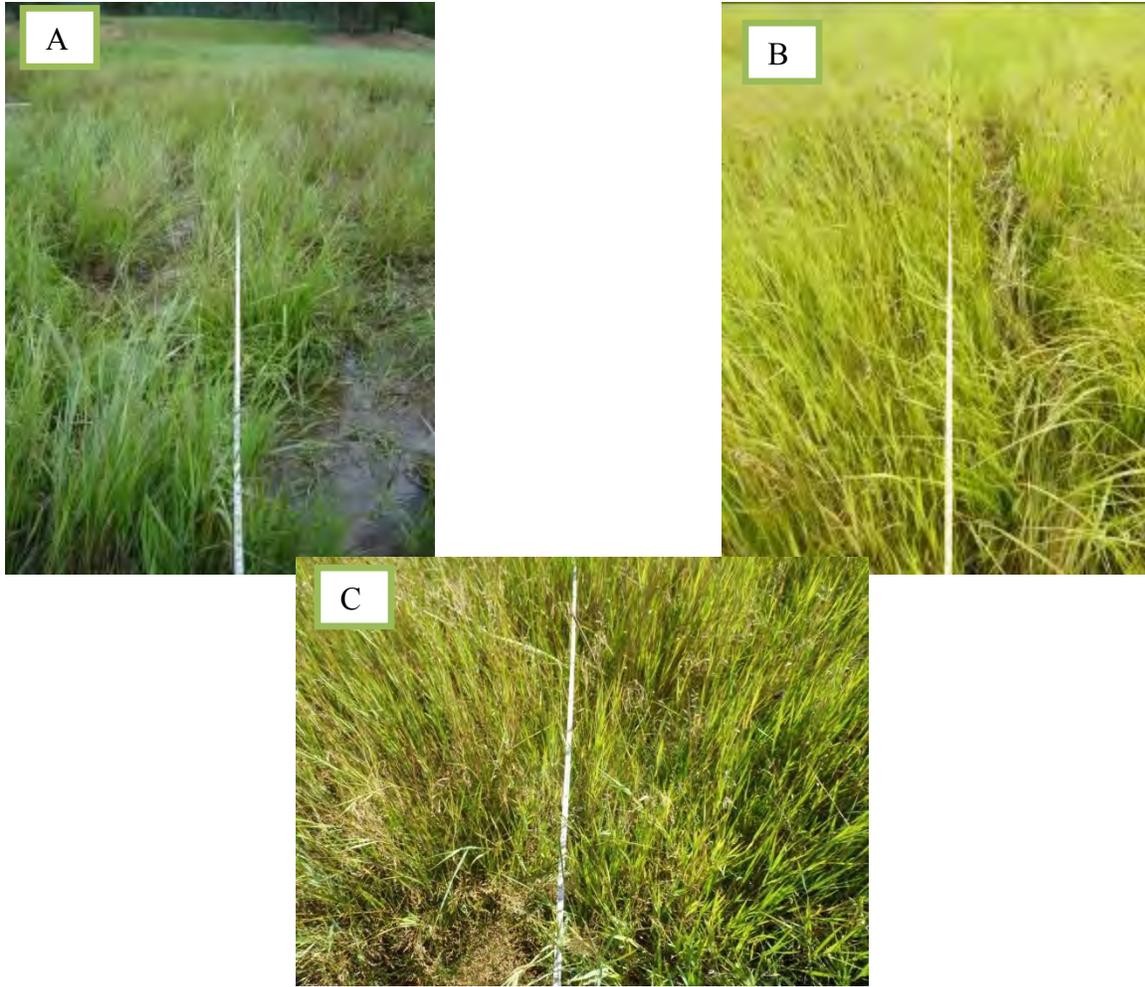
Figure 24. Photographs of Woody Debris Transect 1 at the 50-60' interval in 2008 (A) 2009 (B), and 2012 (C)

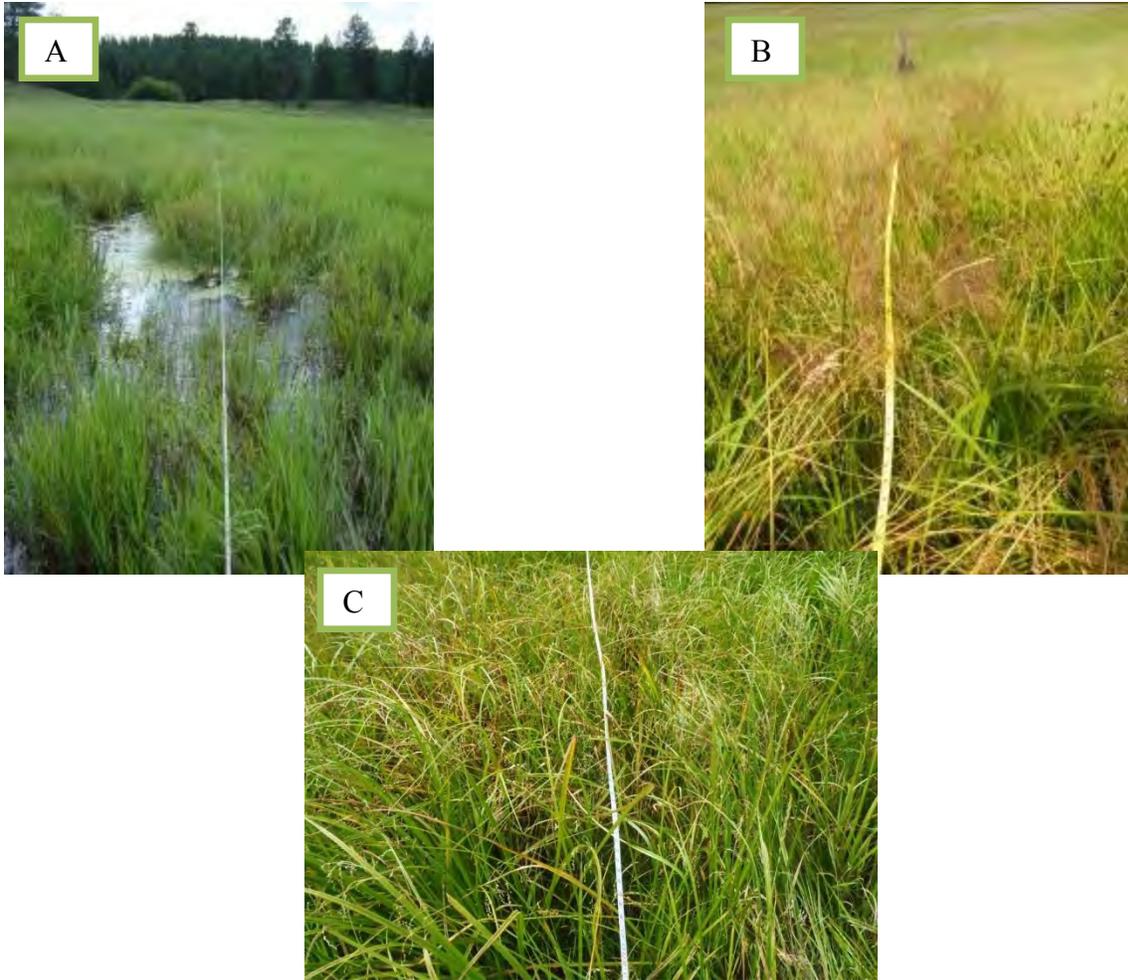
Figure 25. Photographs of Woody Debris Transect 2 at the 50-60' interval in 2008 (A), 2009(B) and 2012 (C).

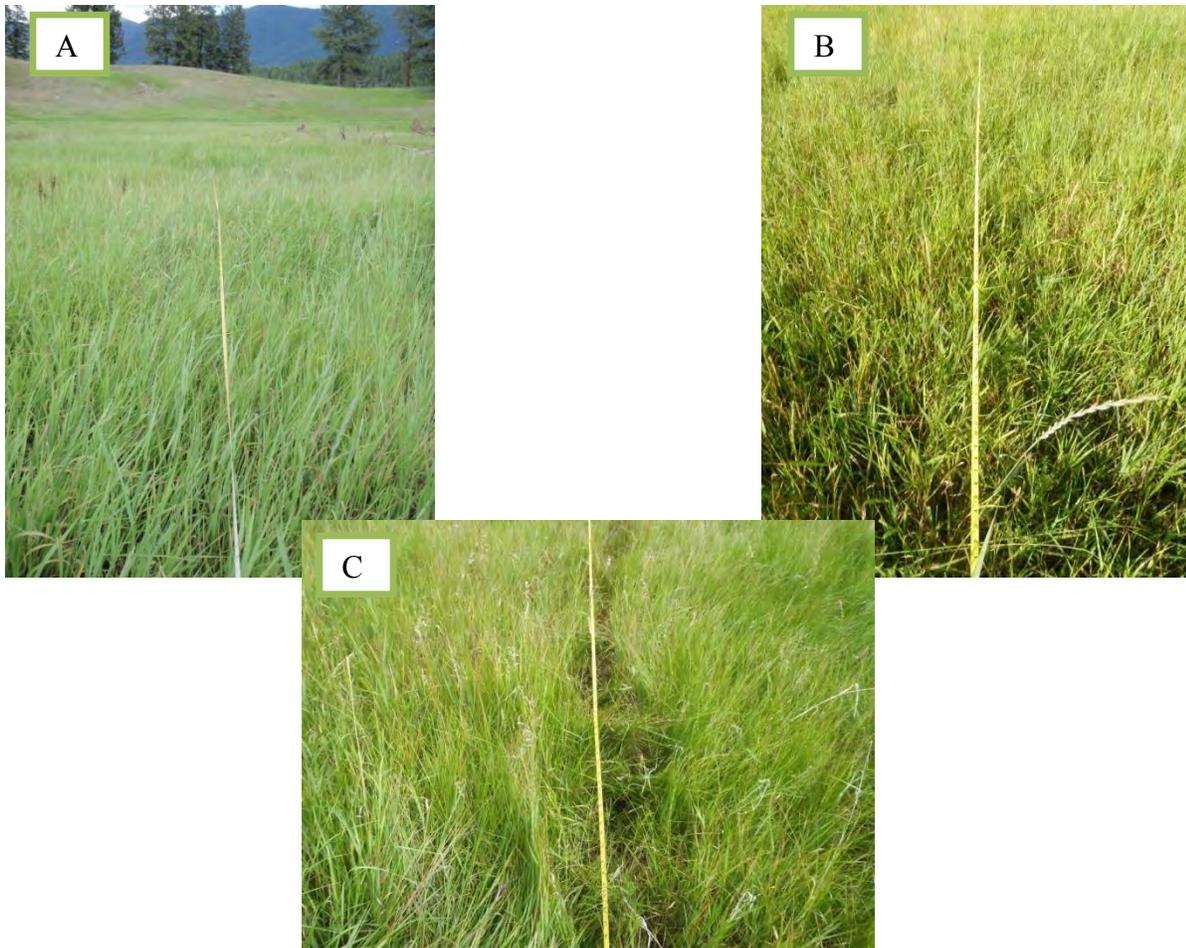
Figure 26. Photographs of Woody Debris Transect 3 at the 60-70' interval in 2008(a), 2009(B), and 2012 (C).

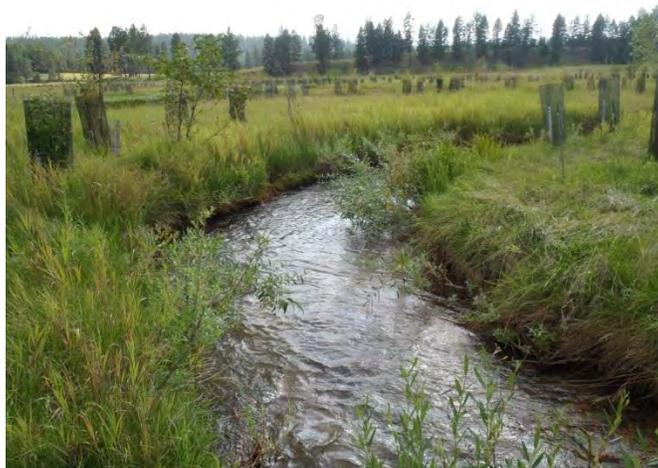
Figure 29. Coir log site 7 showing dense willow growth on the left bank from the coir log and willow cover on the right bank from a willow fascine structure.

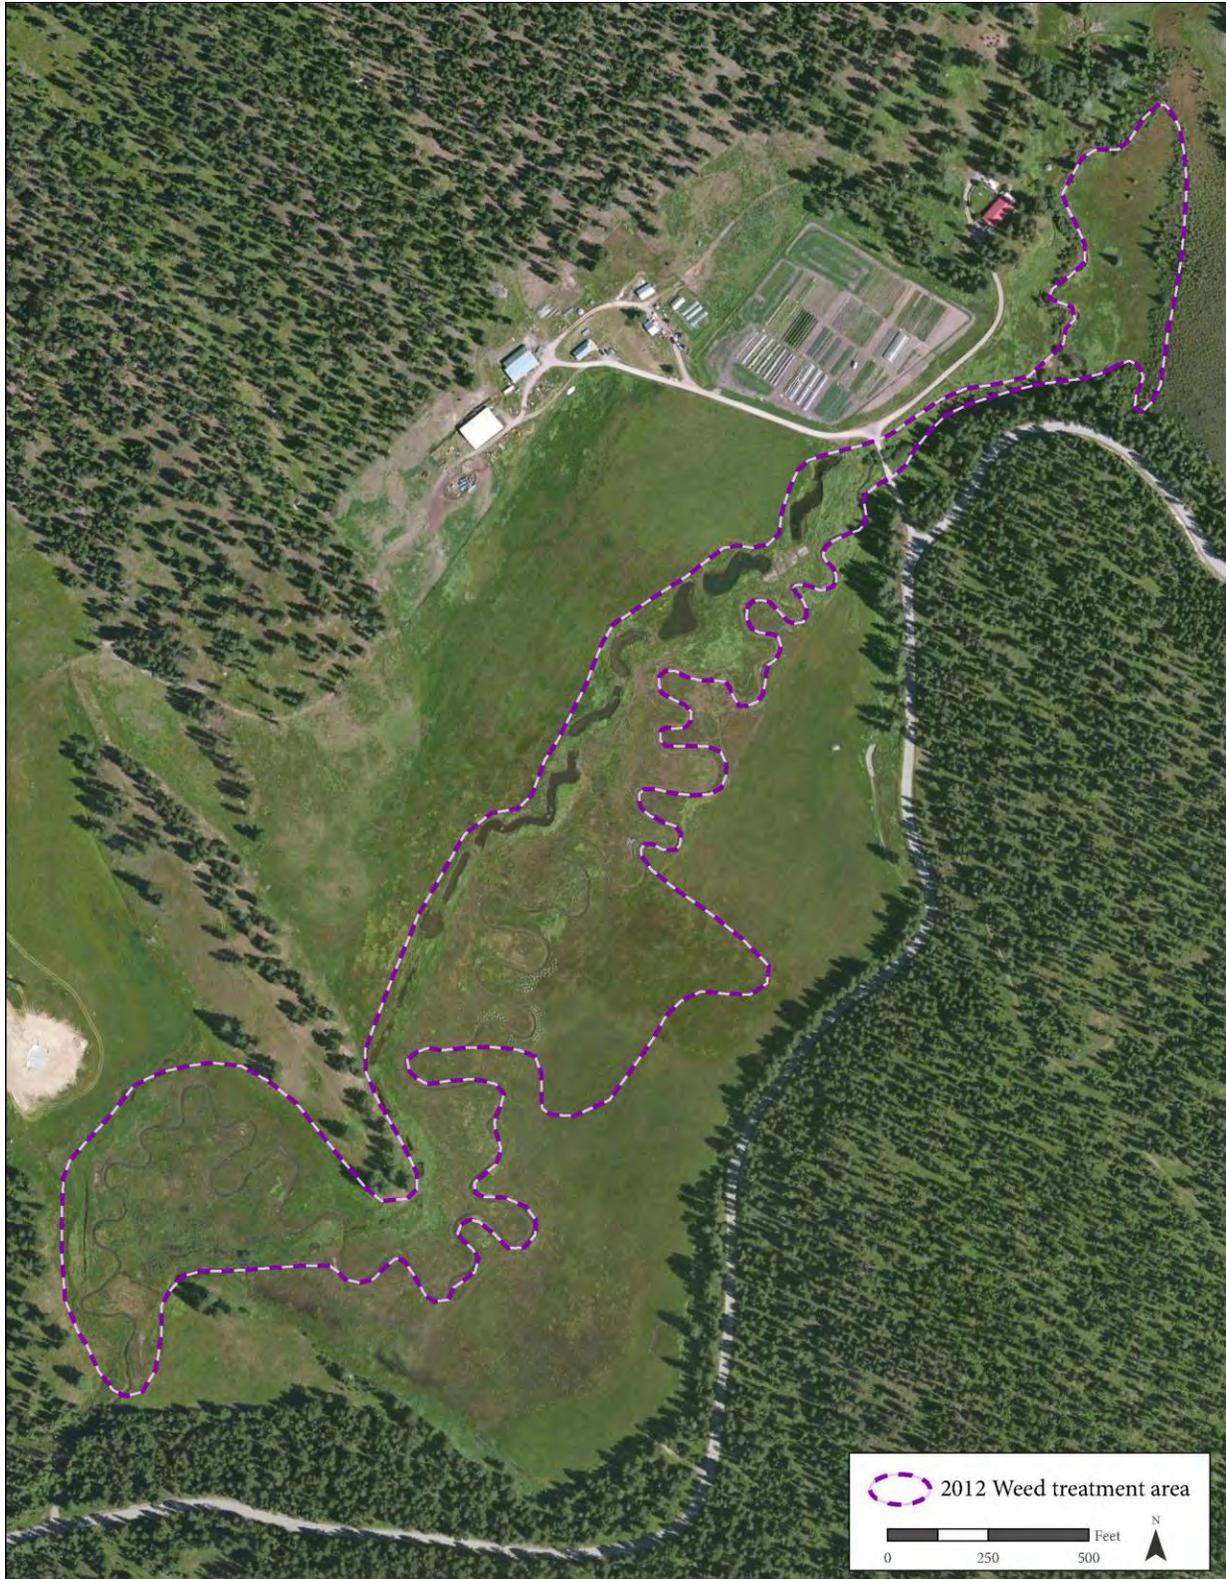
Weed control has been completed annually at the site since 2008. Weed management has consisted of primarily herbicide application due to the extent of infestations and the presence of multiple target species. In 2012, weed control targeted all occurrences of Canada thistle, yellow toadflax, houndstongue and isolated patches of reed canarygrass. In addition, weed control was prioritized for large infestations of Canada thistle located in the hayfield east of the project area and upstream of the project area. Transline® was applied at a rate of 0.5 ounces/gallon and 40 gallons per acre to treat thistle, toadflax and houndstongue. Roundup® was used to treat reed canarygrass. Brash® was used to treat yellow toadflax and houndstongue at a rate of 1 ounce/gallon and 45 gallons per acre. Figure 30 shows a small isolated patch of reed canarygrass after treatment with herbicide. Figure 31 shows Canada thistle plants after treatment. Figure 32 shows the extents of 2012 herbicide application. A total of 26 acres were treated.

Figure 32. Extent of July 2012 herbicide treatments.

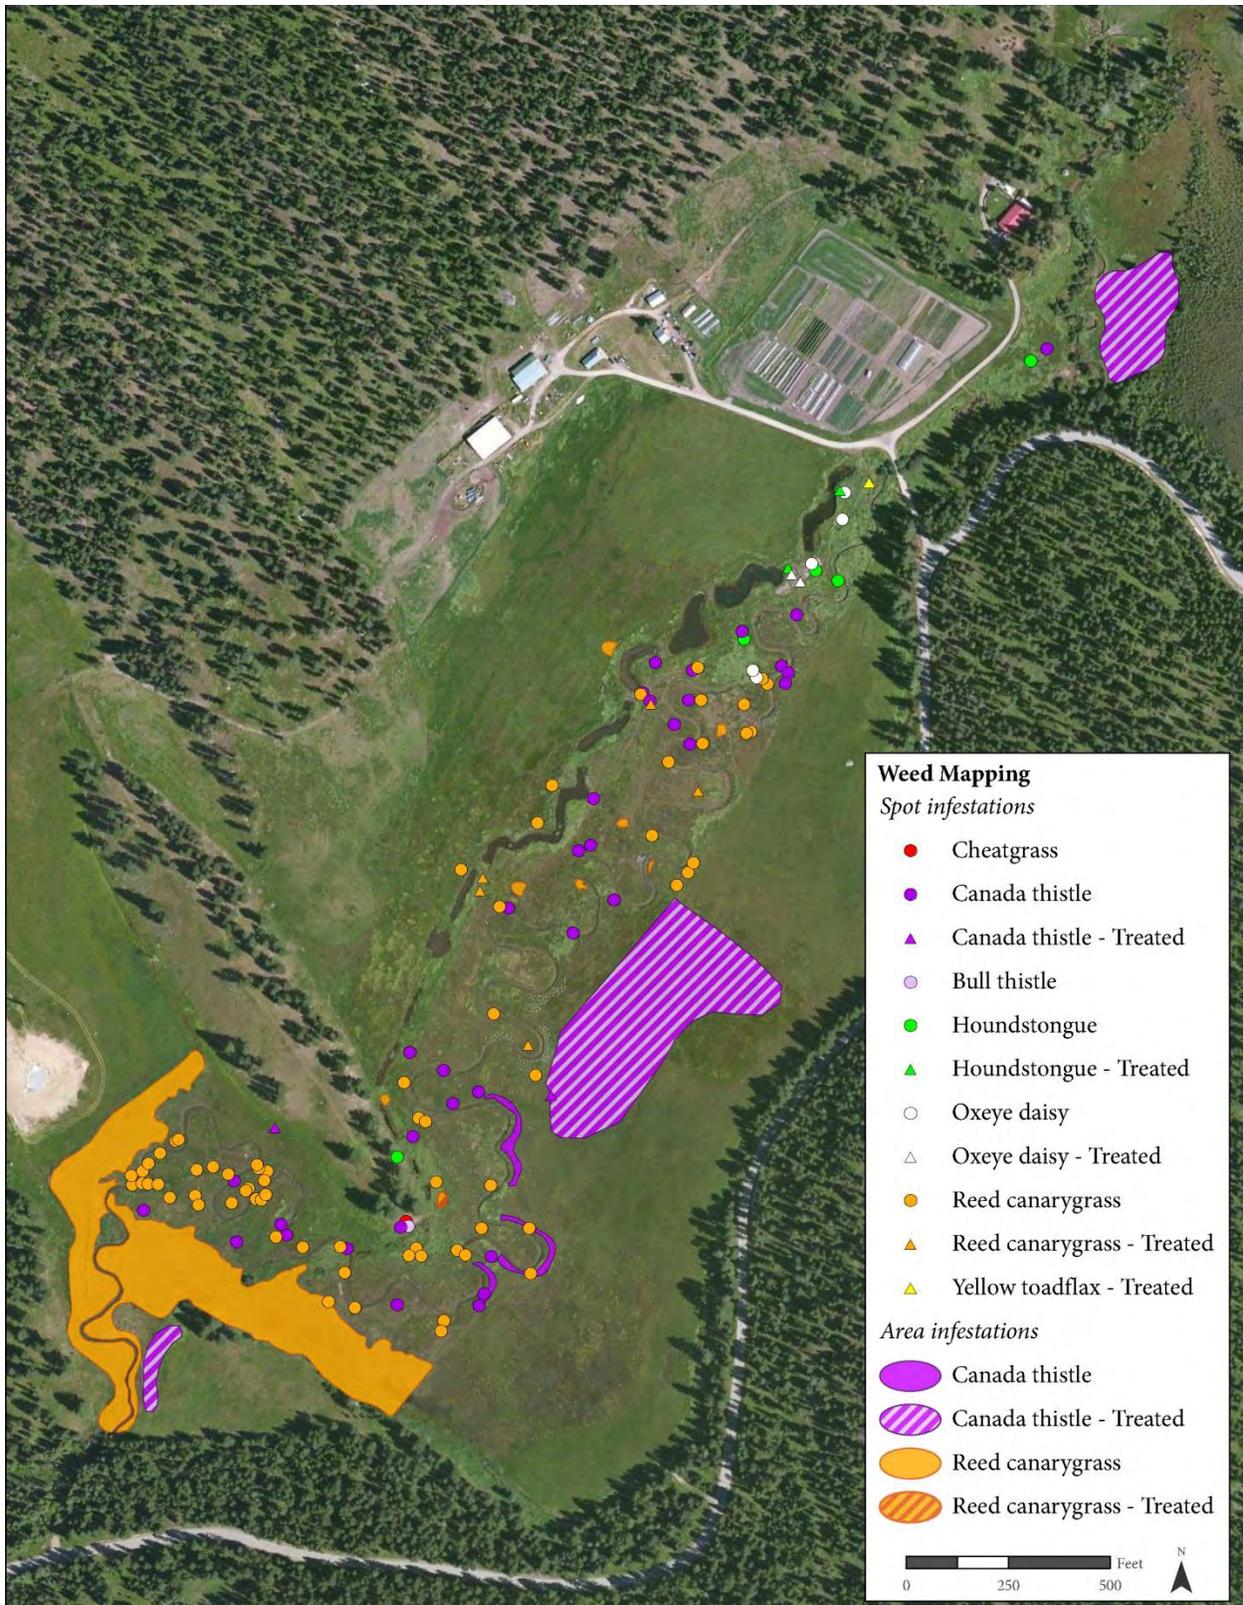
Figure 33 shows the location of existing weeds in the project area. This map includes all occurrences of living weed species but also includes some plants or infestations of plants that showed signs of herbicide treatment in 2012. Most of the spot infestations shown on the weed map consist of a single plant. Some spot infestations consist of areas no greater than 50 square feet. In these areas density is low to moderate. No sulfur cinquefoil was observed in 2012 indicating that this species has been effectively eradicated from the site. Yellow toadflax remains isolated to the area near the bridge. Houndstongue continues only to be present in small patches near the road at the upstream end of the project area and near the newly constructed livestock water gap. Oxeye daisy was recorded in the project area in a few isolated locations. Cheatgrass and bull thistle were also recorded just outside of the fence boundary delineating the revegetation treatment area. Reed canarygrass is still widely distributed throughout the project area, but continues to be present only in small isolated patches in the upper reaches of the project site. A number of patches have been effectively controlled but new patches continue to occur. Reed canarygrass remains dense and widespread near the downstream extent of the project area. These downstream populations have not been treated due to their proximity to the channel and the extent of the infestation. Canada thistle remains the primary target species at the site. Thistle has been effectively controlled in most of the project area and the spot infestations shown on the weed map typically consist of a few immature plants. Phase III planting units 19, 20, and 21 all have numerous immature and mature plants present. In addition, three large infestations of Canada thistle remain in or near the project area (Figure 34). All of these infestations were treated to some extent in July 2012. Thistle density continues to increase in the hayfield to the

Figure 33. Locations of weeds within and immediately adjacent to the Therriault Creek project area.

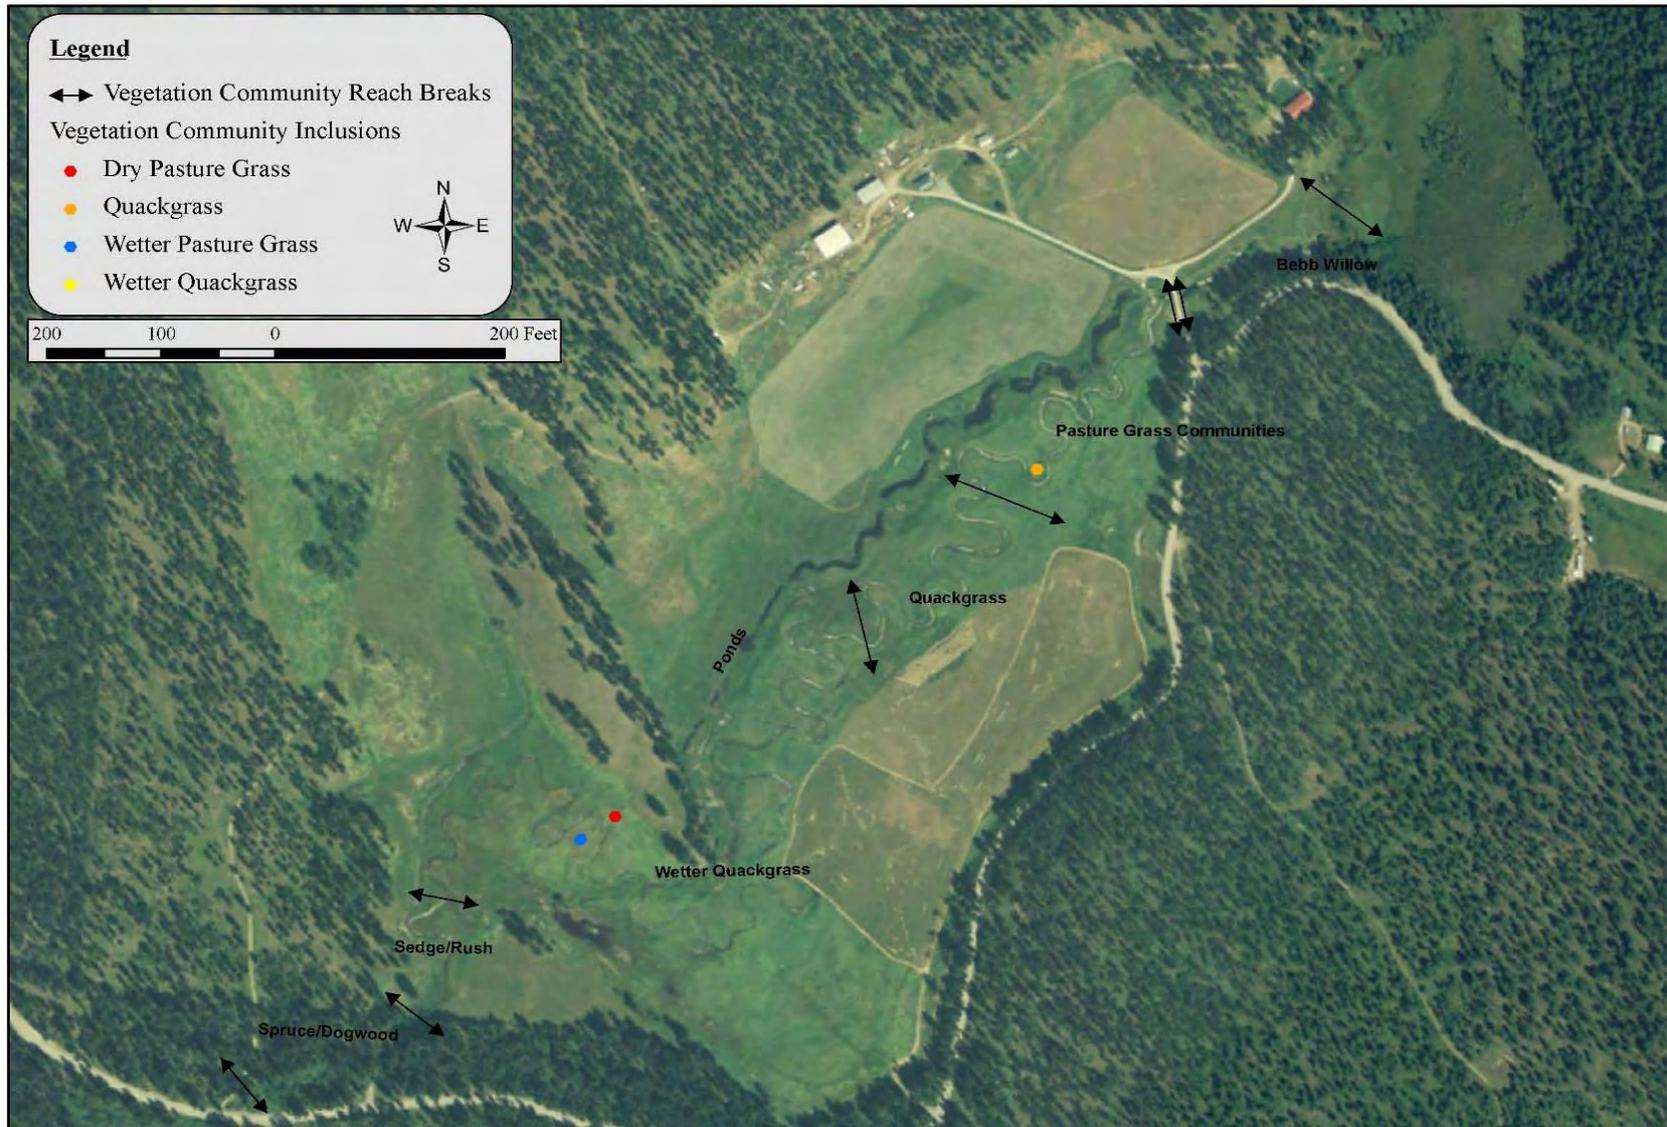
Vegetation communities were broadly mapped in 2006 prior to implementation of the riparian revegetation project. In 2006, five distinct vegetation communities were present in the project reach area (Figure 35). These vegetation communities are described in the *Therriault Creek Revegetation Plan* (Geum Environmental 2007). Vegetation communities mapped in 2006 included:

Figure 35. Vegetation communities mapped in the project area in 2006.

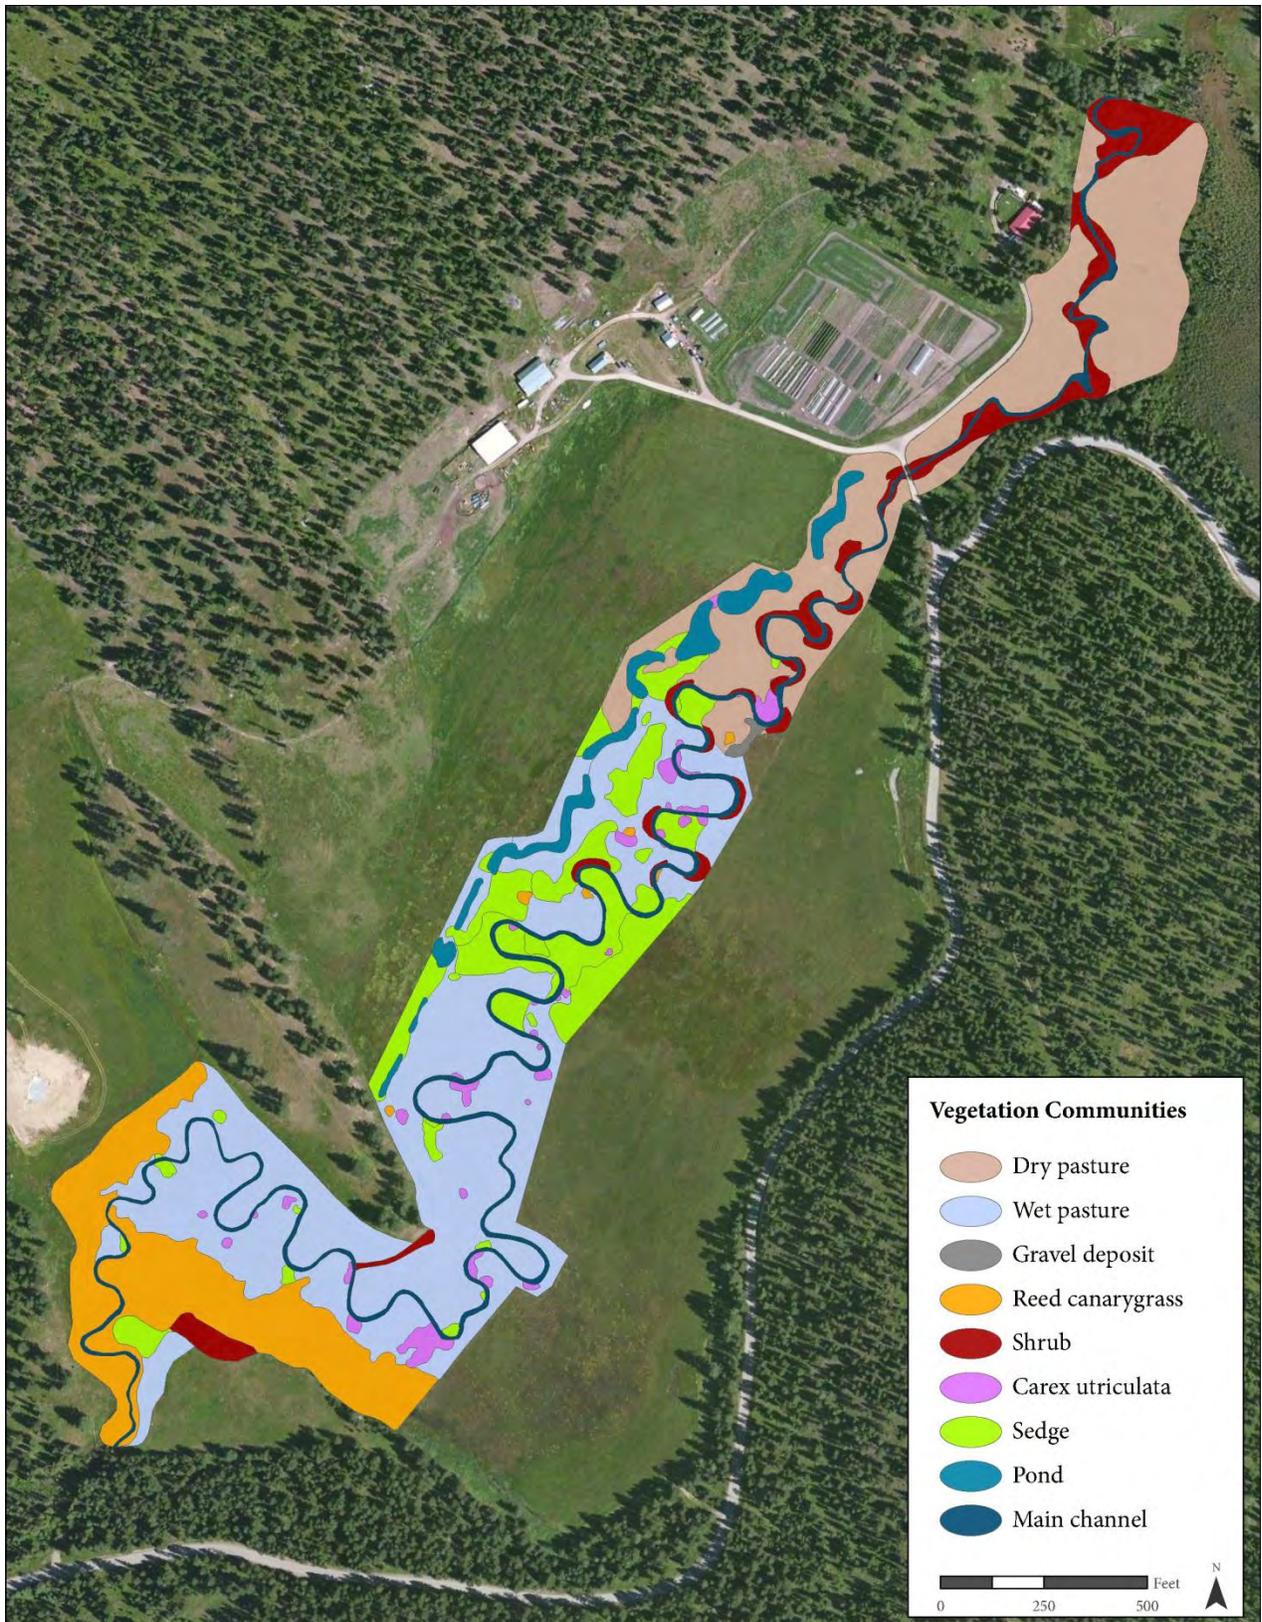
Vegetation communities were mapped again in 2012. In 2012, weed mapping was completed by walking the entire project area and recording distinct vegetation breaks either on 2011 aerial photos or using a resource-grade GPS unit. Figure 36 shows the vegetation communities mapped in the project area in 2012. Plant communities upstream of the road (Shrub and Dry Pasture Grass) and downstream of the channel reconstruction area (Spruce/Red-osier dogwood) have remained similar in the last six years. The upstream portion of the revegetation area is still predominantly drier pasture grasses but there are numerous small inclusions of sedges along the channel and many of the planting units and residual shrub treatment areas have sufficient shrub cover to be mapped as Shrub vegetation communities (Figure 37). The middle portion of the project area is where the most significant shifts in vegetation communities have occurred in the last six years. There are large areas dominated by sedges in the middle portion of the project area (Figure 38). Pond associated plant communities have remained similar in the last six years. The downstream extent of the project area remains dominated by wetter pasture grass species and quackgrass but as shown in the woody debris structures vegetation transects (Table 6 above) there has been a subtle shift towards wetter species. Reed canarygrass has expanded significantly in the downstream portion of the project area.

Figure 36. Vegetation communities mapped in the project area in August 2012.

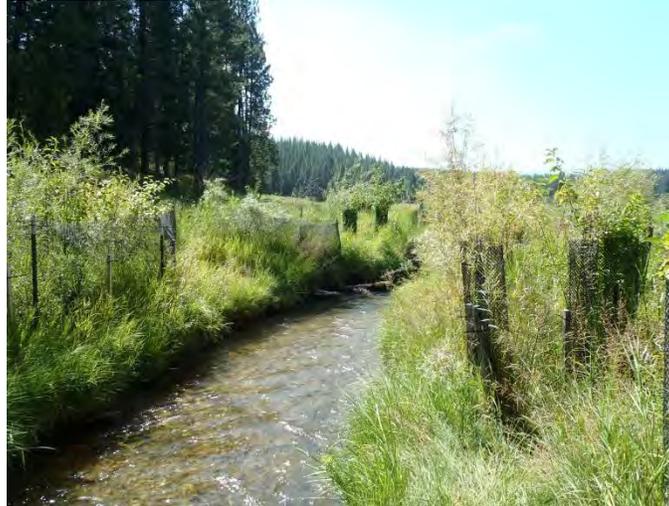
Figure 37. Development of shrub vegetation communities in Phase I.

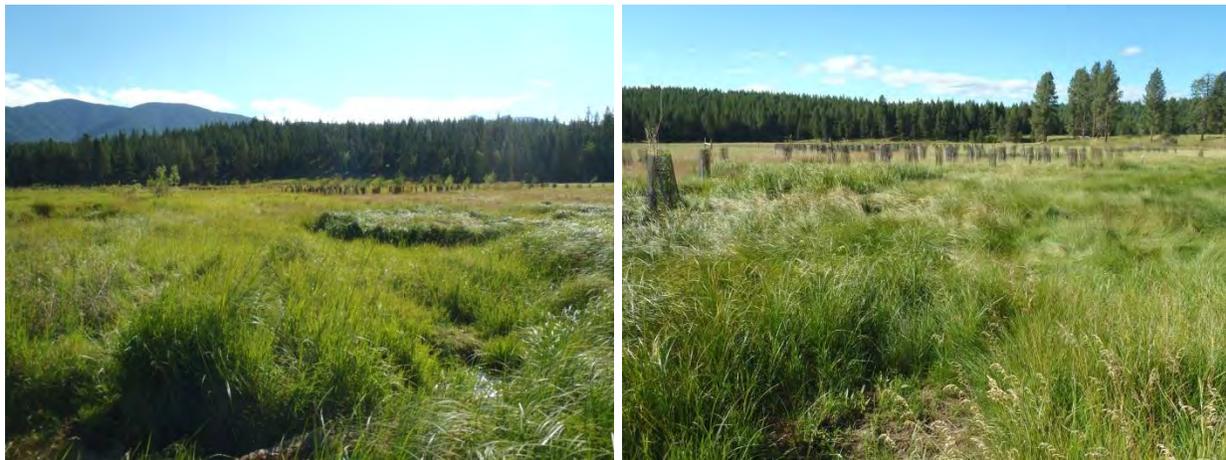
Figure 38. Expansion of sedges in middle portion of project reach.

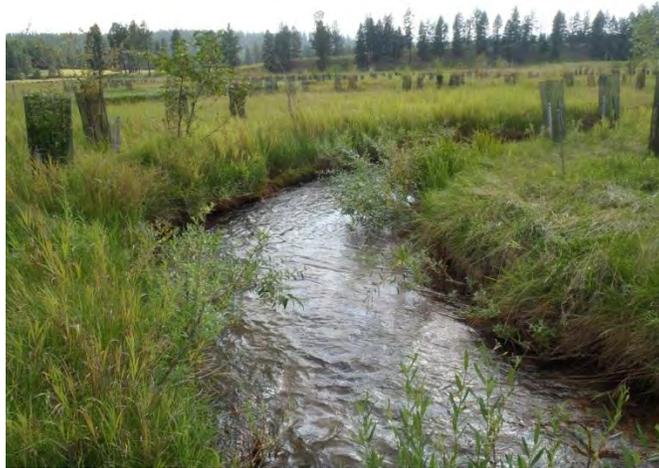
Treatments implemented in the project area to enhance habitat for native fish include vegetated soil lifts, coir logs, willow fascines, residual shrub protection, outer meander planting, and woody debris structures. All of these treatments directly enhance aquatic habitat by providing shade, instream cover, and support for aquatic food web functions. The degree to which treatments currently enhance aquatic habitat varies. In some areas planted shrubs are not big enough to provide substantial thermal cover but in other areas, such as where coir logs, soil lifts or willow fascines were installed, shrubs are over-hanging the stream and providing both thermal and physical cover (Figure 41). To evaluate this objective, solar radiation measurements were recorded in select planting units in Phase I and III using a Solar Pathfinder™. Table 7 shows the results of solar radiation measurements. Planting units in Phase III had the highest solar radiation with an average 97.6 percent available solar radiation. The Phase I planting units, where shrubs are larger, had an average of 82.1 percent available solar radiation. Solar radiation in the channel adjacent to vegetated soil lifts where dense woody vegetation is over-hanging the channel had the lowest available solar radiation with 71.3 percent. This indicates that as woody vegetation establishes it is effectively reducing the amount of solar radiation reaching the channel. Woody debris structures appear to have enhanced habitat for native fish and large numbers of fish are regularly observed moving in and out of these structures during annual monitoring.

Figure 41. Instream cover provided by willows installed in coir log and willow fascine structures.

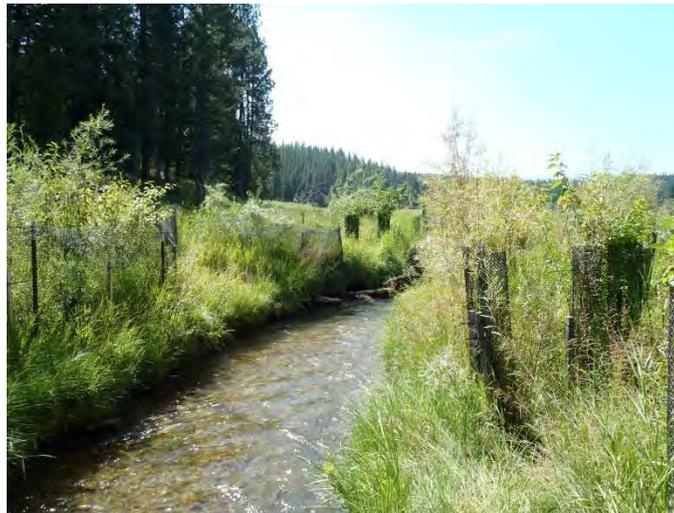
Treatments installed in the project area to protect plants planted during channel construction include residual shrub protection measures. More than 200 residual shrubs have been protected with individual browse protectors in the last five years. This treatment has been very effective and residual shrubs are some of the largest plants in the project area (Figure 42). In addition, residual shrubs have begun to expand through suckering and seed production on a number of inside meanders in Phase I.

Figure 42. Residual protected shrubs at the upstream end of the project area.
