Therriault Creek Riparian Revegetation 2010 Monitoring, Maintenance and Phase III Implementation Report

Contract #110032

Montana Fish, Wildlife and Parks
385 Fish Hatchery Road
Libby, MT 59923

Geum Environmental Consulting, Inc.
307 State Street
Hamilton, MT 59840

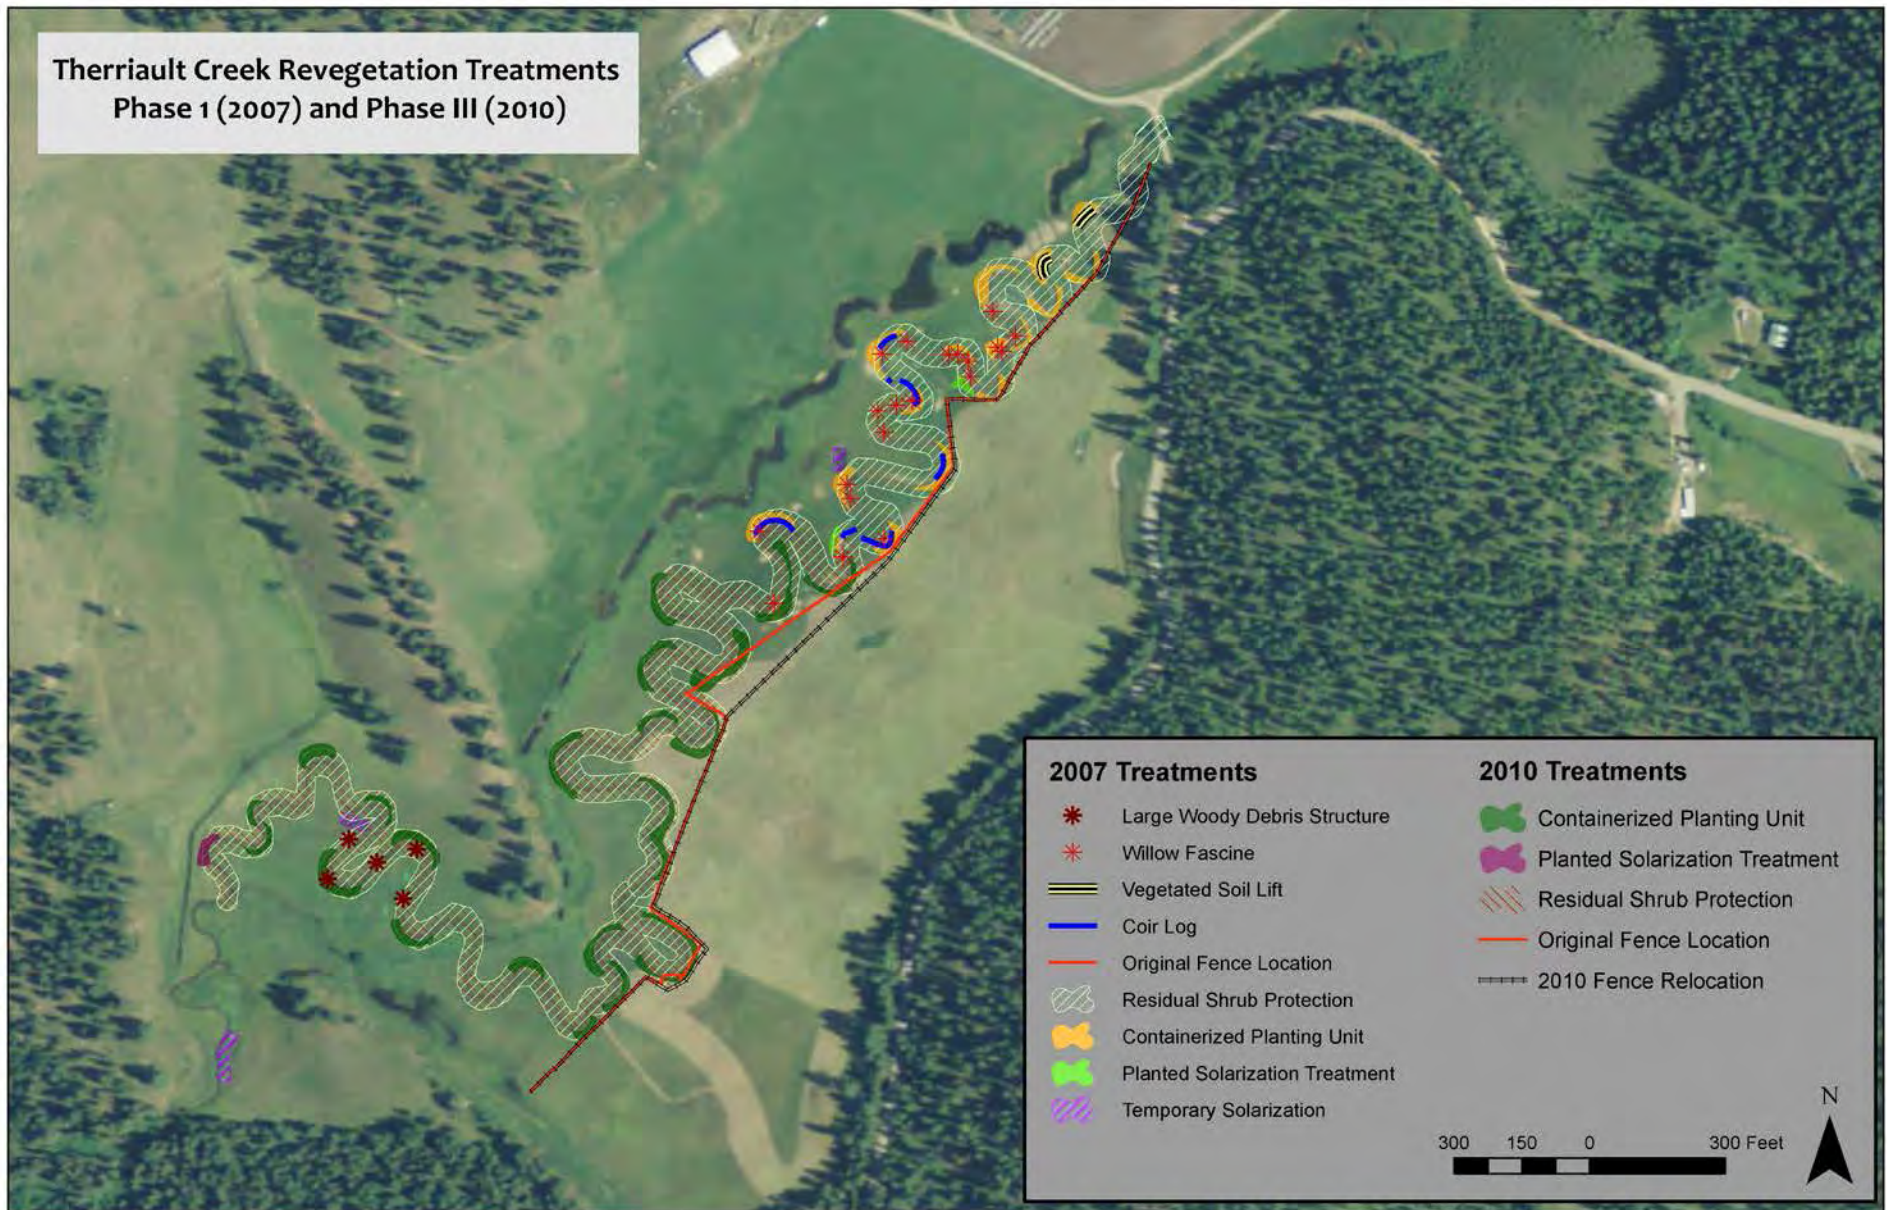
Figure 1. Overview figure showing riparian revegetation treatments installed in 2007 and 2010 at the Therriault Creek Riparian Revegetation project site.

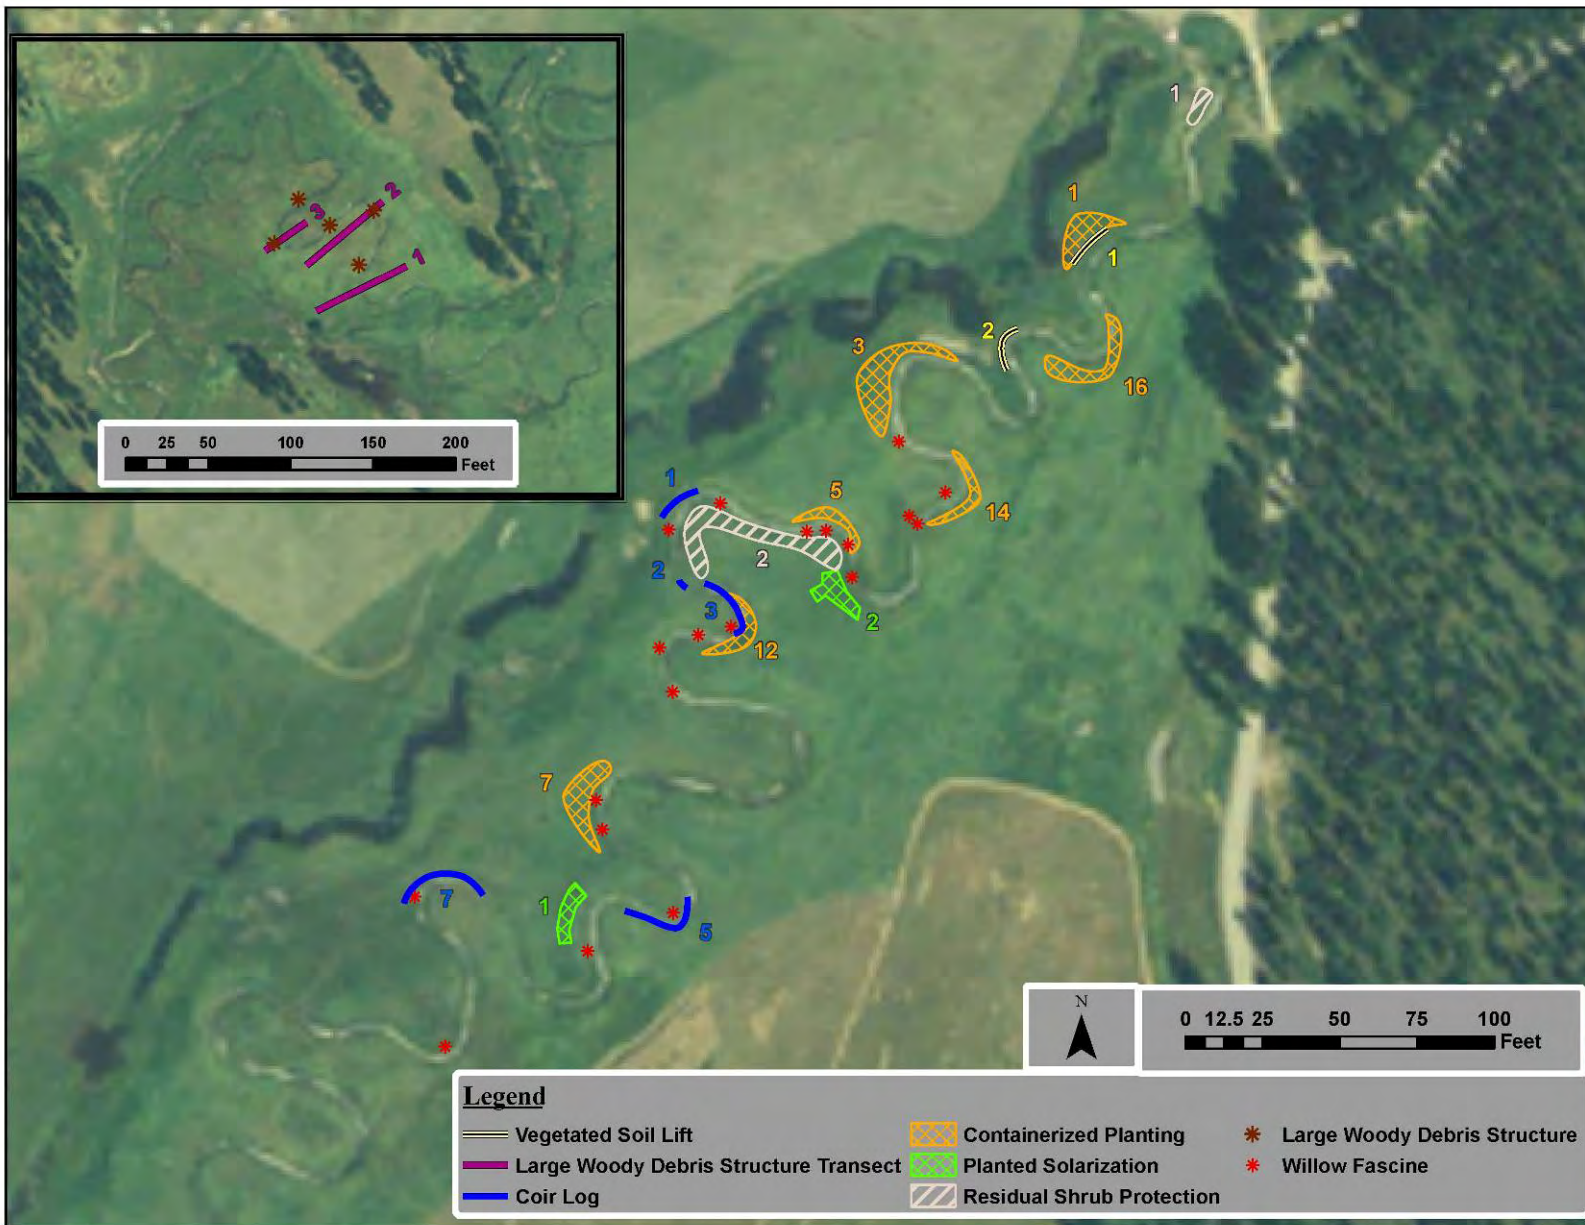
Figure 2. Effectiveness monitoring overview figure showing the locations of treatments monitored in 2008 and 2009. In 2010, survival data was collected at Planting Units 1 and 7 and Planted Solarization Plots 1 and 2.

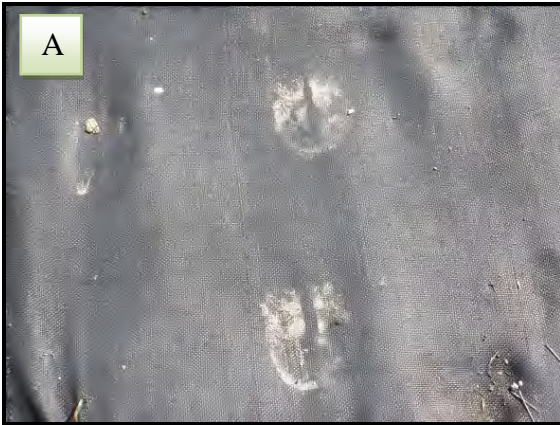
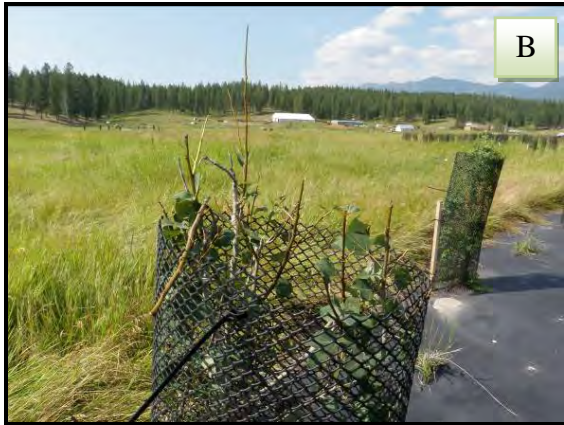
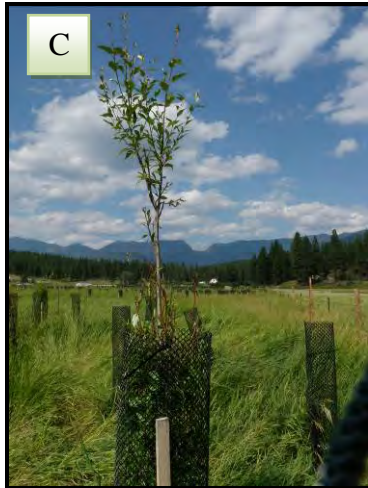
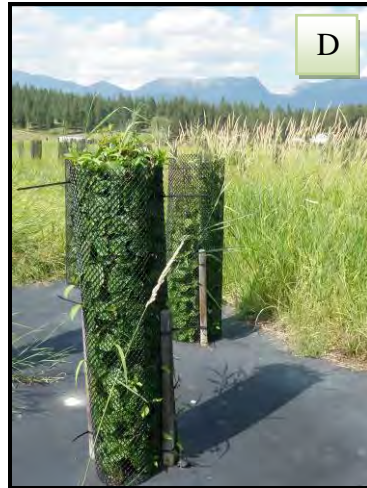
In 2009, most of the browse protectors originally installed in 2007 were expanded to provide additional capacity for plant growth. Despite this expansion, many plants had grown to maximum capacity of the expanded protectors by summer 2010. There were sign of elk use throughout the project reach. A number of browse protectors were damaged and many plants suffered severe hedging; defined as, browse of all growth above the height of the browse protector has been eaten (Figure 8). Although this may slow vegetative growth, given the size of the shrubs hedged, it is likely that the root systems of the surviving plants are established enough to withstand moderate browse pressure. The established root system coupled with protection of the lower half of the plant should enable the plant to survive browse pressure and eventually reach a height that is less vulnerable to browse. If heavy browse continues it may affect growth and survival of damaged shrubs.

Figure 8. Photographs show evidence of browse by ungulates. Photograph A shows tracks through a planted solarization plot. Many plants have been hedged to the top of browse protector (photographs B and D). Plants that have grown above browse height have been browsed at all reachable locations (photograph C). Photograph E provides an example of plant height in July, just one month prior to the August monitoring site visit. It appears that most of the browse observed during monitoring occurred sometime between the end of July and the beginning of August.

- Repair and re-secure damaged browse protectors during summer 2010.
- Water all planted shrubs and trees during August 2010.
- Install additional containerized plants in the lower half of the project reach during fall 2010.
- Install mulch mats, vole protectors and browse protectors around all containerized plants.
- Use shredded mulch instead of wood chips in vole protectors to reduce grass growth inside the vole protector.
- Install 16-inch diameter browse protectors to increase the area available to support plant growth.

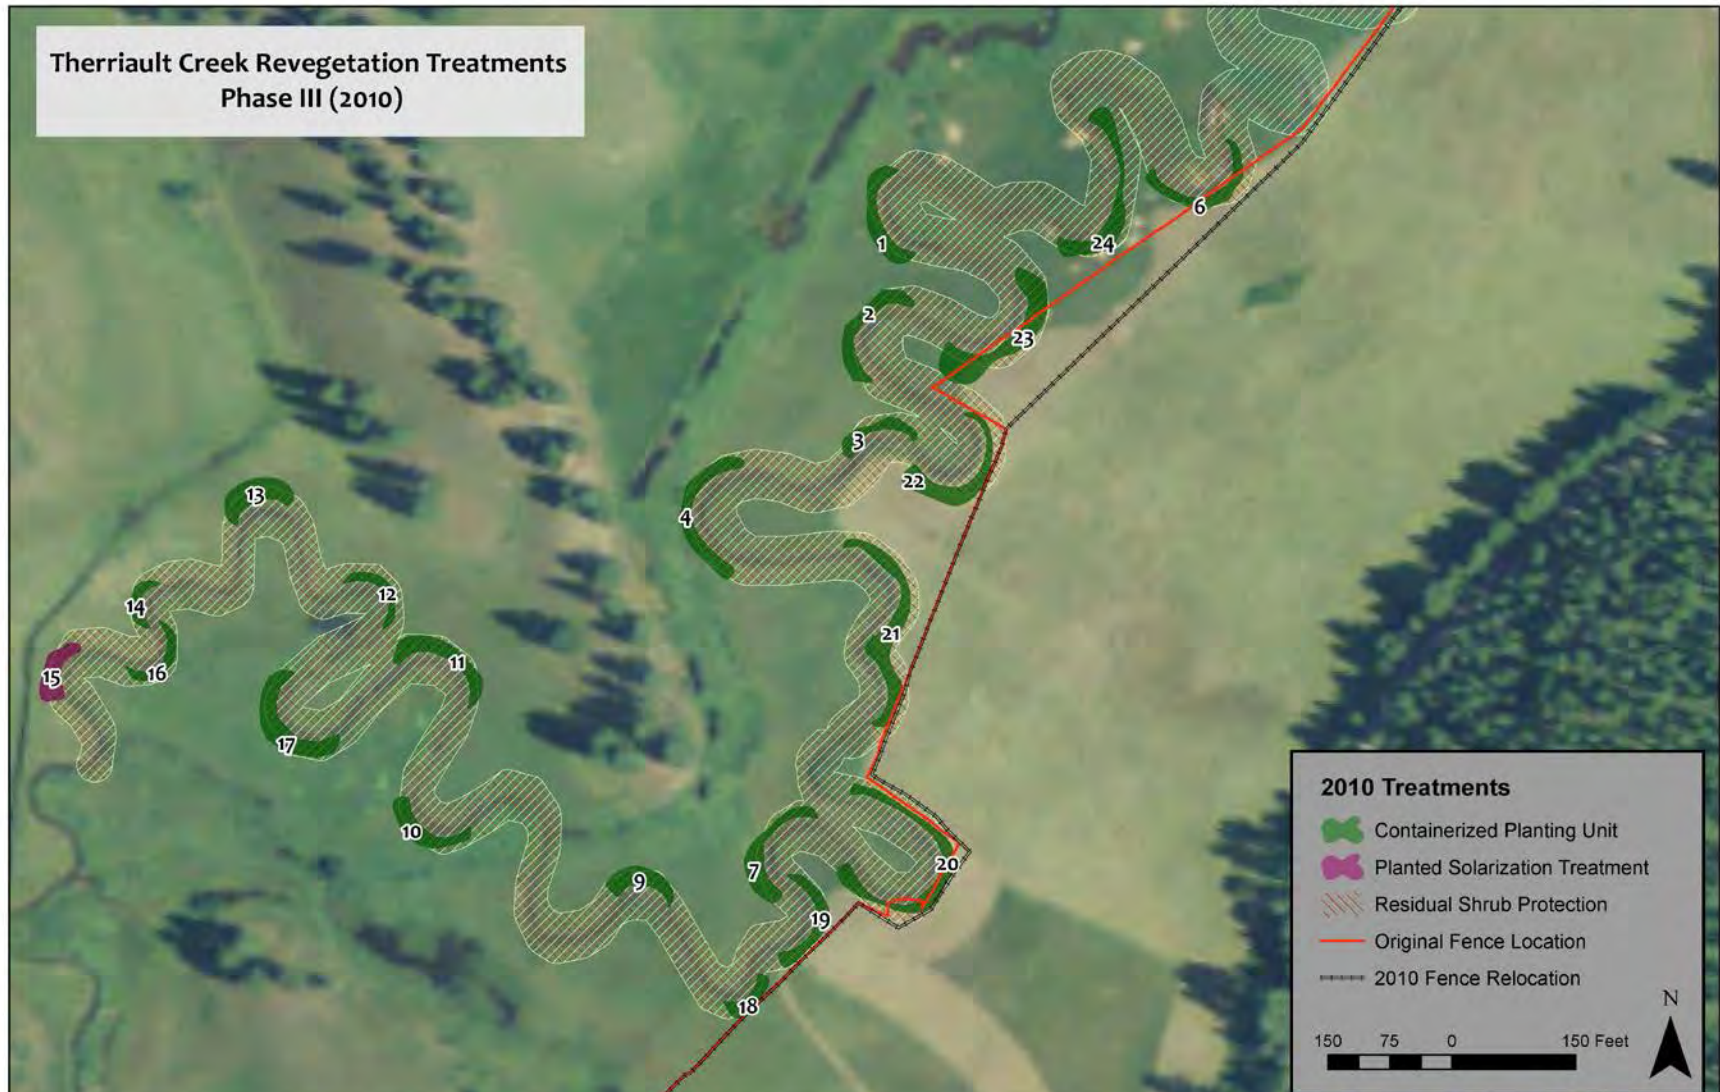
Figure 17. Aerial photograph showing the locations of Phase III (2010) riparian revegetation treatments at the Therriault Creek project site. Figure 1, above, shows these treatments in relation to the Phase I (2007) treatments.

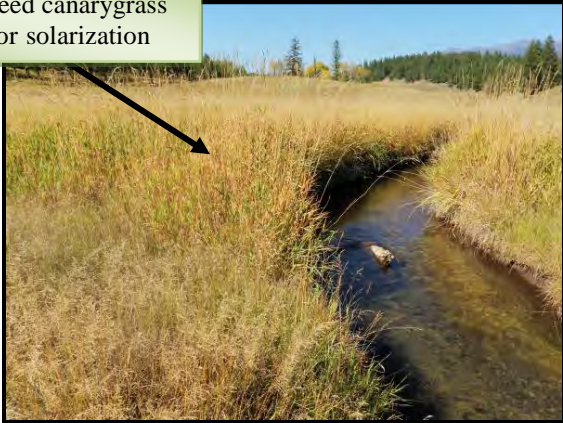
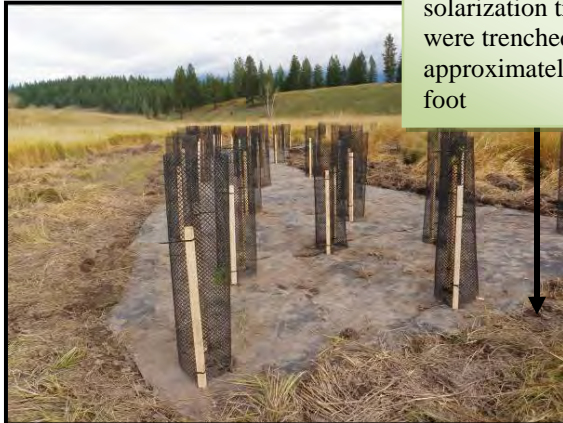
Patch of reed canarygrass targeted for solarization

Fabric edges in planted solarization treatment plots were trenched into the ground approximately 8 inches to 1 foot

Figure 21. Photographs show the long-term planted solarization plot before (left) and after treatment (right).

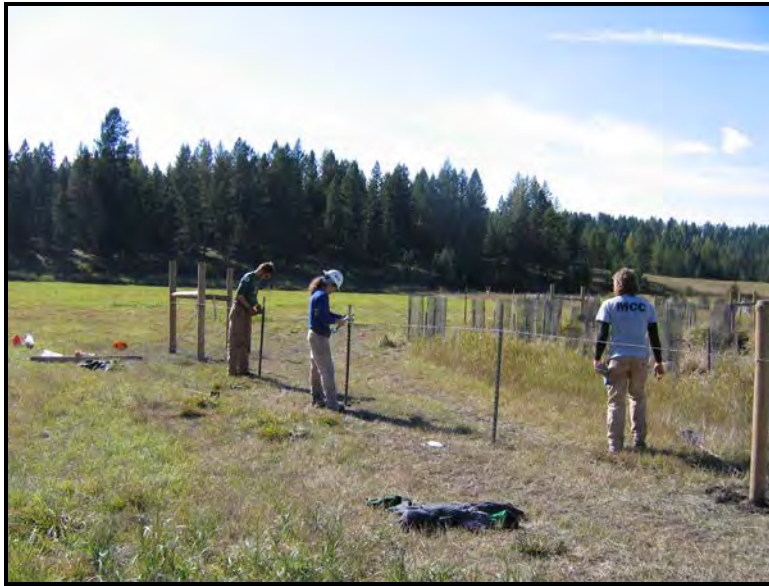
Figure 22. Photograph shows the MCC crew working on the fence re-location in October 2010.

stream. To address this issue and create sufficient space for planting a riparian buffer along the channel, the installed fence was realigned in some areas. Geum provided fence re-alignment recommendations, flagged the recommended fence line location and removed the fence during installation of Phase III revegetation treatments. A Montana Conservation Corps (MCC) crew installed the new fence in late October 2010 (Figure 22). The original fence location and approximate location of the re-aligned section of fence are shown in Figure 17.
