# Therriault Creek Riparian Revegetation 2011 Monitoring and Maintenance Report

Contract #120001

**Prepared for:**

Geum Environmental Consulting, Inc.  
307 State Street  
Hamilton, MT 59840

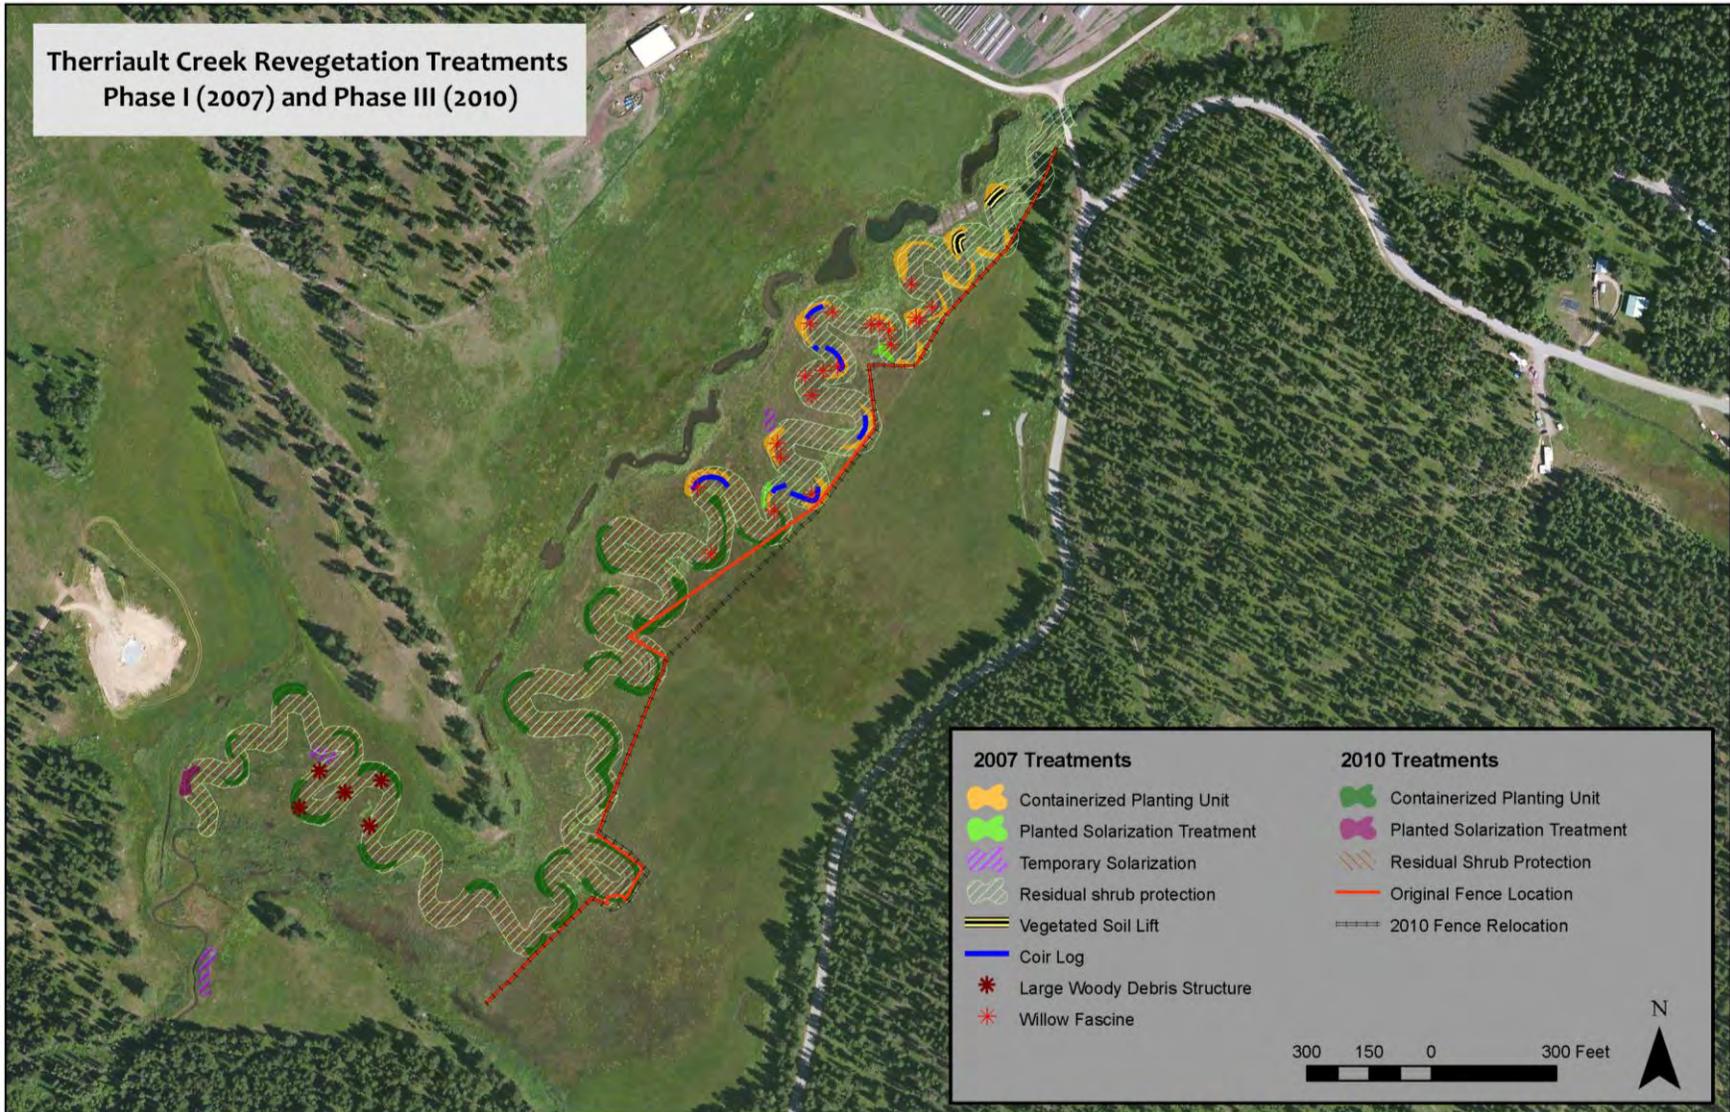
**Figure 1.** Overview figure showing riparian revegetation treatments installed in 2007 and 2010 at the Therriault Creek Riparian Revegetation project site.

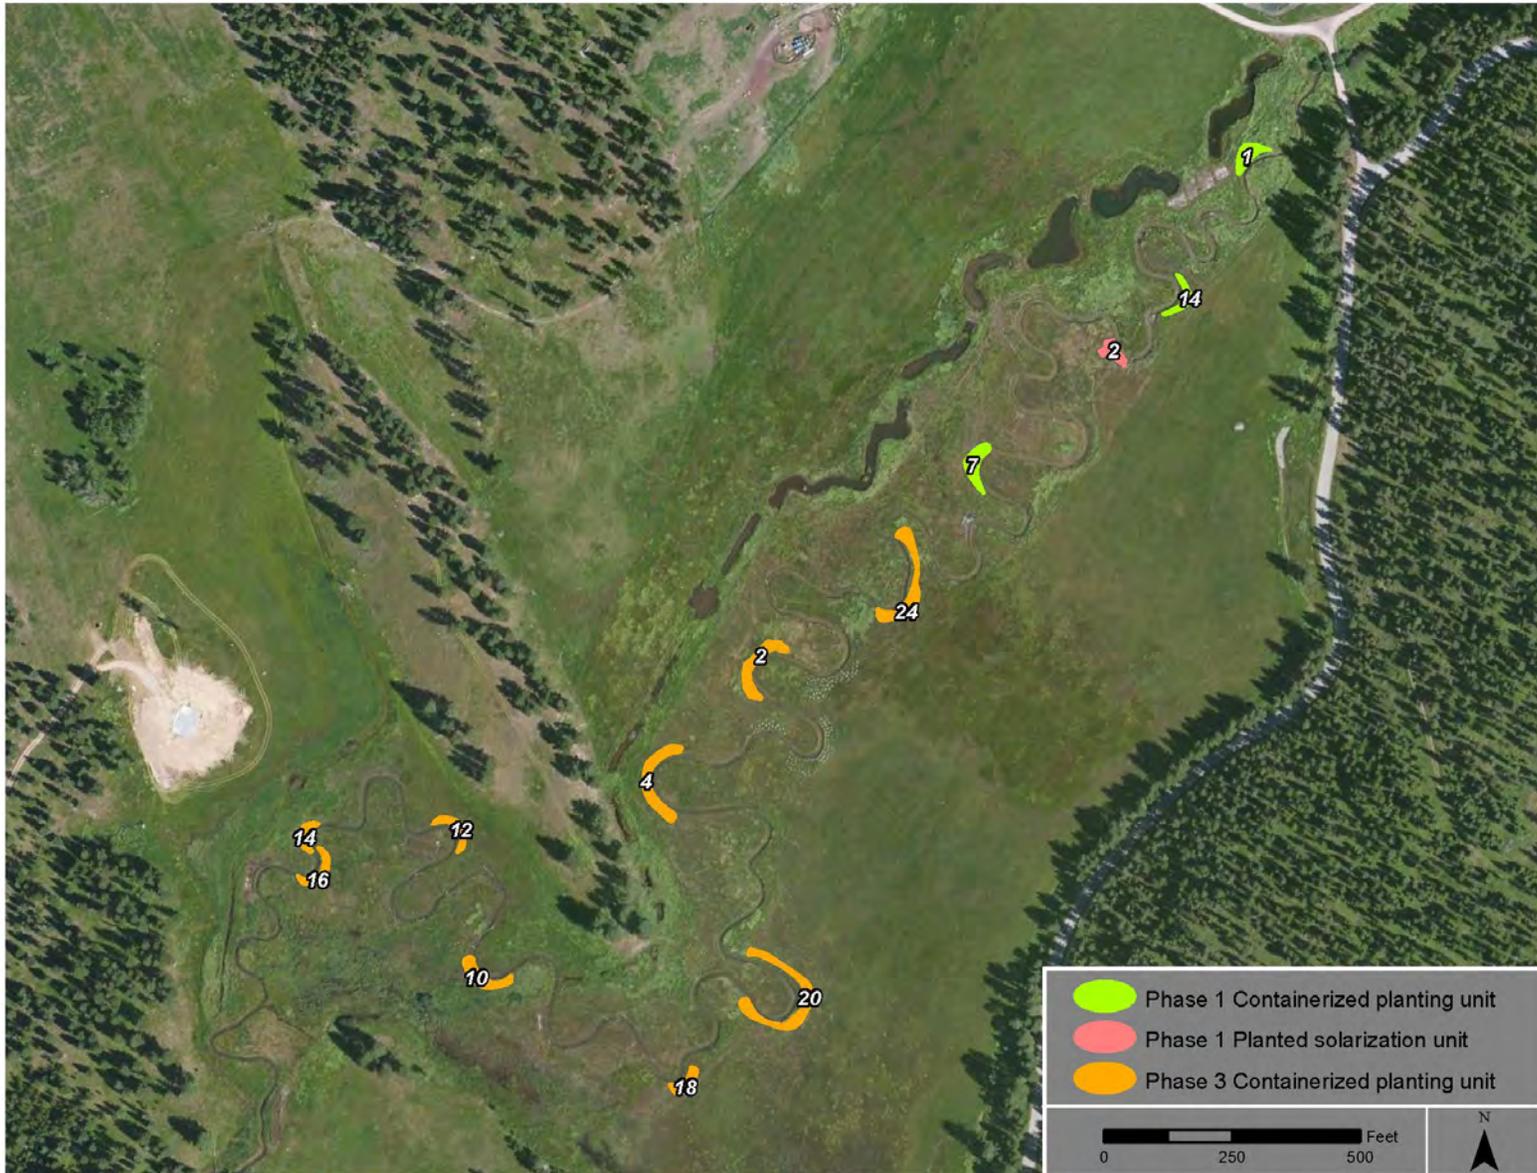
**Figure 2.** Effectiveness monitoring overview figure showing the locations of planting units monitored in 2011 at the Therriault Creek Riparian Revegetation project site.

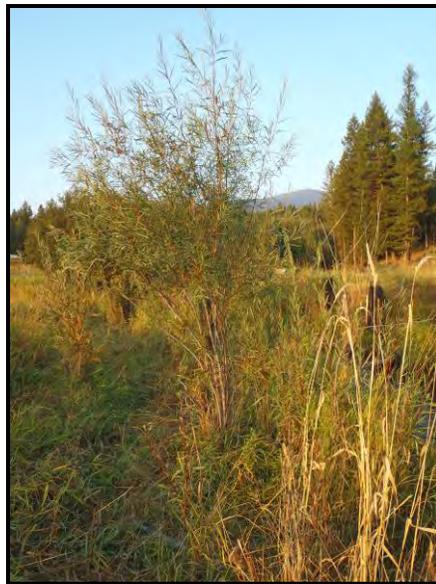
**Figure 4.** Photograph of a previously planted (residual) sandbar willow that has grown tall enough to be less vulnerable to browse. This observation of growth is typical of residual shrubs that have been protected for three growing seasons.

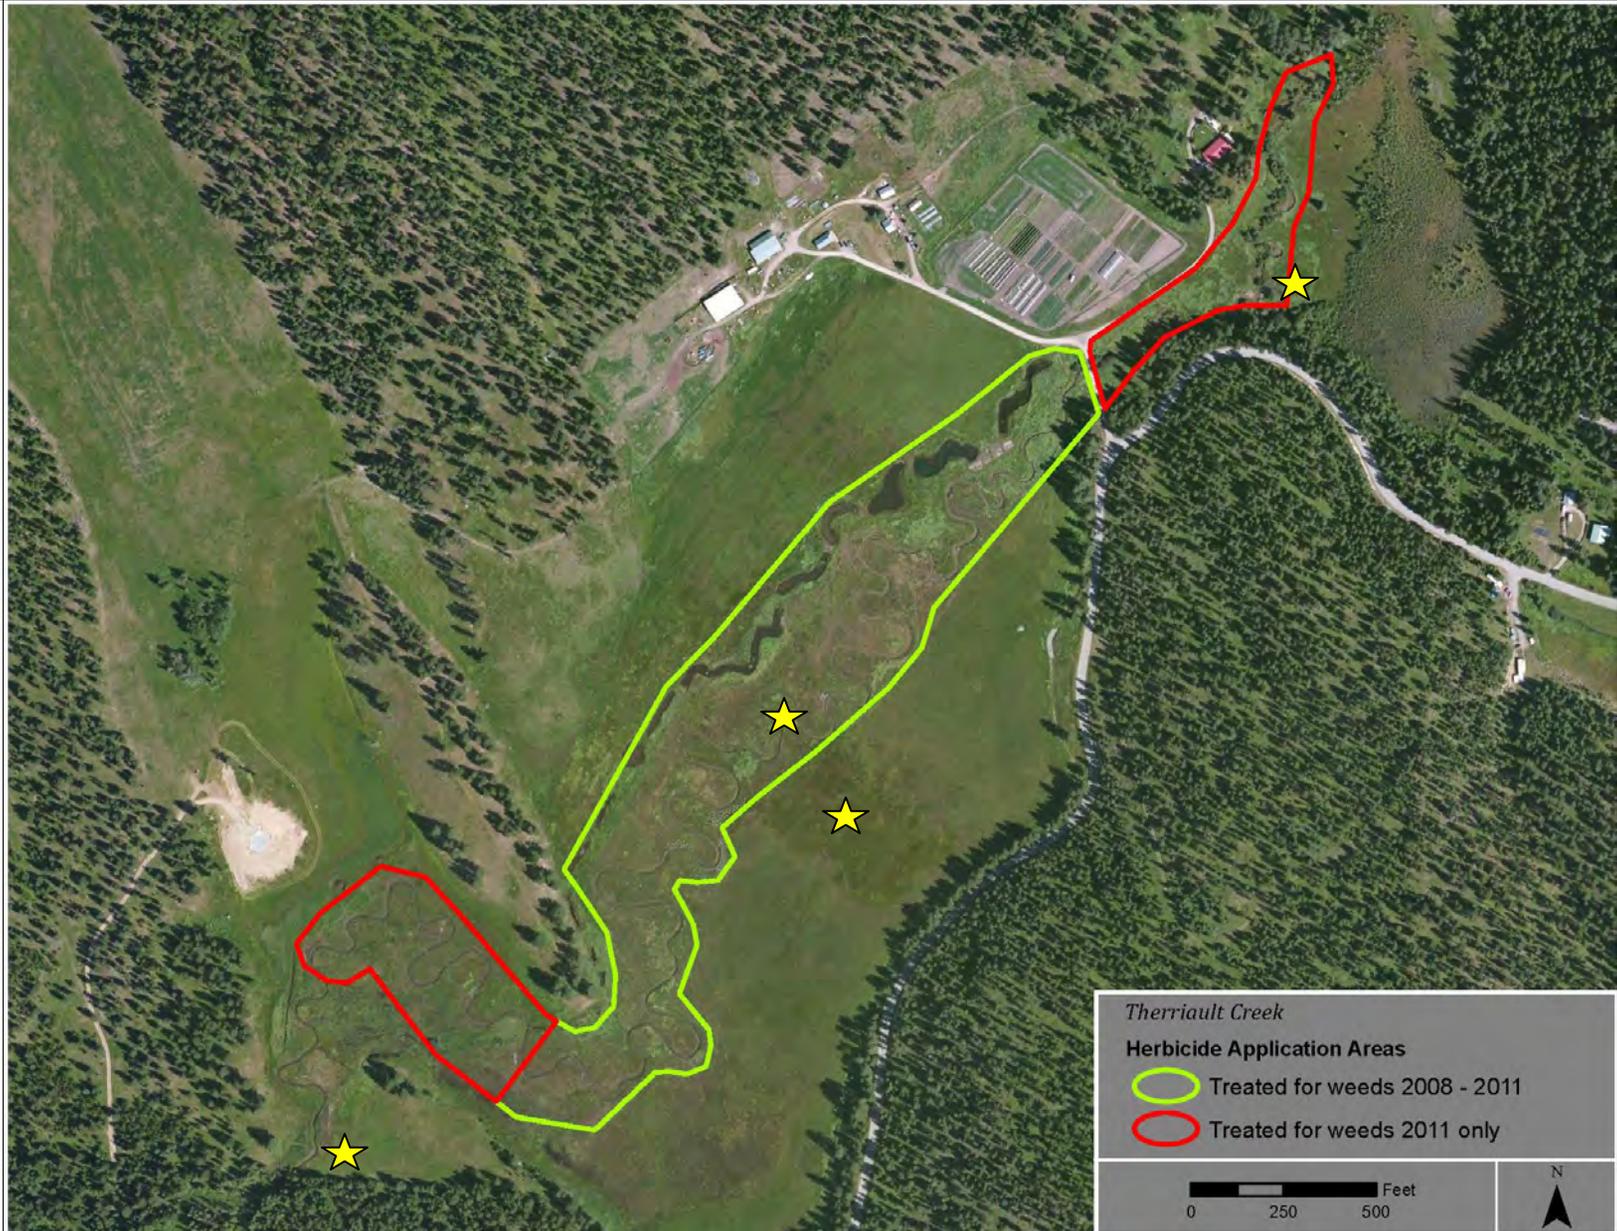
**Figure 22.** Extent of herbicide applications at the project site. Yellow stars indicate priority area for 2012 weed treatment.

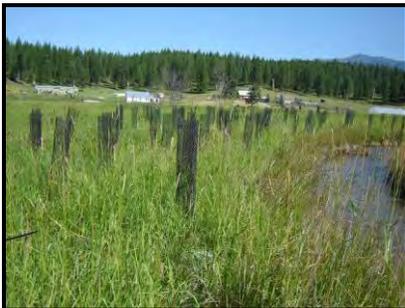
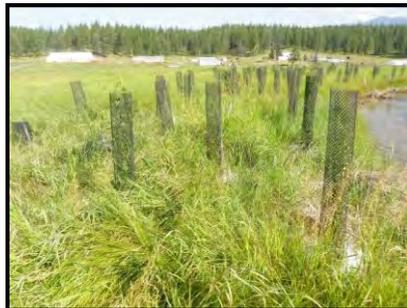
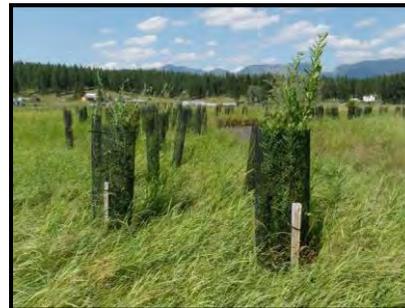
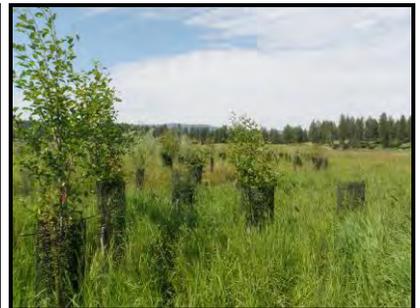
### Planting Unit 3

\*2011 photo taken from upstream viewing downstream. All other photos view upstream.
