Therriault Riparian Revegetation 2008 Monitoring Report

Task Order #0803

Geum Environmental Consulting, Inc.
307 State Street
Hamilton, MT 59840

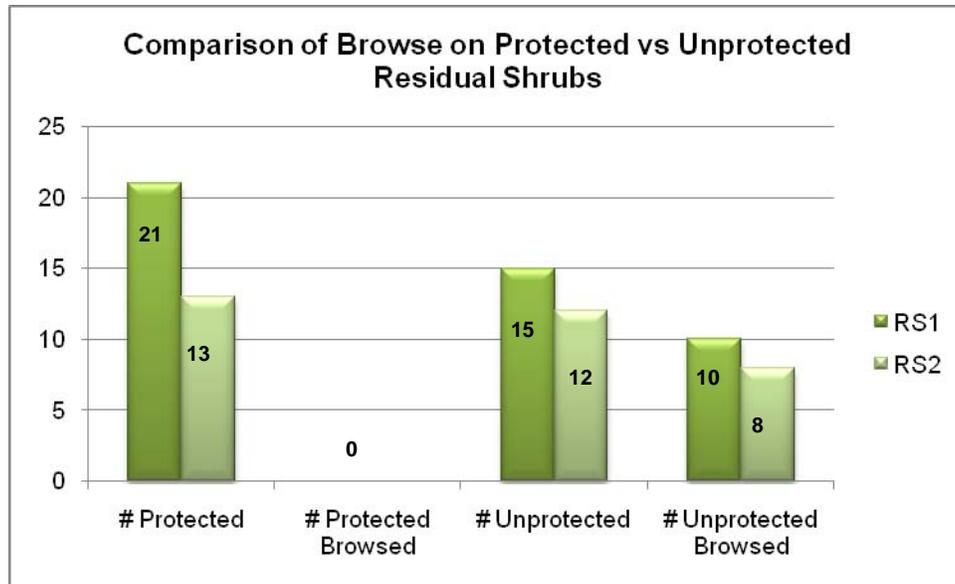
Figure 3. Results of residual shrub protection effectiveness monitoring showing total number of residual protected and unprotected shrubs monitored in each plot and the number of shrubs with observed browse.

Figure 3 shows the results of residual shrub protection effectiveness monitoring for the two monitoring plots (RS1, RS2). Figure 4 compares the height difference between protected and unprotected red-osier dogwood shrubs. No browse was observed on current year growth of protected residual shrubs within plots RS1 and RS2. Browse was observed on a total of 67% of residual shrubs left unprotected within plots RS1 and RS2.

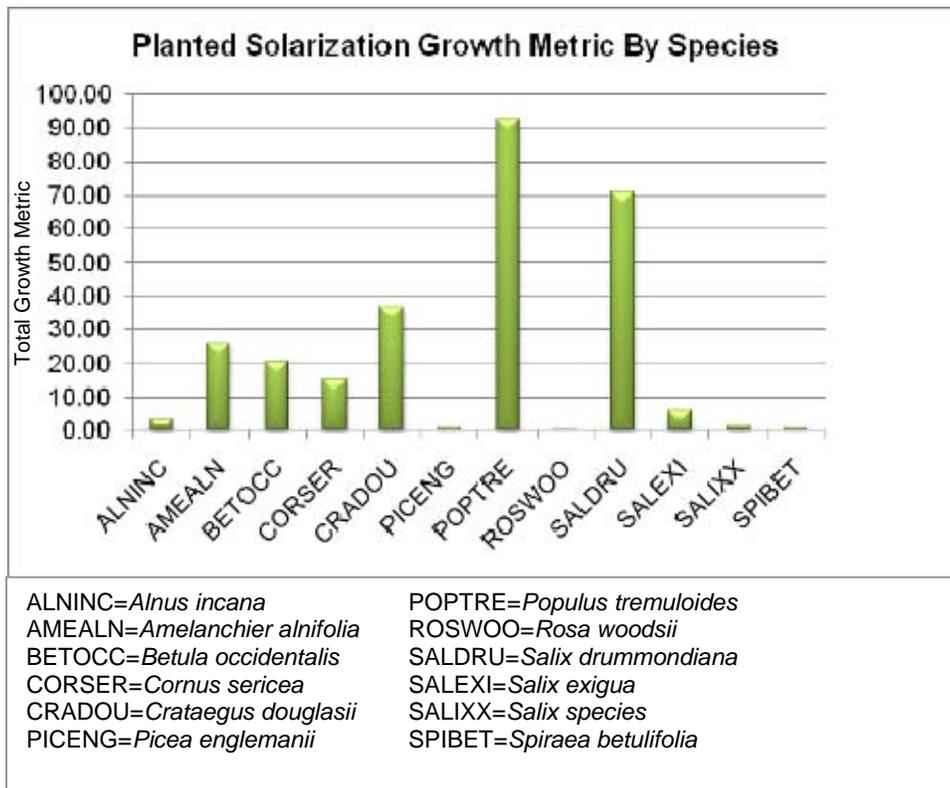
Figure 6. Comparison of growth metric values between species in planted solarization plots 1 and 2. Total represents the sum of growth metric values (height x πr^2) for each species.

Table 5 shows the results of effectiveness monitoring conducted for the two planted solarization plots. This table provides the total growth metric and total percent survival by species. These data are combined for both planted solarization plots. Figure 6 shows the sum of the growth metric for each species. Figure 7 compares conditions in solarization planting plot 1 immediately after installation and during July 2008 effectiveness monitoring.

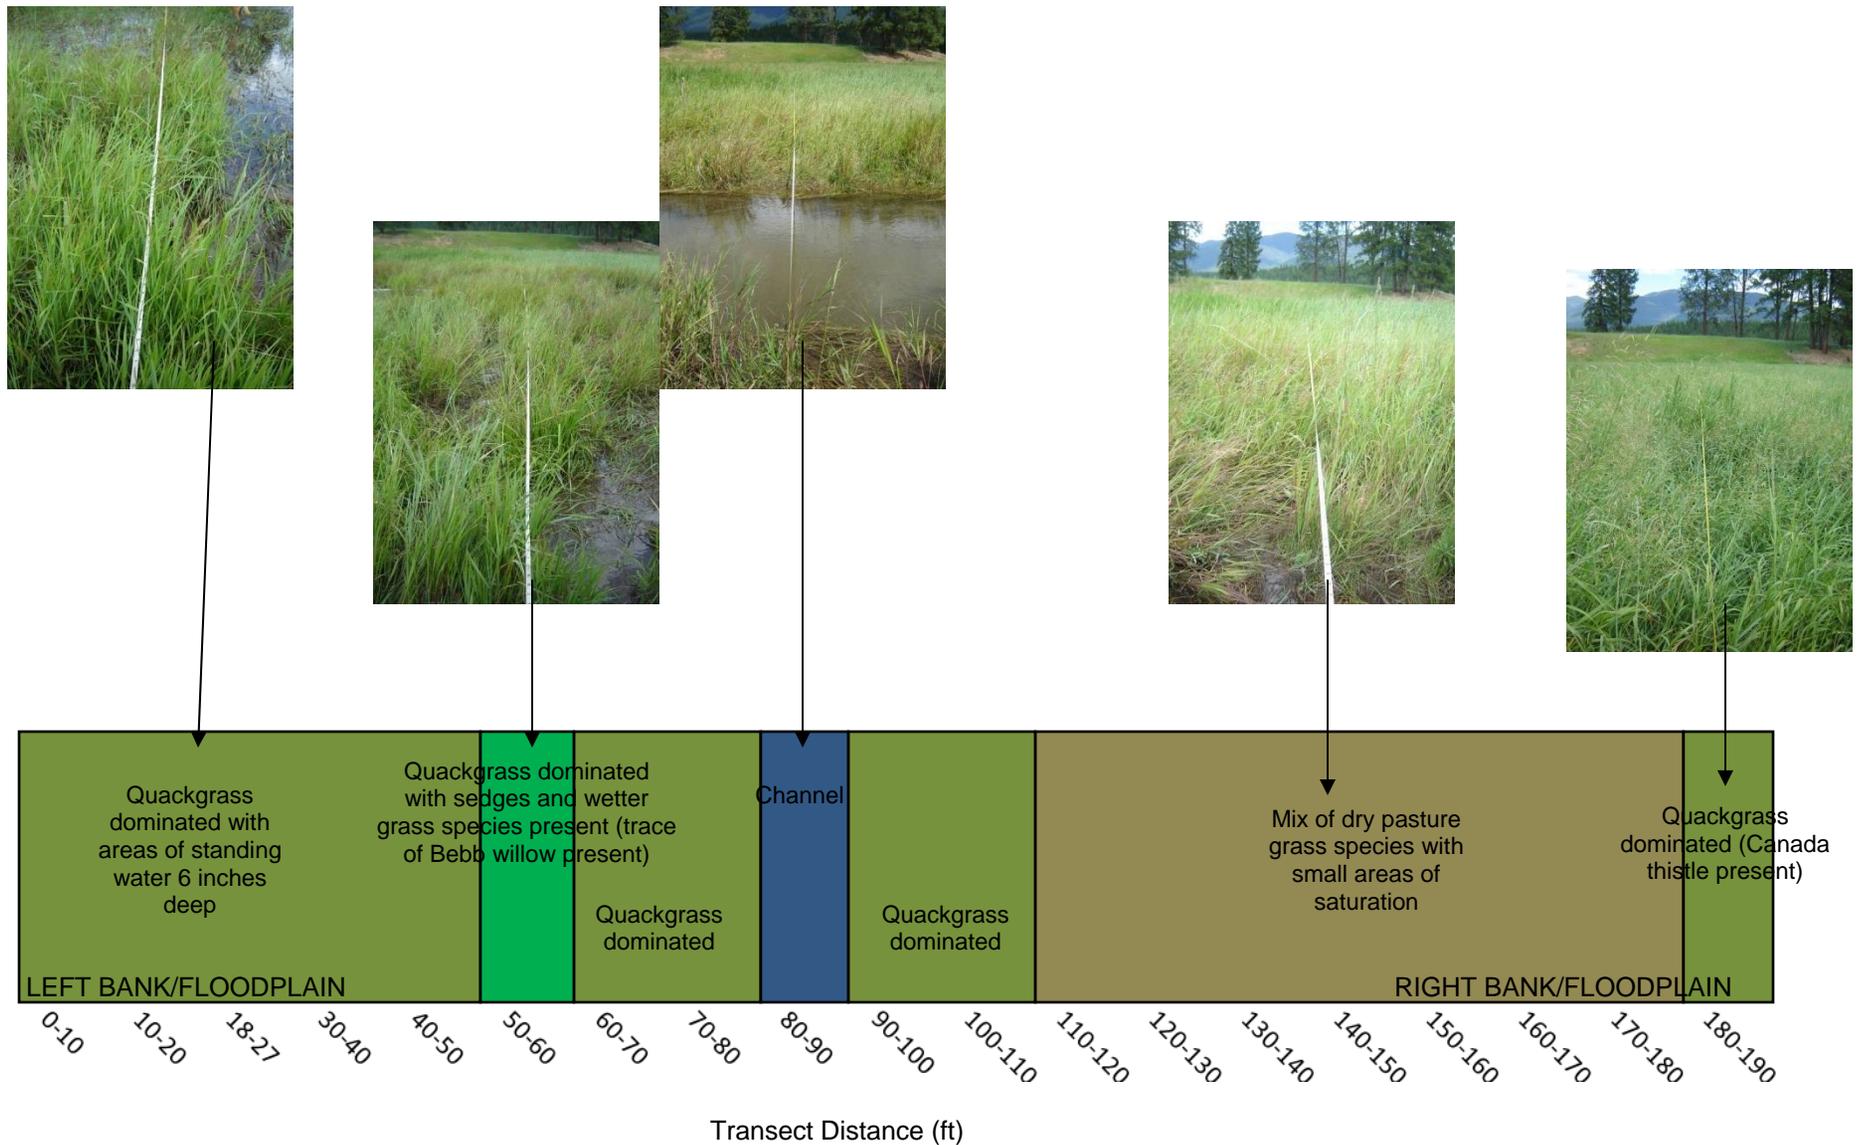
Figure 11. Display of Large Woody Debris Transect 1 showing major vegetation breaks recorded along the transect.

The results of large woody debris structure monitoring transects are provided in Tables A-5 through A-7 in Appendix A. Figures 11 through 13 display the major transitions in plant communities observed along the three transects. All transects were dominated by non-native pasture grasses. Transects one and two had inclusions of wetter species such as sedges, mannagrass (*Glyceria* spp.) and spikerush (*Eleocharis* spp.).

Water depth along Transect 1 ranged from 0 to 6 inches. Water depth along transect 2 ranged from 0 to 6 inches. No standing water or saturated surfaces were present along transect 3.
