GEUM ENVIRONMENTAL CONSULTING, INC.

December 22, 2015

Re: Therriault Creek 2015 Maintenance and Monitoring Summary

2015 Site Observations

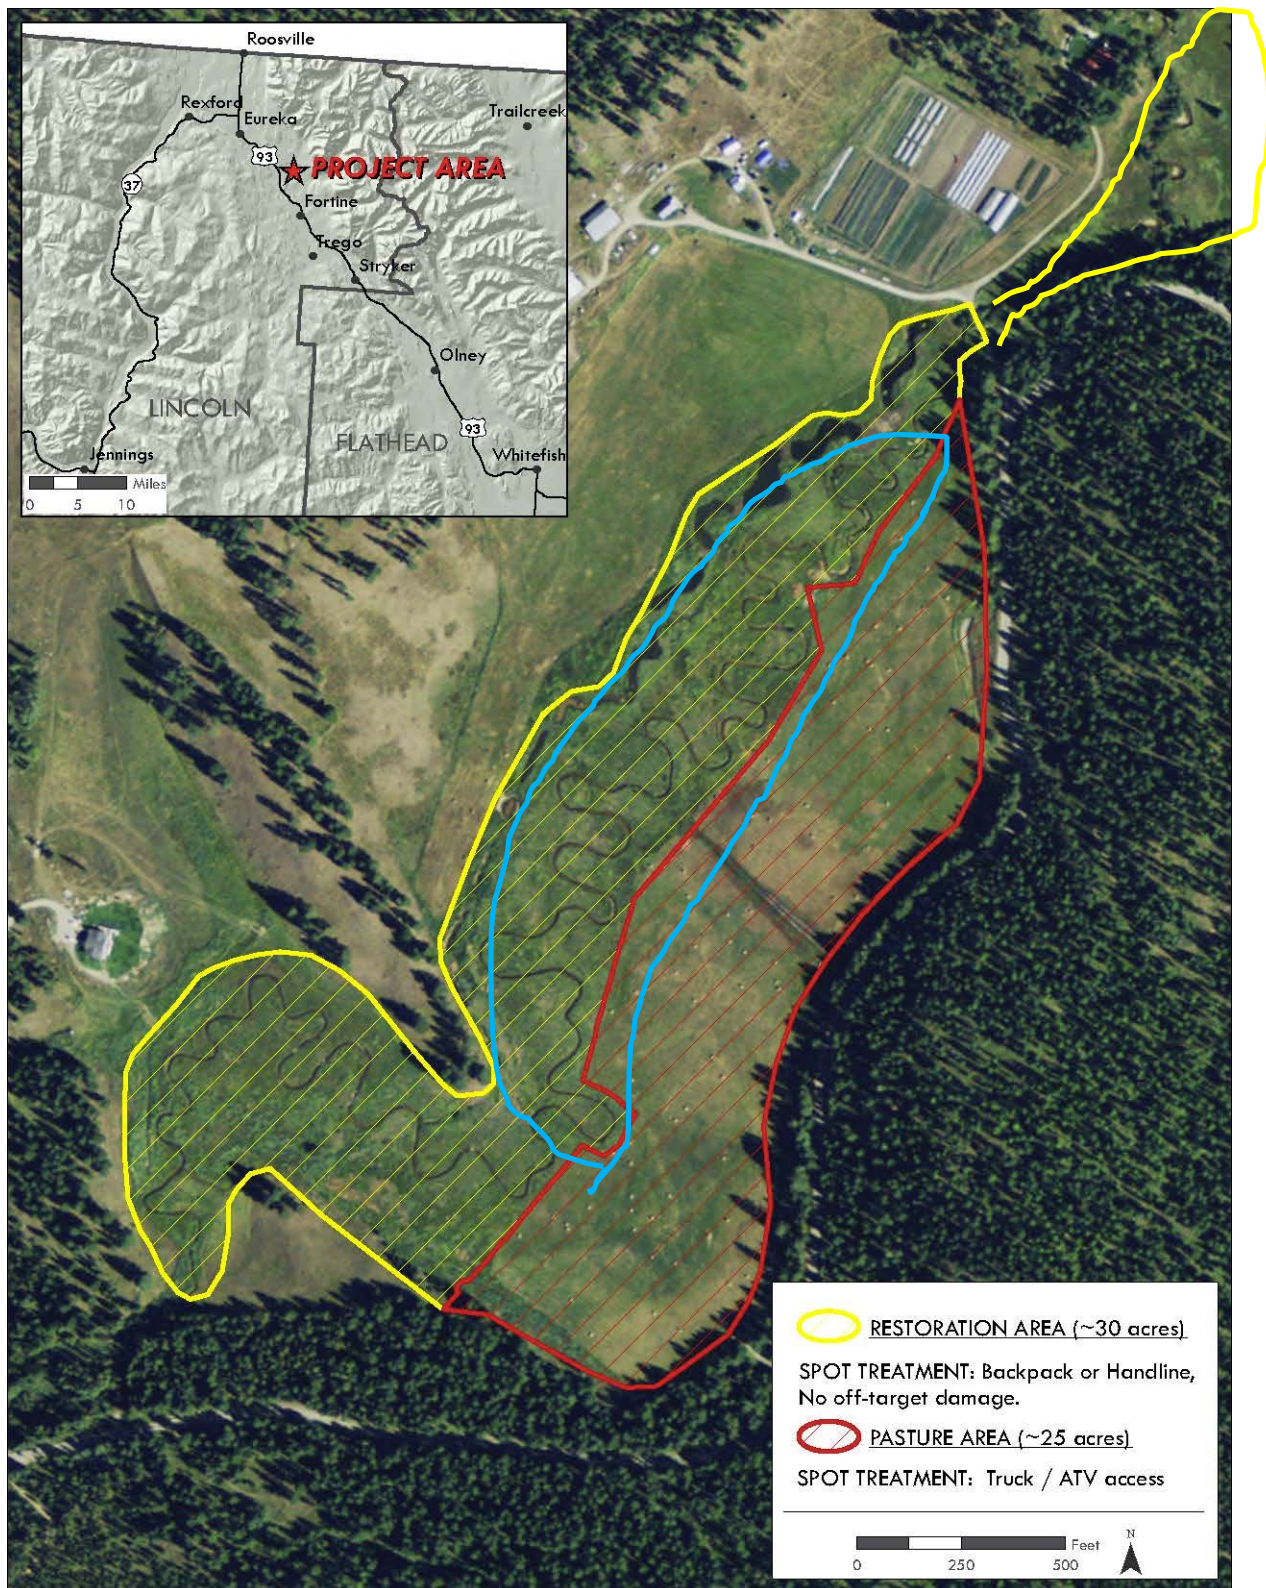
Attachment C: Areas for 2015 Weed Treatment. Blue circled area indicates the portion of the Restoration Area where isolated clumps of reed canarygrass should be treated.
