Therriault Creek Riparian Revegetation 2013 Monitoring and Maintenance Report

Contract #140025

Geum Environmental Consulting, Inc.
307 State Street
Hamilton, MT 59840

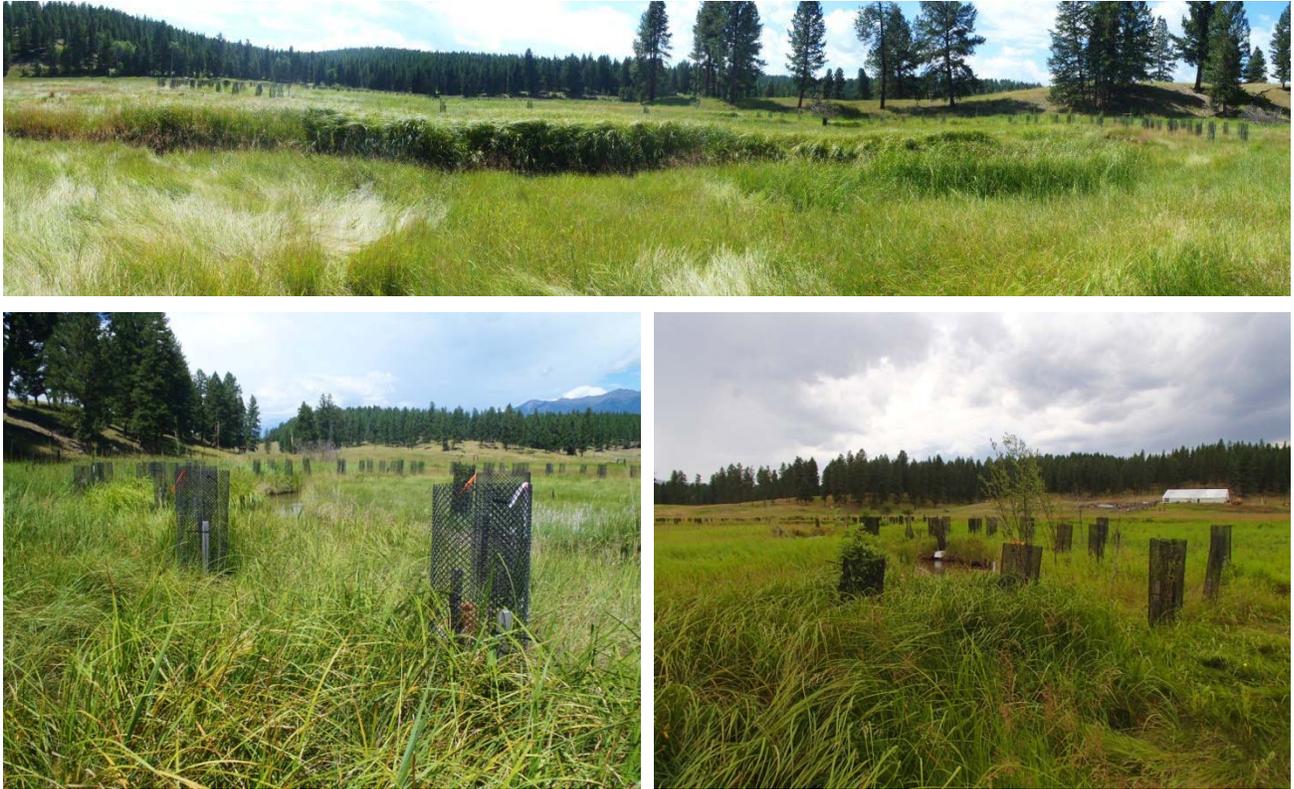
The herbaceous vegetation in both Phases I and III remains a mix of pasture grasses, sedges, rushes, native grasses, and native forbs. The cover of native, wetter species continues to increase in both Phases I and III. The lower end of Phase I and upstream portion of Phase III support large areas dominated by sedges (Figure 8).

Figure 8. Herbaceous vegetation in both Phase I and III continues to shift to wetter native species such as the various sedges seen in the photos above.

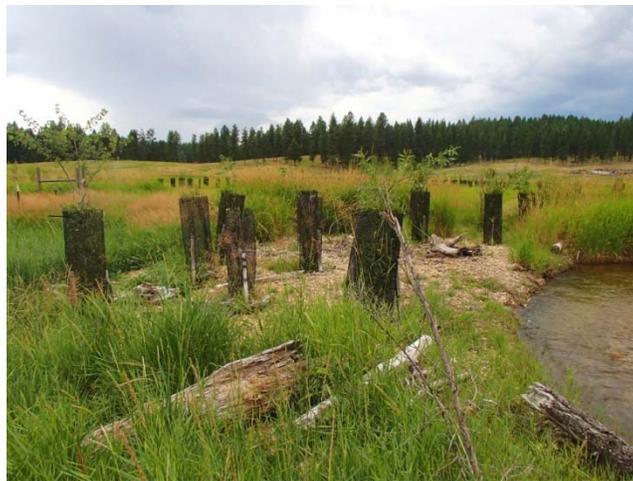
Planted Solarization Plot 2 is located on an outside meander bend. In spring 2012, gravels deposited in the channel at this location resulting in most of the streamflow leaving the channel and re-entering approximately 1,500 feet further downstream. This resulted in deposition of gravels and fine sediments in Planted Solarization Plot 2. To eliminate the risk of a channel avulsion occurring at this location the accumulated gravels were removed and design channel dimensions restored through this section of channel in winter 2013. Based on observations made in August 2013, the sand and gravels deposited in Solarization Plot 2 have been colonized by shrubs, grasses and forbs (Figure 10 and Figure 11).

Figure 10. Overview of planted solarization plot 2. Shrubs, grasses and forbs have begun to colonize the gravel surface.

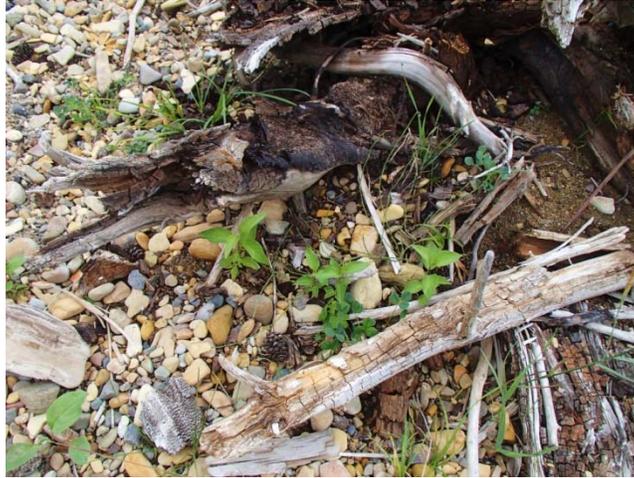
Figure 11. Dogwood colonizing the gravel in Planted Solarization Plot 2.

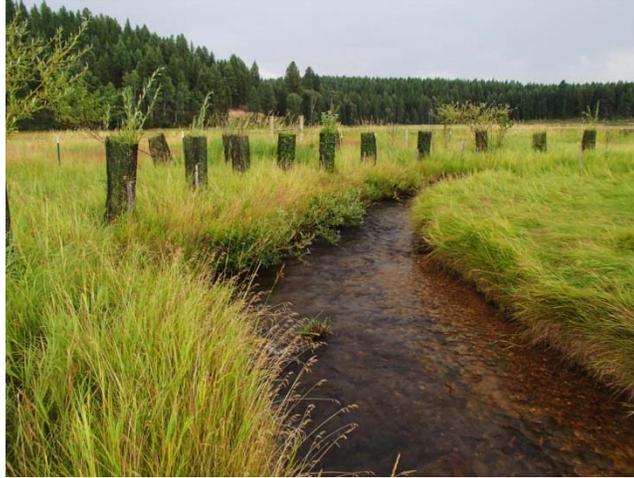
Figure 21. Coir log installation site showing dense willow growth along the left bank.

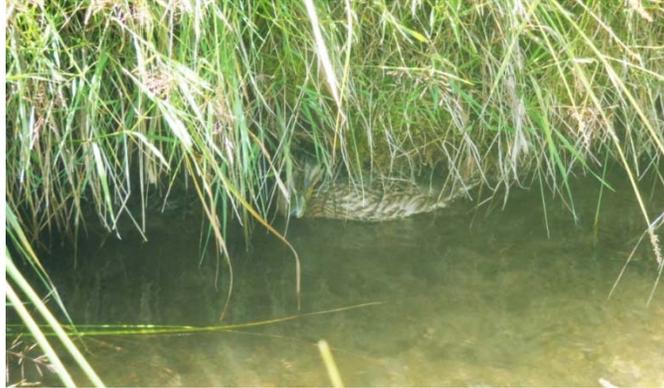
Figure 24. Duck using an overhanging bank and vegetation for cover within Therriault Creek.

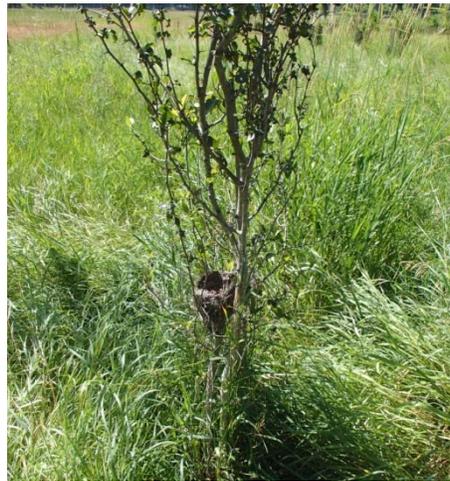
Figure 25. Songbird nest in a planted hawthorne that has been released from its browse protector.
