TERRIAULT CREEK RESTORATION PROJECT

FIVE-YEAR VEGETATION MANAGEMENT PLAN

JANUARY 2019

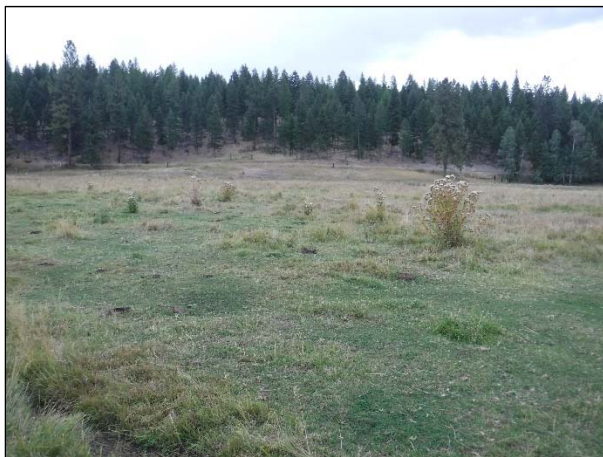
Figure 3. Heavy grazing in hayfield east of Site.

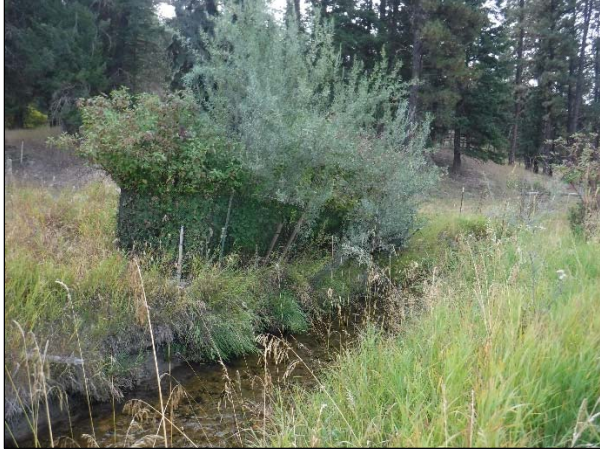
Figure 4. Residual shrubs outside of riparian protection fence near upstream end of Site.

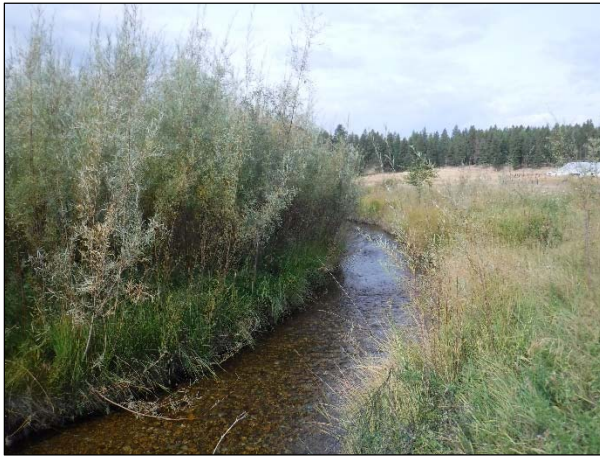
Figure 5. Left photo shows dense sandbar willow cover on well-connected inside meander bend near upstream end of Site. Right photo shows sandbar willow expansion from residual protected shrubs just downstream of where the channel turns northwest and leaves the riparian protection fence. This is one of the few downstream areas where willows have expanded naturally.

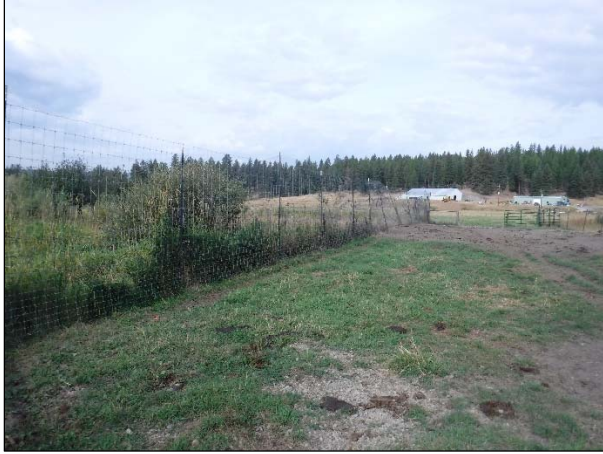
In addition, there was evidence that cattle also entered inside the riparian protection fence in 2018. This occurred right below the water gap/stream crossing. Where cattle accessed the planting area, grass had been grazed, soil was pugged, and manure was present. No damage to streambanks was observed. In response to cattle access, it appears the landowner installed metal panels to replace the net fencing where the cows had accessed the site (Figure 10). This was the first year cattle grazing was observed at the Site. In the past, only a few horses utilized the pasture west of the Site and water gap and little to no livestock use occurred in the hayfield east of the Site.

Figure 10. Wire paneling installed by landowner at upstream end of riparian protection fence. In 2018, this livestock crossing and hayfield east of the Site had much more use by livestock than in the past

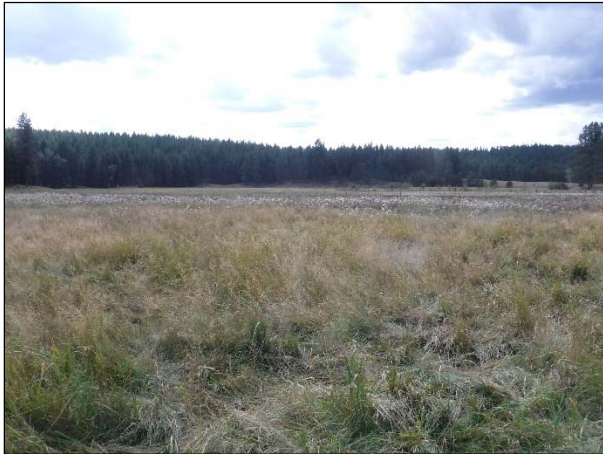
Cover and density of Canada thistle has increased greatly at the site since the last herbicide application in 2015. Within the Site itself, cover of Canada thistle was low in 2015, with few to no mature plants remaining. The hayfield east of the Site was treated several times, but also missed in some years allowing the Canada thistle infestations in this area to persist. These infestations have never been controlled completely and were likely a major contributor to reinfestation of the Site. Dewatering of this area combined with heavy grazing has created significant disturbance, allowing Canada thistle infestations to expand and become denser (Figure 11). Attachment B provides maps of weed distribution and density in 2009 and a map of weed distribution and density observed in 2018. These maps show the significant increase in Canada thistle cover at the site between 2015 and 2018. There are several large, dense infestations of Canada thistle at the Site (Figure 12 and Figure 13). However, there are some large areas on the west side of the channel that still have low densities of Canada thistle. Dense patches mostly occur along the channel, expand out from the edges of the channel, or expand towards the channel from the dense infestations in the hayfield to the east of channel. Canada thistle is well distributed within planting units, within natural willow expansion areas, and throughout areas consisting of dense sedges and willows. These areas will be difficult to treat without damaging desirable vegetation.

Figure 11. Dense infestation of Canada thistle in hayfield on east side of Site (thistle infestation is white band in middle of photo).

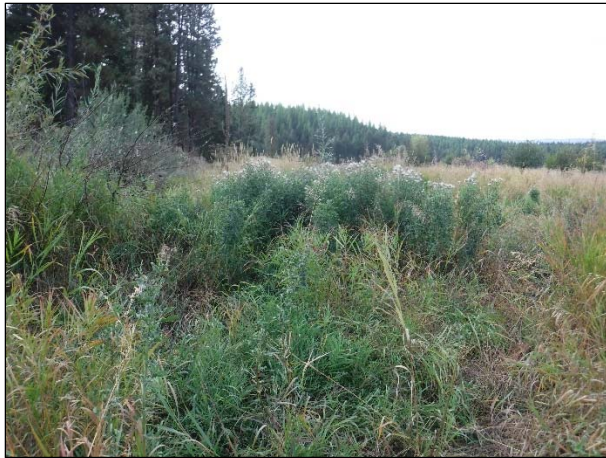
Figure 12. Canada thistle infestations in the upstream portion of Site.

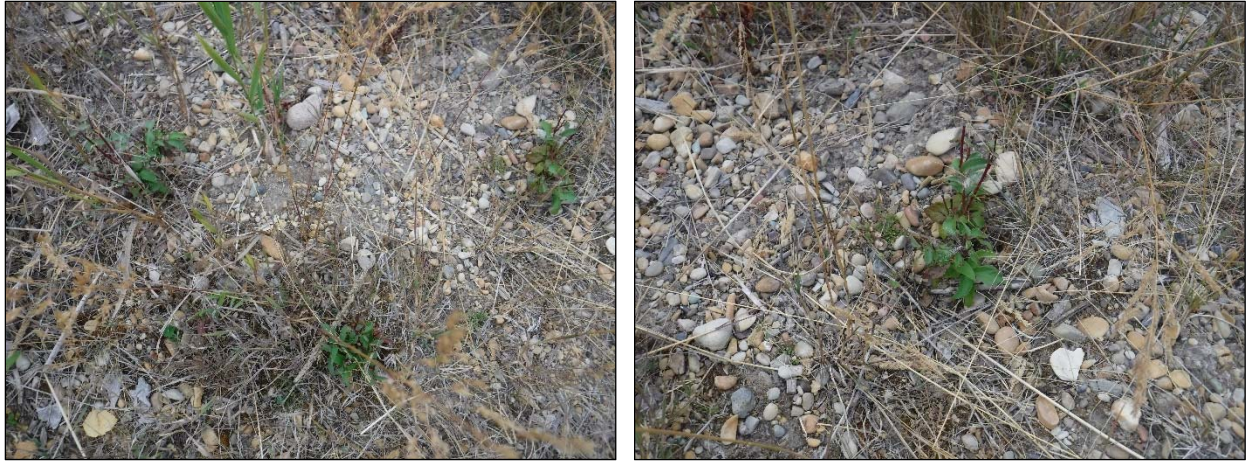
Figure 15. Red-osier dogwood seedlings on gravel deposition from 2012 flood.

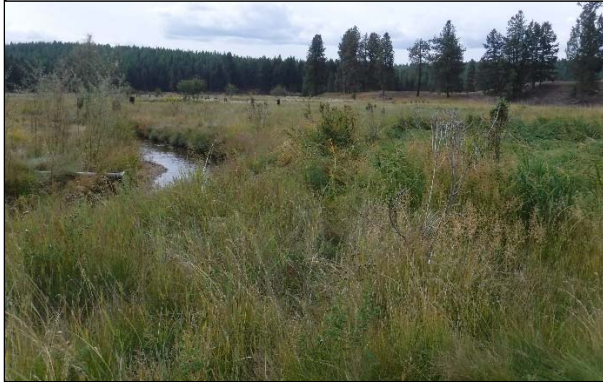
PLANTING UNIT 1 on right bank with heavy browse and some residual shrub expansion on left bank

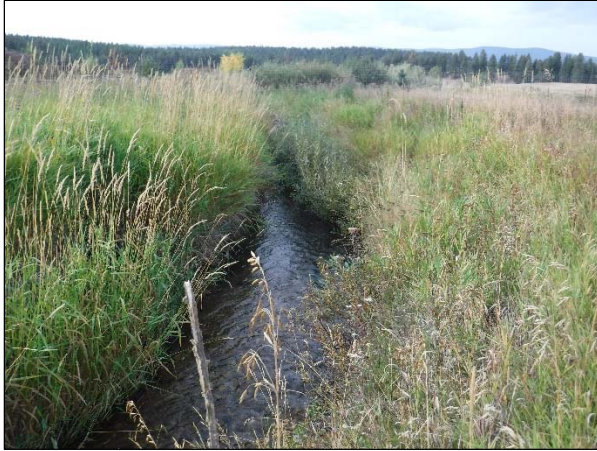
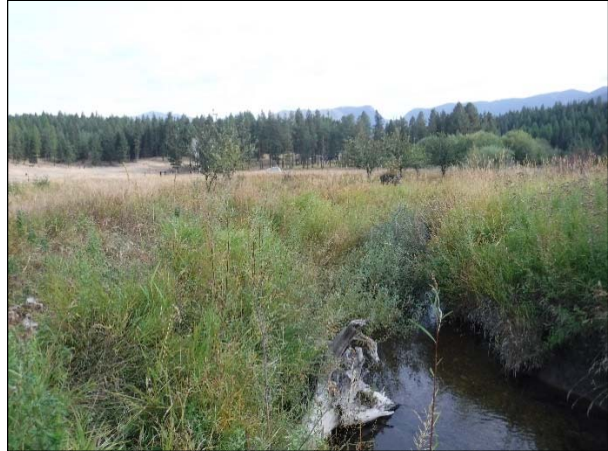
SOIL LIFT 1 – left photo is looking downstream, right photo is looking upstream
This soil lift is located outside of the riparian protection fence and although willow cover is dense, willow height is greatly suppressed. The streambank across from the soil lift is dense reed canarygrass.

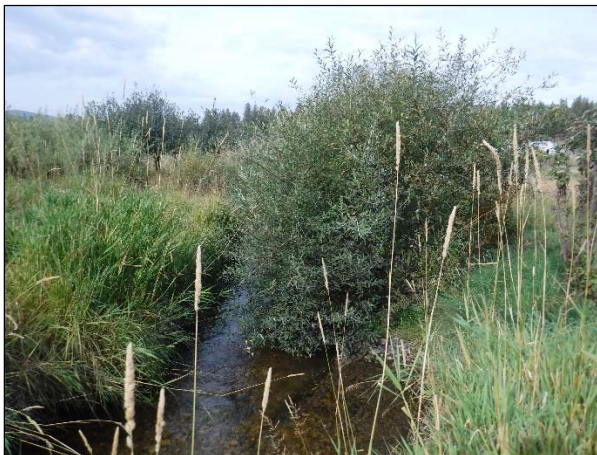
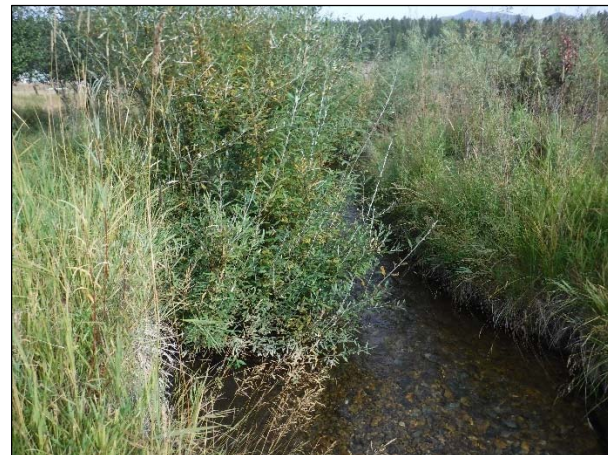
SOIL LIFT 2 – left photo is looking downstream, right photo is looking upstream
This soil lift is located inside of the riparian protection fence and willow cover and height has been protected from browse for four growing seasons. Willows have grown between four and five feet since being released and produce significant amounts of seed each year. Cattle trespass and openings in the fence resulted in some browse of the willows, but only around the edges of the structure. The streambank across from the soil lift is dense reed canarygrass. No willow expansion into the floodplain behind the structure has occurred due to the dense cover of pasture grasses.

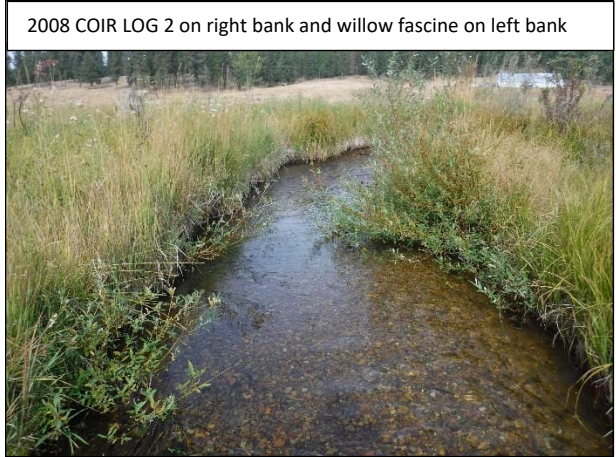
2008 COIR LOG 2 on right bank and willow fascine on left bank

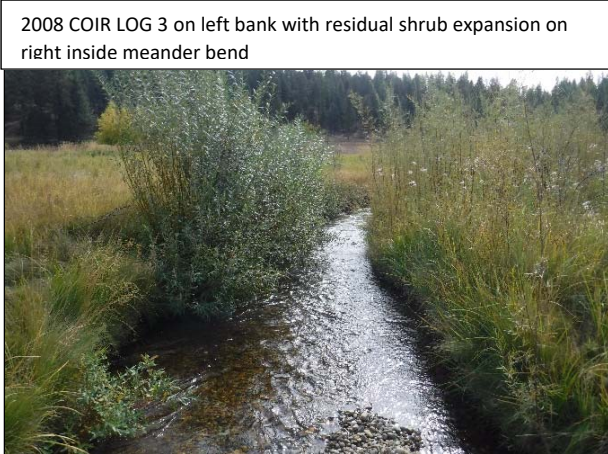
2008 COIR LOG 3 on left bank with residual shrub expansion on right inside meander bend

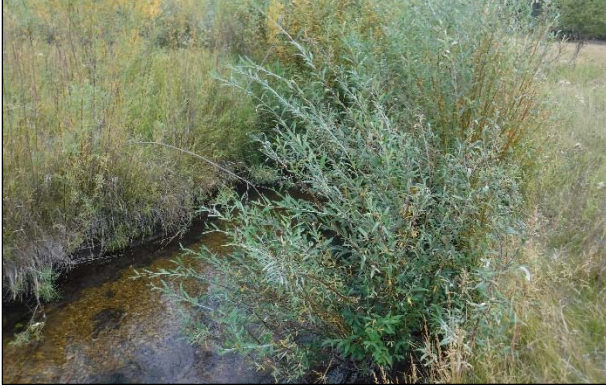
2008 COIR LOG 5 on right bank with residual shrub expansion on left inside meander bend

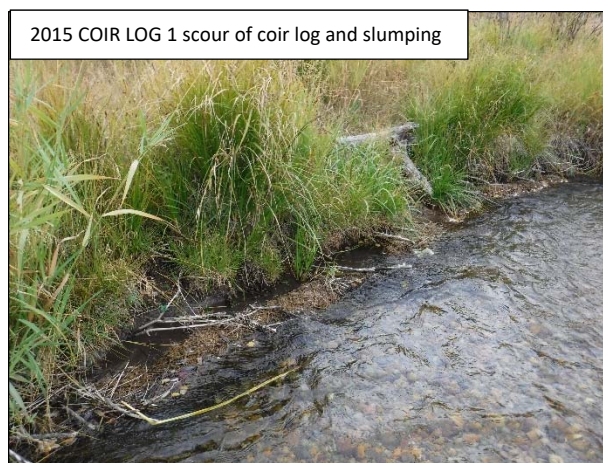
2015 COIR LOG 1 scour of coir log and slumping

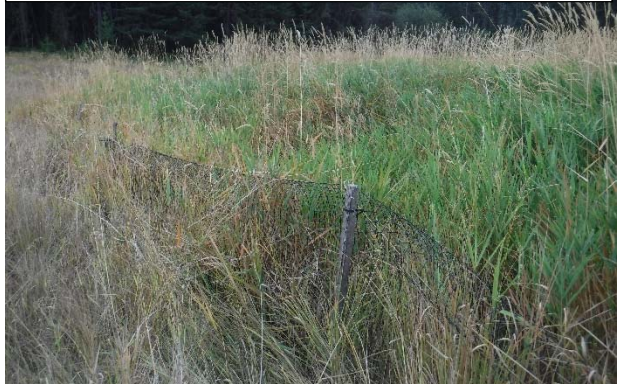
Plot 2 has been recolonized by reed canarygrass. No living willow cuttings were found.
